First Sergeant Inspection Services, LLC

Property Inspection Report

Property address: **123 Steele LN**
Lacey, WA 98501

Inspection date: **Saturday, February 24, 2018**

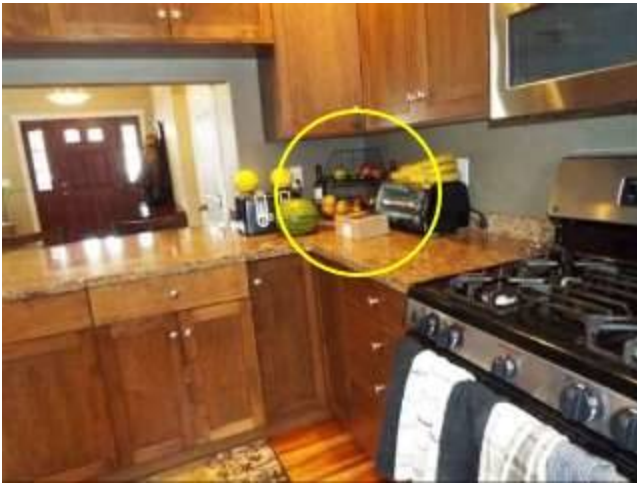
Photo 1-1

Some areas and items at this house was obscured by furniture. This often includes but is not limited to walls, floors, windows, inside and under cabinets, under sinks, on counter tops, in closets, behind window coverings, under rugs or carpets, and under or behind furniture. Areas around the exterior, under the structure, in the garage and in the attic may also be obscured by stored items. The inspector in general does not move personal belongings, furnishings, carpets or appliances. When furnishings, stored items or debris are present, all areas or items that are obscured, concealed or not readily accessible are excluded from the inspection. The client should be aware that when furnishings, stored items or debris are eventually moved, damage or problems that were not noted during the inspection may be found.
