First Sergeant Inspection Services, LLC

Property Inspection Report

Property address: **123 Steele LN
Lacey, WA 98501**

Inspection date: **Wednesday, February 28, 2018**

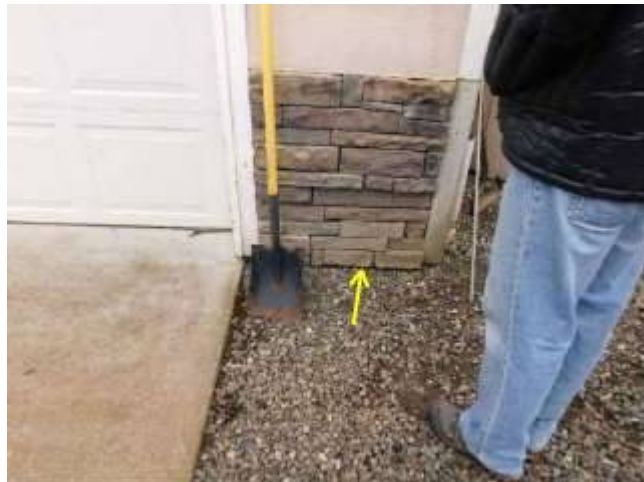
**Photo 10-2**

One of the stones is loose at the base and they were not installed as per manufactures specifications. There should be a gap at the base, some kind of a drip screed. Moisture/condensation will occur behind the stones in the water needs to escape at the base. I recommend reattaching the loose stone, and monitor.

Soil was in contact with or less than 4 inches from brick, stone or faux stone veneer in front of the house around garage door. For most residential installations of this type of veneer, this is a condition conducive to attracting wood-destroying organisms. Weep holes may be covered. Condensed water behind the veneer may not be able to escape, and moisture can accumulate in the wood structure behind. I recommend grading and/or removing soil as necessary to maintain a 4-inch clearance.
