First Sergeant Inspection Services, LLC

Property Inspection Report

Property address: **123 Steele LN**
Lacey, WA 98501

Inspection date: **Thursday, March 1, 2018**

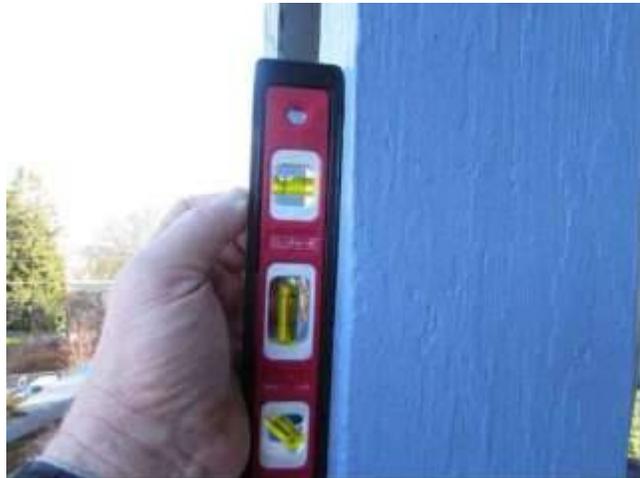
Photo 13-2

The enclosed balcony at the rear of the house was not properly attached due to substandard bracing, lack of diagonal bracing, and lack of attachment to the main building. This is a safety hazard since severe movement may cause the cover to collapse. A qualified contractor should repair as necessary.

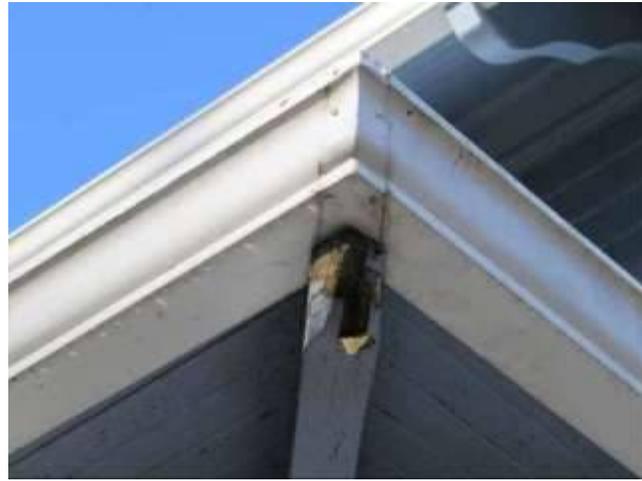
**Photo 14-2**

Fungal rot was found at rafter tails. Conductive conditions for rot should be corrected (e.g. wood-soil contact, reverse perimeter slope). I recommend that a qualified contractor repair as necessary. All rotten wood should be replaced.

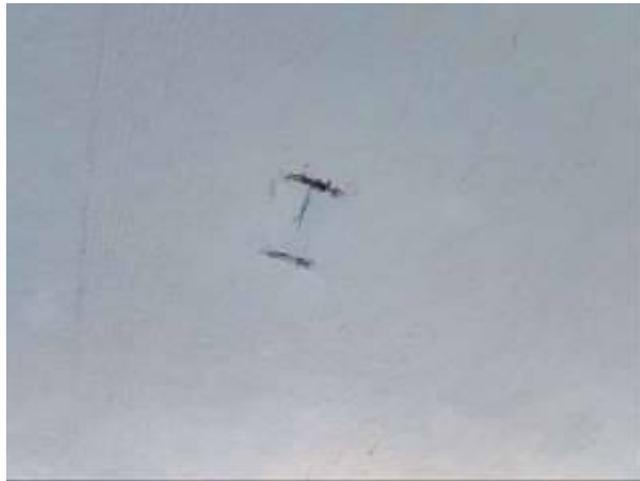
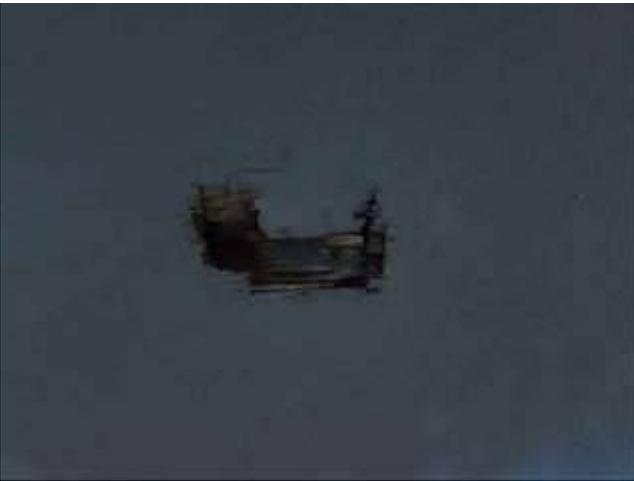
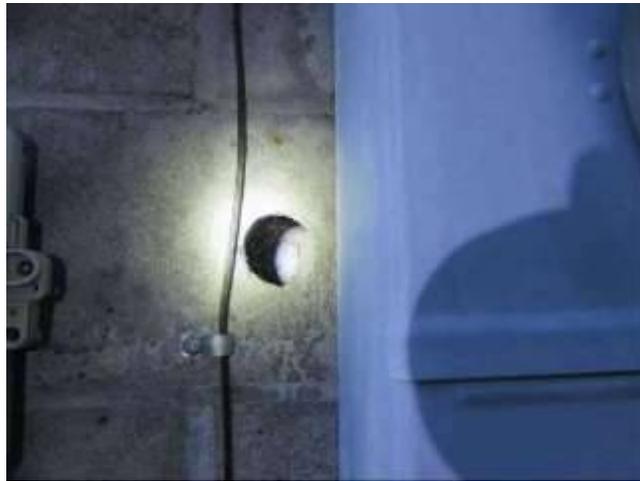
A few holes or gaps were found in siding or trim. Vermin, insects or water may enter the structure. I recommend that a qualified person repair as necessary.

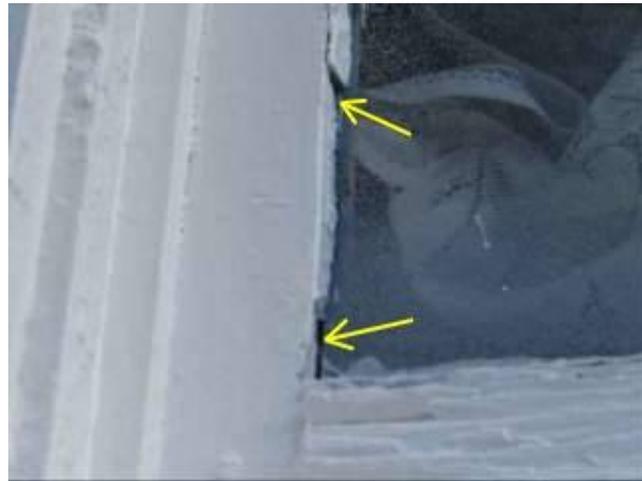
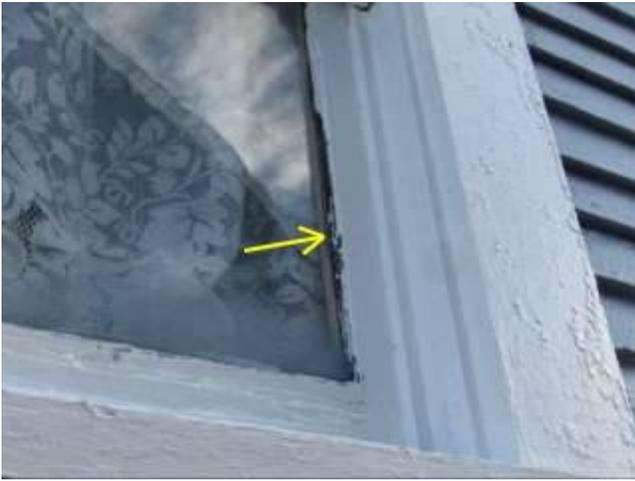
23) 🗝️ Window glazing putty is deteriorating on various windows and windows may be in need of some repair. This is not uncommon with the age of the home as the glazing dry out it become brittle and cracks and sills, stiles and sashes will need some repair. The client will have to evaluate repair versus replacement in some of these windows. I recommend having a qualified person or contractor evaluate and repair as necessary.

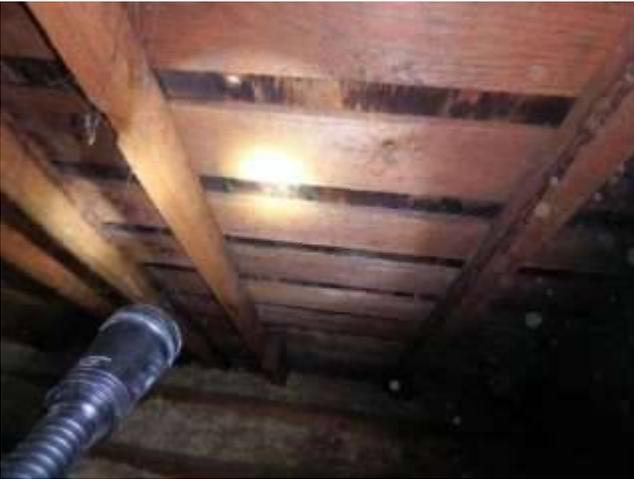
Photo 32-1

32) **i** The roof structure below the shingles or shakes was "skip sheathed," where boards (typically 1x4 inches or 1x6 inches) with wide gaps between them were installed below the shingles, instead of plywood or oriented strand board (OSB) sheathing. Skip sheathing is commonly done with wood shake or shingle surfaces. The client should be aware that if a new composition shingle roof is installed, all existing layers of roofing materials will need to be removed, and continuous sheathing such as plywood or OSB will need to be installed before installing the shingles. This is a significant additional expense.

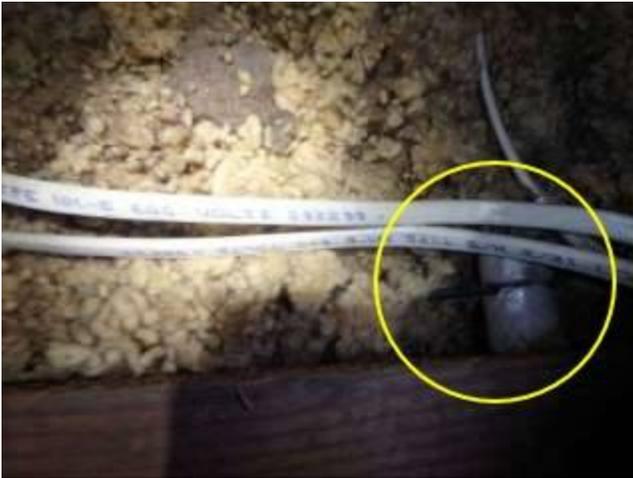
Photo 37-1

Consult with the property owner about the insulation being in contact with the wiring. If no records are available that verify an evaluation by a licensed electrician prior to the insulation's installation, insulation should be moved or removed as necessary, and a qualified electrician should evaluate the wiring and make repairs if necessary. If the local municipality

doesn't allow it, then a qualified contractor and/or electrician should repair as necessary. For example, by removing insulation or replacing knob and tube wiring with modern wiring.

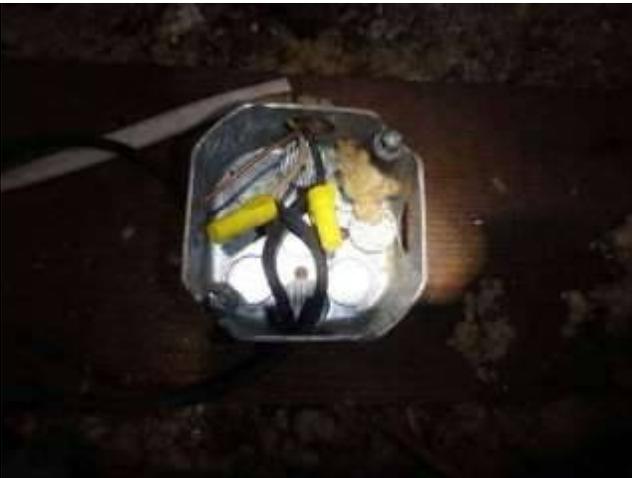
Photo 43-1

Cover plate for junction box in attic was missing. These plates are intended to contain fire and prevent electrical shocks. I recommend that a qualified person install cover plates where necessary.

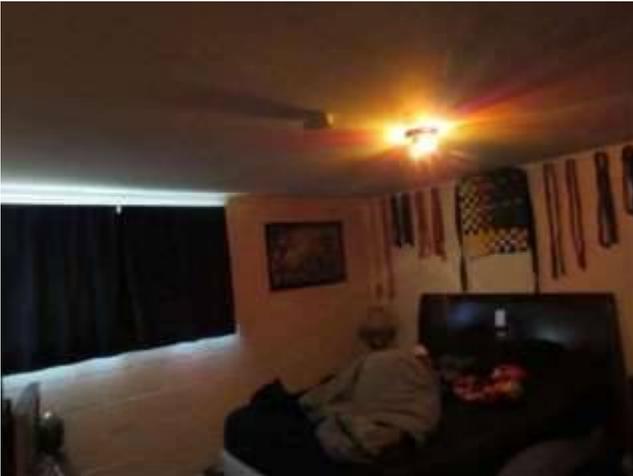
Photo 47-1

Some globes or covers for light fixtures were missing. I recommend replacing as necessary to avoid exposed bulbs. With closet lighting or where flammable stored objects are near light fixtures, missing or broken covers can be a fire hazard.

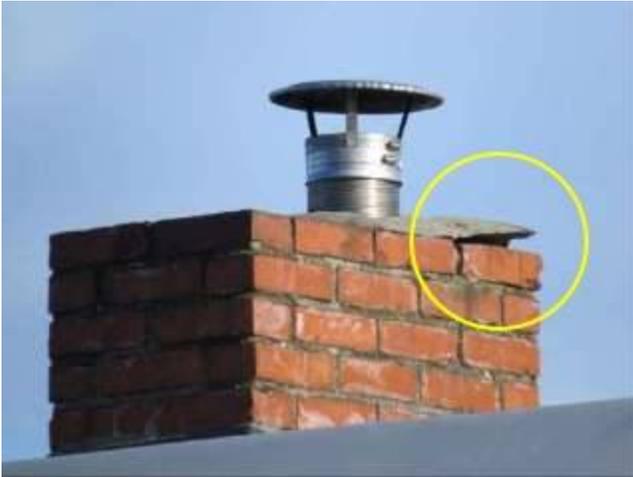
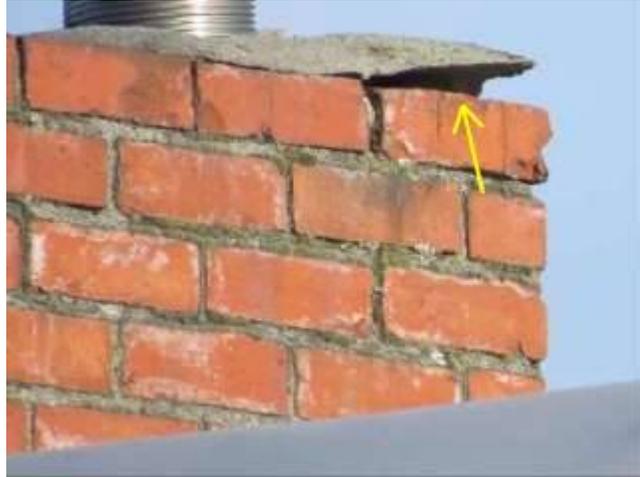
- Be constructed using either pre-cast concrete slabs, cast-in-place steel reinforced concrete, solid stone, or metal
- Be sloped down from the flue a minimum of 3 inches of fall per foot of run
- Extend a minimum of 2 1/2 inches beyond the face of the chimney on all sides
- Not directly contact the flue liner (if installed), with the gap filled with flexible caulk
- Have flashing installed between the bottom of the crown and the top of the brick chimney

I recommend that a qualified contractor repair or replace crowns as necessary, and per standard building practices.

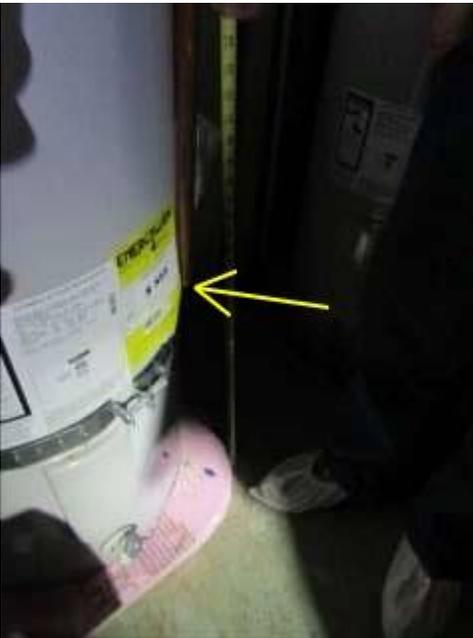
Photo 55-1

The temperature-pressure relief valve drain line was too short. This is a potential safety hazard that contributes to the risk of a scalding burn. I recommend that a qualified plumber repair per standard building practices. For example, by extending the drain line to within 6 inches of the floor, or routing it to drain outside. For more information, visit:

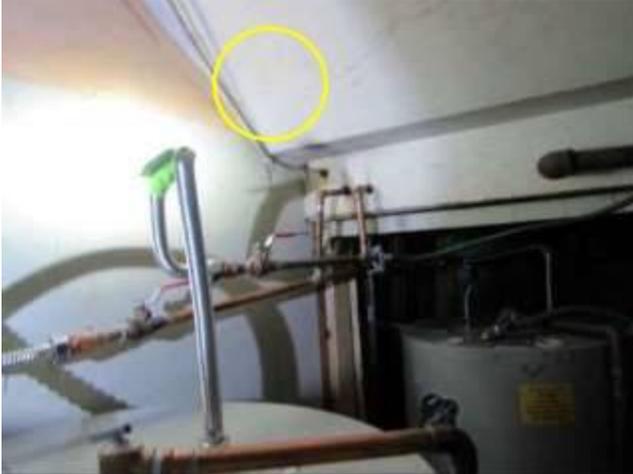
Photo 56-1

- Leaking faucets
- "Weeping" of water through the water heater temperature-pressure relief (TPR) valve
- Noisy water hammer in the pipes

Expansion tanks can eliminate these problems by giving water a place to go when thermal expansion occurs. When a water heating cycle ends, or when any fixture is opened within the system, the impact of thermal expansion is reduced, and water drains out of the expansion tank back into the system. I recommend that a qualified plumber install an expansion tank per standard building practices.

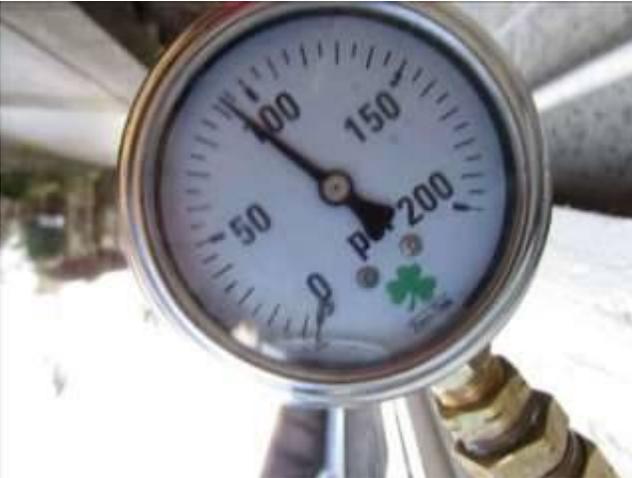
Photo 58-1

58) 🔧🔍 The water supply pressure was greater than 80 pounds per square inch (PSI). Pressures above 80 PSI may void warranties for some appliances such as water heaters or washing machines. Flexible supply lines to washing machines are likely to burst with higher pressures. 40-80 PSI is considered the normal range for water pressure in a home, and most plumbers suggest 50-60 PSI. Typically, the pressure cannot be regulated at the water meter. I recommend that a qualified plumber evaluate and make modifications to reduce the pressure to below 80 PSI. Installing a pressure reducing valve on the main service pipe is a common solution to this problem. If one exists, then it should be adjusted, repaired or replaced as necessary to maintain lower pressures. Note that installing a pressure reducing valve creates a "closed system," which may require installing an expansion tank at the water heater if one is not already installed.

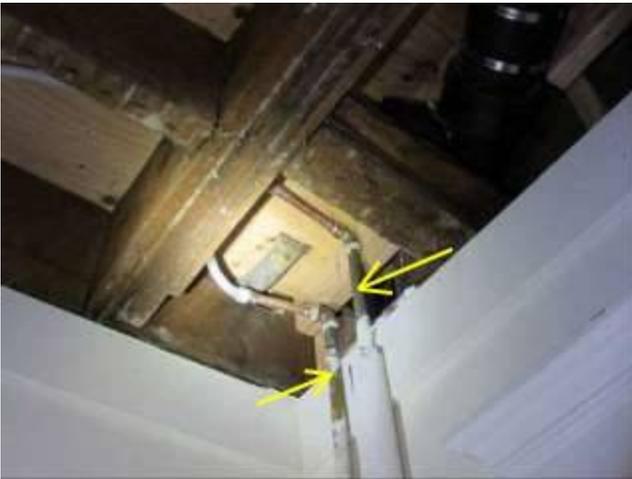
Photo 59-1

59) 🔧🏠 Galvanized steel water supply pipes were found. Based on the age of this structure and the 40-60 year useful life of this piping, it will likely need replacing in the future. Leaks can develop, flooding and/or water damage may occur, flow can be restricted due to scale accumulating inside the piping, and water may be rusty. Note that it is beyond the scope of this inspection to determine what percentage of the piping is older, galvanized steel, as much of it is concealed in wall, floor and/or ceiling cavities. I recommend the following:

- That a qualified plumber evaluate to better understand or estimate the remaining life
- Consulting with a qualified plumber about replacement options and costs
- Monitor these pipes for leaks and decreased flow in the future

- Consider replacing old, galvanized steel piping proactively

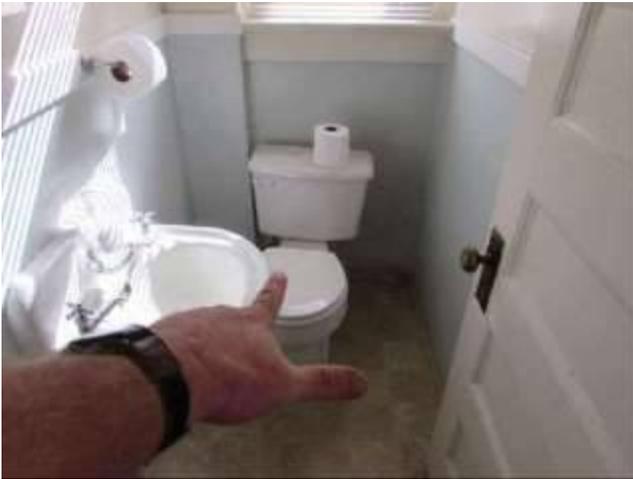
Photo 68-1

The main floor bath room toilet was loose where it attached to the floor. Leaks can occur. Flooring, the sub-floor or areas below may get damaged. Sewer gases can enter living spaces. I recommend that a qualified contractor remove the toilet(s) for further evaluation and repair if necessary. A new wax ring should be installed and toilet(s) should be securely anchored to the floor to prevent movement and leaking.

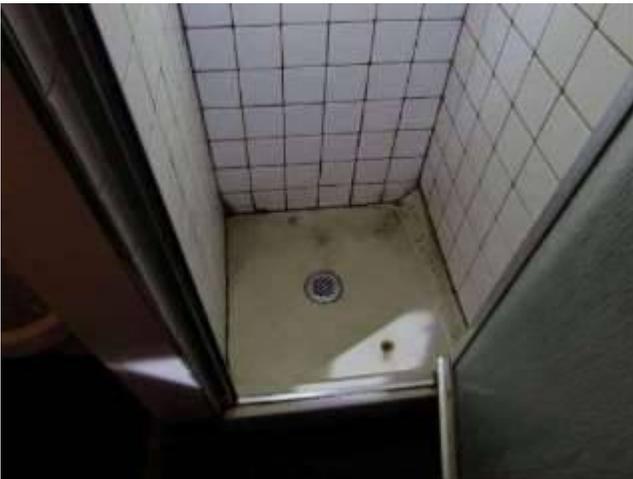
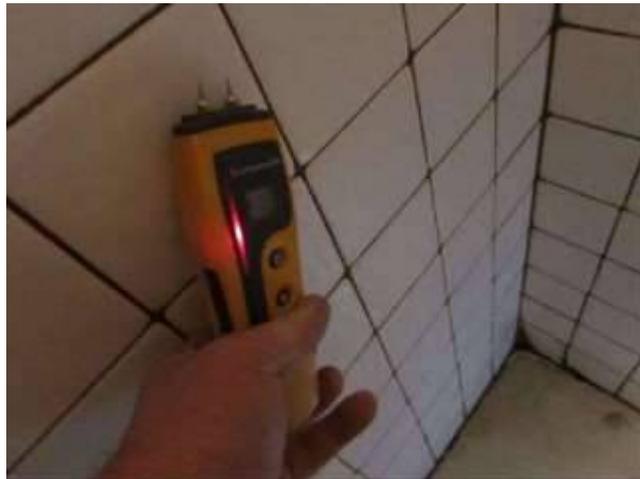
The lower unit shower tile was deteriorated (e.g. loose or cracked tiles, missing grout) or substandard. Water can damage the wall structure as a result. I recommend that a qualified contractor repair as necessary.

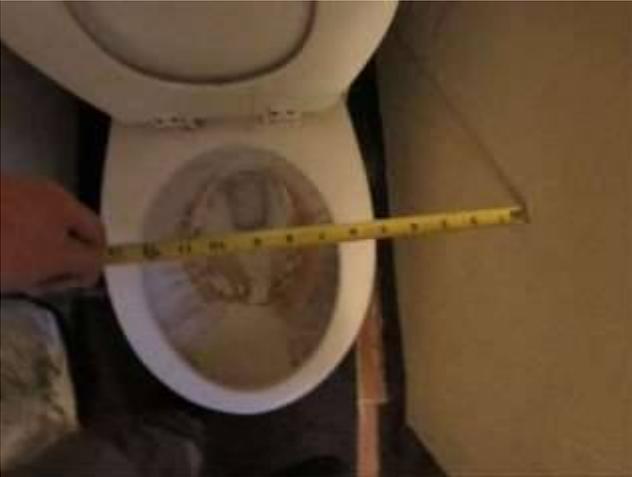
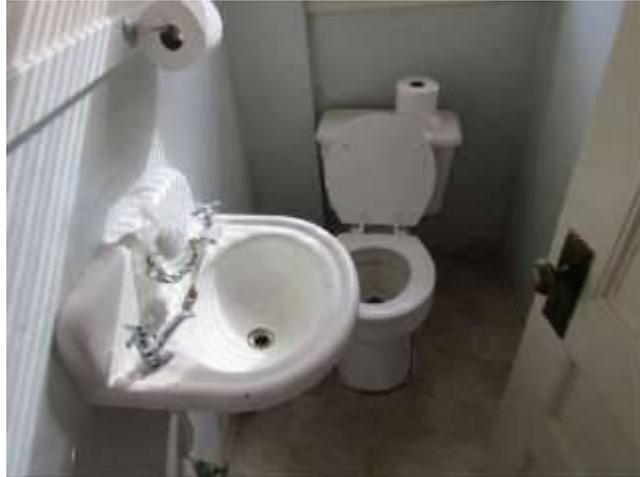
71) Both toilets in the lower unit and main floor did not have adequate spacing. Required to have 15" radius of space from center of toilet bowl. Recommend have a contractor evaluate and repair as necessary.

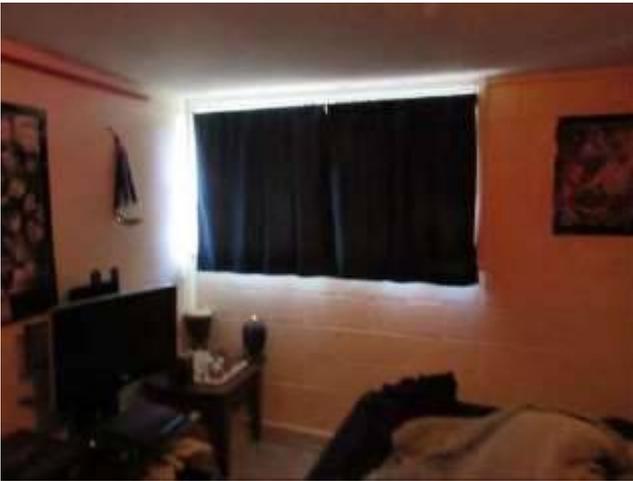
Photo 72-1

The lower unit bedroom had windows that were too high above the floor. Unless a bedroom has an exterior entry door, at least one window requires adequate egress in the event of a fire or emergency to allow escape or to allow access by emergency personnel. The base of openings for egress windows should be a maximum of 44 inches above the floor. At a minimum, keep a chair or something that serves as a ladder below the window at all times. If concerned, have a qualified contractor repair or make modifications per standard building practices. For more information, visit: <http://www.reporthost.com/?EGRESS>

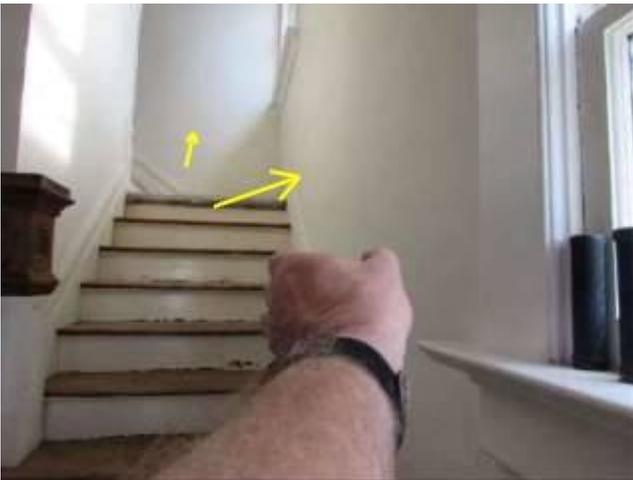
Photo 73-1

Missing handrails from main floor to second floor and posed a fall hazard. Handrails should be 1 1/4 - 2 inches in diameter if round, or 2 5/8 inches or less in width if flat. I recommend that a qualified person install graspable handrails or modify existing handrails per standard building practices.

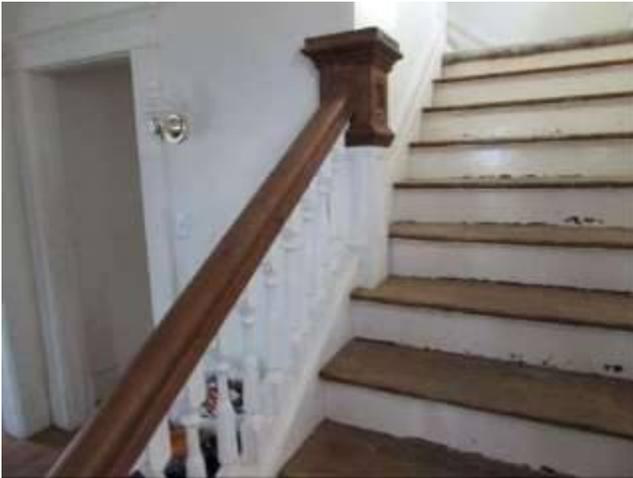
Photo 74-1

Guardrails were too low at main floor with drop-offs higher than 30 inches. This poses a fall hazard. Guardrails

should be at least 36 inches in height. I recommend that a qualified contractor replace or repair guardrails per standard building practices.

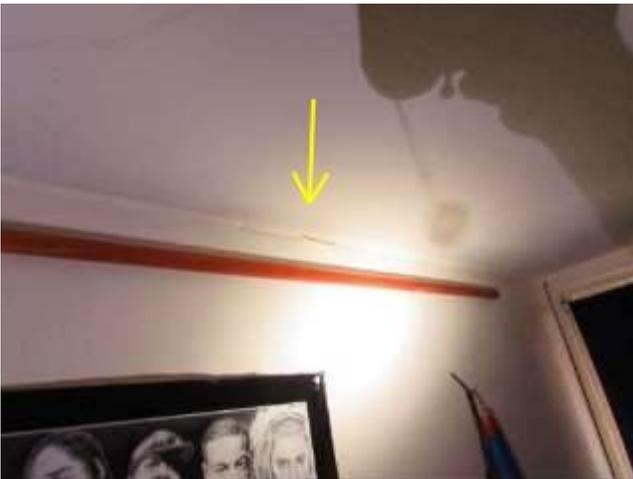
Photo 75-1

75) 🔧🔍 This structure appears to have settled or was leaning significantly based on the presence of cracks in ceilings. I recommend that a qualified contractor and/or engineer evaluate further. Significant repairs may be needed. If so, a qualified contractor should make repairs.

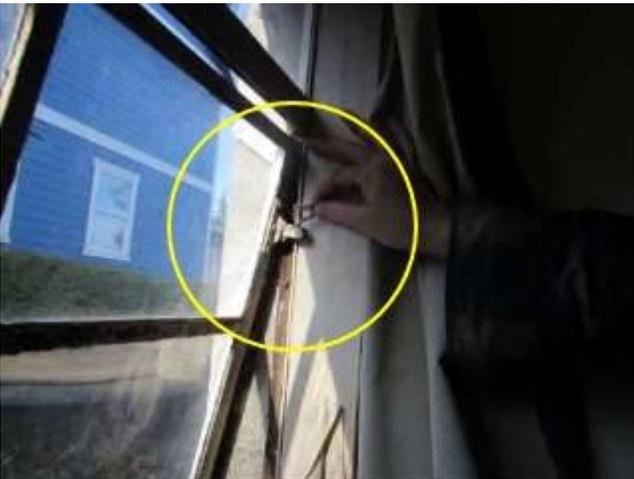
Photo 76-1

Some windows that were designed to open and close were difficult to open and close. I recommend that a qualified person repair windows as necessary so they open and close easily.

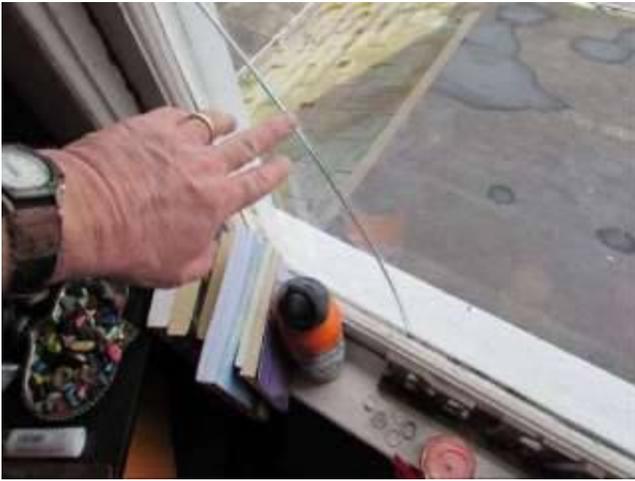
Photo 77-1

Glass in some windows were cracked. I recommend that a qualified contractor replace glass where necessary.

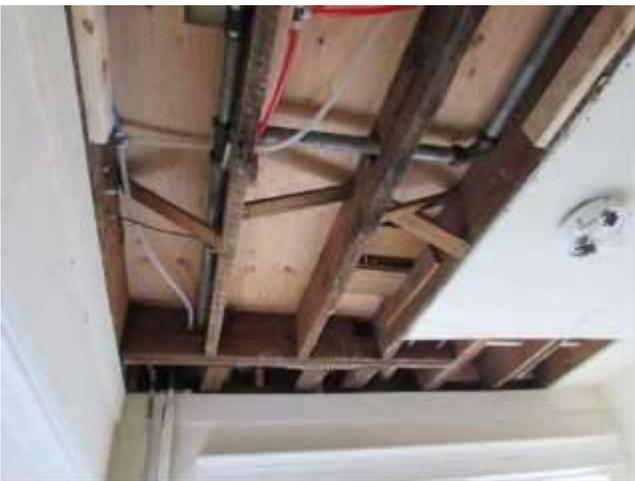
Photo 78-1

Some walls and/or ceilings were damaged. I recommend that a qualified person repair as necessary.

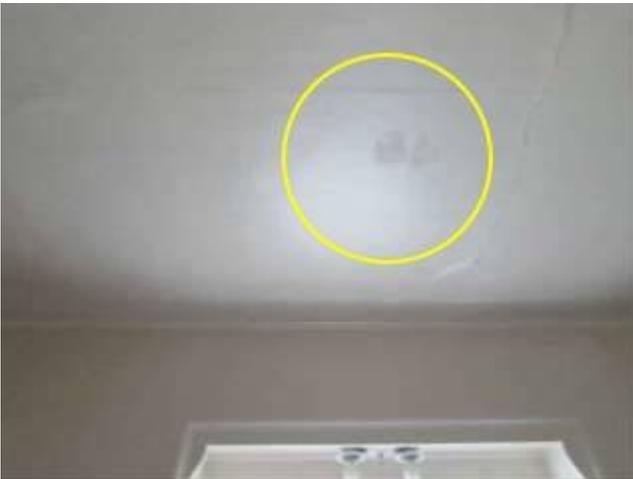
Photo 79-1

Stains were noted in main floor kitchen ceiling. The inspector was unable to determine if active leaks exist (e.g. recent dry weather, inaccessible height). I recommend asking the property owner about this, monitoring the stains, and having a qualified roofing contractor evaluate and repair if necessary.

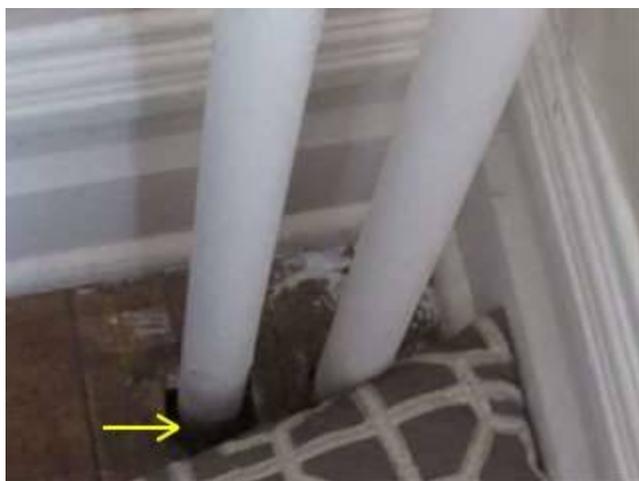
Photo 80-1

Wood flooring at some locations was damaged. I recommend that a qualified contractor refinish or replace wood flooring as necessary.
