## **First Sergeant Inspection Services, LLC**

## **Property Inspection Report**

**Property address: 1234 Main St**

**Inspection date: Saturday, November 10, 2018**

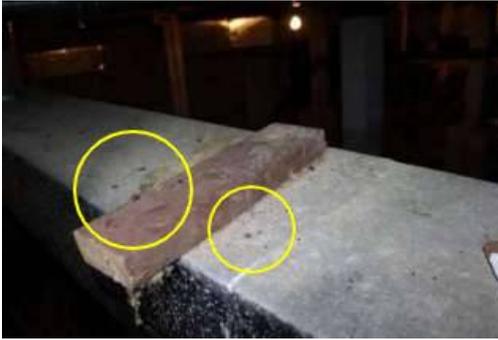
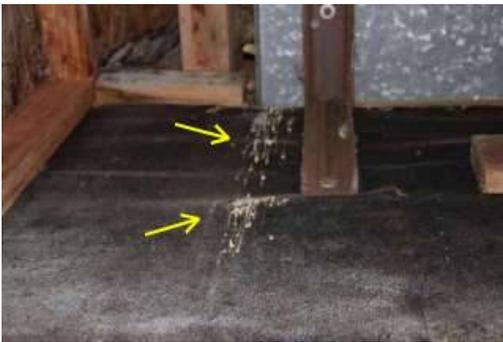
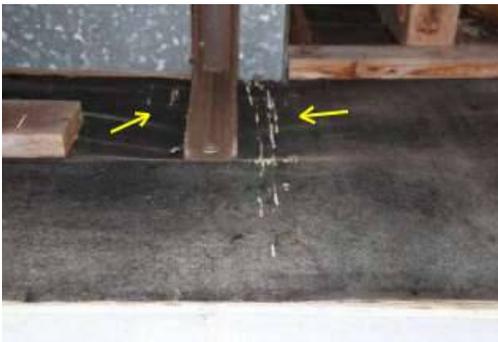
Evidence of rodent infestation was found in the form of feces and/or dead rodents in the basement. Rats and mice can spread disease. Therefore,

Evidence of bird infestation was found in chimney. Recommend having a qualified bird control contractor to evaluate and relocate as necessary.

prior to initiating repairs, I suggest consulting with a pest management professional, who should exterminate rodents and eliminate easy access to the property.

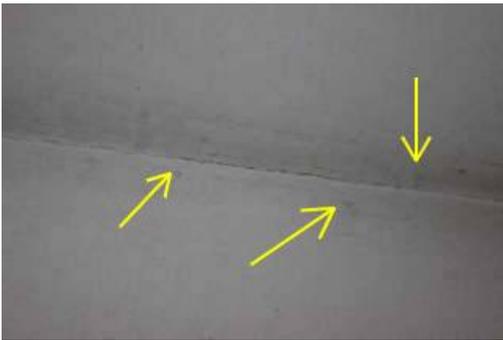
Photo 3-1

Microbial growths were found at the second floor bathroom shower. It is beyond the scope of this inspection to identify what substance or organism this staining is. However such staining is normally caused by excessively moist conditions, which in turn can be caused by plumbing or building envelope leaks and/or substandard ventilation. These conducive conditions should be corrected before making any attempts to remove or correct the staining. Normally affected materials such as drywall are removed, enclosed affected spaces are allowed to dry thoroughly, a mildewcide may be applied, and only then is drywall reinstalled. For evaluation and possible mitigation, consult with a qualified industrial hygienist or mold/moisture mitigation specialist. For more information, visit:

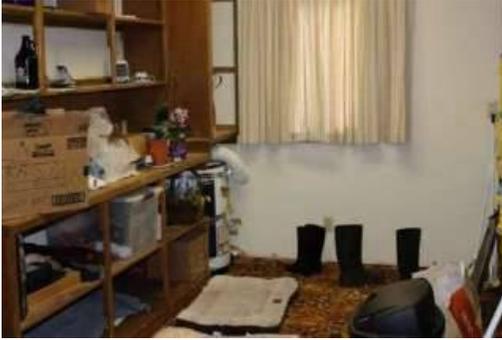
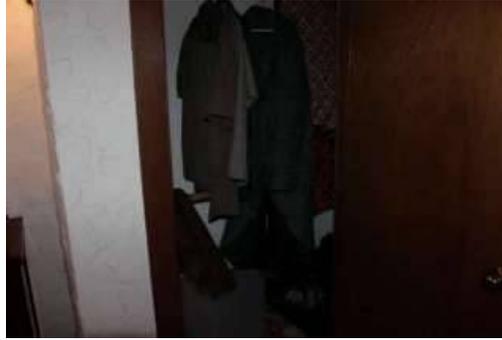
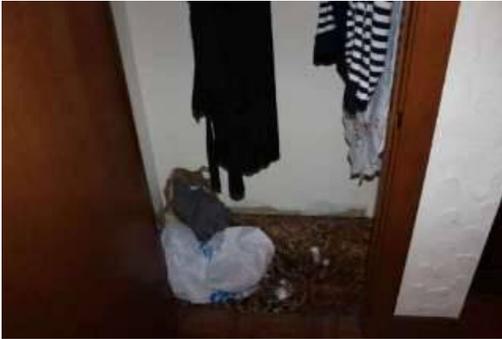
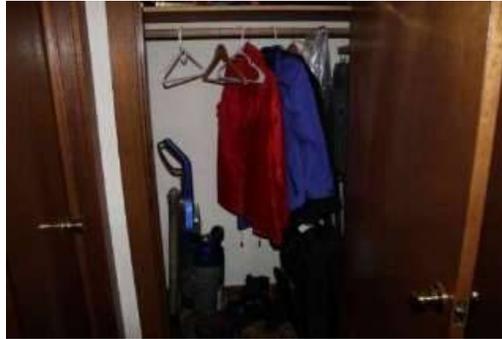
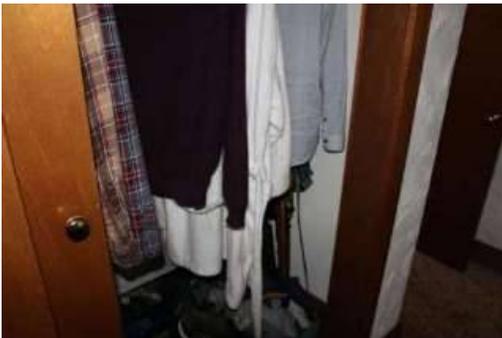
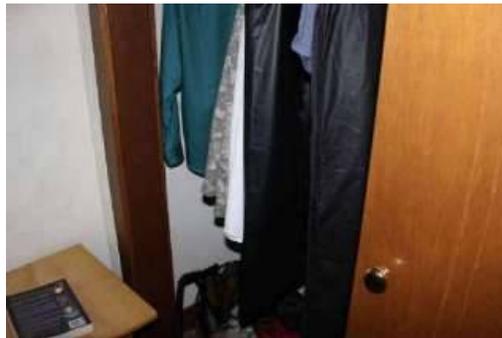
Many areas and items at this property were obscured by furniture and stored items in the utility room and closets. This often includes but is not limited to walls, floors, windows, inside and under cabinets, under sinks, on counter tops, in closets, behind window coverings, under rugs or carpets, and under or behind furniture. Areas around the exterior, under the structure, in the garage and in the attic may also be obscured by stored items. The inspector in general does not move personal belongings, furnishings, carpets or appliances. When furnishings, stored items or debris are present, all areas or items that are obscured, concealed or not readily accessible are excluded from the inspection. The client should be aware that when furnishings, stored items or debris are eventually moved, damage or problems that were not noted during the inspection may be found.

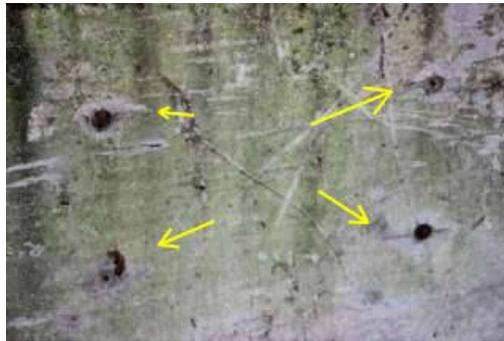
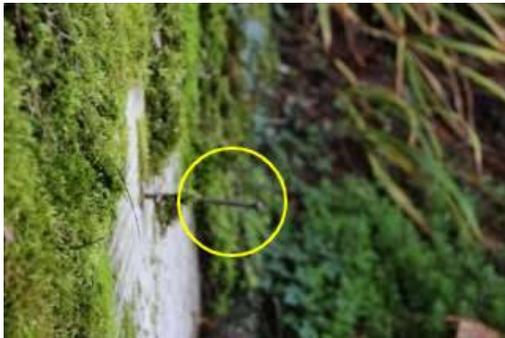
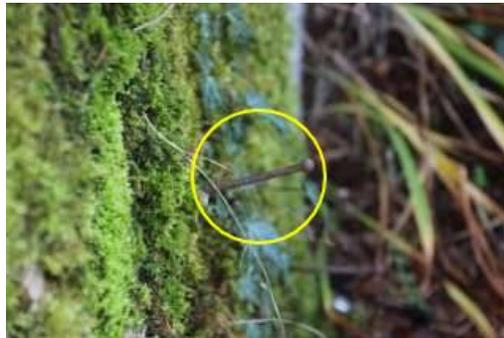
Hardware in the back concrete porch had pins that were significantly corroded. Corroded hardware is more likely to fail prematurely, and is a potential safety hazard. Also, holes that were not sealed that can collect water and corrode the concrete. Recommend that a qualified contractor replace significantly corroded hardware as necessary.

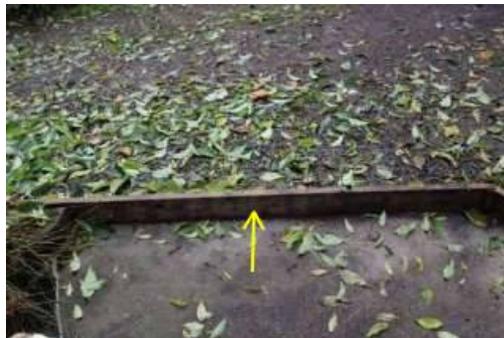
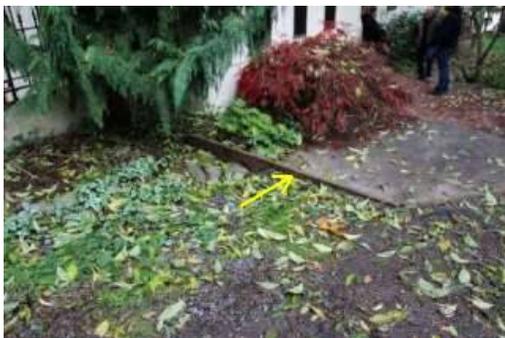
A landscaping timbers was in front of the walkway to the front door poses a trip hazard. Recommend that a qualified person replace landscaping timbers as necessary.

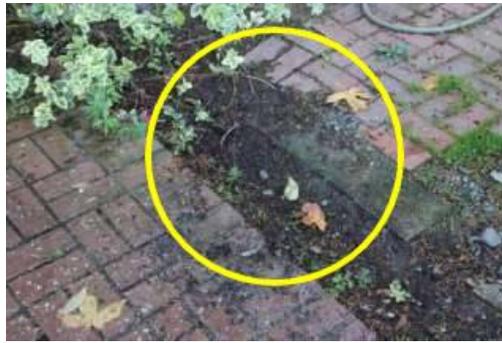
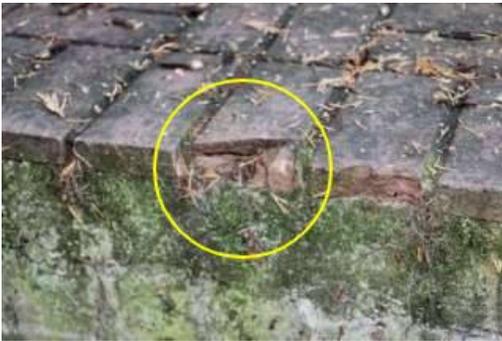
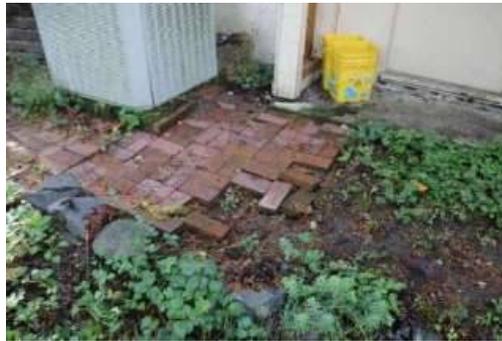
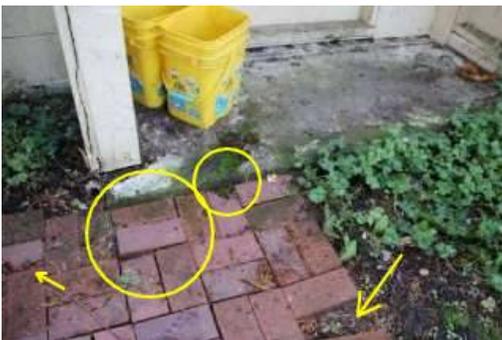
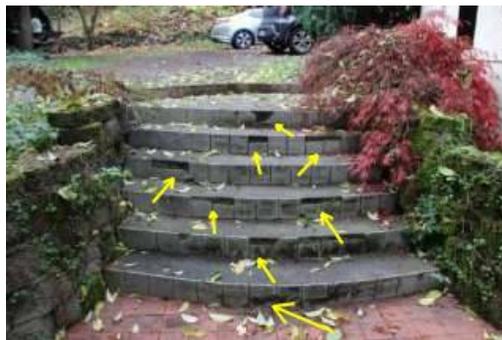
Brick used for the back of the residence for walkways and patios uneven and had gaps poses a trip hazard. Also, the front steps into the residence had several tiles broken or missing. For safety reasons, recommend that a qualified contractor repair as necessary to eliminate trip hazards.

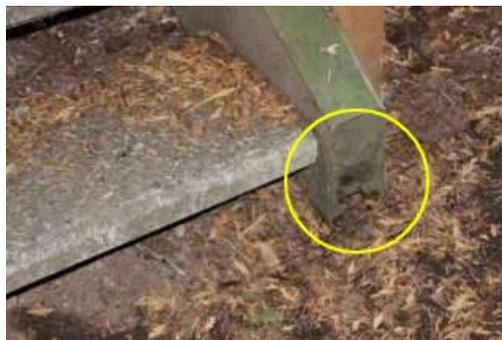
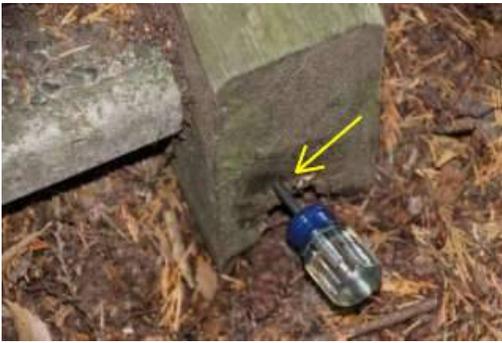
Fungal rot was found in two (2) stringers at the exterior stairs back side patio. Fungal rot in some stair components may pose a safety hazard. Recommend that a qualified person evaluate and repair as necessary. All rotten wood should be replaced.

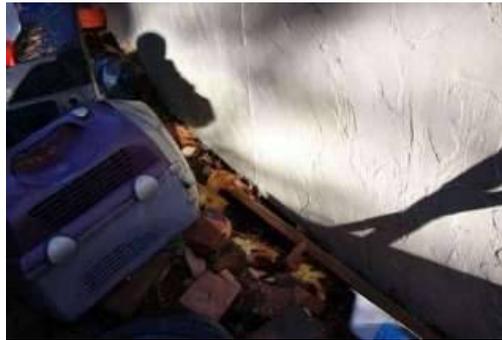
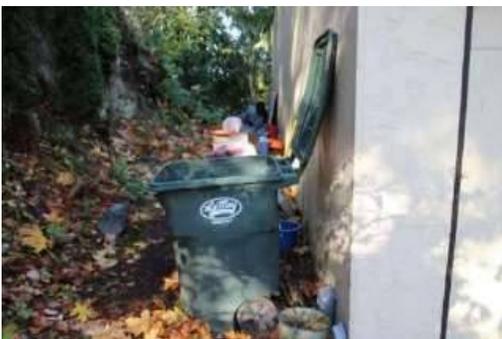
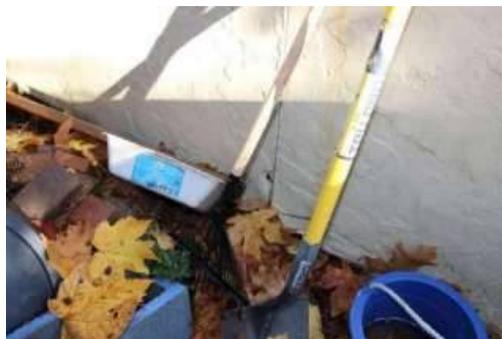
10) Significant amounts of debris and stored items was found in front of and on the side of the garage.

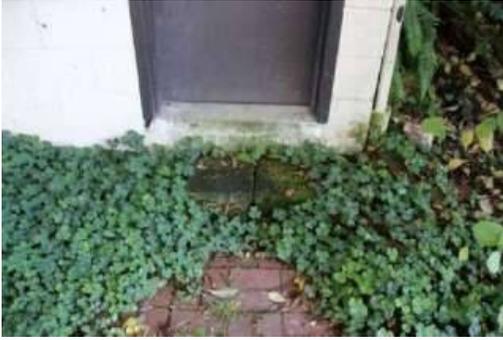
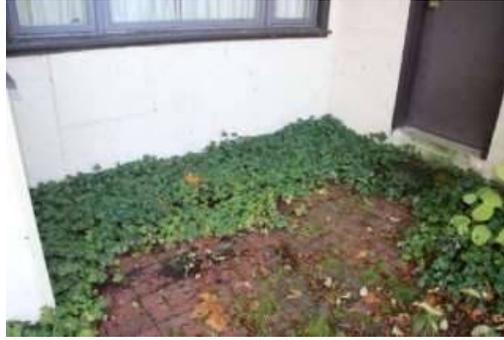
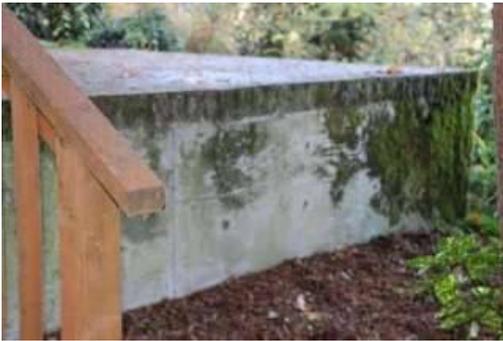
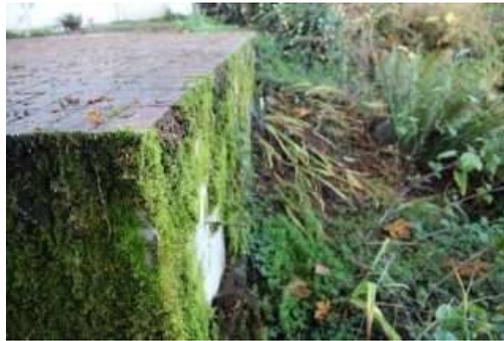
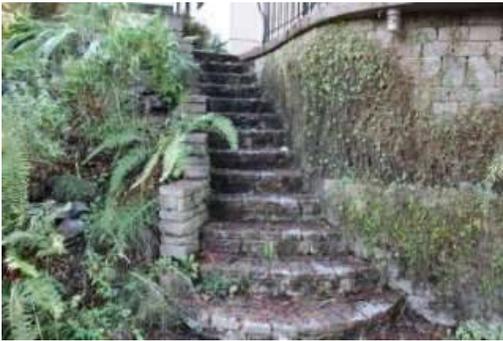
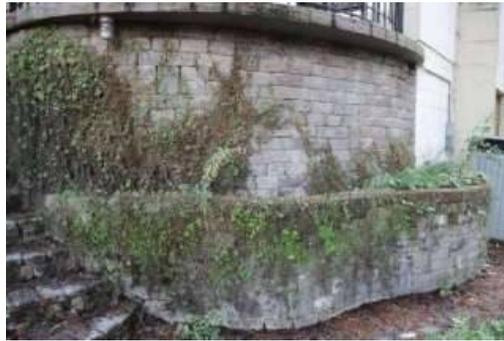
patios were obscured by vegetation and couldn't be fully evaluated on the NW and NE side of the residence.

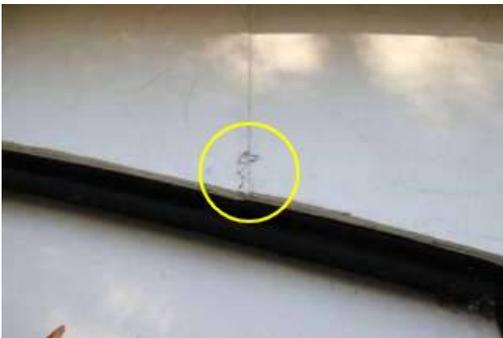
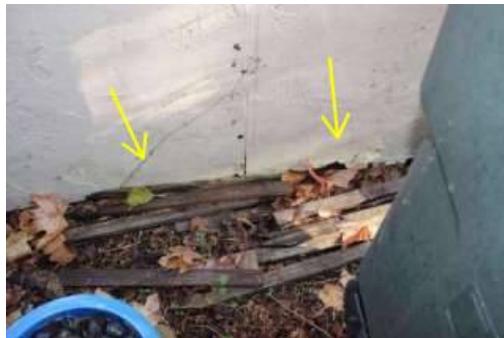
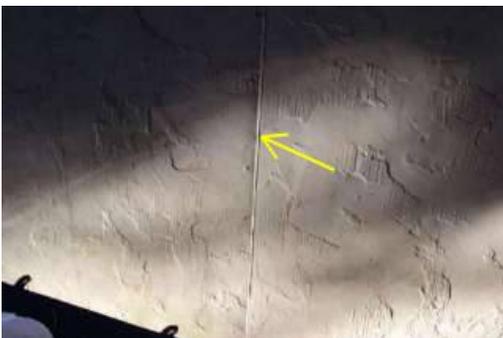
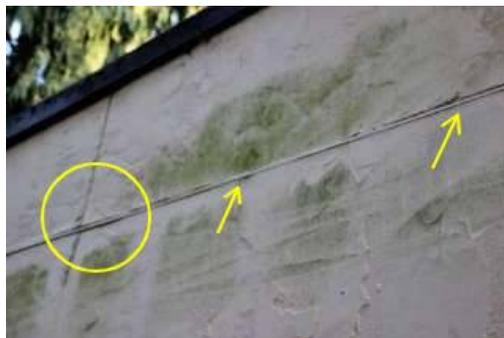
13) Numerous areas around the residence had siding and trim that was warped, damaged, had moss covering, and/or rotten. Also, trim was missing from covering the flashing at several locations on top of roof. Recommend that a qualified person repair, replace or install siding or trim as necessary.

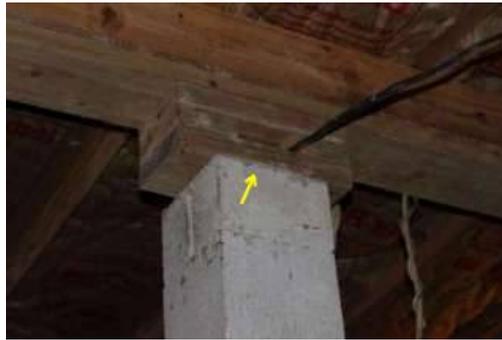
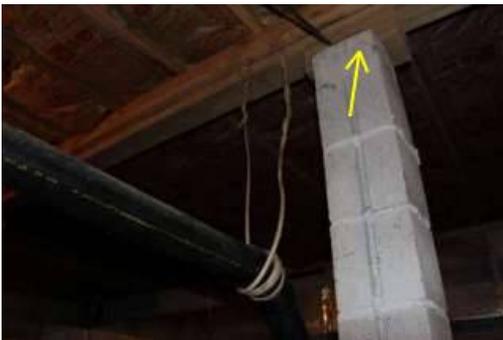
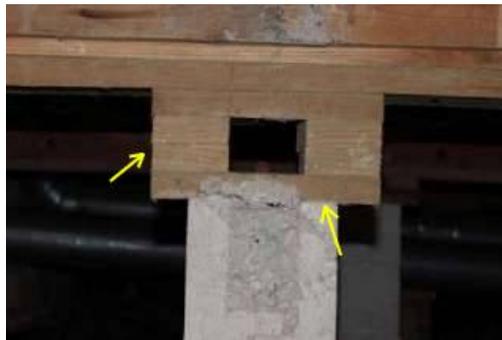
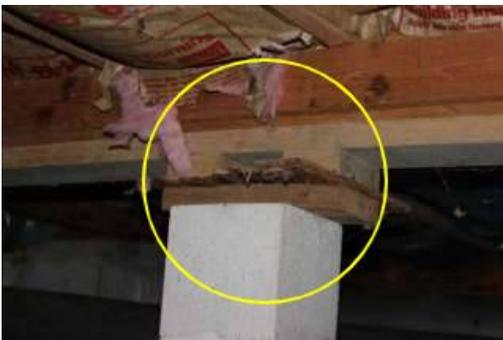
14) 🔍 There was a lack of positive connects at the top of support posts. Recommend that a qualified contractor evaluate and repair as necessary.

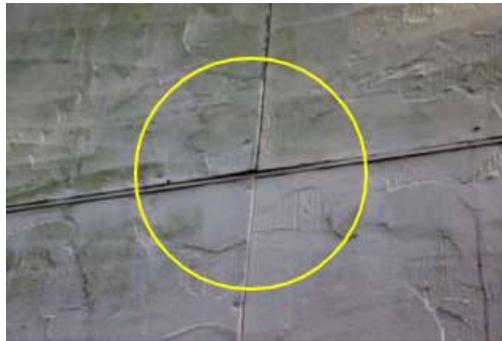
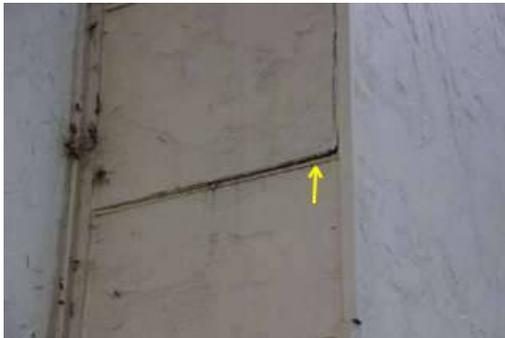
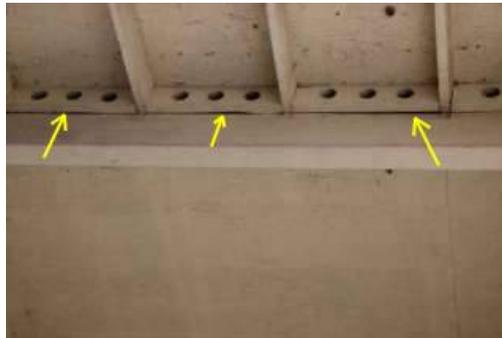
15) 🔍 Multiple gaps found in the siding. Vermin, insects or water may enter the structure. Recommend that a qualified person repair as necessary.

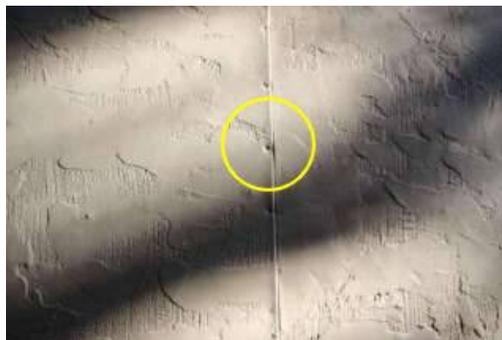
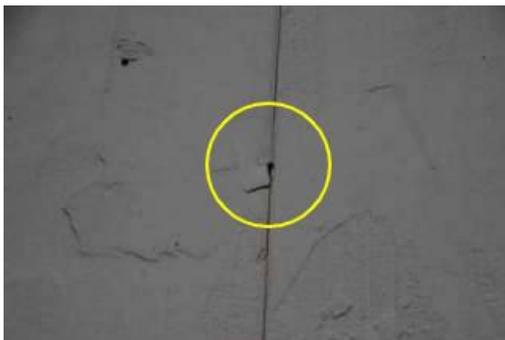
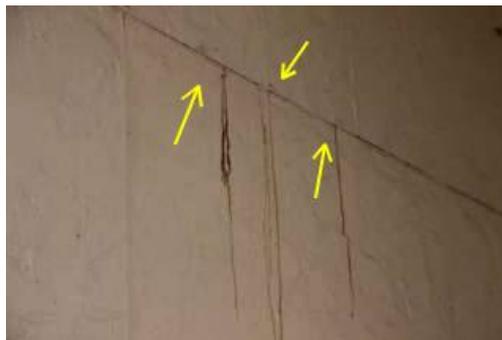
Some nail heads at the composition wood siding were protruding from the wood, or had been nailed in so as to break the surface of the siding, and caulk was missing. Most manufacturers of composition wood siding specify that nail heads should be flush with the surface, and that the surface of the siding should not be broken. If broken, then caulk should be applied to the nail heads to prevent water penetration and subsequent deterioration of the siding. Recommend that a qualified person repair per the siding manufacturer's specifications.

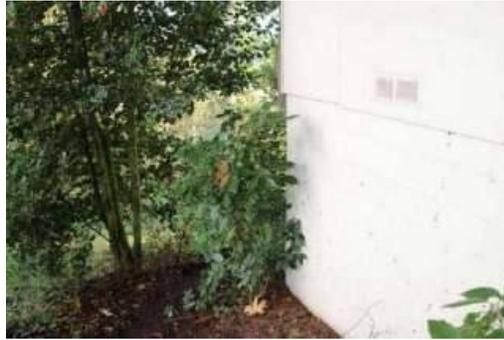
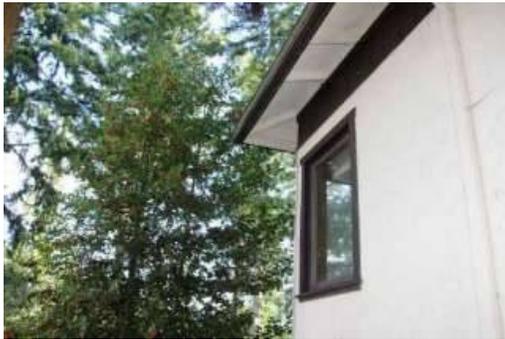
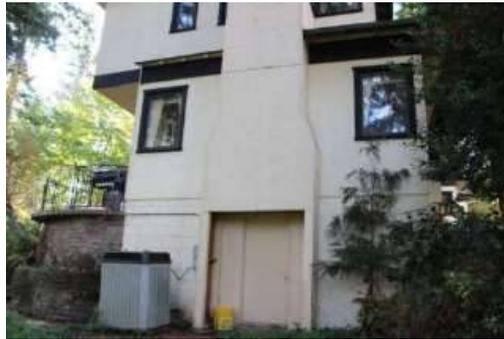
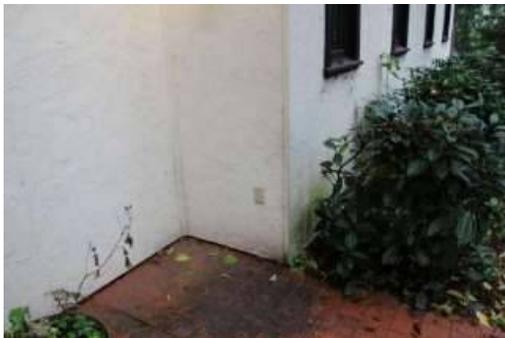
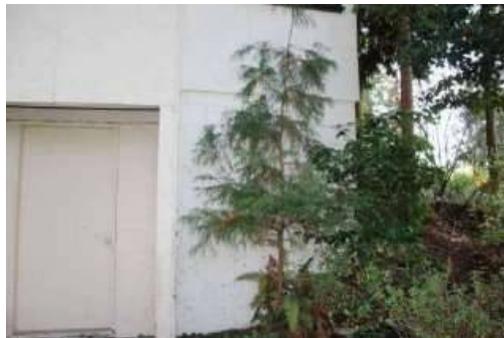
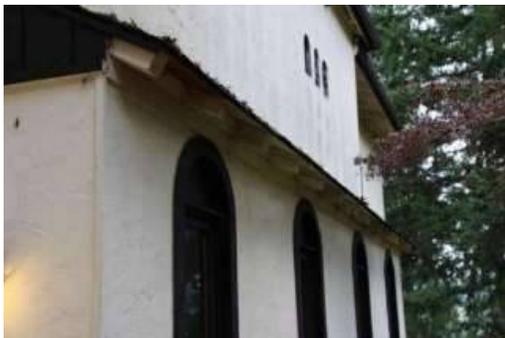
wood-destroying insects and can retain moisture against the exterior after it rains. This is a conducive condition for wood-destroying organisms. Recommend pruning, moving or removing vegetation as necessary to maintain at least 6 inches of space between it and the building exterior. A 1-foot clearance is better.

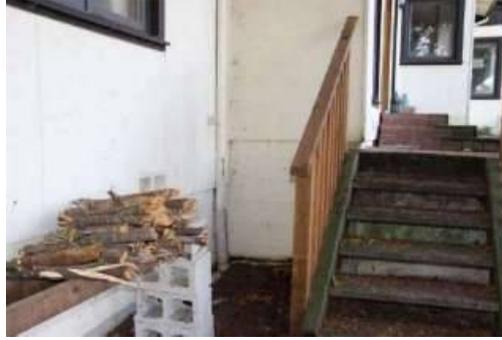
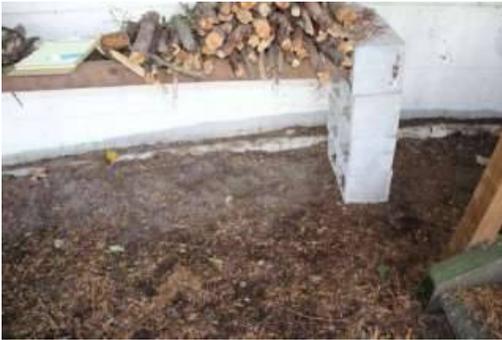
18) **i** Firewood was stored so that it was in contact with or close to the building exterior. This is a conducive condition for wood-destroying organisms. Recommend storing firewood outdoors in an open area, and as far away from buildings as practical to keep insects away from buildings. For more information visit:

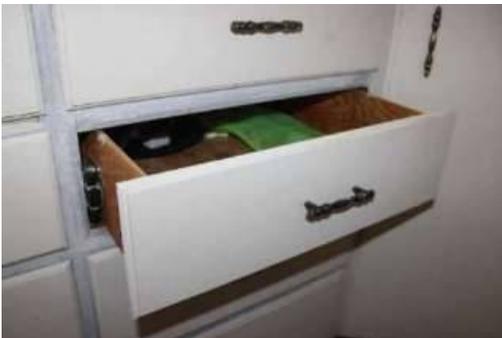
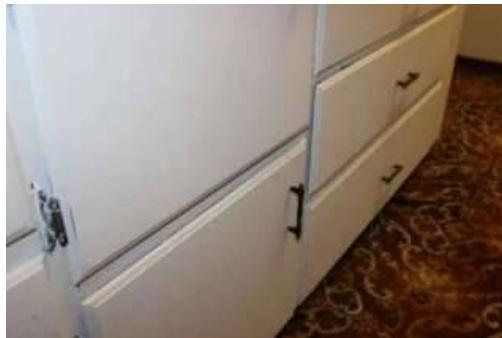
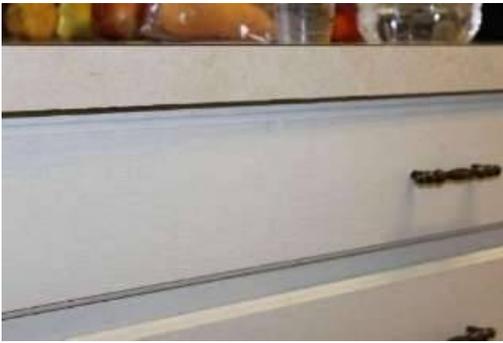
Several cabinet drawers were difficult to open or close and/or loose. Recommend that a qualified person repair as necessary.

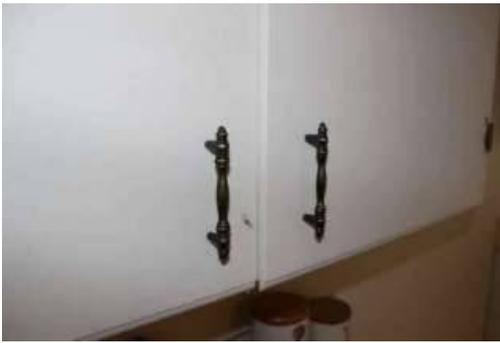
Two (2) cabinets were loose, or were secured with too few or substandard fasteners. An adequate number of appropriate fasteners should be used. For wall-hung cabinets, inadequate fasteners can pose a safety hazard if cabinets fall. Recommend that a qualified person repair as necessary.

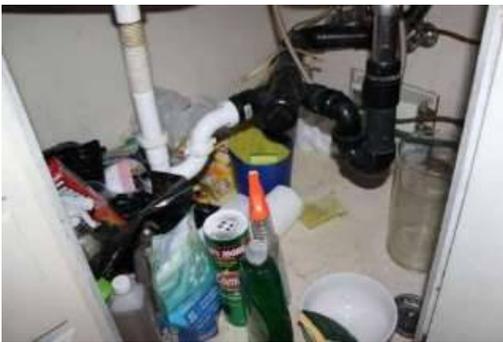
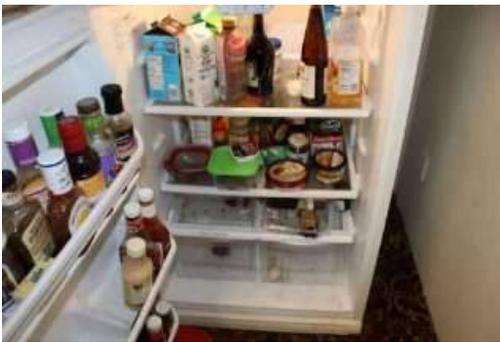
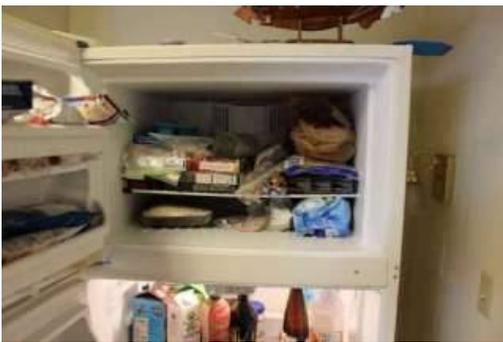
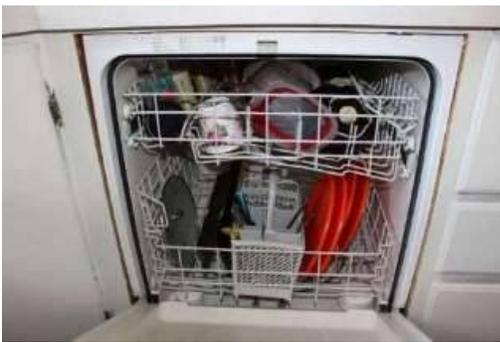
The areas below the sink, dishwasher, and refrigerator was by stored items or dishes and couldn't be fully evaluated.

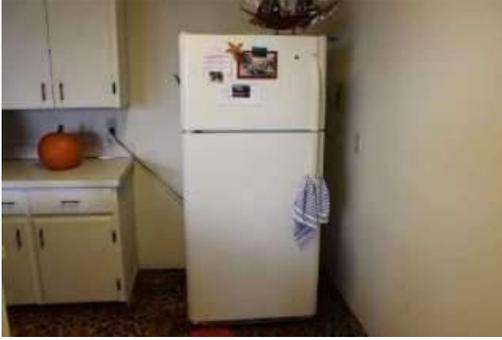
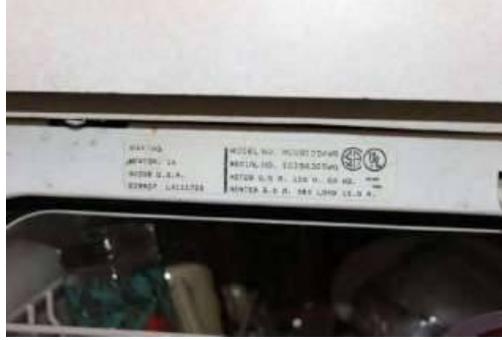
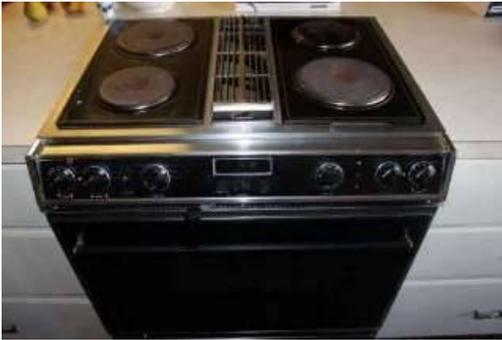
The estimated useful life for most kitchen appliances is 10-15 years. The dishwasher, refrigerator and range appeared to be near, at or beyond their

service life. Even if operable, recommend budgeting for replacements in the near future.

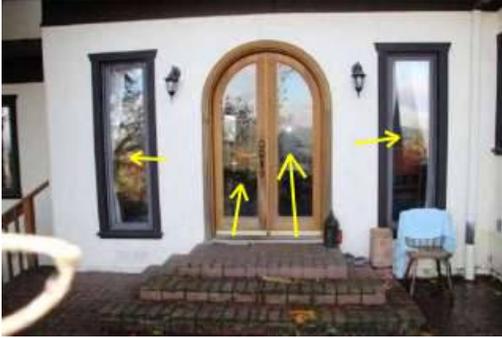
Photo 25-1

25) 🛠️🔍 The inspector was unable to verify that the glass used in the dining room windows was approved safety glass. Glazing that is not approved safety glass, located in areas subject to human impact, is a safety hazard. Standard building practices generally require that approved safety glass be used in swinging and sliding doors except where "art glass," jalousie windows or glazing smaller than a 3-inch opening is used. Recommend that a qualified contractor evaluate further to determine if glazing is approved safety glass, and replace glass if necessary, and per standard building practices.

Note that "art glass" (leaded, faceted, carved or decorative) may be an acceptable alternative for safety glass due to its visibility. Also, a 1 1/2-inch-wide protective bar on the accessible side of the glass, placed 34-38 inches above the floor, can serve as an acceptable substitute for safety glass. Recommend that a qualified contractor evaluate further to determine if glazing is approved safety glass, and replace glass if necessary, and per standard building practices.

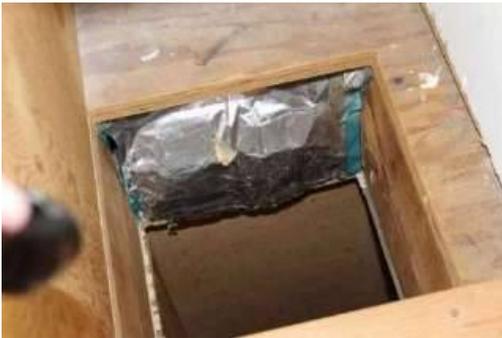
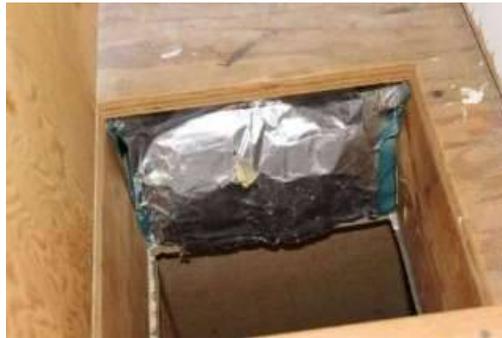
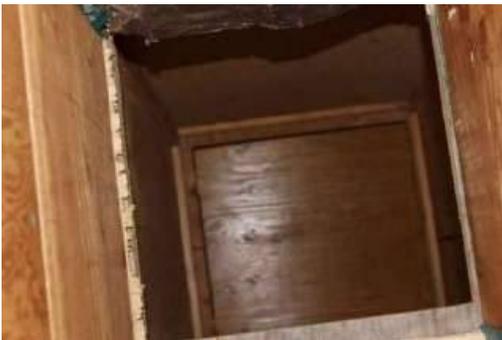
A less than professional laundry chute was found in closet. This is a safety and fire hazard. A child fall in or get stuck. If a fire started in the laundry room, it can easily make its way through to the second floor due to the fact the fire blocking has been removed. Recommend a qualified contractor evaluate and repair as necessary.

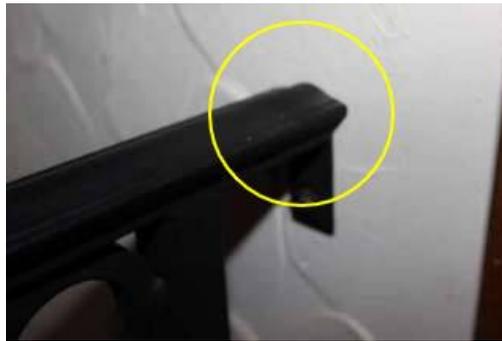
Photo 28-2

The guardrail on the second floor with drop-offs higher than 30 inches was loose and wobbly, and poses a fall hazard. Recommend that a qualified person repair guardrails as necessary.

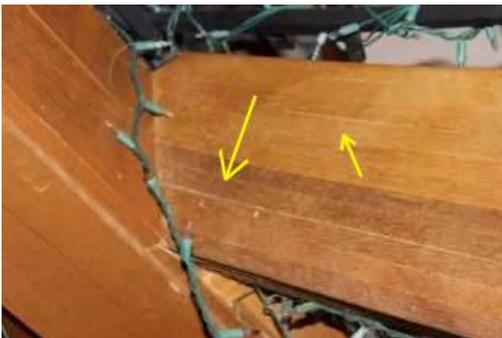
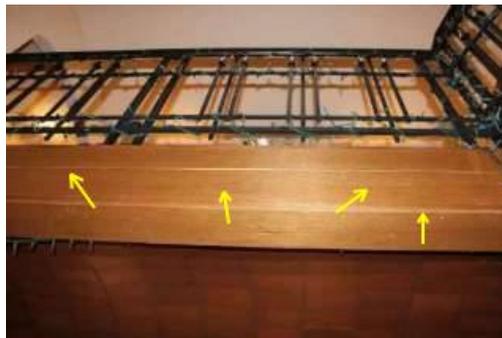
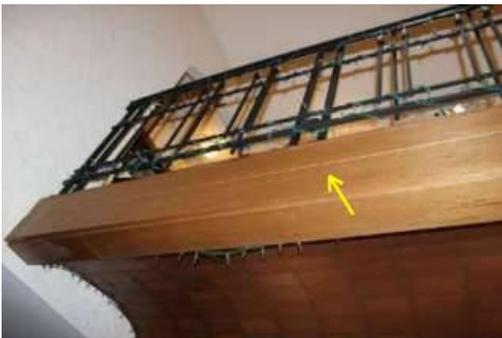
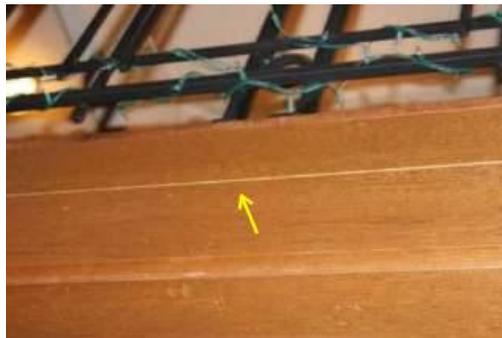
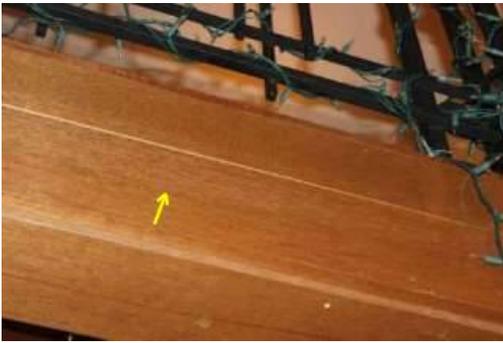
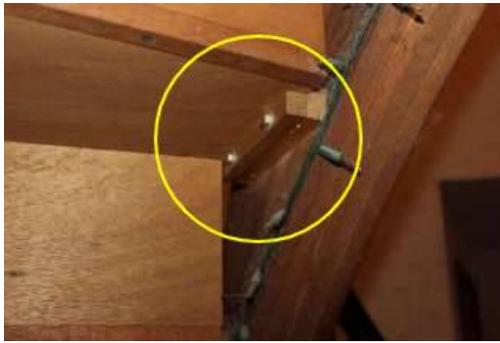
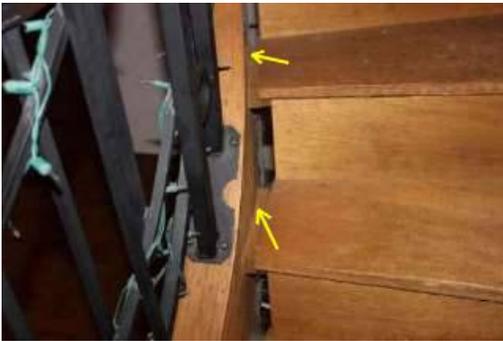
The stairs had several cracks in the wood, gaps between stringers and treads, and made excessive noise when walking up/down. This can be a safety risk. Recommend have a qualified person evaluate and repair/replace as necessary.

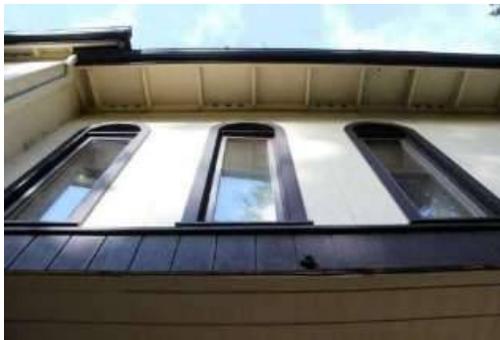
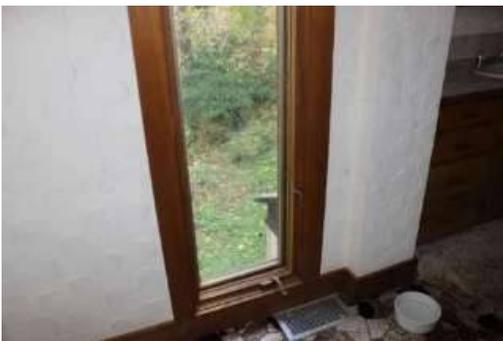
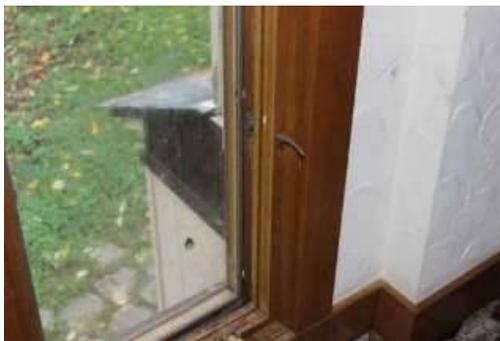
Based on height of windows from the ground and planned occupancy (children in home), recommend that the client consider installing window guards for child safety. For more information, visit: <https://www.reporhost.com/?WNDWGRDS>

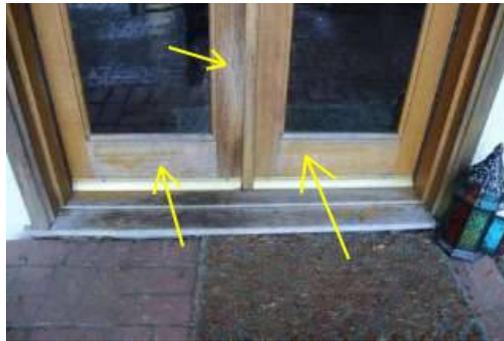
Photo 31-2

Dining room door was difficult to open/close and had obvious wear/damage on the exterior. Recommend that a qualified person repair as necessary.

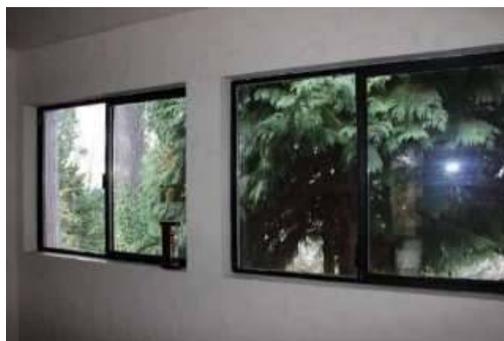
Photo 34-2

Several windows in the master bedroom sitting room were stuck shut. Recommend that a qualified person repair windows as necessary so they open and close easily.

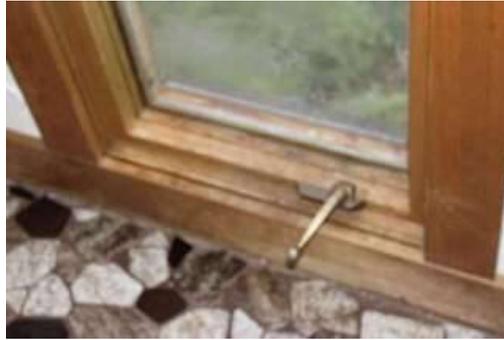
Photo 35-2

The lock mechanisms on the kitchen and master bedroom casement windows were difficult to open/lock. Recommend that a qualified person repair as necessary.

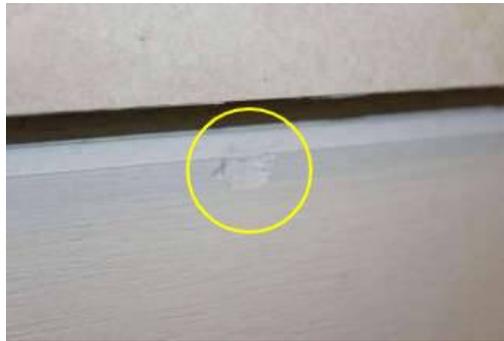
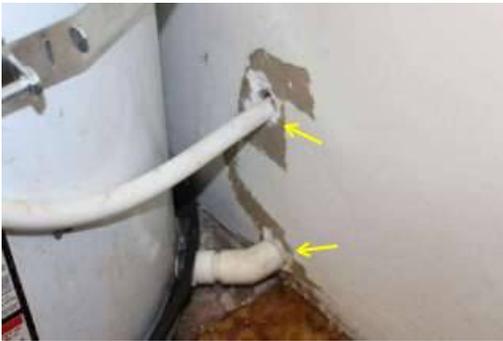
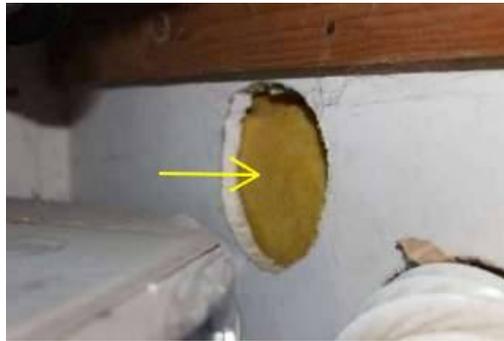
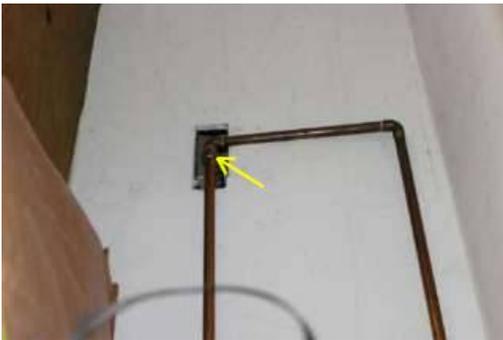
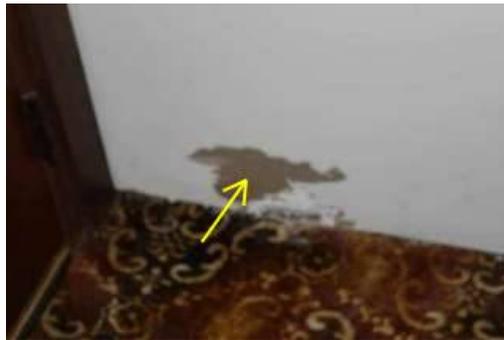
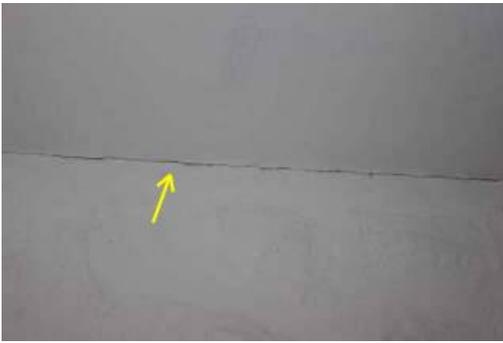
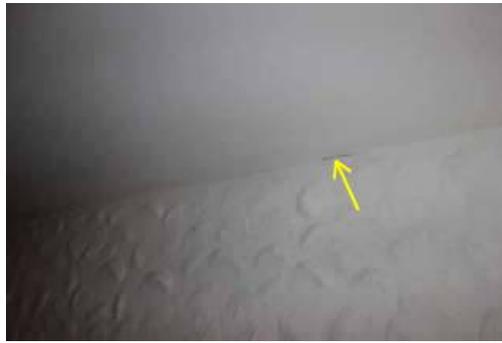
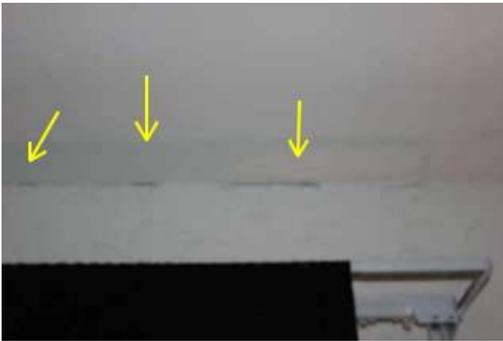
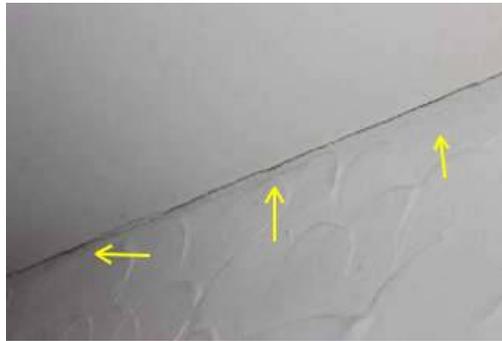
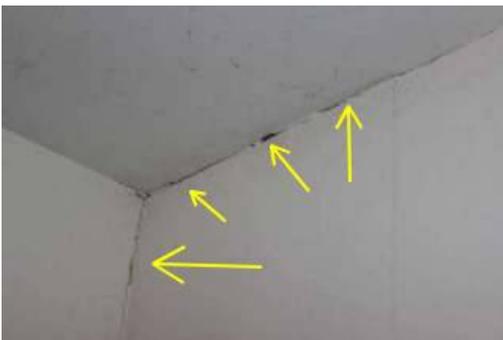
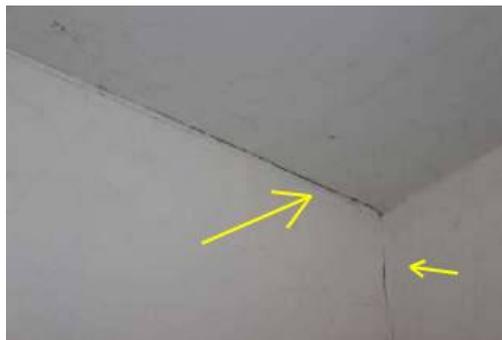
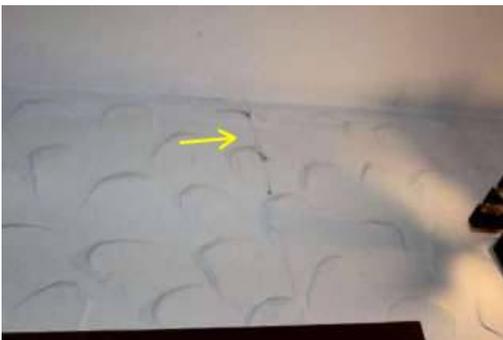
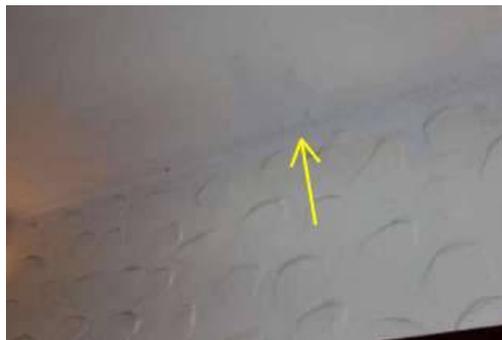
Multiple holes and cracks throughout residence. Recommend that a qualified person repair as necessary.

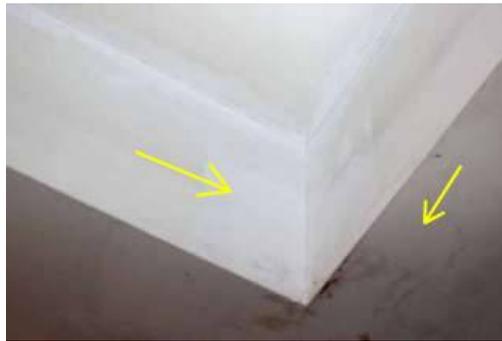
**Photo 38-2**

Master bathroom showed signs of damage, possibly by past condensation or water leaks. Recommend that a qualified person evaluate and repair as necessary.

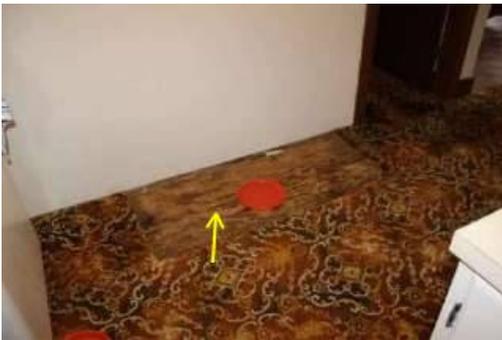
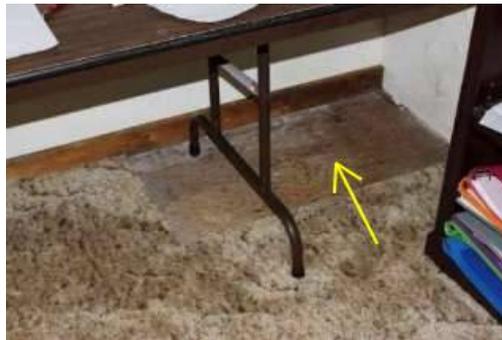
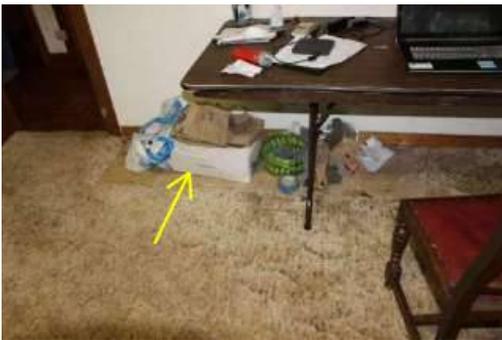
- 42) **i** All exterior doors were missing screen doors.
- 43) **i** All windows were missing screens. Windows may not provide ventilation during months when insects are active.
- 44) **i** Carpeting was present in the kitchen and laundry room. Both can be subjected to standing water and damage carpeting. Also, the kitchen and the bedroom/office has patches of the carpet cut out. Recommend having removed and replaced vinyl or tile be a qualified person.

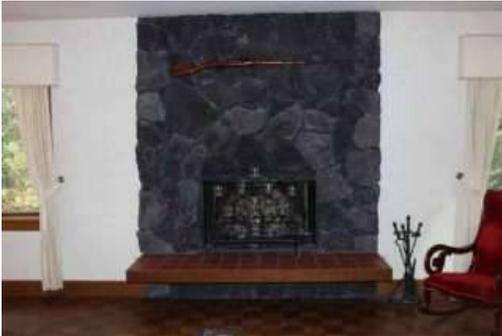
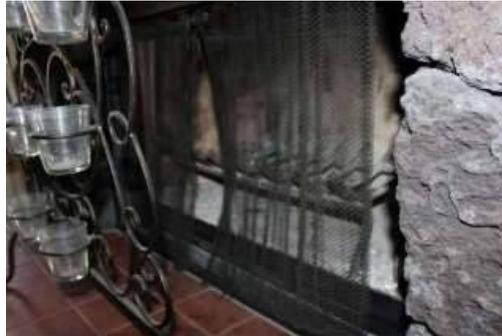
Solid fuel-burning fireplace was found at the property. When such devices are used, they should be professionally inspected and cleaned annually to prevent creosote build-up and to determine if repairs are needed. The National Fire Protection Association states that a "Level 2" chimney inspection should be performed with every sale or transfer of property with a wood-burning device. Recommend consulting with the property owner about recent and past servicing and repairs to all wood-burning devices and chimneys or flues at this property. Recommend that a qualified specialist evaluate all solid fuel-burning devices and chimneys, and clean and repair as necessary. Note that if a wood stove insert is installed, it may need to be removed for such an evaluation. For more information, search for "chimney inspection" at: <https://www.reporhost.com/?CSIA>

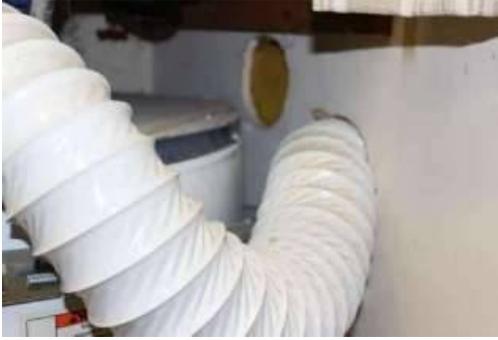
Photo 47-2

The clothes dryer's flexible exhaust duct was routed through a wall, building substructure or attic. This type of duct is easily damaged, prone to clogging and not suitable for this purpose. Clothes dryers may overheat. This is a potential fire hazard. It is acceptable for a short length of corrugated, semi-rigid metal duct (not accordion flex-duct) be used between the dryer and the wall or floor fitting, but duct runs through walls, building substructures and attics should be made of rigid metal, and wrapped in R-4 insulation if routed through an unheated space. Recommend that a qualified person replace

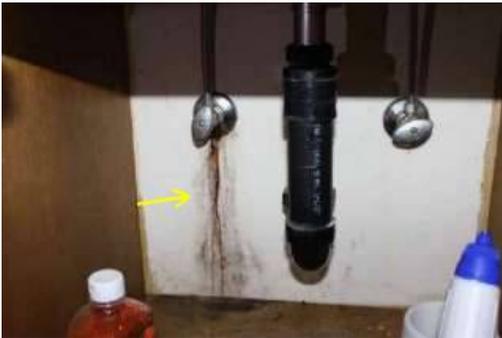
Photo 52-1

52) 🛠️ Old leak stains was found at water shut-off valves for the sink at location(s) #A. A qualified plumber should repair as necessary.

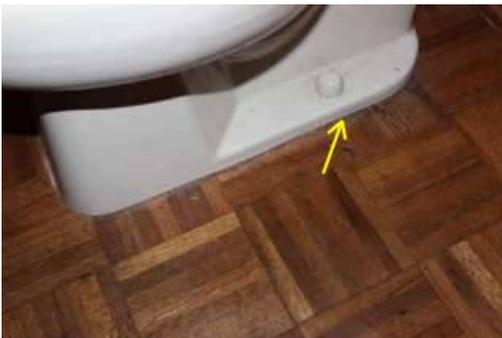
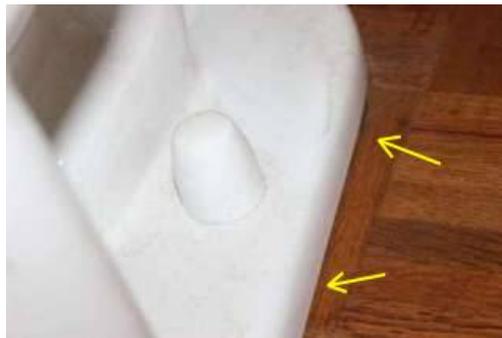
53) 🛠️ Caulk around the base of the toilet at location(s) #A, B and C was missing, substandard and/or deteriorated. Modern standards require caulk to be installed around the entire toilet base where it meets the floor for sanitary reasons. Without it, soiled water can soak into flooring and sub-floor materials if the toilet overflows. Condensation from the toilet can also soak into the flooring. Recommend that a qualified person caulk around toilet bases per standard building practices.

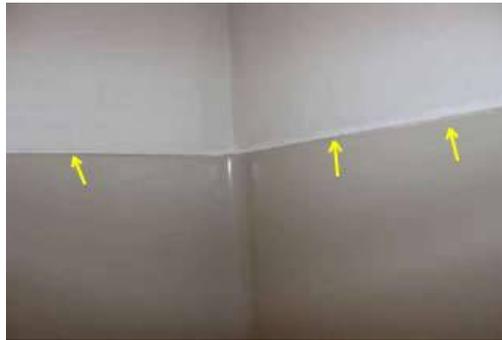
Photo 54-2

Substandard caulking was found between the bathtub and the walls at location(s) #B. Water may penetrate these areas and cause damage. Recommend that a qualified person re-caulk or install caulking as necessary.

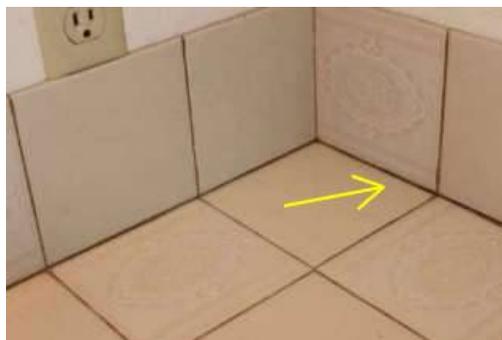
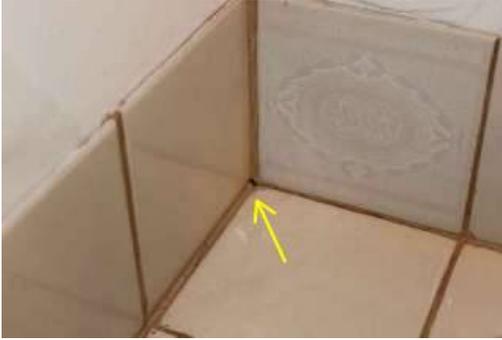
Recommend cleaning and sealing the grout at countertops at location(s) #C now and in the future as necessary to prevent staining and to improve waterproofing.

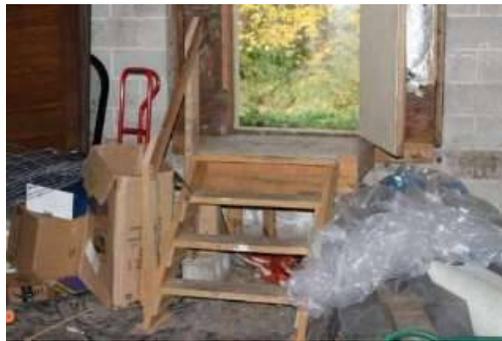
Photo 58-2

Guardrails at basement with drop-offs higher than 30 inches were missing. This poses a fall hazard. Guardrails should be installed where walking surfaces are more than 30 inches above the surrounding grade or surfaces below. Recommend that a qualified contractor install guardrails where missing and per standard building practices.
