## **First Sergeant Inspection Services, LLC**

## **Property Inspection Report**

**Property address: 1234 Main St**

**Inspection date: Saturday, November 10, 2018**

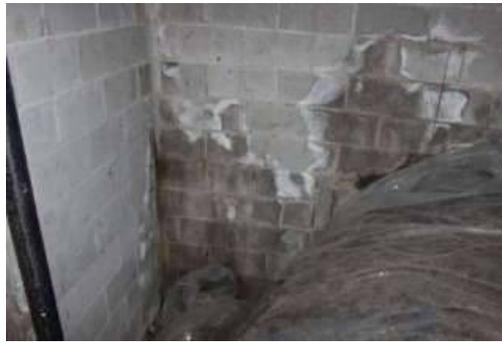
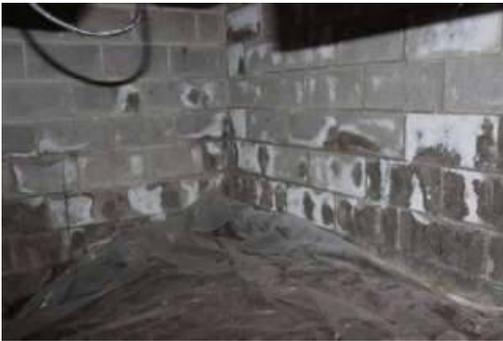
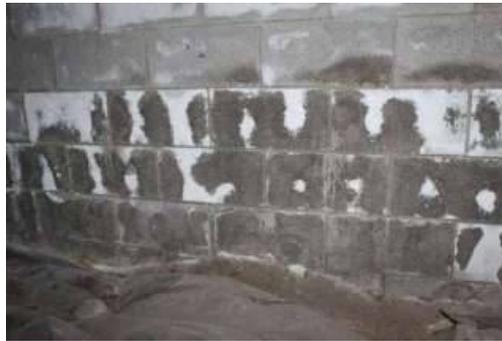
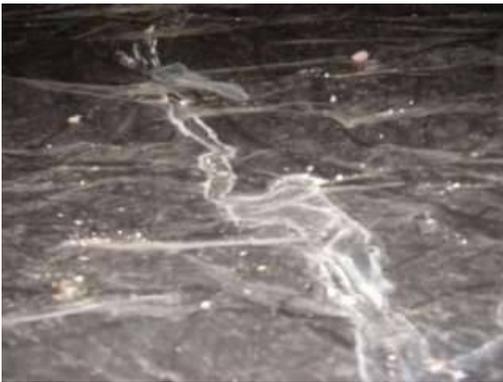
Evidence of prior water intrusion was found in one or more sections of the basement. For example, water stains or rust at support post bases, efflorescence on the foundation, etc. Accumulated water is a conducive condition for wood-destroying organisms and should not be present in the basement. Recommend reviewing any disclosure statements available and ask the property owner about past accumulation of water in the basement. The basement should be monitored in the future for accumulated water, especially after heavy and/or prolonged periods of rain. If water is found to accumulate, then recommend that a qualified contractor who specializes in drainage issues evaluate and repair as necessary. Typical repairs for preventing water from accumulating in basements include:

- Repairing, installing or improving rain run-off systems (gutters, downspouts and extensions or drain lines)
- Improving perimeter grading
- Repairing, installing or improving underground footing and/or curtain drains

Ideally, water should not enter basements, but if water must be controlled after it enters the basement, then typical repairs include installing a sump pump.

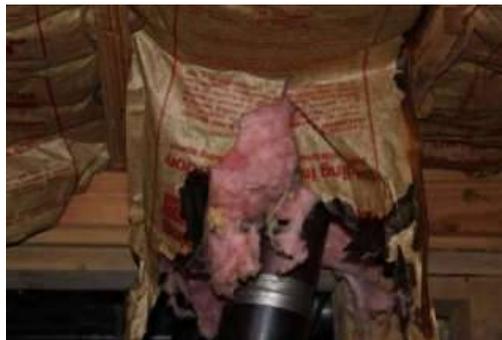
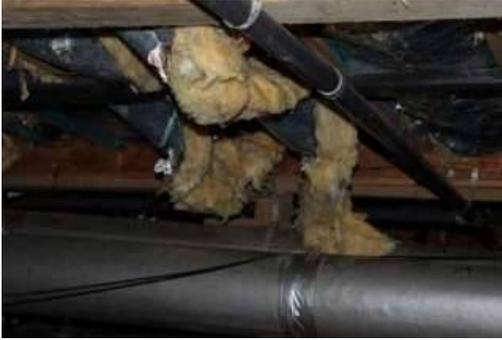
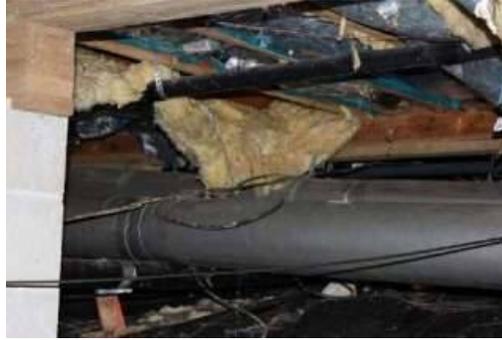
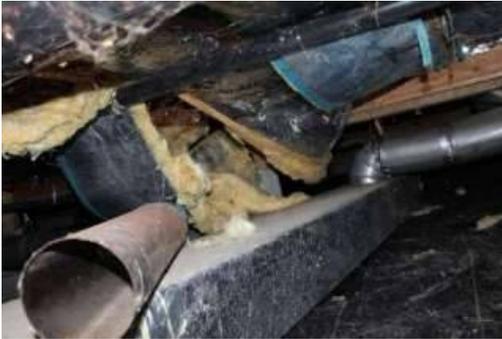
Under-floor insulation in the basement was damaged apparently by rodents. This may result in reduced energy efficiency and may produce unpleasant odors. For energy efficiency and sanitary reasons, recommend that a qualified contractor replace all under-floor insulation.

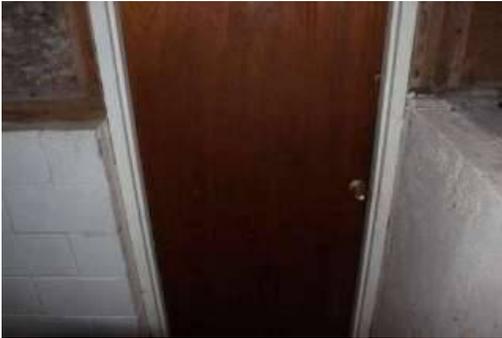
Photo 64-1

The door between the garage and the house did not appear to be fire resistant, or the inspector was unable to verify that it was via a label. This is a potential safety hazard. House to garage doors, to prevent fire and fumes from spreading from the garage into interior living space, should be constructed of fire-resistant materials. Doors, generally considered to be suitable for the purpose, are solid core wood, steel, honeycomb steel or a door that has been factory labeled as fire rated. Recommend that a qualified contractor replace or repair the door and, at that time, make any other corrections that might be required to provide suitable fire resistance between the garage and the dwelling per standard building practices. For more information, visit: <https://www.reporhost.com/?AGFR>

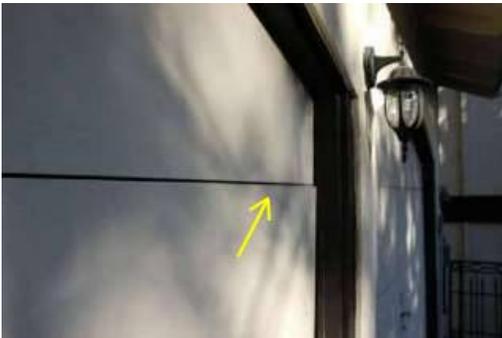
Photo 66-1

The garage vehicle door on far right was damaged. Recommend that a qualified contractor repair or replace door(s) as necessary.

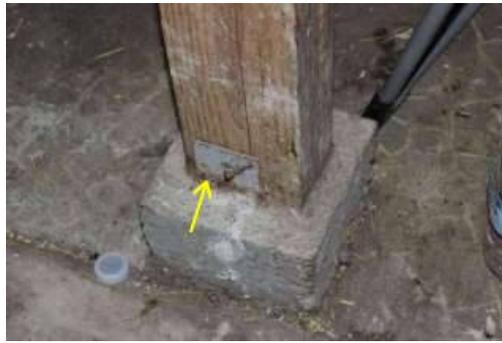
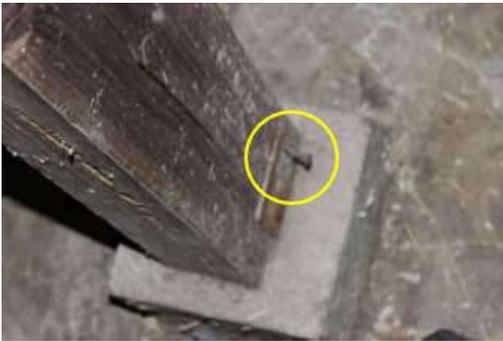
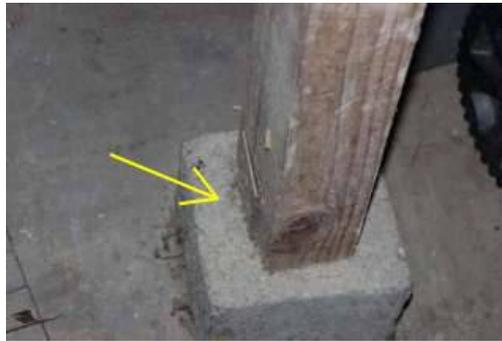
Several garage support posts were not positively secured to the beam above and/or the foundation below. While this is common in older homes, current standards require positive connections between support posts and beams above for earthquake reinforcement and for impact resistance from vehicles. Recommend that a qualified contractor repair per standard building practices. For example, by installing metal plates, plywood gussets or dimensional lumber connecting posts and beams, and/or installing anchors to the slab/footing below. Note that some support posts have concealed fasteners at their bases that are not visible.

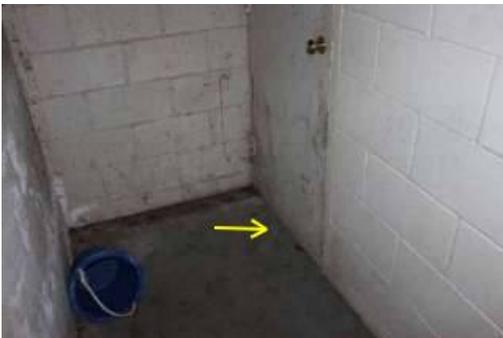
Photo 68-1

Weatherstripping around one or more exterior doors was missing. Water may enter the building, or energy efficiency may be reduced. Recommend that a qualified person repair or replace weatherstripping as necessary.

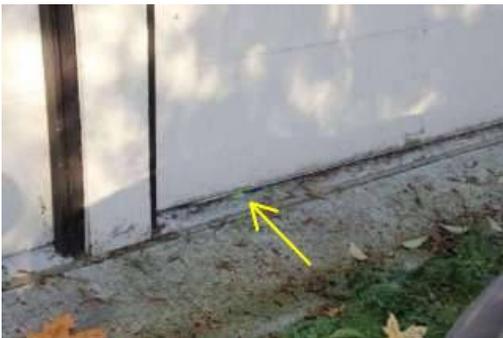
Photo 69-1

Significant gaps were found below or around one or more garage vehicle doors. Vermin and insects can enter the garage as a result. Recommend that a qualified person repair as necessary to eliminate or minimize gaps.

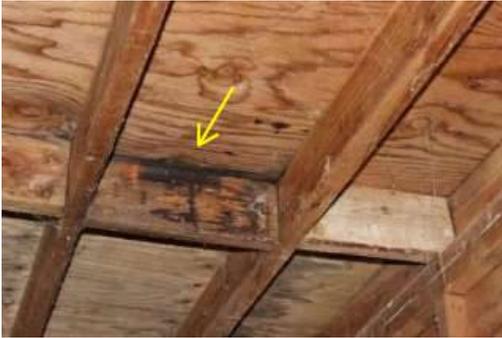
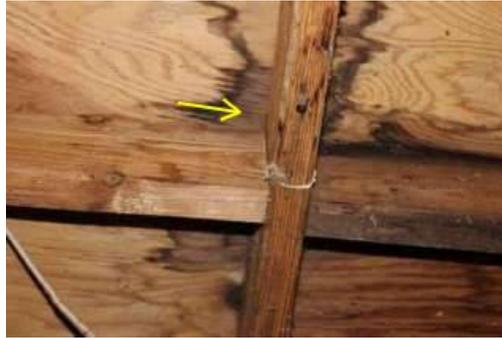
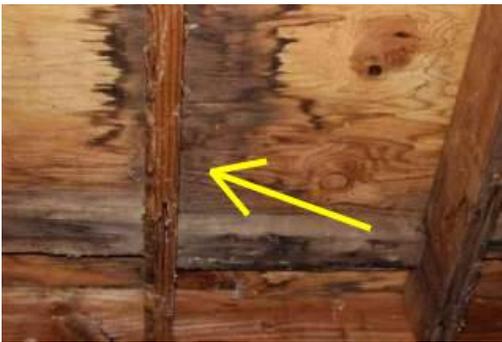
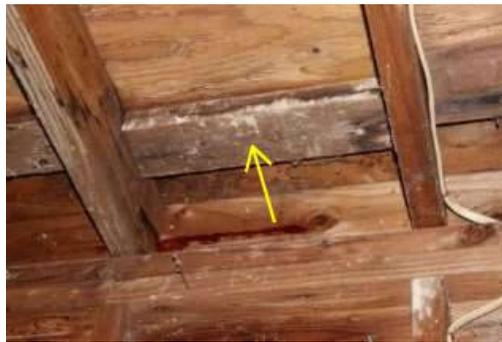
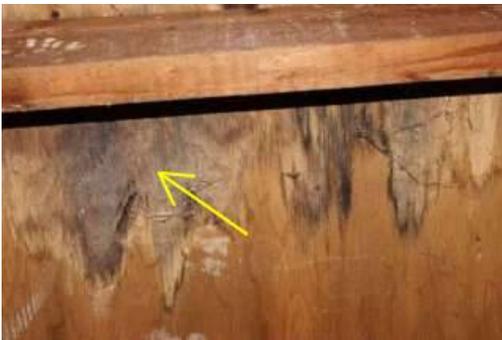
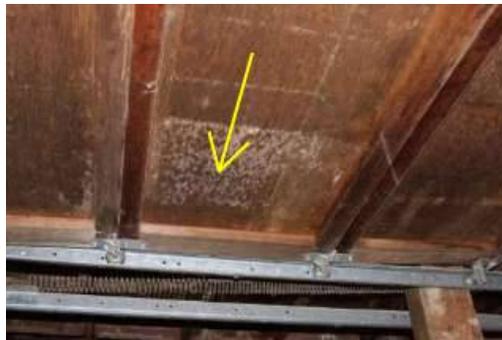
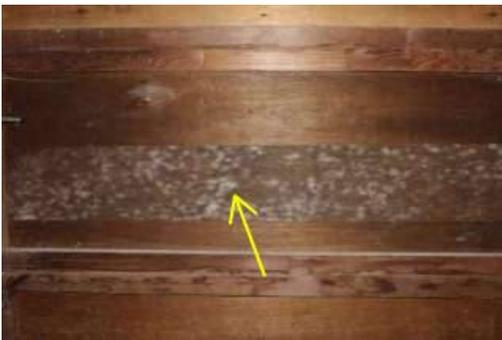
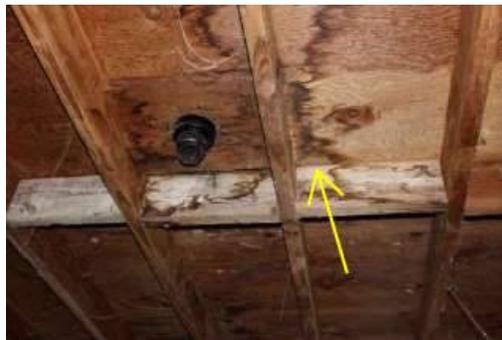
What appeared to be past water stains were visible on the roof structure at several locations in the garage. The stains may have been caused by a past leak. Recommend asking the property owner about past leaks. Monitor these areas in the future, especially after heavy rains to determine if active leaks exist. If leaks are found, recommend that a qualified contractor evaluate and repair as necessary.

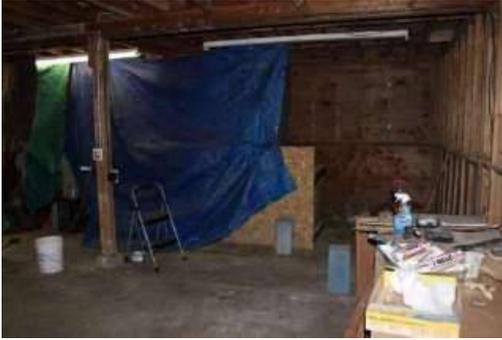
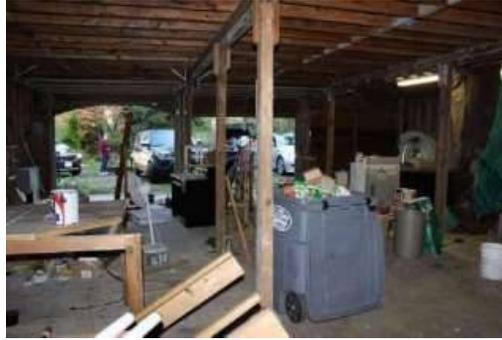
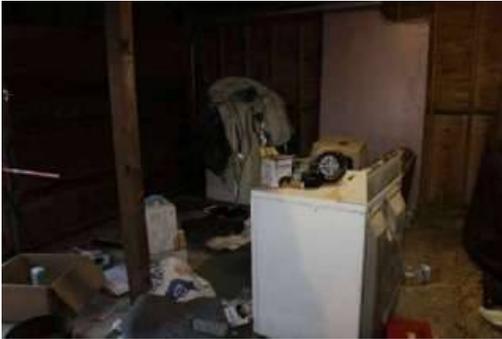
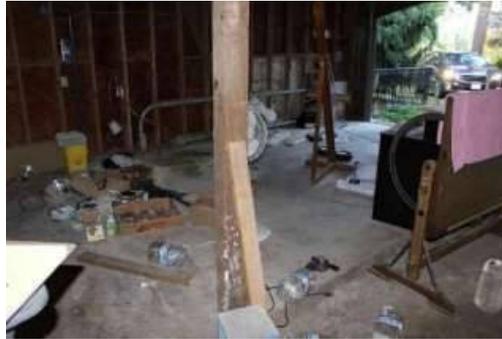
Many floor areas were obscured by stored items and/or debris and couldn't be fully evaluated.

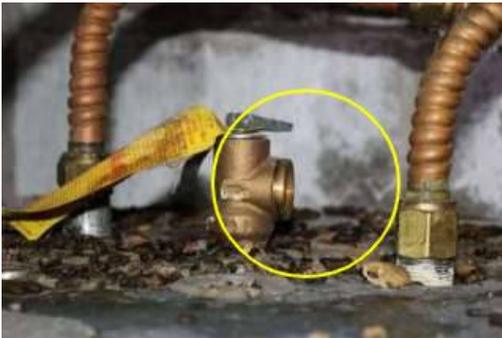
Photo 74-1

No temperature-pressure relief valve was installed on the water heater tank in the basement. This is a potential safety hazard due to the risk of explosion. A qualified plumber should install a temperature-pressure relief valve and drain line per standard building practices.

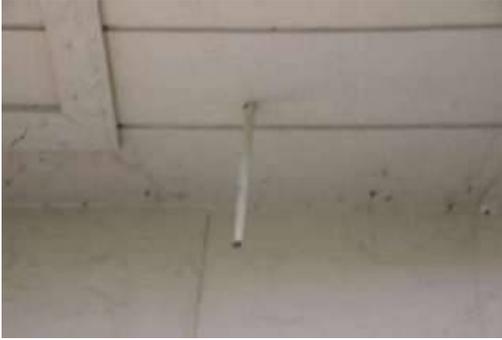
Photo 76-1

The temperature-pressure relief valve drain line terminated too high above the ground outside from water heater in sauna. Someone standing next to the drain line could be scalded if the valve opens. Recommend that a qualified person repair per standard building practices. For example by extending the drain line. For more information, visit:

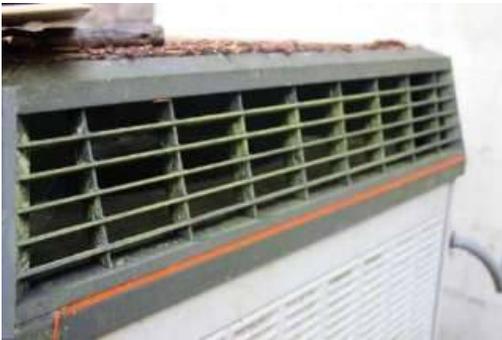
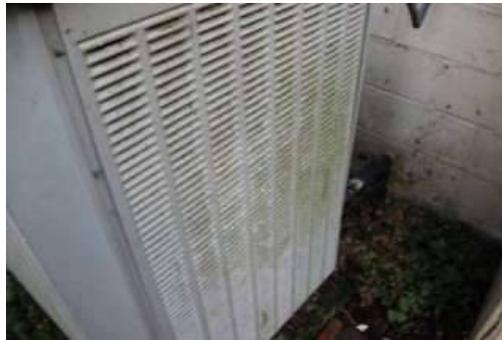
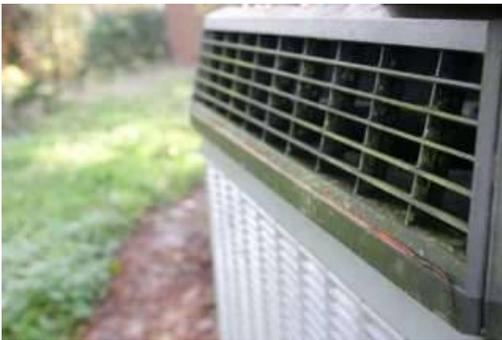
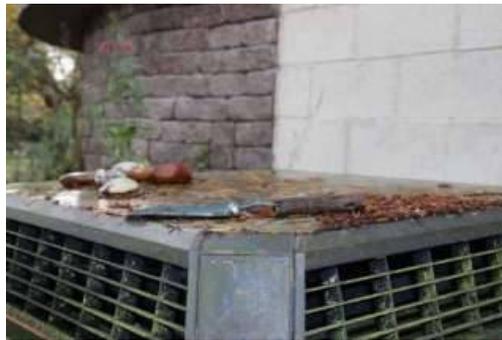
The last service date of the heating/cooling system is unknown. Ask the property owner when it was last serviced. If unable to determine the last service date, or if this system was serviced more than 1 year ago, recommend that a qualified HVAC contractor clean and service this system and make repairs if necessary. Because this system has a compressor and refrigerant system, this servicing should be performed annually in the future. Any needed repairs noted in this report should be brought to the attention of the contractor when it's serviced.

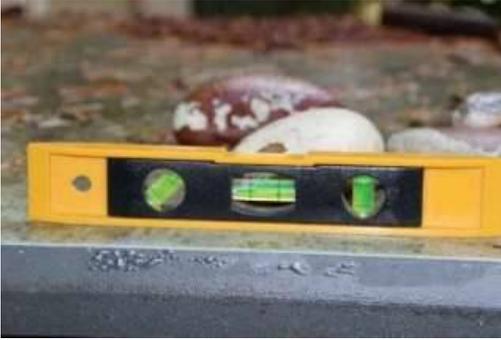
Photo 84-1

The pad for the heat pump or air conditioning condensing unit was not level. This unit requires adequate support. The compressor may be damaged if this unit is tilted 10 degrees or more. Also, the pad should elevate the unit above the soil to prevent corrosion. Recommend that a qualified person repair as necessary.

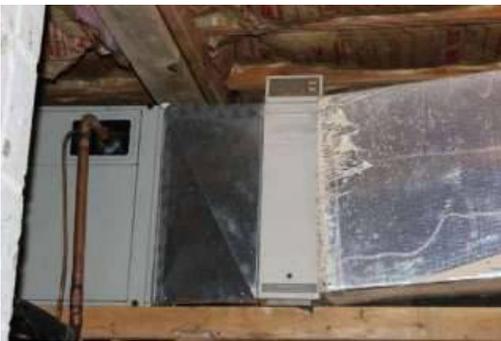
Photo 85-1

An electronic air filter was installed. For home buyers, recommend checking filters upon taking occupancy. Check filters monthly in the future. Guidelines vary depending on the manufacturer, but when the filters are dirty, the following steps should normally be performed:

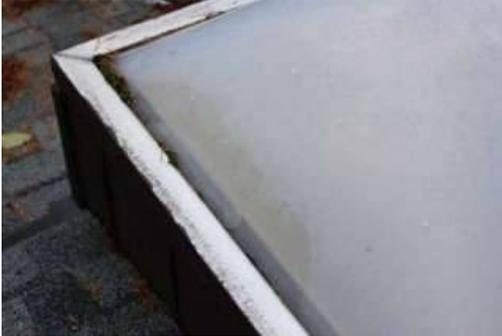
Photo 87-1

Water damage and/or evidence of past leaks was found at one of the skylights. Consult with the property owner to determine if leaks have occurred, or if repairs have been made. Recommend that a qualified contractor evaluate and repair as necessary.

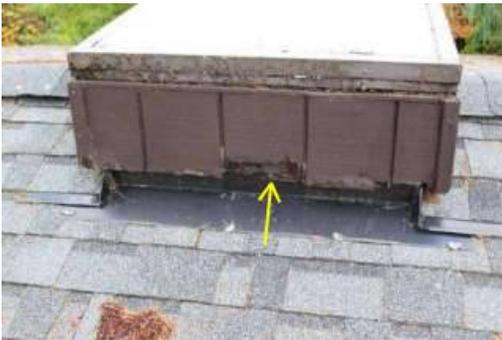
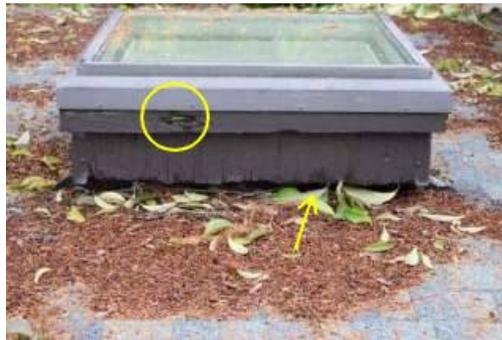
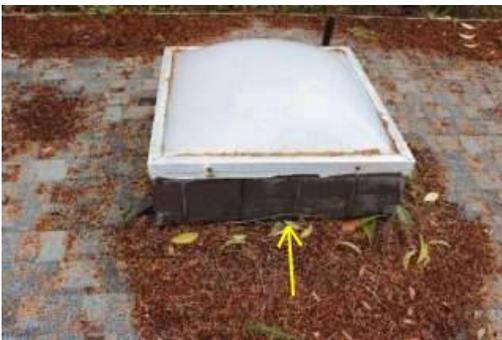
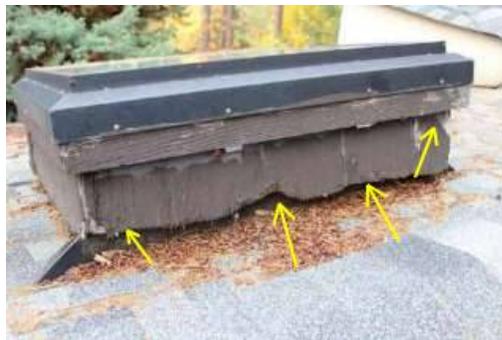
All the skylights had damage to siding material. Recommend that a qualified contractor evaluate and repair as necessary.

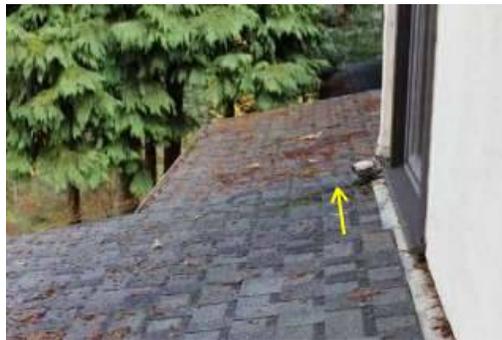
Photo 90-2

90) Extensions such as splash blocks or drain pipes for several downspouts was missing on top of garage and first/second floor on back side of residence. Water can accumulate around the building foundation or basement and/or cause excessive wear on shingles as a result. Recommend that a qualified person install, replace or repair extensions as necessary so rainwater drains away from the structure.

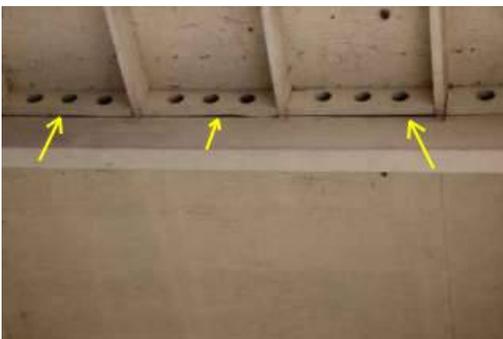
Photo 91-1

91) Gaps were found in or around roof soffits and can allow birds or vermin to enter the attic on SE side of residence. Recommend that a qualified person repair as necessary to eliminate gaps.

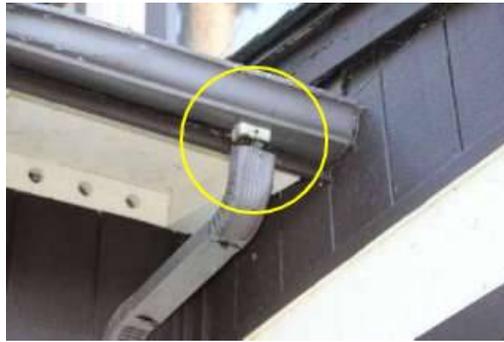
Photo 92-2

Downspouts on NE side detached. Rainwater can come in contact with the building exterior or accumulate around the foundation as a result. This is a conducive condition for wood-destroying organisms. Recommend that a qualified person repair as necessary.

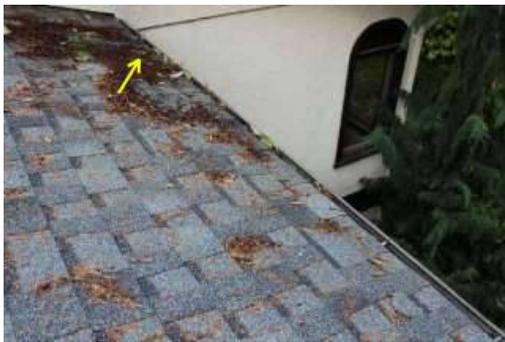
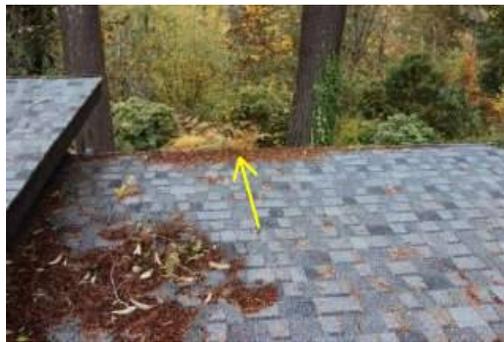
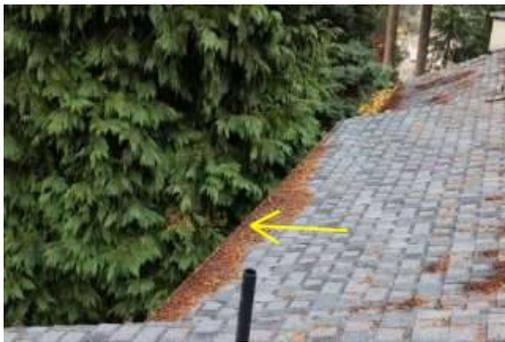
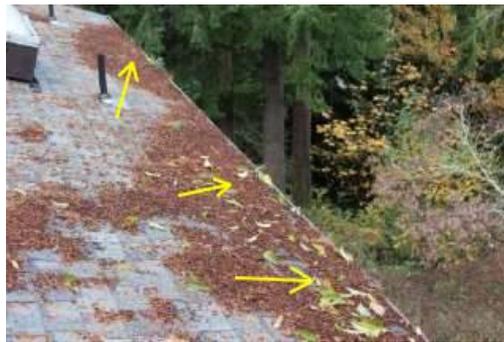
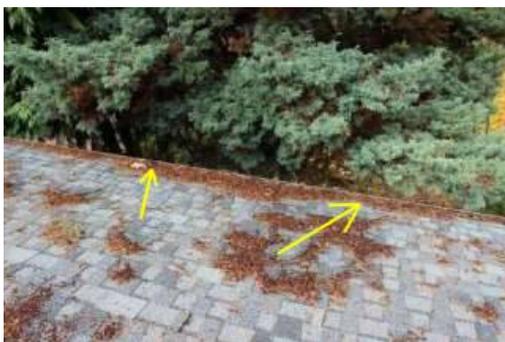
Significant amounts of debris have accumulated in one or more gutters or downspouts. Gutters can overflow and cause water to come in contact with the building exterior, or water can accumulate around the foundation. This is a conducive condition for wood-destroying organisms. Recommend cleaning gutters and downspouts now and as necessary in the future.

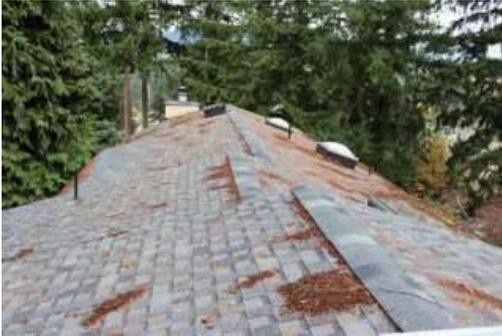
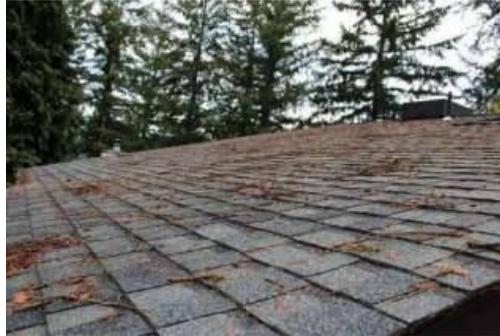
Significant amounts of debris such as leaves, needles, seeds, etc. have accumulated on the roof surface. Water may not flow easily off the roof, and can enter gaps in the roof surface. Leaks can occur as a result. This is a conducive condition for wood-destroying organisms. Recommend cleaning debris from the roof surface now and as necessary in the future.

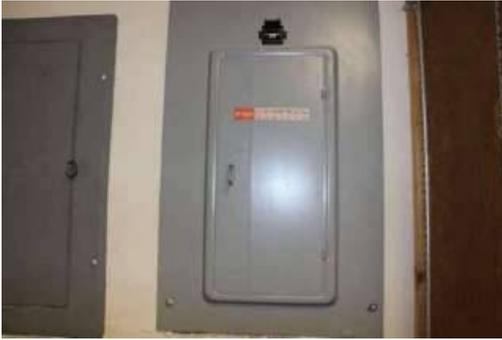
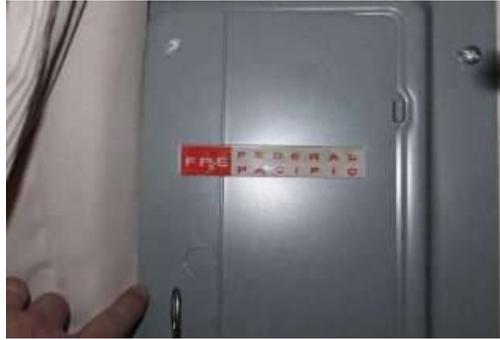
Panel(s) #A, B and C were manufactured by the Federal Pacific Electric company and used "Stab-Lok" circuit breakers. There is significant evidence that both double and single pole versions of these circuit breakers fail by not tripping when they are supposed to. However, in 2011 the Consumer Products Safety Commission (CPSC) closed an investigation into this product because they did not have enough data to establish that the circuit breakers pose a serious risk of injury to consumers. Regardless, and due to other evidence of safety issues, recommend that a qualified electrician carefully evaluate all Federal Pacific panels and make repairs as necessary. Consider replacing Federal Pacific panels with modern panels that offer more flexibility for new,

safer protective technologies like ground fault circuit interrupters (GFCIs) and arc fault circuit interrupters (AFCIs). For more information, visit:  
<https://www.reporthost.com/?FP1>  
<https://www.reporthost.com/?FP2>  
<https://www.reporthost.com/?FP3>

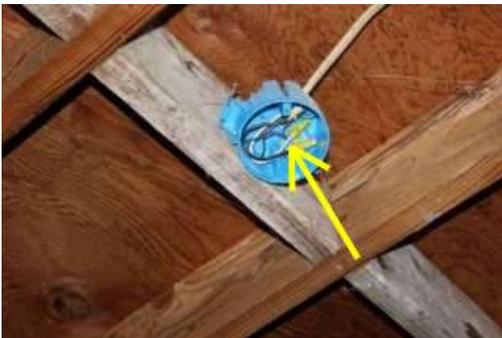
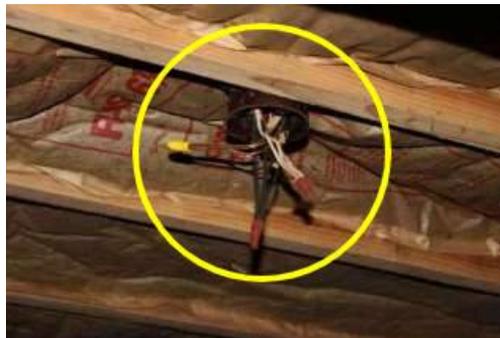
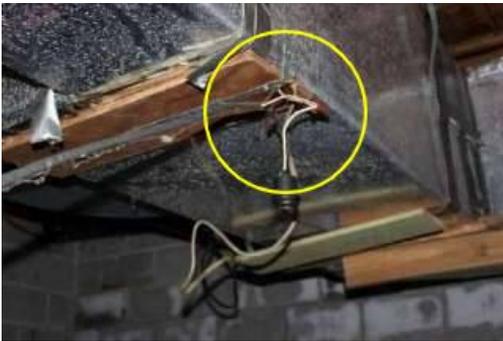
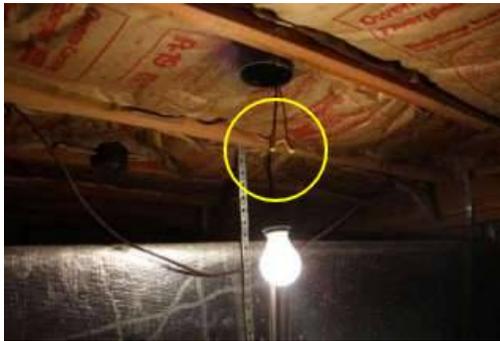
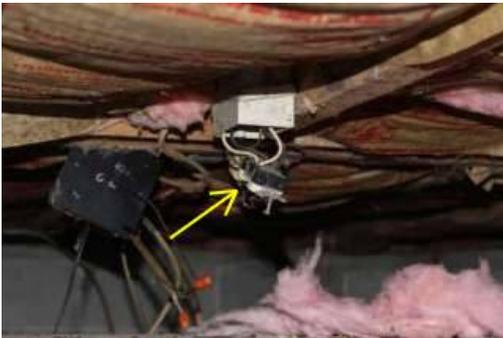
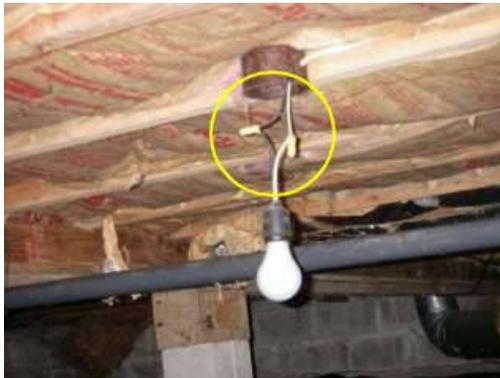
Wire splices were exposed and were not contained in a covered junction box throughout garage and basement. This is a potential shock or fire hazard. Recommend that a qualified electrician repair per standard building practices. For example, by installing permanently mounted junction boxes with cover plates where needed to contain wiring splices.

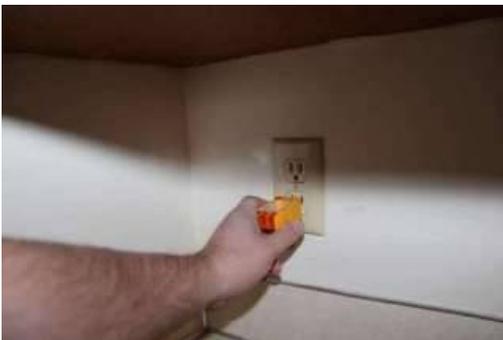
Several receptacles were worn, broken, or damaged throughout residence. This is a potential shock or fire hazard. Recommend that a qualified electrician replace such receptacles as necessary.

Photo 100-1 Kitchen

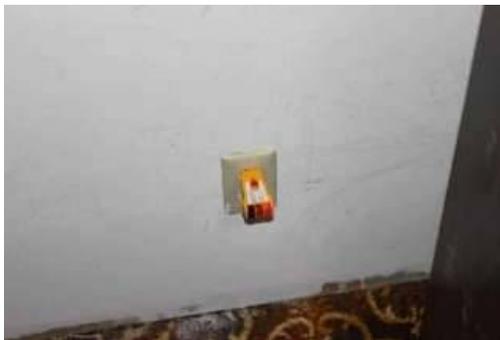
Photo 100-2 Utility room

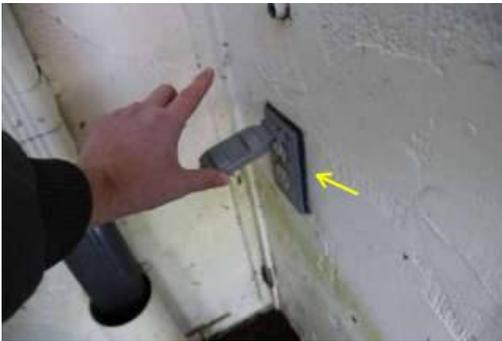
Photo 101-1

Exterior electric receptacles on SE side of residence was loose and/or not securely anchored. Wire conductors can be damaged due to repeated movement and/or tension on wires, or insulation can be damaged. This is a shock and fire hazard. Recommend that a qualified electrician repair as necessary.

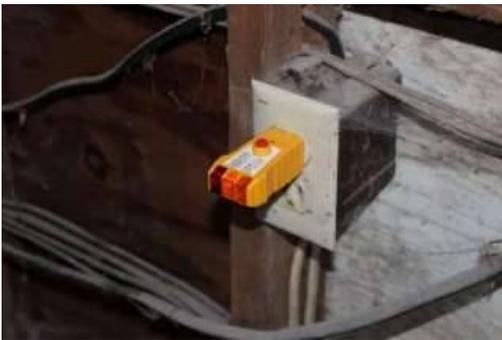
Photo 102-1

One electric receptacle had reverse-polarity wiring in the garage, where the hot and neutral wires were reversed. This is a shock hazard. Recommend that a qualified electrician repair as necessary. For more information, visit: <https://www.reporhost.com/?RPR>

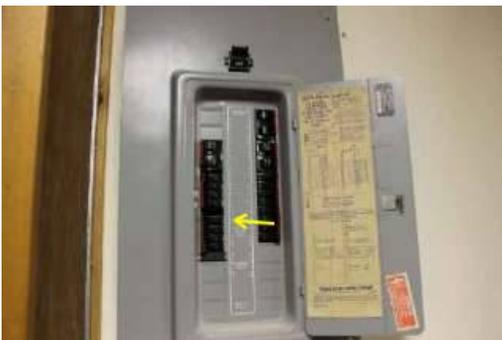
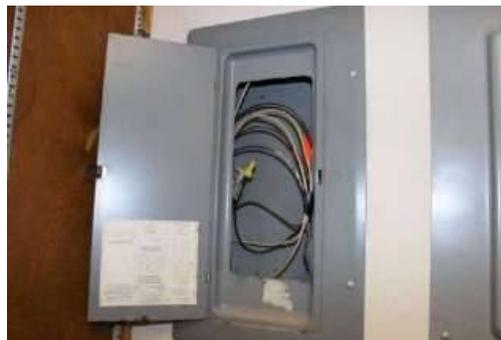
One slot where a circuit breakers is normally installed was open in panel(s) #A & #D has open spliced wires. Energized equipment was exposed and is a shock hazard. Recommend that a qualified person install closure covers where missing.

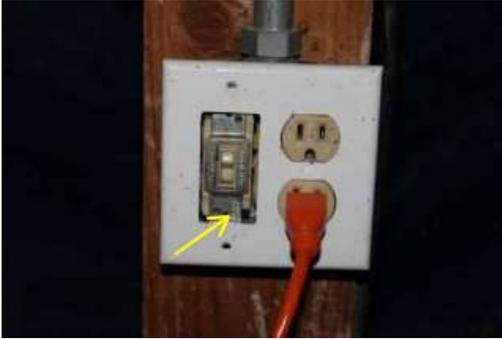
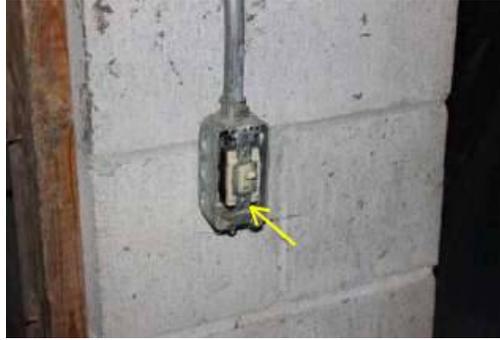
Cover plates for switches in the garage and basement was missing. These plates are intended to contain fire and prevent electric shock from occurring due to exposed wires. Recommend that a qualified person install cover plates where necessary.

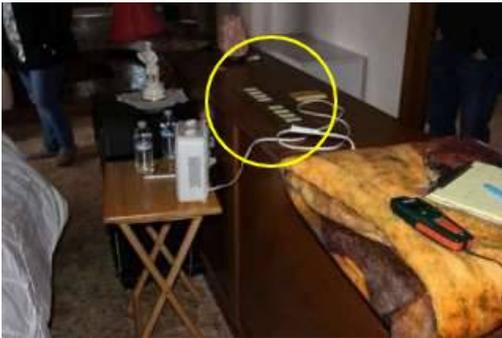
Photo 107-1

Electrical panel in master bedroom that controls lighting and other unknown functions has several broken buttons and missing the legend. Have qualified electrician evaluate and repair as necessary.

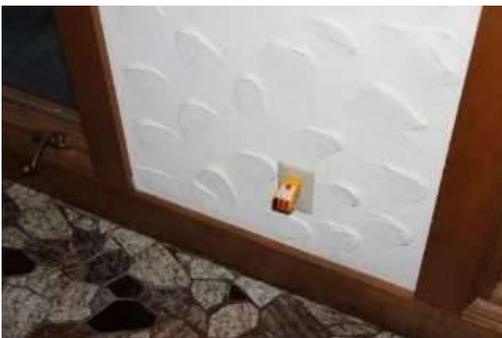
Photo 108-1

Receptacle in master bedroom tripped circuit once tester was installed. The bedroom lost power and the owner had to re-trip breaker. Have qualified electrician evaluate and repair as necessary.

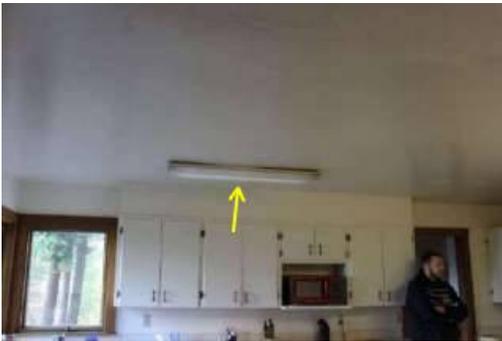
One or more light fixtures were inoperable (didn't turn on when nearby switches were operated). Recommend further evaluation by replacing bulbs and/or consulting with the property owner. If replacing bulbs doesn't work and/or no other switch(es) can be found, then recommend that a qualified electrician evaluate and repair or replace light fixtures as necessary.

Photo 109-1 Kitchen

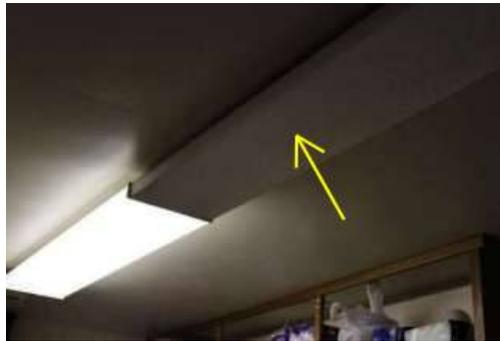
Photo 109-2 Laundry room

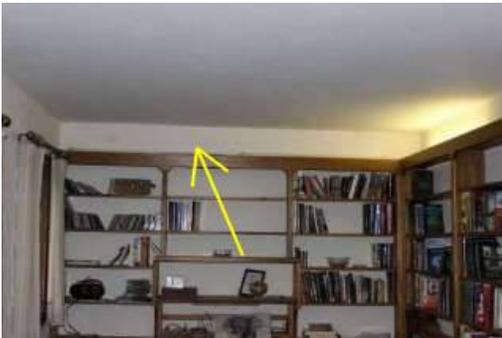
Photo 109-3 Wet bar

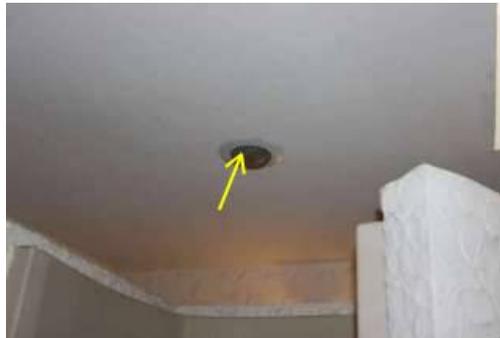
Photo 109-4 Master bathroom shower

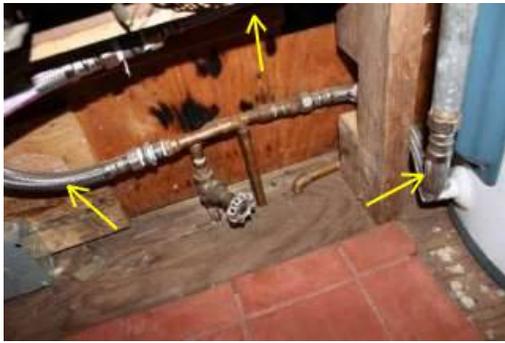
Photo 110-1

Multiple flexible connectors were installed in series in one or more water supply lines in the sauna to the water heater. Only one flexible connector should be used between rigid piping and appliances. Recommend that a qualified plumber evaluates and repairs as necessary.

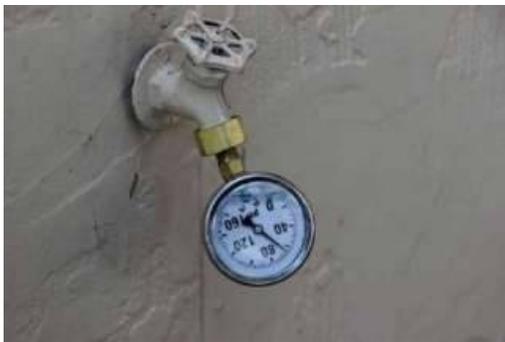
Photo 111-1

111) 🛠️🔧 Both hose bibs were missing backflow prevention devices. These devices reduce the likelihood of gray water entering the potable water supply. Recommend installing backflow prevention devices on all hose bibs where missing. They are available at most home improvement stores and are easily installed. For more information, visit: <https://www.reporhost.com/?BKFLOW>

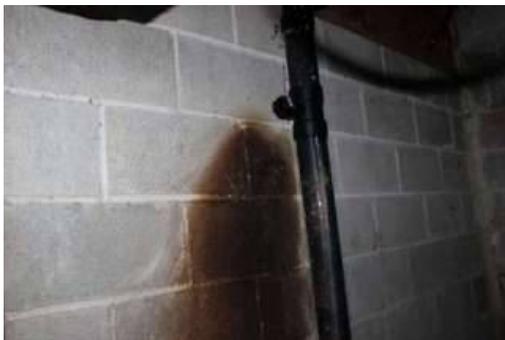
Photo 112-1

112) 🔍🔧🔧 Stains were found in one of the waste lines in the basement, but no active leaks were found near the stains. This may indicate that past leaks have occurred. Consult with the property owner about this, and either monitor these areas in the future for leaks or have a qualified plumber evaluate and repair as necessary.

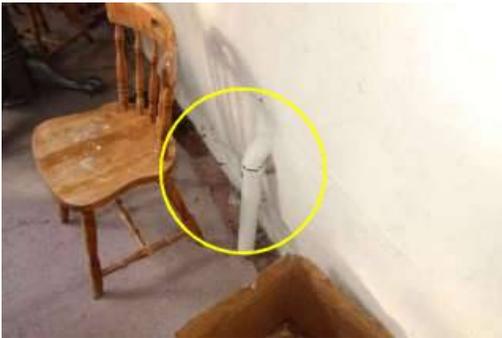
Photo 113-1

113) 🔍 Unknown pipe broke on exterior of residence. Have qualified person evaluate and repair as necessary.

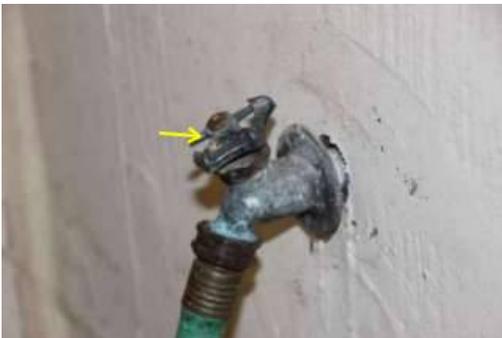
Photo 114-1

114) 🔍 Hose bib handle was broken next to the front door. Recommend that a qualified person replace handles or make repairs as necessary.

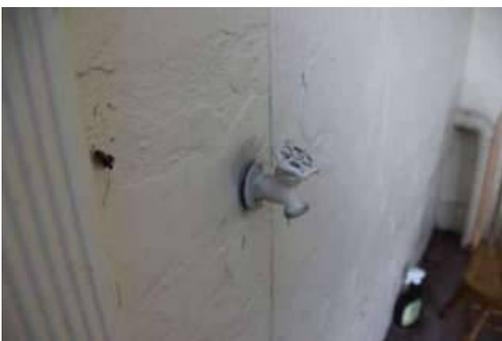
Photo 115-1

115) 🚨 Both hose bibs weren't anchored securely to the structure's exterior. Water supply pipes can be stressed when hose bibs are turned on and off and when hoses are pulled. Leaks may occur as a result. Recommend that a qualified person install fasteners per standard building practices.
