# Inspection Report

Elma WA 98541

**Prosser Inspections**

<b>Date:</b> 1/14/2021	<b>Time:</b> 01:00 PM	<b>Report ID:</b>
<b>Property:</b>	<b>Customer:</b>	<b>Real Estate Professional:</b> Floyd Sheldon Windermer Yelm

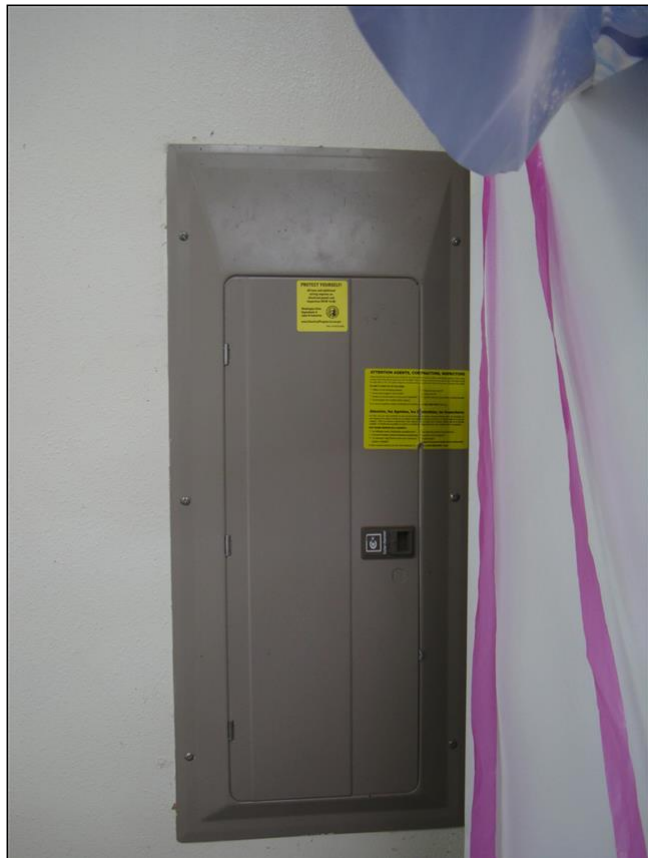
4.1 Item 1(Picture)

**4.1** At the time of the inspection a non-invasive visual inspection of the electrical panel revealed no obvious major issues. We make every effort to uncover any issues at the time of the inspection, however, underlying issues may be present and events after the inspection may cause issues to arise.

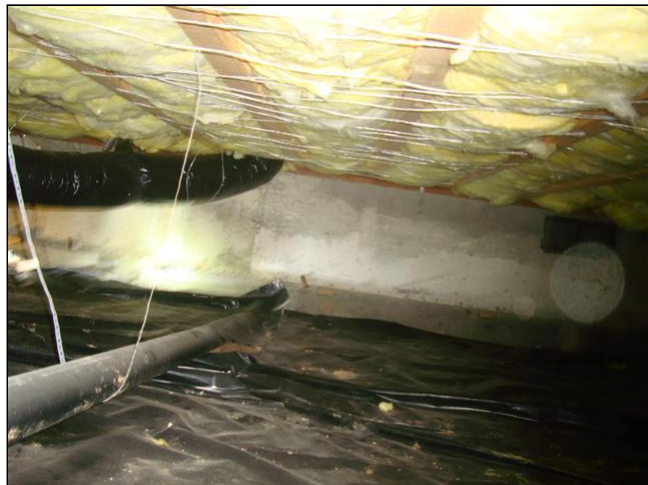
7.0 Item 1(Picture)

7.0 (1) At the time of the inspection a non-invasive visual inspection of the foundation and crawlspace revealed no obvious major issues. We make every effort to uncover any issues at the time of the inspection, however, underlying issues may be present and events after the inspection may cause issues to arise.
