**COGGESHALL
HOME
INSPECTIONS**

Home Inspection Report

2870 W Polk Ave., Anaheim , CA 92801

Friday, August 16, 2019

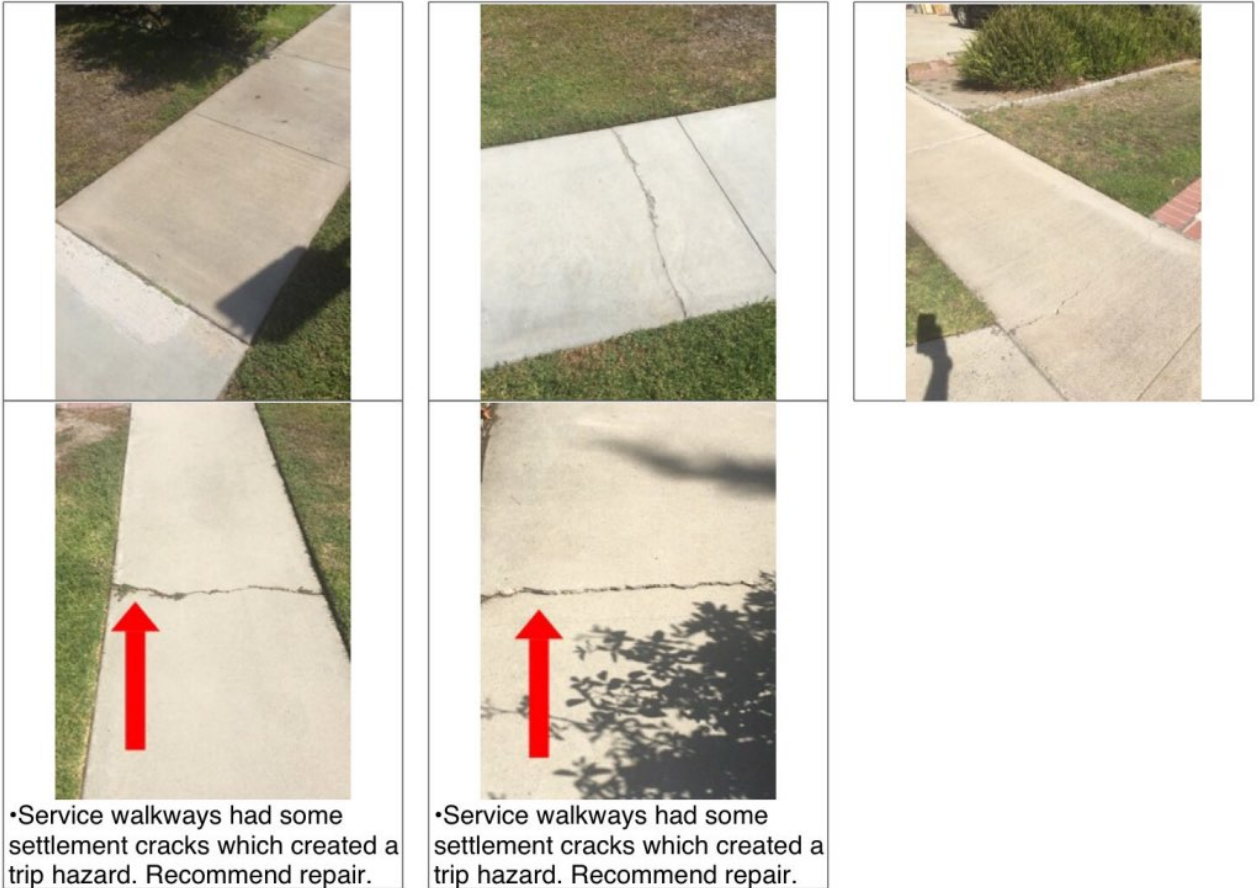
- None Not Visible
Material Concrete Flagstone Gravel Brick Other:
Condition Satisfactory Marginal Poor Trip hazard Typical cracks Pitched towards home
 Settling cracks Public sidewalk needs repair
Comments **•Service walkways had some settlement cracks which created a trip hazard. Recommend repair.**
Photos

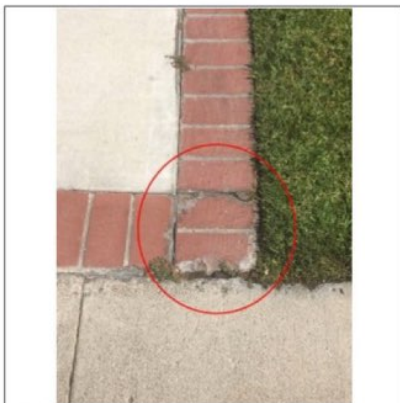
•Driveway had some settlement cracks and damaged bricks. Recommend repair.

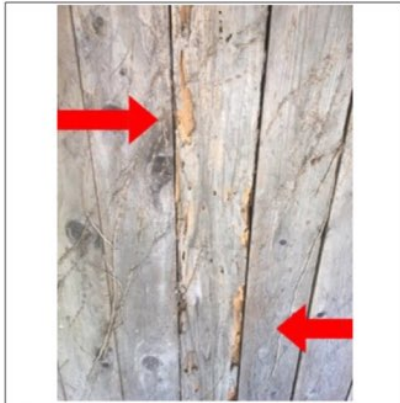
•Sections of wooden fencing showed signs of moisture damage and possible insect damage. Recommend repair damaged sections as needed.

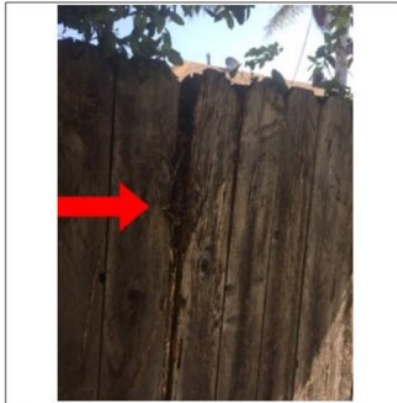
•Sections of wooden fencing showed signs of moisture damage and possible insect damage. Recommend repair damaged sections as needed.

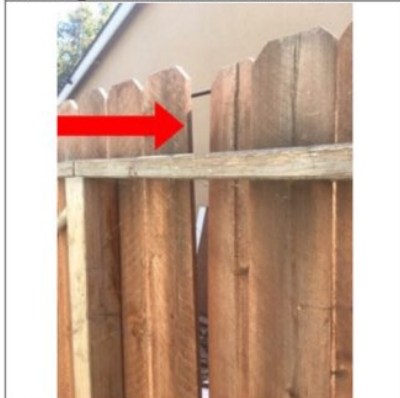
•Sections of wooden fencing showed signs of moisture damage and possible insect damage. Recommend repair damaged sections as needed.

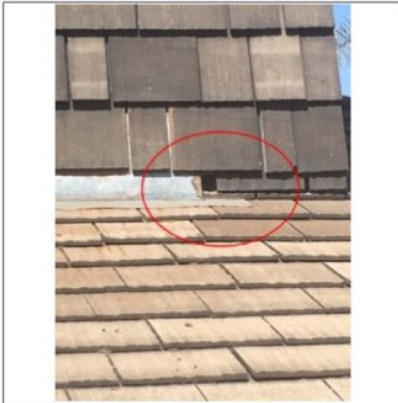
•Flashing had Pulled away from chimney. Recommend repair.
•Some sections of flashing at eaves edge was damaged/missing. Recommend repair.

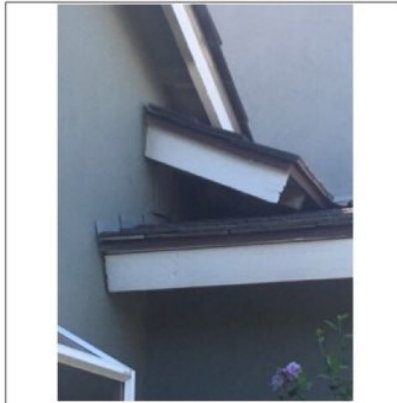
•Flashing had Pulled away from chimney. Recommend repair.
•Some sections of flashing at eaves edge was damaged/missing. Recommend repair.

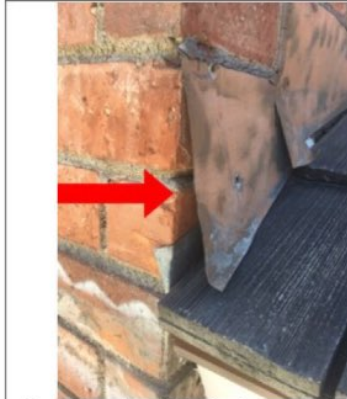
•Flashing had Pulled away from chimney. Recommend repair.
•Some sections of flashing at eaves edge was damaged/missing. Recommend repair.

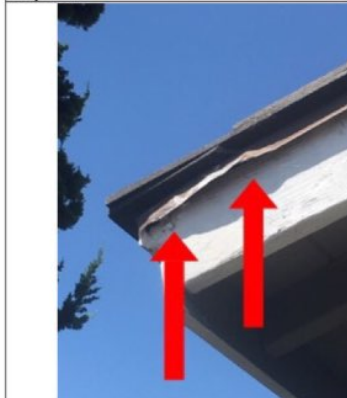
•Flashing had Pulled away from chimney. Recommend repair.
•Some sections of flashing at eaves edge was damaged/missing. Recommend repair.

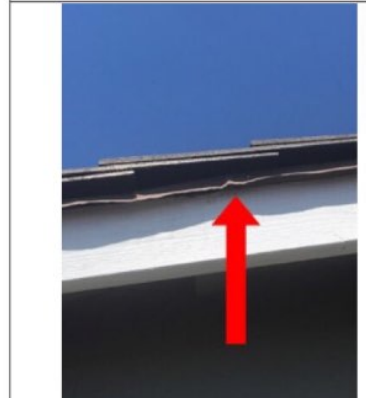
•Flashing had Pulled away from chimney. Recommend repair.
•Some sections of flashing at eaves edge was damaged/missing. Recommend repair.

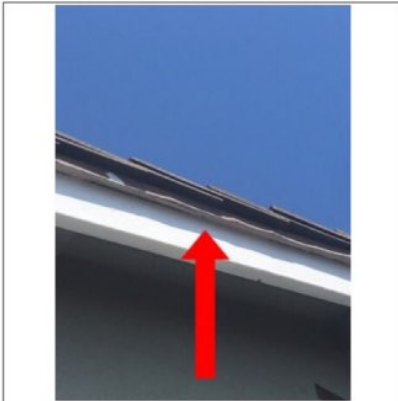
•Flashing had Pulled away from chimney. Recommend repair.
 •Some sections of flashing at eaves edge was damaged/missing. Recommend repair.

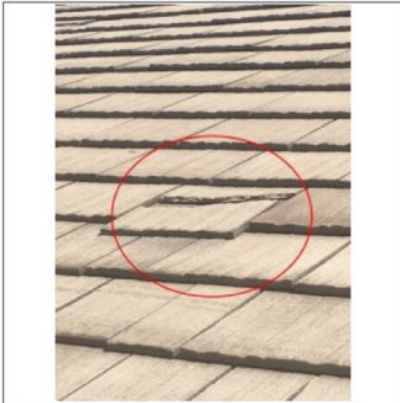
•Roof had damaged and missing concrete tile shingles. Recommend licensed roofing contractor inspect and evaluate further for repairs.

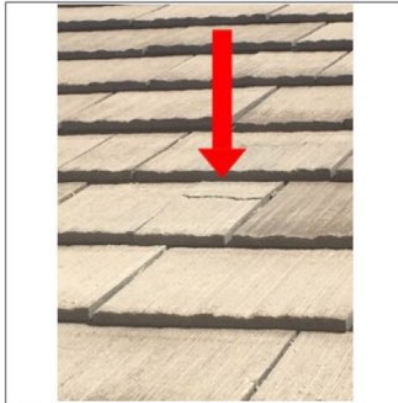
•Roof had damaged and missing concrete tile shingles. Recommend licensed roofing contractor inspect and evaluate further for repairs.

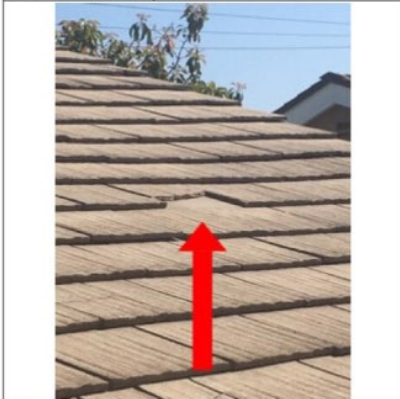
•Roof had damaged and missing concrete tile shingles. Recommend licensed roofing contractor inspect and evaluate further for repairs.

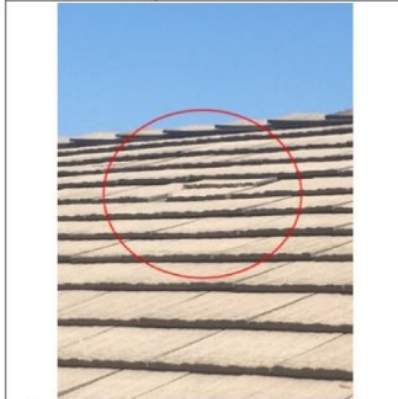
•Roof had damaged and missing concrete tile shingles. Recommend licensed roofing contractor inspect and evaluate further for repairs.

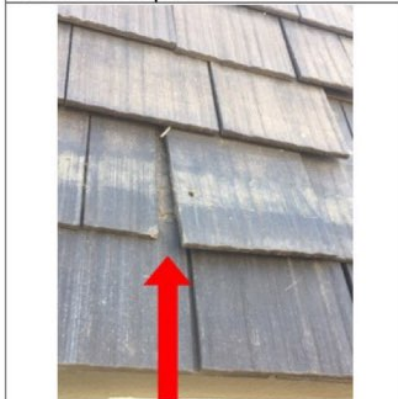
•Roof had damaged and missing concrete tile shingles. Recommend licensed roofing contractor inspect and evaluate further for repairs.

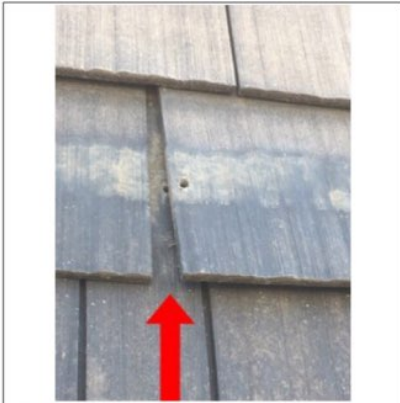
•Roof had damaged and missing concrete tile shingles. Recommend licensed roofing contractor inspect and evaluate further for repairs.

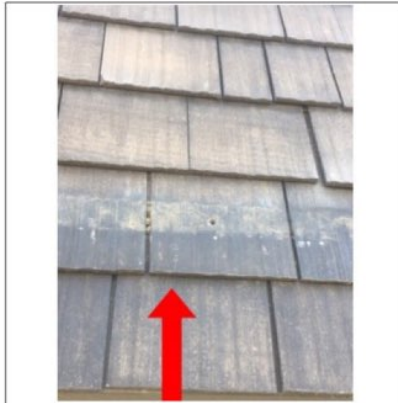
•Roof had damaged and missing concrete tile shingles. Recommend licensed roofing contractor inspect and evaluate further for repairs.

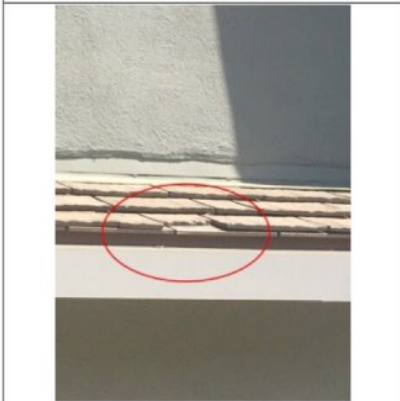
•Roof had damaged and missing concrete tile shingles. Recommend licensed roofing contractor inspect and evaluate further for repairs.

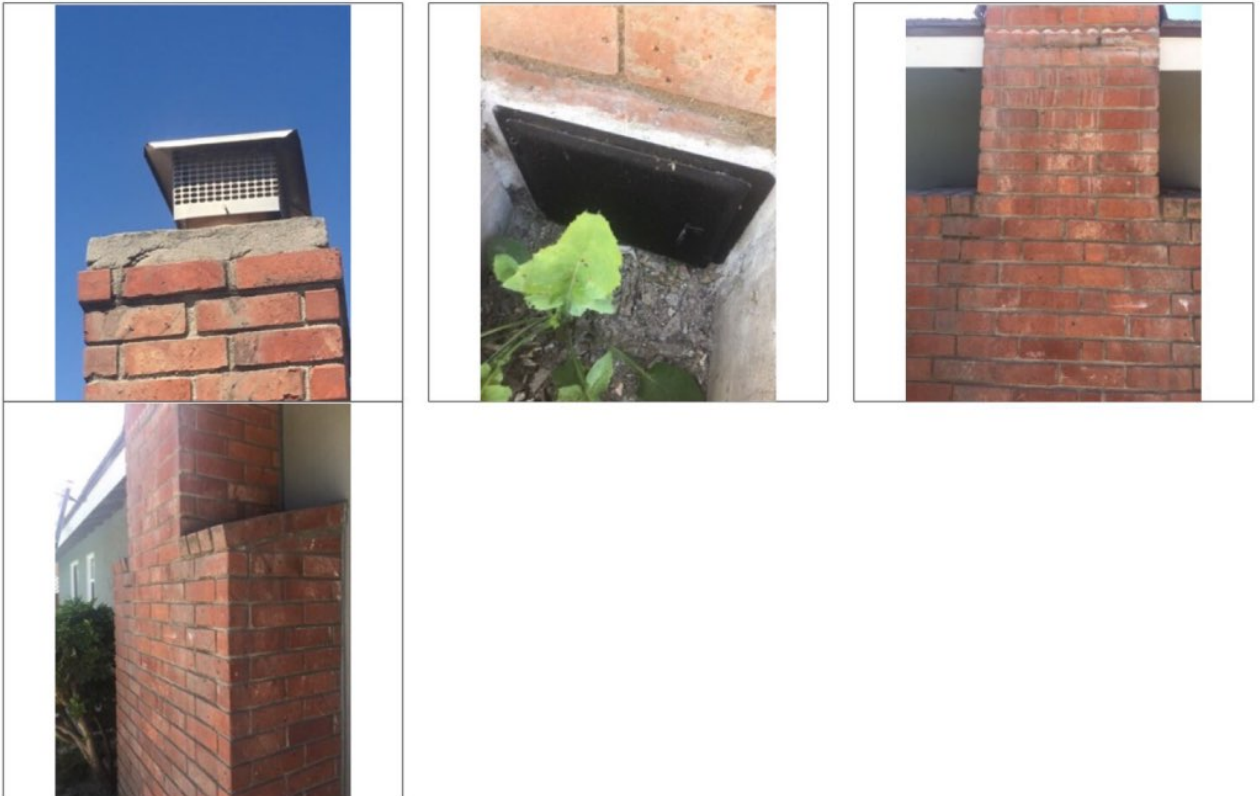
Comments Chimney chase had some minor cracks but was in overall satisfactory condition at time of inspection.

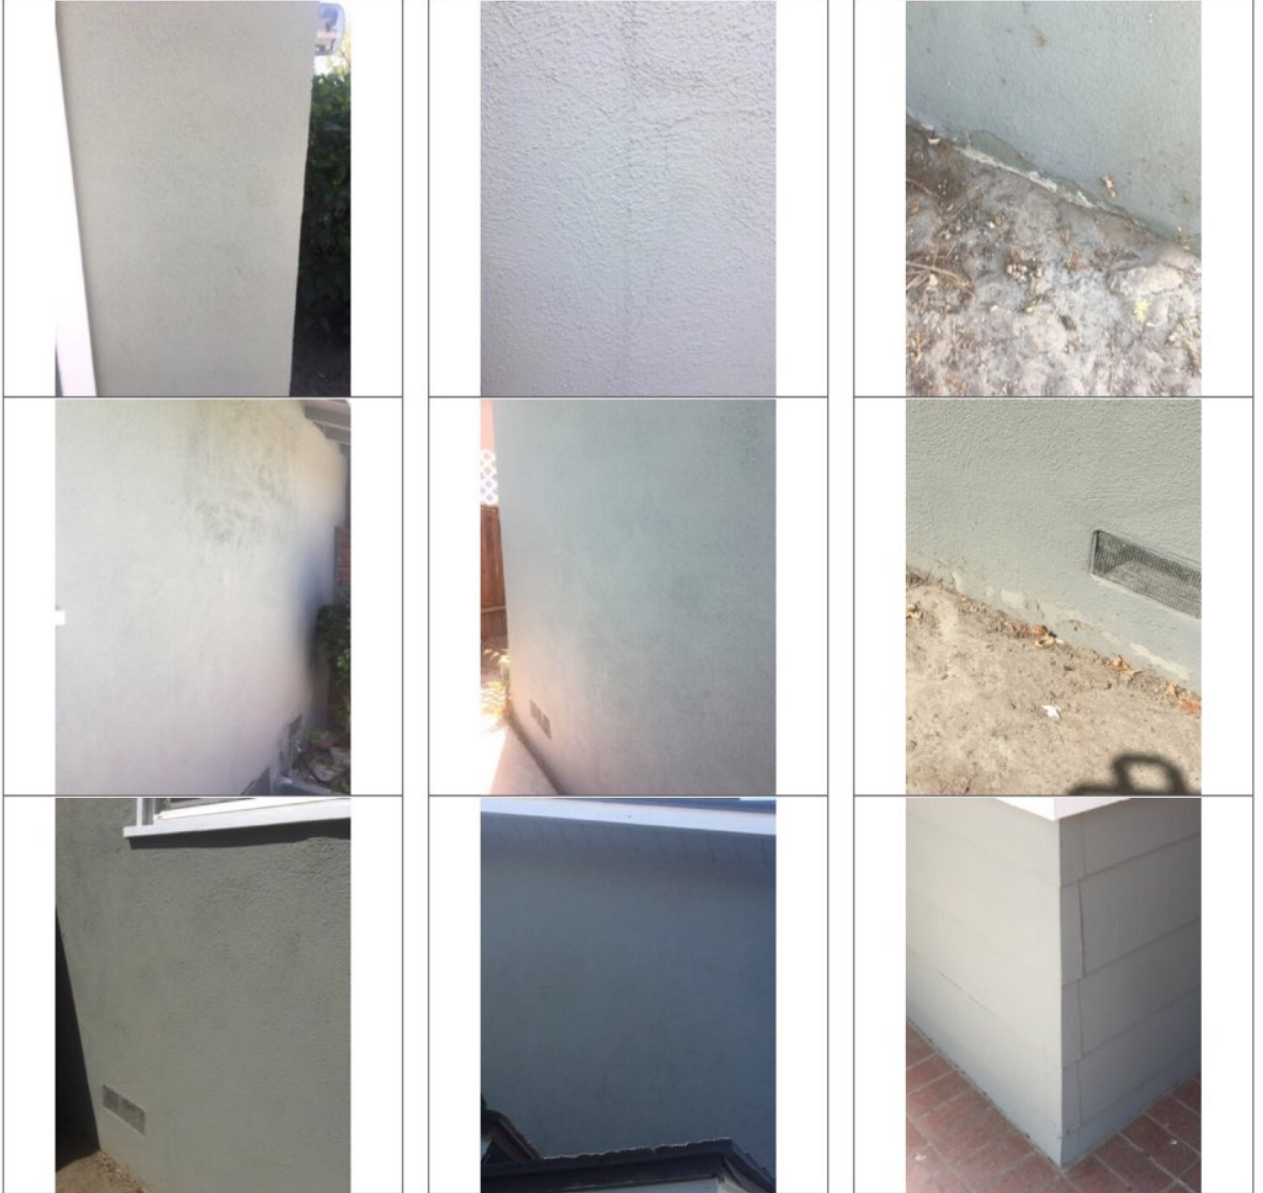
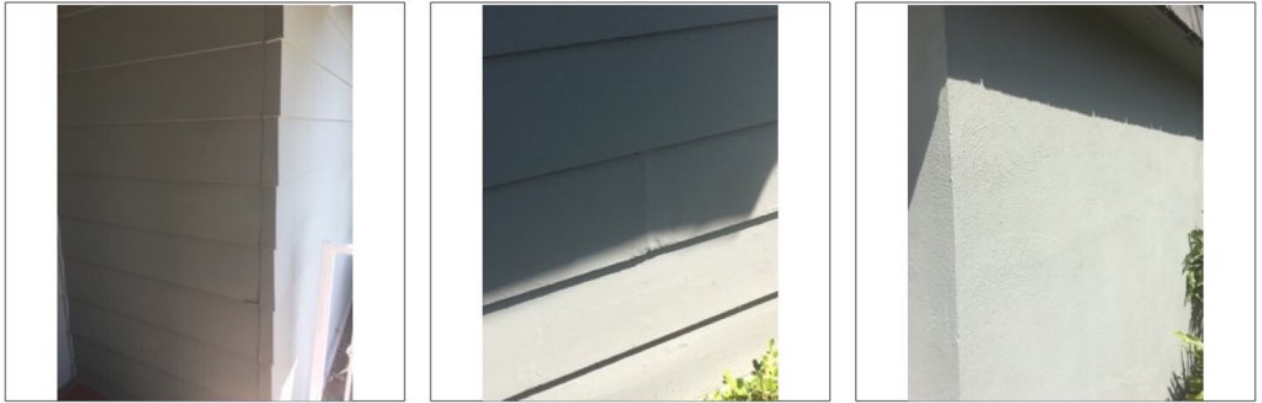
-Stucco and wood siding was in need of painting and caulking in some sections but was in overall satisfactory condition at time of inspection.

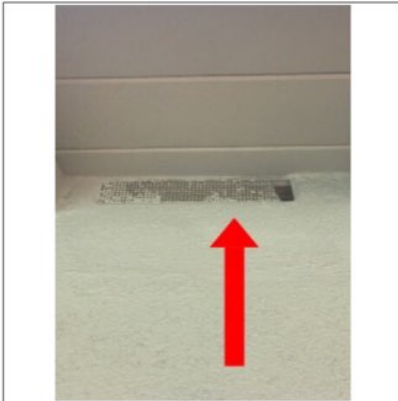
•Some Soffit vents damaged. Recommend repair to prevent pest intrusion.
•Some sections of wooden soffits showed signs of possible insect damaged.

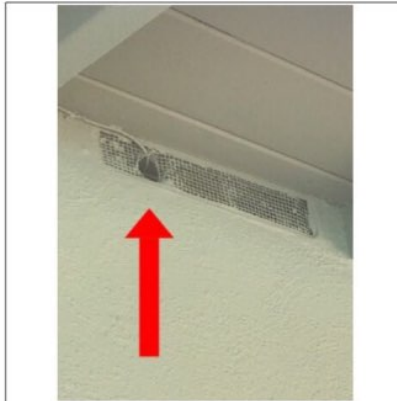
•Some Soffit vents damaged. Recommend repair to prevent pest intrusion.
 •Some sections of wooden soffits showed signs of possible insect damaged.

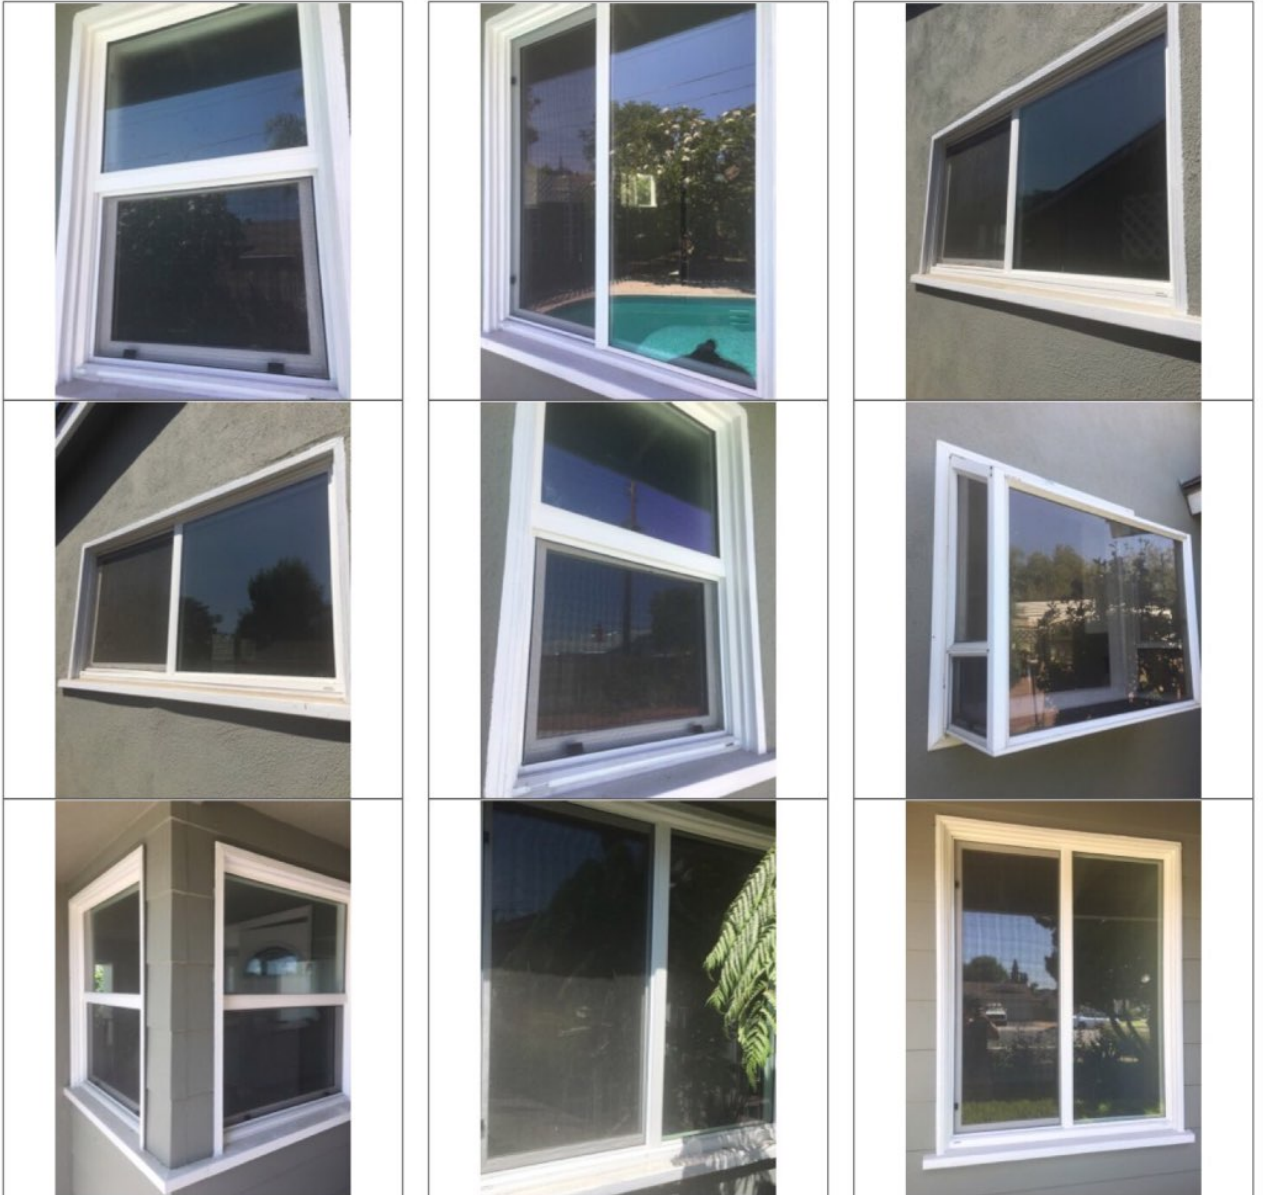
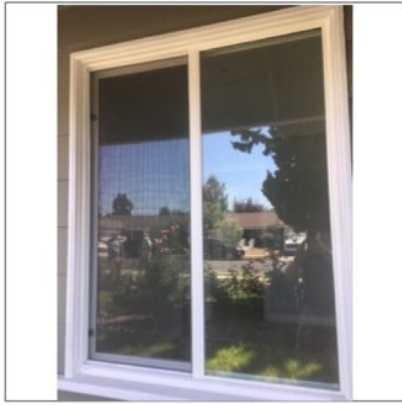
Comments •Windows were in overall satisfactory condition at time of inspection.

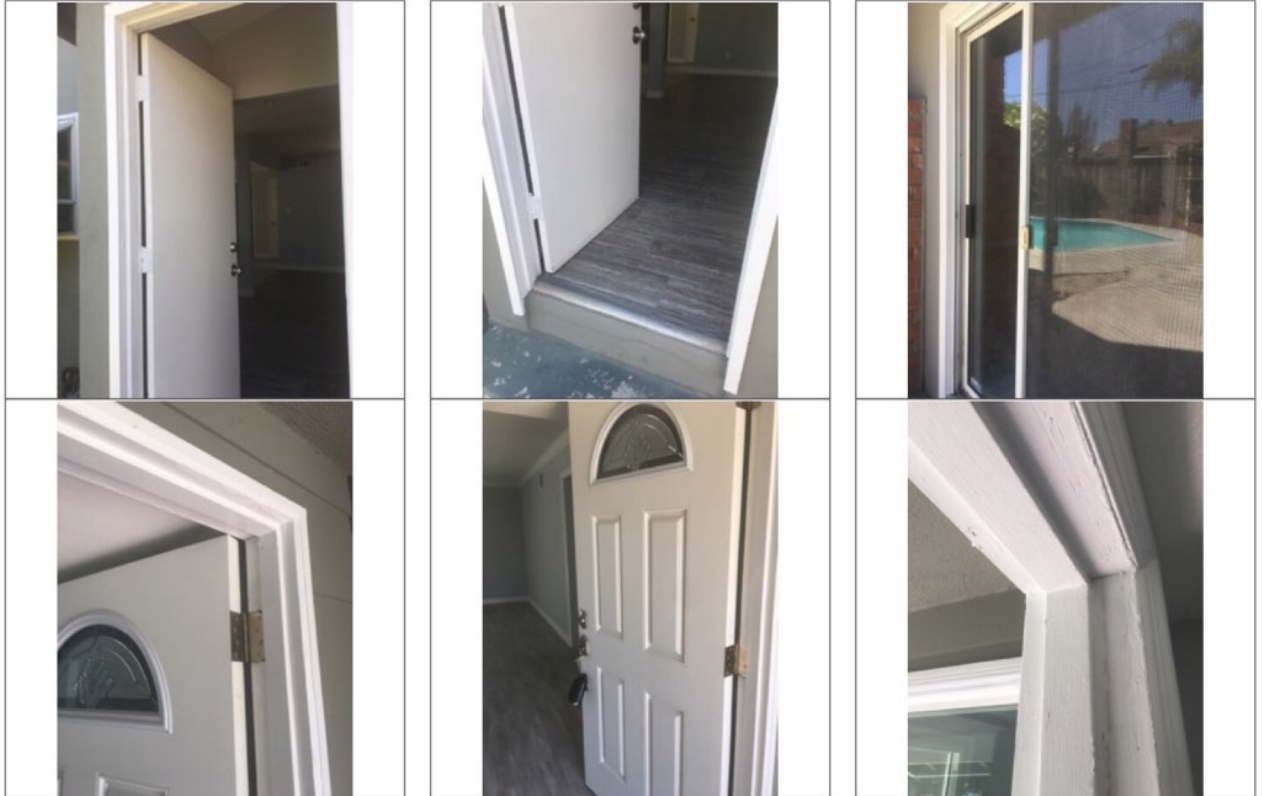
Comments **Exterior doors were in overall satisfactory condition at time of inspection.**

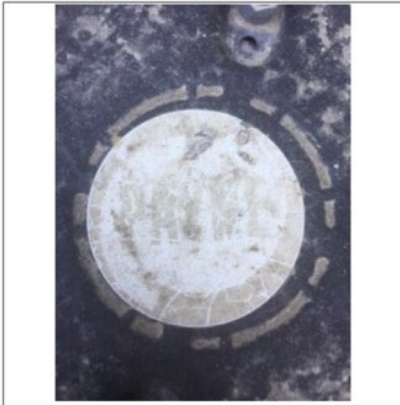
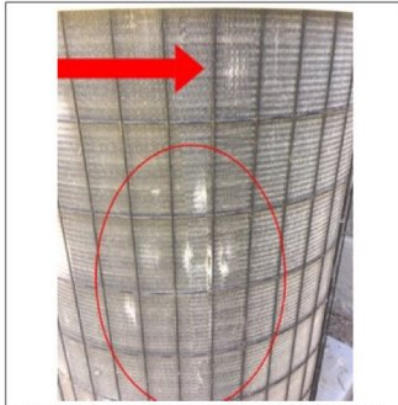
Comments **Outside condenser unit coils on AC unit were damaged. Recommend licensed licensed HVAC technician inspect and evaluate further for repairs.**

•Outside condenser unit coils on AC unit were damaged. Recommend licensed HVAC technician inspect and evaluate further for repairs.

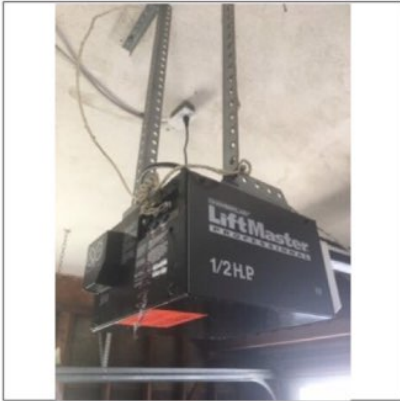
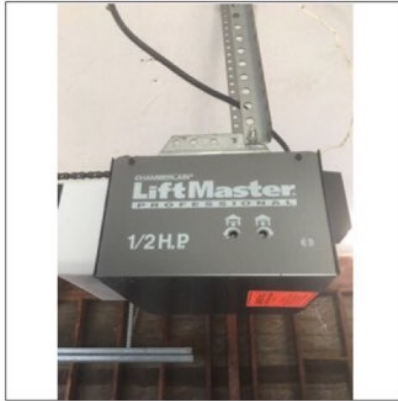
- None N/A
 Operable Inoperable
- Garage door opener was not working at time of inspection.**
- Operation
Comments
Photos

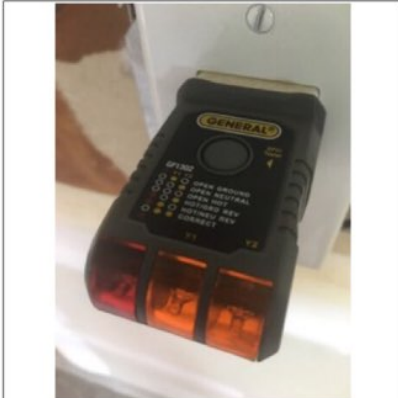
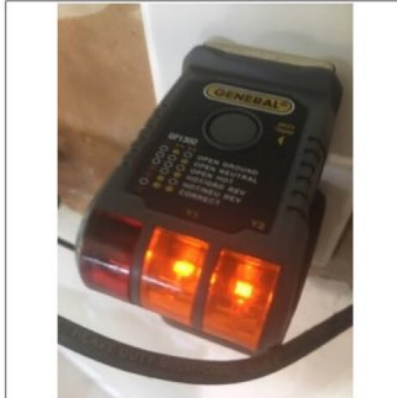
Comments **Some electrical receptacles in garage did have power. Recommend licensed electrician inspect and evaluate further for repairs.**

Some electrical receptacles in garage did have power. Recommend licensed electrician inspect and evaluate further for repairs.

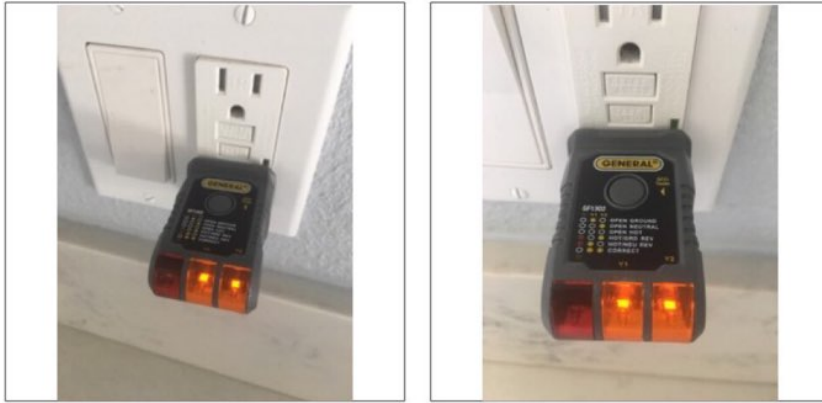
Comments **One electrical receptacle in kitchen was ungrounded. Recommend upgrading to grounded electrical receptacle.**

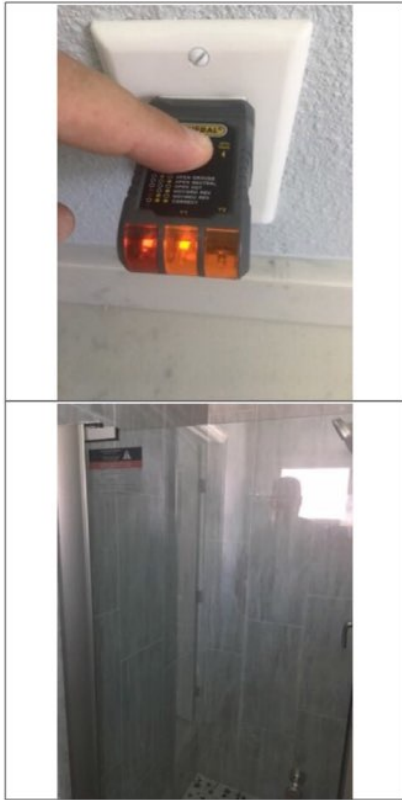
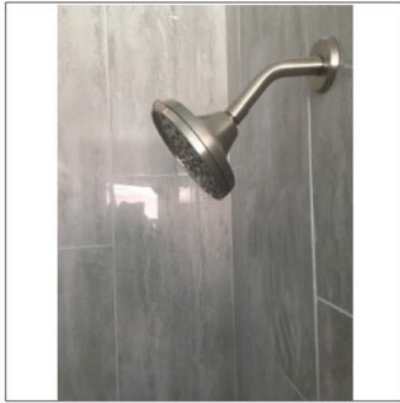
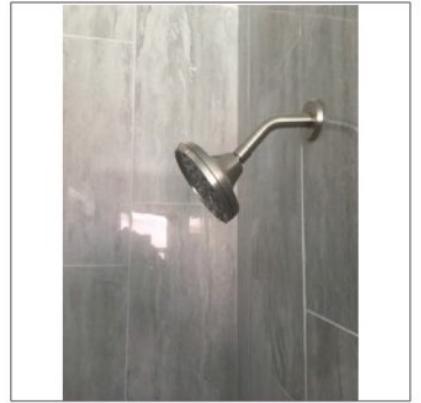
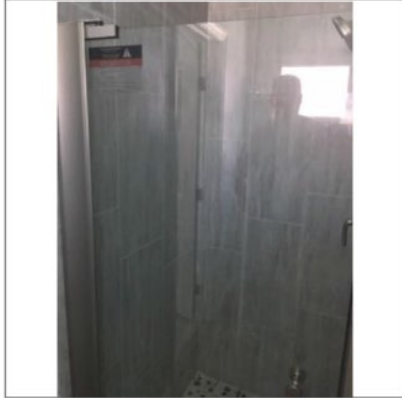
- Water flow for shower was extremely poor. Recommend licensed plumber inspect and evaluate further for repairs.
- Ungrounded non GFCI electrical receptacles were found in master bathroom. Potential safety hazard. Recommend licensed electrician inspect and evaluate further for repairs.
- Shower door in master bathroom was loose and improperly installed. Recommend repair.

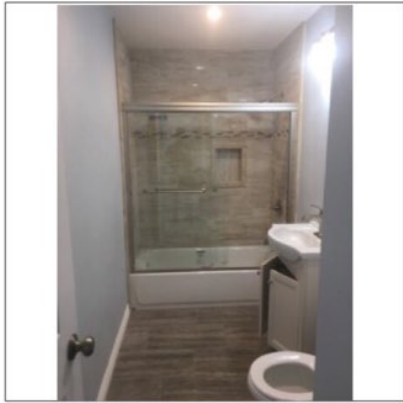
Comments
 -Water flow for shower in hallway bathroom was extremely poor. Recommend licensed plumber inspect and evaluate further for repairs.
 -Ungrounded non GFCI electrical receptacles were found in hallway bathroom. Potential safety hazard. Recommend licensed electrician inspect and evaluate further for repairs.

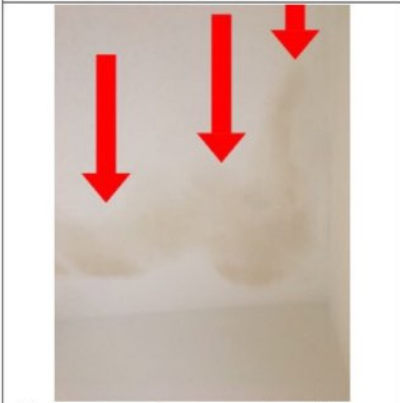
Location First floor
Type BEDROOM
Walls & Ceiling Satisfactory Marginal Poor Typical cracks Damage
Moisture stains Yes No
 Where: **Moisture stains found in guest bedroom 2 ceiling in closet and also ceiling of main room.**
Floor Satisfactory Marginal Poor Squeaks Slopes Tripping hazard
Ceiling fan None Satisfactory Marginal Poor Recommend repair/replace
Electrical Switches: Yes No Operable Receptacles: Yes No Operable
 Open ground/Reverse polarity: Yes No Safety hazard Cover plates missing
Heating source present Yes No Holes: Doors Walls Ceilings
Bedroom Egress restricted N/A Yes No
Doors None Satisfactory Marginal Poor Cracked glass Broken/Missing hardware
Windows None Satisfactory Marginal Poor Cracked glass Evidence of leaking insulated glass
 Broken/Missing hardware
Comments **Moisture stains were found on ceiling in guest bedroom 2. When tested with a moisture meter, moisture was detected at 100%. Recommend licensed mold remediation contractor inspect and evaluate further for repairs.**

•Moisture stains were found on ceiling in guest bedroom 2. When tested with a moisture meter, moisture was detected at 100%. Recommend licensed mold remediation contractor inspect and evaluate further for repairs.

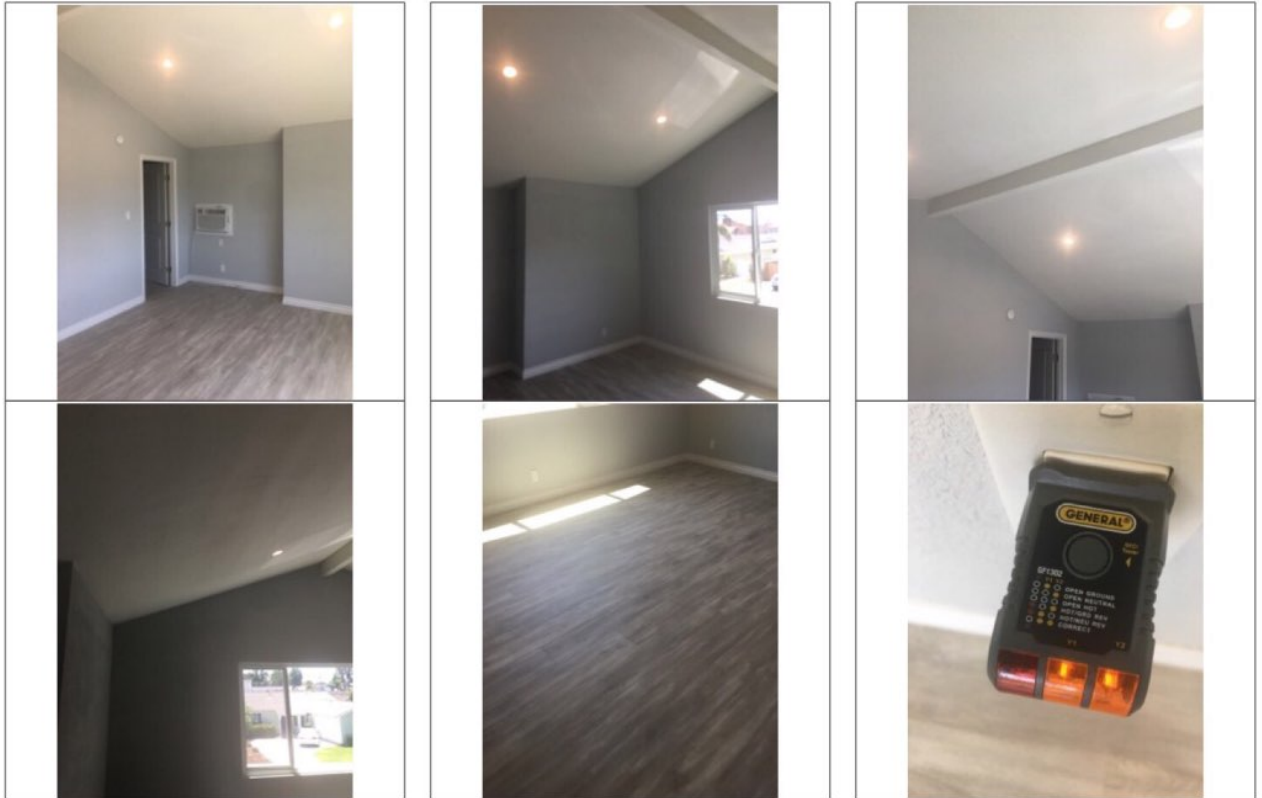
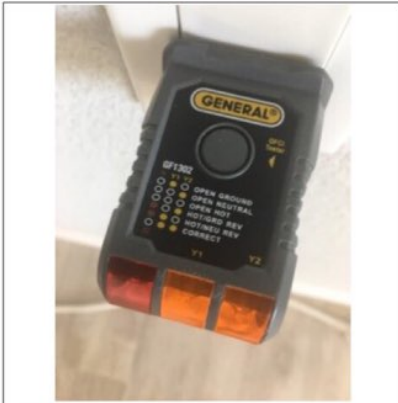
Comments •One electrical receptacle did not have power when tested with Voltage meter and GFCI detector. Recommend licensed electrician inspect and evaluate further for repairs.

•One electrical receptacle did not have power when tested with Voltage meter and GFCI detector. Recommend licensed electrician inspect and evaluate further for repairs.

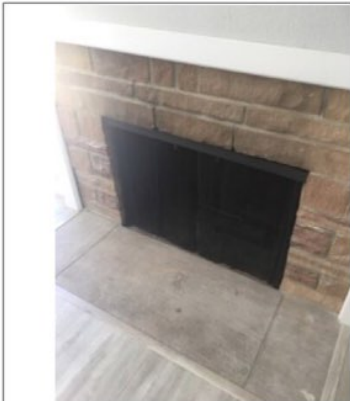
Comments •Open joints or cracks in firebrick of fireplace. Recommend properly sealing and repair.

•Open joints or cracks in firebrick of fireplace. Recommend properly sealing and repair.

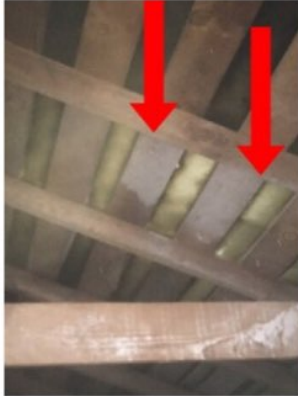
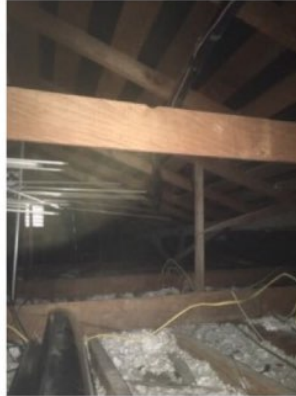
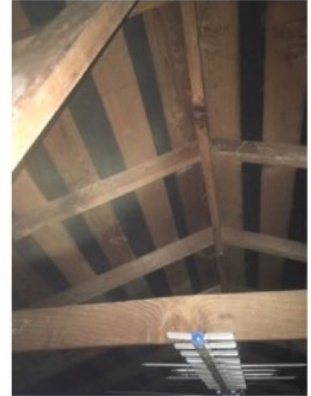
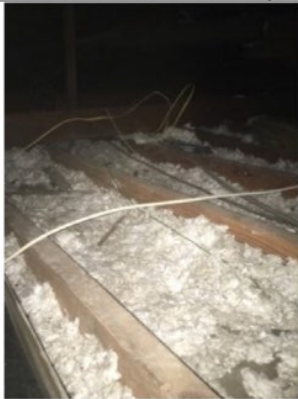
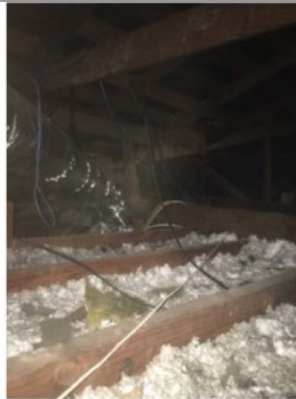
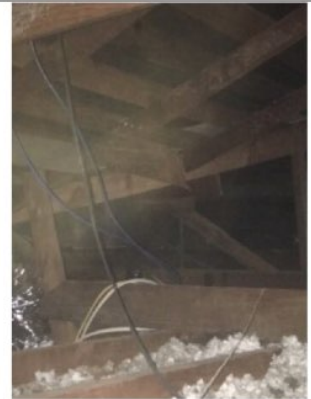
Comments **•Sheathing, examined from the attic, had some water damage, recommend repair.**
•Sheathing, examined from the attic, had some delamination due to moisture, recommend repair.
•Ventilation was marginal recommend additional ventilation be added.
•Recommend outlets be covered - SAFETY HAZARD.
•Recommend junction boxes be covered-SAFETY HAZARD.

•Sheathing, examined from the attic, had some water damage, recommend repair.
•Sheathing, examined from the attic, had some delamination due to moisture, recommend repair.

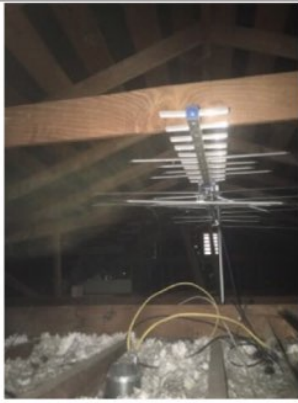
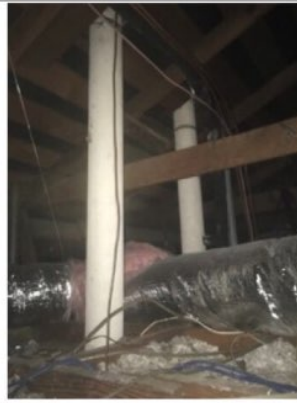
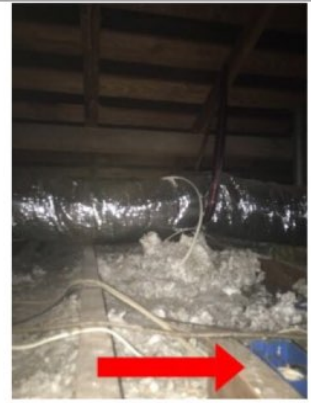
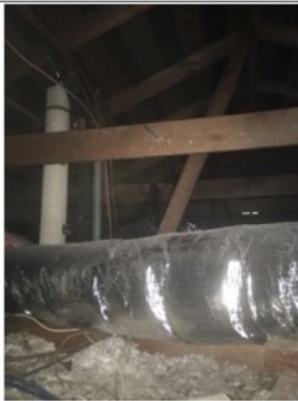
- Recommend outlets in attic be covered - SAFETY HAZARD.
- Recommend junction In attic boxes be covered-SAFETY HAZARD.

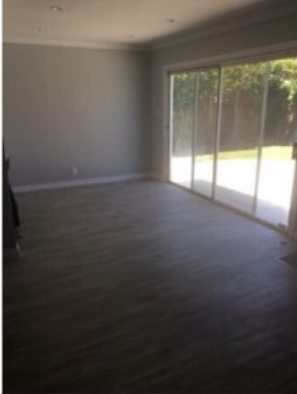
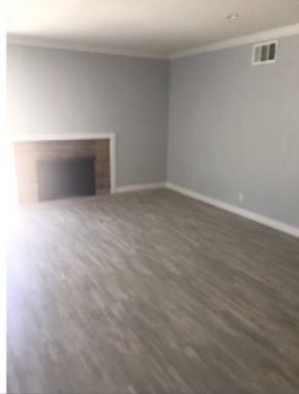
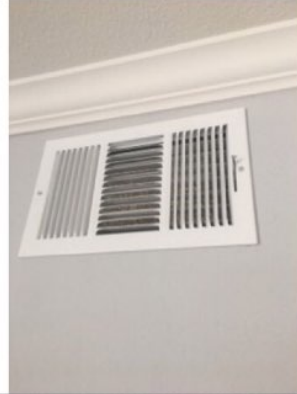
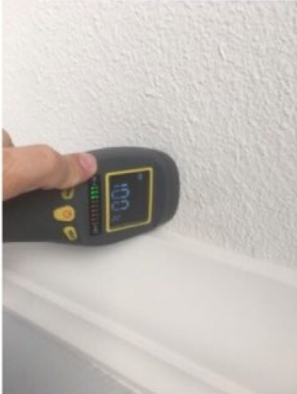
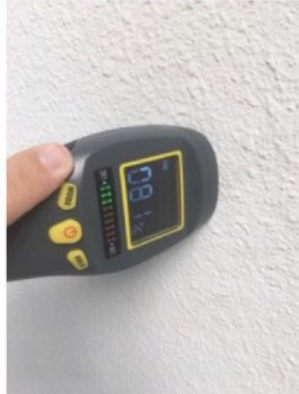
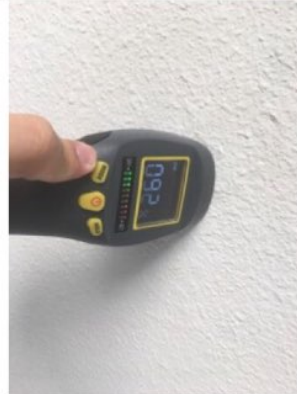
Comments **Moisture stains were found on ceiling of living room. When tested with a moisture meter it tested as wet. Recommend licensed mold remediation contractor inspect and evaluate further for repairs.**

| <p>•Moisture stains were found on ceiling of living room. When tested with a moisture meter it tested as wet. Recommend licensed mold remediation contractor inspect and evaluate further for repairs.</p> | <p>•Moisture stains were found on ceiling of living room. When tested with a moisture meter it tested as wet. Recommend licensed mold remediation contractor inspect and evaluate further for repairs.</p> | <p>•Moisture stains were found on ceiling of living room. When tested with a moisture meter it tested as wet. Recommend licensed mold remediation contractor inspect and evaluate further for repairs.</p> |

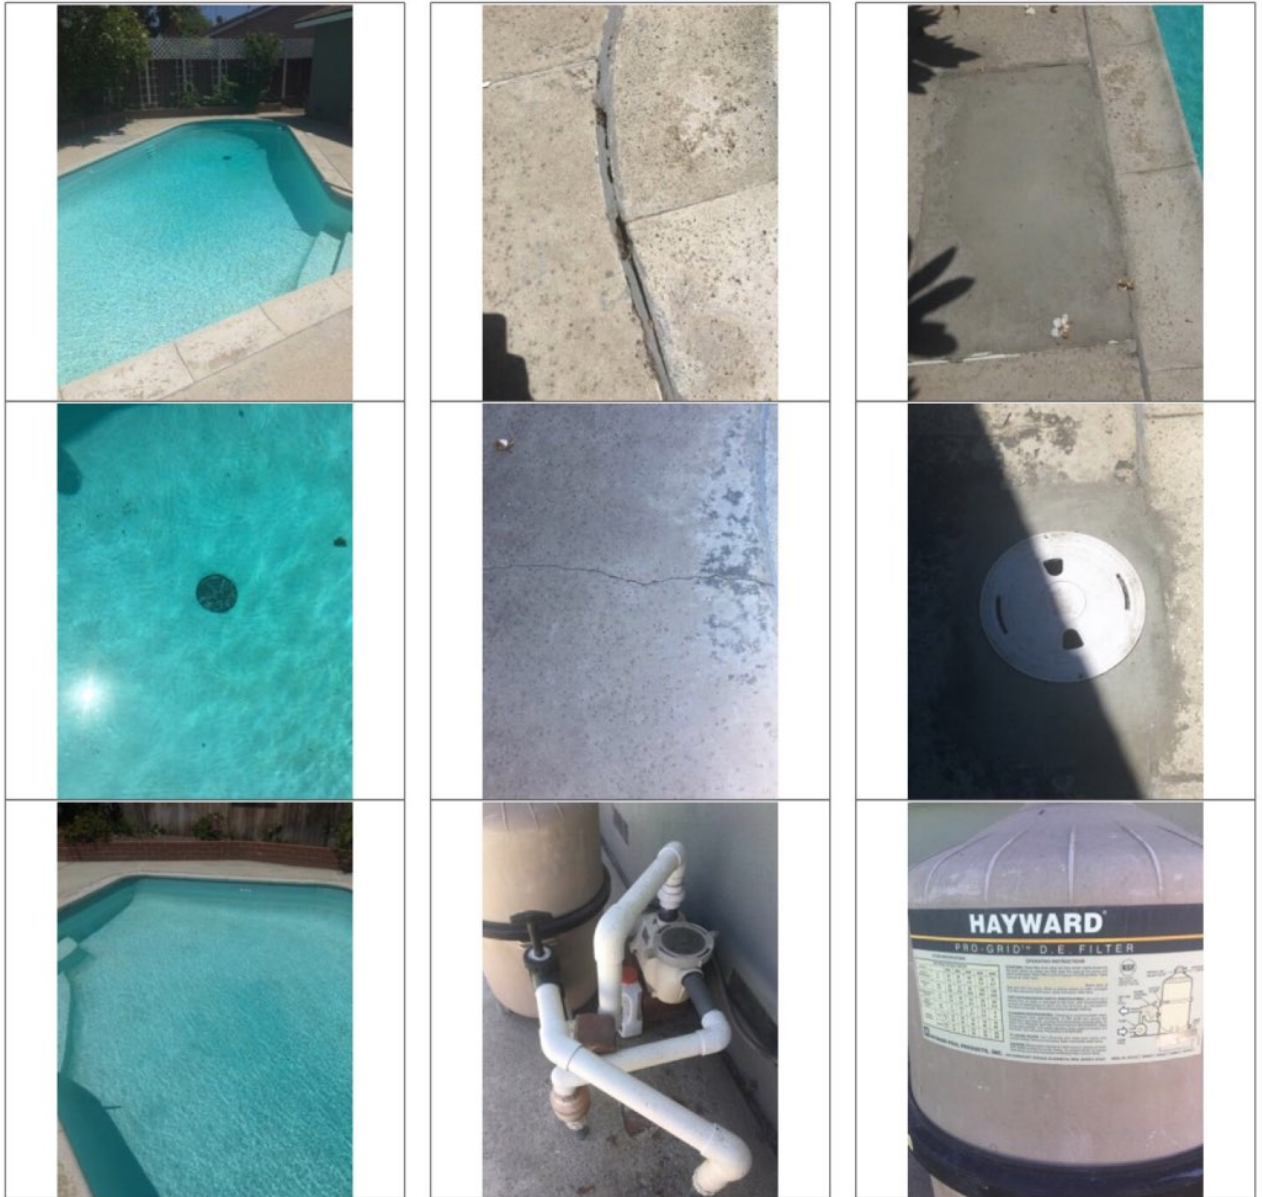
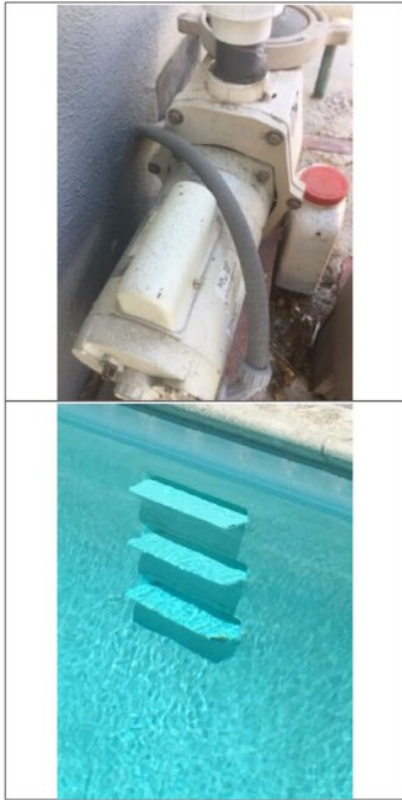
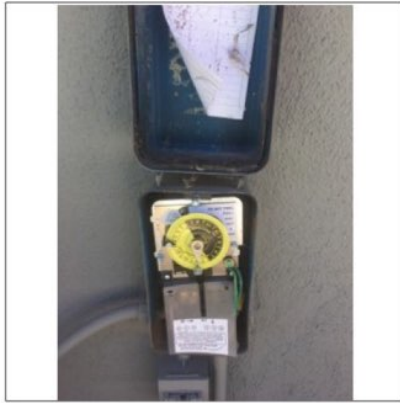
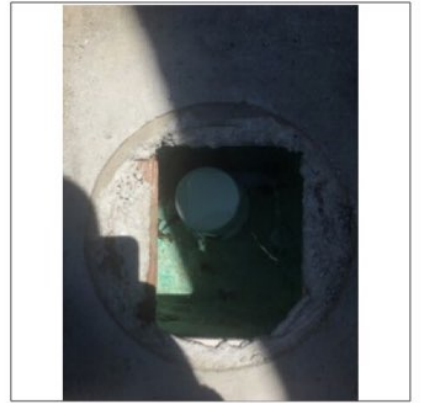
- Grout around concrete pool slabs were damaged. Recommend repair.
- Typical cracks were found around pool area.
- Filter plate at bottom of of pool was improperly installed. Recommend repair.
- Filtration system of pool was not on at time of inspection. Recommend licensed pool specialist inspect and evaluate further.
- Steps inside of pool were chipped and cracked. Potential safety hazard. Recommend repair.
