**COGGESHALL  
HOME  
INSPECTIONS**

## Home Inspection Report

**2614 184th St., Redondo Beach , CA 90278**

Monday, March 11, 2019

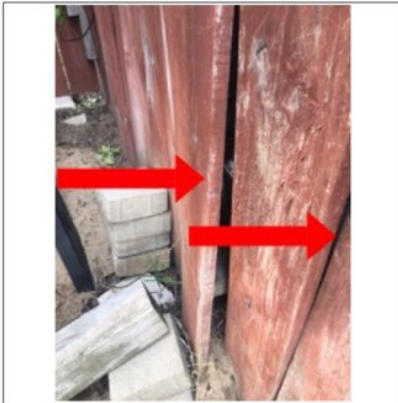
Backyard wooden fence had some damaged/rotted wooden planks. Recommend repair or replace as needed.

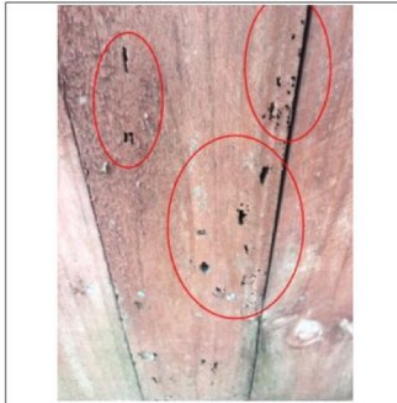
Backyard wooden fence had some damaged/rotted wooden planks. Recommend repair or replace as needed. Evidence of termite damage found in some of the wooden planks. Recommend licensed termite contractor inspect and evaluate further for repairs.

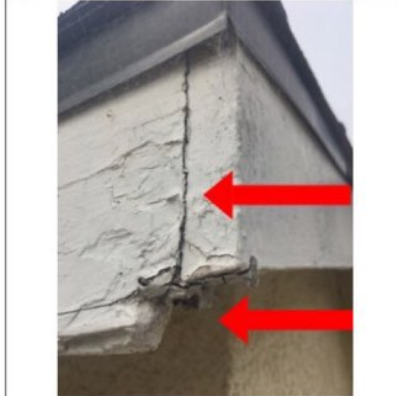
Trim had some deterioration recommend repair and painting. Some loose and missing trim recommend repair. Some rotted/damaged trim boards recommend repair/replacing damaged sections. Recommend repair of damaged trim by a qualified licensed contractor.

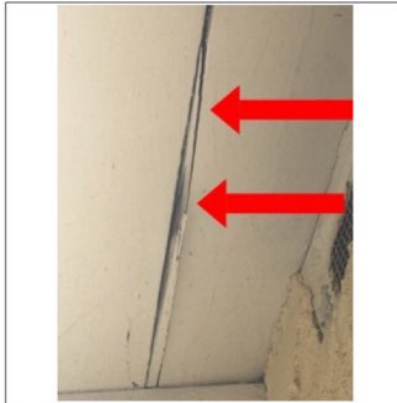
Soffit damaged/rotted, recommend repair by licensed contractor.

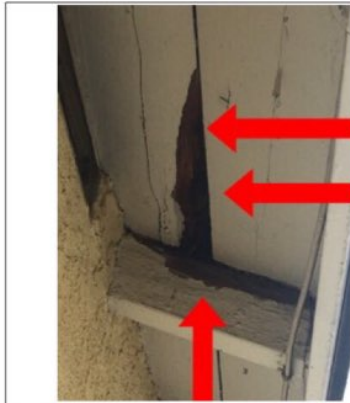
Soffit damaged/rotted, recommend repair by licensed contractor.

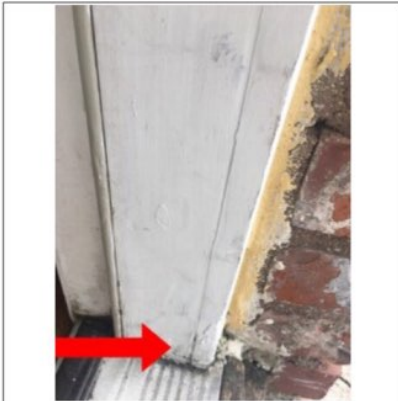
Entry door weathered, recommend paint/stain to protect from further damage.

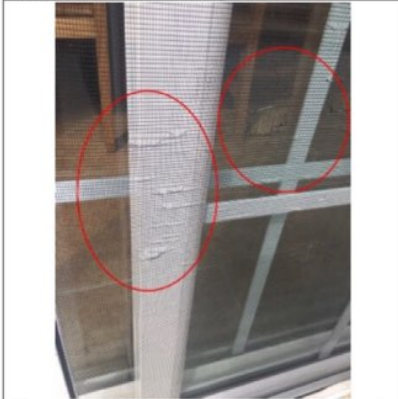
Screen patio door was damaged and torn. Recommend replace.

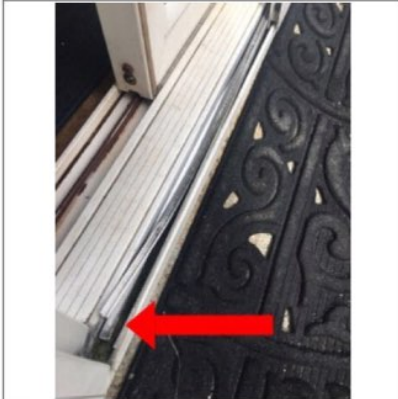
Patio door does not slide easily, rollers damaged. Recommend repair/replace as needed.

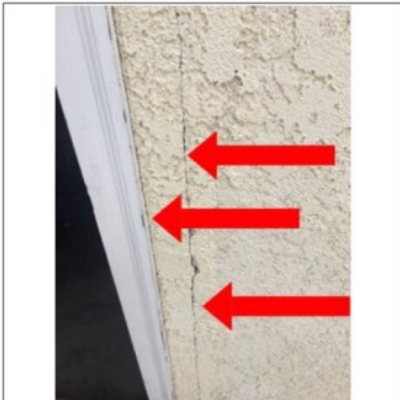
Siding had some damage/cracking recommend repair by licensed contractor. Garage Trim/soffit had some damage recommend repair by licensed contractor.

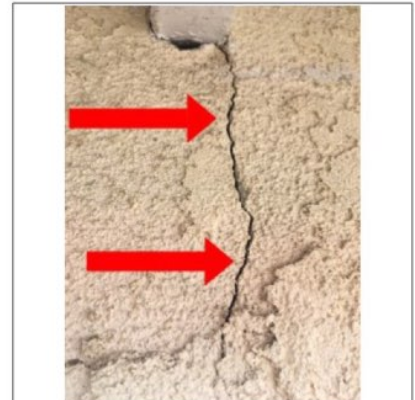
Siding had some damage/cracking recommend repair by licensed contractor.

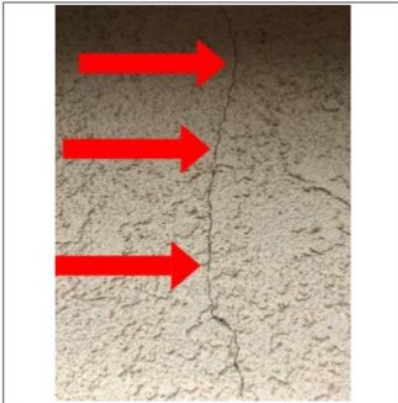
Siding had some damage/cracking recommend repair by licensed contractor.

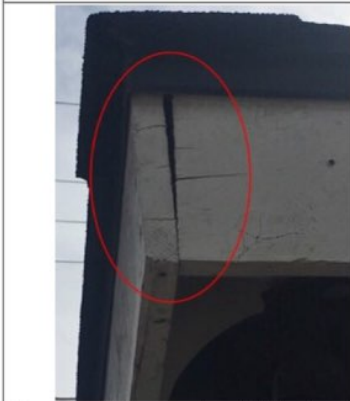
Garage Trim and soffit had some damage recommend repair by licensed contractor.

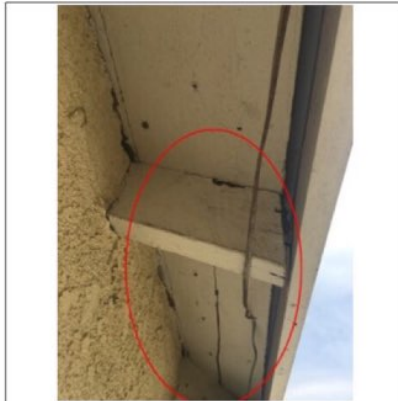
Garage Trim and soffit had some damage recommend repair by licensed contractor.
