Tennessee Real Estate Inspections

Property Inspection Report

Property address: **123 Main St
Anywhere USA**

Inspection date: **Friday, March 02, 2018**

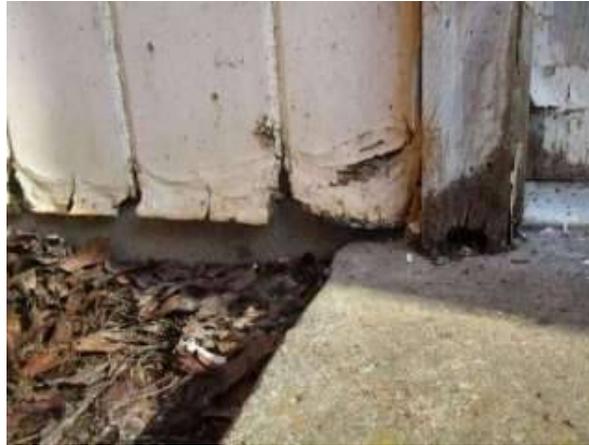
Photo 5-2

5) Repair/Replace, Evaluate - Rot or water damage was found at one or more sections of siding and/or trim. A qualified person should evaluate and repair as necessary. All rotten wood should be replaced.

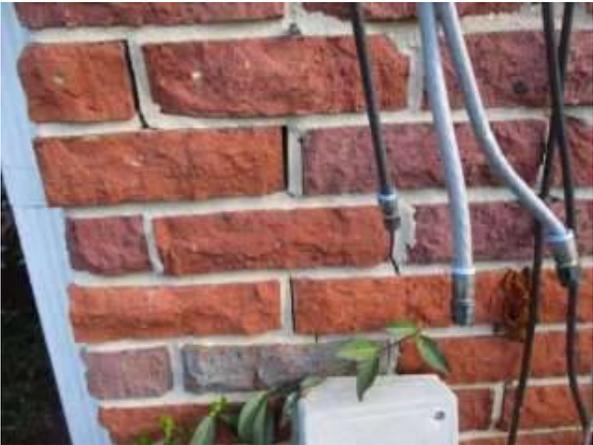
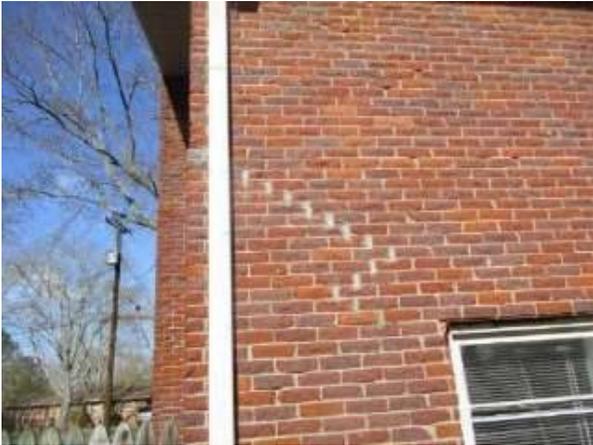
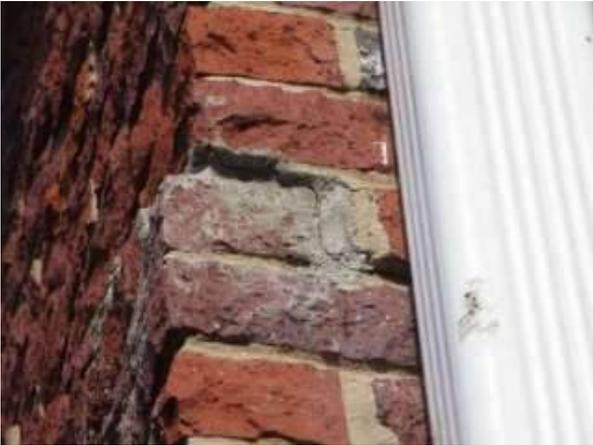
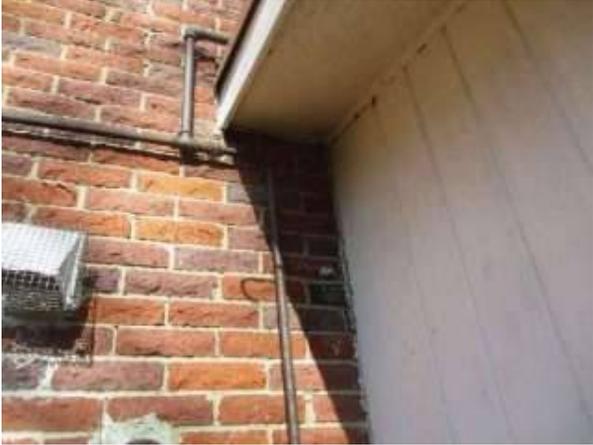
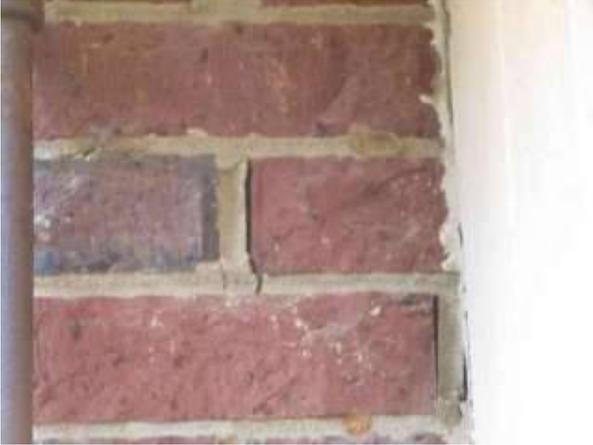
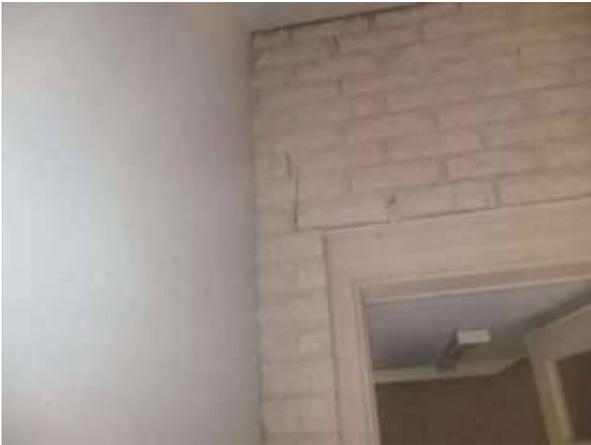
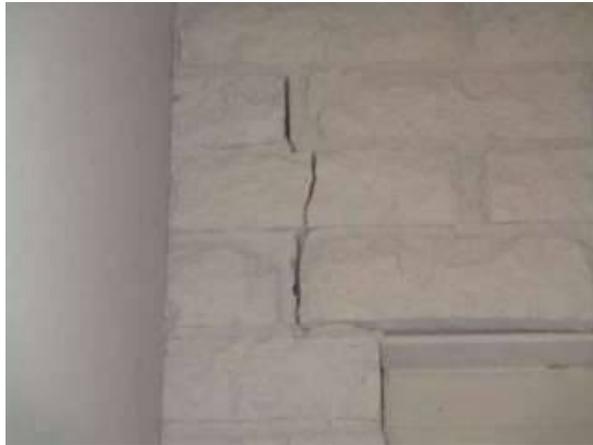
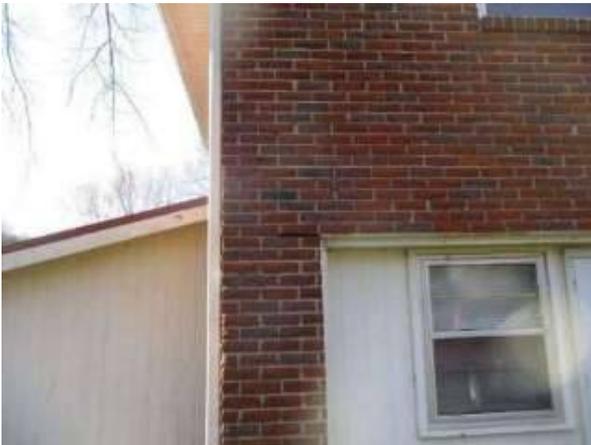
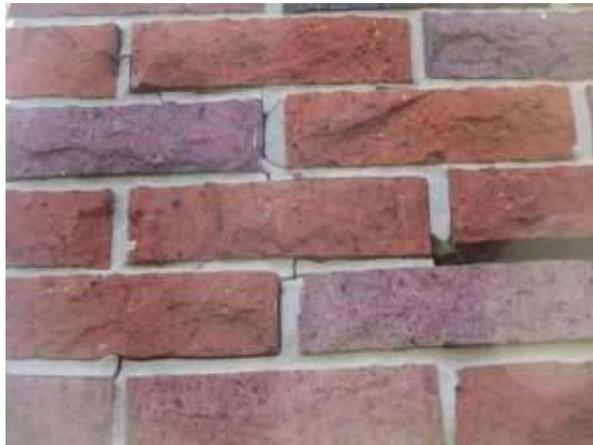
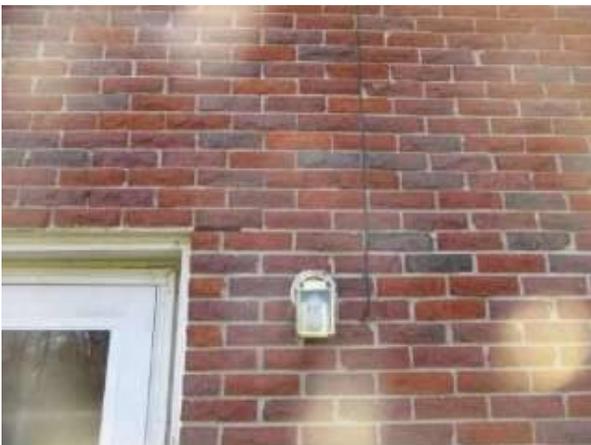
6) Repair/Replace, Evaluate - Cracks or deterioration were found in one or more sections of brick veneer. A qualified contractor should evaluate and make repairs as necessary, such as repointing mortar, replacing bricks and/or sections of veneer.

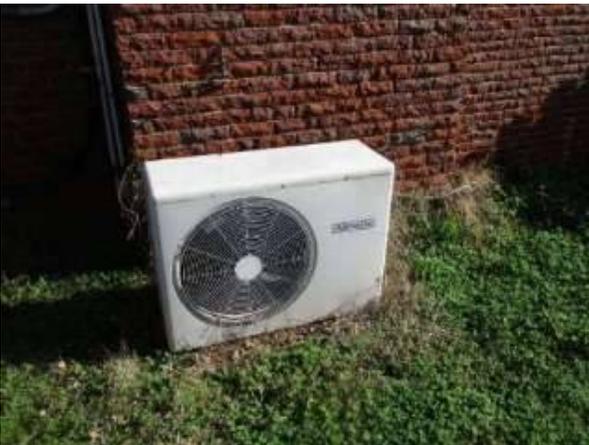
Photo 8-1

8) **Repair/Replace** - Gaps existed at one or more openings around the exterior, such as those where electric lines, refrigerant lines, and/or gas supply pipes penetrate the exterior. Gaps should be sealed as necessary to prevent moisture intrusion and entry by vermin.

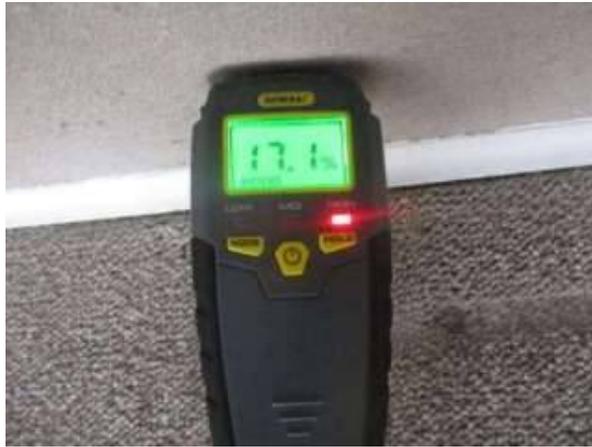
Photo 9-2

9) **Repair/Maintain, Evaluate** - Elevated levels of moisture and/or bowing was found in the basement walls. The client should consider hiring qualified contractors and/or engineers as necessary for further evaluation with repairs as necessary.

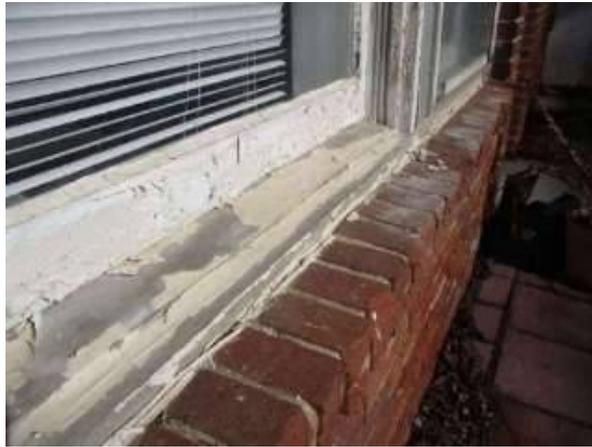
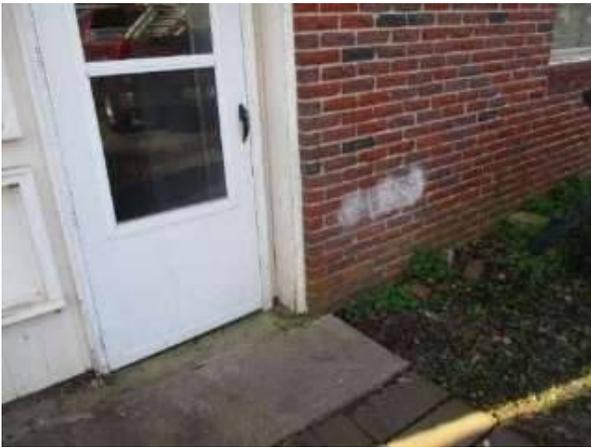
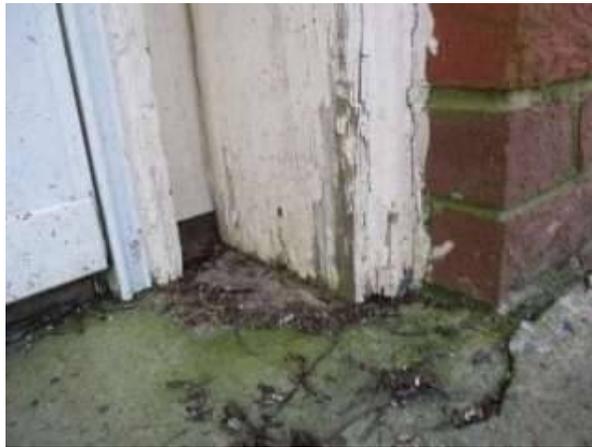
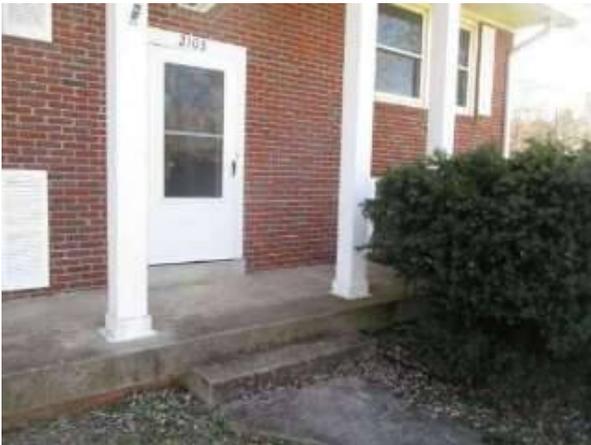
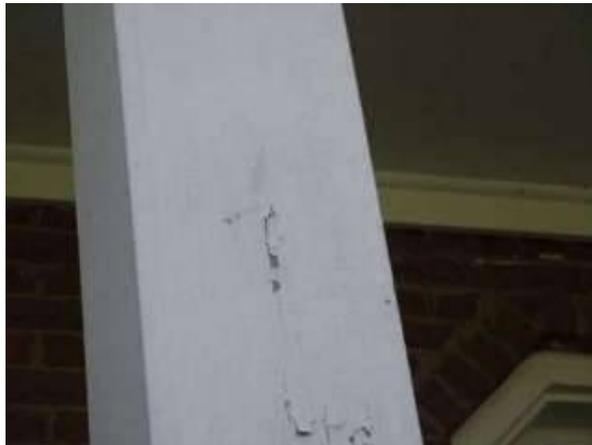
11) Maintain - The exterior finish in some areas was failing. A qualified contractor should prep (pressure wash, scrape, sand, prime caulk, etc.) and repaint or restrain areas as needed and as per standard building practices.

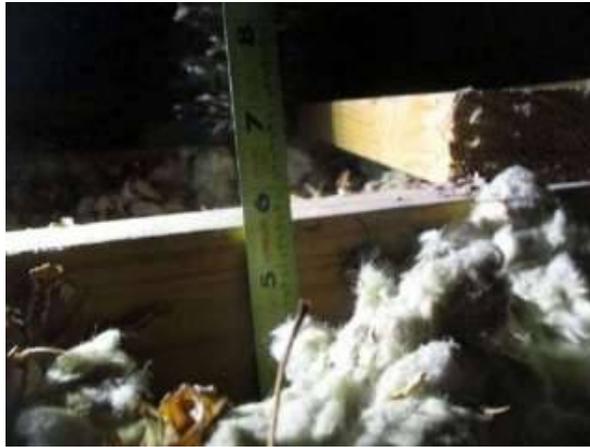
Photo 13-2

13) Repair/Replace - The ceiling insulation's R rating was significantly less than what's recommended for this area. Recommend having a qualified contractor install additional insulation as per standard building practices for better energy efficiency. For more information, visit:

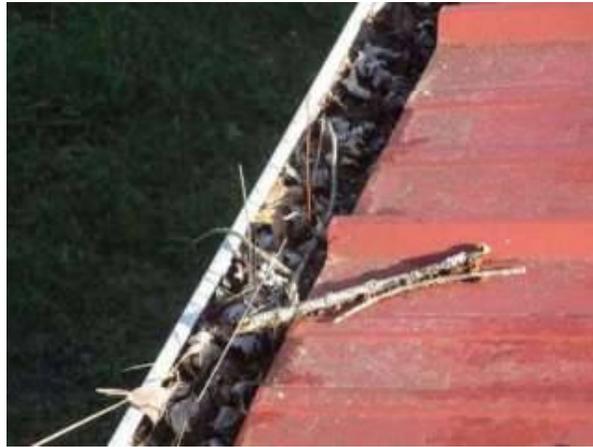
Photo 15-2

15) **Maintain** - Debris had accumulated in one or more gutters. This is a conducive condition for wood destroying insects since gutters may overflow and cause water to come in contact with the building exterior or make water accumulate around the foundation. Gutters should be cleaned now and as necessary in the future.

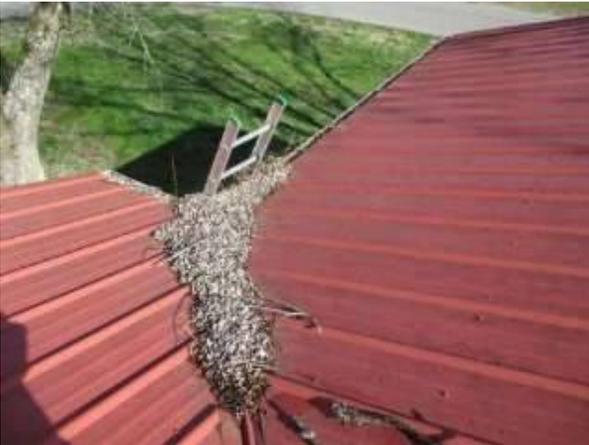
Photo 16-1

16) **Maintain** - Debris such as leaves, needles, seeds, etc. had accumulated on the roof. Debris should be cleaned from the roof now and as necessary in the future.

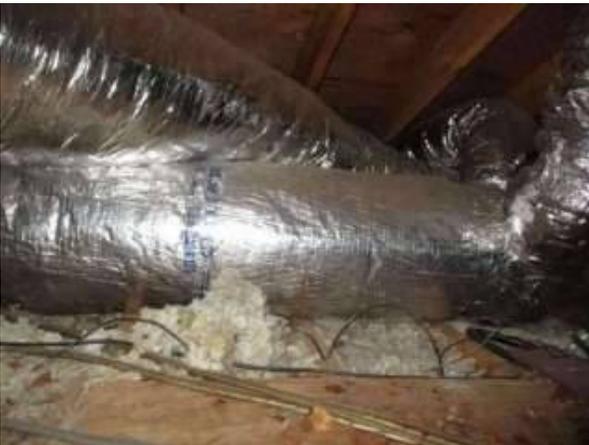
Photo 17-1

17) **Comment** - Some attic and roof structure sections were not evaluated due to lack of access from the following conditions: ducts or pipes blocking.

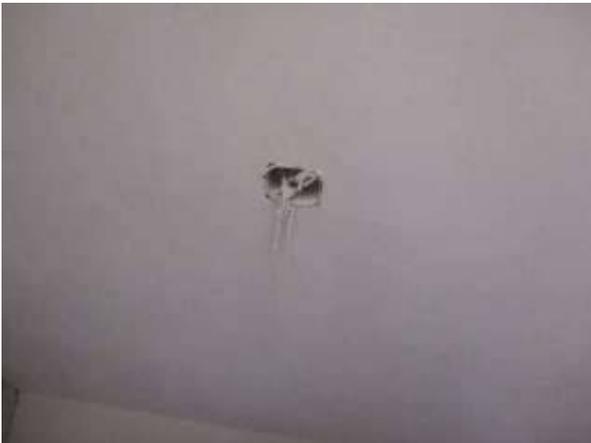
Photo 22-1

22) Safety, Repair/Replace, Evaluate - One or more light fixtures were missing. A qualified person should evaluate and repair or replace as necessary.

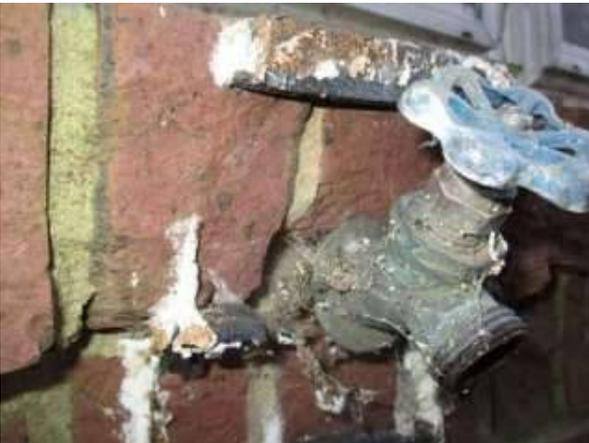
Photo 28-1

28) Repair/Replace - One or more outside faucets weren't anchored securely to the structure's exterior. Fasteners should be installed or replaced as necessary so faucets are securely anchored to prevent stress on plumbing supply lines and possible leaks.

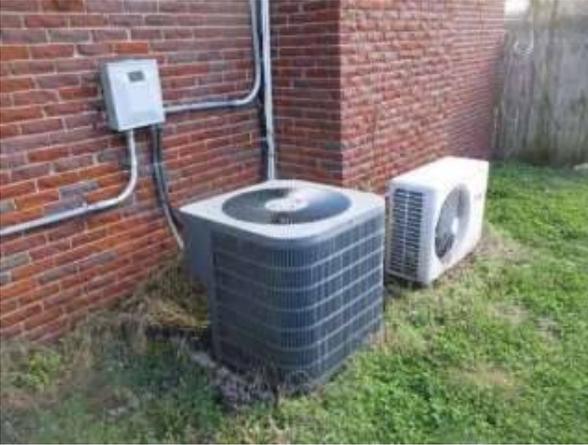
Photo 34-1

34) *Repair/Replace* - Insulation for the outside condensing unit's refrigerant lines was deteriorated in areas. This may result in reduced efficiency and increased energy costs. A qualified person should replace insulation as necessary.

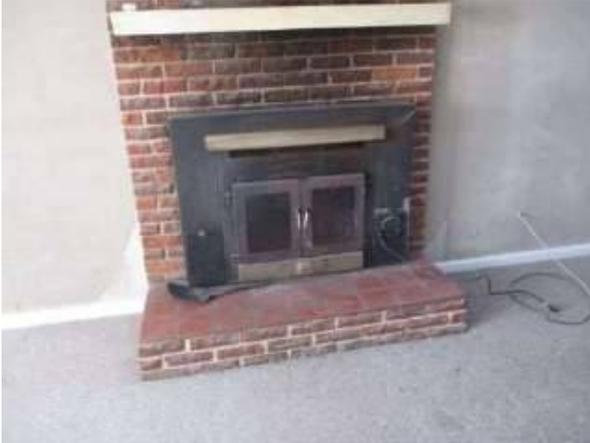
Photo 39-1

39) Safety, Repair/Replace, Evaluate - The wood stove's door gasket at location # A was deteriorated and/or missing. Leaks around the door may exist and efficiency may be reduced. A qualified contractor should evaluate and repair as necessary. For more information, visit:

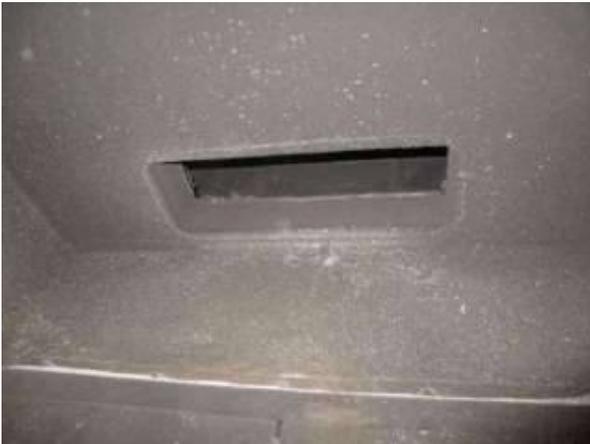
Photo 40-1

40) Safety, Repair/Replace, Evaluate - The inspector was unable to determine if flue(s) had significant amounts of accumulated creosote. Recommend that a qualified contractor inspect, and clean and repair if necessary.

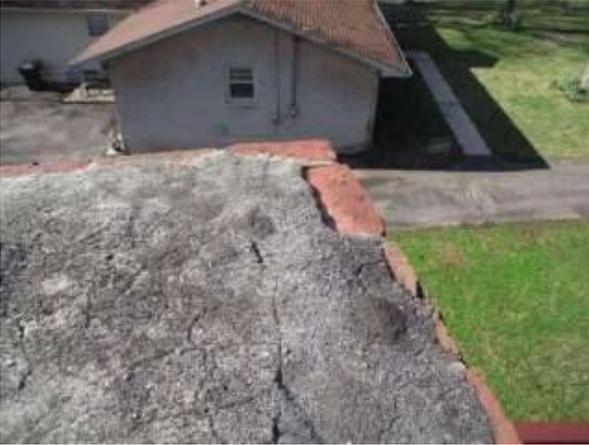
Photo 41-1

41) Repair/Replace, Evaluate - The masonry chimney crown at location #A was deteriorated and/or substandard. The crown is meant to keep water off of the chimney structure. The chimney can be damaged by wet masonry going through freeze-thaw cycles. A properly constructed chimney crown should:

- Be constructed using either pre-cast concrete slabs, cast-in-place steel reinforced concrete, solid stone, or metal
- Be sloped down from the flue a minimum of 3 inches of fall per foot of run
- Extend a minimum of 2-1/2 inches beyond the face of the chimney on all sides
- Not directly contact the flue liner (if installed), and this gap should be filled with flexible caulk
- Have flashing installed between the bottom of the crown and the top of the brick chimney

A qualified chimney service contractor or mason should evaluate and repair or replace the crown as necessary.

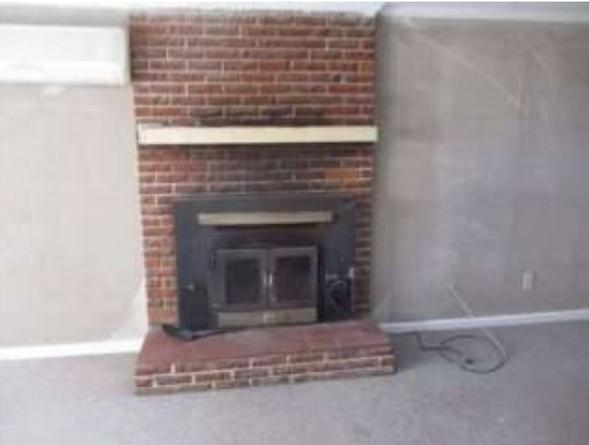
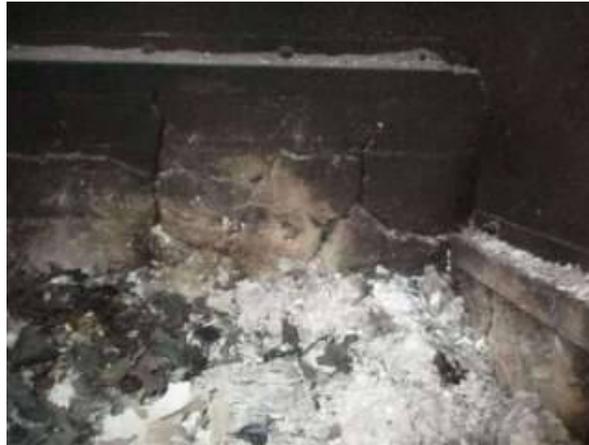
42) Repair/Replace - Firebricks lining the woodstove at location #A are cracked and/or broken. A qualified person should replace firebricks as necessary.

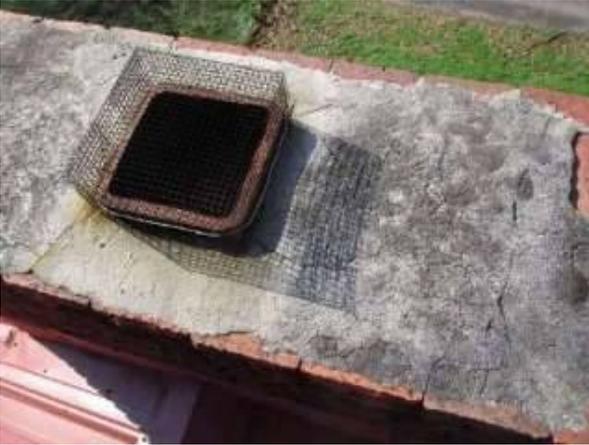
Photo 43-1

43) Repair/Maintain - The rain cap for the chimney flue at location #A was missing. They prevent the following:

- Rainwater entering flues and mixing with combustion deposits, creating caustic chemicals which can corrode flues
- Rainwater entering flues and causing damage to masonry from freeze-thaw cycles

A qualified person should install or replace rain caps, or make repairs where necessary.

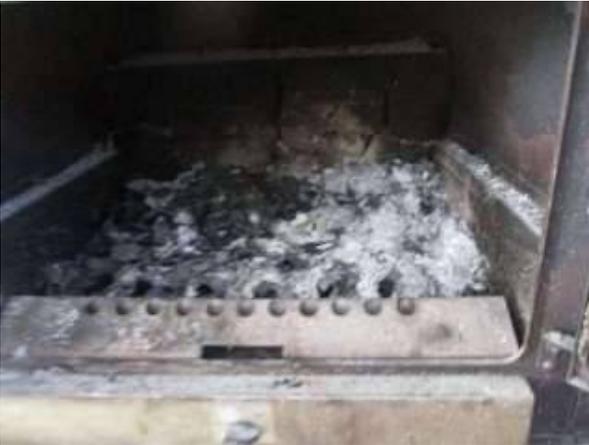
Photo 44-1

44) **Comment** - Parts of the firebox at location #A were obscured by ashes. The inspector was unable to fully evaluate.

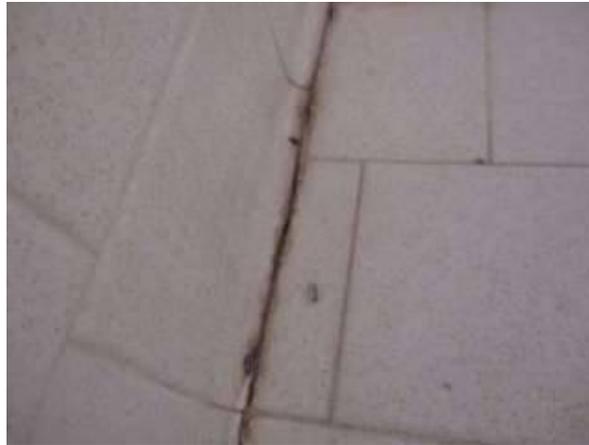
Photo 54-2

54) Repair/Maintain - The grout between the shower enclosure and the floor at location #A was deteriorated. A qualified person should repair as necessary.

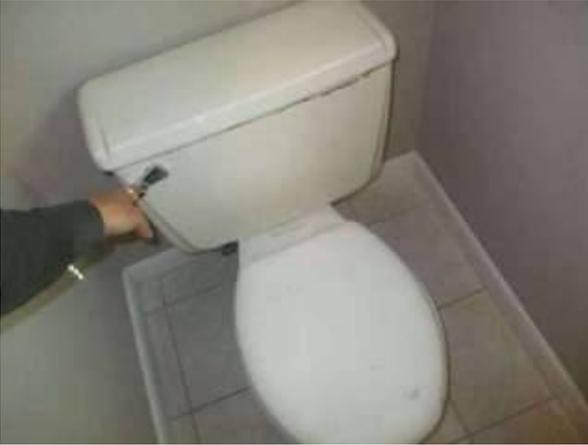
**Photo 55-1**

55) Evaluate - The toilet at location #B had no water supply and could not be fully evaluated. The shut-off valve(s) may be turned off, or repairs may be necessary. The client should ask the property owner about this, and have a qualified plumber evaluate and repair if necessary.

The supply valve would not turn

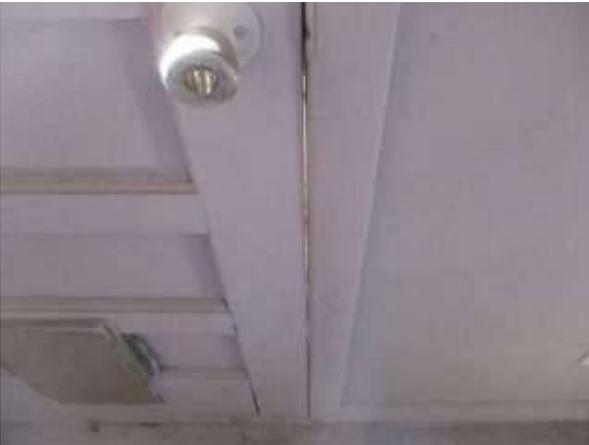
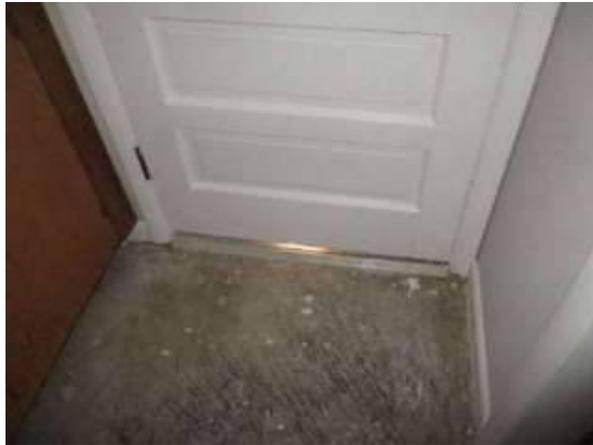
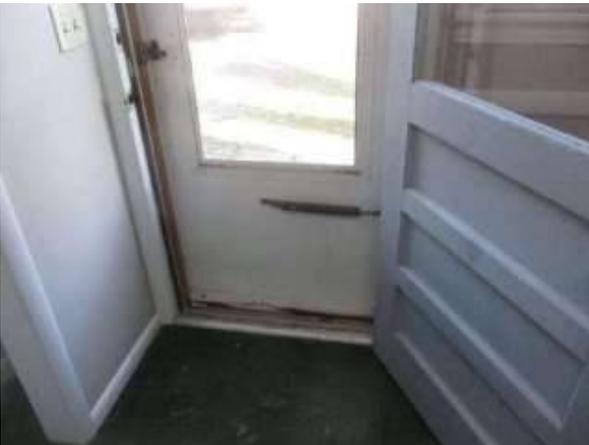
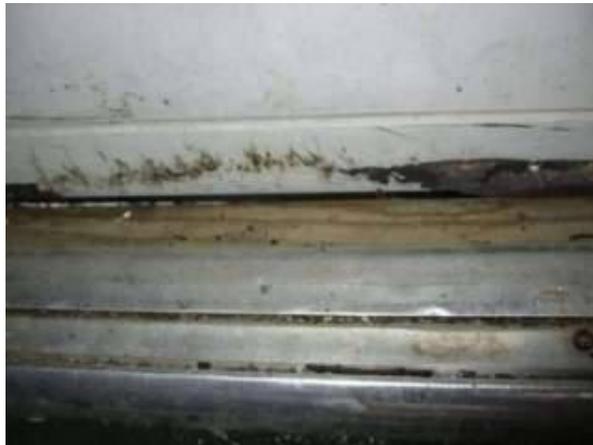
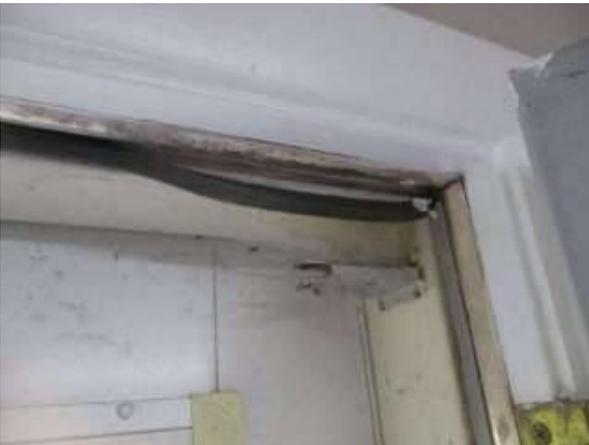
64) Repair/Replace - The weatherstrip around one or more exterior doors was deteriorated. A qualified person should repair or replace as necessary.

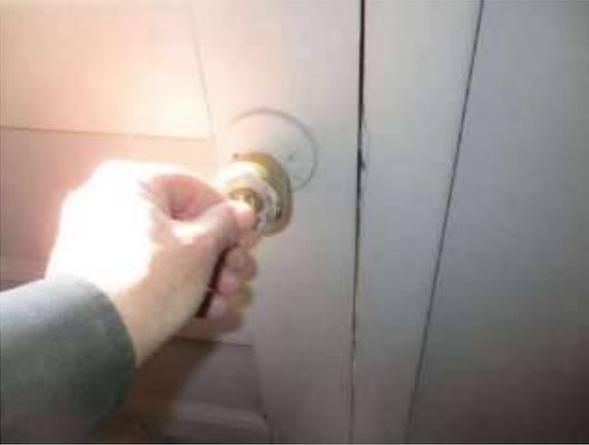
**Photo 65-1**

65) Repair/Replace - Door locks on one or more exterior doors were difficult to operate. A qualified person should repair as necessary.

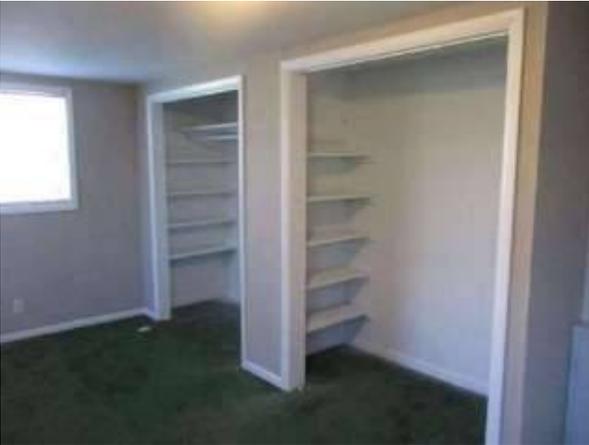
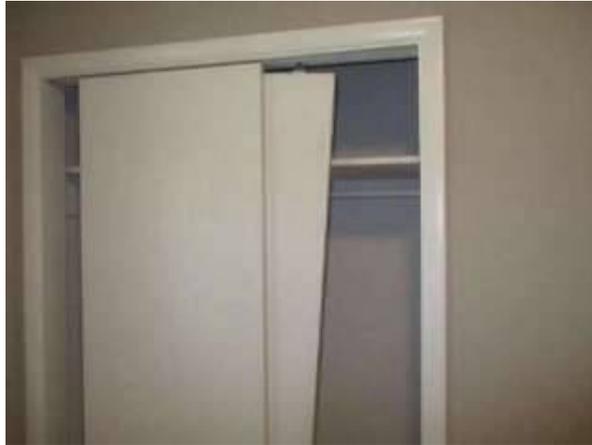
66) Repair/Replace - Some interior doors were missing and/or off track. A qualified person should repair or replace as necessary.

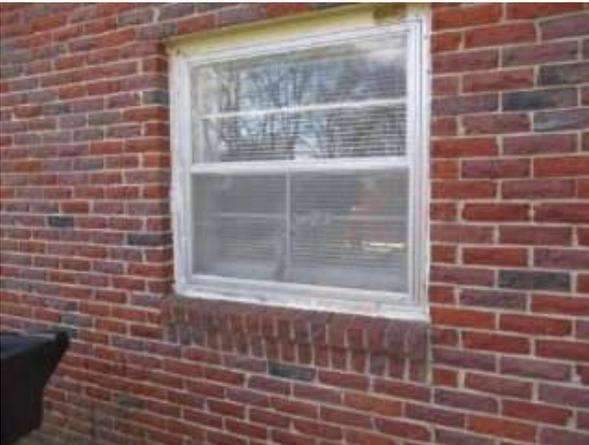
**Photo 67-1**

67) Repair/Replace - Glass in one or more windows was cracked or broken. A qualified contractor should replace glass where necessary.

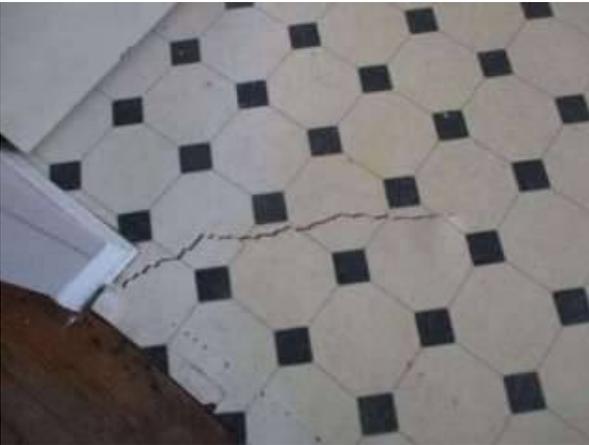
Photo 68-1

68) Repair/Replace - Some sections of linoleum flooring had deterioration or damage. For example, torn sections. A qualified person should repair as necessary.

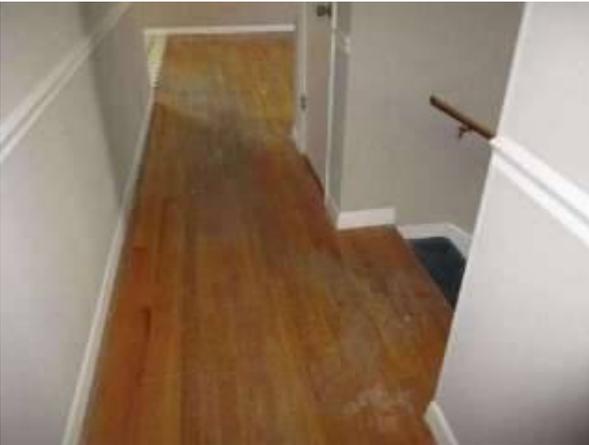
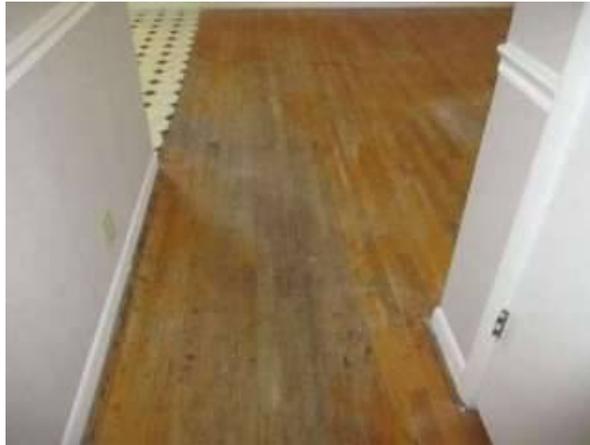
69) Repair/Replace - Wood flooring in some areas was significantly worn, deteriorated or damaged. A qualified contractor should refinish wood flooring as necessary.

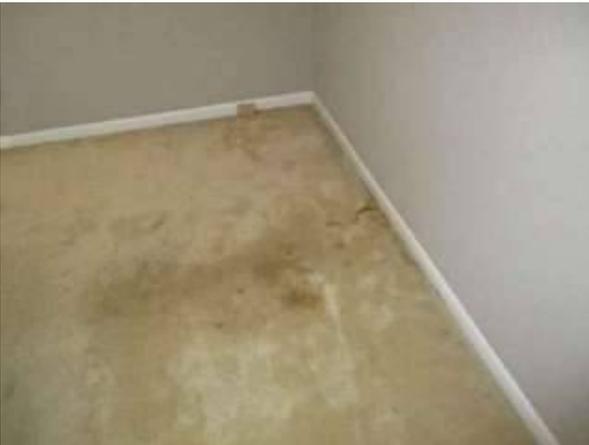
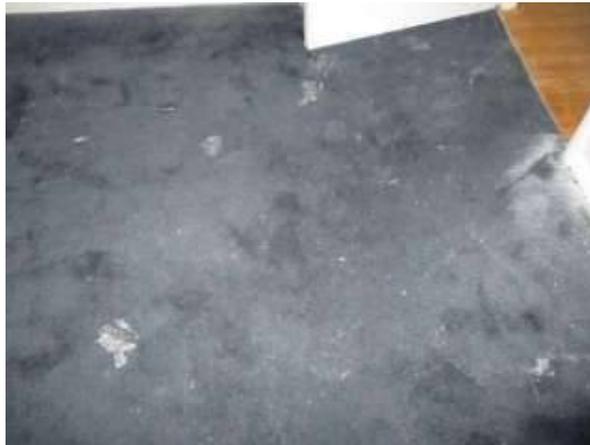
70) Repair/Replace - Carpeting in some areas was stained. A qualified contractor should replace as necessary

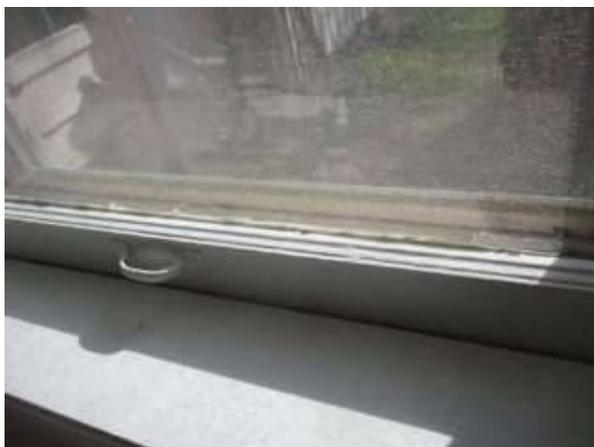
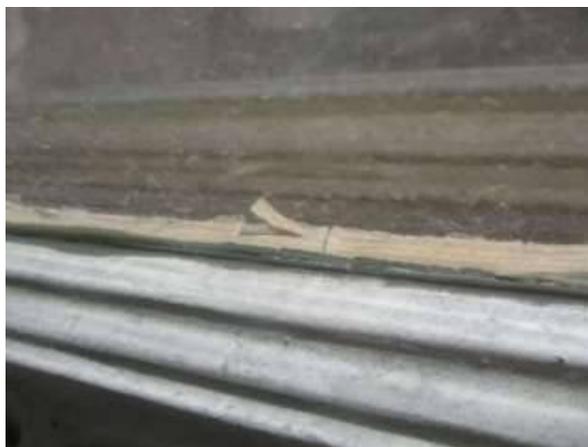
71) Repair/Maintain, Evaluate - The glazing putty at some windows was deteriorated. A qualified person should evaluate and repair as necessary. For more information, visit:
