Valle Verde Ranch

Reconnaissance Level – Preliminary Drainage Analysis

By Ben Lomeli, Hydrologist CFM

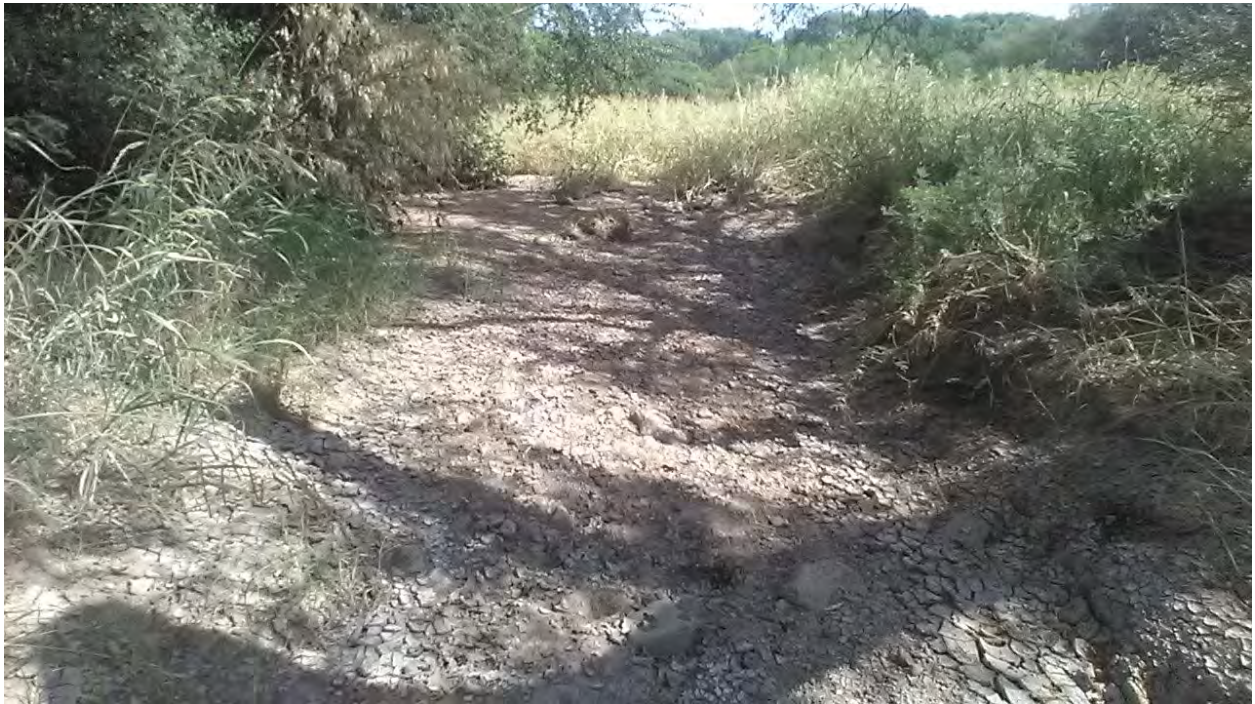
Looking downstream towards river at beginning of sediment high spot.

Sediment deposits are currently semi-stabilized with dense tall grass (*Johnson grass?*). Excess sediment deposits have accumulated to create a “high-spot” that effectively forms a low crossflow berm that partially obstructs downstream low flows. The obstructive crossflow sediment berm causes upstream backwater ponding and consequent overflow flooding and sedimentation, primarily NE towards Valle Verde Ranch. Water and sediment flows both follow the laws of physics and seek the “Natural” NE flow direction.

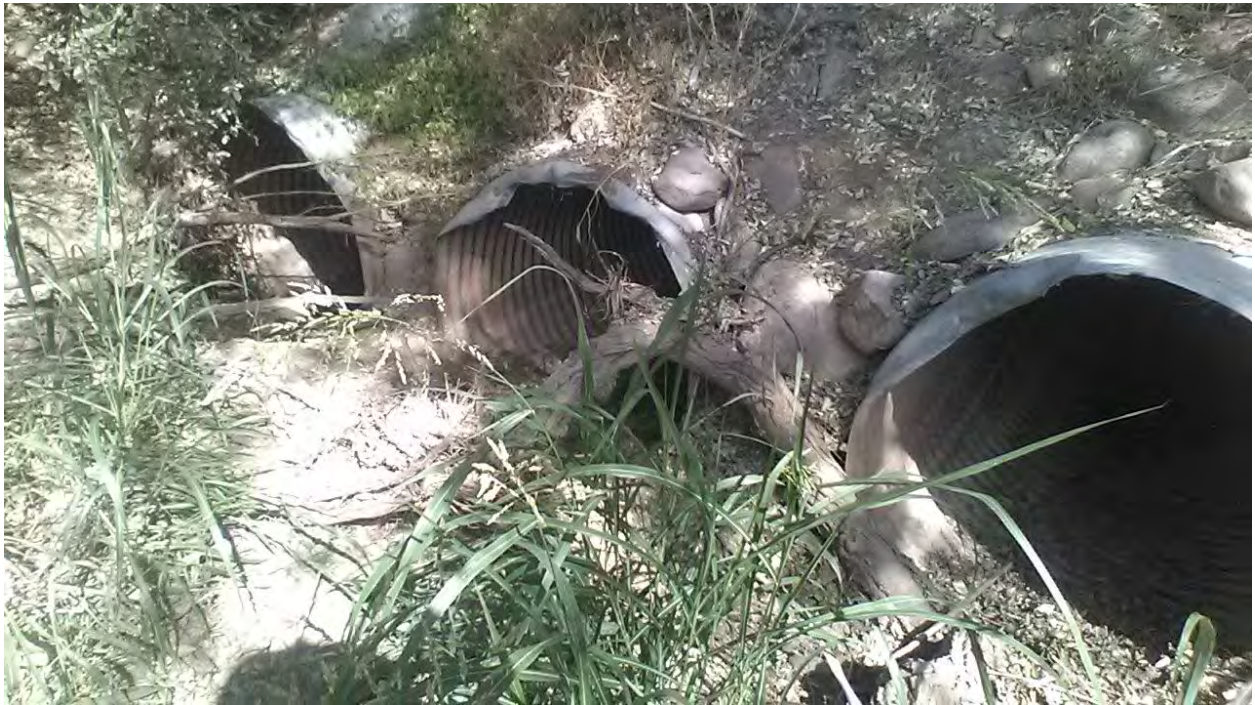
3 CMPs at Anza Trail appear to be undersized.

(Much less conveyance capacity than all upstream box and arch culverts).
