## Schematic Design Report

**The Metropolitan Condo  
5320 N Sheridan Road  
Chicago, IL**

**ZS Project Number: 257018.1**

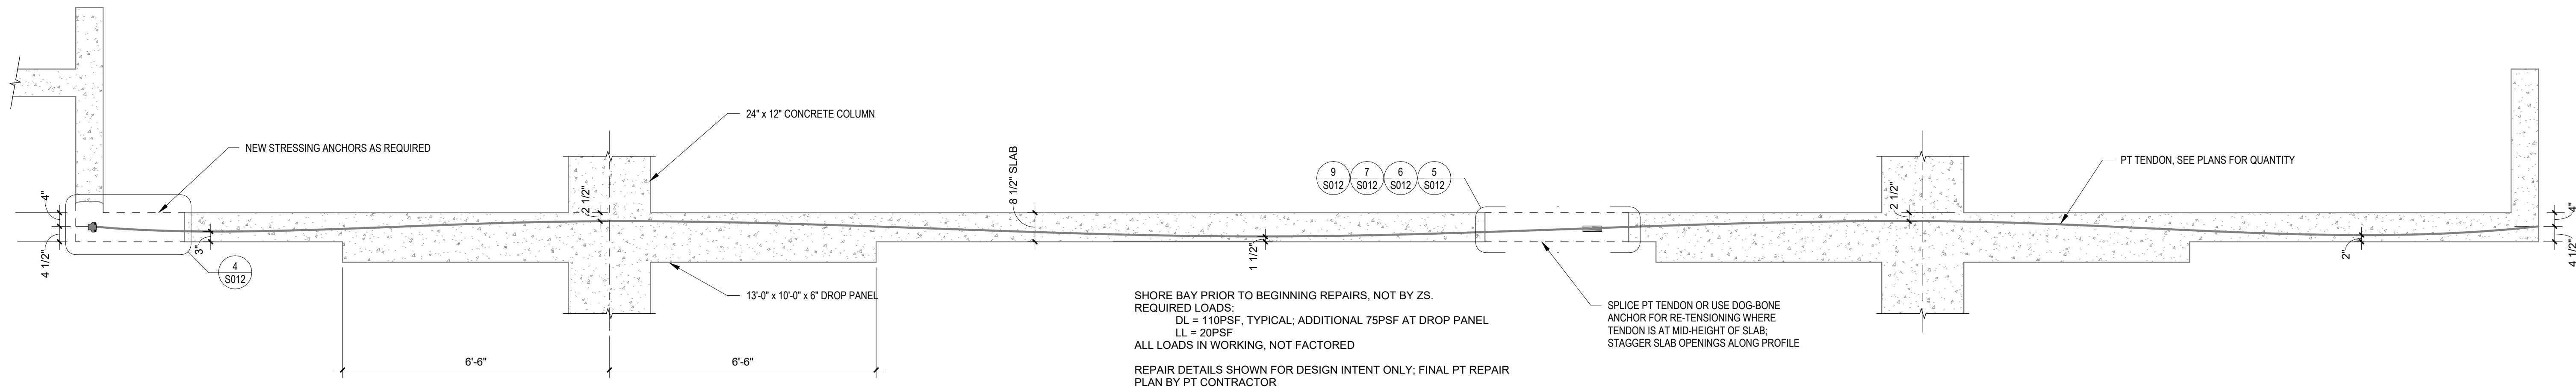
1  
S011  
MAIN TENDON SECTION  
1/2" = 1'-0"

There were 52 main reinforcing tendons tested; of those 52, 12 tendons (23%) were no longer holding tension. The majority of the failed tendons were in areas where the garage floor was flat. There were 23 temperature tendons tested (temperature tendons run perpendicular to the main reinforcing and help with load distribution). Ten of the temperature tendons were found to be failed (43%). Those ten were evenly distributed throughout the structure. Based on a detailed review of the original construction plans, the total number of tendons in this structure is 1,010 (562 main tendons and 448 temperature tendons). Therefore, and based on the test results, ZS estimates 200 tendons will require repair.

That there were more failed tendons in the flat areas of the structure suggests runoff from vehicles may not be affectively draining from those areas of the parking structure. A properly maintained traffic coating as well as power-washing of the floor to remove road salt deposits will be essential in maintaining the health of the structure.
