FAA
Aviation Safety

SPECIAL AIRWORTHINESS INFORMATION BULLETIN

SAIB: 2026-10R1

SUBJ: Equipment / Furnishings - Restraint Systems

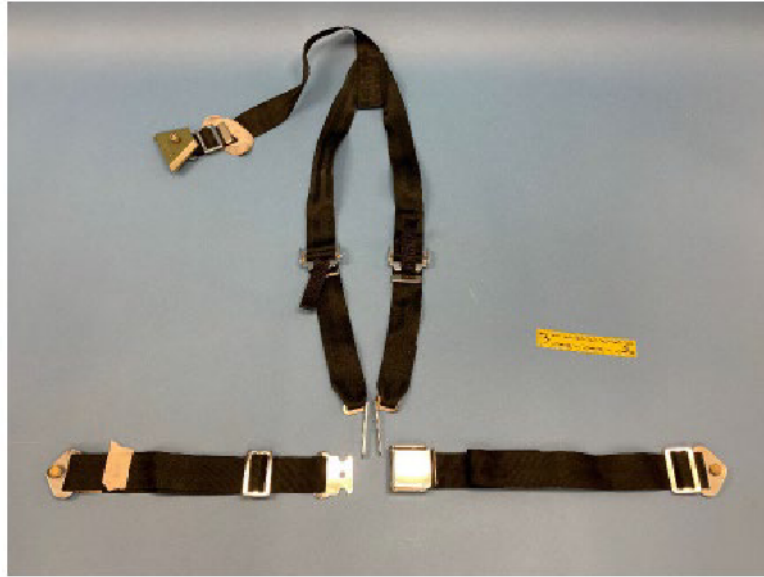
Figure 1
Four-point restraint assembly

A search of NTSB public dockets identified at least fifteen other general aviation accidents resulting in full or partial failure of the occupants' restraint system. Many of these failures occurred at the Y-junction threading as shown in Figure 2. These accidents often involved serious or fatal injuries of the occupants. Further inspection of the accident findings revealed that these restraints are often designed to obsolete TSO requirements. Minimum torso restraint system performance requirements are currently prescribed in [TSO-C114](#) dated March 27, 1987. Minimum safety belt performance requirements are currently prescribed in [TSO-C22g](#) dated March 5, 1993. Both TSOs provide standards equivalent to SAE Aerospace Standard (AS) Document No. AS8043, "Torso

- Perform routine preflight and annual visual inspections of both the shoulder and pelvic restraints to check for signs of wear, deformation, discoloration, defects, or fraying. Special attention should be paid to the threading on the Y-junction that separates the two shoulder straps and connects to the fuselage attach strap behind the occupant’s head as well as the fastener hardware.
- Report findings of damage to the FAA point of contact. Please include the make, model, and serial number of the restraint and aircraft; a description of the damage; photographs; recommended inspection techniques to locate the damage; the damaged parts’ time in service; and any other information that may assist in our evaluation of this issue.
