Level I – FULL Reserve Study Report **For Fiscal Year Beginning January 1, 2023**

Sample Condo

Your Town, WA

January 4, 2023

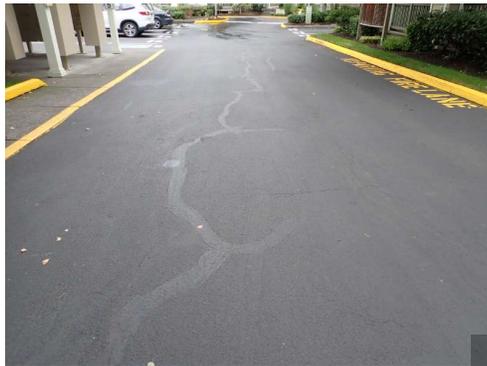
Asphalt - Overlay - 2046

55,000 GSF	@ \$4.00
Asset ID	1015	Asset Actual Cost	\$220,000.00
		Percent Replacement	100%
	Grounds	Future Cost	\$434,189.03
Placed in Service	January 2008		
Useful Life	40		
Adjustment	-2		
Replacement Year	2046		
Remaining Life	23

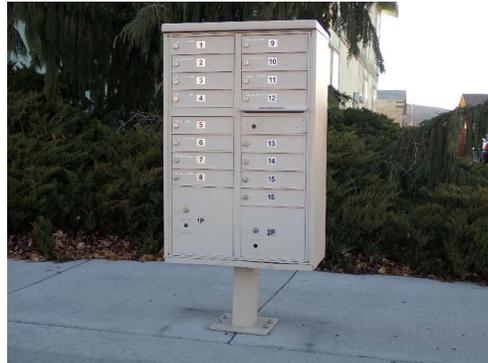
Mailboxes - Replace - 2033

4 Cluster Boxes @ \$3,000.00
Asset ID	1065	Asset Actual Cost	\$12,000.00
		Percent Replacement	100%
	Grounds	Future Cost	\$16,127.00
Placed in Service	January 2008		
Useful Life	25		
Replacement Year	2033		
Remaining Life	10

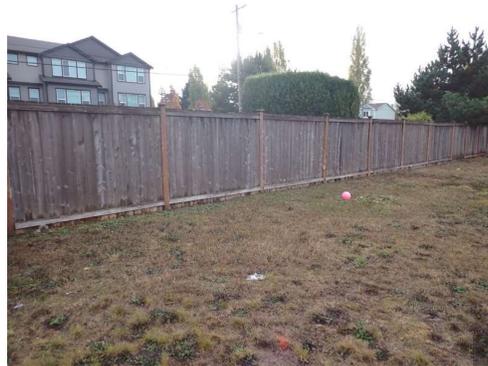
Wood Fence - Replace - 2027

235 LF	@ \$45.00
Asset ID	1070	Asset Actual Cost	\$10,575.00
		Percent Replacement	100%
	Grounds	Future Cost	\$11,902.26
Placed in Service	January 2008		
Useful Life	20		
Adjustment	-1		
Replacement Year	2027		
Remaining Life	4

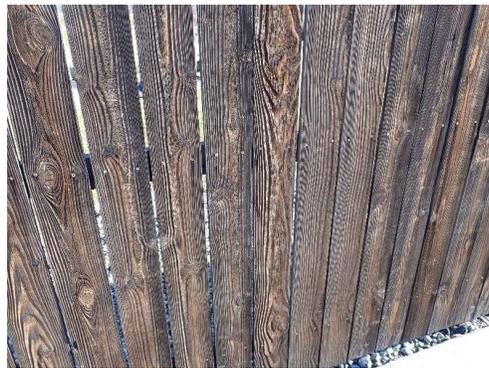
Wood Fence - Repair & Stain - 2027

235 LF	@ \$12.00
Asset ID	1075	Asset Actual Cost	\$2,820.00
		Percent Replacement	100%
	Grounds	Future Cost	\$3,173.93
Placed in Service	January 2022		
Useful Life	5		
Replacement Year	2027		
Remaining Life	4

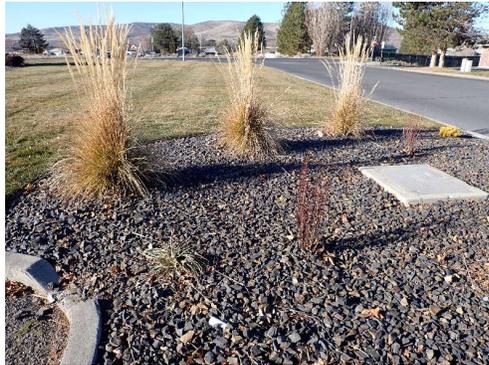
Landscape - Refurbish - 2023

1 Allowance	@ \$2,500.00
Asset ID	1135	Asset Actual Cost	\$2,500.00
		Percent Replacement	100%
	Grounds	Future Cost	\$2,500.00
Placed in Service	January 2019		
Useful Life	3		
Replacement Year	2023		
Remaining Life	0

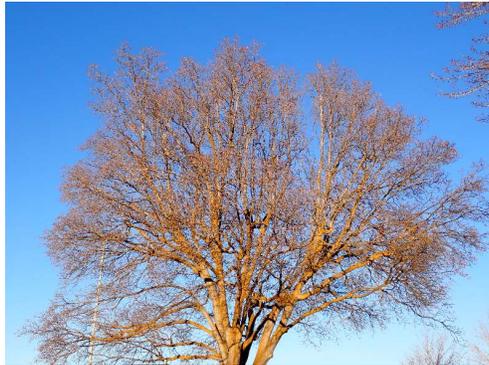
Trees - Trim/Remove - 2023

Asset ID	1145	1 Allowance	@ \$1,500.00	
		Asset Actual Cost	\$1,500.00	
		Percent Replacement	100%	
	Grounds	Future Cost	\$1,500.00	
Placed in Service	January 2020			
Useful Life	3			
Replacement Year	2023			
Remaining Life	0

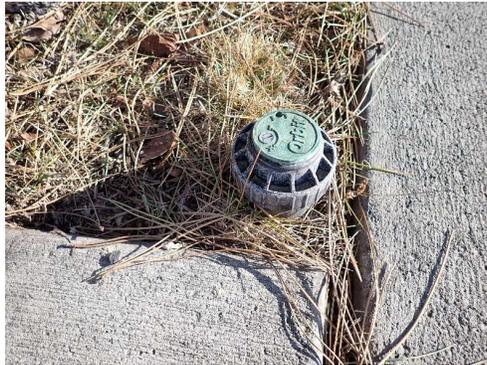
Irrigation System - Repair - 2024

1 Allowance	@ \$1,500.00
Asset ID	1155		Asset Actual Cost	\$1,500.00
			Percent Replacement	100%
	Grounds		Future Cost	\$1,545.00
Placed in Service	January 2019			
Useful Life	5			
Replacement Year	2024			
Remaining Life	1

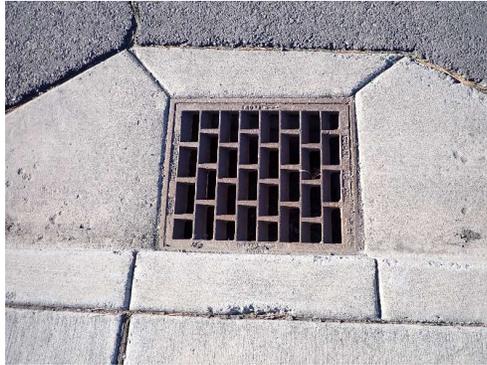
Drainage System - Maintain

Location: Common area drainage

Component History: No major projects known

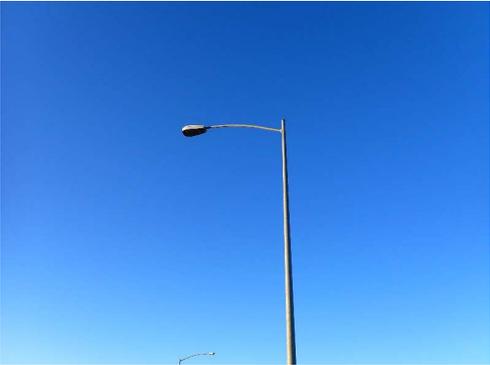
Pole Lights - Replace

Location: Adjacent to parking areas

Component History: Original to ~ 2008 construction

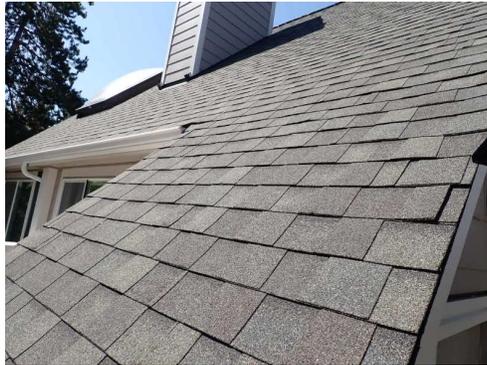
Composition Roof - Replace - 2038

36,500 GSF	@ \$6.00
Asset ID	4000	Asset Actual Cost	\$219,000.00
		Percent Replacement	100%
	Building Exterior	Future Cost	\$341,194.86
Placed in Service	January 2008		
Useful Life	30		
Replacement Year	2038		
Remaining Life	15

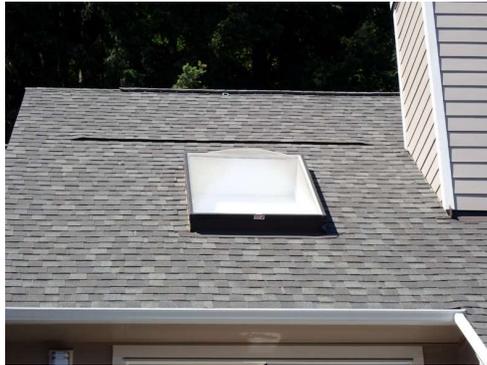
Skylights - Replace - 2038

50 Each	@ \$700.00
Asset ID	4025	Asset Actual Cost	\$35,000.00
		Percent Replacement	100%
	Building Exterior	Future Cost	\$54,528.86
Placed in Service	January 2008		
Useful Life	30		
Replacement Year	2038		
Remaining Life	15

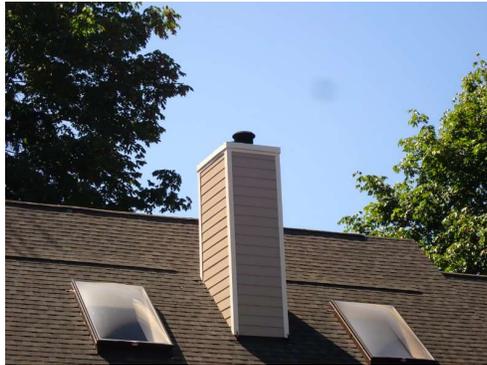
Chimney Caps & Covers - Replace - 2038

50 Each	@ \$800.00
Asset ID	4030	Asset Actual Cost	\$40,000.00
		Percent Replacement	100%
	Building Exterior	Future Cost	\$62,318.70
Placed in Service	January 2008		
Useful Life	30		
Replacement Year	2038		
Remaining Life	15

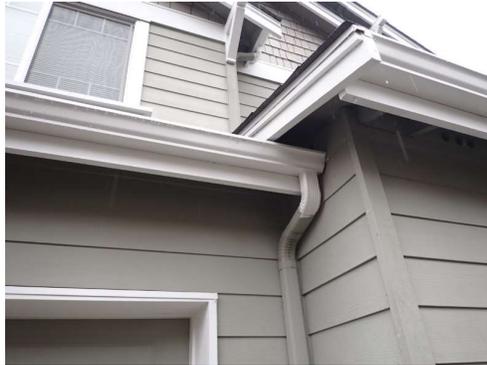
Gutters/Downspouts - Replace - 2038

4,150 LF	@ \$10.00
Asset ID	4035	Asset Actual Cost	\$41,500.00
		Percent Replacement	100%
	Building Exterior	Future Cost	\$64,655.65
Placed in Service	January 2008		
Useful Life	30		
Replacement Year	2038		
Remaining Life	15

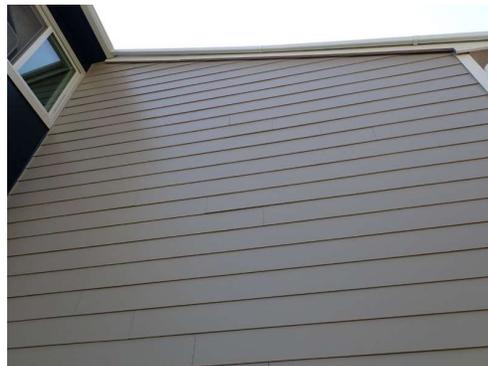
Fiber-Cement Siding - Replace - 2058

Asset ID	4040	50,250 GSF	@ \$21.00
		Asset Actual Cost	\$1,055,250.00
		Percent Replacement	100%
		Future Cost	\$2,969,328.35
	Building Exterior		
Placed in Service	January 2008		
Useful Life	50		
Replacement Year	2058		
Remaining Life	35

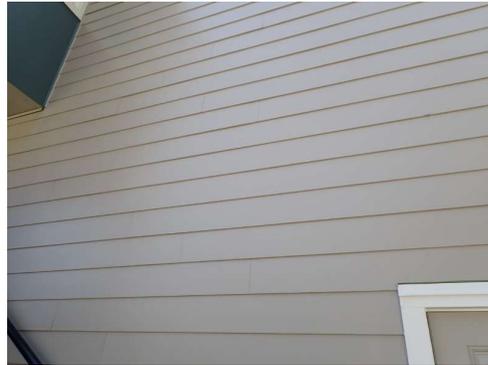
Exterior Surfaces - Repair & Paint - 2028

50,250 GSF	@ \$4.00
Asset ID	4065	Asset Actual Cost	\$201,000.00
		Percent Replacement	100%
	Building Exterior	Future Cost	\$233,014.09
Placed in Service	January 2018		
Useful Life	10		
Replacement Year	2028		
Remaining Life	5

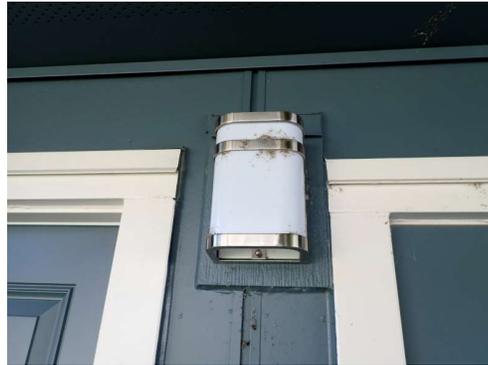
Exterior Lights - Replace - 2033

150 Each	@ \$95.00
Asset ID	4068	Asset Actual Cost	\$14,250.00
		Percent Replacement	100%
	Building Exterior	Future Cost	\$19,150.81
Placed in Service	January 2008		
Useful Life	25		
Replacement Year	2033		
Remaining Life	10

It is beyond the scope of a reserve study to test lighting, therefore no testing was conducted as part of this report. No problems reported by client. Plan for regular cycles of fixture replacement to maintain function and aesthetics, best timed to occur in conjunction with exterior paint cycles for cost efficiencies. Funding allowances factor replacement with mid-range fixture as cost can vary widely based on quality of fixture chosen. Funding includes professional installation of fixtures, however extensive wiring/electrical work may increase cost. Inspect fixtures regularly, clean as needed and replace bulbs. Some utility companies offer rebates for installation of energy efficient fixtures; check with your local utility company prior to replacement to see if any rebates are available in your area.

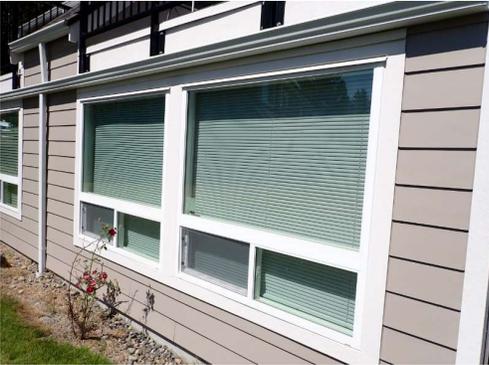
Windows/Sliders - Replace

Location: Exterior building walls

Component History: Majority original to ~ 2008 construction, spot replacements by owners

Client reports that windows and sliding glass doors are the responsibility of the unit owner to maintain, repair and replace therefore no reserve funding included.

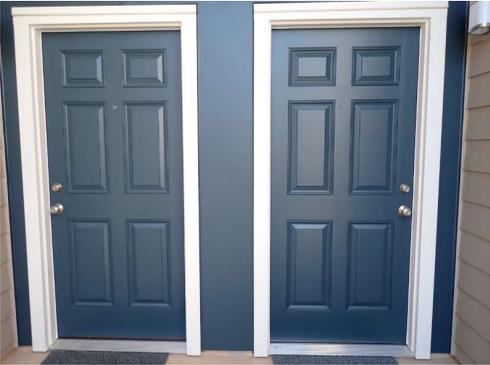
Exterior Doors - Replace

Location: Unit entry doors & deck storage closet doors

Component History: Reportedly original to ~ 2008 construction

Client reports that exterior doors are the responsibility of the unit owner to maintain, repair and replace therefore no reserve funding included.

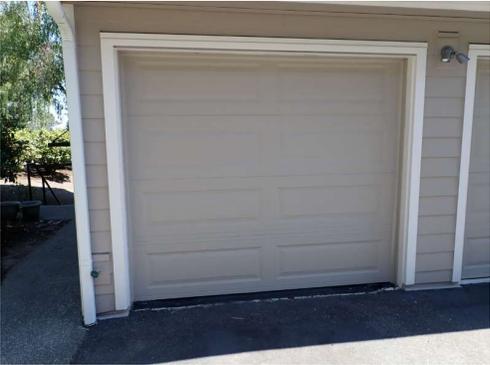
Garage Doors - Replace

Location: Garage at each individual unit

Component History: Majority reportedly original to ~ 2008 construction

Client reports that garage doors are the responsibility of the unit owner to maintain, repair and replace therefore no reserve funding included.

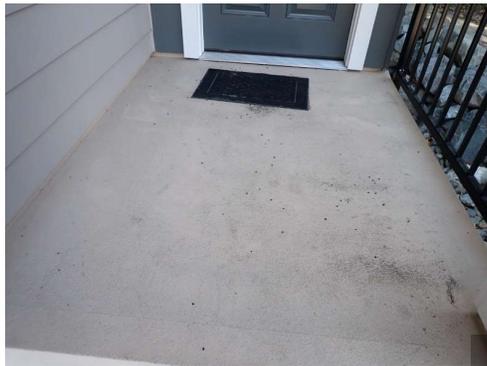
Traffic Coated Decks & Porches - Repair & Coat - 2023

3,950 GSF	@ \$10.00
Asset ID	4115	Asset Actual Cost	\$39,500.00
		Percent Replacement	100%
	Building Exterior	Future Cost	\$39,500.00
Placed in Service	January 2018		
Useful Life	5		
Replacement Year	2023		
Remaining Life	0

Traffic coated decks are typically comprised of a coating system using three or more layers including a base coat, an aggregate for anti-slip properties and a top coat. The top coat must be periodically reapplied in order to maintain the weatherproofing capabilities of the coating system. Many associations attempt to postpone recoating because the decks “look ok”, however top coat deterioration is the result of UV exposure and foot traffic and cannot typically be seen with the naked eye. It is a best practice to routinely, and proactively, recoat decks at regular cycles. Failure to regularly reapply top coat may result in damage to other layers of the coating, requiring stripping and complete reapplication of the coating system, and/or damage to the wood structure of the deck.

Use caution when cleaning decks to prevent damage to coating. Encourage residents to elevate planters above the deck surface by placing them on feet and installing protectors on patio furniture legs. Keep drains clear and free flowing, if present, and do not place items such as carpeting, AstroTurf, etc. over the deck surface.

Funding allowances here factor recoating of decks with a small allowance for repairs as needed. Track actual expenses and update future reserve studies as needed.

Hidden damages and deterioration which could have been prevented through proper deck maintenance and periodic repairs is one of the most common surprise expenses experienced by associations, therefore proactive deck maintenance is absolutely imperative to avoiding future unexpected (and preventable) costs.

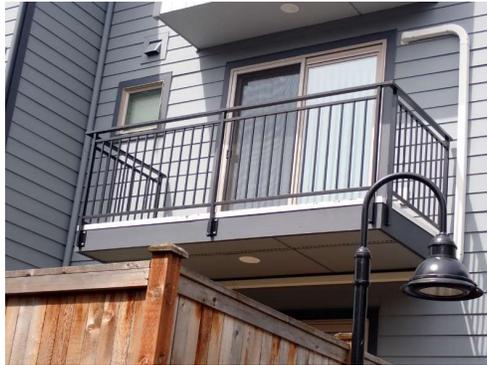
Metal Deck Rail - Replace - 2058

1,425 LF	@ \$115.00
Asset ID	4130	Asset Actual Cost	\$163,875.00
		Percent Replacement	100%
	Building Exterior	Future Cost	\$461,121.71
Placed in Service	January 2008		
Useful Life	50		
Replacement Year	2058		
Remaining Life	35

We did not test railings for structural integrity as this is beyond the scope of a reserve study. The average useful life of deck railings is approximately 40-50 years. There is no predictable basis to expect regular cycles of paint at these railings as the powder coated finish is expected to have a long useful life (documents provided by client indicate that railings have a 10 year warranty on the finish). Inspect regularly, repair and touch up paint as needed through the annual operating budget. The preferred method for installation of deck railings is mounting through the front of the fascia board, as opposed to through the top of the deck surface. Installation through the top of the deck surfaces increases opportunities for water to penetrate into the structure of the deck, risking decay and hidden damages.

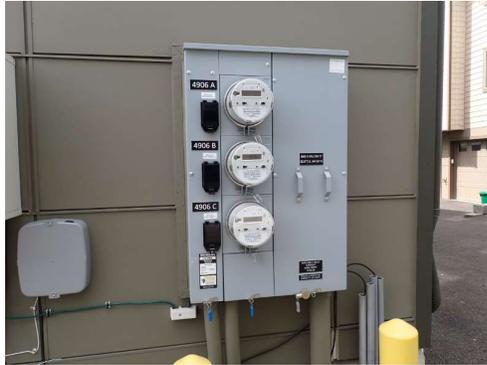
Electrical System - Repair/Replace

Location: Common area electrical

Component History: No history reported

No problems reported of electrical system at the time of this report. Evaluation of electrical components is beyond the scope of a reserve study; if problems are suspected, consult with a qualified electrician immediately. Generally, if installed without defect, there is no predictable basis to expect complete replacement of electrical system within the scope of this report therefore no reserve funding included. No known defects reported by client.

Regularly inspect common area electrical panels and equipment. Contact a qualified electrician if breakers routinely trip or fuses regularly blow, or if you notice a sizzling sound or a burning odor. Ensure that electrical plugs near wet locations (restrooms, exterior building walls, outdoor parking garages, etc.) are Ground-Fault Circuit Interrupters (GFCI).

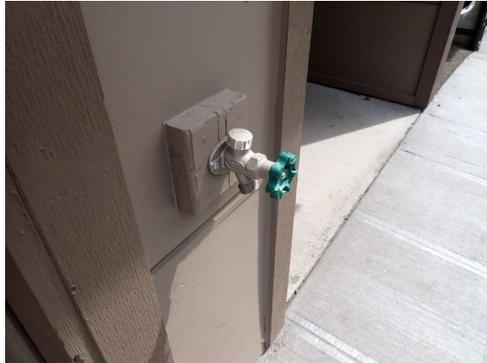
Plumbing System - Repair/Replace

Location: Common area plumbing

Component History: Exterior faucet repairs 2020 \$11,850

No problems reported of plumbing system at the time of this report. Evaluation of plumbing systems is beyond the scope of a reserve study; if problems are suspected, consult with a qualified plumber. Generally, if installed without defect, there is no predictable basis to expect complete replacement of plumbing system within the scope of this report, therefore no reserve funding included. No known defects reported by client.

Some plumbing systems are known to have deficiencies which may become more prevalent over time. These systems may include galvanized plumbing installed in older buildings, and CPVC lines installed in newer buildings. If you have not done so already, consult with a plumber to inspect and evaluate the plumbing system at your association to determine whether the system will require eventual replacement. Plumbing system renovations can be very costly, therefore it is best to determine this information early for financial planning purposes.

Regularly inspect common area plumbing and equipment. Contact a qualified plumber if you are experiencing low water pressure, discoloration and/or leaks. Protect exposed lines from freezing temperatures.

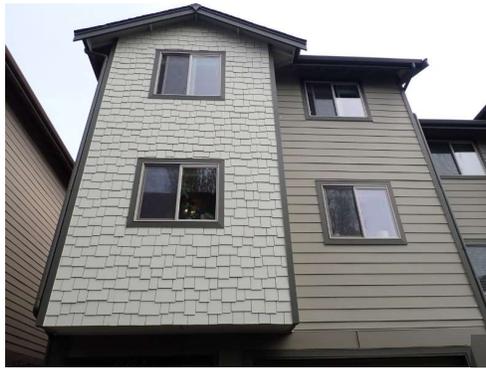
Building Envelope Investigation - 2031

Asset ID	6000	1 Investigation	@ \$5,500.00	
		Asset Actual Cost	\$5,500.00	
		Percent Replacement	100%	
		Future Cost	\$6,967.24	
	Professional			
Placed in Service	January 2021			
Useful Life	10			
Replacement Year	2031			
Remaining Life	8

A reserve study site visit conducts a limited visual review for budgetary purposes only and does not include any invasive testing or structural evaluation. As a result, periodic building envelope investigations are strongly recommended to ensure that building envelope components are performing as designed and to help identify the potential for hidden damages early, thus reducing the risk of unanticipated repair costs. When performed prior to exterior work such as siding and window replacement, a building envelope investigation also helps determine the extent of hidden damages, if any, so the association is not surprised by a significant increase in costs after the project starts. Building envelope investigations should be performed after being turned over from the developer, at 5-10 year intervals thereafter based on building age and individual needs, and prior to performing large exterior envelope projects. Some governing documents may require annual envelope investigations; we recommend reviewing your association's governing documents for any requirements unique to your association.
