Level I – FULL Reserve Study Report

For Fiscal Year Beginning January 1, 2024

Sample Condo

January 18, 2024

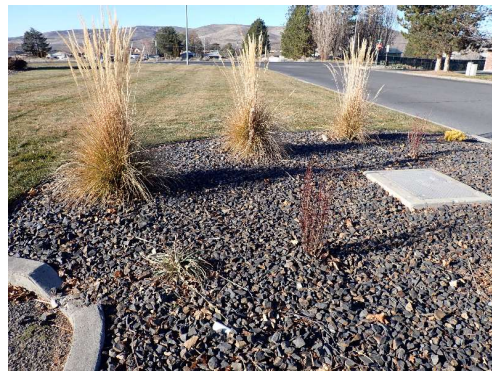
Landscape - Refurbish - 2025

Asset ID	1135	1 Allowance	@ \$2,500.00
Category	Grounds	Asset Actual Cost	\$2,500.00
Placed in Service	January 2022	Percent Replacement	100%
Useful Life	3	Future Cost	\$2,575.00
Replacement Year	2025		
Remaining Life	1

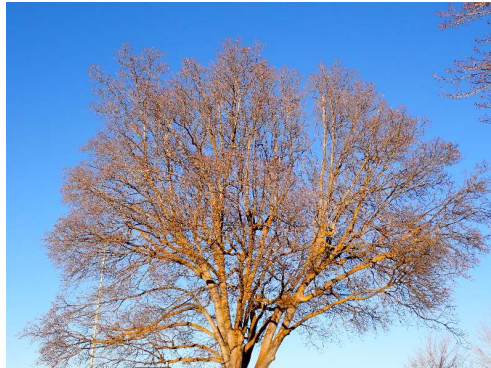
Trees - Trim/Remove - 2024

Asset ID	1145	1 Allowance	@ \$1,600.00
Category	Grounds	Asset Actual Cost	\$1,600.00
Placed in Service	January 2021	Percent Replacement	100%
Useful Life	3	Future Cost	\$1,600.00
Replacement Year	2024		
Remaining Life	0

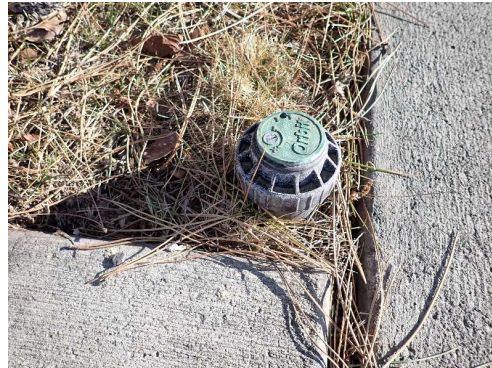
Irrigation System - Repair - 2028

Asset ID	1155	1 Allowance	@ \$1,500.00
		Asset Actual Cost	\$1,500.00
		Percent Replacement	100%
Category	Grounds	Future Cost	\$1,688.26
Placed in Service	January 2023		
Useful Life	5		
Replacement Year	2028		
Remaining Life	4

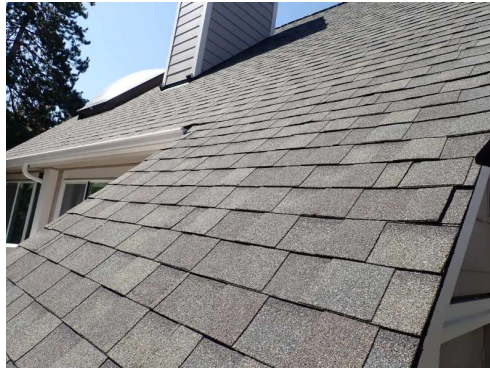
Composition Roof - Replace - 2038

Asset ID	4000	36,500 GSF	@ \$7.00
Category	Building Exterior	Asset Actual Cost	\$255,500.00
Placed in Service	January 2008	Percent Replacement	100%
Useful Life	30	Future Cost	\$386,466.67
Replacement Year	2038		
Remaining Life	14

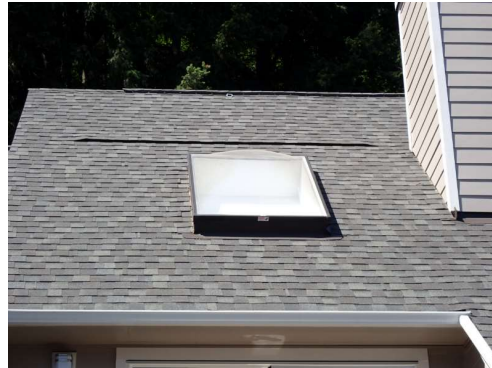
Skylights - Replace - 2038

Asset ID	4025	50 Each	@ \$700.00
		Asset Actual Cost	\$35,000.00
		Percent Replacement	100%
Category	Building Exterior	Future Cost	\$52,940.64
Placed in Service	January 2008		
Useful Life	30		
Replacement Year	2038		
Remaining Life	14

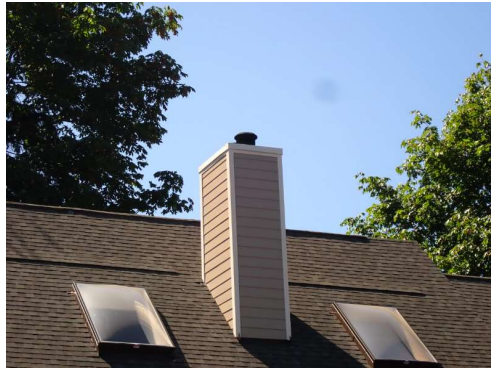
Chimney Caps & Covers - Replace - 2038

Asset ID	4030	50 Each	@ \$800.00
		Asset Actual Cost	\$40,000.00
		Percent Replacement	100%
Category	Building Exterior	Future Cost	\$60,503.59
Placed in Service	January 2008		
Useful Life	30		
Replacement Year	2038		
Remaining Life	14

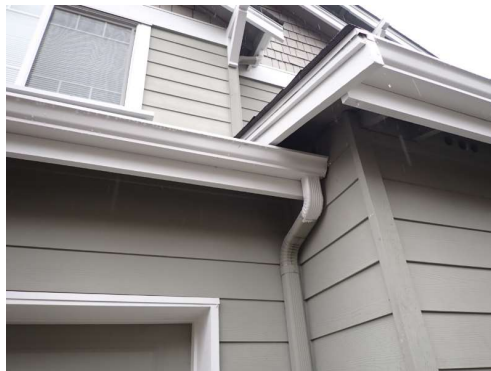
Gutters/Downspouts - Replace - 2038

Asset ID	4035	4,150 LF	@ \$9.00
Category	Building Exterior	Asset Actual Cost	\$37,350.00
Placed in Service	January 2008	Percent Replacement	100%
Useful Life	30	Future Cost	\$56,495.23
Replacement Year	2038		
Remaining Life	14

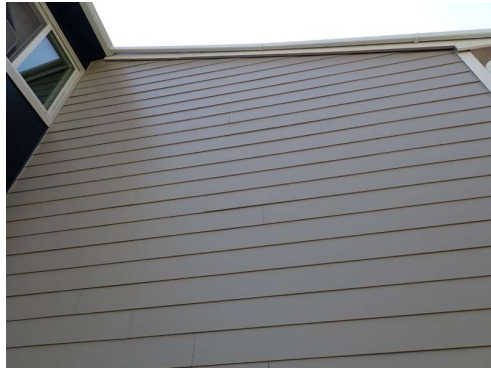
Fiber-Cement Siding - Replace - 2058

Asset ID	4040	50,250 GSF	@ \$24.00
Category	Building Exterior	Asset Actual Cost	\$1,206,000.00
Placed in Service	January 2008	Percent Replacement	100%
Useful Life	50	Future Cost	\$3,294,677.78
Replacement Year	2058		
Remaining Life	34

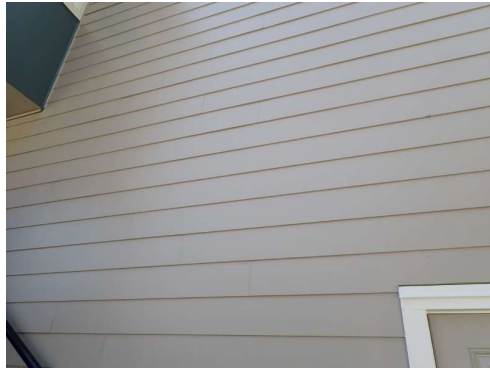
Exterior Surfaces - Repair & Paint - 2028

Asset ID	4065	50,250 GSF	@ \$3.00
Category	Building Exterior	Asset Actual Cost	\$150,750.00
Placed in Service	January 2018	Percent Replacement	100%
Useful Life	10	Future Cost	\$169,670.45
Replacement Year	2028		
Remaining Life	4

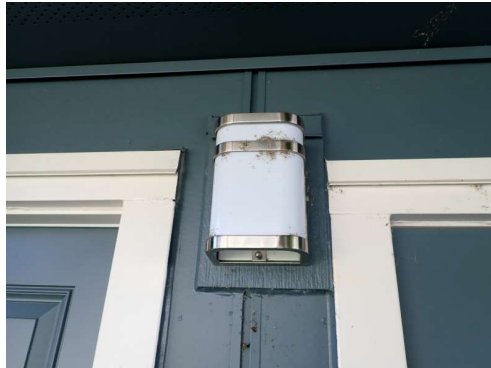
Exterior Lights - Replace - 2033

Asset ID	4068	150 Each	@ \$125.00
		Asset Actual Cost	\$18,750.00
		Percent Replacement	100%
Category	Building Exterior	Future Cost	\$24,464.50
Placed in Service	January 2008		
Useful Life	25		
Replacement Year	2033		
Remaining Life	9

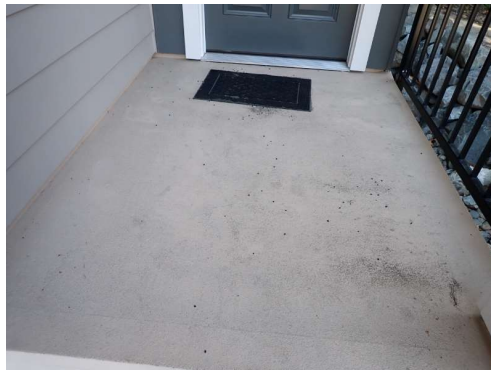
Traffic Coated Decks & Porches - Repair & Coat - 2024

Asset ID	4115	3,950 GSF	@ \$15.00
		Asset Actual Cost	\$59,250.00
		Percent Replacement	100%
Category	Building Exterior	Future Cost	\$59,250.00
Placed in Service	January 2018		
Useful Life	5		
Replacement Year	2024		
Remaining Life	0

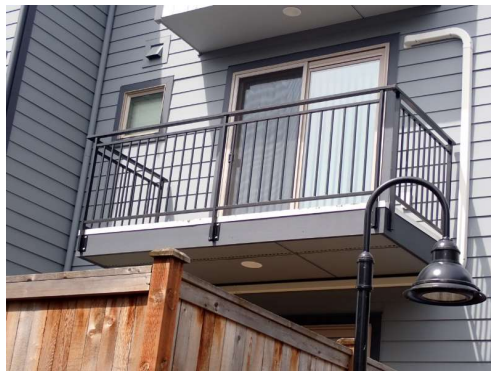
Metal Deck Rail - Replace - 2058

Asset ID	4130	1,425 LF	@ \$150.00
		Asset Actual Cost	\$213,750.00
		Percent Replacement	100%
Category	Building Exterior	Future Cost	\$583,944.75
Placed in Service	January 2008		
Useful Life	50		
Replacement Year	2058		
Remaining Life	34

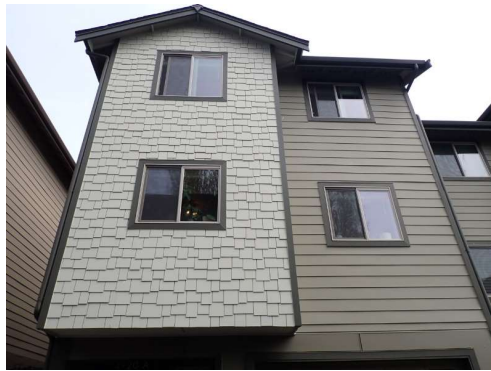
Periodic Investigations - Perform - 2027

Asset ID	6000	1 Investigation	@ \$5,500.00
		Asset Actual Cost	\$5,500.00
		Percent Replacement	100%
Category	Professional	Future Cost	\$6,010.00
Placed in Service	January 2022		
Useful Life	5		
Replacement Year	2027		
Remaining Life	3
