FINEGAN INSPECTION SERVICES, INC.
TERRY FINEGAN
27 LAURELWOOD DRIVE
MILFORD, OHIO 45150
683-0733-PHONE

1). EXTERIOR WALL SURFACE

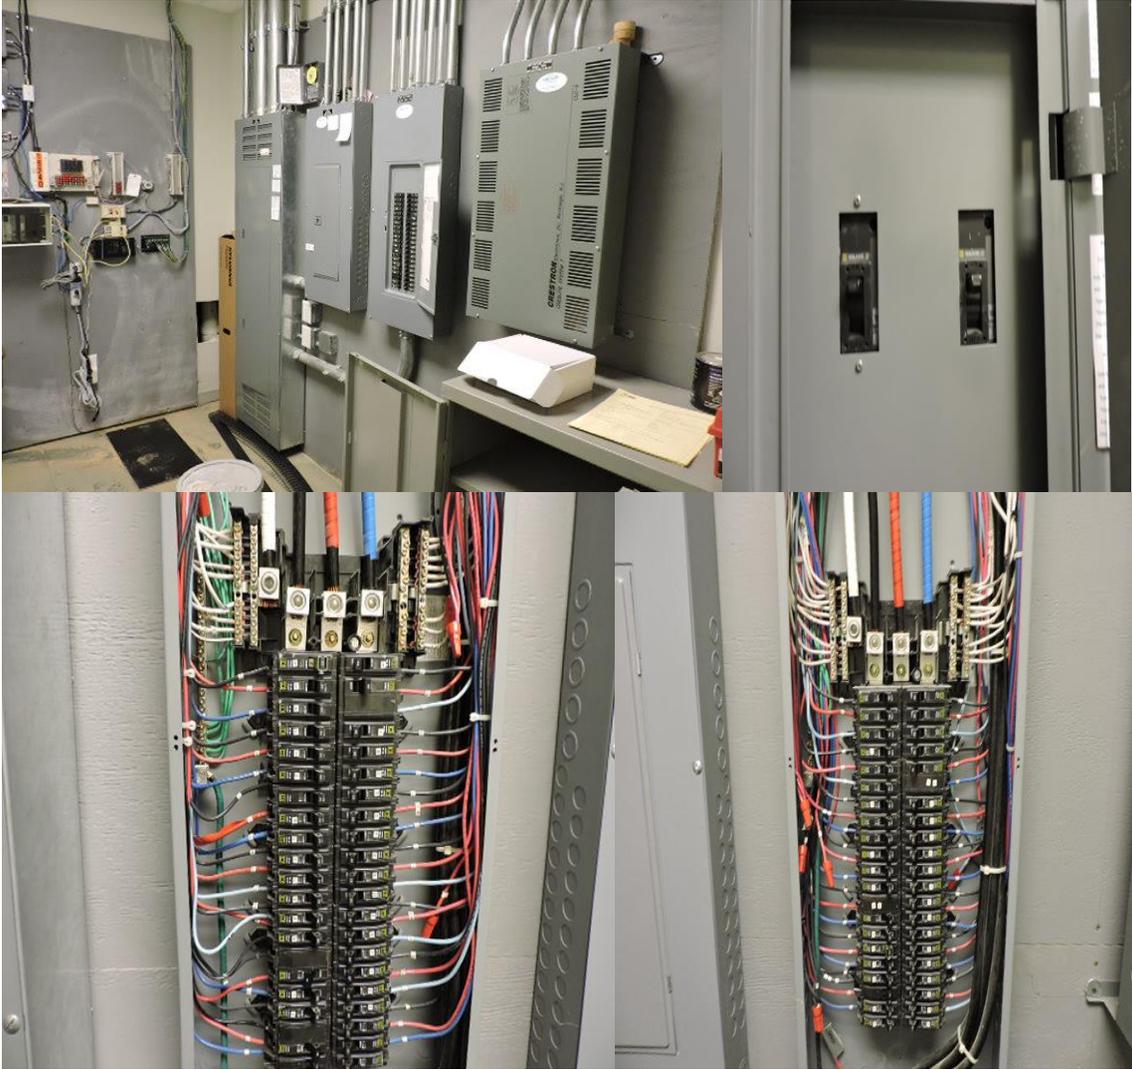
The power to the building is noted at 400 ampere of service. This is a large electrical service and could be moderately extended beyond the existing electrical demand of the building. There were no errors or malfunctions of the electrical equipment or any outlets, switches or other electrical driven equipment. The electrical panel was opened and all wiring was noted to be properly installed and there were no breakers that were noted with evidence of overheating or improper wiring. The interior wiring showed no evidence of improper connections or errors in normal wiring technique.
