FINEGAN INSPECTION SERVICES, INC.
TERRY FINEGAN
27 LAURELWOOD COURT
MILFORD, OHIO 45150
683-0733-PHONE

RESIDENCE

1234 Anystreet, Cincinnati, Ohio

EIFS moisture testing inspection

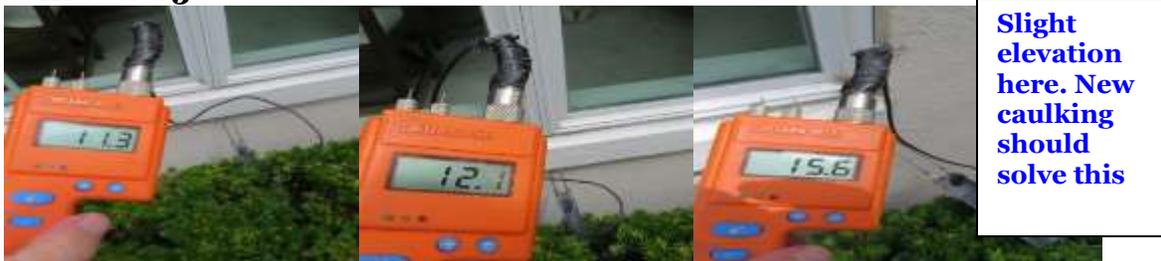
Window #5

Most moisture readings at the front left wall areas were elevated with several above 20 on the impedance meter. **Sill drains and new caulking is needed at these windows.** A new kick out flashing is needed at this wall

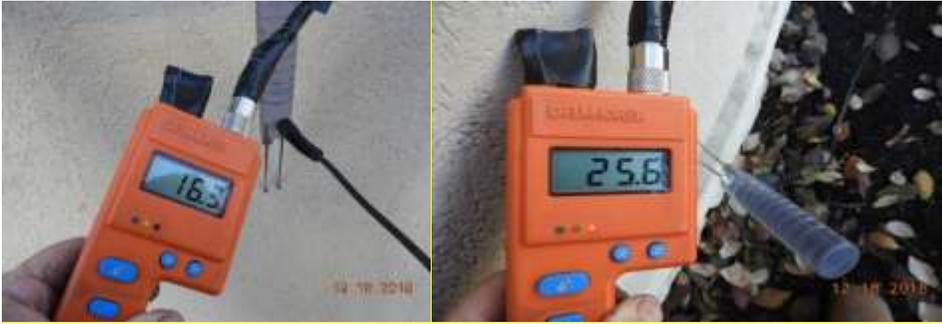
Window #8

The moisture readings are exceedingly elevated and the substrate is very soft below these windows and next to these windows #6 and #7.
