FINEGAN INSPECTION SERVICES, INC.
27 LAURELWOOD DRIVE
MILFORD, OHIO 45150
683-0733-PHONE

NEW HOME INSPECTION REPORT

This is a **punch list report** so as to review the items in the house that are in need of repair or to be finished by the builder as a part of the final walk through process. The inspection was made on _____ p.m.

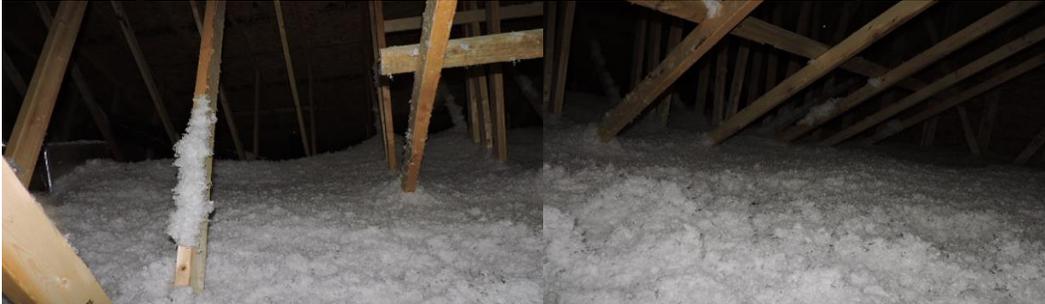
30). The **venting** of the upper attic appears to be sufficient at the apex of the attic space and at the soffit areas. The air passages at the attic areas near the truss bearing points were clear of insulation and blockage. The air passages had baffles installed at the soffit area of the attic.

The **roof structure** was composed of standard trusses. The truss system showed no areas where any departures from standard installation and construction technique were observed. There were no broken or damaged framing components observed at the time of the inspection. The truss system is an engineered product. There were no engineering drawings observed to arrive at this conclusion. The trusses were only visually inspected. No load calculations were accomplished as a part of a punch out inspection.

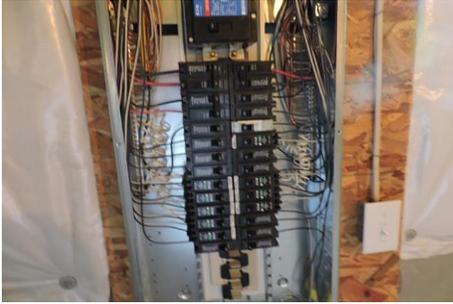
Note that there are **breakers** in this panel that are marked as **AFCI**. This stands for **Arch Fault Circuit Interruption**. These have a **white re-set button** on the breaker. Notice that they are connected to the bedrooms in the home. The reason for the installation of these types of breakers on circuits that are to the bedrooms is because that is where we are most vulnerable.

The **AFCI breaker** is intended to prevent a circuit to which it is connected from overheating if a wire in that circuit is not secure where it connects to a switch or an outlet or a fixture. These new breakers are required by the National Electrical Code. If they should trip to OFF, have an electrician called in immediately and leave the breaker in its OFF position. When these breakers trip to off there may be an “arching” at the connection point of the electrical wire to the outlet, fixtures or switches that are on that specific circuit.
