# Finegan Inspection Services, Inc

## CONFIDENTIAL INSPECTION REPORT

1234 Example Street, Anywhere, Ohio

2/6/2019 10:00 am to 1:00 pm

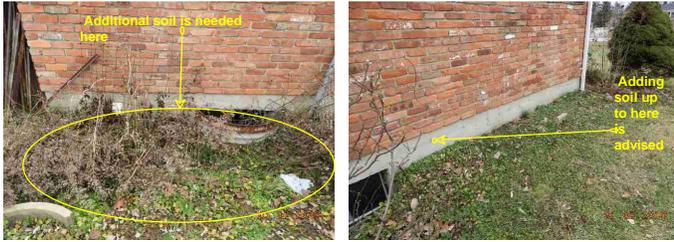
- q There is a low area of the soil grade at the left side of the house close to the foundation of the home. There is surface water that is now draining toward the house foundation given the existing soil conditions. Have the situation modified so that the soil grade will direct the surface water away from the house foundation. The installation of a collection box is advised and then connected to the existing conductor lines for the

downspout.

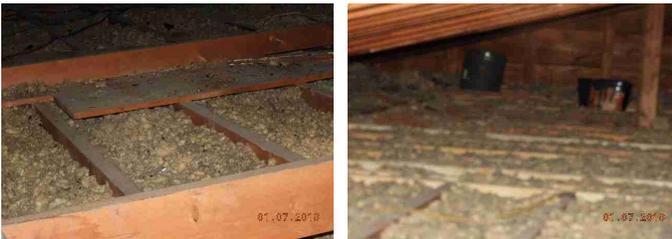
- q The attic insulation in the original house attic area was noted to be about 3" thick which is lower than recommended levels of thickness to provide a proper R value for thermal resistance at today's standards. The attic was noted with compressed loose fiberglass insulation. The addition of 10 " of insulation on top of the existing is recommended at the following locations:
  - 1). Over the entire attic of the house.

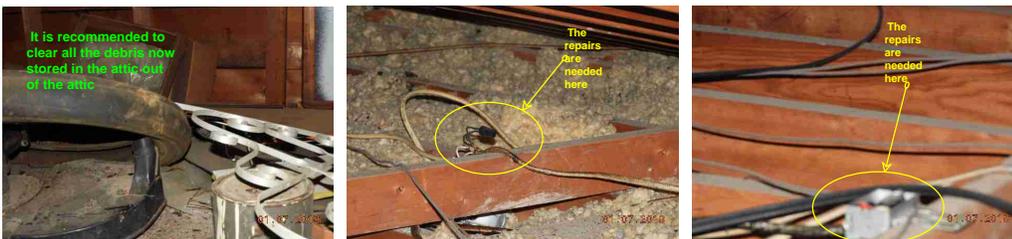
- v Have the electrical wiring that is in the attic above the hallway area properly connected. Have an electrician review the splices and place these in proper junction boxes above the insulation level.

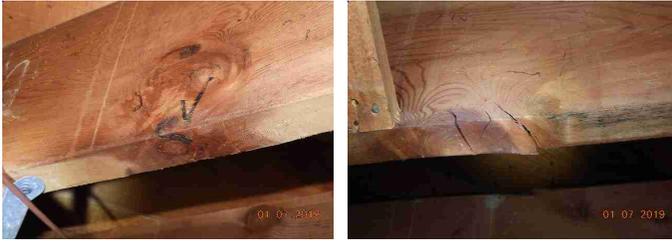
- v The observable floor joist system in this was noted with a knots and a cracks in 2 of the floor joists below the first floor. When the knots in the joist are at the bottoms of a joist and the location of the knot is near the center point of the span of the floor joist, the joist has a higher propensity to crack in that location. The probability is increased even more if there are electric or plumbing lines or pipes that are cut into the joist in these same locations.

The repair of these cracked joist is recommended to insure the overall structural integrity of the floor joist system. A 6' to 8' long "sister" added to the side of these joists is necessary. The sister may not be cut or notched. It should be set on one bearing point at minimum. It must be as wide as the dimensional lumber to which it is attached.

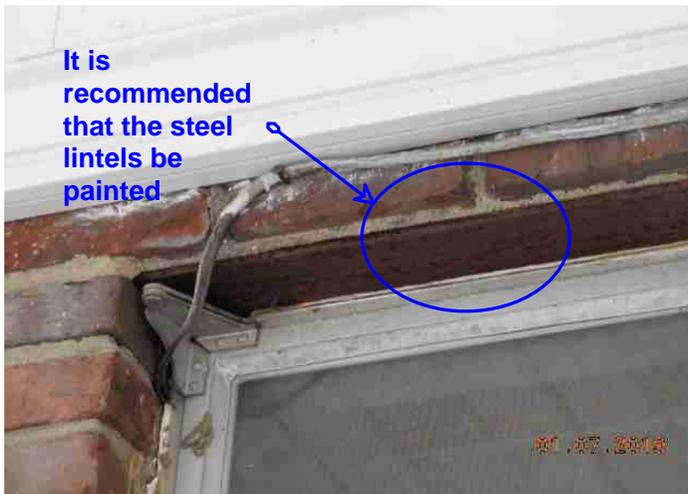
- q There are steel lintels that are installed above the windows and doors of this home. This is a typical construction technique and all steel lintels on this home appear to be properly installed and of the correct size to bear the weight of the brick facade materials above. The steel is noted, however, to be unpainted. Sanding, primer coats and painting the steel with a rust inhibiting paint is advised in all locations where the steel is located at this time on the exterior walls of this home.

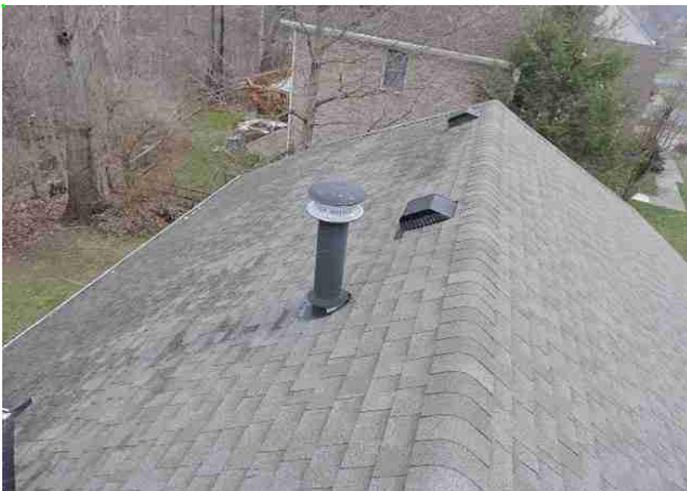
- m All attics should be properly vented. There is a cubic feet ratio that should be followed on all new buildings. This same ratio should be followed on older buildings if possible. The attic should be properly vented to allow reduction of the moisture content that rises upward through the ceilings. The venting will also reduce the heat build up. This will provide a better the structure and will also increase the overall energy efficiency of the house.  
This attic seems to have proper ventilation by a visual account. Further details will be noted on the attic portion of this report. The individual passive vents were properly secured to the roof surface and the nails were correctly sealed to keep water out of the attic area.

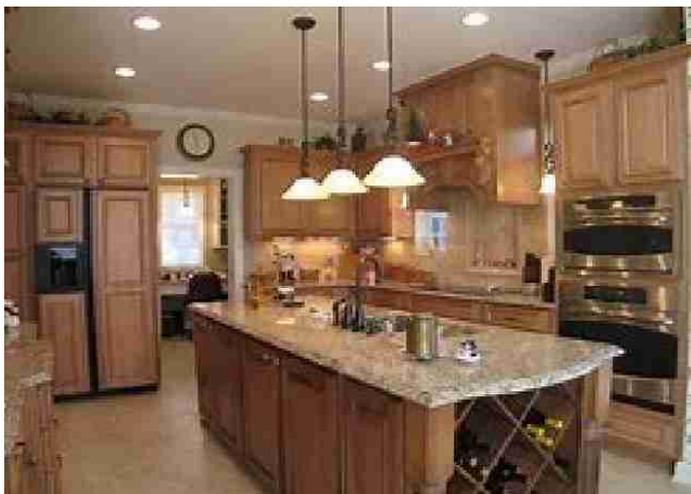
- m The counter tops in the kitchen were examined and noted to be properly installed with no evidence of damage or improper operation/function. All were in good condition.

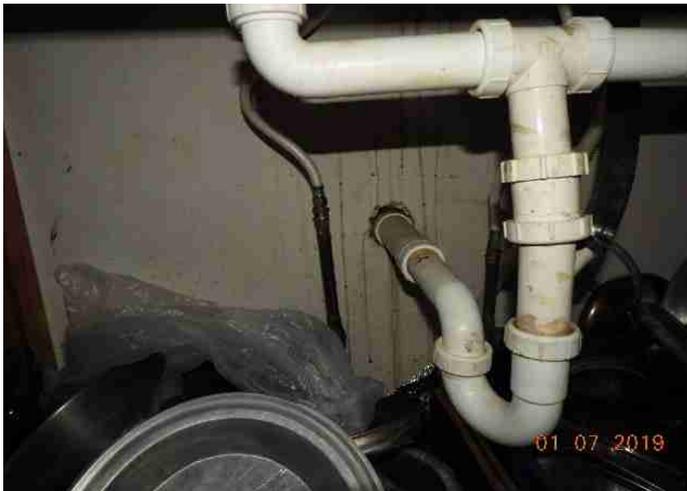
- There is no disposal in this kitchen.

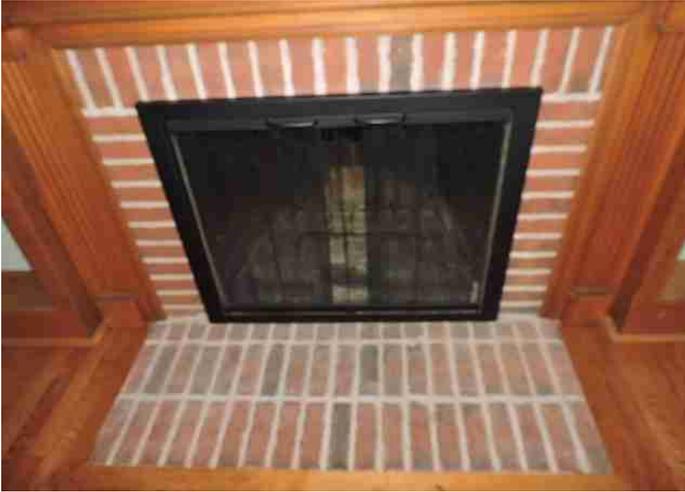
- m There is a masonry firebox in the familyroom fireplace. It is in good condition.

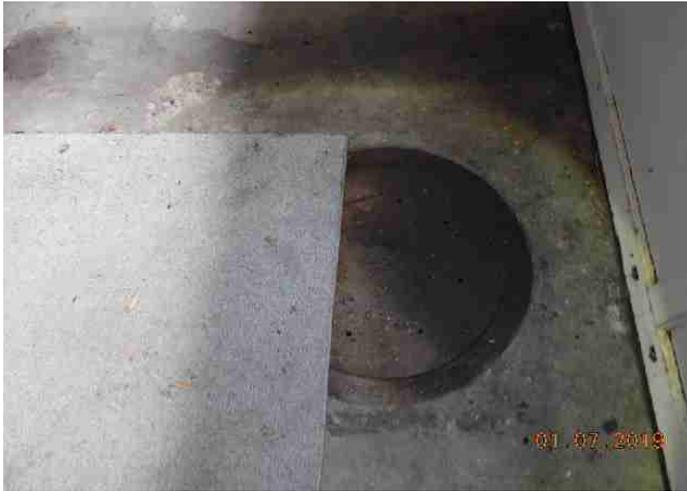
- √ There is an old cistern located under the garage floor. It is no used as a water source and is now a storage area. There is an access lid in the floor to the cistern. Have this bolted to the floor.

**Cistern under the garage - Continued**

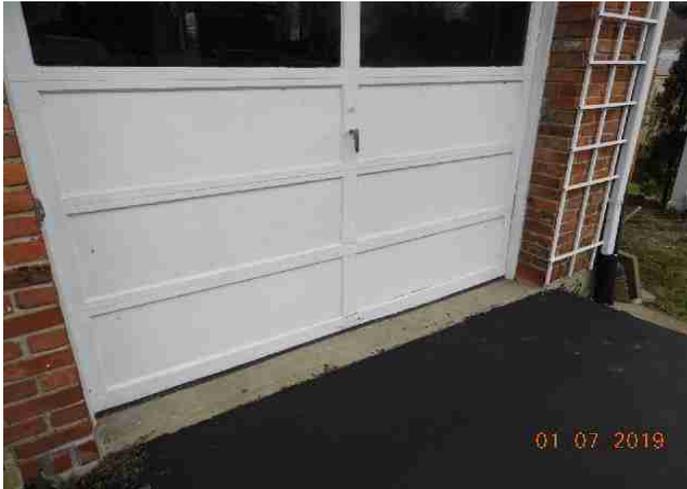
- There was a composite type of door on this overhead garage door opening. These types of composite materials must be kept sealed to function properly over the long term. The glue and fibers will delaminate if moisture can access the surface materials.  
Have this door painted as needed in the future. Doors that face West or South will need more frequent paint than will doors that face North or East. The eventual replacement with a steel insulated door is advised.

Wood and composite single garage overhead door - general notes - *Continued*

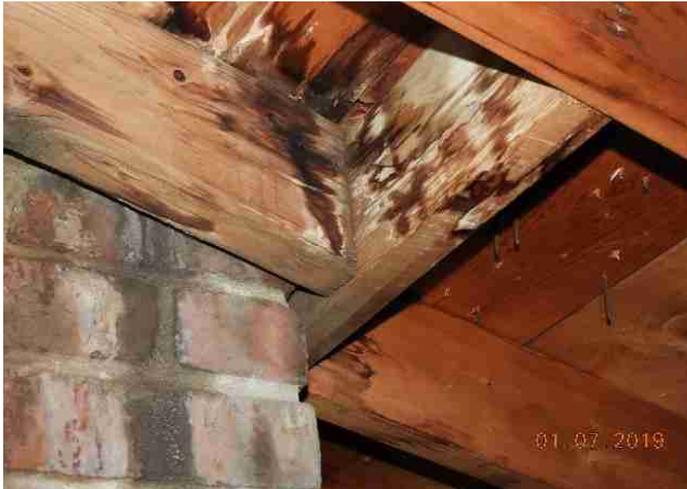
- q There was some stained wood on the roof area near the chimney from the attic observation. The roof above may have leaked in the past at the chimney flashings. There is no evidence of active leaking observed at this time.

Evidence of past leaking - *Continued*

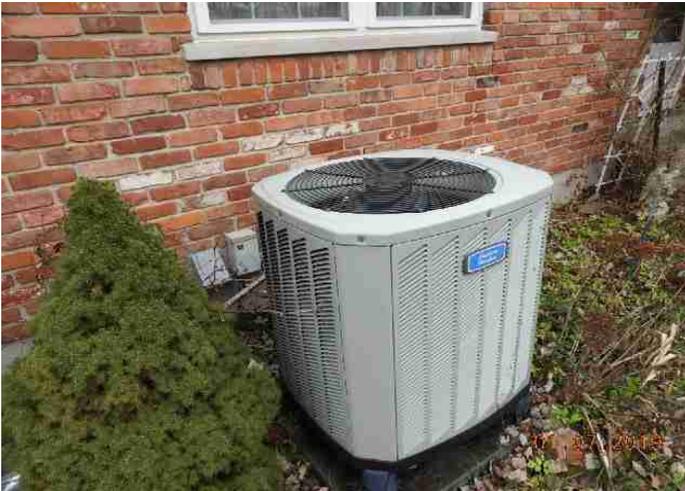
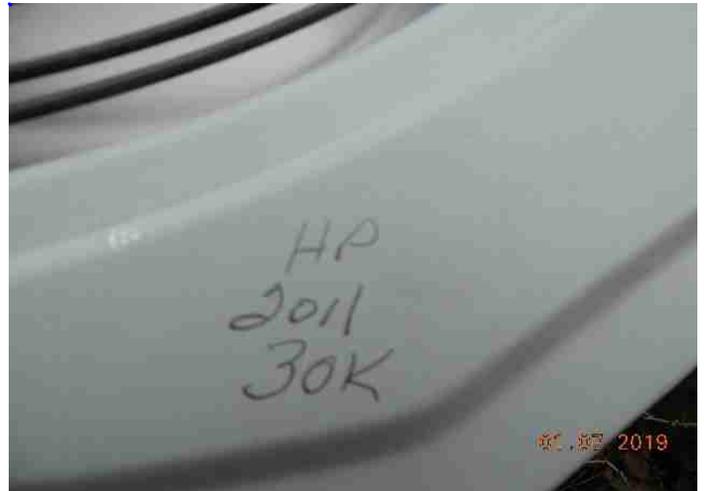
- The unit is a 36,000 BTU unit,( known as a three ton unit),. The only sure method of quantifying the condition of this or any air conditioner would be via a compression test by a professional H.V.A.C. contractor.  
At 36,000 BTU the unit should be moderately adequate to cool the residence, but may need to be larger or supplemental cooling added in the second story. If additional finished space is desired, a split system is advised.  
This is a estimate and no load calculations were made to arrive at this estimate. It is based on past experience only. Load calculation are beyond the scope of this inspection service.

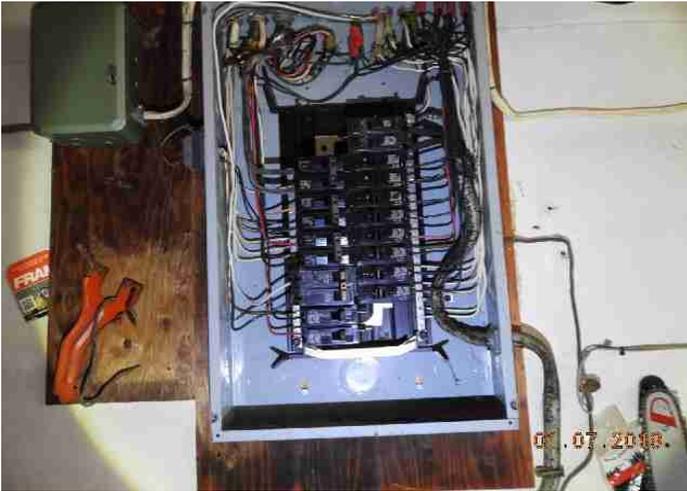
- m The interior of the electrical panel was accessed by removing the "dead front cover" and observing the wiring conditions inside the electrical panel. The wiring conditions inside the panel were observed to be in good condition. The circuit breakers were secure, the load wires were connected tightly to the breakers and without error in size or method of connection. The neutral and ground wiring was also inspected and found to be properly installed.

The main panel in the garage was noted to be in good condition - *Continued*

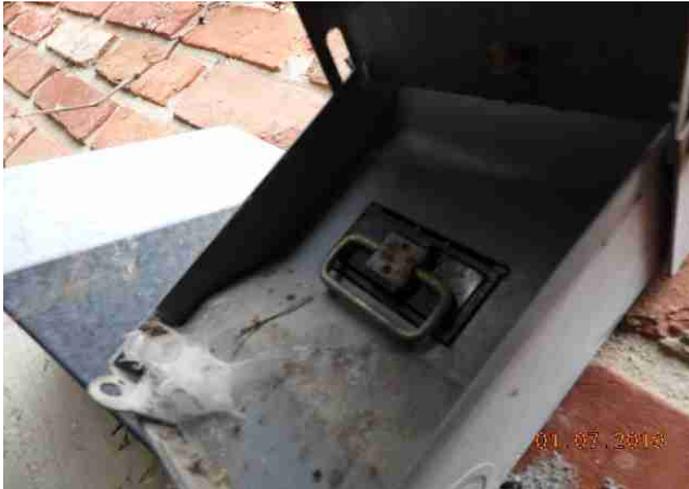
- m The air conditioning/heat pump sub panel was properly mounted without rust in the box. There was proper wiring in the sub panel and there is no fuse or breaker in the panel.

The AC-heat pump sub panel was in good condition - there was no breakers or fuses - *Continued*
