Desert Greens HOA

Level 1 Reserve Study

Report Period - 1/1/2016 to 12/31/2016

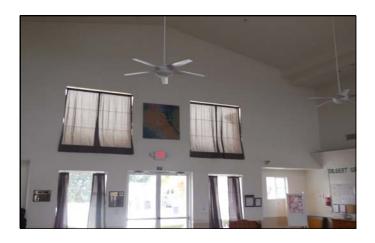
Painted surfaces are in good to fair condition. Due to the minimal quantity of painted surfaces repaint this component as an operating expense. No reserve funding necessary.
