Canterbury 2021 Flood Recovery Update 3

Ken Tarboton (Aqueus Consulting)
Shaun McCracken (Environment Canterbury)

31 March 2022

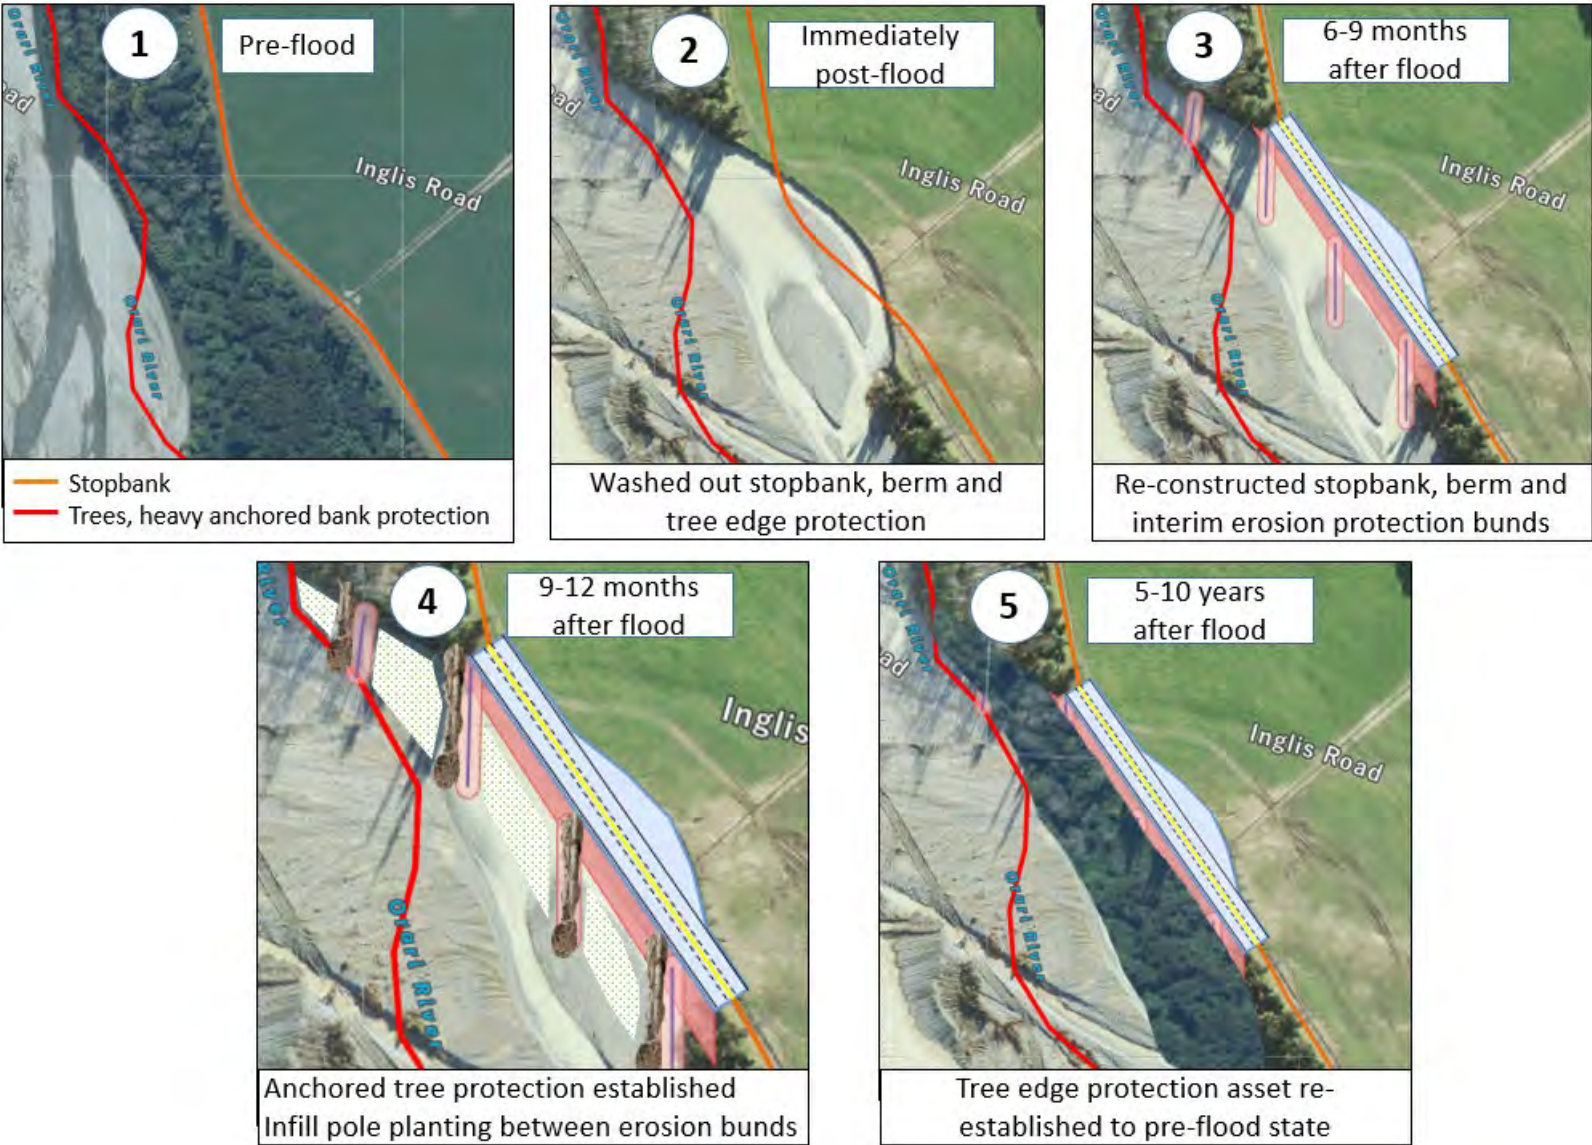
Figure 2-1 below shows the steps and approximate time for the repair of tree edge protection from well-established tree edge protection pre-flood, to re-established tree edge protection over a period of 5-10 years.

Figure 2-1: Sequence and timeline to re-establish stopbank and tree edge protection for typical flood washout.

At each of the locations listed above, not only were stopbanks washed out but also the tree erosion protection assets. Erosion protection bunds have been established along the riverside edge of the stopbanks as a first step towards re-establishing the tree edge protection. Anchored tree protection (ATP) will be installed along the upstream edge of each erosion protection bund, over the next few months and into the winter of 2022 as the next step towards re-establishing tree edge protection. Finally, tree infill planting will be undertaken between the erosion protection bunds. It will take many years (at least 5-10) for the infill trees to grow to the point where the tree edge protection has replaced the edge protection lost during the flood.

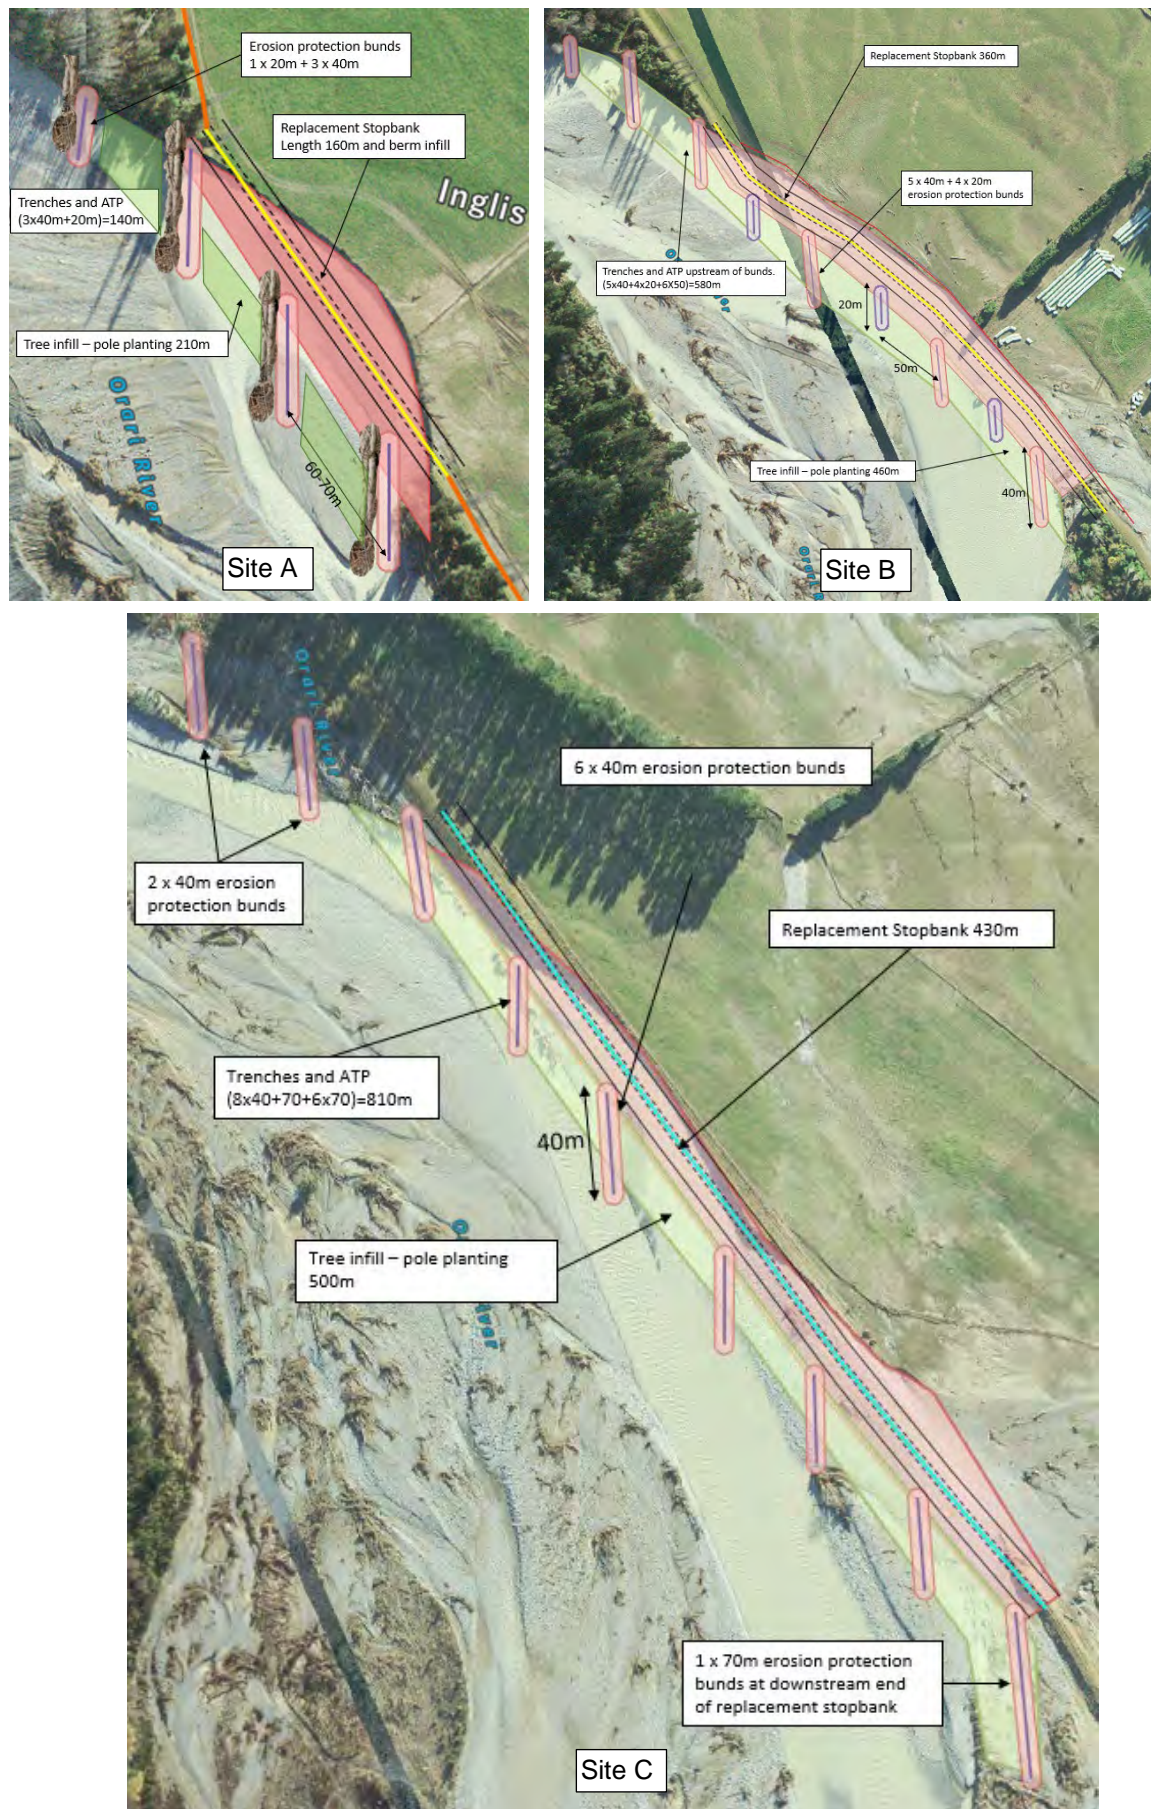
Figure 8-11: Orari at Inglis Road, flood repair design for sites A, B and C.
