**Revised**  
**FULL RESERVE STUDY**  
**Rio Del Sol**  
**Homeowners Association, Inc.**

**Lake Havasu City, Arizona**  
**Inspected - March 18, 2021**  
**Revised - July 7, 2021**

Rio Del Sol Homeowners Association, Inc.  
Lake Havasu City, Arizona

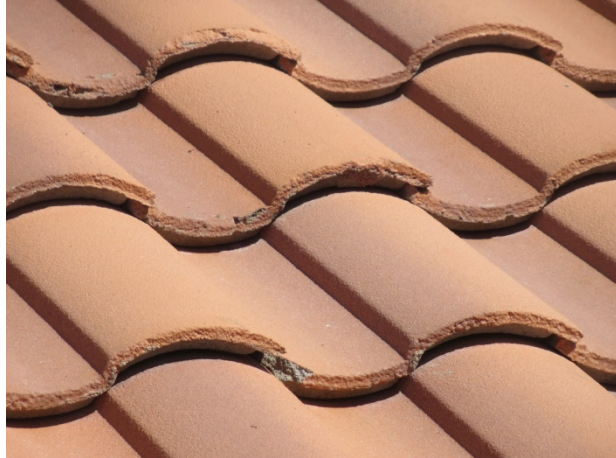
**Minor chipped tiles**

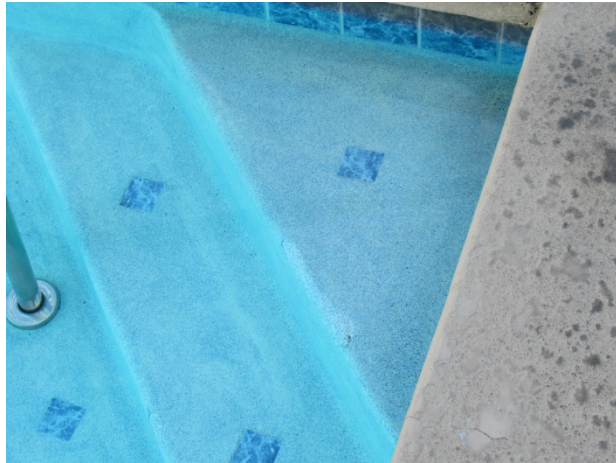
**Chipped finish at pool step**

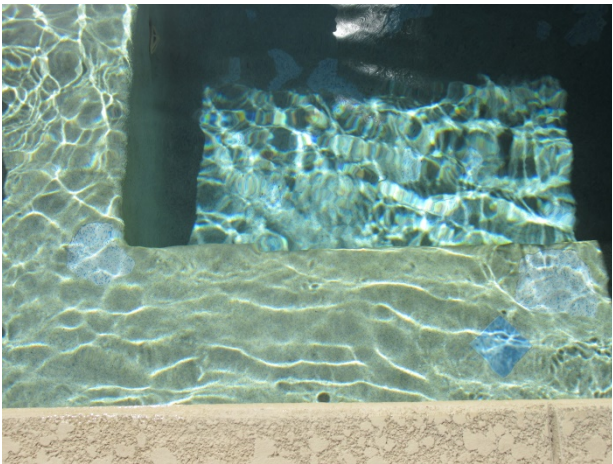
**Chipped plaster at spa #1**

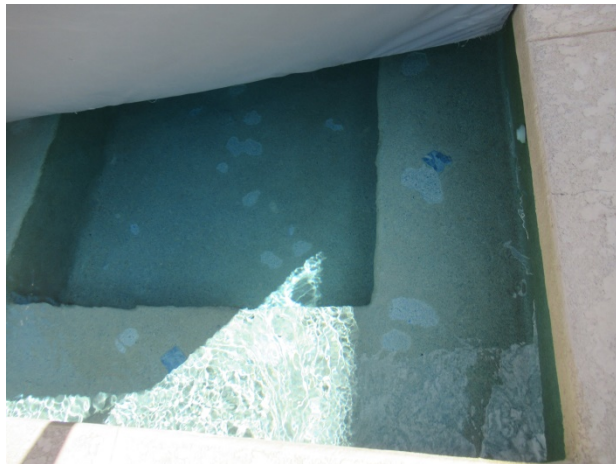
**Chipped plaster at spa #2**
