TYPE OF BUILDING *Ranch, Frame, Stone Veneer*

Inspection Summary

J&K PROPERTY INSPECTIONS

Record 092018 - Sample, Report 12345 Anchor Street, Denver, CO 80008

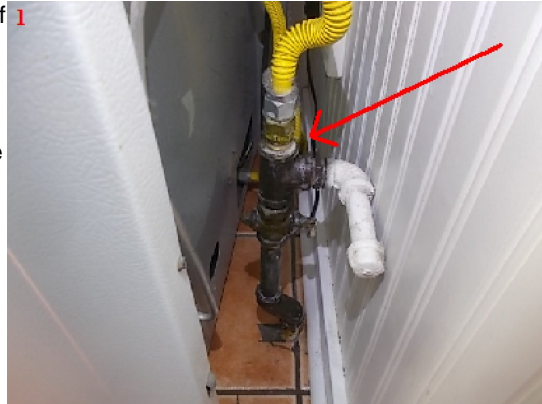
There is a gas leak in the supply lines leading to the range. Leak is located at the connection between the flex pipe and black pipe. This is a hazard and should be repaired immediately.

Contact a qualified plumber to make repairs.

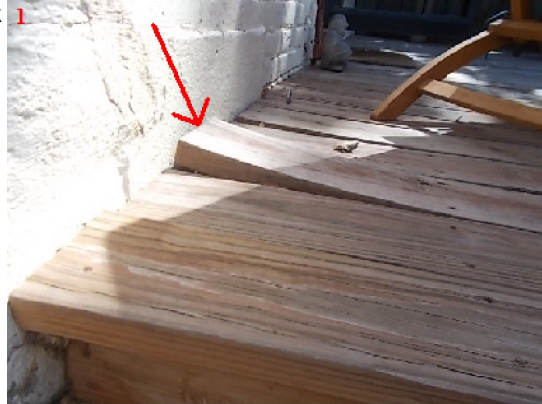
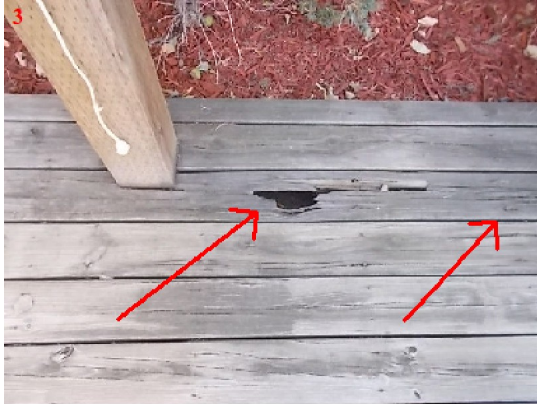
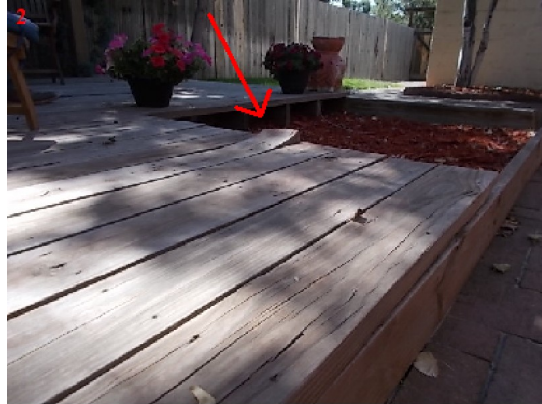
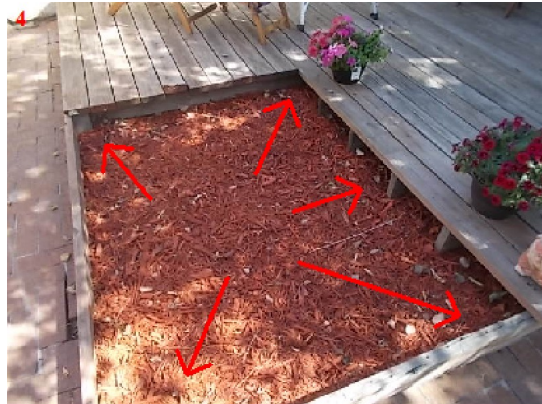
Loose and lifting deck planks noted at various areas of the back deck. These areas create a trip hazard. Loose planks may also be an indication of damaged floor joists and hidden damage. Correct fasteners should be used to secure the planks back into position. Repairs may require some material replacement. This should be evaluated by a qualified contractor and all needed repairs made.

Wood rot noted at the South section of the deck due to lack of sealer. Proper repairs will require some material replacement. Deck material should also be power washed and re sealed to prevent further decay. This should be evaluated by a qualified contractor and all needed repairs made.

Deck framing is contacting the soil which will cause wood rot and may permit water or pest damage. This should be evaluated by a qualified contractor and all needed repairs made.

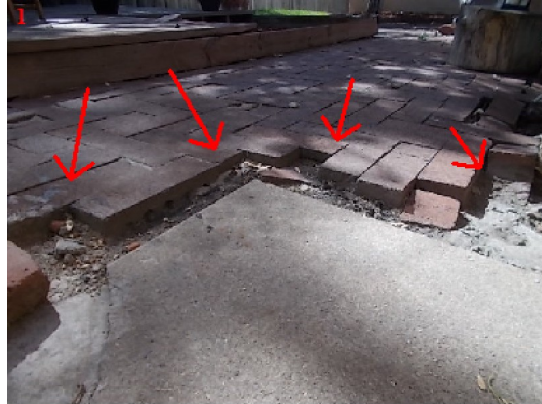
Patio

Settling and movement noted in the back patio brick pavers. This movement has created uneven stepping areas that may create trip hazards. This settlement has most likely occurred due to poor drainage of roof and surface water at the Northwest corner of the house. These areas should be evaluated and properly repaired by a qualified contractor.

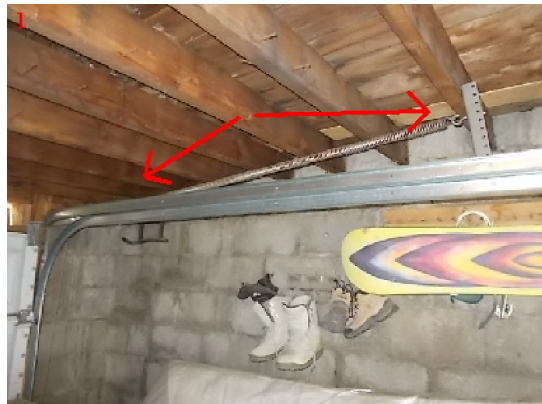
Garage Vehicle Doors

Missing spring retainer cables noted on garage overhead vehicle door. Spring retainers should be installed for safety in the event the sprint become damaged or breaks. Contact a qualified contractor to evaluate and make all needed repairs.

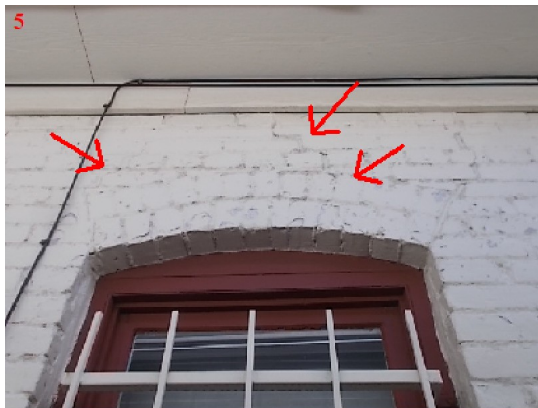
Masonry Walls

Cracking noted in the brick work at all sides of the house. Cracking may be due to previous poor drainage of roof and surface water, along with deteriorating mortar. Cracks should be properly patched or sealed to prevent water intrusion. Mortar and exterior paint should also be sealed to prevent further deterioration. Due to the large number of cracks and possibility of structural damage if repairs are not properly made in the near future this is considered a major concern. For further information I recommend contacting a structural engineer or contractor. Repairs should be made by a qualified contractor.

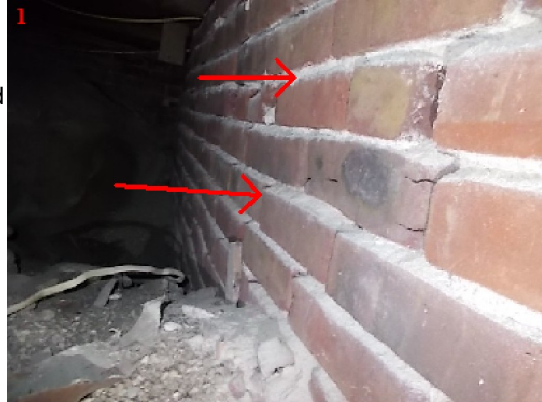
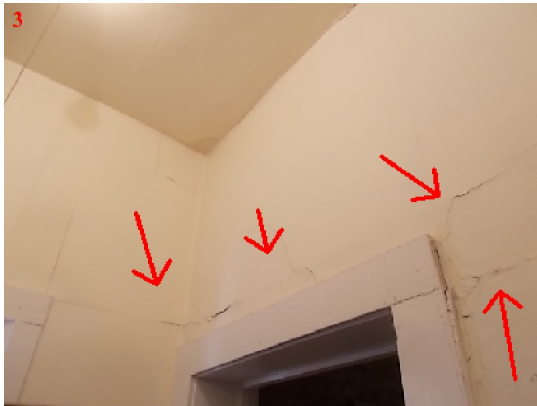
Structural Columns Crawl Space

Structural wall or brick work appear to be deteriorating. This deterioration in the mortar between the brick has allowed for movement and falling bricks. Missing bricks at these locations create excessive movement in the floor joist resulting in cracked floor grout, cracked counter top grout and cracked wall plaster. Additional support should be added at these locations to prevent further movement and damage. Mortar in the structural wall should be repointed and repaired to prevent further deterioration. This should be evaluated by structural contractor and all needed repairs made.

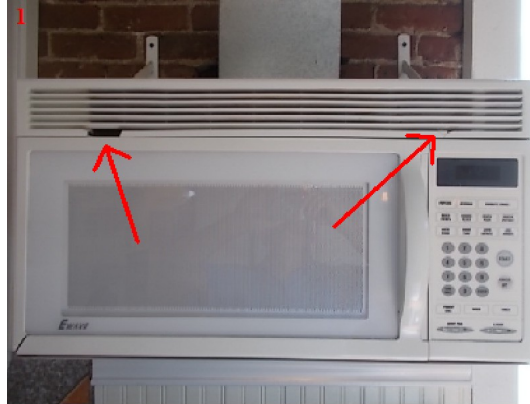
Damage noted at the front door / cover of the microwave unit. This appears to be only cosmetic. However, repairs should be made to prevent further damage. Contact a qualified contractor for corrections.

One of the lights on the exhaust hood or microwave for the range cook top does not appear to be working at time of inspection. Light bulb should be replaced prior to contacting an appliance technician. Contact a qualified contractor for any needed repairs.

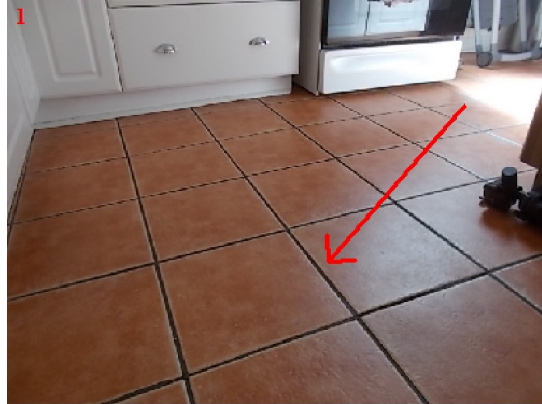
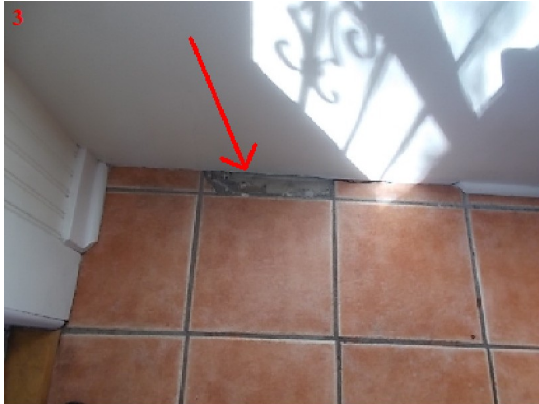
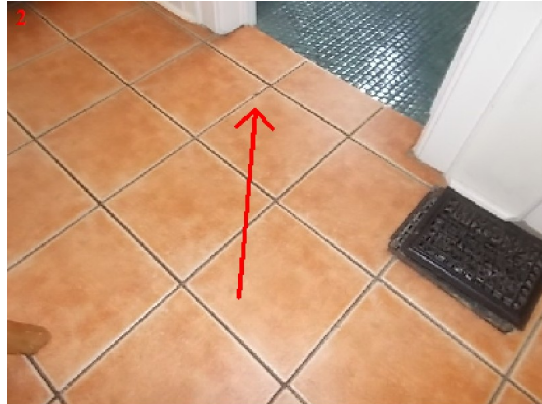
Kitchen Floors

Cracked and missing grout along with tile noted at some areas of the kitchen. This can allow for water intrusion creating damage to the sub flooring and may cause the tile to detach from the backer board.

A qualified contractor should evaluate and make needed repairs.

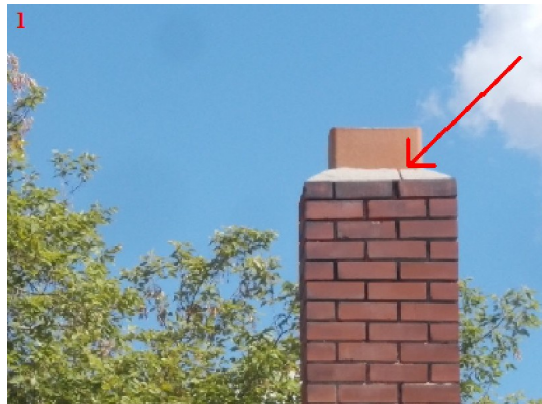
Chimney 1 Top

Some cracks noted in chimney top. Repairs should be made to prevent water penetrations. Contact a qualified contractor to evaluate and make needed repairs.

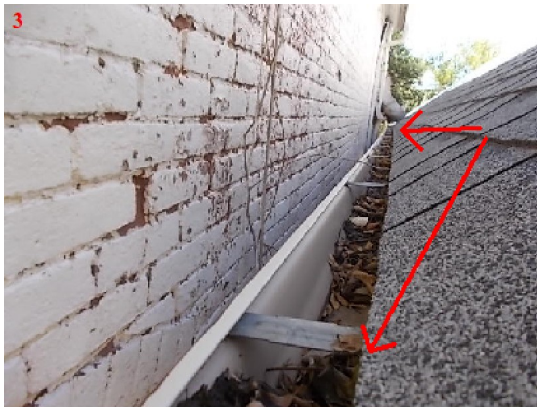
Gutter Type

The gutters are full of debris and should be cleaned so that water can drain properly. This will prevent water from overflowing the gutters causing damage to the soffit and fascia. Contact a qualified contractor to evaluate and make needed repairs.

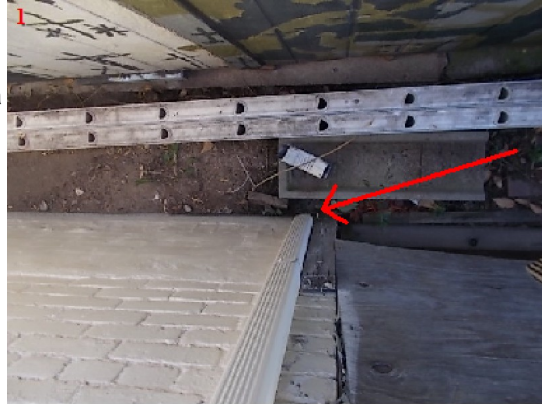
Downspout Extensions / Splash Blocks

Downspout extensions are missing or inadequate at the Southwest corner of the house. This will allow water to drain next to the foundation and may cause water to damage the foundation walls. Downspout extensions should drain water to a downhill slope away from the house. Contact a qualified contractor for corrections.

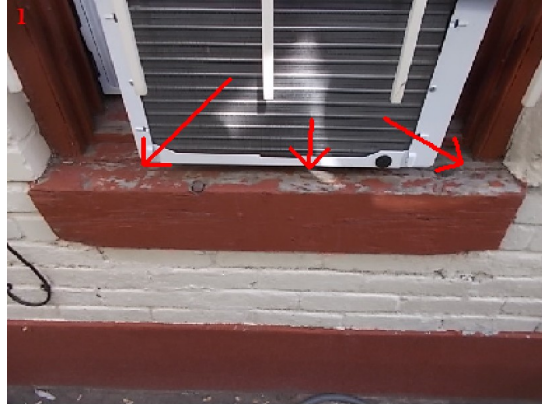
Trim Work

Chipping or peeling paint on exterior trim noted at windows. This should be scraped and repainted to prevent rot. All exterior wood products should be evaluated by a qualified contractor and all needed repairs made.

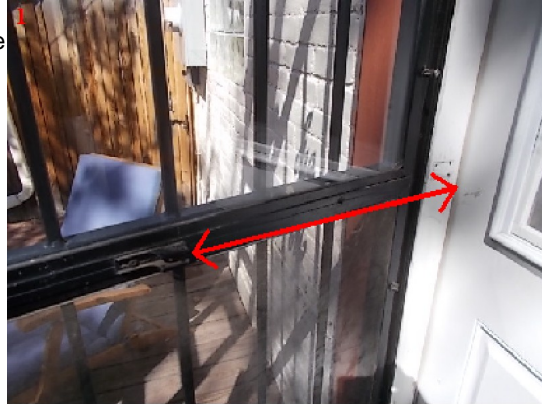
Exterior Doors

Self closing device is missing on the back screen door leading to the deck. The hydraulic cylinder should be installed to pull the door on tight. This may cause damage to the door and door frame if repairs are not made. Repairs should be made by a qualified contractor.

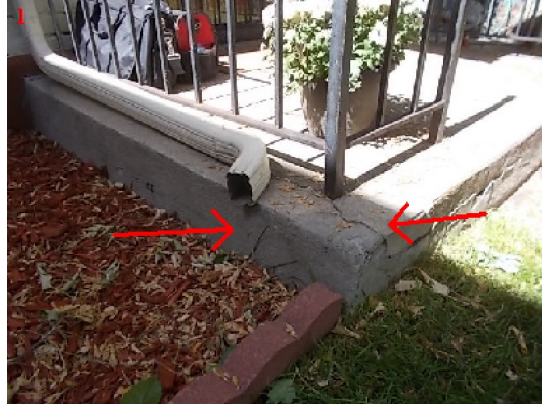
Porches

Some minor cracks noted in front porch concrete slab. Cracks should be sealed now and maintained in the future to help prevent further movement. A qualified contractor should make any needed repairs.

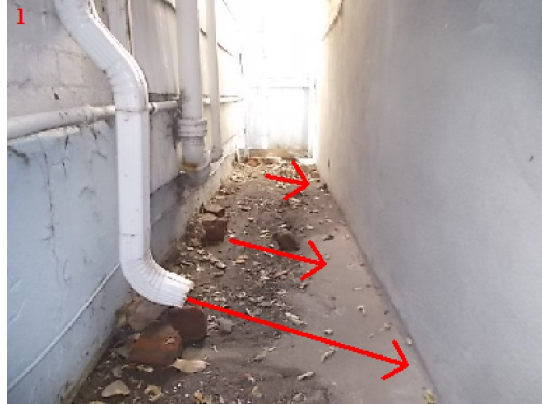
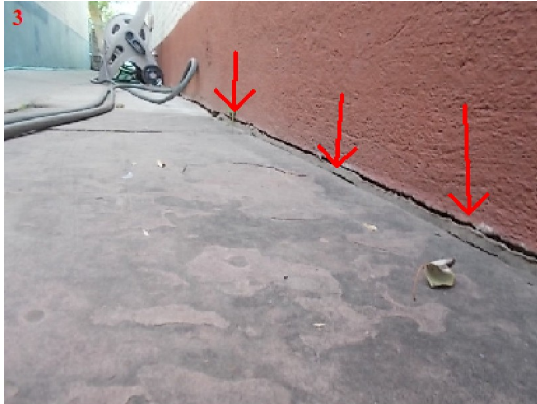
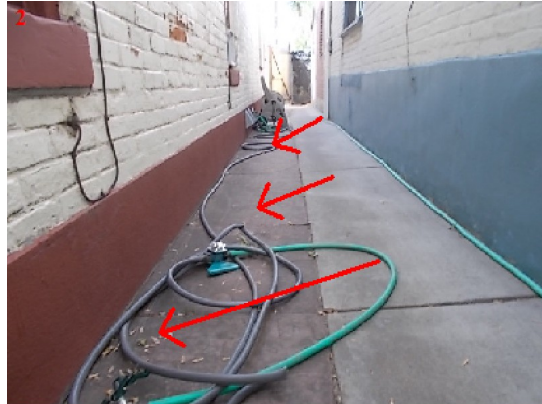
Exterior Grading

Poor grading or negative drainage in areas around the foundation. This may allow water to drain next to the foundation and may cause damage to the foundation walls or allow water to penetrate into interior spaces. These are some recommendations. Soil should be sloped away from the foundation to improve drainage. Downspout extensions should be installed at all gutter downspouts to discharge water at least 4 feet away from the foundation. Landscaping within 3 feet of the foundation should not require water, such as bark or gravel. Do not use solid plastic weed barriers next to the foundation wall: use fabric mesh weed barriers to allow moisture in the soil to evaporate. Sidewalk connections to the foundation should remain sealed at all times. Contact a qualified professional for advise on needed corrections.

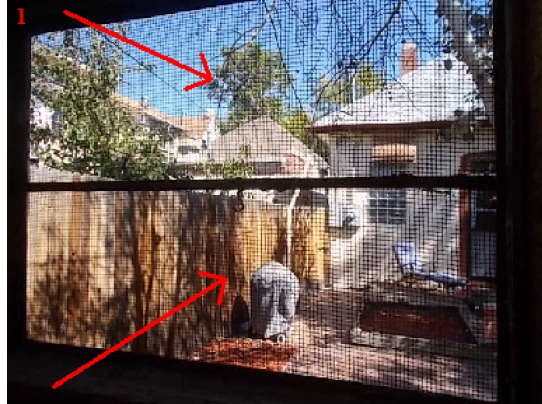
Garage Windows

Missing windows and improper repairs noted at the East and South sides of the detached garage. This locations may allow for water damage and also allows for intruder access. Windows should be serviced by a qualified contractor to ensure proper operation and safety.

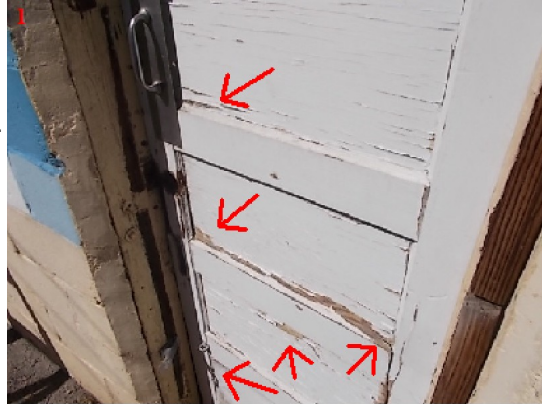
Garage Service Doors

Large amount of material damage, open holes, chipping and peeling paint on detached garage service door and frame. This should be scraped and repainted by a qualified professional. Neglect can cause material to rot. Missing weather stripping at this location can also allow for water intrusion to interior spaces.

Repairs should be made by a qualified contractor.

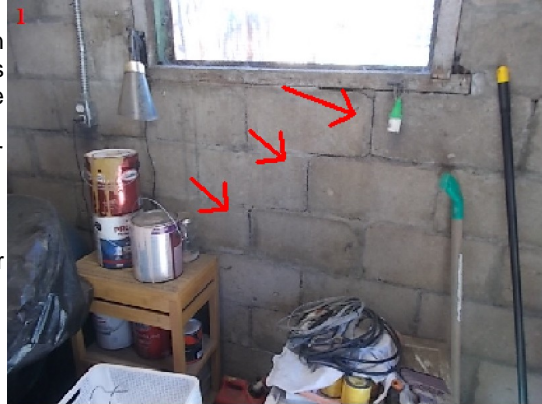
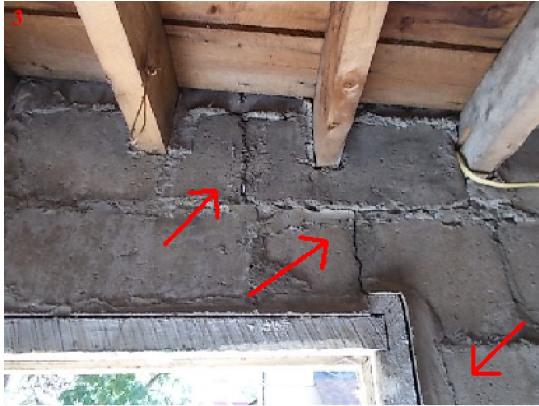
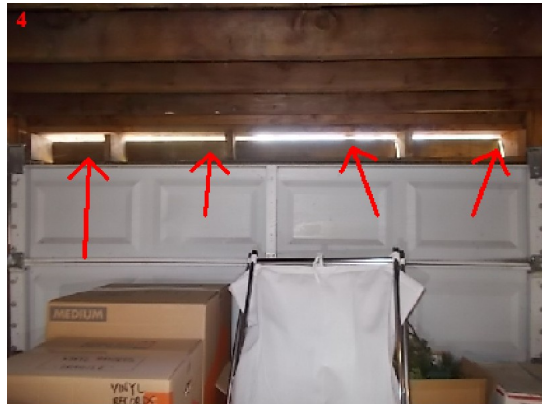
Garage Interior Walls

Cracked mortar noted at the North, East and South sides of the detached garage. This may allow for water intrusion resulting in deterioration and further movement. Cracking and movement is most likely due to poor drainage of roof and surface water at the various locations around the garage and down spout extensions. All mortar joints should be repointed or sealed after drainage has been repaired.

Improper repairs and openings noted at the header located directly above the garage vehicle door. This will allow for water intrusion and damage if not properly sealed on the exterior of the garage. Contact a qualified contractor for repairs.

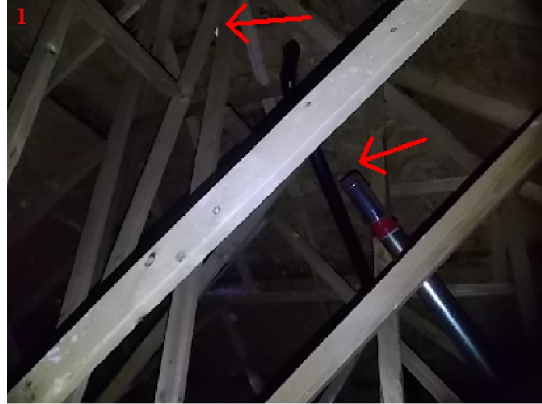
Vent Pipes Visible in Attic

Vent pipe for the full bathroom exhaust fan terminates in the attic. This should be directed to an exterior vent to prevent moisture buildup in the attic leading to possible mold growth.. Contact a qualified contractor for evaluation and repairs.

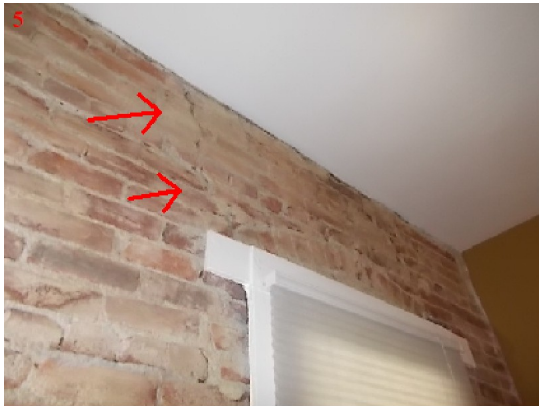
Interior Walls

Cracked plaster and brick work noted at the front entry, East bedroom closet, kitchen South and West walls and center bedroom North wall and closet. Cracking appears to be connected to movement in the foundation due to poor drainage of roof and surface water. Proper repairs should be made to the cracks once exterior issues have been resolved. A qualified contractor should evaluate and make needed repairs.

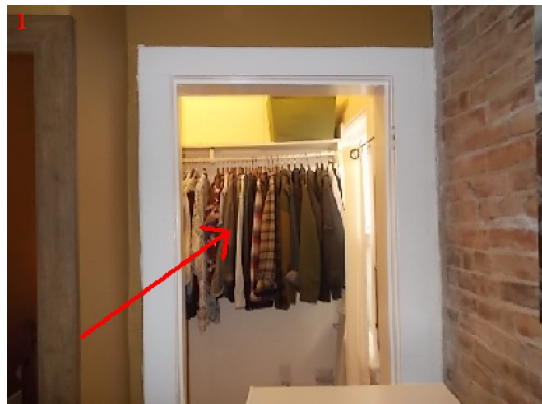
Closets / Cabinets

Missing door slabs noted at the center bedroom closet opening. Repairs should be made to allow for correct use of the space. Contact a qualified contractor for needed correction.

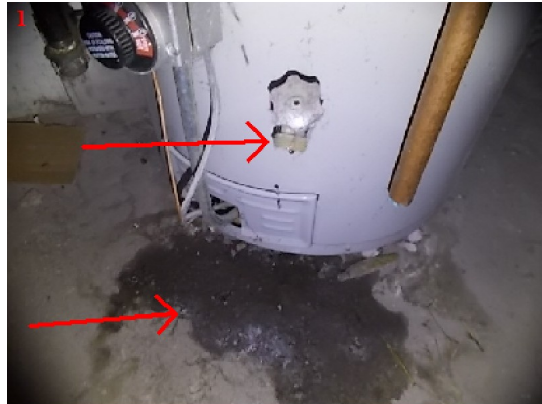
Current leaks noted at the water heater drain valve. Repairs should be made to prevent excessive moisture and damage to the basement concrete.

This should be evaluated by a qualified contractor and all needed repairs made.

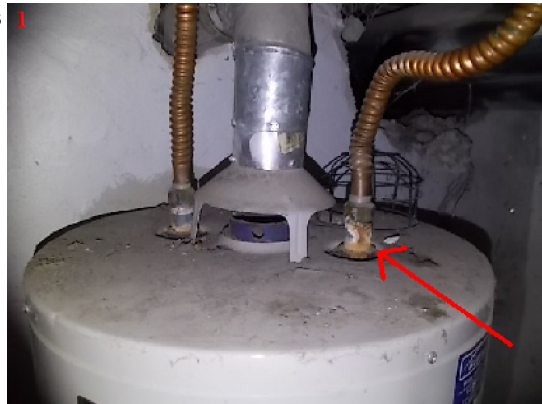
Water Heater Cold Water Valve

There is excessive rust and corrosion on the water supply pipes above the water heater. This may lead to leaks if not repaired. Contact a qualified plumber to evaluate and make any needed repairs.

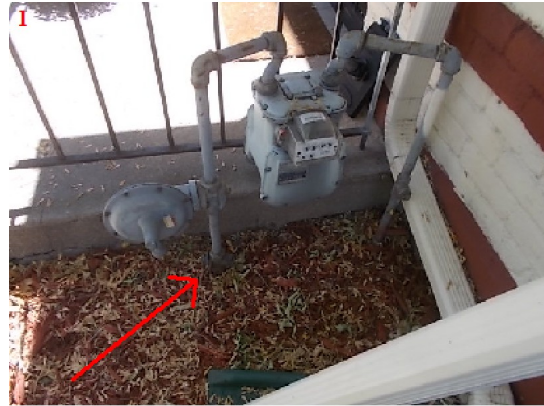
Main Gas Valve Location

Main gas shut off valve is located on the North side of the house.

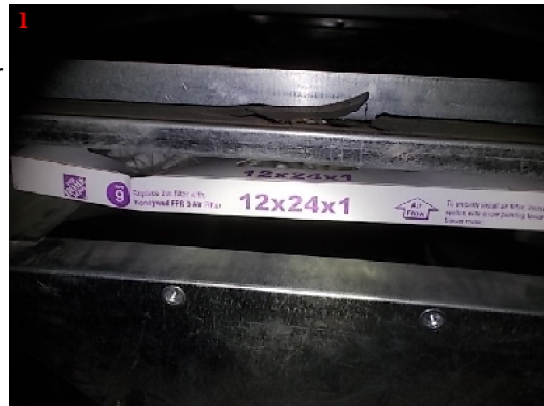
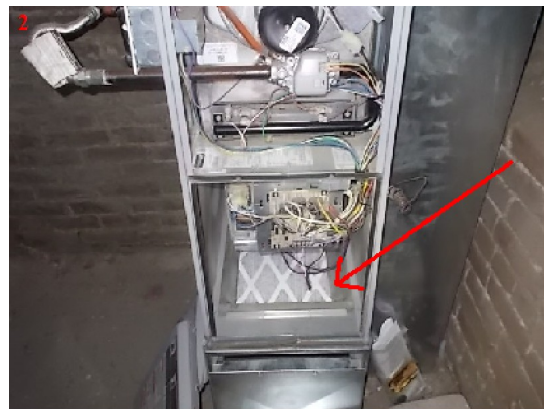
Filter System 1

The furnace filter size is 12x24x1
Furnace filter can be changed through this access door.
Contact a qualified contractor if more information about the filter is needed.
