# Property Inspection Report

1234 Sample Inspection St.  
Dripping Springs, TX 78620

By: Jesse Bryant, Lic #TREC 8511 12/12/2018  
(Name and License Number of Inspector) (Date)

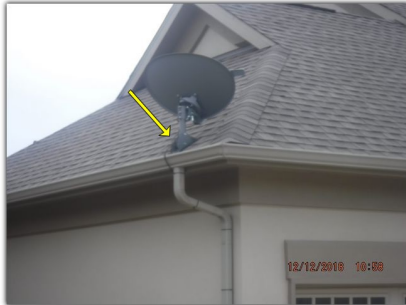
NOTE: A satellite dish bracket was observed to have been installed directly onto the roof surface. Regular sealant maintenance is recommended at this attachment in order to prevent possible water penetration.

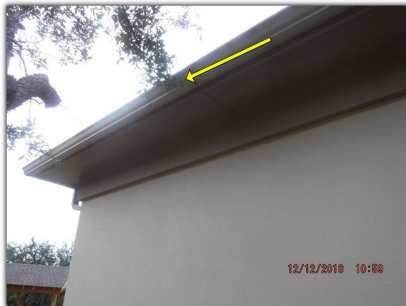
FYI: Nearby tree limbs should be kept trimmed to approximately 2 feet above and away from the roof surface in order to prevent material damage during periods of high wind.

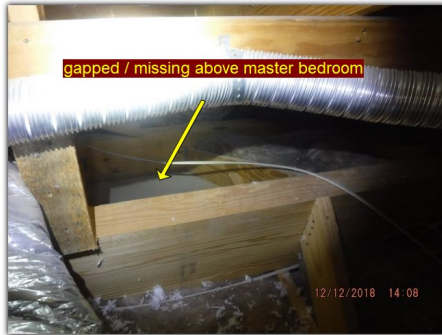
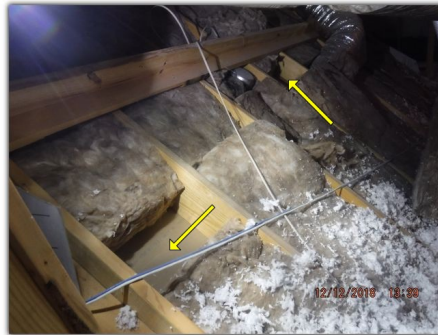
**Missing blocking at wall sheathing seams / joints** (*South gable wall above front living room*). All edges / seams of the exterior wall sheathing should be properly supported / blocked in order to resist movement; particularly when stucco wall coverings systems are present as movement within the sheathing can lead to stucco cracking. Monitoring and repair is recommended as necessary.

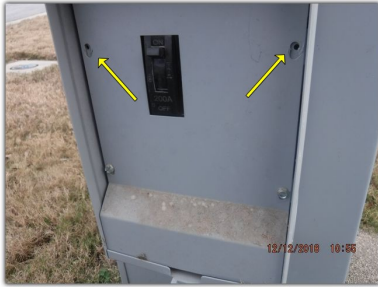
**Missing cover screw(s) at panel box (main service disconnect box).** Repair is recommended (*blunt tip screw*) to ensure the cover remains securely in place.

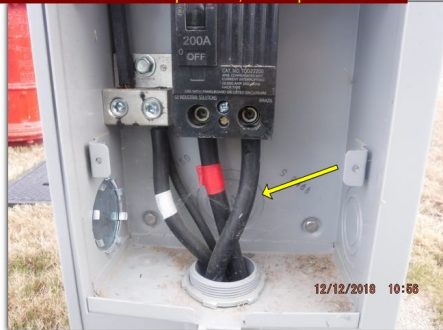
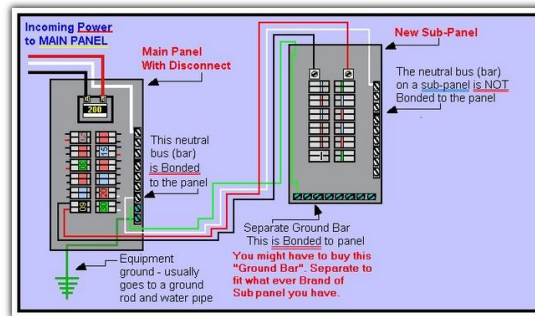
4-wire feeder from meter pedestal, to first panel at house

**Ground / neutral bonding observed at panel(s) downstream of the main service (North exterior panel -- rear exterior panel).** Ground and neutral conductors are to be bonded at the main service only, and should be isolated at all points (panels) downstream. Given that a 4-wire feeder assembly was routed between the service disconnect at the main (1st) panel box, grounds and neutrals should be isolated at this and all subsequent panels. Further evaluation and repair is recommended by a qualified electrician.

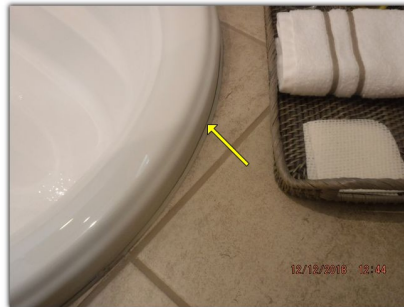
**Gapped open caulk seals at bathtub perimeter** (master bathtub). Sealant improvements are recommended where necessary.

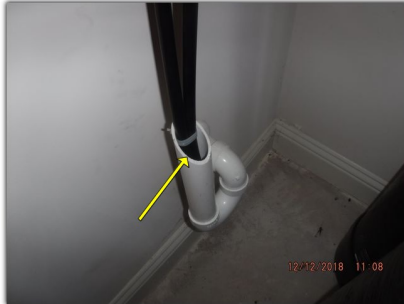
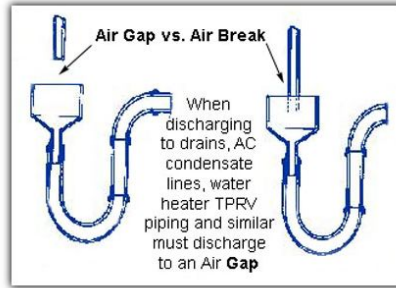
**Cross connection at water softener drain line.** Water softener drain lines installed without an appropriate "air gap" between the tube and the PVC drain line are a potential health hazard. Repairs are recommended in order to prevent a potential cross connection between supply and contaminated water.

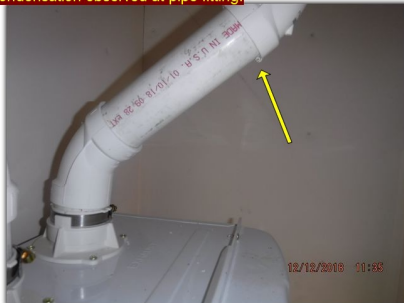
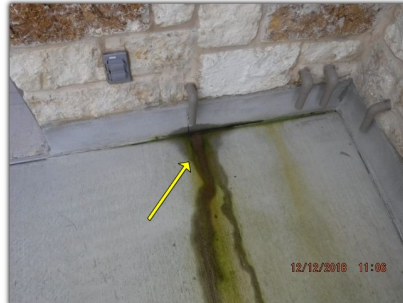
condensation observed at pipe fitting

**Abnormal vent condensation observed at tankless water heater** (condensation leakage observed at vent pipe fitting - potential abnormal amount of condensation at driveway with subsequent staining). Further evaluation is recommended as necessary by a qualified plumber in order to determine if the combination of the newer PVC vent piping with the metal Type B vent is acceptable. Furthermore, given the relative acidity of the condensation (pH of 3-5), consideration should be given to relocating the condensation drain output.

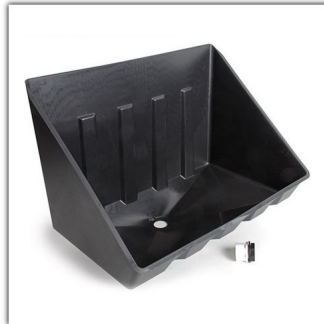
areas lacking protection with a round pan

**Improperly sized drain pan for tankless water heater** (round pan standard for tank style). Ideally, the pan should be replaced with the standard drain pan for wall-mounted, tankless water heaters in order to reduce the risk of property damage from potential leaks.
