Property Inspection Report

1234 Sample St.
Georgetown, TX 78626

Concerning: 1234 Sample St., Georgetown, TX 78626
(Address or Other Identification of Inspected Property)

By: Jesse Bryant, Lic #TREC 8511 01/10/2018
(Name and License Number of Inspector) (Date)

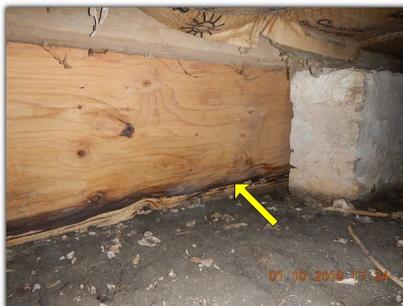
Wood-to-ground contact around / within the crawlspace (possible conducive condition for wood rot and wood-destroying insect activity). Further evaluation and repairs are recommended where necessary.

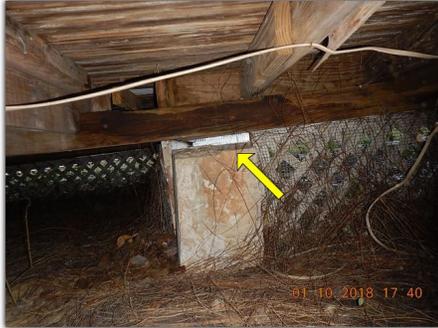
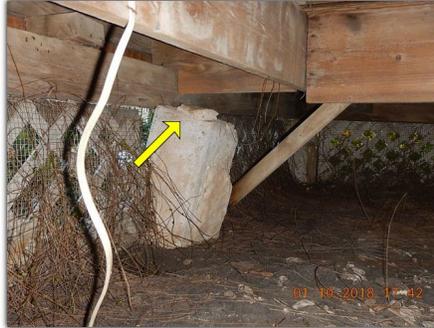
Piers tilted and/or no longer in contact with the structure (front porch areas). Further evaluation and repairs are recommended where necessary to ensure proper support.

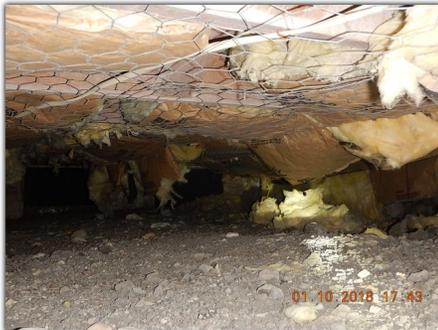
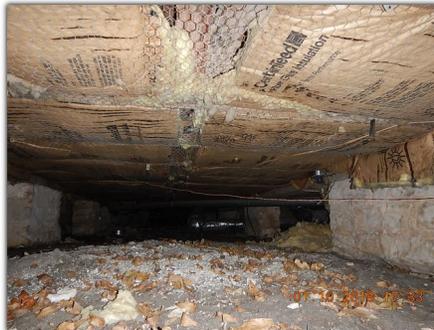
Under-floor insulation damaged, missing and improperly installed (numerous locations within the crawlspace). The insulation batts were observed to have been installed upside down, which can be a potential condensation / moisture trap. Furthermore, many portions of the insulation have fallen or were damaged as a result of previous vermin activity. Further evaluation and repairs are recommended where necessary. *FYI: The presence of the under floor insulation significantly limited visibility in regards to the inspection of the floor framing and subfloor materials.*

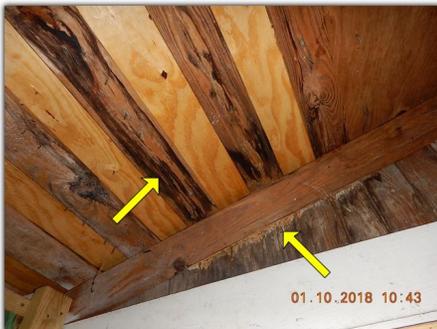
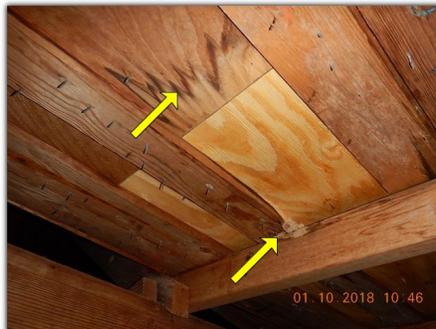
Evidence of previous water penetration and subsequent fungal growth (garage roof structure). although the water penetration issue has likely been corrected by the installation of the current roof covering materials, monitoring is recommended at this time.

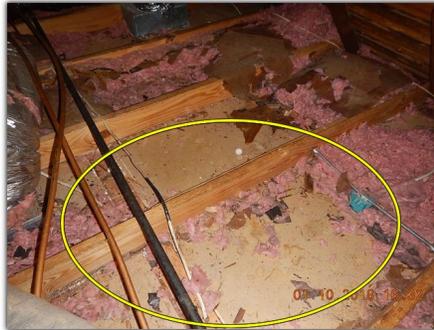
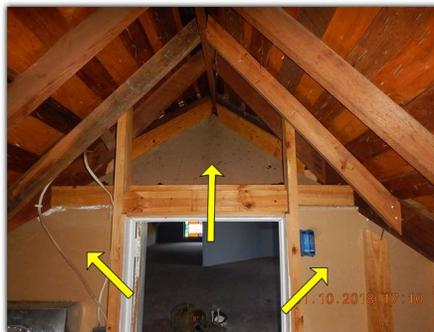
Missing/insufficient insulation (*various attic walls and attic floor locations*). Areas of sparse or compacted insulation (especially 6 inches or less) should ideally be addressed by adding more insulation for improved efficiency. Further evaluation and repairs are recommended where necessary by a qualified insulation contractor.

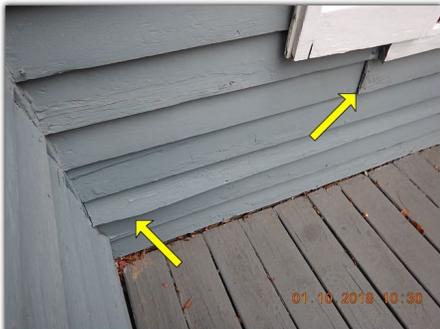
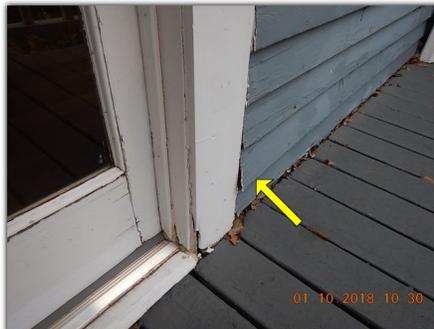
Loose / unsecured siding observed (multiple locations). Further evaluation and repairs are recommended where necessary.

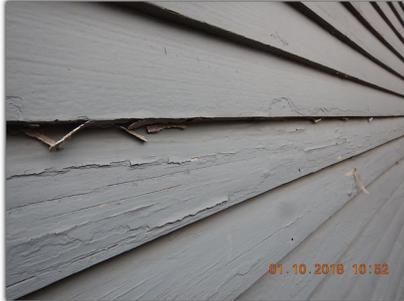
Peeling exterior paint observed (numerous locations). FYI: In homes built prior to 1978, the presence of lead paint is likely. Special precautions should be taken if any work is to be performed that will disturb the paint (scraping, sanding, etc.). For more information on lead paint, visit <http://www.epa.gov/lead/>

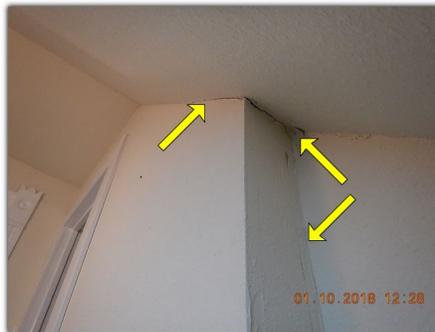
Cracks, buckled drywall tape and other evidence of previous structural stress / movement observed (various locations). Monitoring and repairs are recommended as necessary.

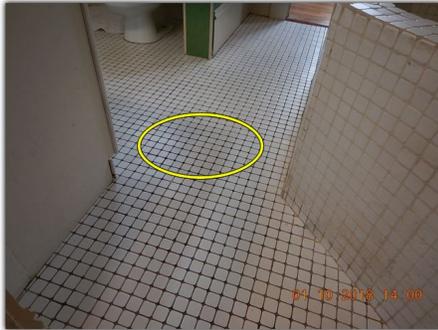
Depression in tiled floor of rear upstairs bathroom. Further evaluation and repairs are recommended as necessary.

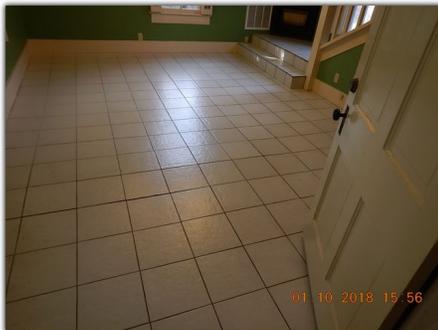
Uneven floor surface and cracked floor tiles (rear bonus room off of kitchen).

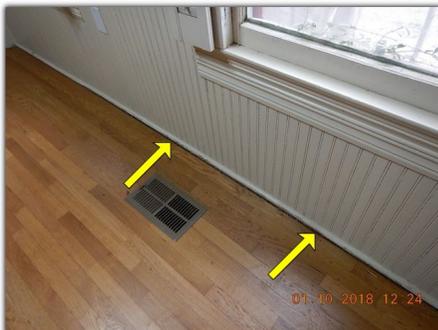
Opening to crawlspace observed at gap between wall and floor (South wall in the kitchen). Further evaluation and repairs are recommended as necessary.

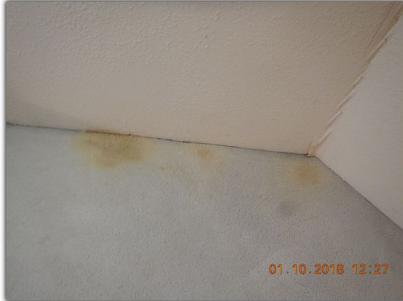
FYI: Carpet stains were observed (landing area to the third floor). Cleaning may be effective, but if not, replacement may be desired.

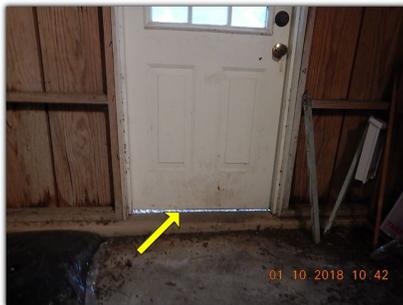
Poor condition of garage pedestrian door (*rubs against jamb when operated -- fogged window glass -- missing threshold weatherstripping*). Repairs are recommended as necessary.

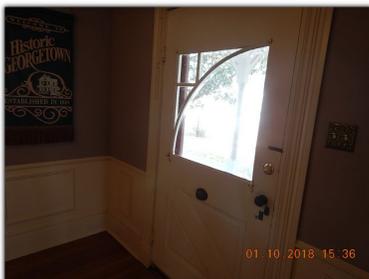
Missing tempered safety glass in door glass (*various locations*). Under today's current safety standards, tempered safety glass is required for all glass within doors that will allow the passage of a 3 inch sphere, and is generally identified by an etching in the corner of the glass pane.

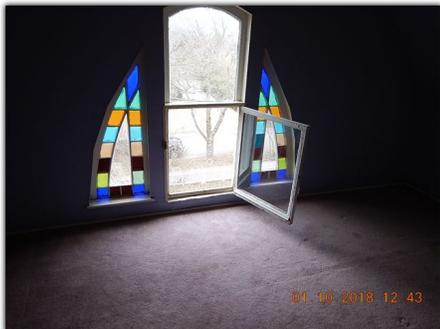
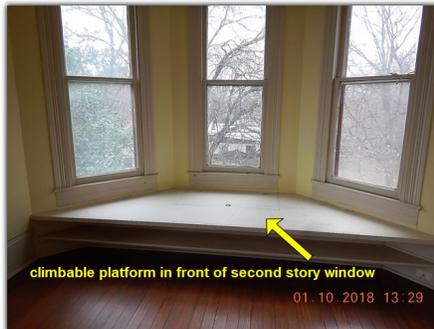
Window(s) missing fall protection measures (*3rd floor room -- front bedroom upstairs*). Under current safety standards, fall protection is required when the window height above exterior grade exceeds 72 inches, and the lowest part of the interior opening is below 24 inches above the finished floor. Although it may not have been required when this property was built, consideration should be given to providing a window operation control device (WOCD) that limits the initial opening of the window to no more than 4 inches.

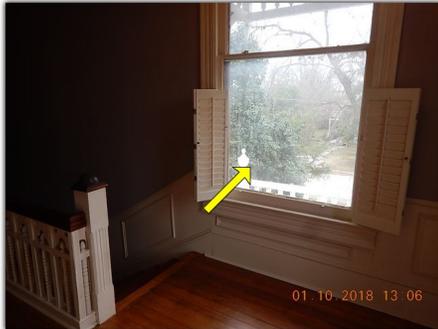
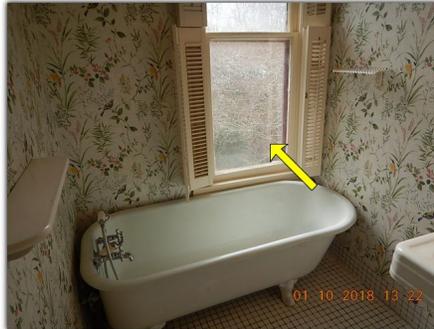
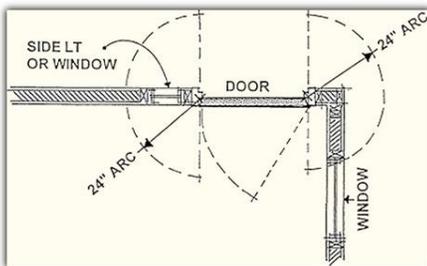
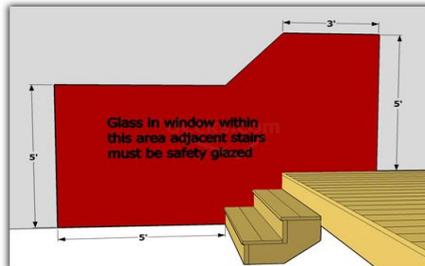
Tempered safety glass missing (*various locations where required by current safety standards*). Tempered safety glass is required for any window glass within 60 inches of the floor, that is over a bathtub or in a shower, any window glass with 60 inches of a stair step or landing and for any glass in a window that is within 2 feet of a door, and within 60 inches of the finished floor surface.

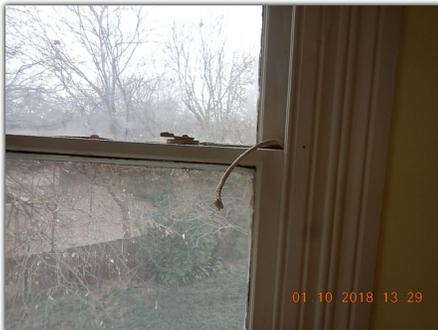
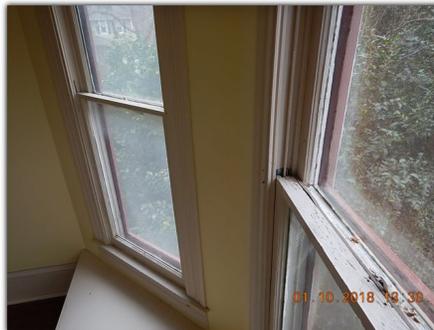
Detached / broken window counterbalance ropes and weights (*various locations*). Repairs are recommended where necessary for improved window operation.

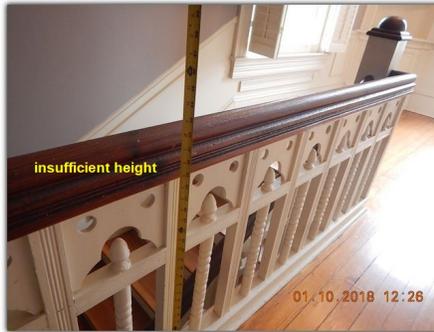
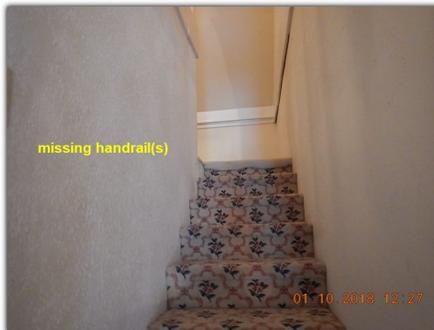
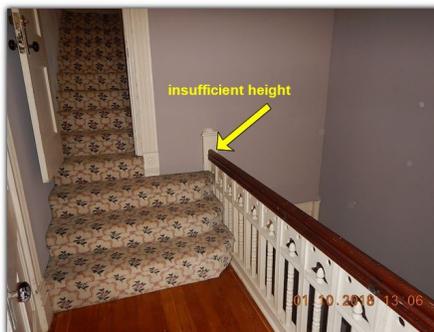
Interior and exterior stairways not built to current safety codes / standards (may be a potential safety hazard for some occupants). Further evaluation and repairs are recommended where necessary.

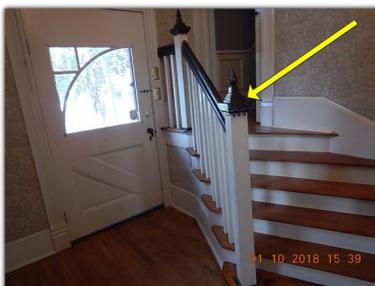
Loose / leaning newel post and handrail (smaller stairway near North entrance). Repairs are recommended.

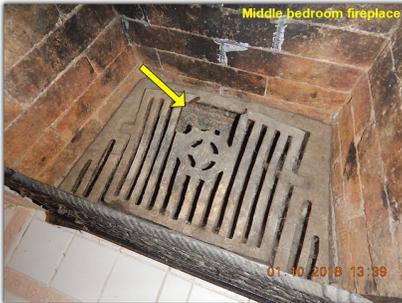
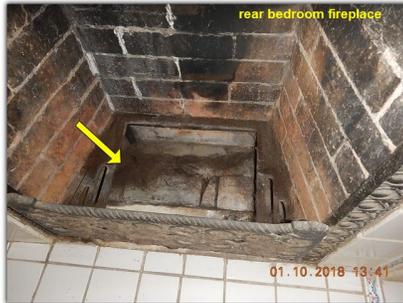
Damaged and missing fireplace grates (middle and rear bedrooms upstairs).

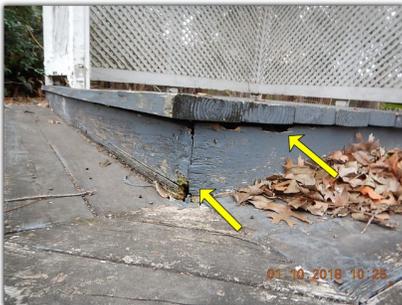
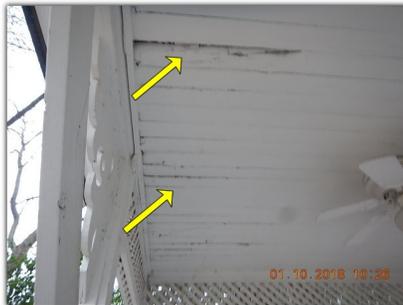
Evidence of wood rot and deterioration at gazebo structure (various locations). Further evaluation and repairs are recommended where necessary.

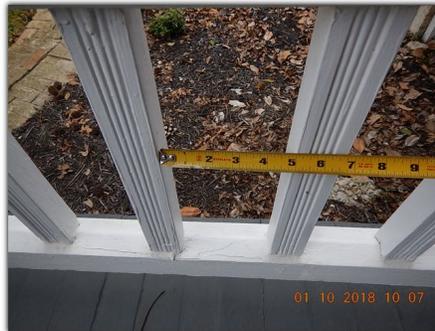
Improper guardrail height and spacing between balusters (porch railings). When guardrails are present at porches, decks, etc., they are required to be at least 36 inches tall (above the standing surface) and the spacing between the balusters shall not exceed 4 inches. This can be a potential safety concern for small children.

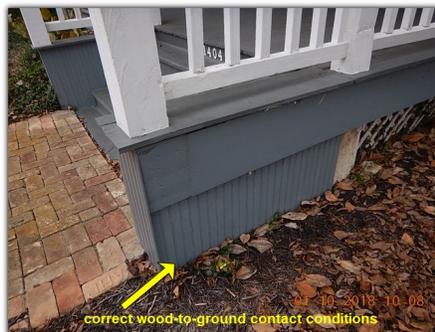
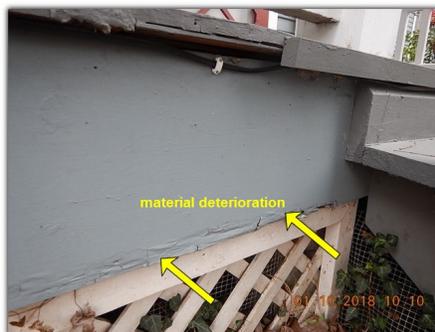
Evidence of previous settlement / movement and deteriorated materials at front and side porch structures (multiple locations). Further evaluation and repairs are recommended where necessary to prevent further movement or material deterioration.

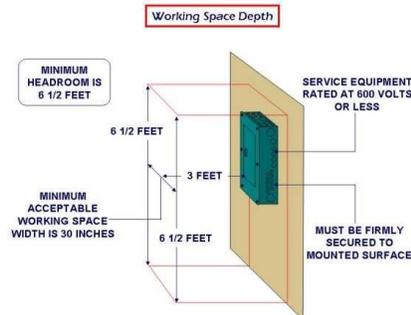
Improper clearance in front of panel boxes / electrical service equipment (main panel in laundry area). All panel boxes and electrical service equipment are required to have a minimum 30 inch by 36 inch clear area in front of the equipment, up to 6 feet from the standing surface (or as tall as the equipment).

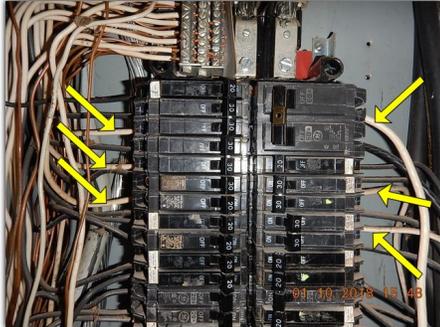
Improperly marked/identified conductors. All white conductors used as a hot wire (240 volt circuits, etc.) should be clearly marked as a "hot" wire with red or black tape for improved identification and safety.

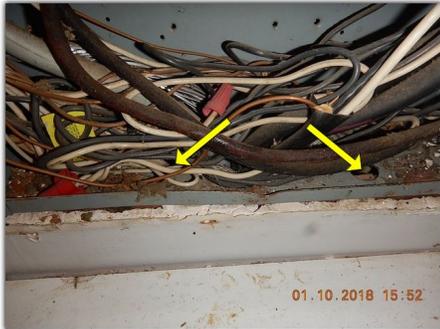
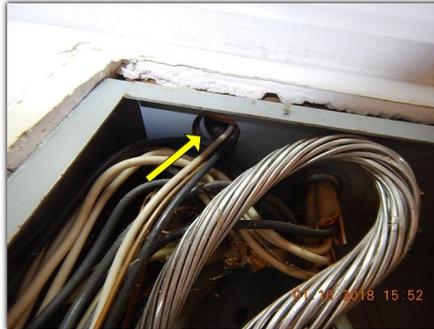
Missing wire clamps and knockout plates. All wiring passing through metal panel boxes shall be properly protected from abrasion damage and all openings in panel boxes or their covers should be filled with the appropriate fill plates/covers in order to prevent shock hazards and potential damage to the components inside the boxes.

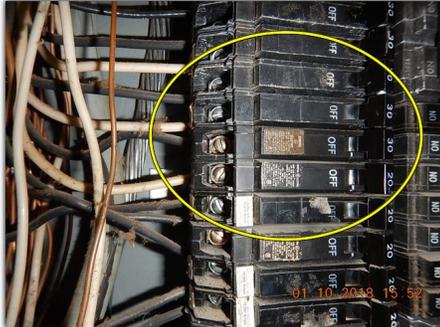
Unlinked and possibly unbalanced 240 volt circuits within panel box. Further evaluation and repairs are recommended as necessary by a qualified electrician.

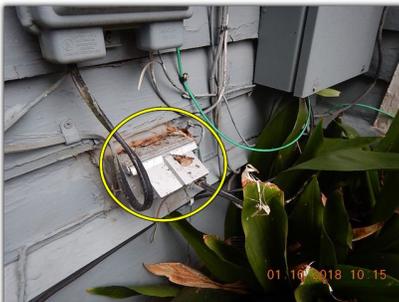
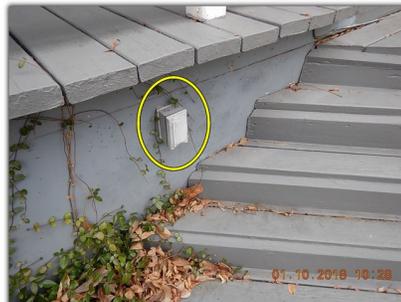
Missing/improper exterior receptacle covers (numerous locations). Exterior receptacle covers in wet locations should ideally be changed out to newer "bubble covers". These covers keep the receptacles covered, even while in use (cords plugged in). Repairs are recommended where necessary.

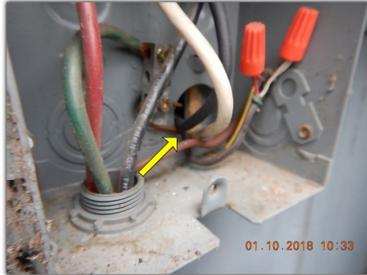
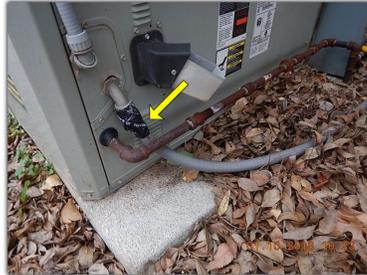
Poor wiring protection at package heating and cooling unit (*no clamp / bushing at disconnect box -- conduit not secured in place*). Further evaluation is recommended by a qualified electrician.

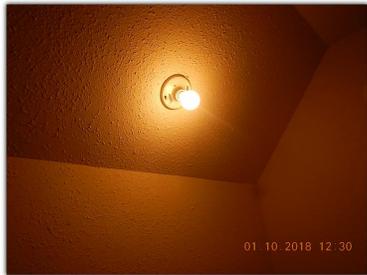
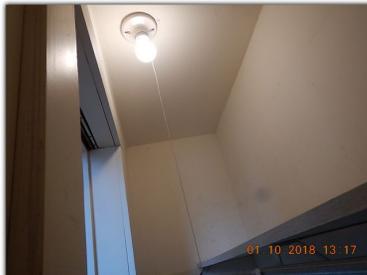
Exposed light fixture bulbs (*various locations, to include some clothes closets*). Incandescent bulb fixtures are required to be fully enclosed when located in closet spaces. Repairs are recommended.

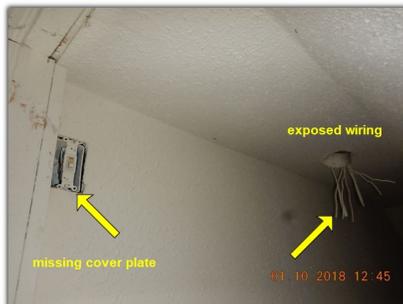
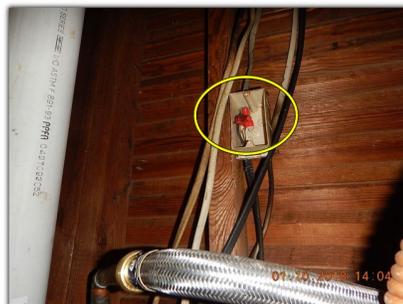
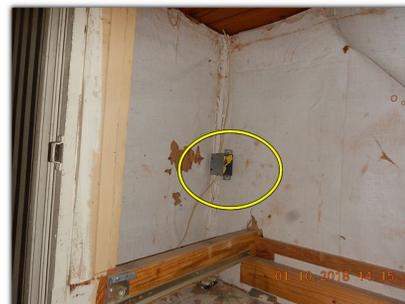
Exposed/unprotected wiring connections (*attic spaces -- closet space at Northwest corner of 3rd floor -- crawlspace -- etc.*). All exposed wire connections should be enclosed in a junction box and protected with an approved junction box cover. For improved safety, further evaluation and repairs are recommended where necessary by a qualified electrician.

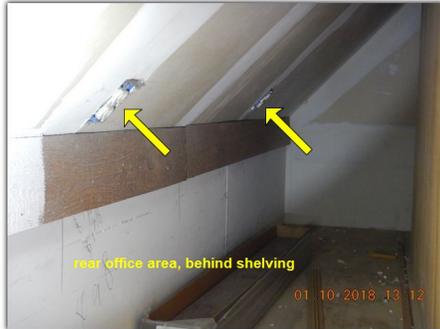
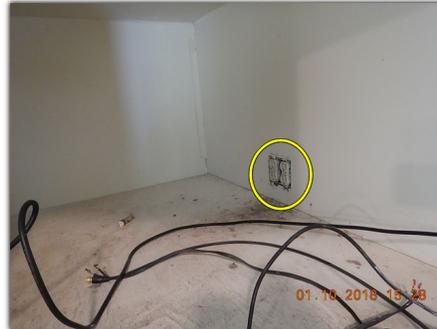
Missing receptacle/switch cover plates (*various locations*). Cover plate replacement is recommended where necessary for improved safety.

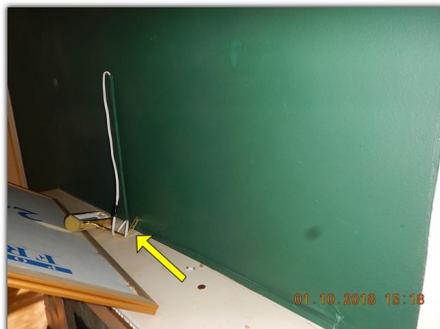
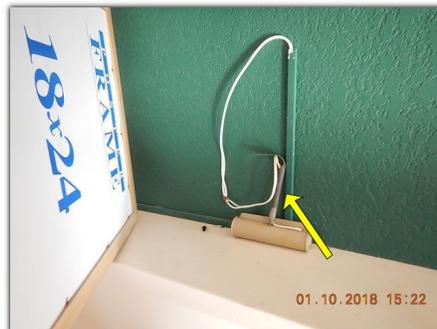
Extension or flexible cords used in-lieu-of permanent wiring (*art work light fixtures above the living room fireplace mantles*). Extension cords shall not be used as permanent wiring as these cords are rated for permanent use.

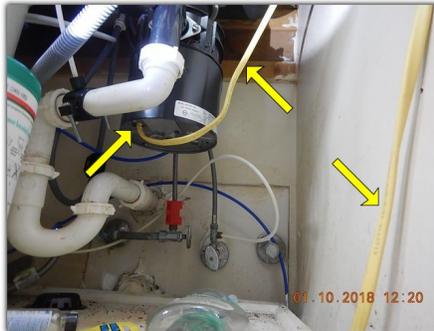
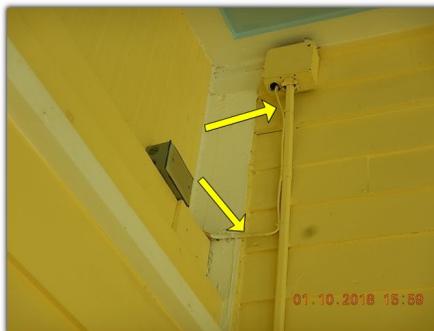
Unprotected exposed wiring (*Disposer -- both water heaters -- rear bedroom closet -- etc*). Branch circuit wiring should be properly secured and not exposed and routed on exposed surfaces; particularly in storage areas. Furthermore, where wiring enters an appliance body, an approved wire clamp is required to provide strain relief and to prevent abrasion damage. Further evaluation and repairs are recommended where necessary.

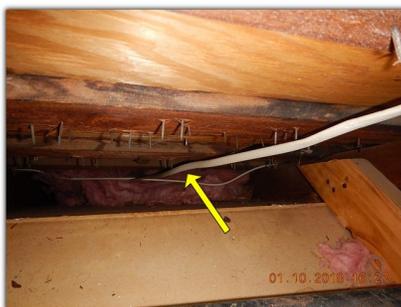
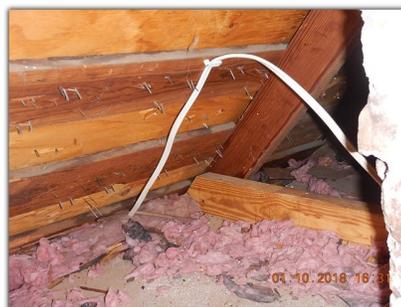
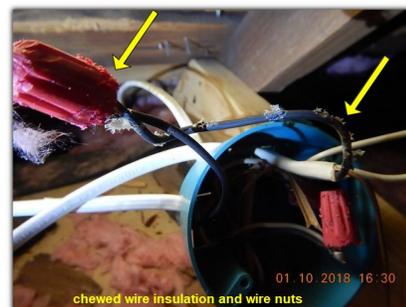
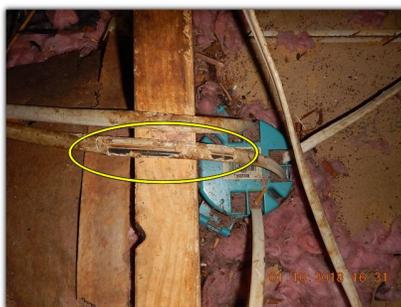
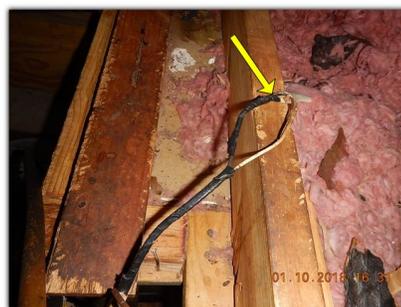
Damaged wiring observed in attic space (*wiring routed against roof surface susceptible to nail damage -- rodent-chewed wire sheathing and insulation at various locations of upper attic*). Further evaluation and repair is recommended where necessary by a qualified electrician.

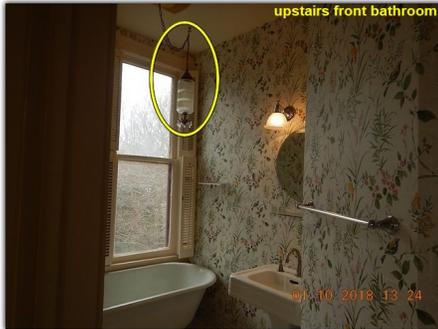
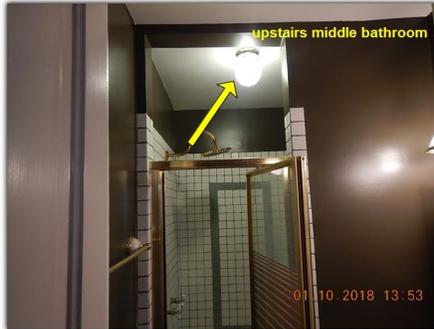
Improper light fixtures above / within tub and shower areas (*front and middle bathrooms upstairs*). Cord-connected lights, hanging lights, lighting tracks, pendants, and ceiling-suspended paddle fans shall not have any parts located within a zone measured 3 feet horizontally and 8 feet vertically from the top of a bathtub rim. Furthermore, all surface-mounted fixtures in shower areas shall be rated for use in wet-locations. Further evaluation and repairs are recommended by a qualified electrician.

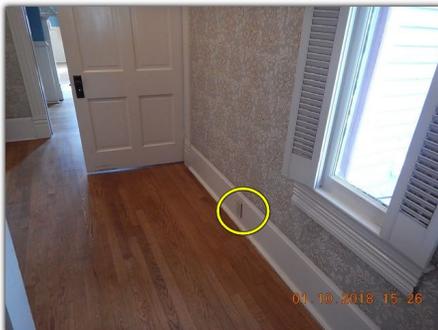
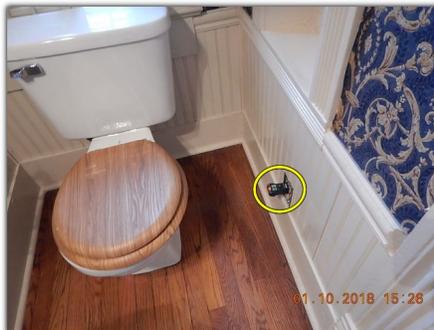
Reversed polarity observed at receptacle(s) (*North entry hall -- downstairs half bathroom -- North wall of kitchen -- laundry/pantry*). A reversed polarity condition is where the hot and neutral conductors are wired backwards at a receptacle.

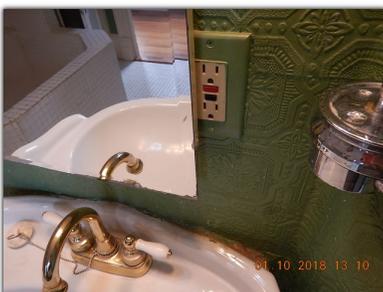
FYI: The GFCI receptacle in the rear second floor bathroom could not be tested due to it's proximity to the medicine cabinet.

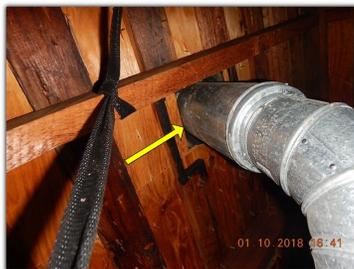
Insufficient clearance between furnace vent and nearby combustible materials and/or insulation (roof decking materials). This type of vent is required to have a minimum 1 inch clearance to all combustible materials and building insulation. Repairs are recommended for improved safety.

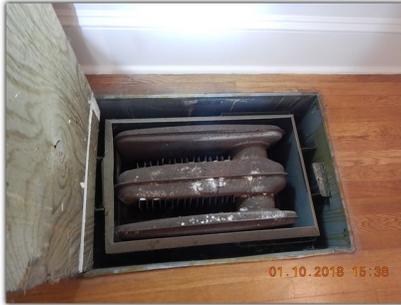
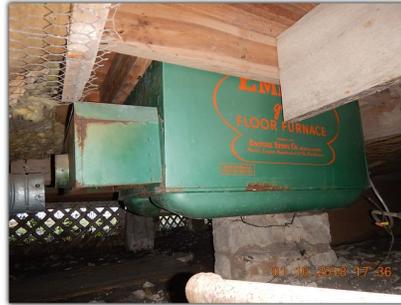
NOTE: An older floor model furnace was observed to have been disconnected / abandoned, but left in place.

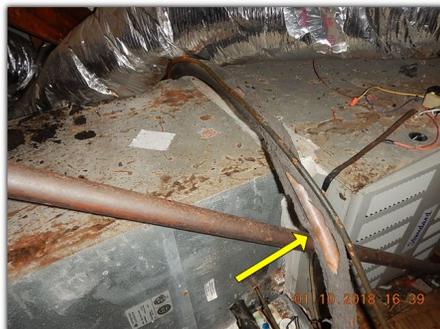
Damaged refrigerant line insulation (Upstairs unit). Repairs are recommended where necessary to prevent condensation and to improve unit efficiency.

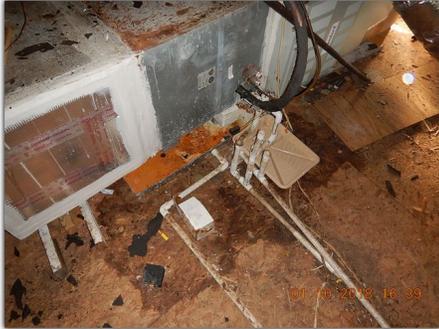
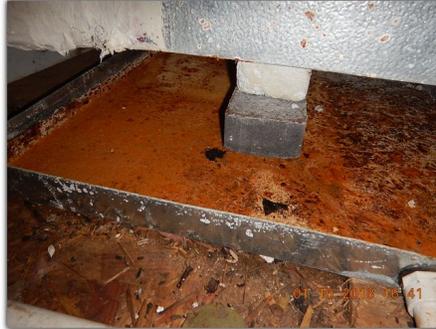
Evidence of previous condensate leakage (*upstairs unit*). No leakage was observed during the inspection. However, given the staining at the decking around the evaporator and the rust within the drain pan, monitoring is recommended. Pan replacement should also be considered.

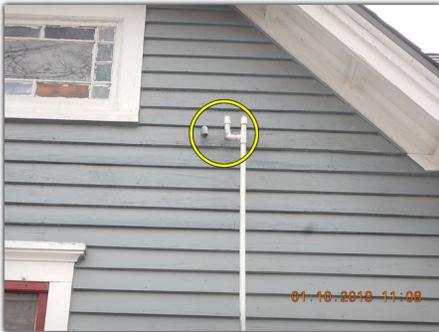
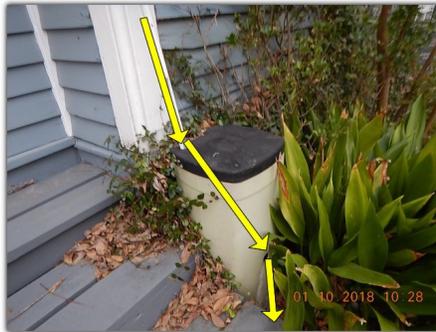
Improper condensate drain line configuration (*upstairs unit*). The primary and auxiliary drain lines were observed to be tied together and terminating close to the foundation. Furthermore, the evaporator coil drain pan line was observed to terminate at the rear exterior, but not directly above a window or door opening, as required. Further evaluation and repairs are recommended by a qualified heating and cooling technician.

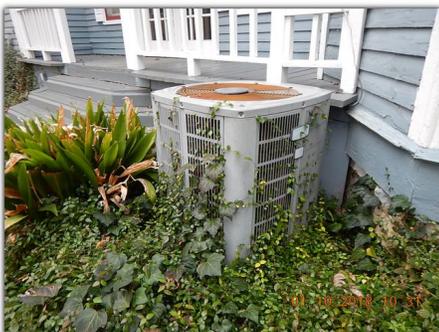
Vegetation growth on condenser unit (*South exterior*). All vegetation should be trimmed off of and away from the condenser unit in order to ensure proper operation and to prevent advanced deterioration / corrosion of the condenser unit components.

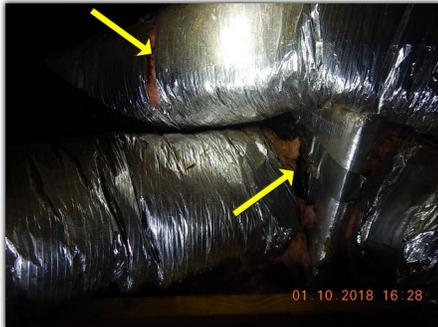
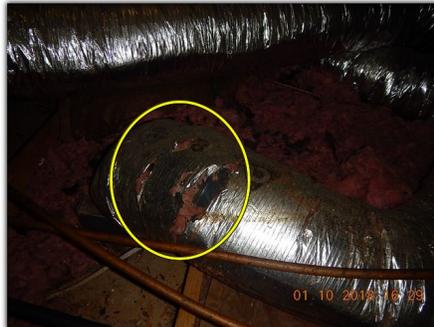
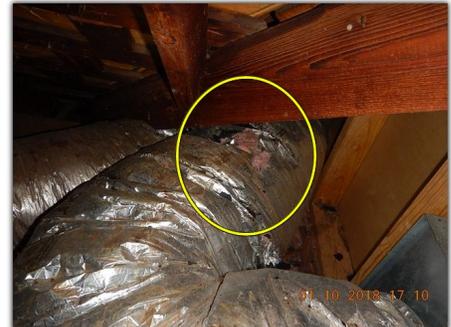
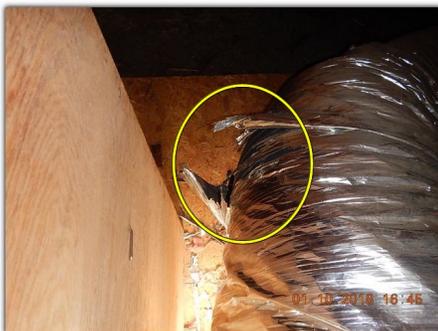
Damaged ductwork (outer shell damage observed at multiple flexible ducts). The damage portions of the duct appear to be due to previous vermin activity. No penetration into the inner duct was visually observed during the inspection, but heated air was adjacent to the crawlspace screening near the supply side of the outdoor package unit (possible detached or damaged supply duct within the crawlspace). Further evaluation and repairs are recommended where necessary by a qualified heating and cooling technician.

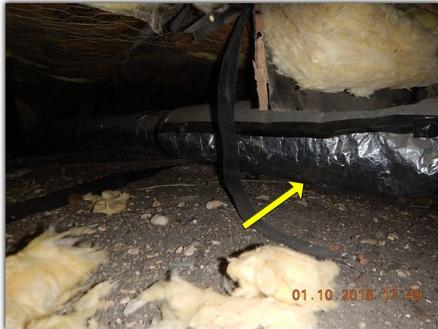
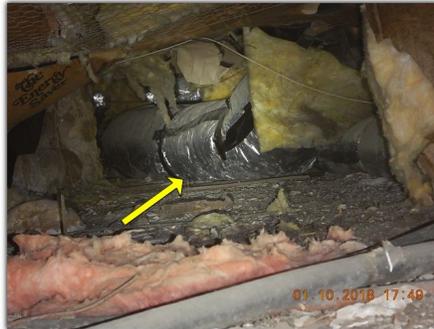
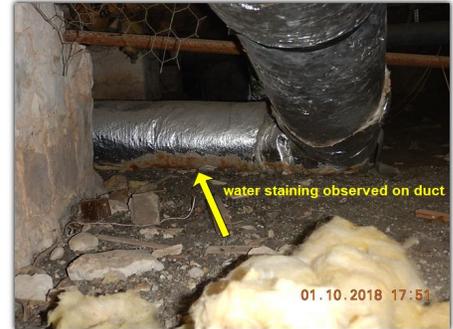
Ductwork in contact with the soil (*multiple locations within the crawlspace*). A minimum 4 inch clearance is required between crawlspace ductwork and the soil. Further evaluation and repairs are recommended where necessary.

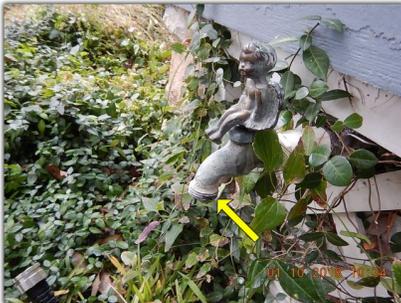
Missing anti-siphon device at hose bib(s) (various locations). Anti-siphon devices help to prevent potential “cross connections” between supply and contaminated water and should be installed where missing.

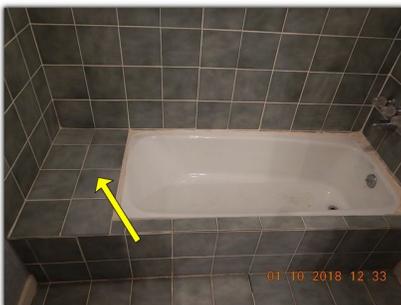
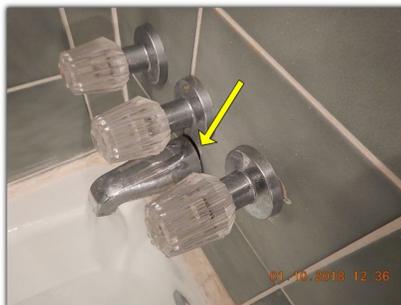
Grout/caulk gaps in tiled tub and shower areas (third floor bathroom). Ensure that all cracked, deteriorated or missing grout/caulk at the shower/tub walls are properly sealed in order to prevent possible water penetration behind the tile.

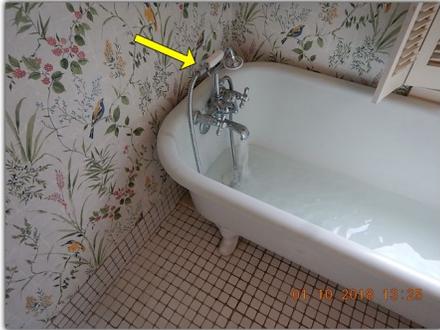
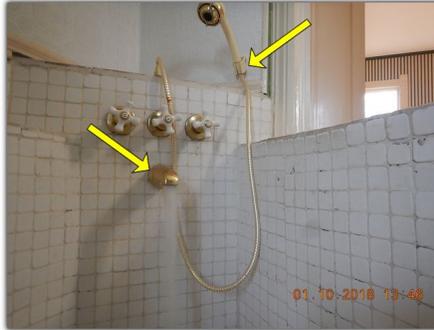
Potential plumbing cross connection(s) (*upstairs bathtub areas*). The detachable shower heads can hang down below the flood rim of the bathtub. The tub faucet in the tiled bathtub is also below the flood rim of the tub. This creates a potential "cross connection" between supply water and contaminated water. If the shower head assemblies do not have a built-in back flow prevention device, repairs are recommended. Further evaluation is recommended by a qualified plumber.

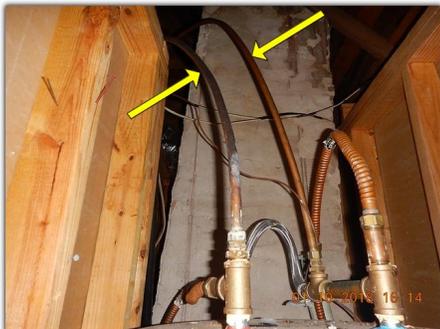
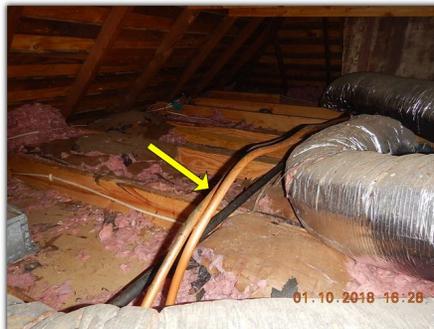
Exposed supply plumbing lines observed within attic and crawlspace (*various locations*). These lines should be protected with pipe insulation in order to prevent potential freezing during the winter months.

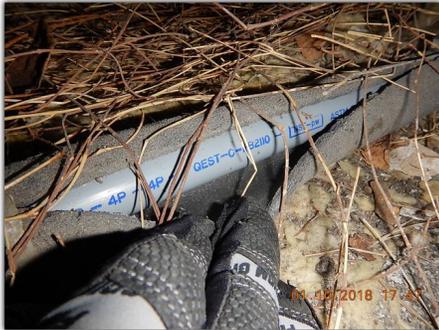
NOTE: A portion of the supply plumbing materials observed during the inspection (observed to be supplying the Southeast hose bib) are suspected to be Polybutylene type piping. This piping has been known to be prone to leakage at stress points, tight bends and at fittings. In some cases, replacement of this type of piping is recommended over repeated spot repairs. As the extent of the piping within this home is unknown, it is recommended that you have this plumbing material evaluated further by a qualified plumber.

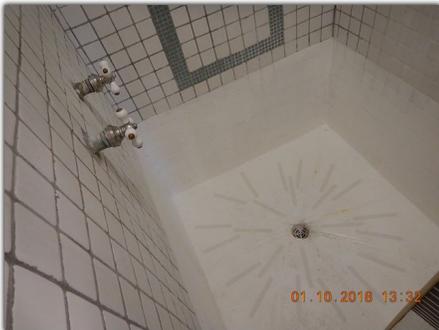
FYI: No evidence of leakage was observed at the upstairs middle bathroom shower stall during the inspection. However, the shower appears to have been seal coated at some point in the past. Monitoring is recommended at this time.

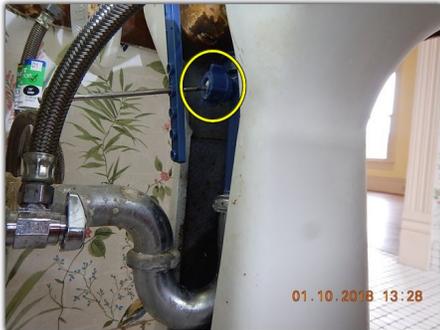
Fixture drain leakage observed (*drainstop mechanism at upstairs front bathroom sink*). Repairs are recommended as necessary.

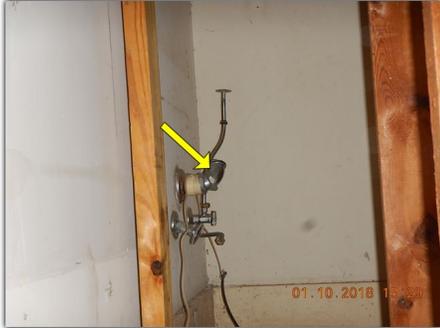
Open / exposed plumbing drain line observed (*underneath rear stairway to office area*). It could not be determined if this previous sink plumbing is currently connected to the drain plumbing system or not. No sewer odors were observed within the home, but the open drain line should ideally be capped for improved safety.

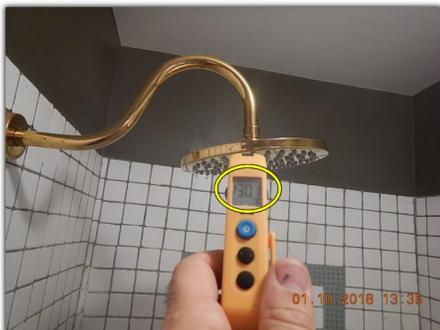
Water heater temperatures in excess of 120-125 degrees (*the maximum temperature recommended by most water heater manufacturers*). Temperature adjustment or the installation of temperature mixing valve(s) is recommended; especially if children, handicapped or elderly residents will be present in the home. Further evaluation and repairs are recommended by a qualified plumber.

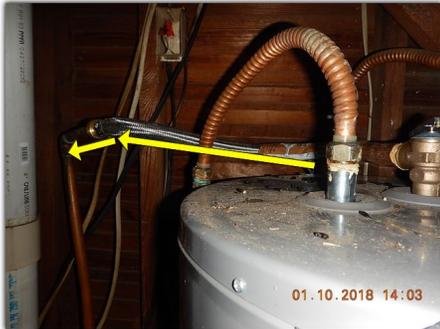
Improper slope of TPRV drain line (downstairs unit). TPRV drain lines should be installed to drain completely by gravity flow in order to prevent potential buildup and blockages in the lines. Repairs are recommended for improved safety.

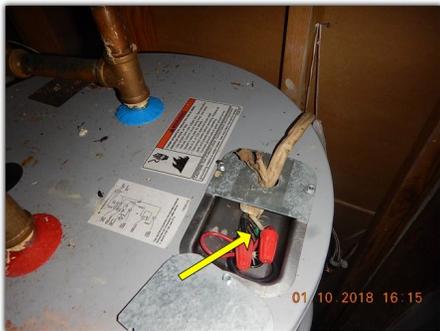
Ungrounded electric water heater (upstairs unit). Further evaluation and repairs are recommended for improved safety.

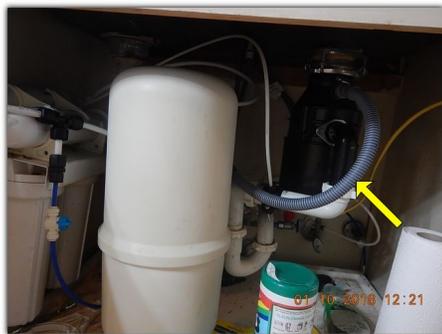
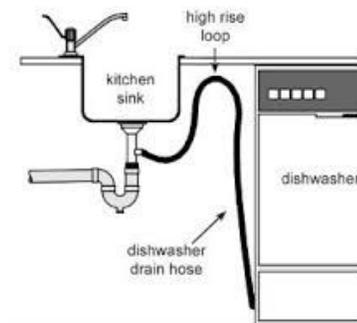
Missing air gap or "high loop" in drain line. Dishwasher drain lines should be installed with an air gap device or configured to form a "high loop" (secured to the underside of the countertop prior to connecting to the drain line or disposer). Air gaps and/or high loop drain lines help to prevent backflow drainage from the sink into the dishwasher. Repairs are recommended.

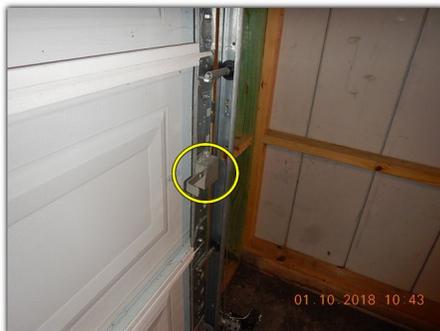
Garage door lock not removed/disabled when operator is present. Garage doors equipped with garage door operators should have their locks removed or disabled in order to prevent accidental damage from attempting to open the door with the operator, when the door is locked. Repairs are recommended for improved safety and garage door operation.

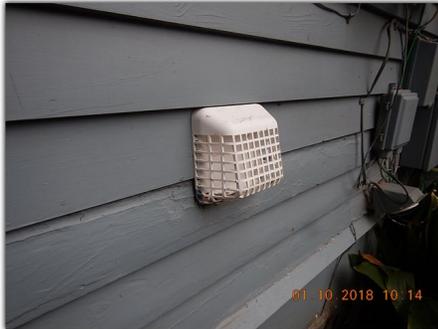
Dryer vent termination screened. Dryer vents are not to be screened as this can cause a buildup of lint at the

termination point. Once the screening has been removed, ensure that the back draft damper operates freely in order allow proper venting, while preventing possible vermin activity/nesting.

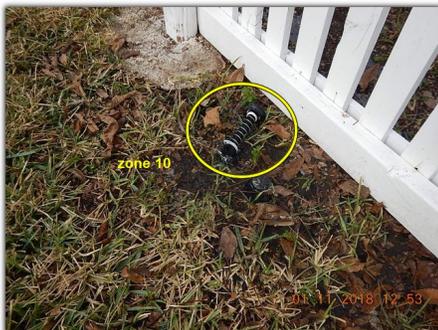
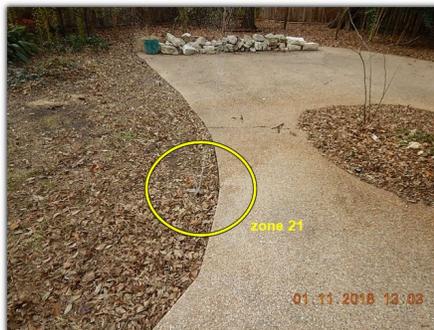
Damaged sprinkler head(s) observed (zone 10 -- zone 21). Further evaluation and repairs are recommended where necessary by a qualified irrigation system technician
