PRE-DRYWALL INSPECTION REPORT

Guided Inspections

Prepared For: Sample Client
Concerning: Sample St. Austin, TX 12345
Inspector: Jesse W. Bryant TREC# 8511 01/12/18

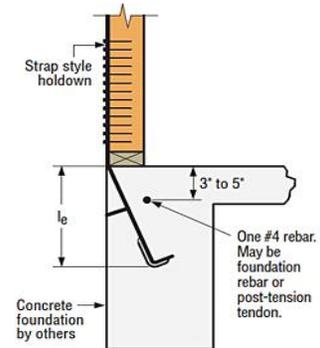
- Some of the foundation anchor straps were observed to be close to the edge of the foundation, exposed and not fully embedded in the concrete, as required by the manufacturer. Furthermore, some of the straps and interior hold-down anchor straps were observed to be missing fasteners (Check all as some straps were taped over and could not be checked). Further review by the strap manufacturer or a qualified engineer is recommended prior to proceeding with exterior masonry.

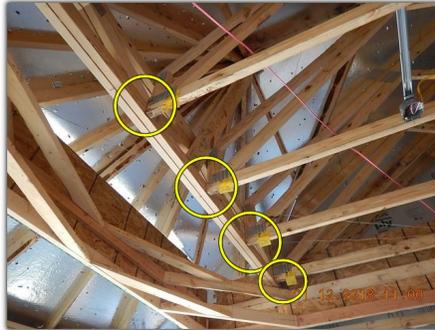
- Various truss end support / attachment points were observed to be questionable, but could not be verified or investigated further without access to building plans and / or truss details. Some of the areas of concern include:
 - truss support at some truss ends at the South garage wall
 - missing hangers / blocking at master bedroom truss ends, near the bay are of the room and at one or more front porch roof trusses
 - gap between master bedroom lower truss corners and the wall between the master bedroom and bathroom
 - unknown cross bracing requirements for these trusses

A further review of the building plans and truss details is recommended by the builder and/or the truss manufacturer to ensure proper support / attachment and bracing of all engineered roof trusses, prior to insulation and drywall

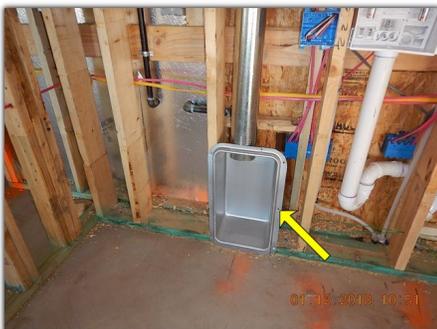
- The dryer vent length (*approximately 27 feet with three 45 degree bends*) was observed to be too long and exceeds the maximum allowable distance to termination. The maximum length of a clothes dryer exhaust duct shall not exceed 25 feet from the dryer location to the wall or roof termination. The maximum length of the duct shall be reduced 2.5 feet for each 45-degree bend, and 5 feet for each 90-degree bend. Furthermore, the total developed length of the dryer vent shall be labeled at or near the dryer vent box. Further evaluation and repairs are recommended as necessary.
