EVALUATION OF STAINLESS STEEL PIPING FOR HIGHLY CORROSIVE LOCATIONS

The objective of this project was to select, demonstrate, and evaluate alternate materials for corroded fire-suppression water pipelines at the Chimu-Wan tank farms on Okinawa Island, Japan.

Members of the research team inspected piping at the three Chimu-Wan tank farms. Chimu-Wan 3 was determined to be in the poorest condition, so it was selected as the test site. Given the highly corrosive chloride-infused environment at the site, SAE* low-carbon stainless steel grades 304L (pipe sections) and 316L (flange fasteners) were selected as the demonstration materials. A rehabilitation design was developed, installed and tested on above-ground sections of fire-protection piping.

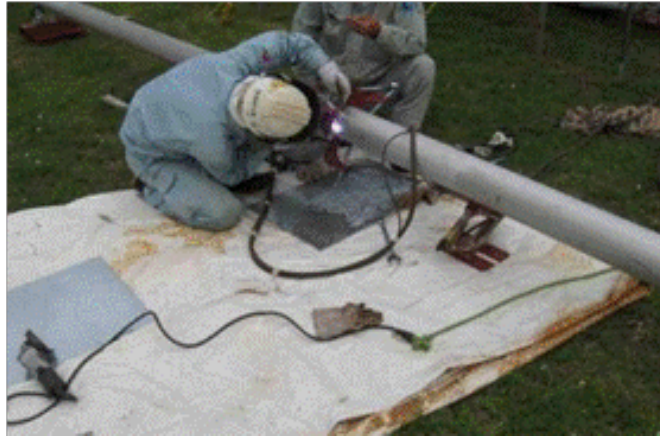
The pipeline was assembled using tungsten inert gas (TIG) arc welding. Pipe segments were joined at a stationary location to form longer segments, which were then transported to the appointed final assembly location. Figure 4 shows workers welding the new pipe together.

Figure 4. Arc welding replacement pipes.

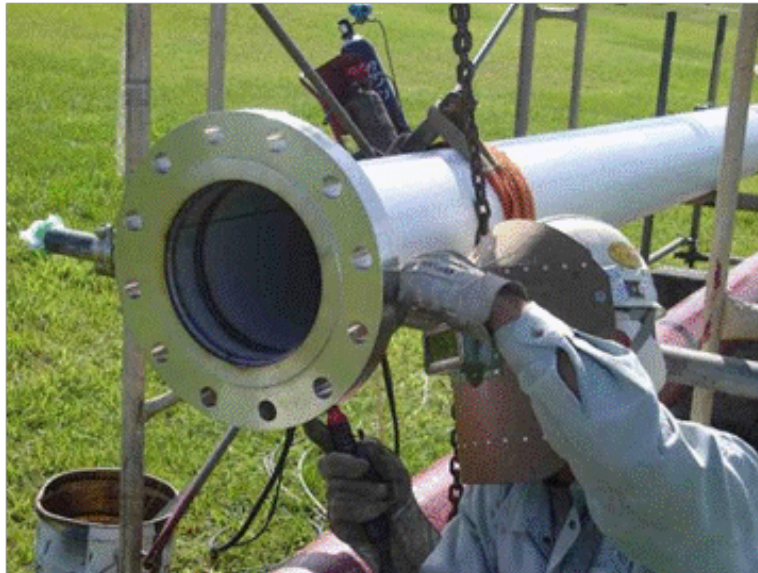
In general, the project was completed without complications. Several factors helped to account for success in planning and implementation. First, the duration of the assembly period was reduced by welding multiple sections of pipe at a stationary work site. The longer sections were then transported to a final assembly position, reducing the time needed to move and set up welding operations. All sections of pipe were assembled over the route of the existing pipe and pressure tested before connecting to the existing pipe (Figure 8). This reduced the period of time needed to have the fire lines out of service for tie-in. Flanged connections were also pre-assembled to make tie-ins quickly, with only two welds necessary for the final assembly of each section. This method allowed the work to be completed more quickly and at lower labor cost than other similar projects.

Figure 8. Pipe placement before removal of existing lines.

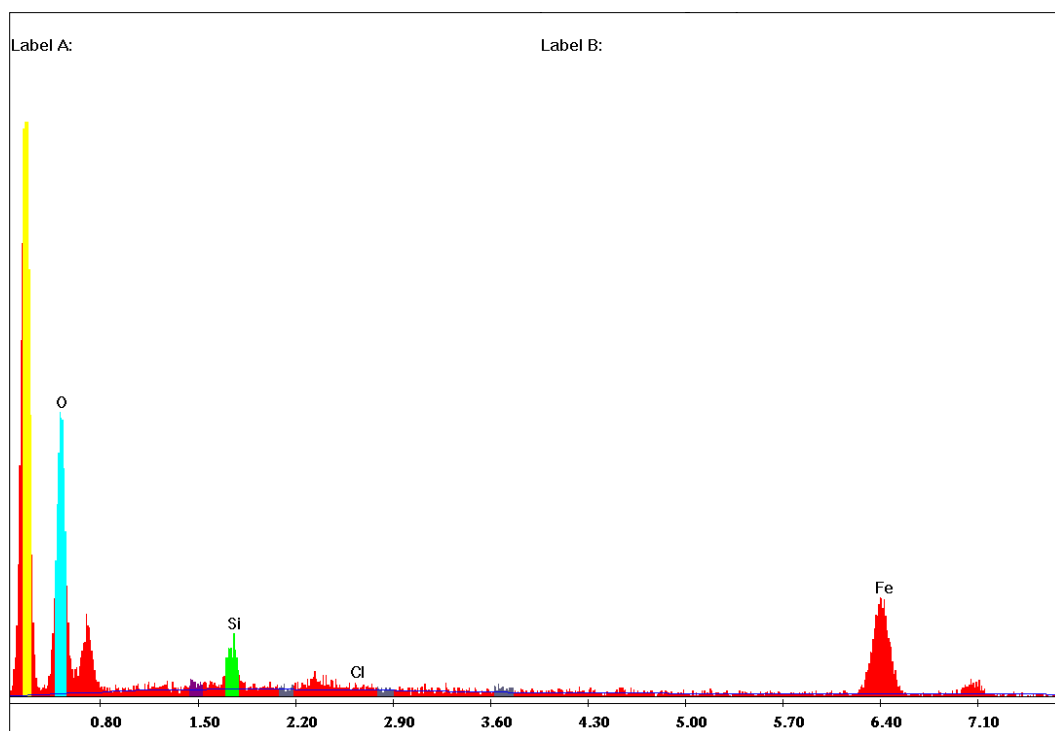
Figure B14. Graph of the x-ray energy versus the number of counts for the area shown in Figure B13.

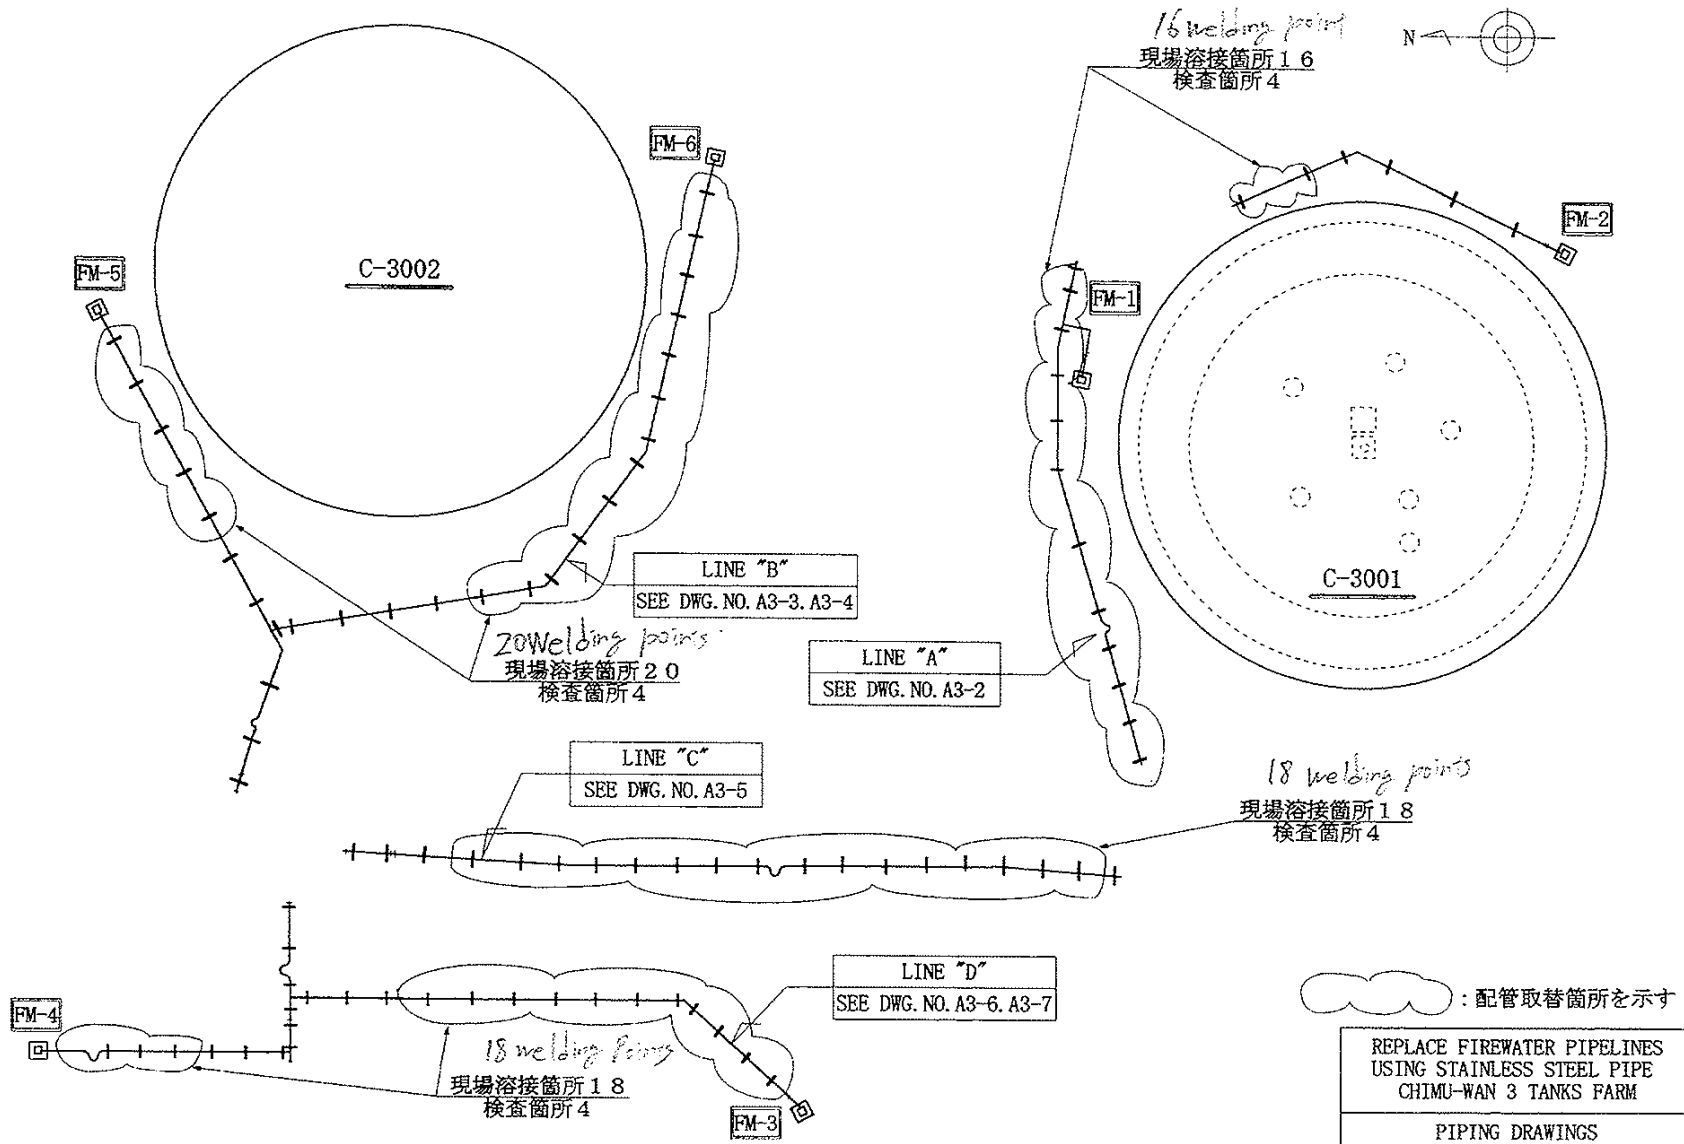
<div style="text-align: center;"> 浸透探傷検査記録 <i>Report of Dye Penetrate test</i> 沖縄非破壊検査株式会社 <small>〒904-2172 沖縄県沖縄市泡瀬3-319-1 TEL. (098)929-3335 FAX. (098)929-3347</small> </div>					
注文主	南石開発 株式会社 殿		検査日時	Date: 平成20年4月10日～5月26日	
工事名称	CHIMU-WAN3 TANKS FARM		検査時期	溶接最終層	
検査物	配管現場溶接継手		表面状態	ワイヤーブラシ仕上げ	
材質	Motexia	SUS 304	検査方法	溶剤除去性染色浸透探傷検査	
数量	8B、10B 16箇所		検査面温度	常温	
浸透探傷材料	銘柄	浸透剤 UP-ST 洗浄剤 UR-ST 現像剤 UD-ST 乳化剤 - メーカー マークテック㈱	浸透探傷法 F: 蛍光 V: <input checked="" type="checkbox"/> 染色 浸透剤のタイプ A: 水洗性 B: 後乳化性 C: <input checked="" type="checkbox"/> 溶剤除去性 現像方法 D: 乾式 A: 湿式 S: <input checked="" type="checkbox"/> 速乾式		
概要 ◎ 適用範囲 <i>Application Standard</i> 8B、10B 消火配管現場溶接部最終層 (16箇所) <i>Welding points</i> ◎ 適用規格 <i>Standard</i> ・JIS Z 2343-2001 「浸透探傷試験方法及び浸透指示模様の分類」 ◎ 検査結果 <i>Test Record</i> <i>clear</i> 有害な浸透指示模様を認めず。 合格 検査員 <i>Inspector: Toshihide Kinjyo</i> <i>License Number</i>					
氏名		資格	免許番号		
金城 善秀		浸透探傷試験・レベル2	N10017456
