EXXONMOBIL FACILITY BATON ROUGE, LA - 2016 ACCIDENT INVESTIGATION

Incident Date: November 22, 2016 4 Workers Injured No. 2016-02-I-LA The **U.S. Chemical Safety and Hazard Investigation Board** (CSB) is an independent Federal agency whose mission is to *drive chemical safety change through independent investigations to protect people and the environment*.

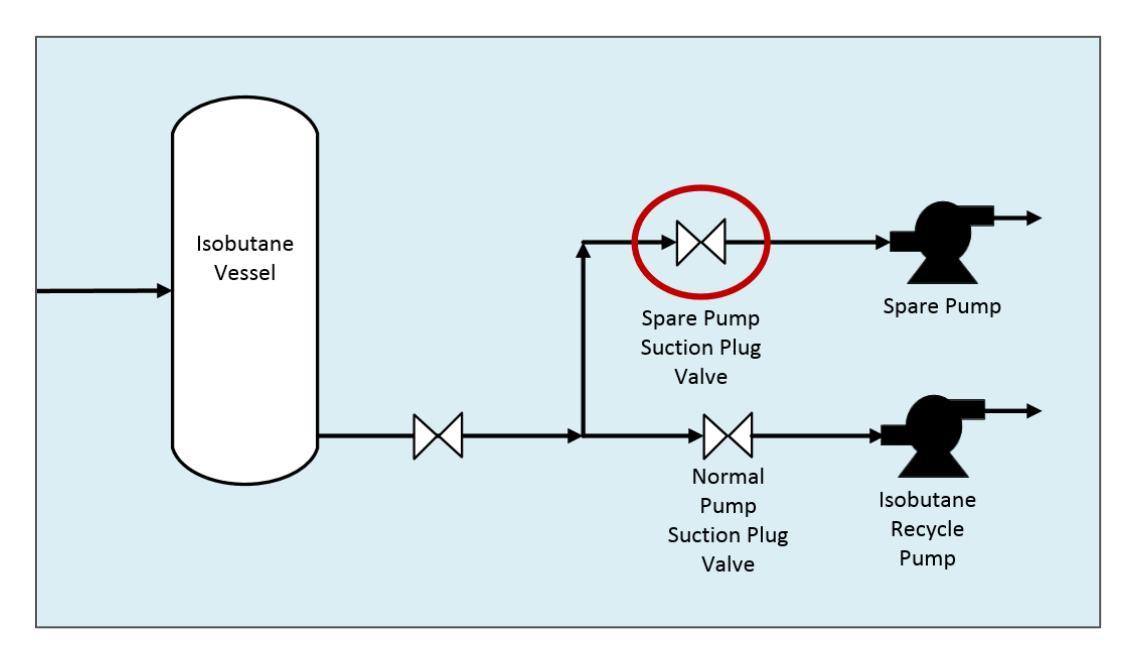
On the afternoon of November 22, 2016, two Baton Rouge refinery alkylation unit operators were preparing isobutane equipment for maintenance.⁶ As part of this preparation, the operators needed to adjust valves to put a spare isobutane pump into service. (Figure 1). To switch the pumps, the operators needed to open the inlet (suction) plug valve to the spare pump. The refinery used a type of valve known as a quarter-turn plug valve for many applications in the alkylation unit, including the inlet valves to these isobutane pumps.⁷

Figure 1. Simplified diagram of the alkylation unit equipment where the release occurred.
