Williams Geismar Olefins Plant

Reboiler Rupture and Fire Geismar, Louisiana

Incident Date: June 13, 2013

No. 2013-03-I-LA

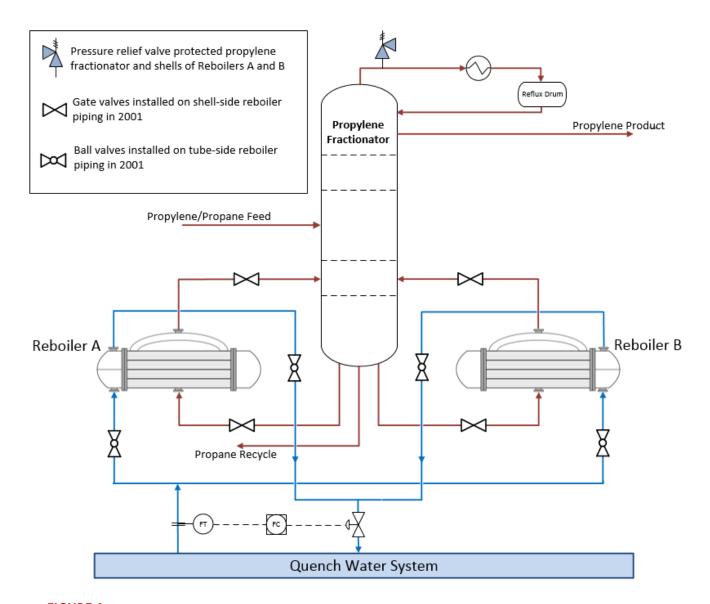
Propylene fractionator schematic. This schematic represents the equipment configuration at the time of the incident. The valves (gate valves) isolating the reboilers from the pressure relief valve at the top of the propylene fractionator were not part of the original design, and were installed in 2001. Section 5.1 provides additional information about these valves.

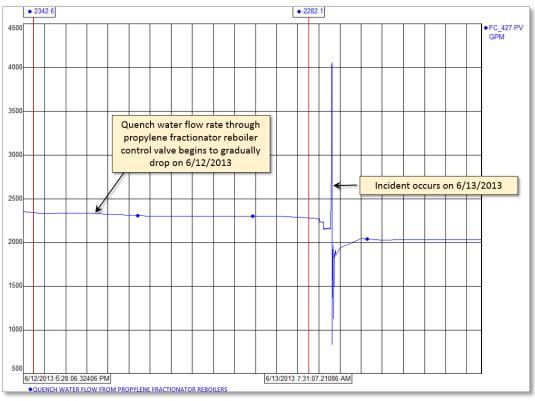
FIGURE 5

Graph of quench water flow rate through propylene fractionator Reboiler A prior to incident. Williams personnel identified that quench water flow rate had dropped.

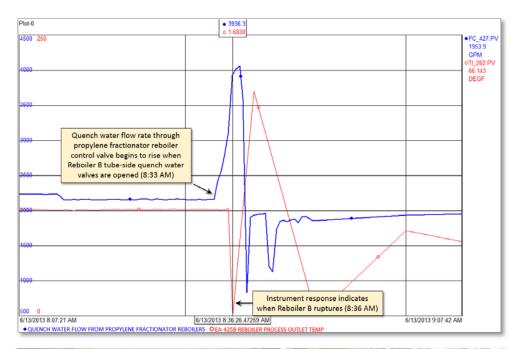
FIGURE 6

Graph of quench water flow rate immediately prior to incident. Quench water flow rate rises when Reboiler B tubeside quench water valves are opened. Reboiler B ruptures approximately three minutes later.

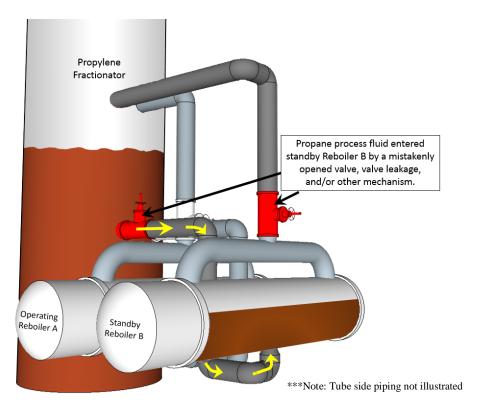
FIGURE 9

Propane process fluid mixture entered standby Reboiler B by a mistakenly opened valve, valve leakage, and/or another mechanism.

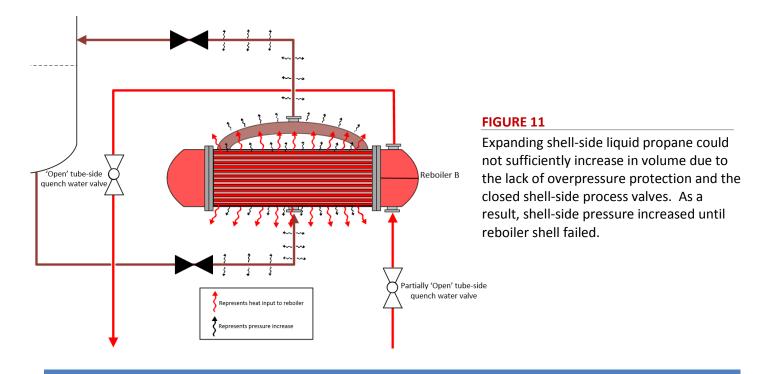
The high pressure generated from liquid thermal expansion of the propane cracked the reboiler shell. The shell contents began to vaporize near the crack opening, and a jet release of liquid and vapor accelerated out of the crack. The pressure loading on the open edges of the crack caused the crack to continue to grow along the vessel length. As the crack opening increased in size, the liquid and vapor jet release also rapidly grew. The continued internal pressure caused the reboiler shell to fail suddenly and catastrophically, splitting wide open (Figure 7 and Figure 12).

The propane then found an ignition source and ignited, creating a massive fireball. The blast effects flattened the reboiler shell (Figure 12).

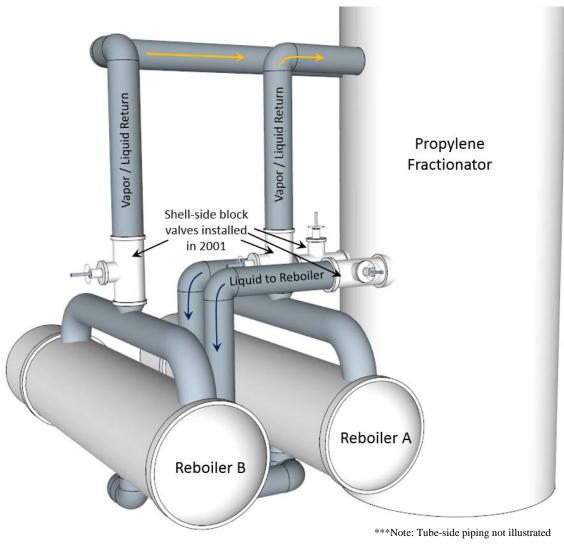
FIGURE 14

The original 1967 design of the propylene fractionator required both Reboiler A and Reboiler B in service at the same time. This design had no valves between the reboilers and the propylene fractionator, protecting the two reboilers from overpressure with the relief device located on top of the propylene fractionator. In subsequent years, Williams determined that the propylene fractionator could operate with only one reboiler in service. Operating with a single reboiler allowed continuous propylene fractionator operation and avoided shutdowns when the reboiler tubes fouled and required cleaning. To implement single reboiler operation, in 2000 Williams Geismar management approved a \$270,000 investment to install valves on both the process side and quench water side of six of the quench water heat exchangers, including the propylene fractionator's Reboiler A and Reboiler B. In 2001, Williams installed the valves (Figure 14); however, Williams did not identify the overpressure hazard that resulted from this change.

Illustration of the propylene fractionator reboilers prior to the incident, with shell-side piping shown. The four shell-side process valves were installed in 2001.

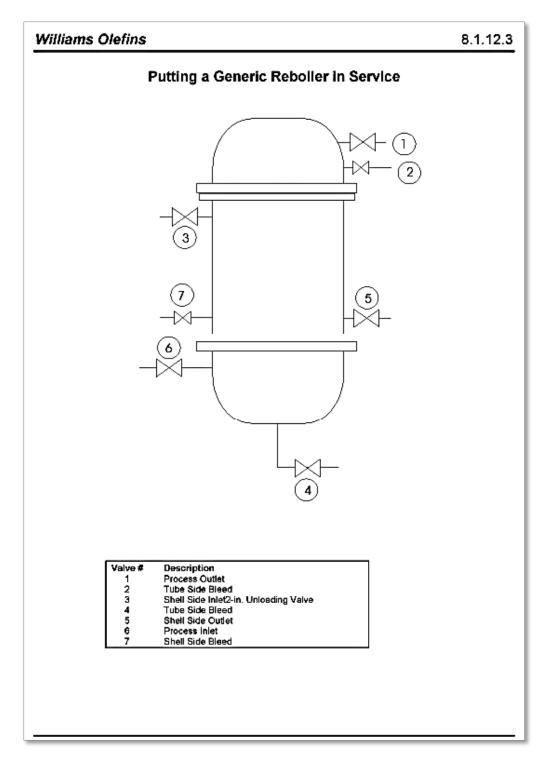
Schematic from the Williams Geismar Generic Reboiler Startup Procedure. This was the applicable procedure to startup the propylene fractionator reboilers. Since the procedure uses the reverse of the Reboiler B configuration, it can be confusing, and workers could initiate a high-pressure scenario on the shell (process) side. Williams had not equipped this reboiler with a protective pressure relief device.

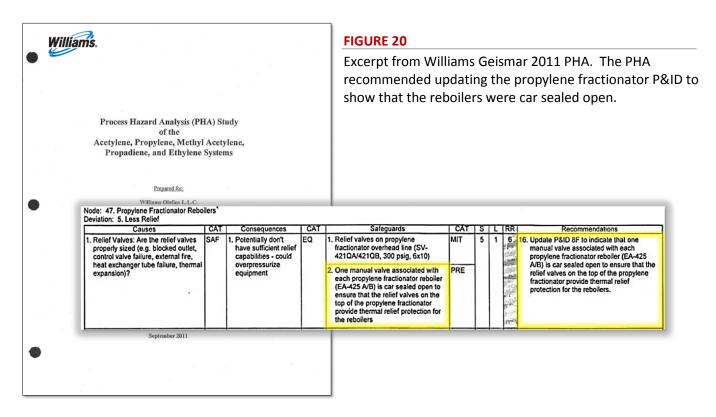
Relying on erroneous documentation that the outlet valve for each propylene fractionator reboiler was car sealed open, the 2011 PHA team identified that the applicable P&ID did not show the car seals. Therefore, the PHA team recommended updating the relevant P&ID (Figure 20):

During the 2011 PHA, Williams correctly identified the high potential severity from equipment rupture, but incorrectly assessed the likelihood of an overpressure incident (see severity (S) and likelihood (L) rating in Figure 20). The 2011 PHA team categorized the likelihood of a propylene fractionator reboiler overpressurization as "improbable." Such a low frequency indicates a weak evaluation and poor understanding of the availability of procedural safeguards such as car seals.

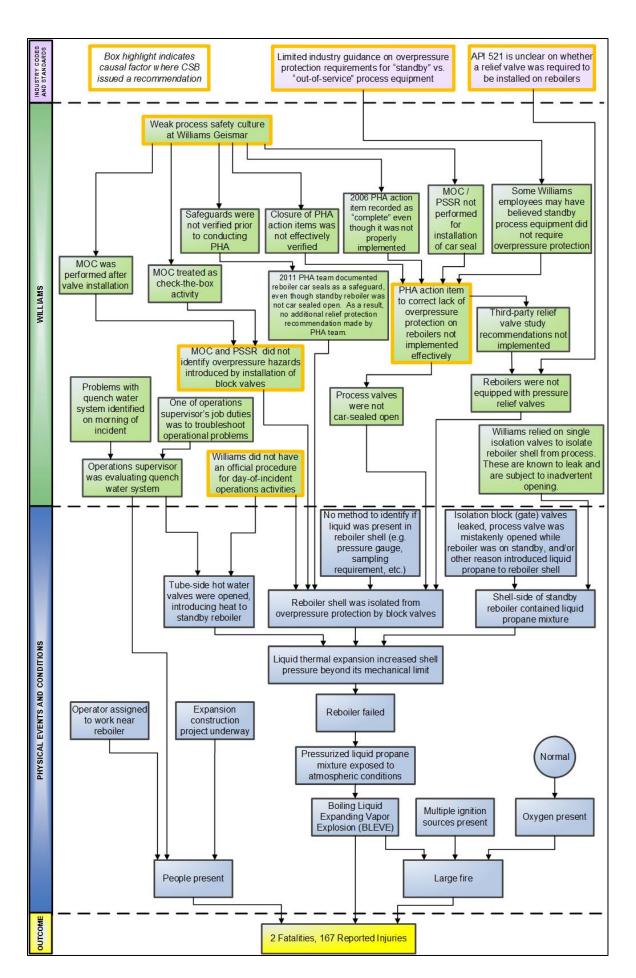
CSB ANALYSIS OF LIKELY REBOILER FAILURE SCENARIO

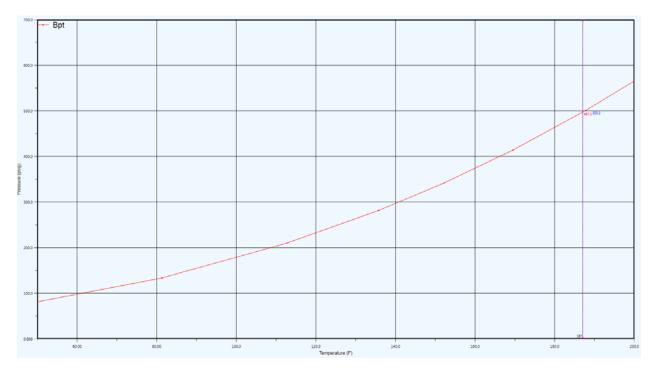
FIGURE B-1

Boiling Point Curve of Williams reboiler process fluid. Graph indicates process fluid could generate a vapor pressure of 496 psig at equilibrium conditions.

The tube-side quench water was at a temperature of 187 °F. At equilibrium conditions at 187 °F, the shell-side propane mixture generates a vapor pressure of approximately 496 psig (Figure B-1). This pressure is not high enough to have ruptured the reboiler, which Finite Element Analysis predicts ruptured between 674 and 1,212 psig. Ref. The CSB concludes that the overpressurization of the Williams reboiler was likely not caused by an increase in vapor-liquid equilibrium pressure when heat was introduced to the closed shell side of the reboiler.

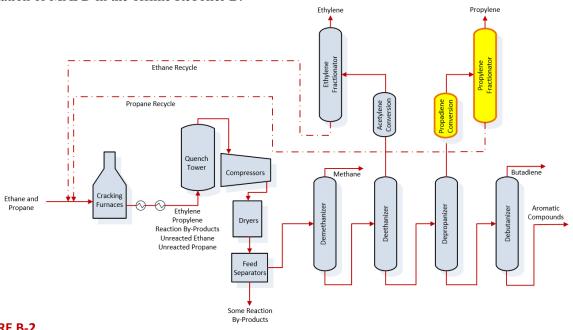
FIGURE B-2

The CSB analyzed whether the decomposition and ignition of MAPD in the reboiler shell caused this incident. Williams regularly sampled the MAPD composition exiting the propadiene converter, which was immediately upstream of the propylene fractionator (Figure B-2). The propadiene converter was installed into the process specifically to prevent accumulation of MAPD in the process. Plant data indicates the propadiene converter was functioning normally between a February 2012 maintenance activity and the day of the incident. Between the time Reboiler B was last opened for maintenance (February 2012) and the incident, available composition data indicates that the process fluid entering the propylene fractionator did not exceed approximately 1.4 mol% MAPD. This concentration likely was not enough to accumulate a high percentage of MAPD in the standby reboiler, which was isolated from the propylene fractionator by closed valves.

Simplified flow diagram of the olefins process. The propadiene converter and the propylene fractionator are highlighted in yellow.

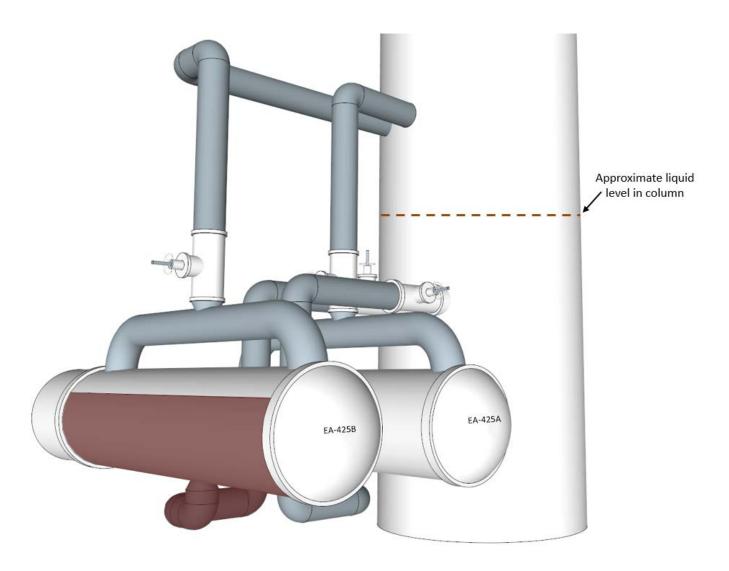
FIGURE B-3

The piping and exchanger shell between the two closed reboiler process valves had to be *at least* 65.5 vol% full of the liquid propane mixture prior to the introduction of hot quench water to the tube side of the reboiler for liquid expansion to result in overpressurization of the exchanger shell and piping. A liquid inventory of at least this

minimum quantity of liquid is reasonable because (1) it would have resulted in a level in the reboiler below the liquid level in the propylene fractionator, and (2) this quantity of liquid would have had enough contact with the reboiler tubes to sufficiently heat and expand (Figure B-3). Reboiler B was likely between 65.5 vol% and 100 vol% full of the liquid propane mixture prior to the introduction of the 187 °F quench water.

Depiction of minimum required liquid level in reboiler EA-425B (Reboiler B) to result in possible liquid overpressurization of reboiler shell.
