DEEPWATER HORIZON GULF OF MEXICO - 2010 ACCIDENT INVESTIGATION

INVESTIGATION REPORT VOLUME 1

EXPLOSION AND FIRE AT THE **MACONDO WELL** (11 Fatalities, 17 Injured, and Serious Environmental Damage)

MISSISSIPPI CANYON BLOCK #252, GULF OF MEXICO

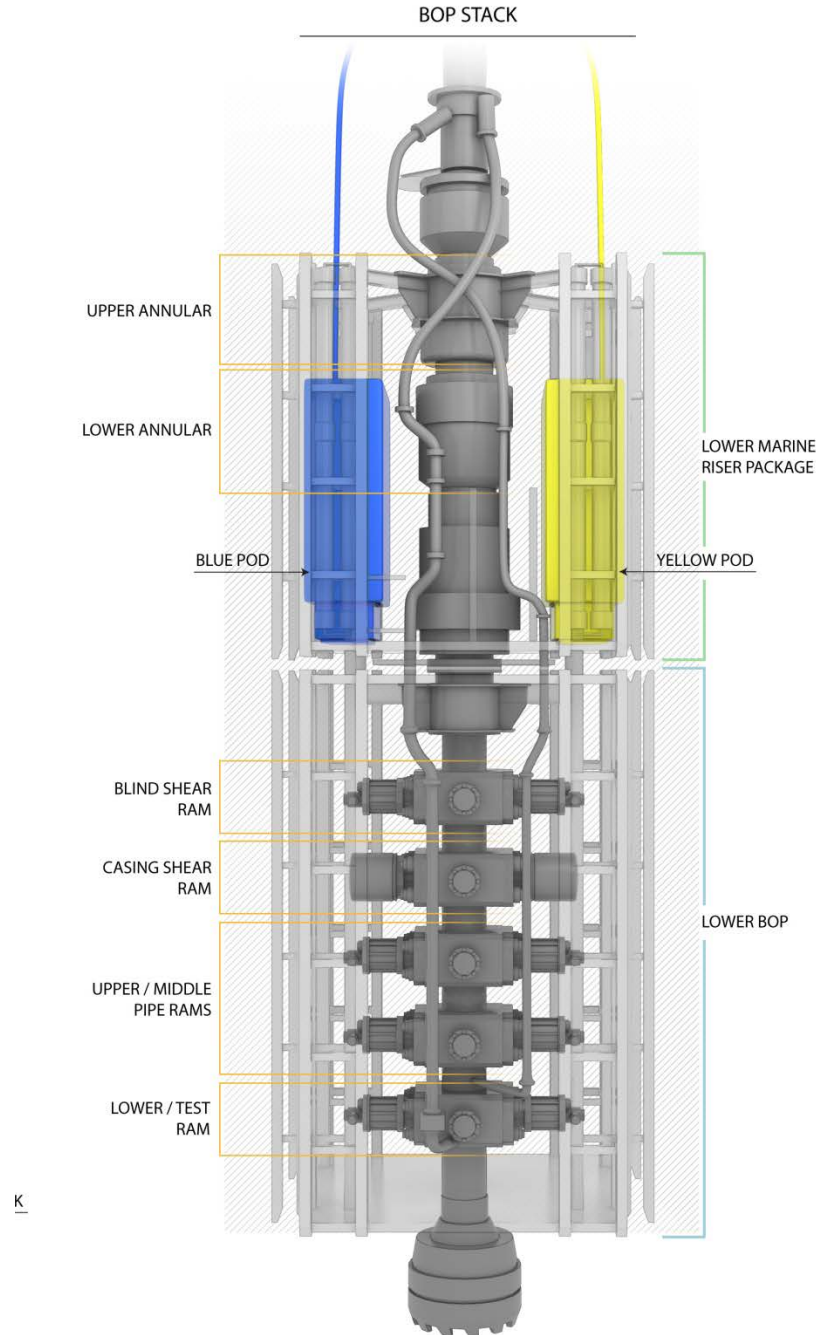
Figure 2-5. The Deepwater Horizon BOP

When drilling mud and hydrocarbons began pouring out of the well and onto the Deepwater Horizon, the drilling crew activated a component called an annular preventer, which should have sealed the space around the drillpipe and prevented further hydrocarbons from rising above the BOP.^a However, well data indicate that this component failed to seal the well.^b Not only did the riser fluids—the hydrocarbons, drilling mud and seawater—that already passed above the BOP continue to travel up the riser and release onto the rig floor, but the riser was also being replenished by the flow of even more hydrocarbons through the leaking component.

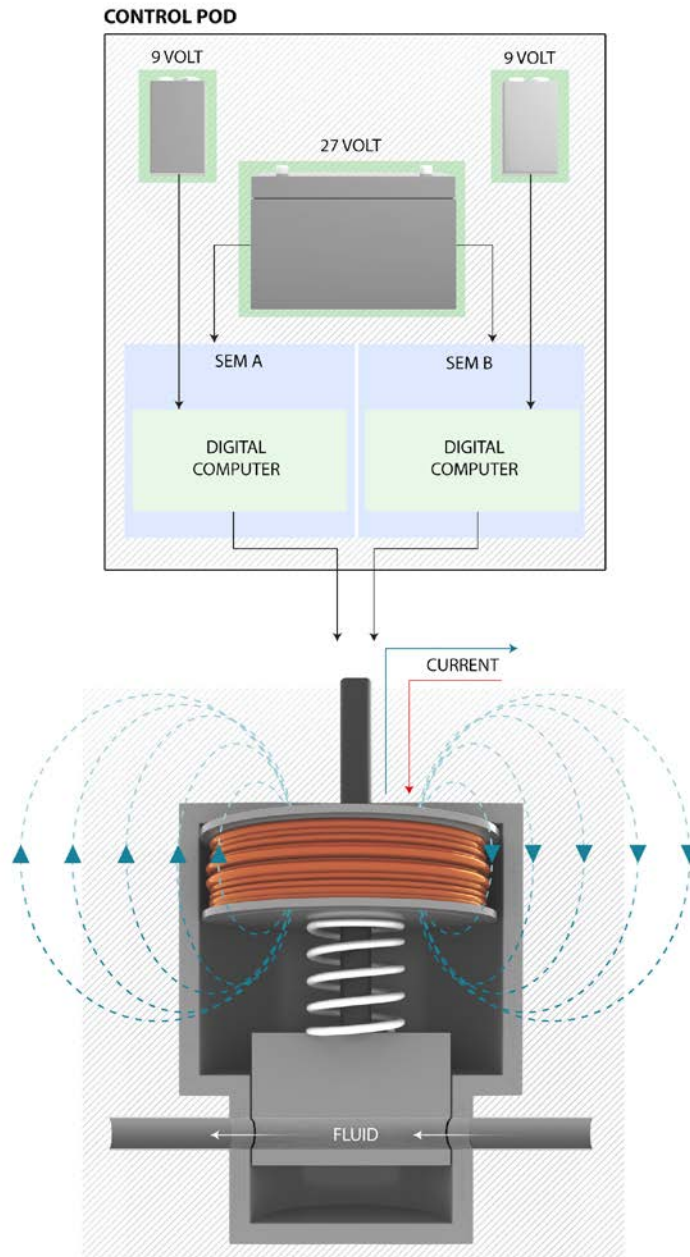
Figure 2-7. Simplified schematic of the control pod battery arrangement.

either the SEM A or SEM B 9-volt battery were to fail, the initiating command would not be sent; thus, the remaining SEM would send its command, and the solenoid valve would open from one coil. If both 9-volt batteries were operable but the shared 27-volt battery failed, neither coil would receive power, and the solenoid valve would remain closed. (See Appendix 2-B for more details.)

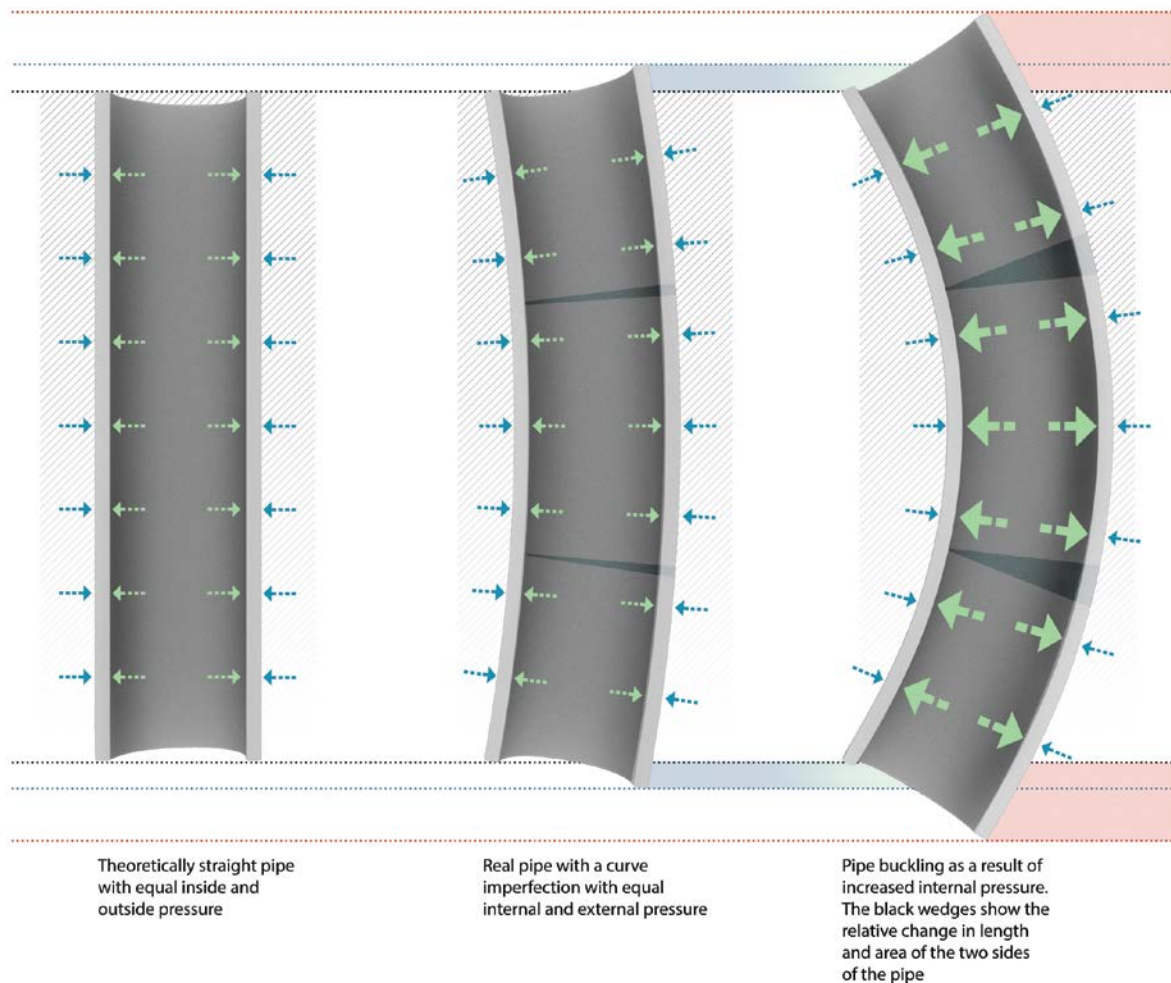
Figure 3-5 illustrates conceptually the effect on a pipe when the inside pressure is much higher than outside, and how this differential pressure can cause buckling. On the left side of the figure is an ideally straight pipe. It is shown with equal pressure (represented by the arrows) acting on both the inside and outside walls. In reality, no pipe is perfectly straight, as shown in an exaggerated manner in the figure. The result of this minor inherent curvature is that the wall of the pipe on the right side is slightly longer than the left side.⁴² With the same pressure acting on the unequal areas of the walls, the right side of the pipe, having a larger area, actually experiences a greater net force.^a If the pressure inside the pipe is increased further, the force imbalance (as a bending moment) also increases and eventually overcomes the bending resistance of the pipe, causing it to buckle.

Well pressures and forces on the drillpipe during most of the Macondo well-control event are not fully known due to the uncertainties of blowout flow rates and physical properties of the well fluids. However, a critical period occurred shortly before the initial explosion, when the well was essentially static with no new flow from the well into the riser. Computer modeling of this period presented in Appendix 2-A demonstrates that effective compression of drillpipe would have resulted in buckled, off-center drillpipe in the well as a pipe ram was closed. The subsequent explosions then likely triggered the AMF/deadman emergency system.

Figure 3-5: Theoretically straight pipe with equal inside and outside pressure (left); real pipe with a curve imperfection with equal internal and external pressure (center); pipe buckling as a result of increased internal pressure (right). The black wedges show the relative change in length and area of the two sides of the pipe.

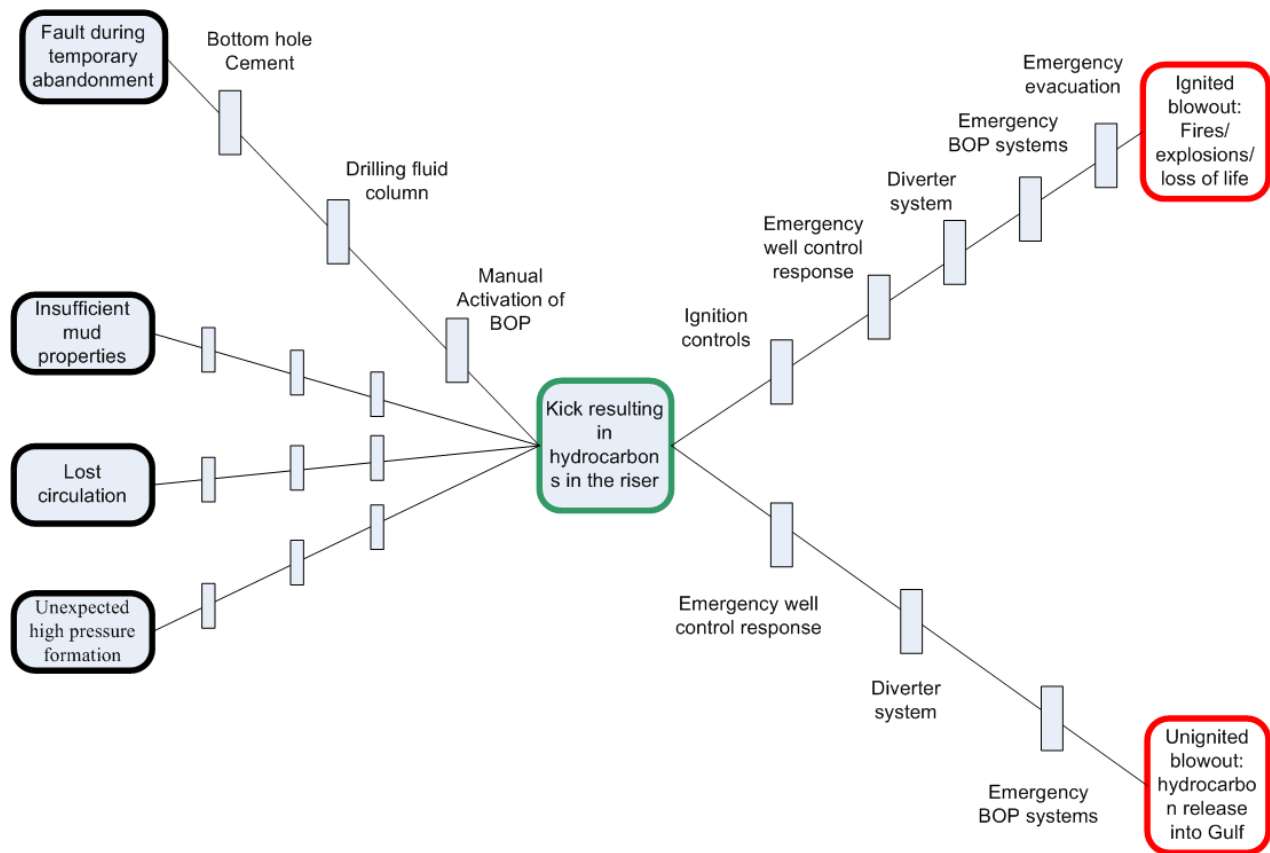
Figure 4-2. Bowtie diagram depicting the relationships between hazards, barriers, and the major accident events they are intended to prevent.^a

In this figure, technical barriers are represented along the lines connecting the threat and hazard, but only the barriers related to a “faulty temporary abandonment process” have been identified. Other circumstances could compromise the technical barriers, and, as indicated in Figure 4-3 organizational and operational barriers are in place to avoid these potential barrier decay mechanisms.^b

The BOP is the only barrier to appear on both sides of the bowtie diagram in Figure 4-2, because the BOP is a collection of well control devices and emergency systems. As described in Section 2.2, well control actions by the crew should result in manual activation of the BOP, but automated emergency shear functions may also be initiated.

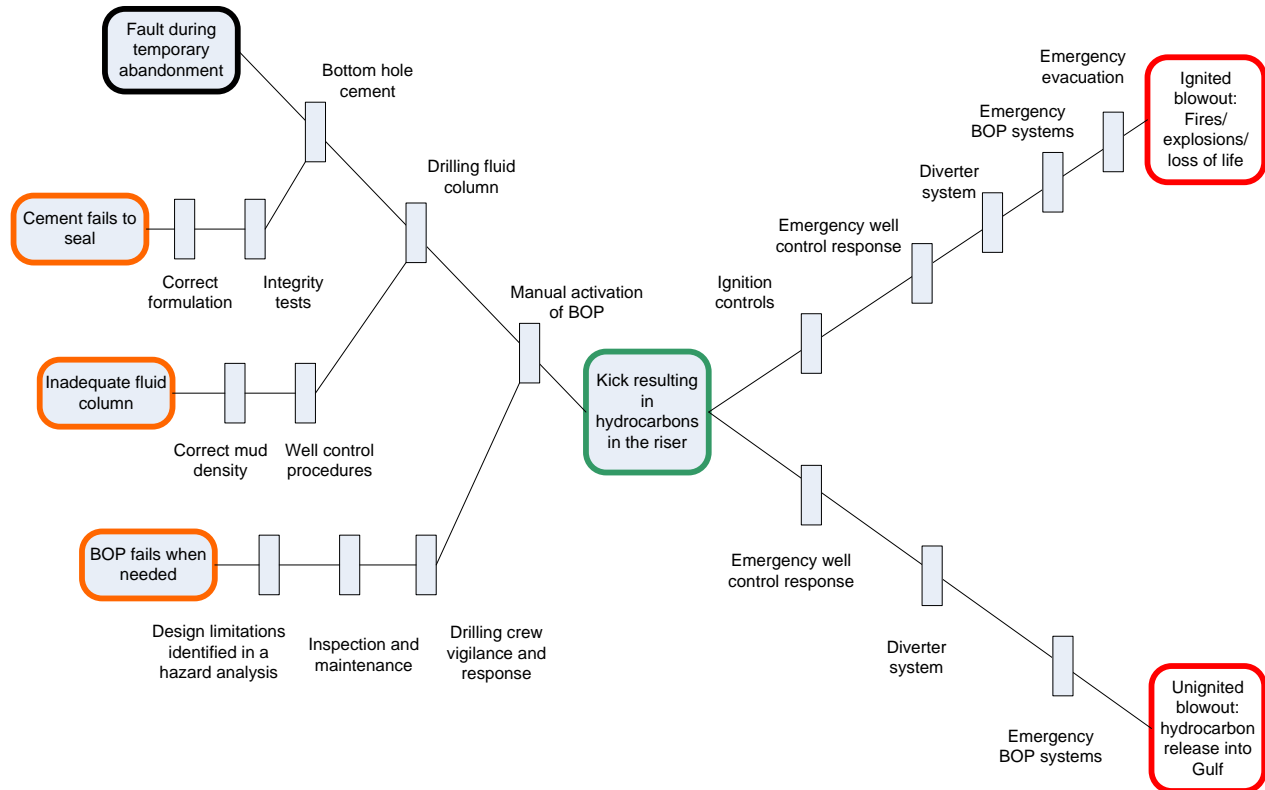
Figure 4-3. Bowtie diagram showing potential decay mechanisms of the technical barriers intended to prevent a fault during temporary abandonment activities.

By tracing the lines leading from a threat to a consequence, and any barrier decay mechanisms listed, one can follow how the scenario would evolve. In the case of a fault during the temporary abandonment process, Figure 4-3 demonstrates that the following must occur:

- The bottom hole cement barrier has to fail as do the tests to detect that failure;
- The drilling fluid column has to either be removed or inadequately formulated;
- Well control actions by the crew have to result in failure to detect changes in density, volume, and flow rate of the circulating (or displaced) drilling fluid column, which would indicate a kick has occurred;^a

- The drilling crew has to then fail to activate the BOP, or the BOP fails to shut in the well upon manual activation due to inadequate design, inspection, or maintenance.

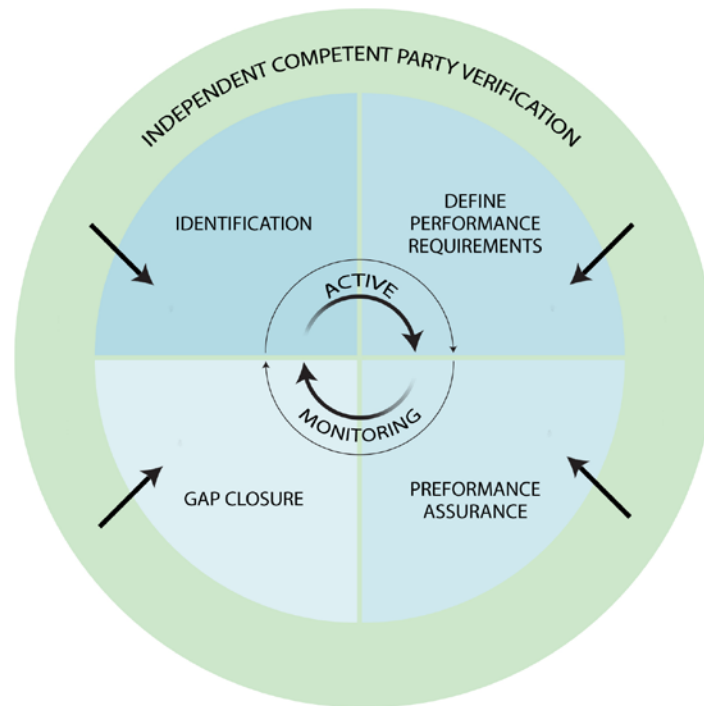
Figure 5-1. Simplified representation of the management system for the lifecycle of a safety critical element

While Transocean identified the Deepwater Horizon BOP as safety critical in a hazard analysis, it operated the BOP beyond its design limits for reliable drillpipe shearing and did not track modifications to individual components that ultimately affected the reliability of the emergency systems. As required by regulations,⁸⁵ regular testing of some BOP functions was performed, but this testing did not assess the emergency systems and were could not detect the latent failures presented in Chapter 3.0. The CSB concludes that post-incident testing changes now required in the United States are not sufficient to ensure industry will detect deficiencies like those found in the Deepwater Horizon BOP.

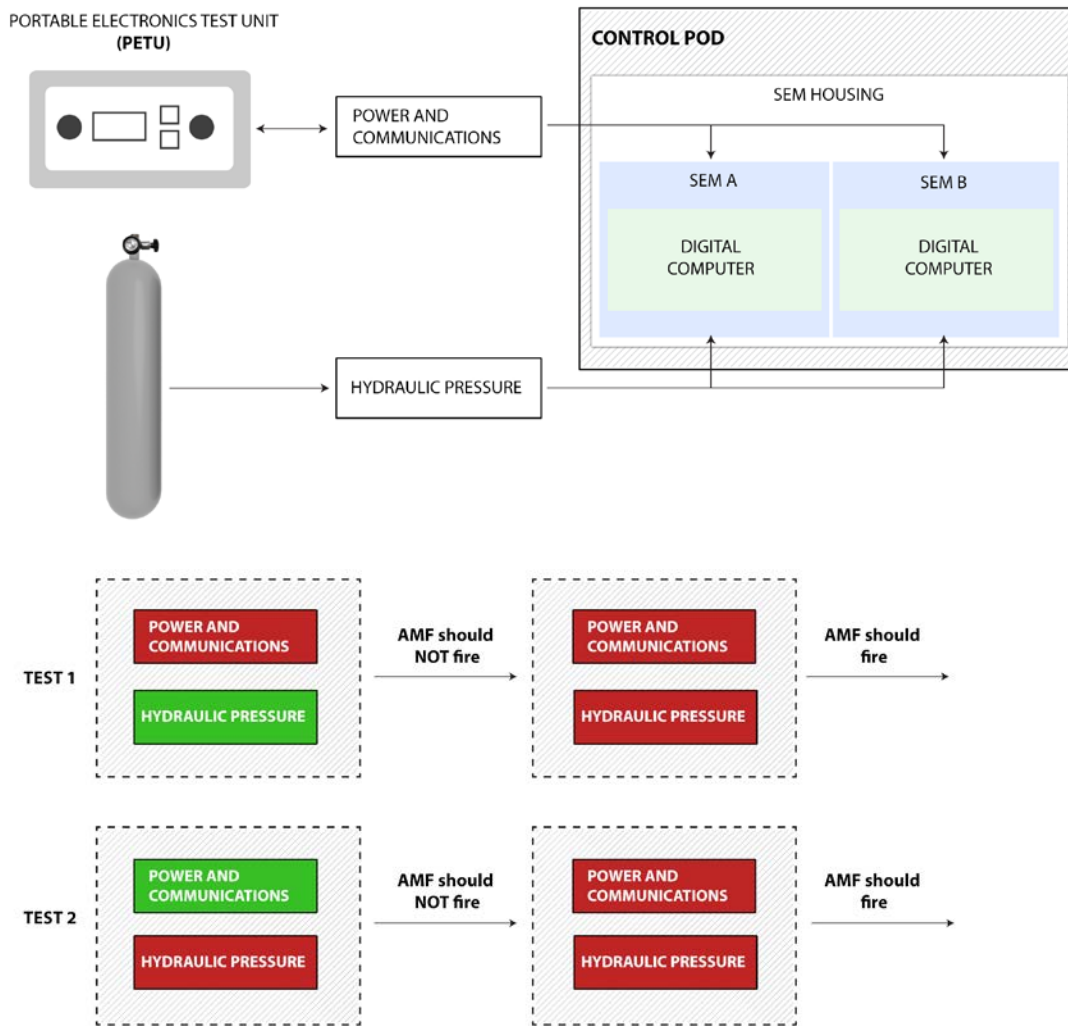
Determining the most effective means to verify a BOP's performance may lie, in part, with factory acceptance testing developed by BOP manufacturers. The deficient wiring found in the blue pod and solenoid Y103 could not have passed Cameron factory acceptance testing (FAT) procedures. In contrast with the testing recommended by API Std 53 and BP, Cameron's FAT procedure for the AMF/deadman system is completed through SEM A and SEM B of each control pod separately. Two tests are completed for each SEM (A and B) to verify that each can independently complete the AMF/deadman sequence (Figure 5-2).^a

Important to highlight is that the user is instructed to switch the sequence in which the power and hydraulics are being disconnected from the SEM. By testing the SEMs in this way, if the wire deficiencies in the blue pod existed at the time of testing, the AMF/deadman system would have initiated after step (a) in Test 1, a result which should have indicated a problem to the user. (See Appendix 2-B.)

Figure 5-2. Simplified schematic of the Cameron FAT procedure to test the AMF/deadman.
