Investigation of the April 19, 2018, Communication Tower Collapse in Fordland, Missouri.

U.S. Department of Labor
Occupational Safety and Health Administration
Directorate of Construction

October 2018

Report Prepared by
Bryan D. Ewing, Ph.D., P.E.
Mohammad Ayub, P.E., S.E.
Office of Engineering Services
Directorate of Construction

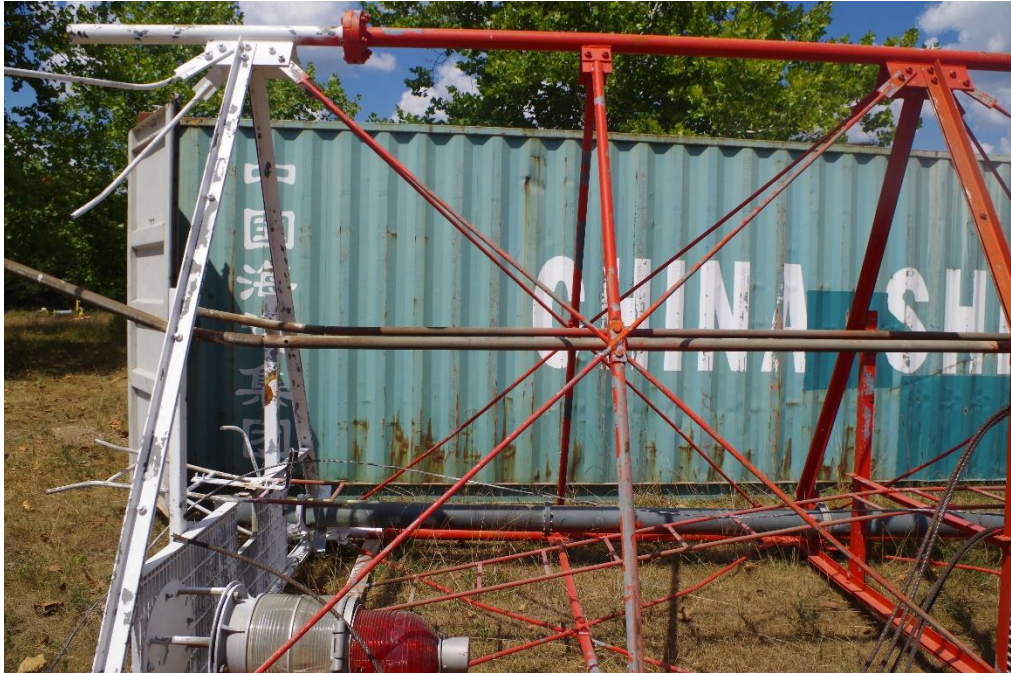
Figure 12. Representative Section from the Top of the Tower

A representative section of the 105' tower elevation is shown in Figure 12. Figure 12 is a photograph of one of the tower bays of the top section of the tower that remained essentially intact after the collapse. The tower legs are braced by the diagonal rod members and the horizontal (appears vertical in the photograph as the tower is on its side) redundant. The typical tower bay is 10' wide by 10' tall. Therefore, this configuration of the bracing members creates unbraced lengths of five feet for the tower legs and redundant. The diagonals and the redundant were connected with two bolts at their mid-span as shown in Figure 13.

TCI's erection drawings states that the diagonals must be replaced one at a time. However, in order to replace a diagonal, the two bolts on each end of the diagonal and the two bolts at the diagonal's mid-span must be removed. The removal of the bolts at the mid-span, however, results in doubling the unbraced length of the tower legs and redundant from five to ten feet.
