BONNEVILLE POWER ADMINISTRATION 115KV LINE 2013 ACCIDENT INVESTIGATION

Level I Accident Investigation Report

Wilson Construction Company Employee Fatality on the Bandon-Rogue No. 1 115kV Line

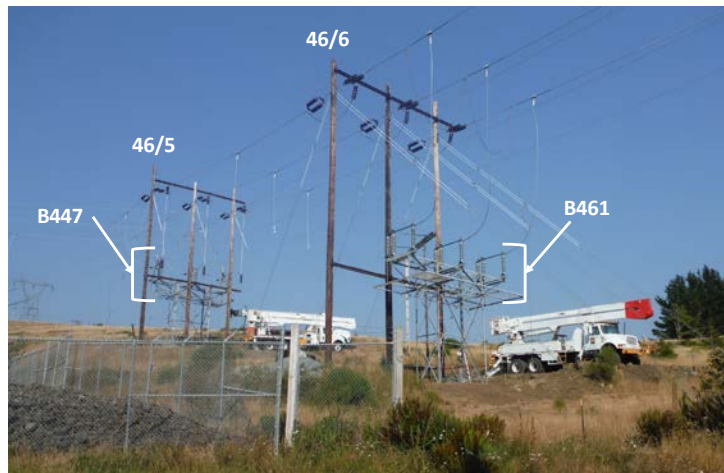
By about 0930, WCC Crew Foreman 2 (CF2) climbed up to the top of B447 switch stand to attach lift slings suspended from the crane. Once the lift slings were placed and pulled up snug, CF2 positioned himself to assist in the removal of the blade end sectionalizing jumper on B-phase.

At approximately 0945, CF2 made contact with a difference of potential across the blade end insulator stack of B447.

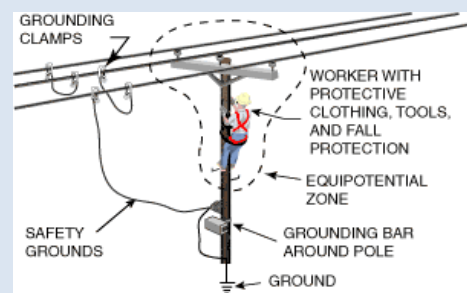
The Board concluded the **direct cause** of the accident was that CF2 made contact with a difference of potential across the blade end insulator stack of B447.

The Board concluded the **root cause** of the accident was Crew 2's failure to establish an equipotential zone (EPZ).

An equipotential zone is a work zone in which the worker is protected from electric shock from differences in electric potential between objects in the work area. These differences in potential can be caused by induced voltage, line re-energization, or lightning.

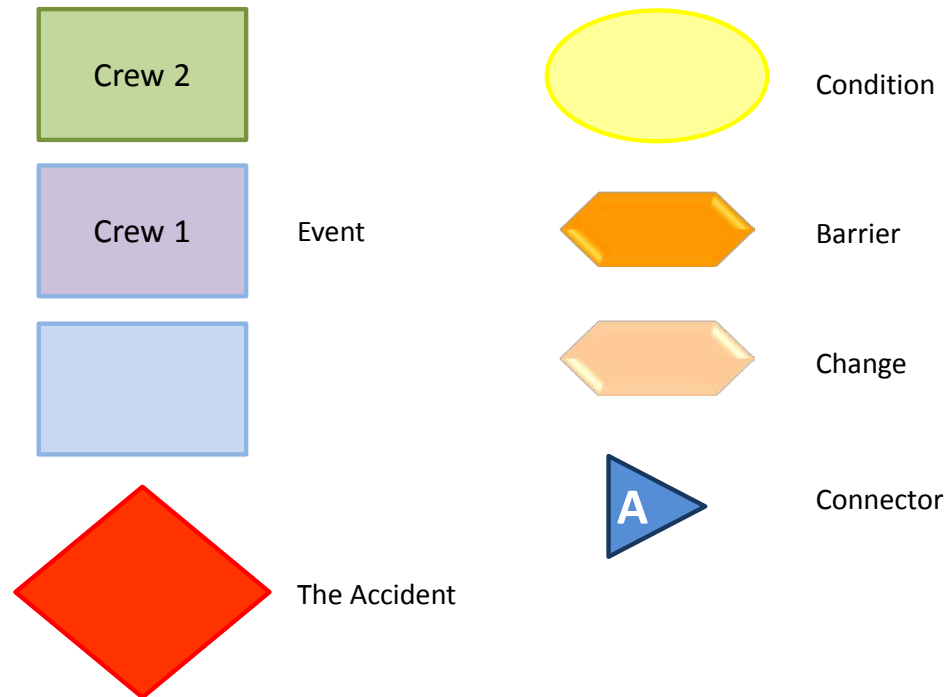
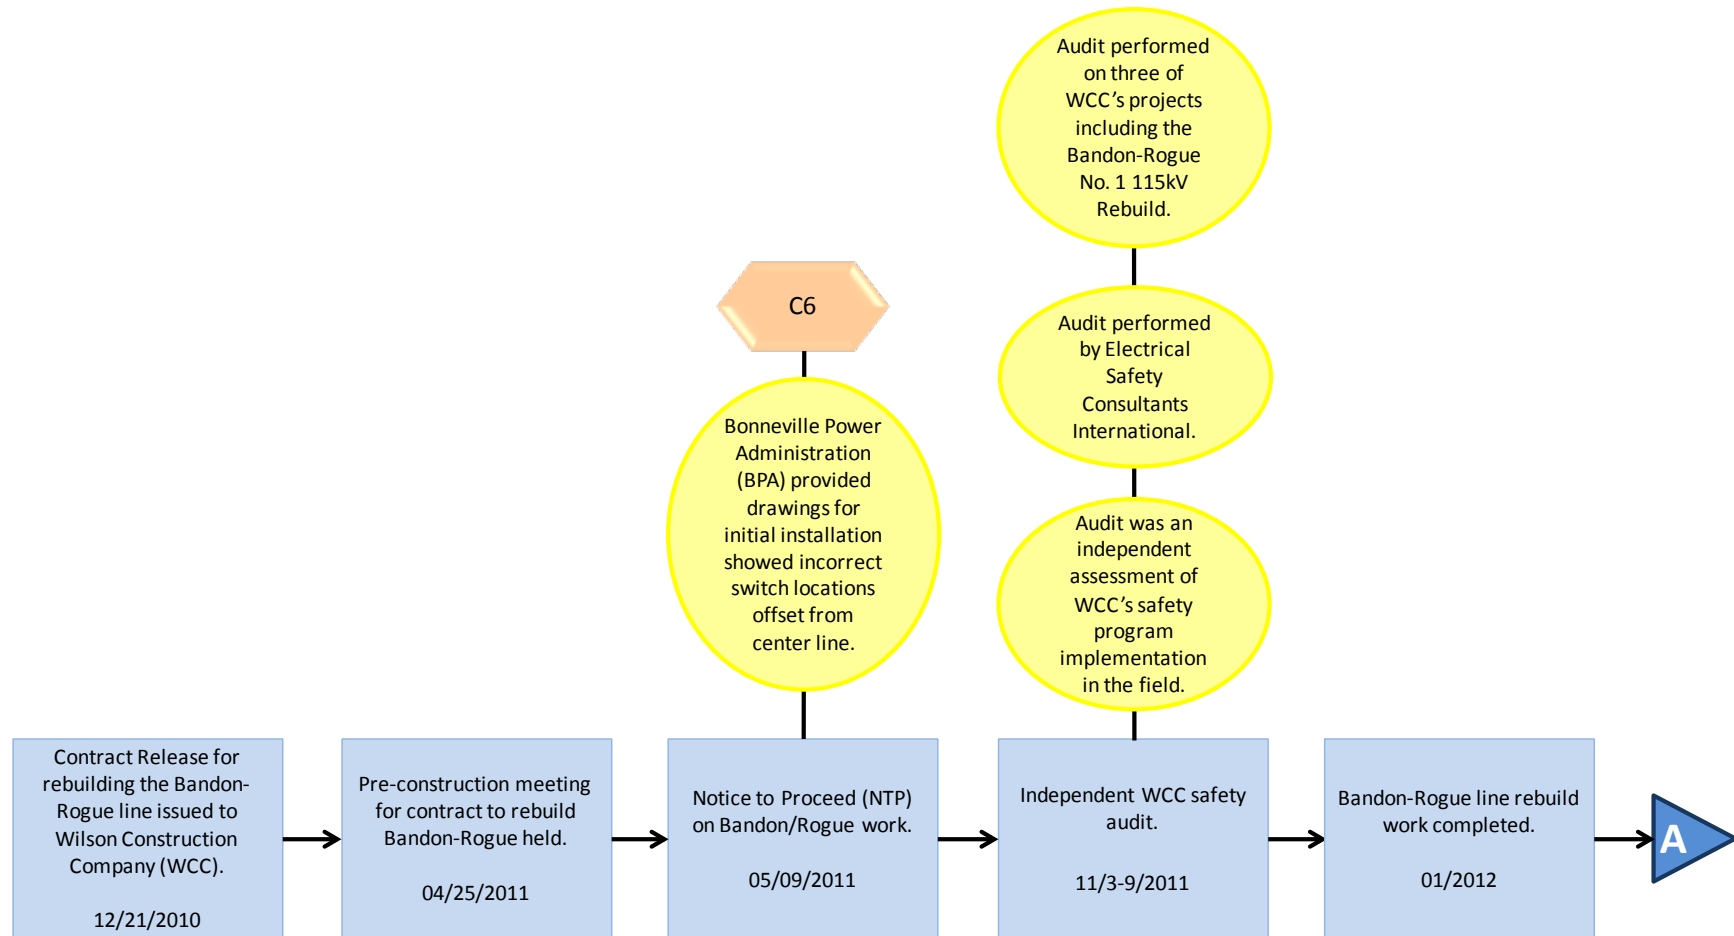
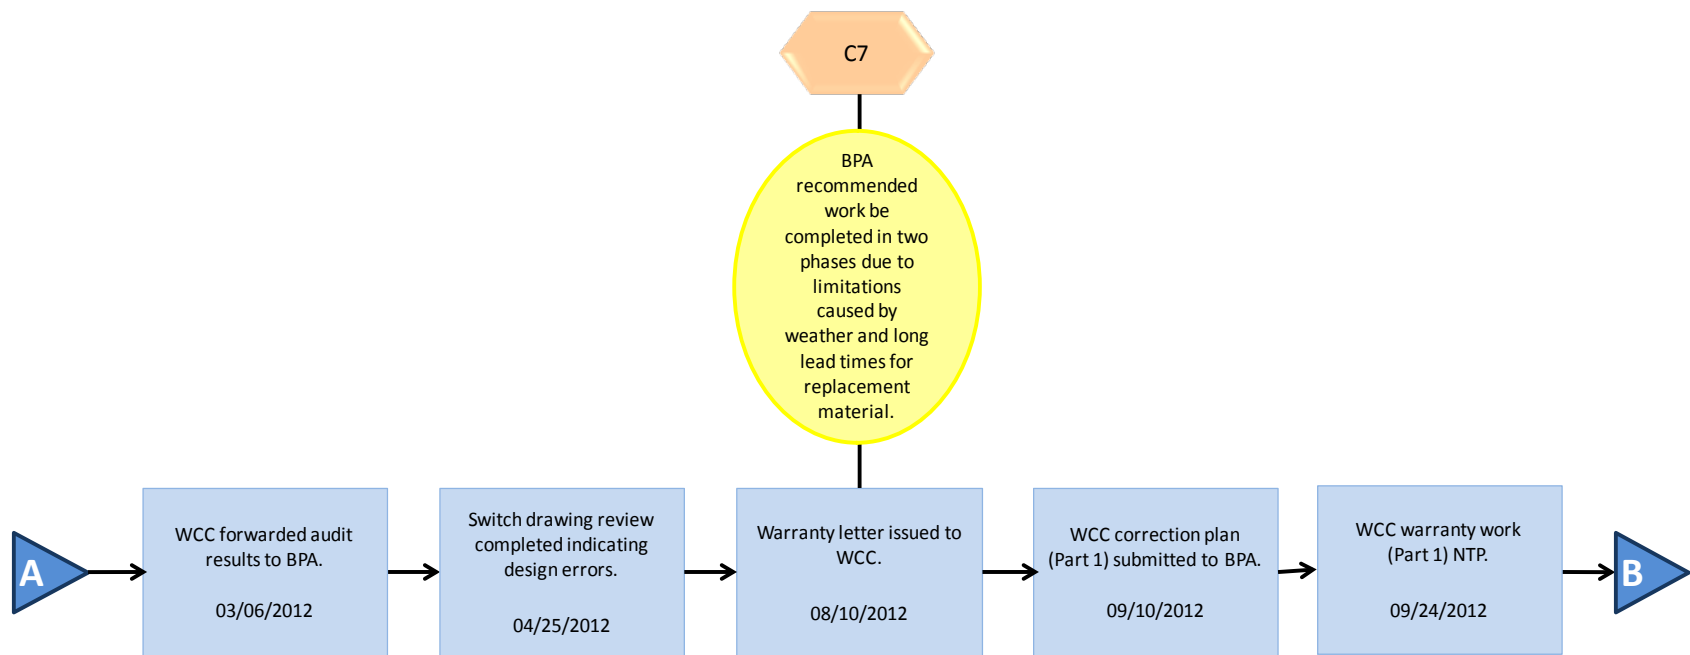
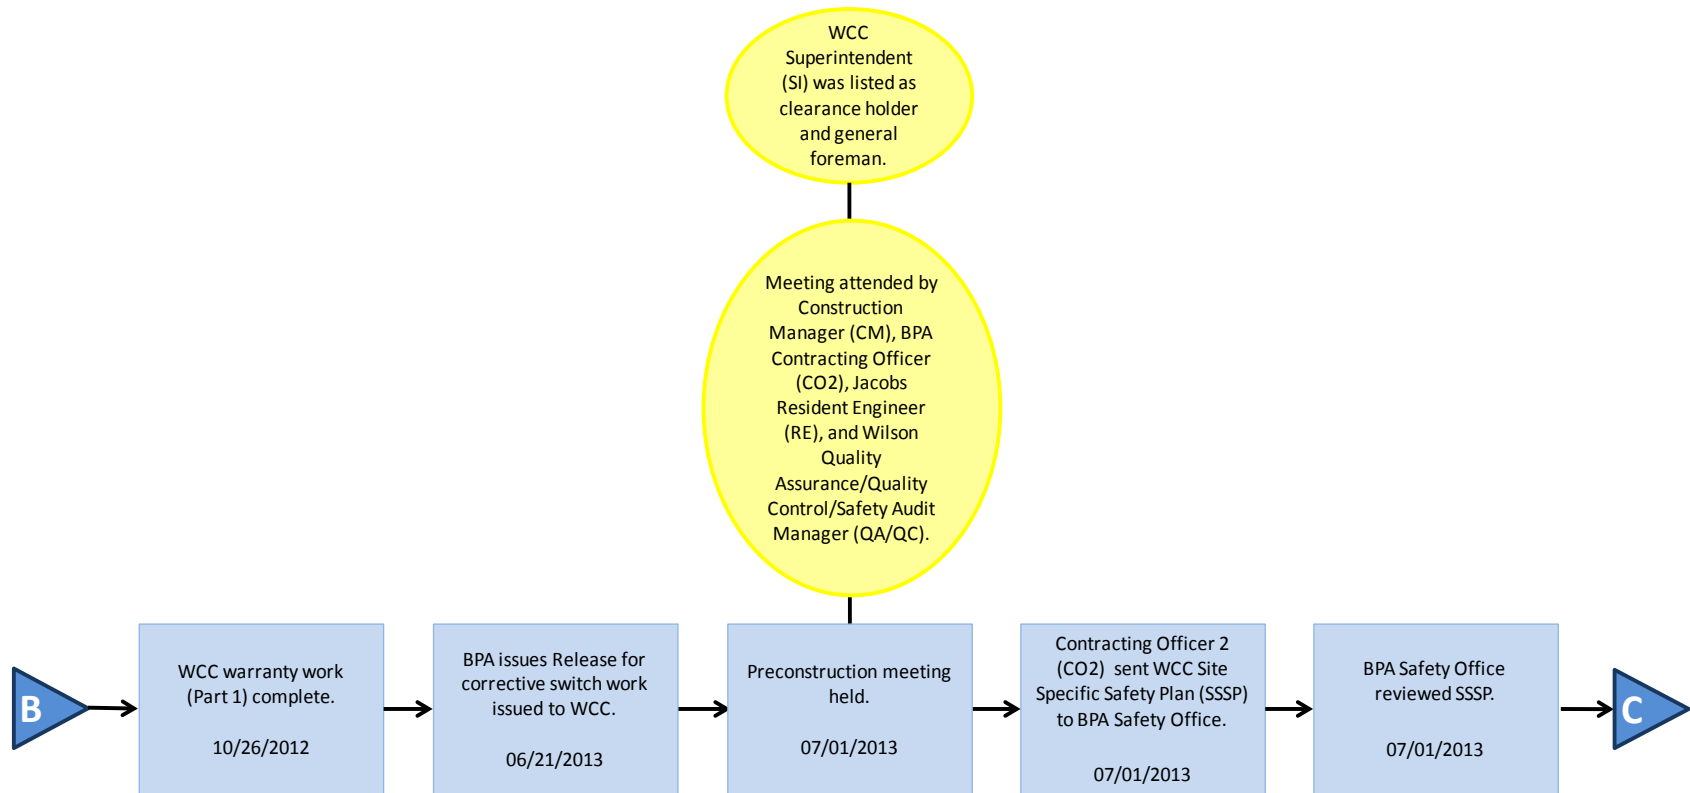
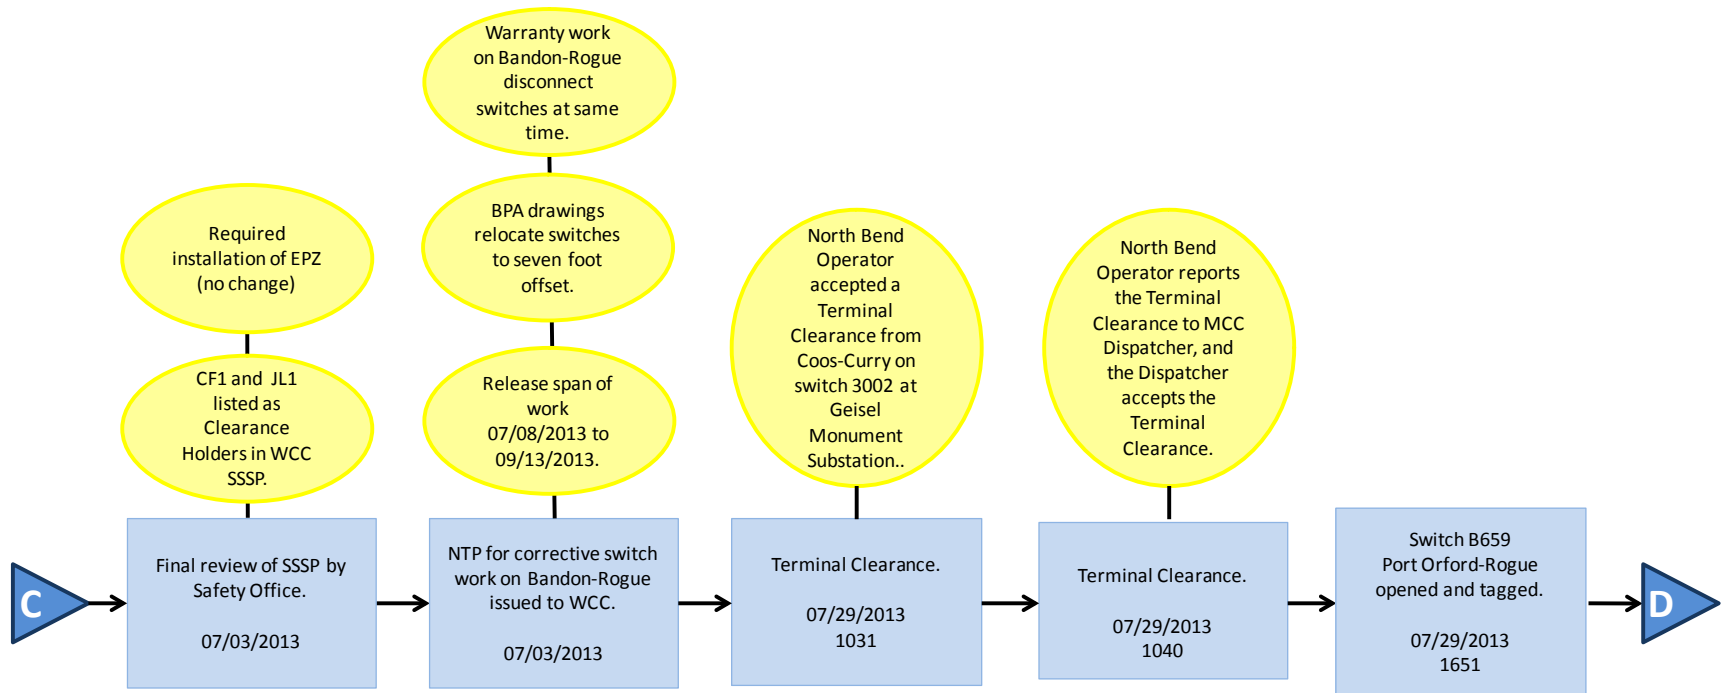
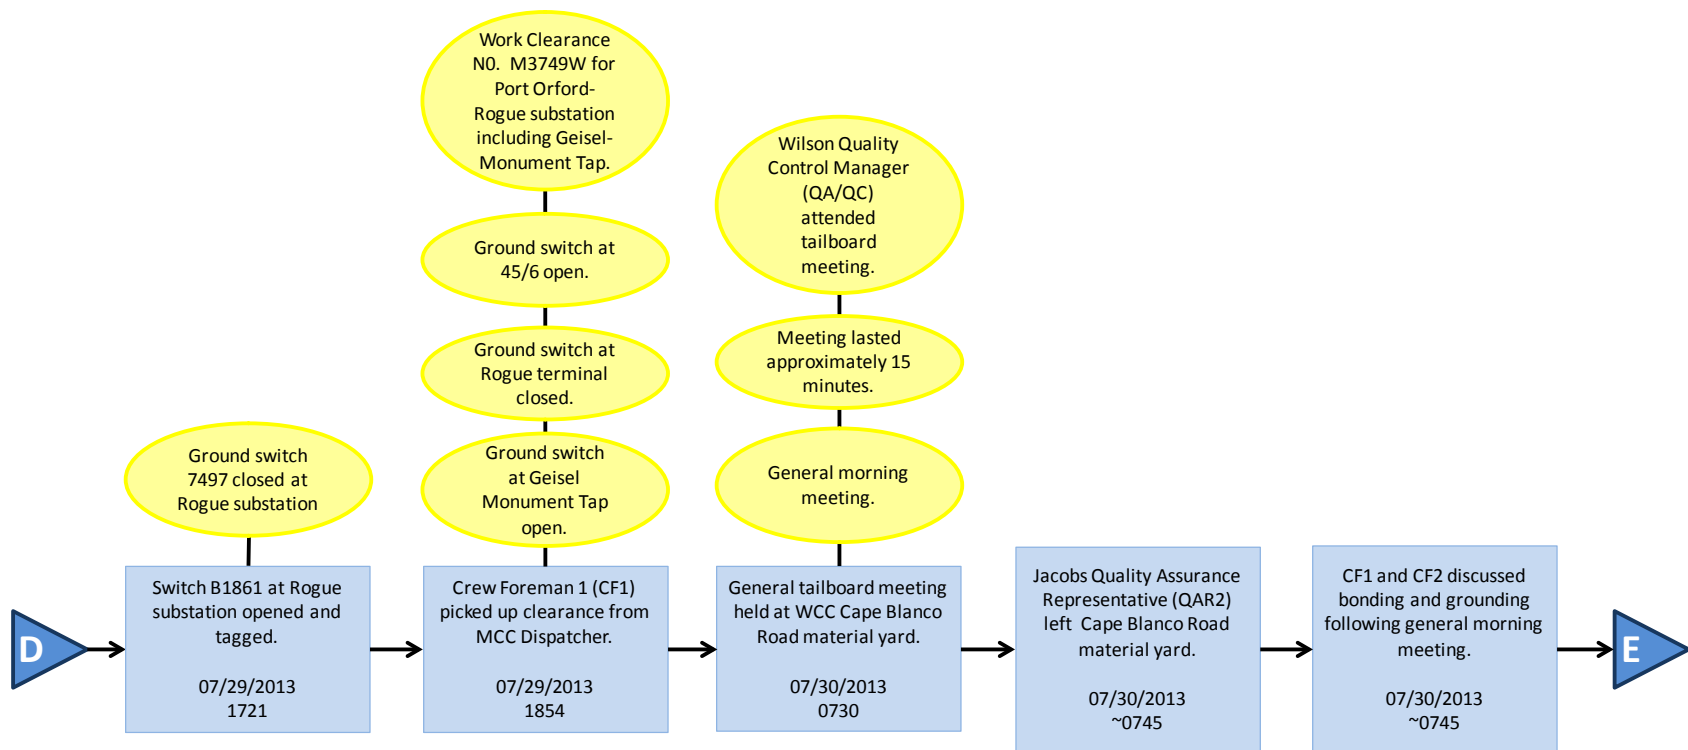
Table D-1: Events and Causal Factors Chart

An events and causal factors analysis was performed in accordance with the DOE workbook *Conducting Accident Investigations*. The events and causal factors analysis requires deductive reasoning to determine those events and/or conditions that contributed to the accident. Causal factors are the events or conditions that produced or contributed to the accident, and they consist of direct, contributing, and root causes. The direct cause is the immediate event(s) or condition(s) that caused the accident. The contributing causes are the events or conditions that, collectively with the other causes, increased the likelihood of the accident, but which did not solely cause the accident. Root causes are the events or conditions that, if corrected, would prevent recurrence of this and similar accidents. The causal factors are identified in Table D-1: Events and Causal Factors Analysis Chart.
