IDAHO NATIONAL ENGINEERING LABORATORY ELECTRICAL SHOCK 1996 ACCIDENT INVESTIGATION

**Type A Accident
Investigation Board Report
August 13, 1996
Electrical Shock
at
TRA-609, Test Reactor Area,
Idaho National Engineering Laboratory**

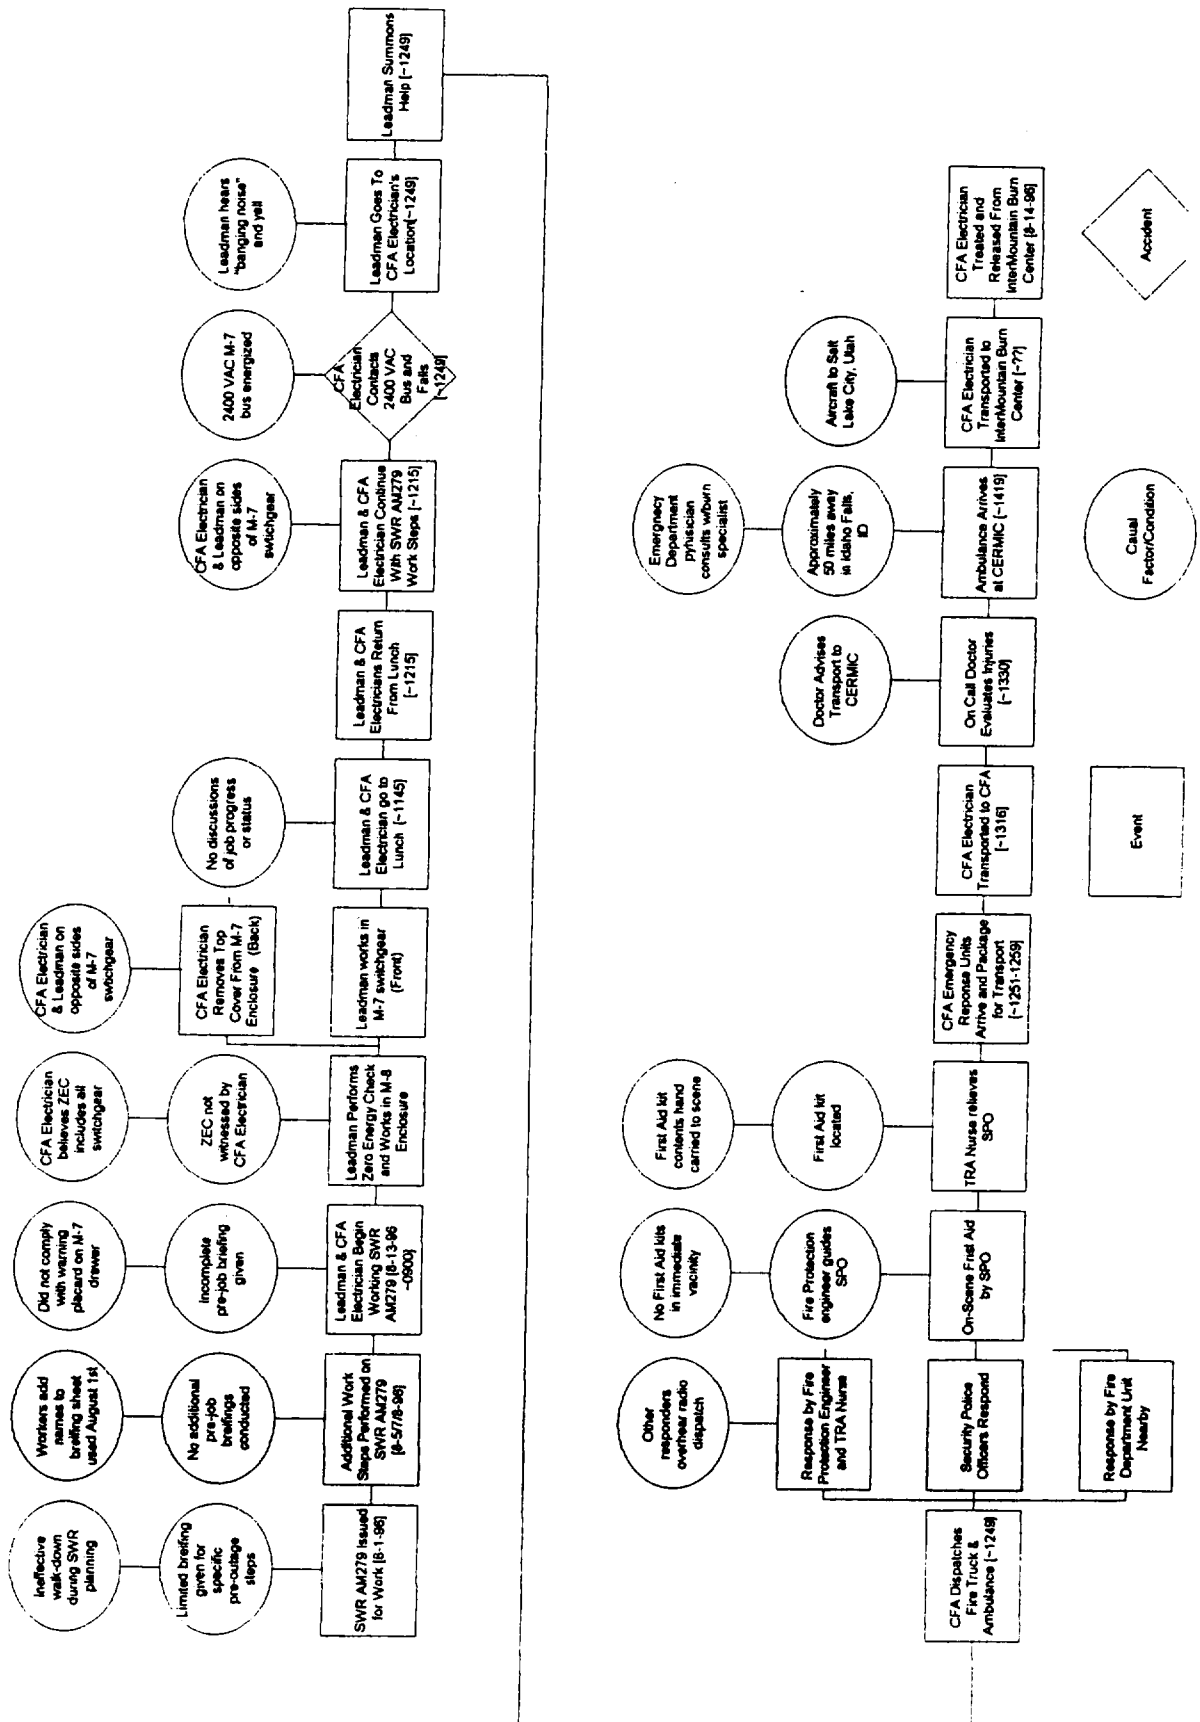
Figure 2.6 Events and Causal Factors Chart

The **direct cause** of the accident was the lack of effective work control. However, there were also root causes and contributing causes. Root causes are the fundamental causes that, if corrected, would prevent recurrence of this and similar accidents. Contributing causes are other causes that, would not, by themselves, have prevented the accident but are important enough to be recognized as needing corrective action. An Events and Causal Factors Chart used to analyze the causal factors is presented as Figure 2.6. A tabular summary of the analysis is in Table 2.2.
