PRYOR TRUST GAS WELL BLOWOUT & FIRE – 2018 ACCIDENT INVESTIGATION

Pittsburg County, Oklahoma | Incident Date: January 22, 2018 | No. 2018-01-I-OK

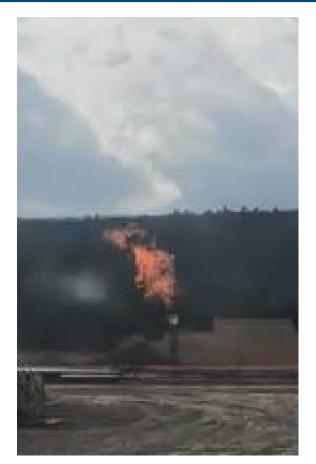
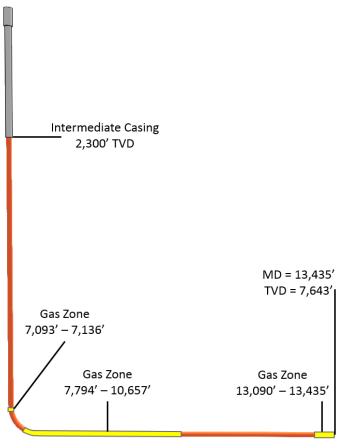
The well profile at this point is shown in Figure 10. Post-incident analysis of the well data shows that the 11,000 feet of uncased, open wellbore included three areas where some amount of gas had entered the well while drilling, as interpreted from measured gas units during the drilling operation and the flaring at the surface that occurred on January 21.

Figure 10. Areas where gas entered the wellbore while drilling.

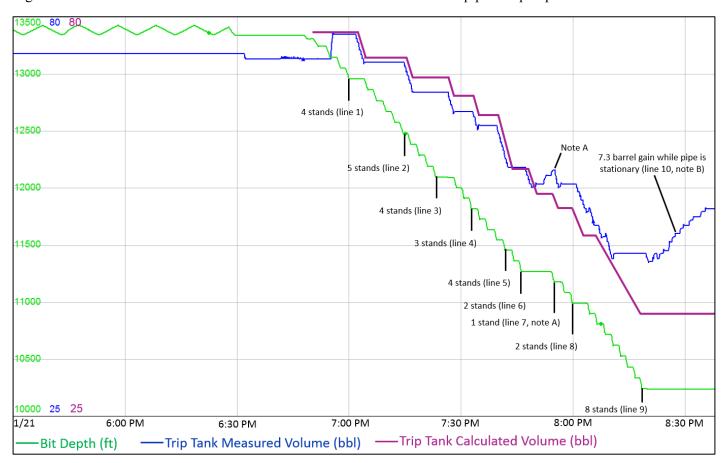
By the time the drill bit reached 10,237 feet MD in the horizontal section of the well, there were 14.3 barrels less mud in the well than needed to replace the volume of drill pipe removed. This volume had evidently been replaced by the equivalent volume of gas entering the well.

Figure 13. Rig data during the trip out of the wellbore from 13,337 feet to 10,237 feet. The blue line shows the actual, measured trip tank volume, and the purple line shows what the trip tank volume would be had a mud volume equal to the calculated volume of the drill pipe removed been pumped into the well. The line numbers and notes indicated in parentheses correspond to the line numbers and notes in Table 1 below.

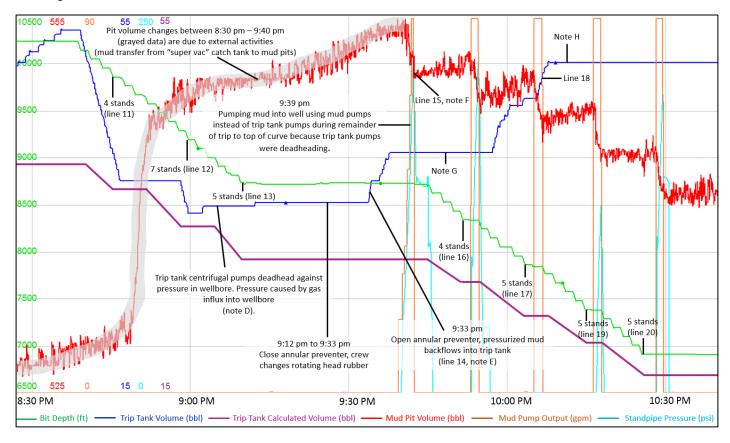
Figure 15 and Table 2 show the rig data and explain the operations during this portion of the tripping operation. By the time the drill bit reached the top of the curve, 20 barrels fewer than the calculated drill pipe displacement volume had been pumped into the well since the beginning of the tripping operation and had evidently been replaced by gas.

Figure 15. Rig data during the trip out of the wellbore from 10,237 feet to 6,905 feet. The blue line shows the actual, measured trip tank volume, and the purple line shows what the trip tank volume would have been had the calculated drill pipe volume been pumped into the well. The line numbers and notes indicated in parentheses correspond to the line numbers and notes in Table 2 below.

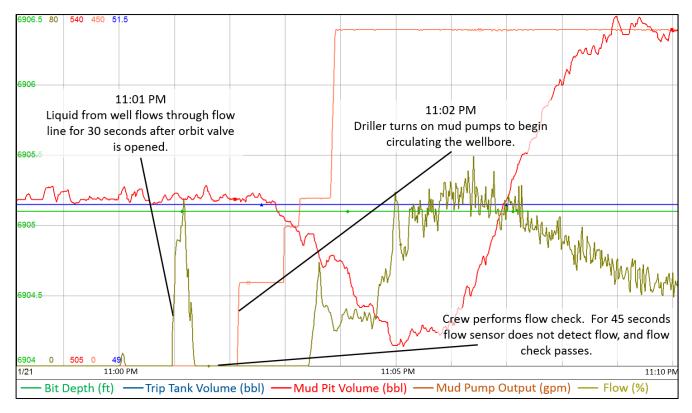
Before beginning circulation, with the mud pumps off, the driller opened the orbit valve to perform a flow check. The rig data shows that a small amount of fluid flowed through the flow line, then stopped. The flow check was conducted for 45 seconds. With no flow observed, the flow check was considered to have passed (Figure 18).

return line (Figure 17). The height of mud in the well might have been increasing during this flow check, but not to the point of reaching the flow line. This hypothesis is supported by the 80-second delay between when the mud pumps were turned on and when mud began flowing through the flow line (Figure 18).

Figure 18. Rig data when the drill bit reached the top of curve. Crew performed a flow check at top of curve. No flow was observed for 45 seconds. Driller turned on pumps to circulate the well.

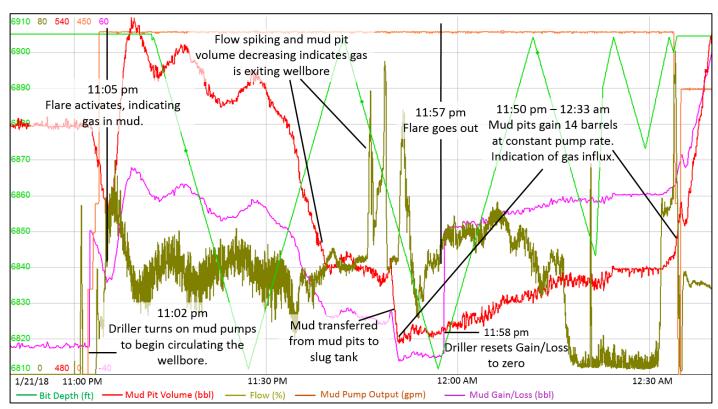
Figure 20. Rig data while circulating the wellbore at the top of the curve. The flare activated while circulating, indicating gas in the mud. Between 11:50 pm and 12:33 am, the mud pits gained 14 barrels while the mud pumps were circulating at a constant pump rate. This pit gain indicates there was gas in the well.

The driller told the CSB he observed full returns, no losses and no gains, while circulating the well. Post-incident review of the well data, however, indicates that while circulating, the mud pits were gaining mud, indicating gas was in the well; between 11:50 pm and 12:33 am, the mud pits gained about 14 barrels (Figure 20).^a

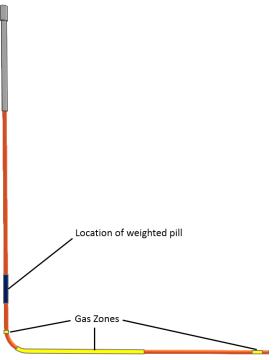
Figure 21. Depiction of well with gas zones and location of weighted pill.

derrickhand was already mixing the LCM pill. Instead of starting over, he added weighting material to the already-prepared LCM pill, bringing it to the 50-barrel volume and 10 pound-per-gallon density specified by RMO.

At 12:35 am, the drilling crew pumped 46 barrels of the pill into the drill pipe. Following the pill with mud, they pumped the pill out of the bottom of the drill pipe and into the annulus with the bottom of the pill at a depth of about 6,500 feet, and with the top of the pill at about 5,800 feet (Figure 21). Some of the pill material remained in the bottom of the drill pipe.

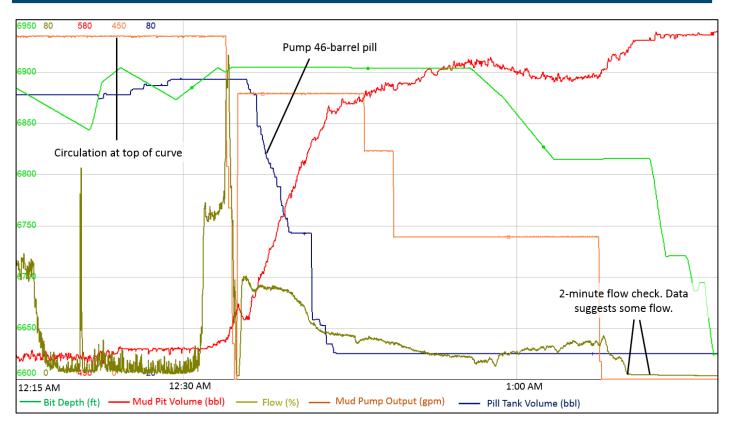
After spotting the pill, at about 1:10 am the crew performed a visual, 2-minute flow check. The flow check passed. However, the CSB could not verify that the crew observed no flow during this flow check. The return flow meter data indicates some very small flow (1% of the flowmeter scale) during this flow check (Figure 22). Despite the flow check result, gas was still entering or expanding in the well. The 50-barrel volume and 10-pound-ger-gallon weighted pill did not produce the hydrostatic pressure necessary to prevent gas from entering the vertical portion of the well. After pumping the weighted pill, the well was still underbalanced and the primary well control barrier was still not in place (Section 6.5).

Figure 22. Data during pumping of pill and subsequent flow check.

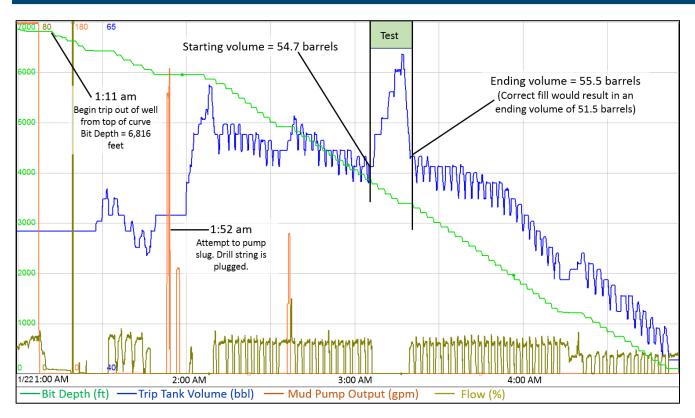
During the tripping operation, the driller and company man performed a test to determine if the well was taking proper fill. The company man wanted to double check that dry pipe volume was the correct displacement volume for their trip sheet calculations (Figure 25). They turned off the trip tank centrifugal pumps and removed five stands of drill pipe from the wellbore. They then turned on the trip tank centrifugal pumps to see if a corresponding five drill-pipe-stand volume of mud pumped into the well. The driller and company man believed they saw the proper volume of mud enter the well, and they resumed tripping normally. A review of the data, however, shows that the full calculated volume for five stands of drill pipe did not enter the well. From start to end of test, the trip tank volume should have reduced by 3.2 barrels, the volume required to replace the five stands of pipe. By the end of the test, however, the trip tank volume had actually increased by 0.8 barrels, indicating that the well did not take any fill, and in fact had gained four barrels of influx or expanded gas. It is unclear why the driller and the company man believed this test passed. The result was that, unknown to Patterson and RMO, gas continued to enter or expand inside the well during the tripping operation. By the end of the trip, less than half of the drill pipe volume removed from the well had been replaced with mud.^a The other half of the drill pipe

^a This calculation considers the tripping operation between 2:13 am and when the final stand above the BHA reached the surface at 4:50 am. During this period, 60 stands of drill pipe were removed from the well. The last stand was plugged with the pill material. The calculated displacement volume of these 60 drill pipe stands is 39.5 barrels. About 16.8 barrels of mud were pumped into the well during this time period to replace the drill pipe removed. Only about 43% of the drill pipe volume was replaced with mud.

Figure 25. Rig data during trip out of vertical portion of the well on January 22, 2018. The driller and company man were confused by the trip tank volume fluctuations and about what pipe volume to use in trip sheet calculations. The company man and driller incorrectly concluded that the test they performed to determine if the well was taking proper fill had passed.

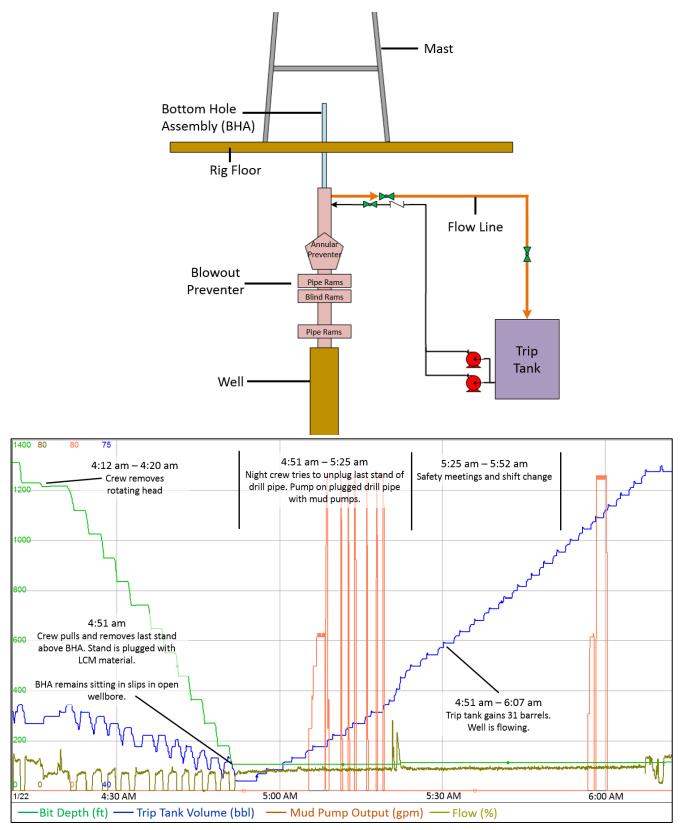
Between 4:51 am and 6:07 am, while the crew was trying to unplug the stand of drill pipe and during shift change, the trip tank gained 31 barrels of mud (Figure 26). The well was flowing because gas was in the well. No one observed this gain in the trip tank, and no one realized the well was flowing.

Figure 26. Rig equipment lineup and rig data between 4:10 am and 6:12 am. Between 4:51 am and 6:07 am, the trip tank gained 31 barrels of mud.

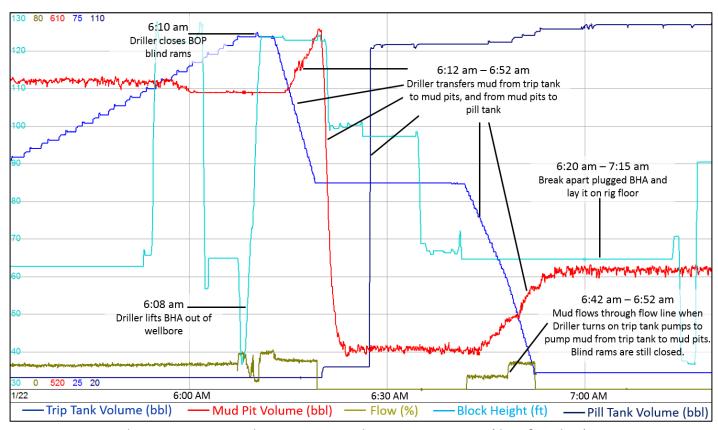
At 6:08 am, the day shift driller lifted the BHA out of the wellbore. At 6:10 am, with the BHA out of the wellbore, the driller closed the BOP blind rams.^a The driller then transferred mud from the nearly-full trip tank to the mud pits. The mud pits were also nearly full of mud, and mud was transferred from the mud pits to the pill tank.

Figure 27. Rig Data between 5:32 am and 7:20 am on Monday, January 22, 2018 (day of incident).

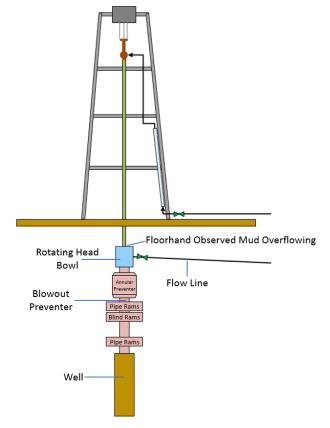
The driller lowered the BHA into the well, until only about 2-3 feet of it remained above the rig floor. At 8:09 am, with the piping now aligned so that flow from the well was routed to the mud pits, the driller reset the mud Gain/Loss indicator on his rig data monitor to zero. He then turned on the pumps to test the BHA tool. A floorhand observed and told the driller—that when the pumps turned on, mud was coming up out of the top of the rotating head bowl (Figure 28).^b A crewmember told the CSB that this was

Figure 28. Depiction of where floorhand observed mud coming out of BOP stack while BHA was being tested.

expected because the rotating head rubber was not installed. At some point during the testing, the same floorhand observed that mud had stopped coming over the rotating head bowl. He communicated his observation to the driller.

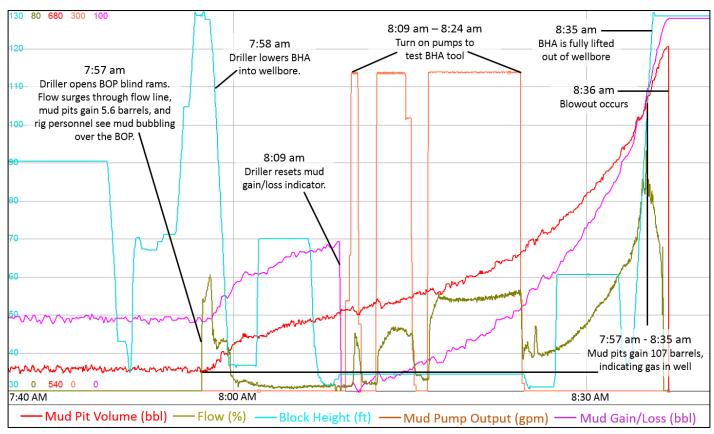
From the time the BOP blind rams were opened at 7:57 am through the completion of BHA testing and removal from well at 8:35 am, the mud pits gained 107 barrels of mud due to gas influx/gas expansion within the well (Figure 29), a

significantly large volume. It is unknown if the driller saw this gain, which would have displayed as a number on a monitor in front of him (Figure 37). No action was taken to shut in the well.

Figure 29. Rig Data between 7:40 am and 8:41 am on Monday January 22, 2018 (day of incident).

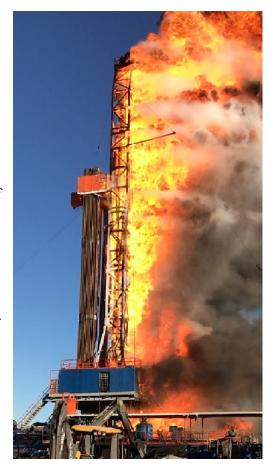
At 8:36 am,^a shortly after the driller communicated that he was going to close the blind rams, mud started spraying out of the well. The floorhand saw the motorhand and the second floorhand open the door to the driller's cabin so they could run into it from the rig floor. The mud continued to spray out of the well and covered the windows of the driller's cabin. The floorhand moved behind the drill pipe rack on the rig floor with the rig manager. Very quickly after the mud started spraying out of the well, the diesel oil-based mud and gas escaping the well caught on fire (Figure 30).^b Between the removal of the BHA from the well at 8:35 am and the blowout at 8:36 am, the mud pits gained an additional 12 barrels of mud, totaling to a 119-barrel gain since the blind rams had been opened at 7:57 am.

Figure 30. Video still of the blowout and fire taken shortly after it started.

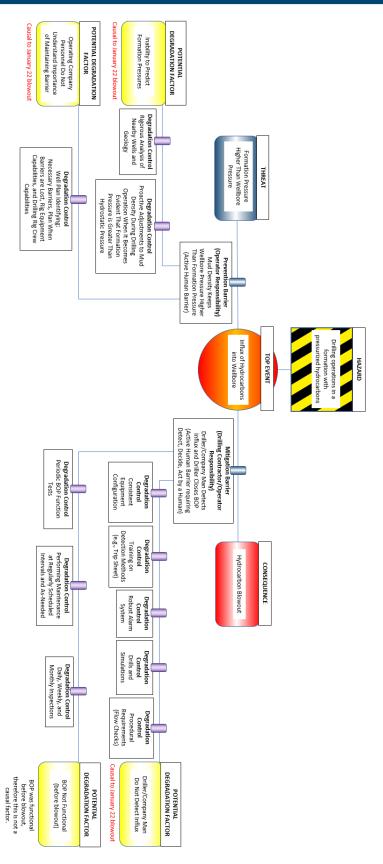
The CSB created a bowtie diagram (Figure 34) to illustrate the two planned barriers to prevent a blowout. Both barriers had associated degradation factors that could, and ultimately did, reduce the reliability and availability of the barriers.

Figure 34. Bowtie diagram of Pryor Trust Well 1H-9 barriers

Like any barrier, the mud barrier was subject to failure. Figure 34 shows two main degradation factors that contributed to the failure of the mud from preventing a gas influx, and no sufficient degradation controls were in place to prevent those degradation factors from leading to failure of the barrier.

Shown in Figure 34, a number of "degradation controls" could have been in place to reduce the likelihood that rig workers would miss the signs of gas influx. These controls include:

Shown in Figure 34, drills are an important control to increase the likelihood that the driller will detect a gas influx. Without drills, the degradation factor that "driller does not detect influx" is a greater risk, increasing the likelihood of failure of the secondary "Driller Detects Influx and Closes BOP" barrier.

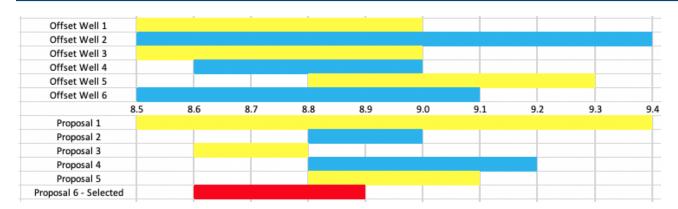
A common method for mud program evaluation in a region where other wells have already been drilled is to review what earlier wells have used. RMO evaluated at least six offset wells in Pittsburg County targeting the Woodford formation in its planning phase for Pryor Trust well 2H-16, the well drilled before 1H-9 (incident well). The offset wells used the following mud weights (densities) during the drilling operations (Figure 35):

RMO received six different proposals from mud companies for the mud program for Pryor Trust well 2H-16, which were based on the following mud weights for the "production zone" (2,340 ft - 15,929 ft)—the portion of the well where gas was anticipated (Figure 35):

- 1. 8.5-9.4 ppg
- 2. 8.8-9.0 ppg
- 3. 8.6-8.8 ppg
- 4. 8.8-9.2 ppg
- 5. 8.8-9.1 ppg
- 6. 8.6 8.9 ppg (Program selected by RMO)

Figure 35. Comparison of the offset well mud weights, and the proposed mud weights provided in the various mud program proposals for the 2H-16 well.

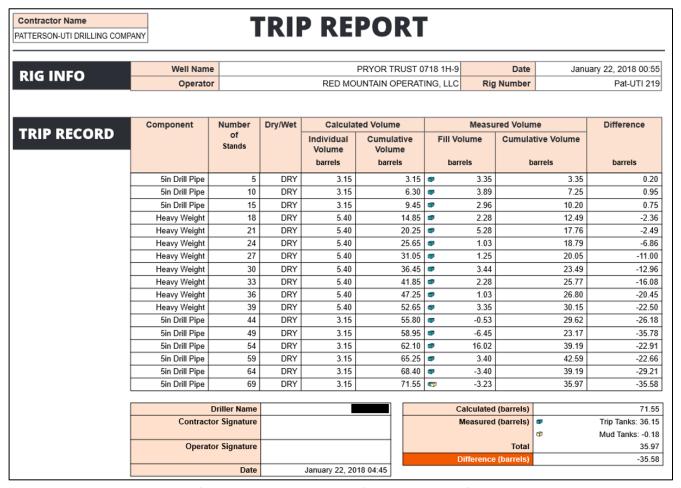
The electronic trip report for the tripping operation out of the lateral portion of the well on January 21, 2018 is shown in Figure 36. The trip sheet auto-populated the "Number of Stands" column as 5 stands for normal drill pipe and 3 stands for heavy weight drill pipe. The driller, however, chose to monitor the well at intervals of drill pipe stands different from these values, but he did not know how to change the default number of stands on the electronic trip sheet. As a result, the values on the electronic trip sheet—"Number of Stands," "Calculated Volume" values ("Individual Volume" and "Cumulative Volume"), and "Difference" columns—were not reflective of the actual operation. Instead, the driller attempted to track the differences between the sheet and the actual condition by making a mental note of the number of stands pulled, and he assessed the "Fill Volume" only in comparison to what he recalled the calculated volume would be for each set of stands pulled.

Figure 36. Electronic trip report for tripping operation out of lateral portion of well on January 21, 2018. The date and time shown on the trip sheet are in UTC time. This trip sheet was started at 6:55 pm local time on January 21 and was closed out at 10:45 pm local time on January 21.

Using this method, the driller assessed whether the well was taking proper fill on very narrow intervals, evaluating fill for each individual set of stands pulled without monitoring the cumulative "Difference" column. If at one set of stands the well did not look like it took proper fill, he would resume to the next set of stands to monitor fill. If that next set

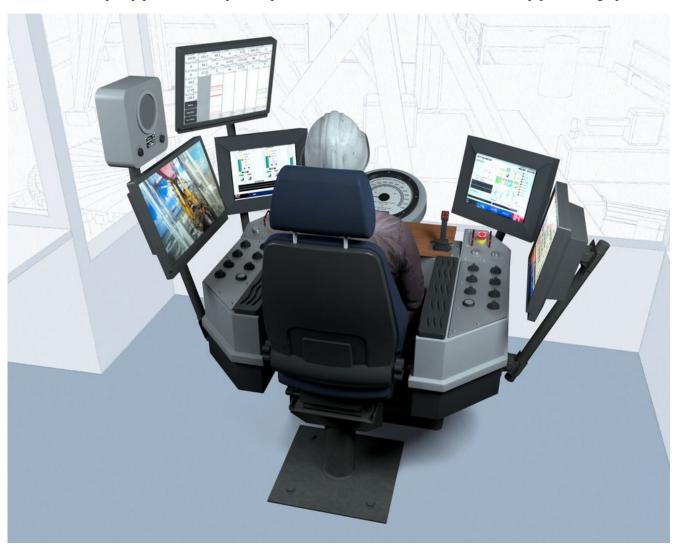
The driller's cabin was equipped with several monitors displaying data and camera footage essential to the drilling operation. A re-creation of the setup is shown in Figure 37. The top screen to the left of the driller displayed an aggregate of the drilling data, including drill bit depth, weight on bit, torque, stroke count, mud pit volumes, trip tank volume, gain/loss, mud return flow, and other parameters. The other monitors in front of the driller displayed data for the drawworks, pump parameters, top drive parameters, and camera feed to watch drill pipe latching operations.

Figure 37. Depiction of driller console on Rig 219. The upper screen to the left of the driller displayed the aggregate of the drilling data.

On the drilling data monitor (upper left monitor), the driller could adjust alarm set points, silence individual alarms, silence all alarms for all parameters by turning the alarm horn off, or completely deactivating the alarm system so that both the horn and visual indications of alarms would be disabled. The data system installed was provided by Pason,

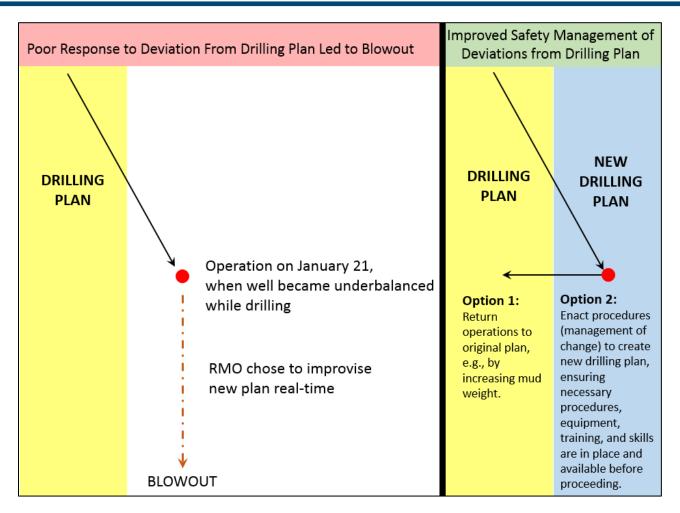
In operations with a healthy safety management system, when deviations from the original drilling plan occur, one of two options should be enacted, as shown in Figure 39. One option is to adjust parameters to return to the original drilling plan, which in this case would have required increasing the mud weight to return to overbalanced drilling. The second option is to stop operations and create a new drilling plan—using a management of change process—ensuring that necessary procedures, equipment, training, and skills are available so that the new plan can be performed safely before proceeding.

Figure 39. Depiction of RMO's and its representatives' response to deviation from drilling plan (left), and improved safety management of deviations from drilling plan (right)

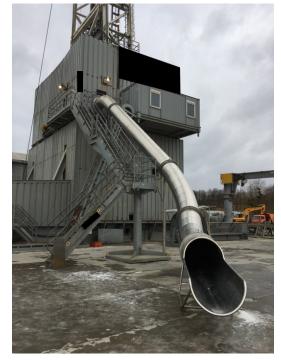
The design and location of the driller's cabin on Rig 219 appears to be typical across the industry. Drilling rig design changes are needed to help protect workers on the rig floor and in the driller's cabin from blowout and fire hazards, and to allow quick escape from the rig. Had the fire rating of the driller's cabin been ensured for a minimum time (e.g., 10 minutes), with emergency escape options from the driller's cabin floor (e.g., an escape hatch) or from the back wall, there could have been a better chance for the workers in the driller's cabin to survive this incident. As an example of a quick evacuation design, the CSB was informed that escape slides are required in Ukraine for the safety of drilling rig workers (Figure 47). This and other escape options would need to be evaluated by the U.S. drilling industry.

Figure 47. Example design strategy to provide quick egress from drilling rig during a blowout.

API should develop guidance on drilling rig floor and drilling cabin design to increase crew member survival during a blowout. Needed design guidance should:

- (a) Protect drilling cabin occupants from blowout hazards including heat, blast overpressure, and projectiles; and
- (b) Establish the minimum required evacuation methods from the drilling cabin, rig floor, and mast in the event of a blowout so personnel can quickly escape in variable hazard location conditions.

The drilling industry should also consider alternative design methods, such as locating the driller's cabin at a safe distance from the well, for example at ground level. Such a design could incorporate the use of cameras to allow the driller to view and direct rig floor activities, keeping workers in the driller's cabin out of range of fire and explosion hazards. [Recommendation 2018-01-I-OK-R5]

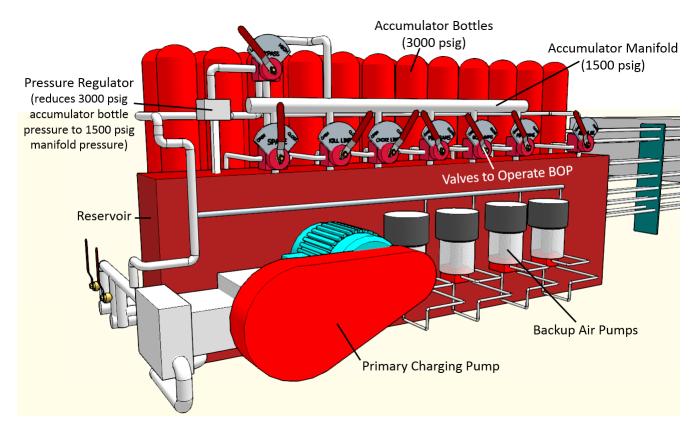
Blowout preventers are hydraulically operated equipment, using high-pressure hydraulic fluid stored in an accumulator.^a A depiction of the Rig 219 accumulator is shown in Figure 48.^b Hydraulic fluid at 3,000 psig is stored in the accumulator bottles. That pressure is reduced to 1,500 psig through a pressure regulator for the manifold. Hydraulic fluid in the accumulator manifold is used to function the blowout preventer.

Discussed in Appendix A, post-incident testing found that the charging pump activated at an accumulator pressure of about 2,000 - 2,100 psig and automatically switched off when the accumulator pressure reached 2,800 psig. Based upon information from Patterson rig crew members that the accumulator pressurized normally to 3,000 psig pre-incident, this change to the accumulator pump set points may have been a result of the fire and post-incident activities.

Figure 48. Depiction of the Patterson Rig 219 accumulator. The top valve on the accumulator is the Bypass valve. From left to right, the bottom valves are Spare, Kill Line, Choke Line, Bottom Pipe Rams, Blind Rams, Top Pipe Rams, and Annular Preventer.

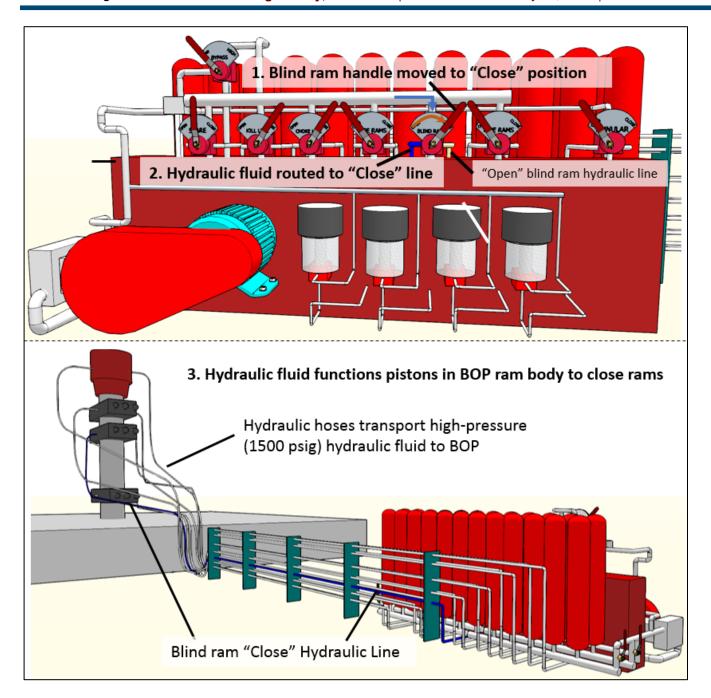
Figure 49 illustrates how the accumulator is used to function the blowout preventer. When a person moves an accumulator handle to its "close" position for, for example, the blind rams, 1500 psig hydraulic fluid from the accumulator manifold is routed to the blind ram "close" hydraulic line, which then moves two pistons inside the ram body to close the rams. The pressurized hydraulic fluid that was in the "open" piston chambers and hydraulic line drains into the accumulator reservoir. When a person then moves the handle to the "open" position, high-pressure hydraulic fluid is routed to the blind ram "open" hydraulic line, which then moves the pistons in the ram body in the opposite direction to then open the rams. The pressurized hydraulic fluid that was in the "close" piston chambers and hydraulic line drains into the accumulator reservoir.

Figure 49. Illustration of how hydraulic fluid in the accumulator functions the blowout preventer blind rams when the blind rams valve is moved to the "close" position. The portion of the hydraulic lines in the support racks is hard piping, and the portion of the hydraulic lines between the support rack and the blowout preventer is flexible hose.

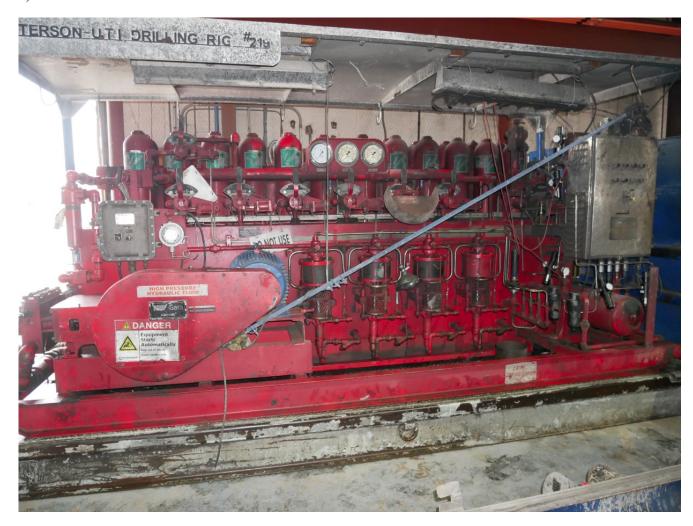
The accumulator was manufactured by NOV SARA INDIA (P), LTD. It was manufactured in 2008 (Figure A1).

Figure A- 1. Photo of Patterson Rig 219 accumulator

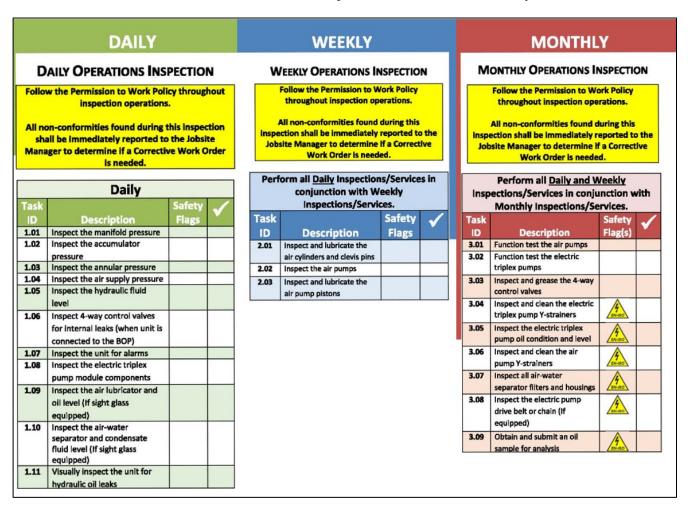
• The Patterson Rig 219 motorhand performed daily, weekly, and monthly inspections on the accumulator. The Patterson inspection requirements are shown below (Figure A- 3). The motorhand on the night tour performed more than one daily inspection of the accumulator during his shift before the incident, and the accumulator was functioning properly. The last monthly check performed on the accumulator was between December 24-26, 2017, less than a month before the incident. The inspection was marked "satisfactory."

Figure A- 3. Patterson accumulator inspection requirements

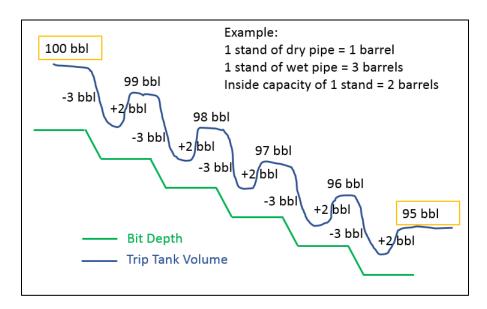
• Figure C- 1 illustrates how a trip tank volume could behave when tripping wet pipe, when the drill pipe contents drain back into the trip tank as shown in Figure C- 2.

Figure C- 1. Example trip tank fluctuation pattern when tripping wet pipe when mud bucket drains to trip tank.

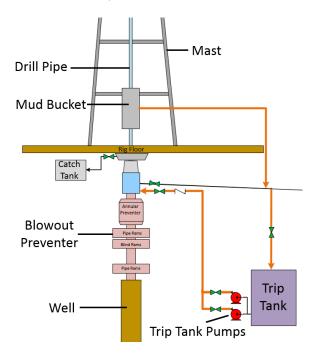
Figure C- 2. Example equipment alignment that could cause the trip tank volume fluctuations shown in Figure C- 1.

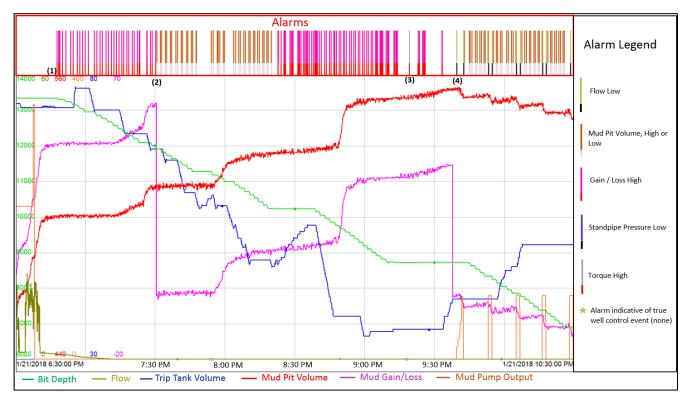
Figure E- 1 depicts what alarms would have been active during this period. Each line on the top of Figure E- 1 does not indicate a separate alarm; instead, each alarm line is simply a recorded data point above the alarm set point in the data provided to the CSB. The figure is to be interpreted that when those lines for that parameter are visible, that alarm would have been active as a continuous beeping. Had the alarm system been on during the tripping operation out of the lateral part of the well on January 21, between 6:45 pm and 10:30 pm, alarms would have activated for Gain Loss High, Total Mud, Flow Low, Standpipe Pressure Low, and Torque (Figure E- 1). While these alarms and set points would have been important during a drilling operation, none were not applicable to the tripping operation in alerting to a well control event. More information about the specific alarms is in Table E- 1.

Figure E- 1. Information from alarm system data, indicating what alarms would have activated between 6:45 pm and 10:30 pm during the trip out of the lateral section, had the alarm system been turned on. Information about the specific alarms is in Table E- 1 below. The numbers in parentheses correspond with the note numbers in Table E- 1.

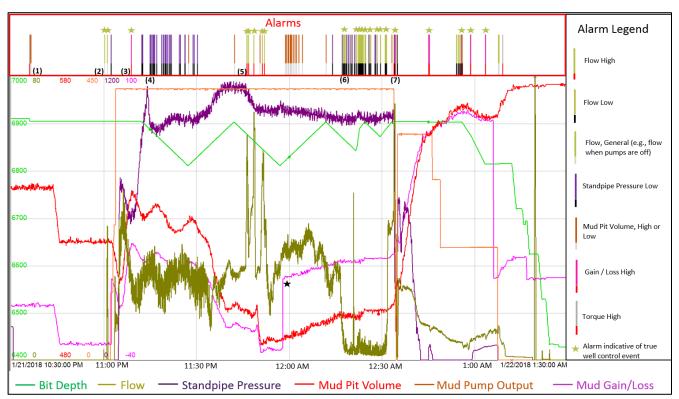
Figure E- 2 depicts what alarms would have been active during this period. Each line on the top of Figure E- 2 does not indicate a separate alarm; instead, each alarm line is simply a recorded data point above the alarm set point in the data provided to the CSB. The figure is to be interpreted that when those lines for that parameter are visible, that alarm would have been active as a continuous beeping.

Figure E- 2. Information from alarm system data, indicating what alarms would have activated between 10:30 pm and 1:10 am while circulating at the top of the curve, had the alarm system been turned on. Some of these alarms could have alerted to the well control event. Information about the specific alarms is in Table E- 2 below. The numbers in parentheses correspond with the note numbers in Table E- 2.

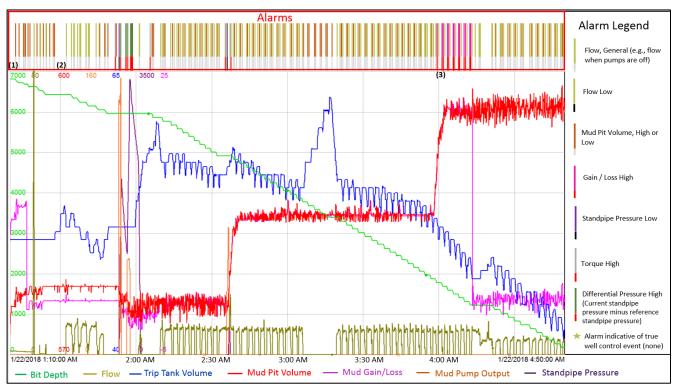
Figure E- 3 depicts what alarms would have been active during this time period. Each line on the top of Figure E- 3 does not indicate a separate alarm; instead, each alarm line is simply a recorded data point above the alarm set point in the data provided to the CSB. The figure is to be interpreted that when those lines for that parameter are visible, that alarm would have been active as a continuous beeping. More information about the alarms is in Table E- 3.

Figure E- 3. Information from alarm system data, indicating what alarms would have activated between 1:10 am and 4:50 am while tripping out of the vertical section of the well, had the alarm system been turned on. None of the alarms would have alerted to the well control event. Information about the specific alarms is in Table E- 3 below. The numbers in parentheses correspond with the note numbers in Table E- 3.

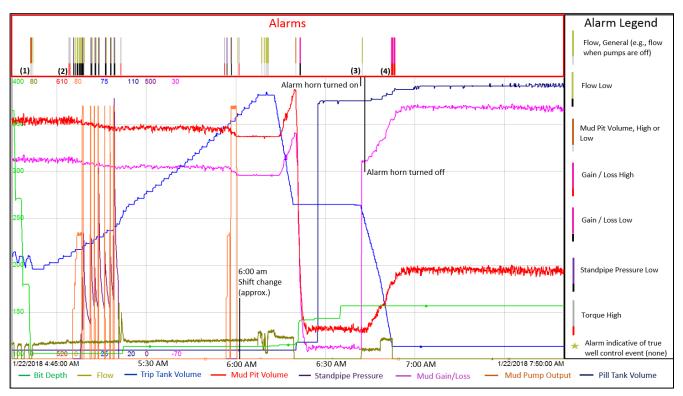
During this period a shift change occurred at around 6:00 am. At 6:42 am, the alarm system was reactivated, likely by the new driller on tour. Non-critical alarms would have been continuously sounding while the alarm system was on. Twenty seconds after the alarm system was turned on, it was turned off again. The alarm horn remained off through the blowout at 8:36 am.

Figure E- 4 visually depicts what alarms would have been active during this period. Each line on the top of Figure E- 4 does not indicate a separate alarm; instead, each alarm line is simply a recorded data point above the alarm set point in the data provided to the CSB. The figure is to be interpreted that when those lines for that parameter are visible, that alarm would have been active as a continuous beeping.

Figure E- 4. Information from alarm system data, indicating what alarms would have activated between 4:50 am and 7:50 am during the rig floor operations, had the alarm system been turned on. None of the alarms would have alerted to the well control event. Information about the specific alarms is in Table E- 4 below. The numbers in parentheses correspond with the note numbers in Table E- 4.

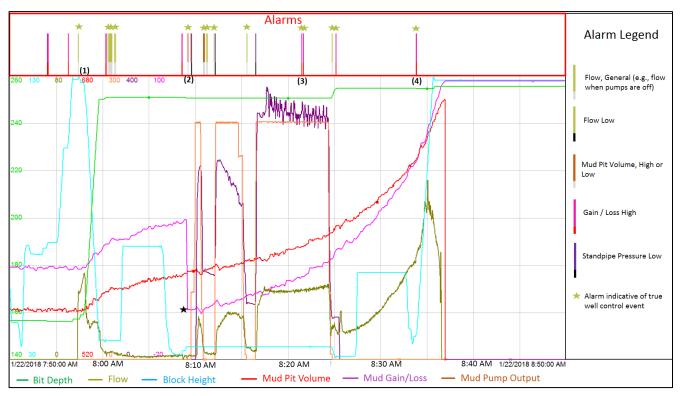
Between 7:50 am and the blowout at 8:36 am, alarms would have activated for Flow, Mud Pit Volume, Standpipe Pressure, Gain/Loss, and Torque. This time, almost all of the alarming would have been indicative of the true well control event.

Figure E- 5 depicts what alarms would have been active during this period. Each line on the top of Figure E- 5 does not indicate a separate alarm; instead, each alarm line is simply a recorded data point above the alarm set point in the data provided to the CSB. The figure is to be interpreted that when those lines for that parameter are visible, that alarm would have been active as a continuous beeping.

Figure E- 5. Information from alarm system data, indicating what alarms would have activated between 7:50 am and 8:36 am (blowout), if the alarm system was on. Almost all of the alarms would have alerted to the well control event. Information about the specific alarms is in Table E- 5 below. The numbers in parentheses correspond with the note numbers in Table E- 5.

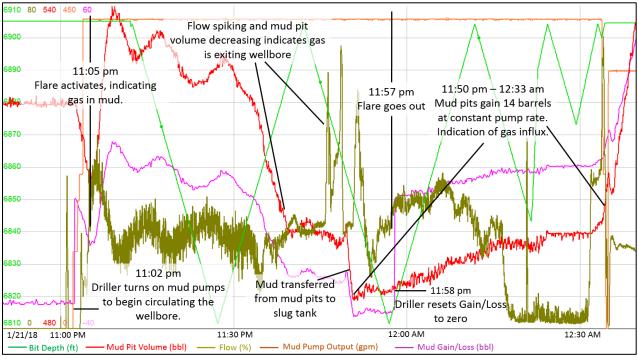
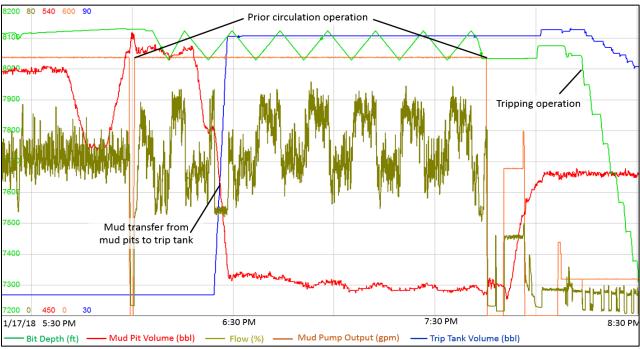
The top graph below shows rig data while circulating the wellbore at the top of the curve. The flare activated while circulating, indicating gas in the mud. Between 11:50 pm and 12:33 am, the mud pits gained 14 barrels while the mud pumps were circulating at a constant pump rate. This pit gain indicates there was a gas influx (kick). For comparison purposes, the bottom graph shows a normal circulation operation performed on January 17, 2018 on Pryor Trust Well 1H-9.
