# ALLIED TERMINALS TANK COLLAPSE - 2008 ACCIDENT INVESTIGATION

# INVESTIGATION REPORT

## ALLIED TERMINALS, INC.— CATASTROPHIC TANK COLLAPSE

(Two Serious Injuries, Community Evacuation)

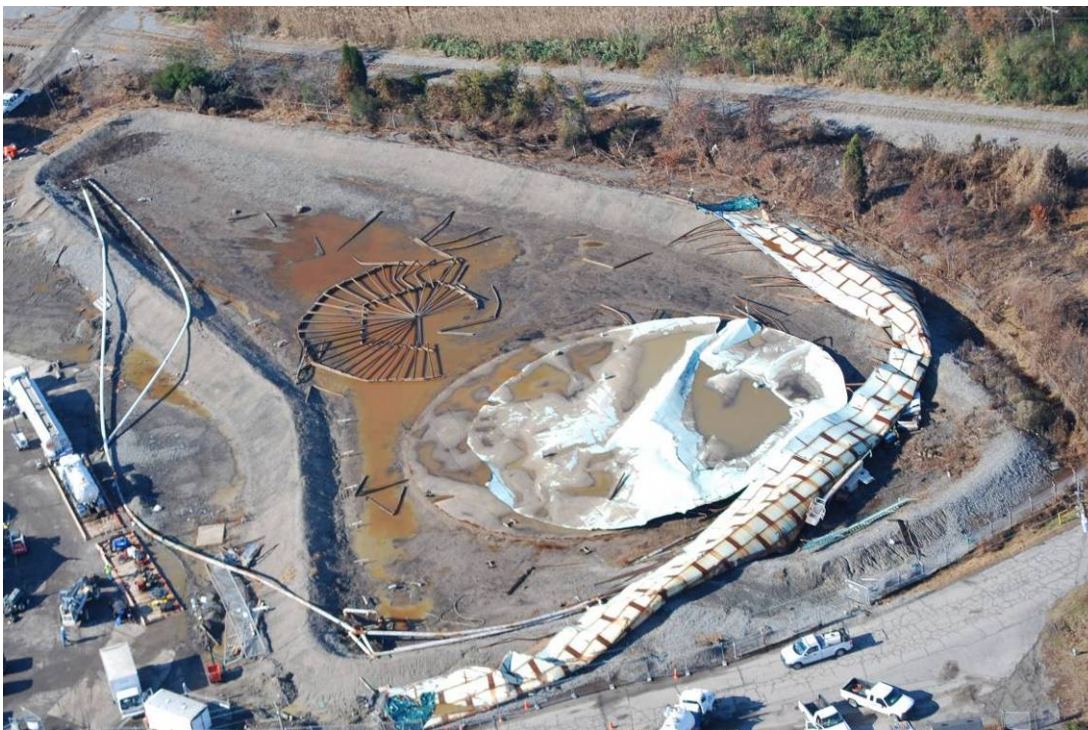
Figure 1. Allied collapsed tank and neighboring business.

At a fill level about 3.5 inches below the calculated maximum liquid level, the tank split apart vertically, beginning at a defective weld located midway up the tank. Within seconds, the liquid fertilizer overtopped the secondary containment, partially flooding the site and adjacent neighborhood. The collapsing tank wall injured the welder and his helper, who were working on the tank. Employees of a neighboring business responded and extricated them. At least 200,000 gallons of the liquid fertilizer were not recovered; some entered the southern branch of the Elizabeth River.

On November 12, 2008, at about 2:20 pm, a 2-million-gallon nominal capacity liquid fertilizer tank catastrophically failed at the Allied Terminals, Inc. (Allied) facility in Chesapeake, Virginia (Figure 1). The tank split open vertically and nearly instantaneously released about 2.1 million gallons of liquid fertilizer. A welder and his helper were working on the opposite side of the tank as it collapsed. Both sustained serious injuries due to the collapsing tank and immersion in the liquid fertilizer. Employees from a neighboring business (shown in upper left of Figure 1) rescued the two workers.

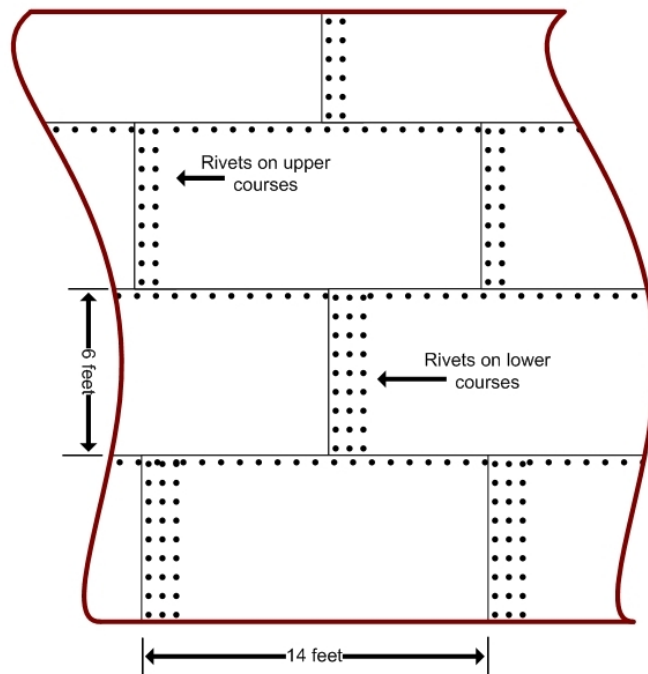
Figure 7. Tank 201 design prior to modification.

Tank 201, originally designed and constructed in 1929 for petroleum product storage, was 116 feet in diameter and about 30 feet high. The shell was constructed of overlapping riveted plates, each approximately 6 feet high and 14 feet long. The plates were joined end to end to form six rings (courses) that were stacked to form the tank. A single row of rivets joined the courses horizontally, while three vertical rivet rows joined the plate ends on the bottom two courses and two rows joined the plate ends on the upper four courses (Figure 7). Overlapping welded plates were used on the bottom and the cone-shaped roof. A second tank bottom was added inside the tank prior to Allied's purchase of the facility.

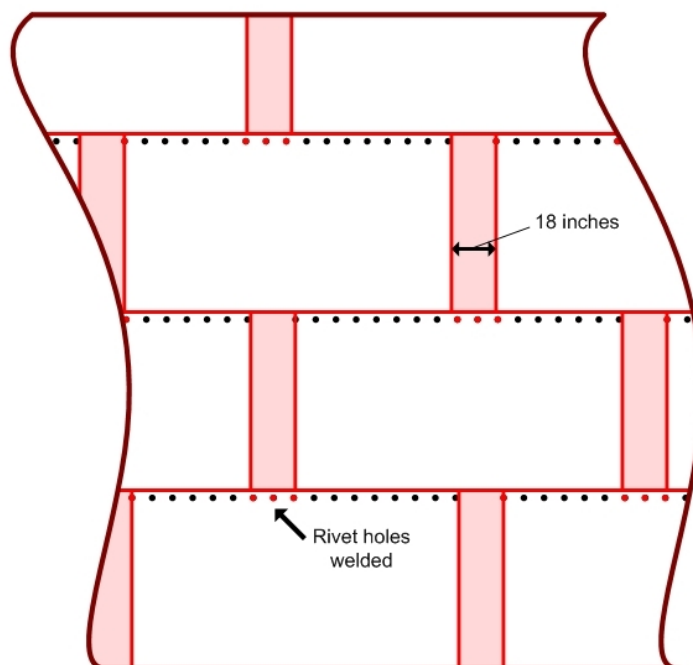
Figure 8. Tank 201 modification design.

The liquid fertilizer stored in Tank 201 weighed more per unit volume (density) than the petroleum products for which the tank was designed (about 11 pounds per gallon for the UAN 32 solution compared to 6 pounds per gallon for petroleum products). To increase the usable capacity of the tank, Allied contracted G&T to remove 18-inch wide sections of the shell plates containing the vertical riveted joints and replace them with butt-welded plates,<sup>14</sup> following the requirements of API 653 (Figure 8). Allied intended this modification to strengthen the joints and permit a higher maximum liquid level, and contracted G&T to perform the same modification on three similar tanks: Tanks 202, 205, and 209.

Following the modifications, Allied paid a non-destructive testing company to examine the welds for defects using spot radiography.<sup>15</sup> However, Allied paid for the examination of only the lower two courses of Tanks 202 and 209. The upper courses of Tanks 202 and 209 and the entirety of Tanks 201 and 205 were not radiographed prior to returning these tanks to service. The radiography performed identified multiple weld defects in the lower courses of both 202 and 209.<sup>16</sup>
