U.S. CHEMICAL SAFETY AND HAZARD INVESTIGATION BOARD

INVESTIGATION REPORT

CATASTROPHIC VESSEL OVERPRESSURIZATION (4 DEATHS)

Sonat Exploration Company
Temple 22-1 Common Point Separation Facility
Pitkin, Louisiana
March 4, 1998

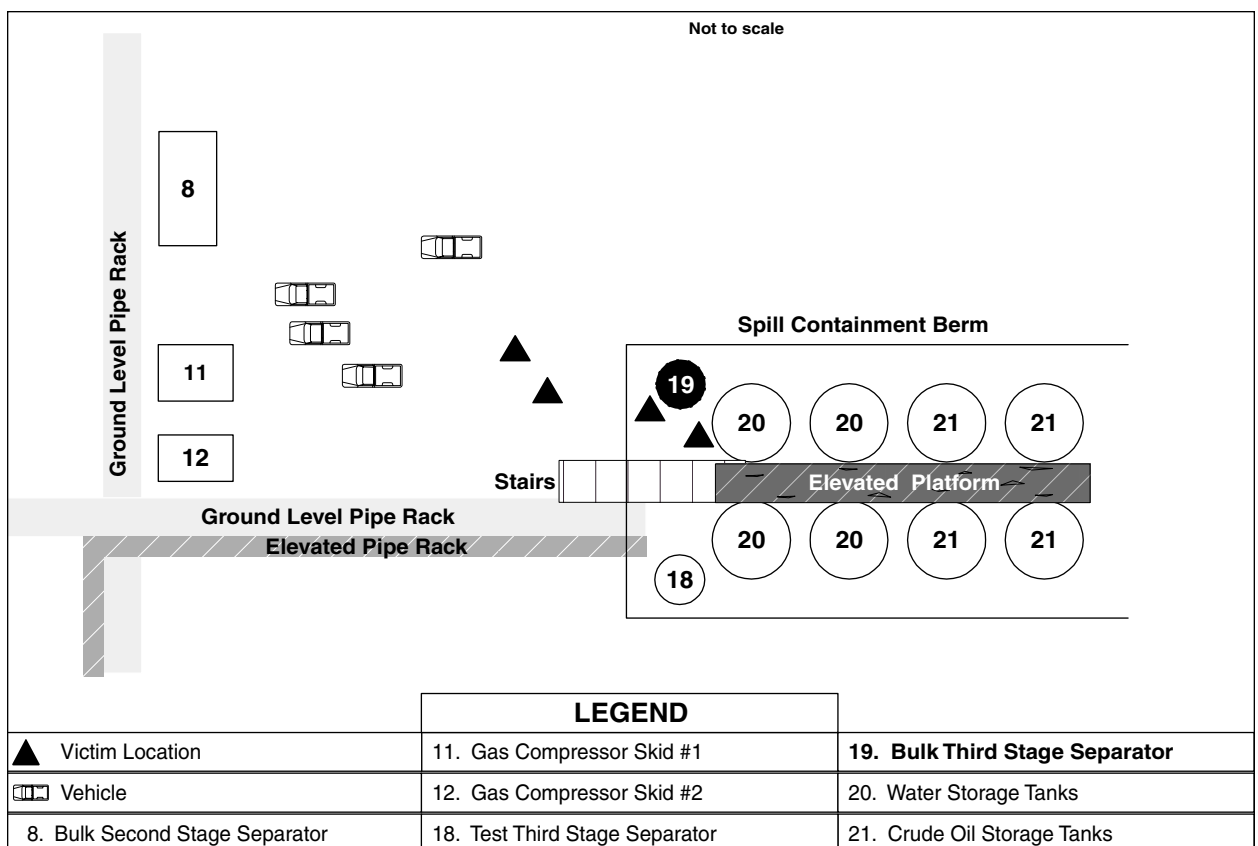
Figure 6. Locations of the Four Victims Found after the Incident

All four operators who were near the separator at the time of the failure were killed at once; in each case the cause of death was severe blast injuries. Figure 6 shows the approximate locations of the four victims, as found after the incident. The operator stationed near the header, about 190 feet from the separator, was thrown about five feet by the blast, and the construction supervisor was severely jolted as he exited his truck over 300 feet away at the pipeline valve. Both survived without serious injury.
