BIOCHEMICAL EXPLOSION- 2003 ACCIDENT INVESTIGATION

U.S. CHEMICAL SAFETY AND HAZARD INVESTIGATION BOARD

EXPLOSION AT BIOCHEMICAL FACILITY: LIQUID NITRIC OXIDE RELEASE

No. 2003-15-C-OH
August 2004

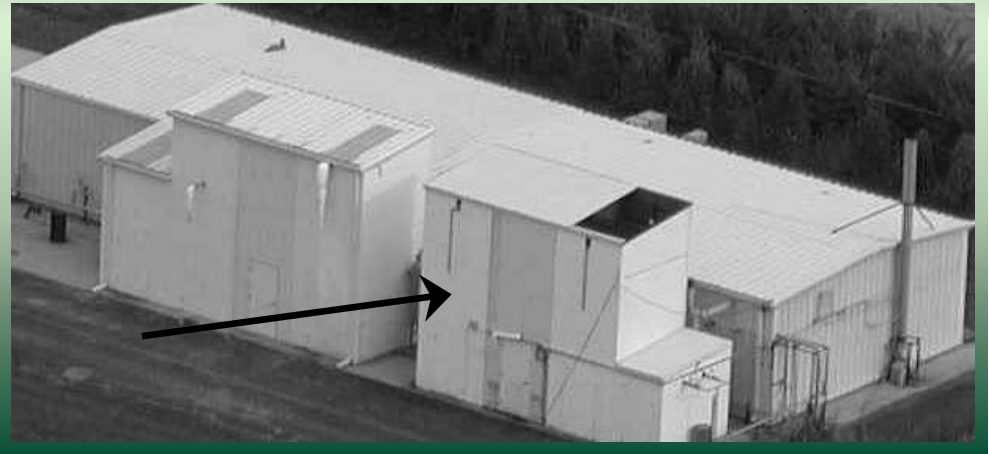
Figure 8

- ◆ The portion of the column installed in the well casing below ground to accommodate its extreme length provided a high level “shielding.”
- ◆ The exterior blast shield structure (Figure 8)—installed in response to similar LANL upgrades—was intended to protect employees and equipment in the unlikely event of an NO detonation in the aboveground equipment.

Blast shield around N6 distillation column, similar to N3 blast shield

A more effective blast shield structure would have included a labyrinth opening (Figure 9) and a steel wire mesh top similar to the LANL blast structure. This configuration would be much less likely to catastrophically fail.
