BS5837 2012 Tree Information Oakfield, Llantarnam – Proposed Footpath/Cycleway Construction

Torfaen County Borough Council
Llantarnum Playing Fields and Industrial
Park.

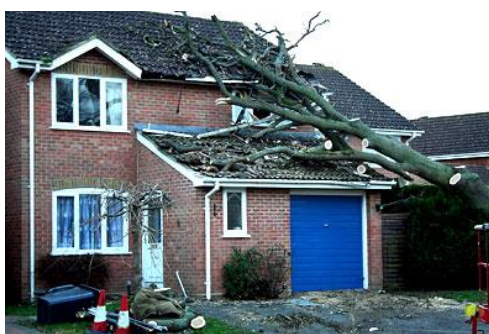
If adequate protection is not given the disaster below is not far behind!

The only way to avoid needless destruction is to give them the space they require and provide adequate protection from the construction process.
