Bayview Condominium Association, Inc.
2025 Annual Budget Report

Bayview Condominium Association

Millbrae, CA

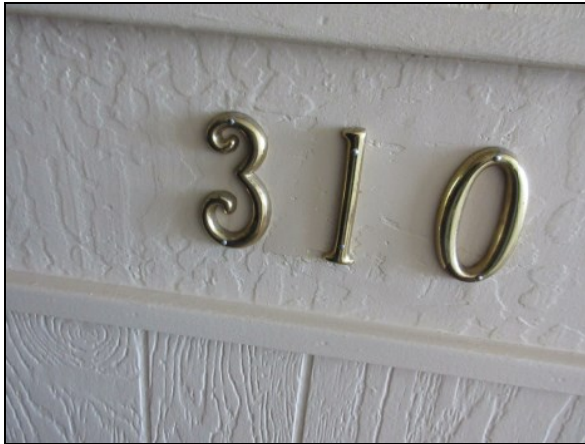
Comp #: 710 Address Signs - Replace

Comments: Address numbers remain intact and remain securely attached to the interior walls. No missing numbers noted. Fair condition overall. Replacement timing at the discretion of the Board.

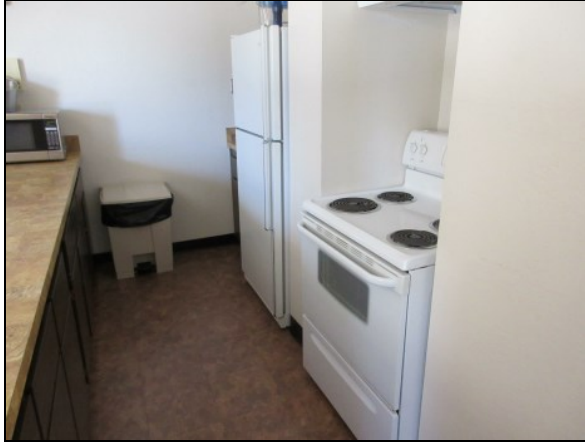
Comp #: 901 Appliances - Replace (Rec Room)

Comments: Informed appliances receive minimal overall usage. There is no expectation for the replacement of all appliances at one time. Individual replacement cost is too small for Reserve designation. Handle replacement as needed out of the Operating budget.

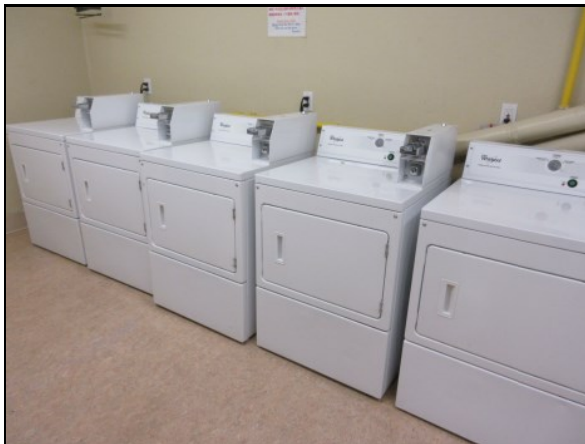
Comp #: 901 Washers/Dryers - Replace (Frontera)

Comments: Washers and dryers appear intact and functional. Funding for replacement of the washer and dryer units at the interval below.

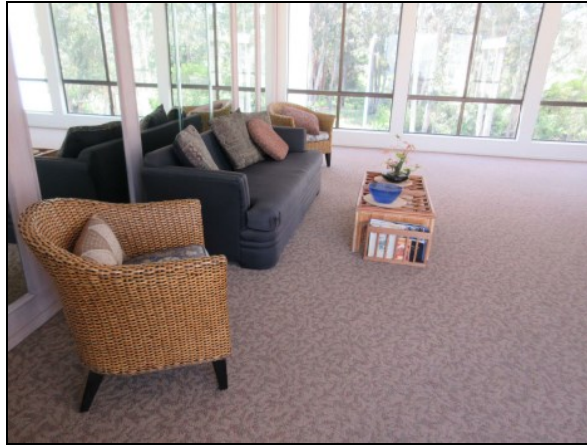
Comp #: 903 Furniture - Replace (Corridors)**Quantity: (24) Assorted Pieces**

Comments: Furniture varied in style and age. No abnormal wear or significant damage. Replacement timing is largely dependent on the Association's desired aesthetics. At this time, the corridor furniture is assumed to be a lower priority. Funding for partial replacement as needed.

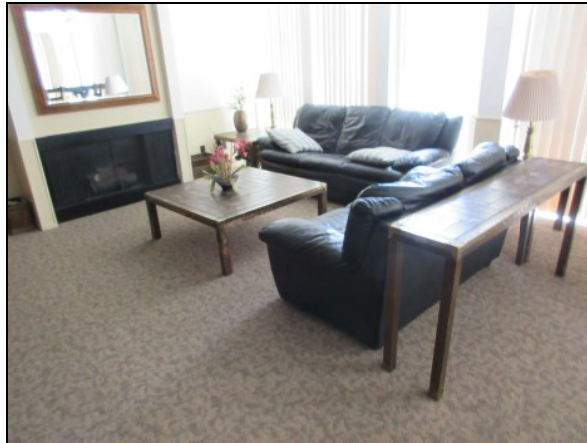
Comp #: 903 Furniture - Replace (Rec Room)**Quantity: (32) Assorted Pieces**

Comments: The furniture appearance is dated but functional. Informed the recreation room furniture receives minimal overall use and is mostly used during meetings. Replacement timing is largely dependent on the Association's desired aesthetics. At this time, the recreation room furniture is assumed to be a lower priority.

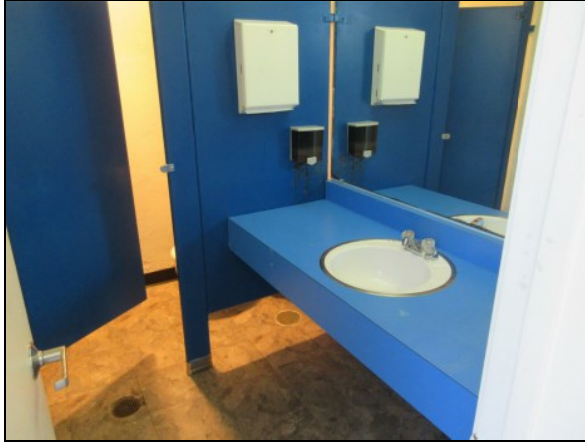
Comments: Bathrooms are functional with no significant issues noted. Minor cracking on the tile floor and general wear noted. This component provides an allowance for general refurbishment at the interval indicated below.

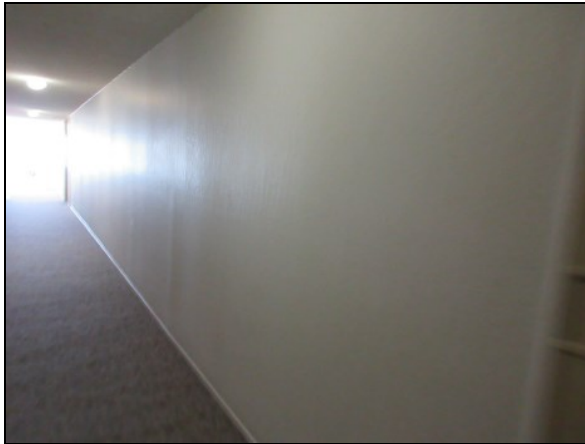
Comments: Paint in fair condition overall. We recommend painting the interior surfaces every 10-12 years to maintain an attractive appearance. If possible, cycle complete interior surface painting with future carpet replacement project.

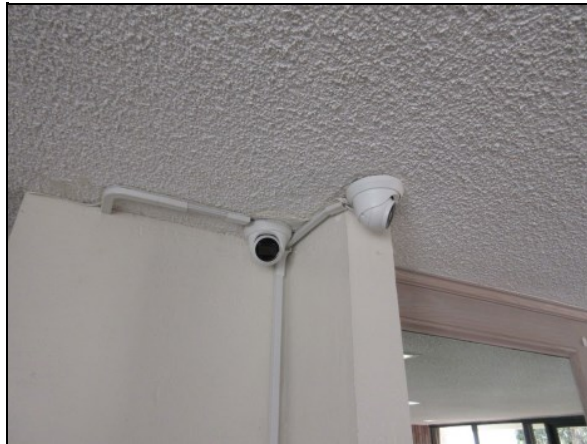
Comp #: 305 Security System - Replace**Quantity: (1) System, (17) Cameras**

Comments: (1) DVR system and (17) cameras. Functional with no significant issues reported. Plan to replace/upgrade the security system at the interval below. Typical modernization projects may include the addition and/or replacement of camera fixtures, recording equipment, monitors, software, etc. In many cases, replacement or modernization is warranted due to advancement in technology, not a functional failure of the existing system.

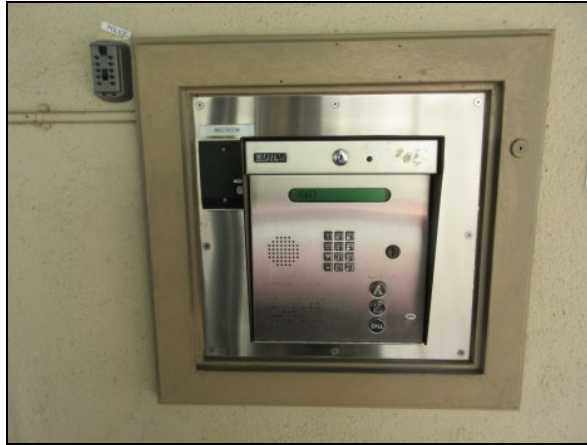
Comp #: 703 Entry Access System - Replace**Quantity: (2) DKS Systems**

Comments: No problems or issues reported. Clean and wipe down regularly with an appropriate cleaner. Handle any minor repairs as needed out of the Operating budget. We recommend regular service and maintenance by a licensed professional to help ensure the intercom system continues to function properly.

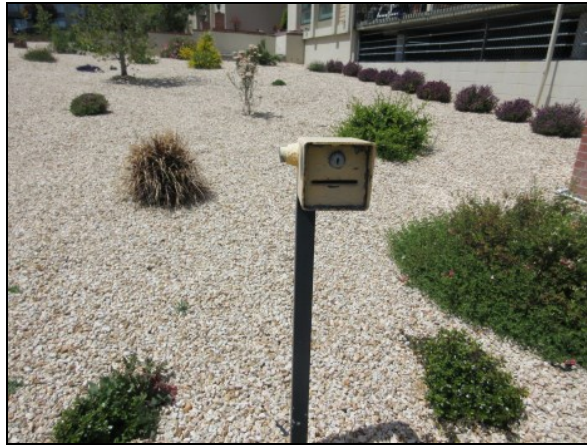
Comp #: 703 Key Card Readers - Replace**Quantity: (2) Readers**

Comments: Key card readers are assumed to be functioning properly. No problems or issues reported during the site visit. The key card reader post at the Vallejo Street garage entry is misaligned. Handle any minor repairs as needed out of the Operating budget.

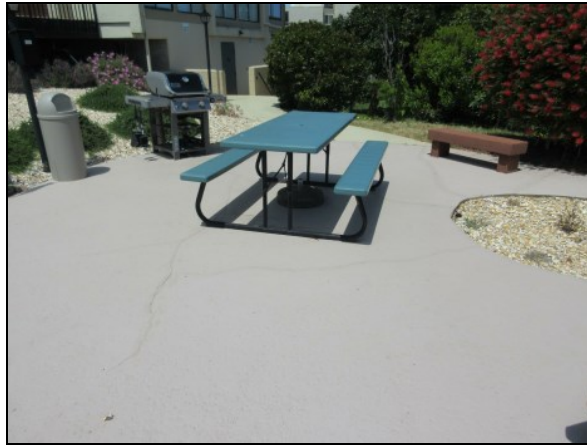
Comp #: 404 Picnic Table - Replace**Quantity: (1) Table**

Comments: The picnic table appears to be functional but has an aged appearance. Surfaces appear faded and worn. Individual replacement cost does not meet the minimum threshold to qualify as a Reserve component. Handle replacement as needed out of the Operating budget. No Reserve funding allocated.

Funded?: No. Handle replacement of this component as needed out of the Operating budget. No Reserve funding allocated.

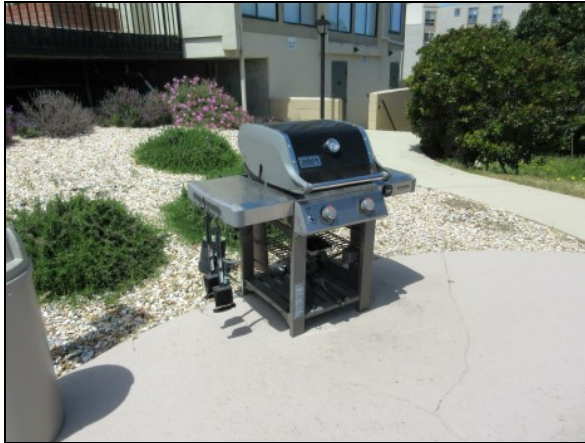
Comp #: 407 Gas BBQs - Replace

Comments: Clean periodically to maintain the functionality of bbq's. Adjust funding as future conditions dictate.

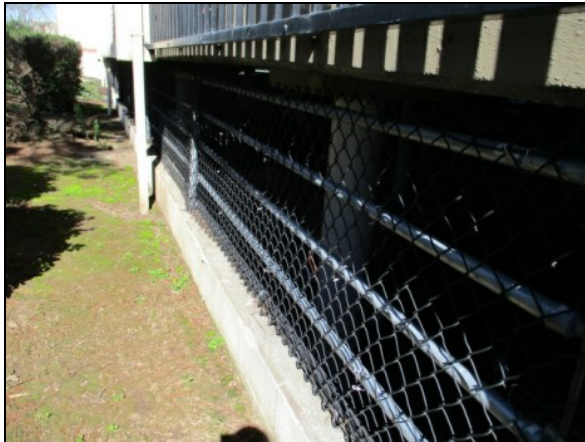
Comp #: 502 Chain Link Fence - Replace

Comments: Chain link fencing appears to be intact and upright. No signs of abuse or significant damage. We anticipate future replacement in the interval outlined below.

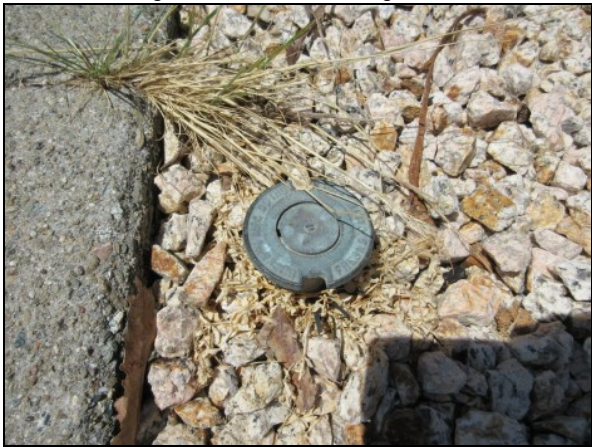
Comp #: 1001 Irrigation System - Replace

Comments: Irrigation system is assumed to be functioning properly. No reported issues or problems during the site visit. At this time, there is no expectation for complete replacement of the irrigation system. Repairs are typically handled as an Operating expense out of the landscape maintenance budget. No Reserve funding allocated.

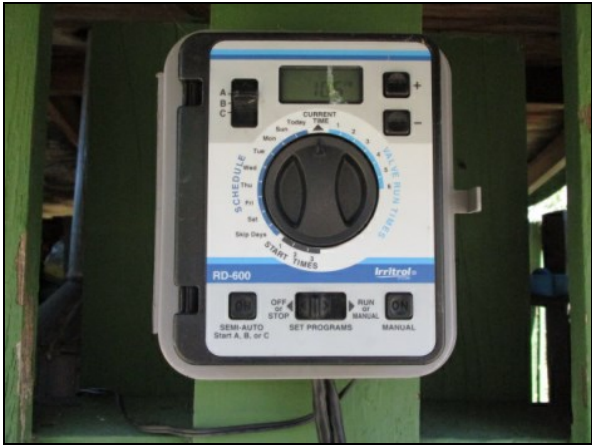
Comp #: 1003 Irrigation Controllers - Replace

Comments: No major issues were reported by the on-site maintenance personnel. Individual replacement of the irrigation controllers is a minimal overall expense. We suggest handling replacement as needed out of the Operating budget. No Reserve funding allocated.

Funded?: No. Individual replacement of this component does not meet the minimum cost threshold to be deemed a Reserve component. No Reserve funding allocated.

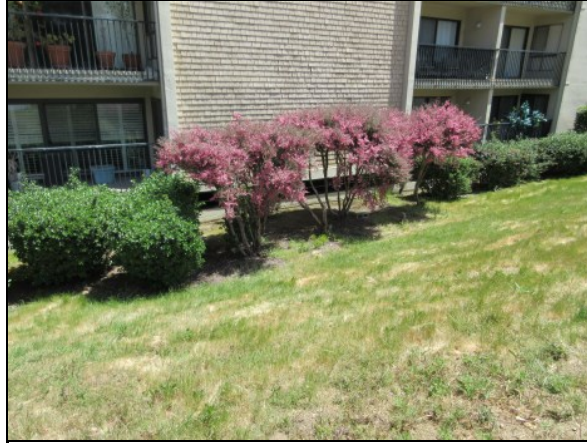
Comp #: 1005 Landscaping - Replace (Partial)**Quantity: Extensive Area**

Comments: Combination of turf, shrubs, plants, and trees. Landscaped areas at the terrace deck area planters provide an attractive appearance. Remaining landscaped areas adjacent to the pool area appear to be dry and aging. Landscaped areas are in fair to aging condition depending on location. This component funds an allowance for periodic landscape replenishment at the interval below. Adjust funding as needed in future years.

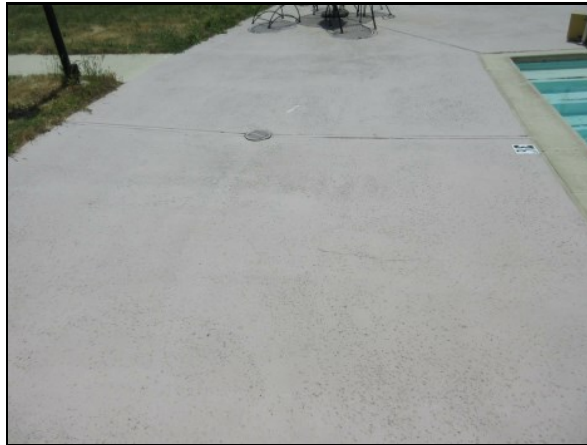
Comp #: 1010 Concrete Terrace Drains - Repair**Quantity: Approx 400 LF**

Comments: Drains appear to be intact and assumed to be functional. Funding for repairs of the concrete terrace deck drains is included with terrace deck seal/repair (comp. #107). No separate Reserve funding necessary at this time.

Funded?: No. Funding for this component is included with terrace deck seal/repair (comp. #107). No separate Reserve funding necessary.

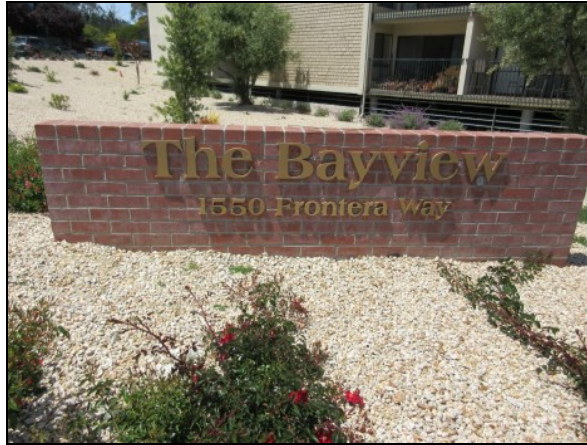
Comments: Monument sign is brick with metal letters. Monument signs provides a clean and attractive entry appearance. No missing letters or signs of vandalism. Clean periodically to maintain overall appearance. This component provides funding for future refurbishment at the interval below.

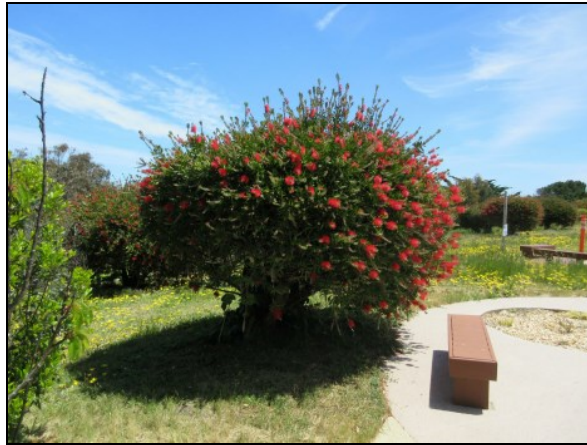
Comments: Trees are various sizes and species. No significant overgrowth observed. Monitor trees to ensure there are no areas of tree obstruction and no contact with buildings. Tree trimming is handled as needed out of the Operating budget. No Reserve funding allocated.
