## Bayview Condominium Association *Millbrae, CA*

Report #: 14259-17  
Beginning: January 1, 2025  
Expires: December 31, 2025

# RESERVE STUDY Update "With-Site-Visit"

November 26, 2024

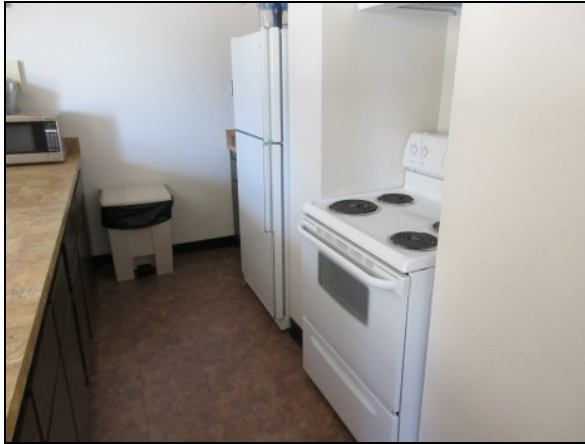
**Comp #: 901 Appliances - Replace (Rec Room)**

Comments: Informed appliances receive minimal overall usage. There is no expectation for the replacement of all appliances at one time. Individual replacement cost is too small for Reserve designation. Handle replacement as needed out of the Operating budget.

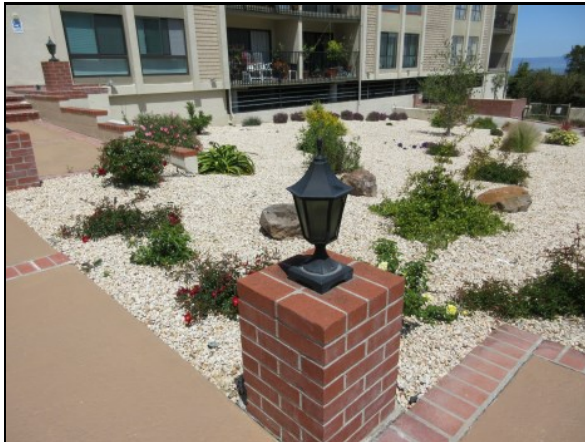
**Comp #: 330 Coach Lights - Replace****Quantity: (6) Fixtures**

Comments: We recommend periodic cleaning and painting to maintain an attractive corrosion-free appearance. This component provides funding for replacement in the interval outlined below.

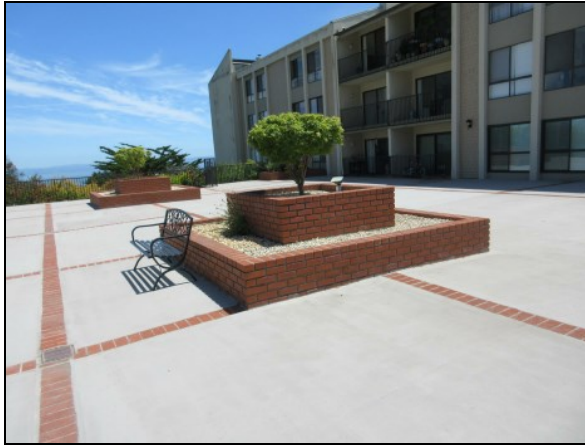
**Comp #: 404 Benches - Replace****Quantity: (5) Benches**

Comments: The benches remain intact and sturdy with no issues noted. Inspect regularly and repair or replace any damaged pieces promptly to ensure safety. We recommend replacing all pieces together in order to maintain a consistent style. Costs can vary greatly based on the type of pieces selected for replacement.

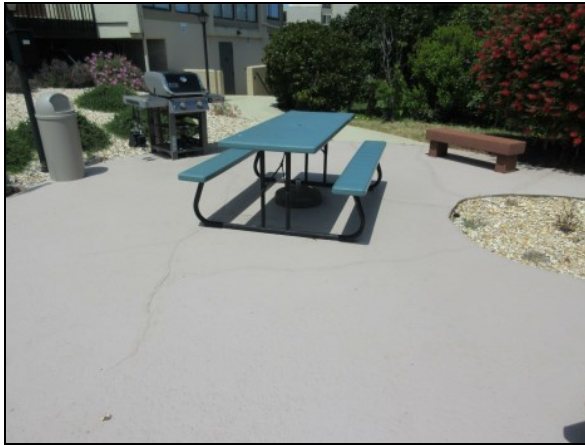
**Comp #: 404 Picnic Table - Replace****Quantity: (1) Table**

Comments: The picnic table appears to be functional but has an aged appearance. Surfaces appear faded and worn. Individual replacement cost does not meet the minimum threshold to qualify as a Reserve component. Handle replacement as needed out of the Operating budget. No Reserve funding allocated.

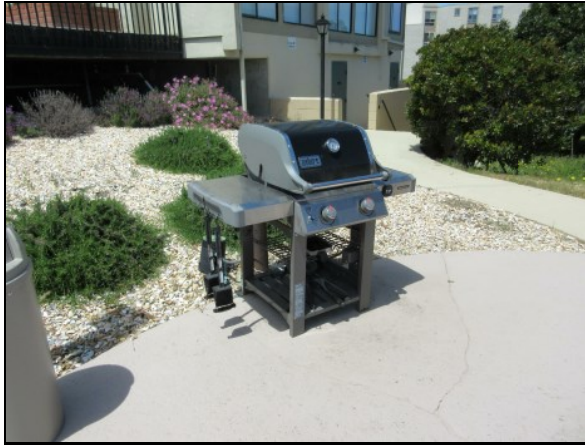
**Comp #: 407 Gas BBQs - Replace**

Comments: Clean periodically to maintain the functionality of bbq's. Adjust funding as future conditions dictate.

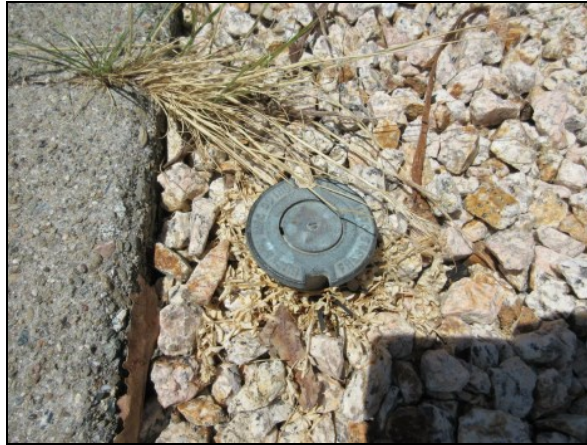
**Comp #: 1001 Irrigation System - Replace**

Comments: Irrigation system is assumed to be functioning properly. No reported issues or problems during the site visit. At this time, there is no expectation for complete replacement of the irrigation system. Repairs are typically handled as an Operating expense out of the landscape maintenance budget. No Reserve funding allocated.

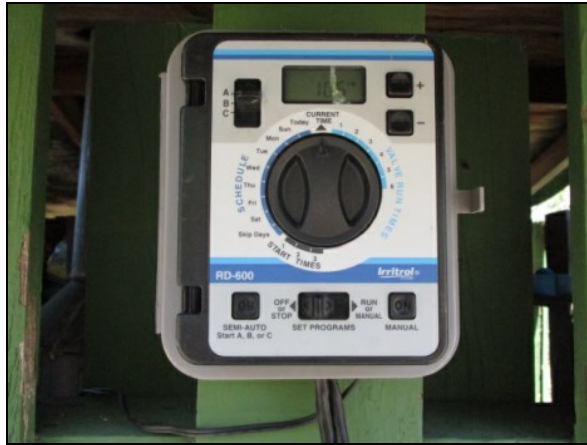
**Comp #: 1003 Irrigation Controllers - Replace**

Comments: No major issues were reported by the on-site maintenance personnel. Individual replacement of the irrigation controllers is a minimal overall expense. We suggest handling replacement as needed out of the Operating budget. No Reserve funding allocated.

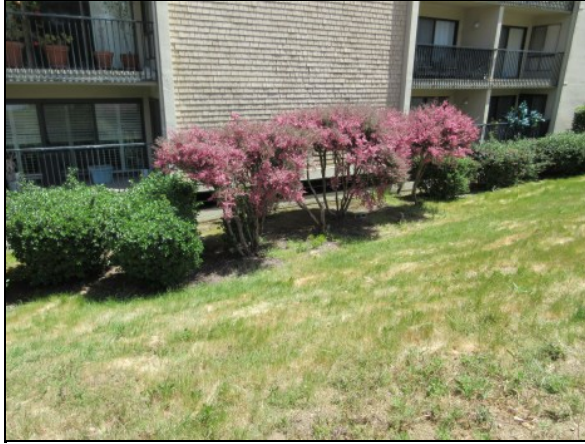
**Comp #: 1005 Landscaping - Replace (Partial)****Quantity: Extensive Area**

Comments: Combination of turf, shrubs, plants, and trees. Landscaped areas at the terrace deck area planters provide an attractive appearance. Remaining landscaped areas adjacent to the pool area appear to be dry and aging. Landscaped areas are in fair to aging condition depending on location. This component funds an allowance for periodic landscape replenishment at the interval below. Adjust funding as needed in future years.

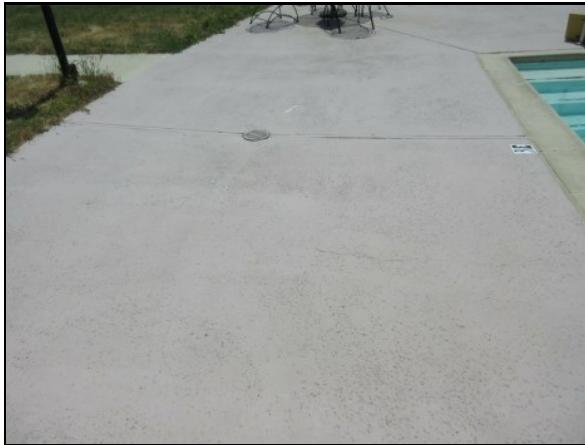
**Comp #: 1010 Concrete Terrace Drains - Repair****Quantity: Approx 400 LF**

Comments: Drains appear to be intact and assumed to be functional. Funding for repairs of the concrete terrace deck drains is included with terrace deck seal/repair (comp. #107). No separate Reserve funding necessary at this time.
