RE: Hazardous Materials Survey Report
Pre-Demolition
Asbestos
Former Fashion Tannery
108 Van Road
Johnstown, NY
Ambient Project Number: 230928AB

HAZARDOUS MATERIALS SURVEY

Pre-Demolition

*Former Fashion Tannery
108 Van Road
Johnstown, NY*

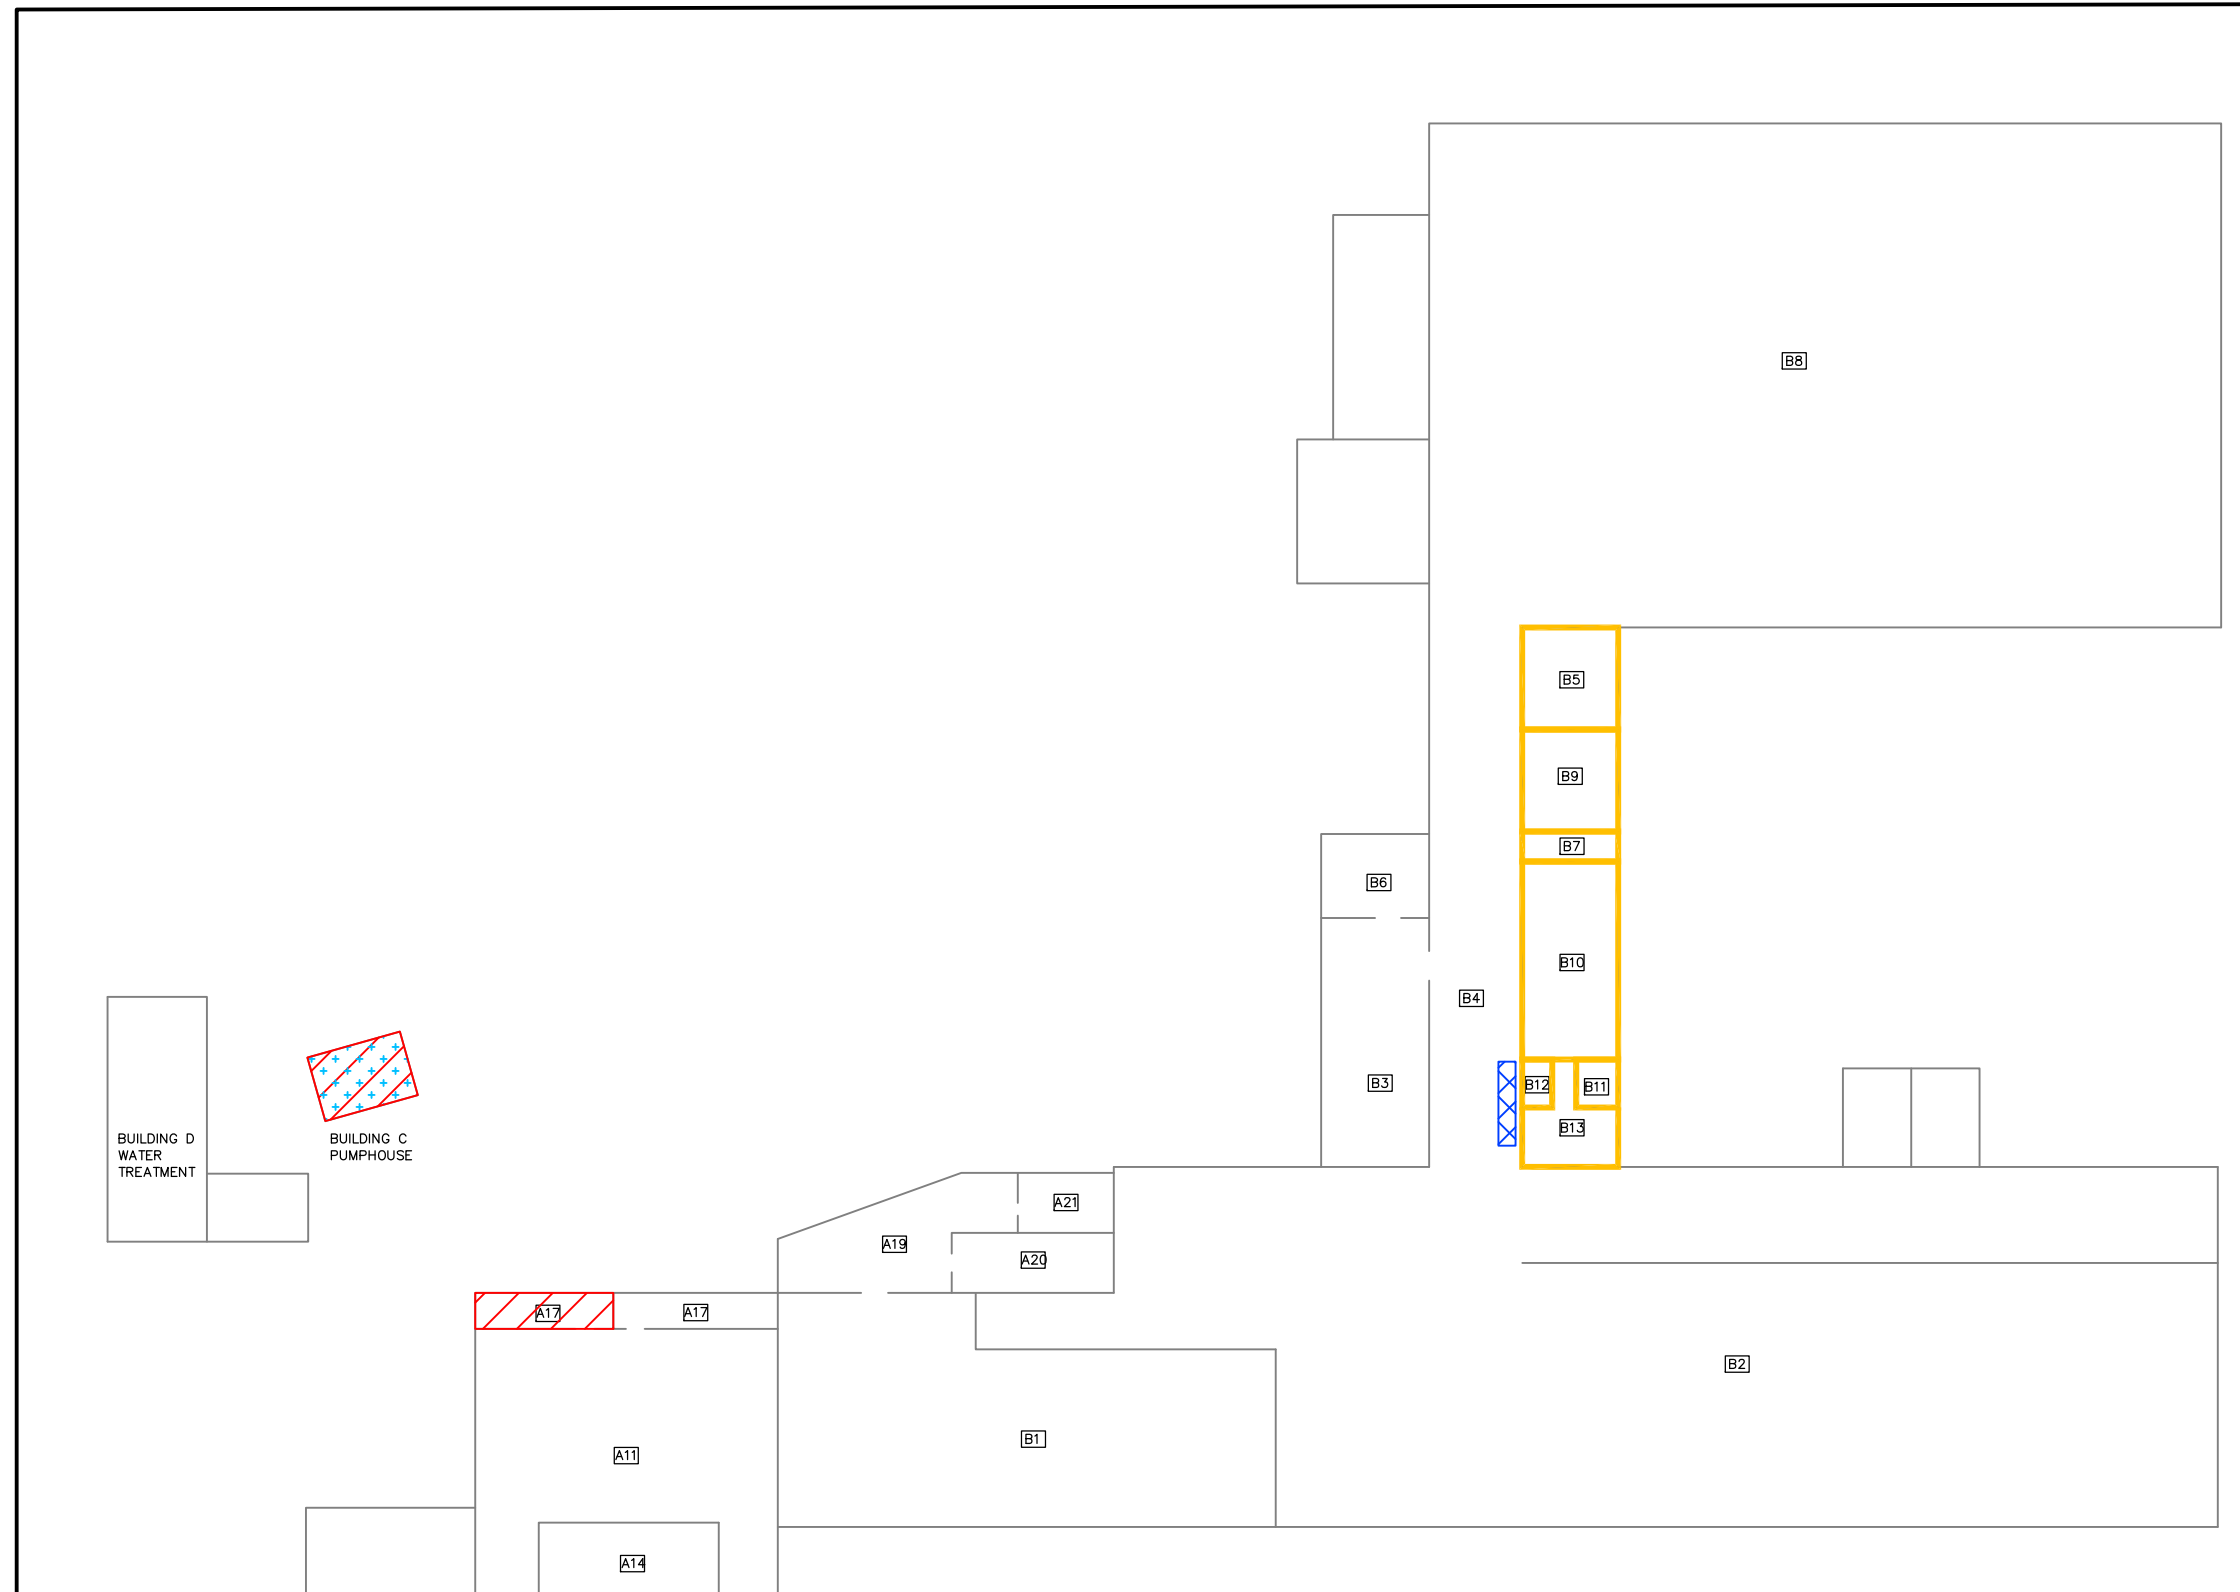
- (006-01) TRANSITE PANELS
- (023-01) WOOD PANELING ADHESIVE
- (028-01) SPRINKLER PIPING FLANGE GASKETS
- (029-01) FOAM INSULATION ADHESIVE

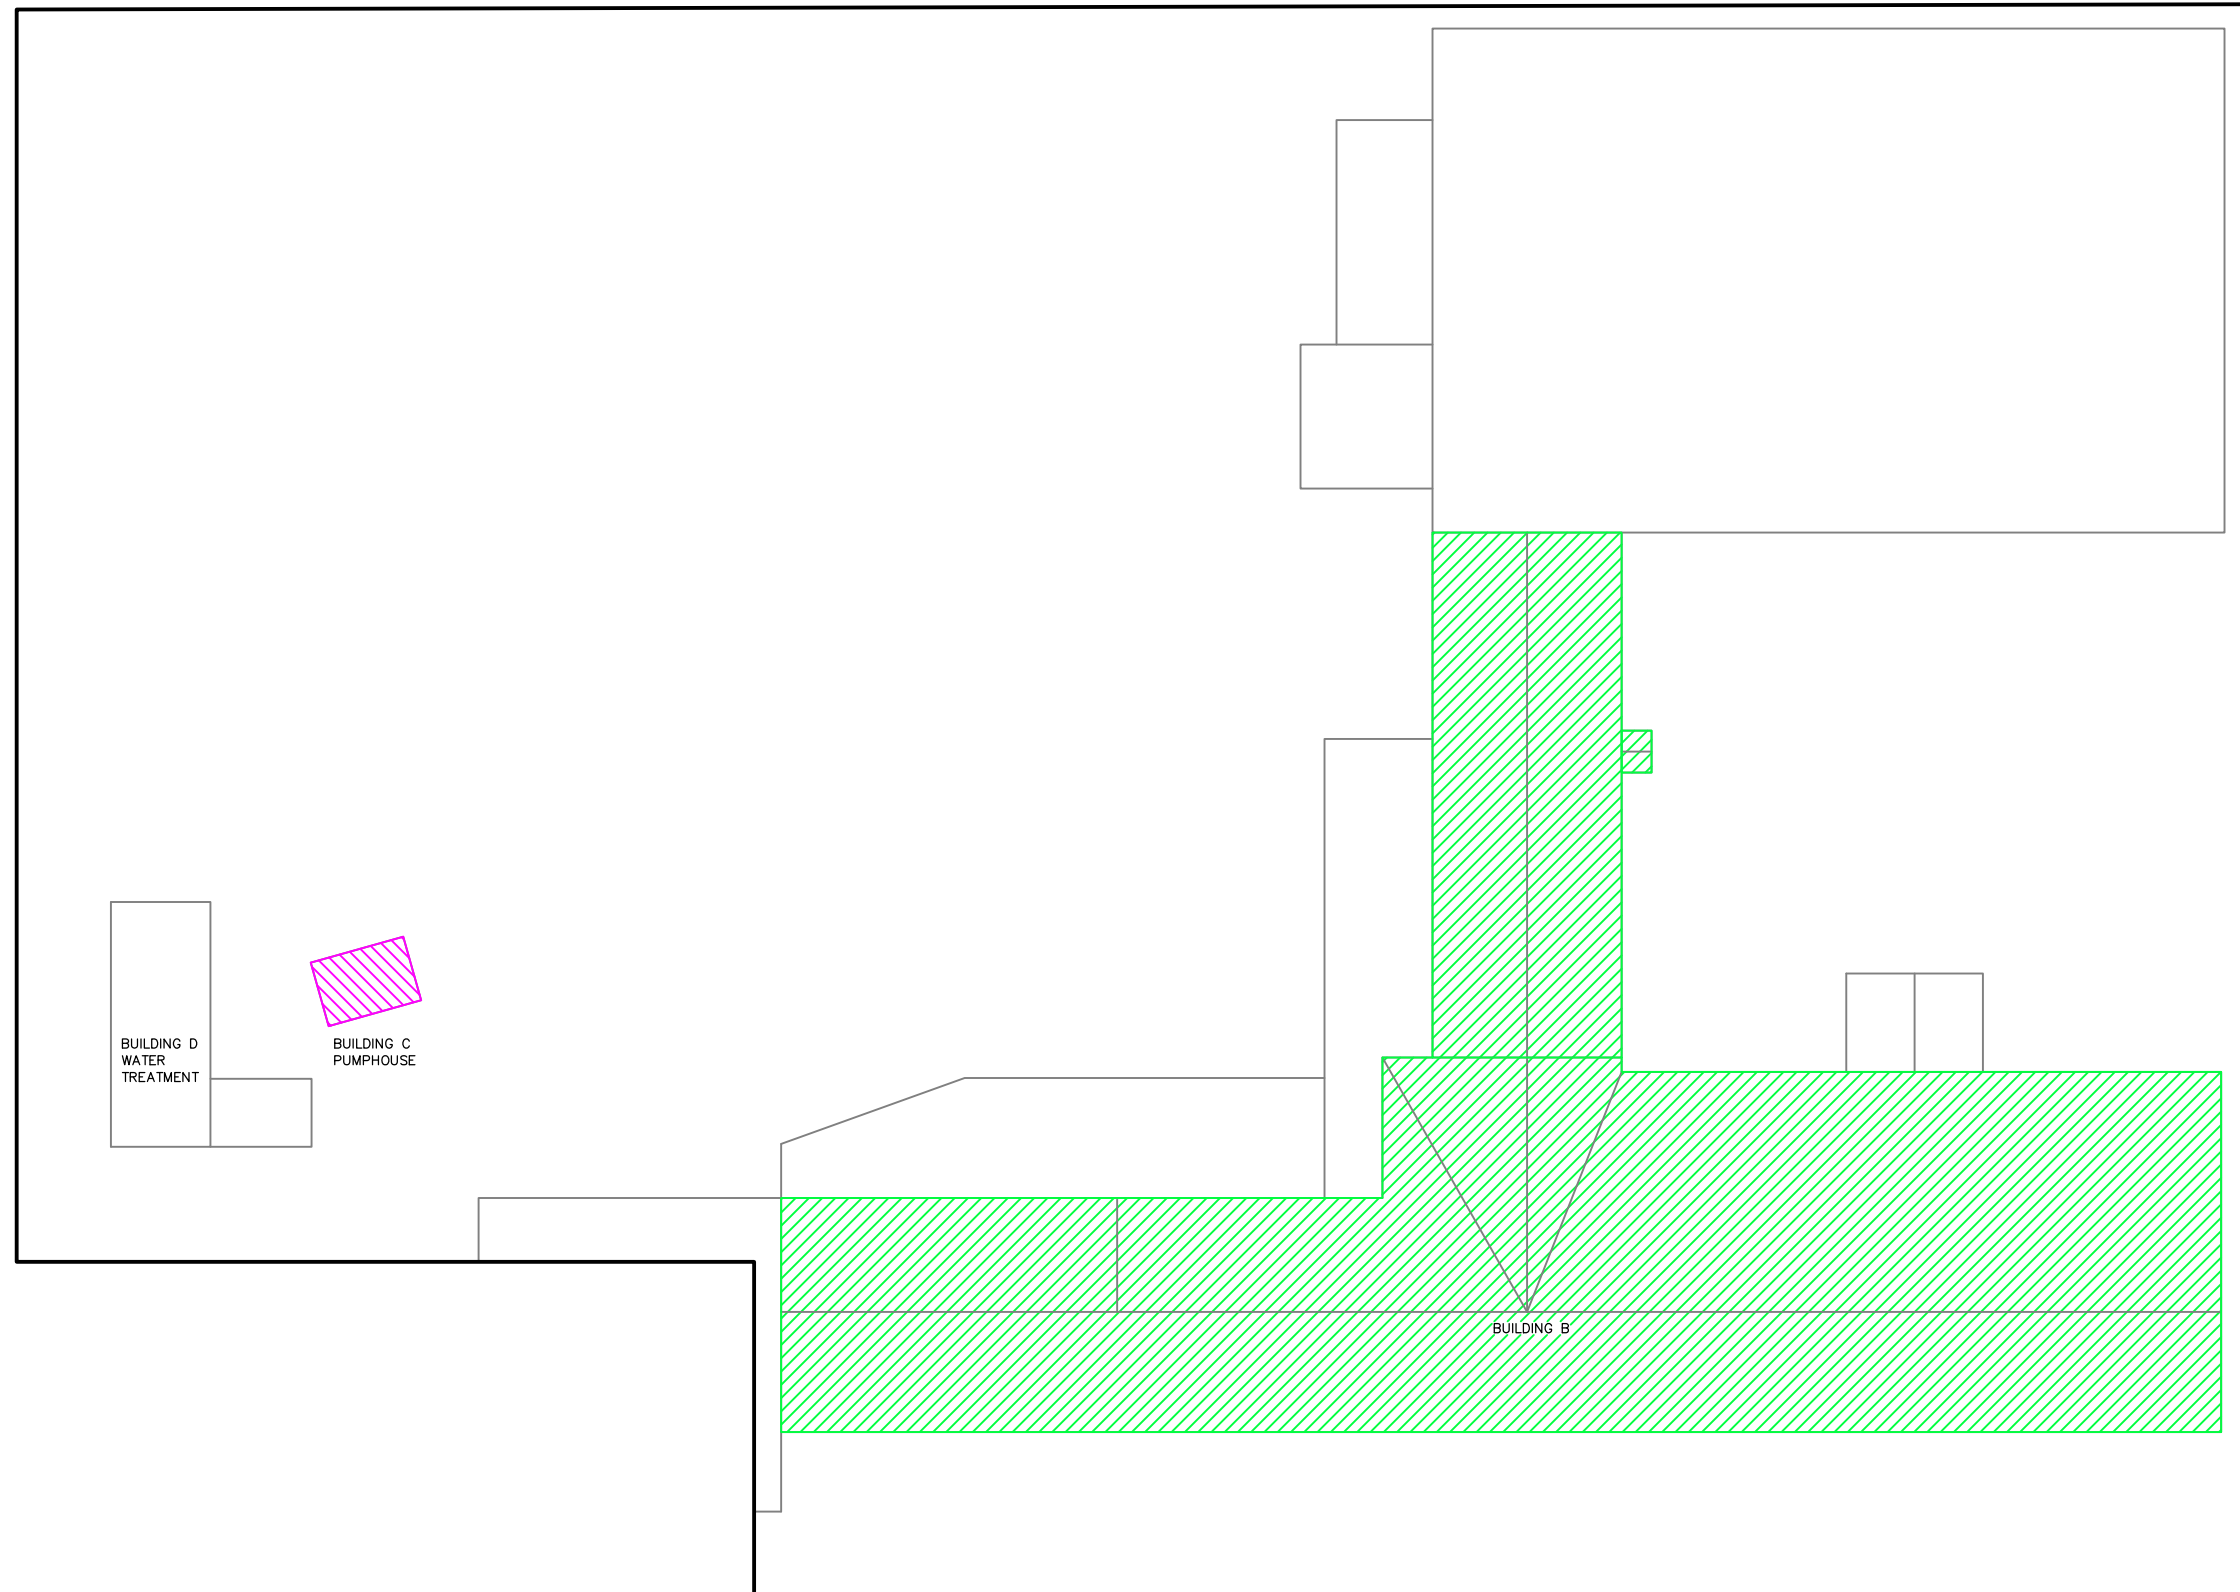
- (027-01) BUILT-UP ROOFING
- (025-01) ROOFING SHINGLES
