PROPERTY INSPECTION REPORT

12345 Your Home Dr., Los Angeles, CA 90039

DATE OF INSPECTION: 3/4/2025

VILLA PROPERTY INSPECTIONS
www.inspectaproperty.com

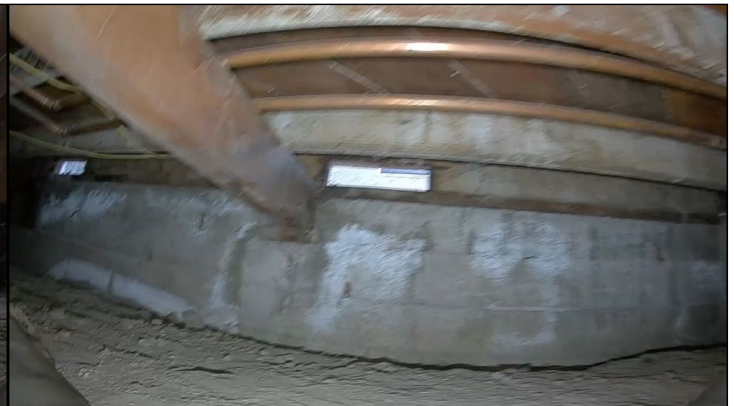
Efflorescence observed on walls indicates the presence of periodic moisture.
