# Villa Home Inspections

## Property Inspection Report

12345 Commercial Lane, Los Angeles, CA 90001  
Inspection prepared for: John Doe  
Real Estate Agent: - -

Date of Inspection: 7/30/2019 Time: 11:00 a.m.

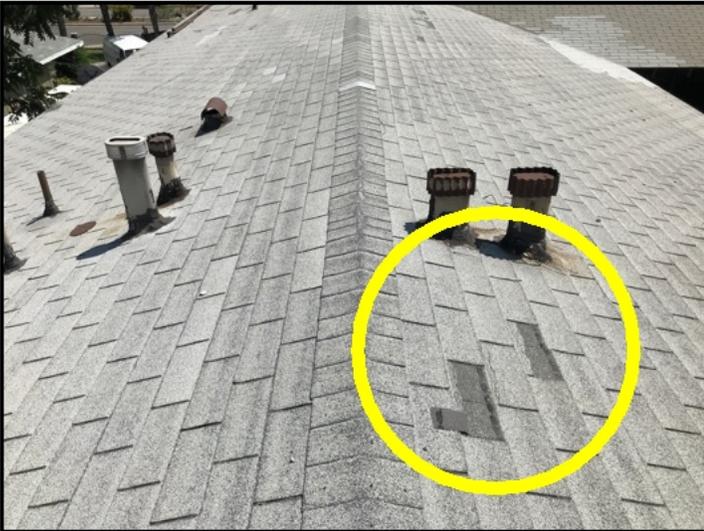
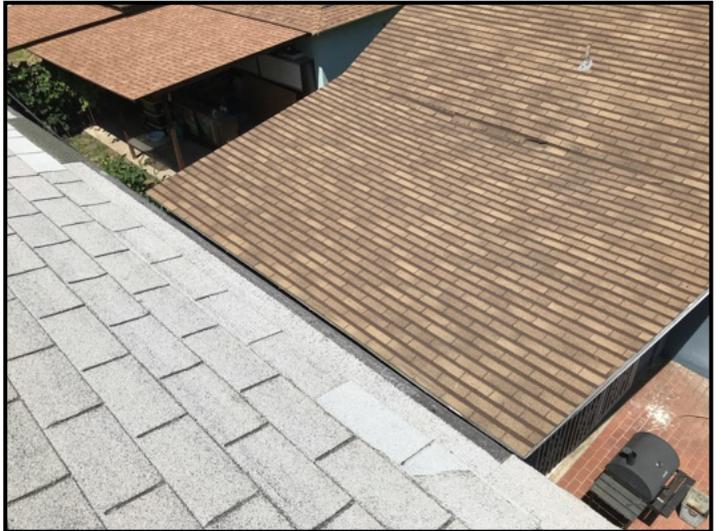
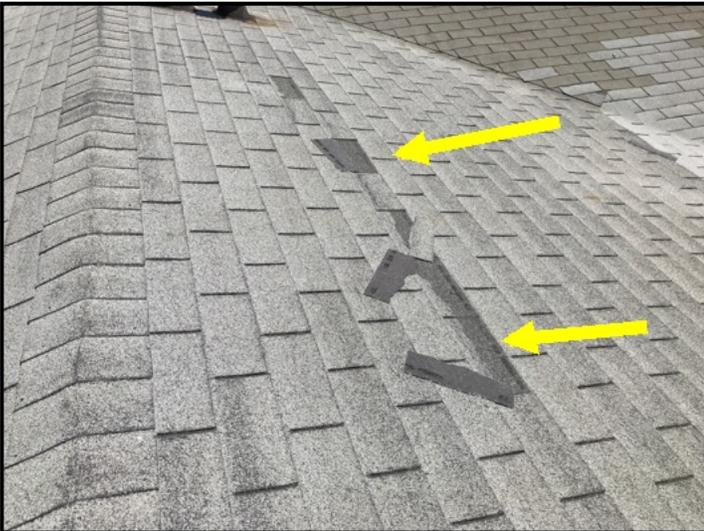
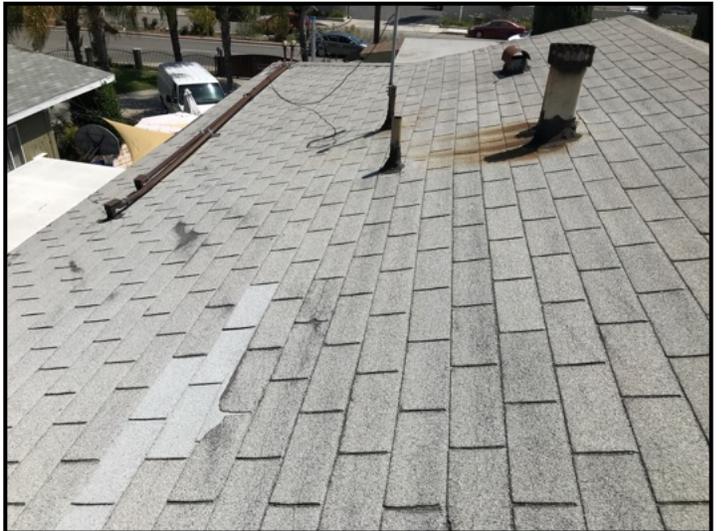
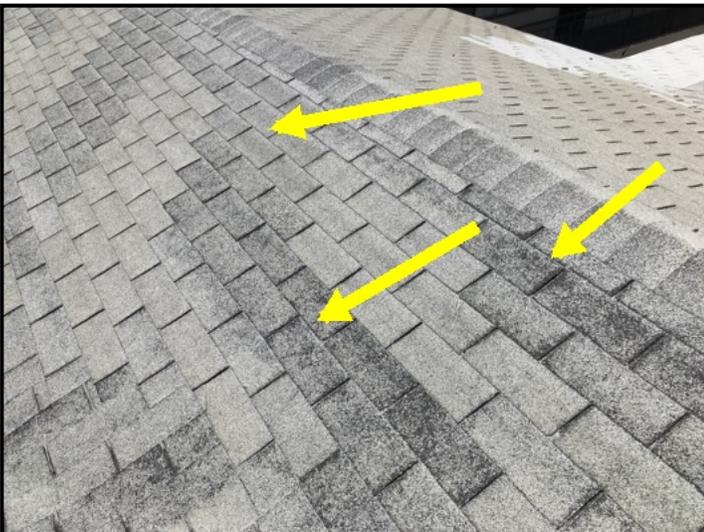
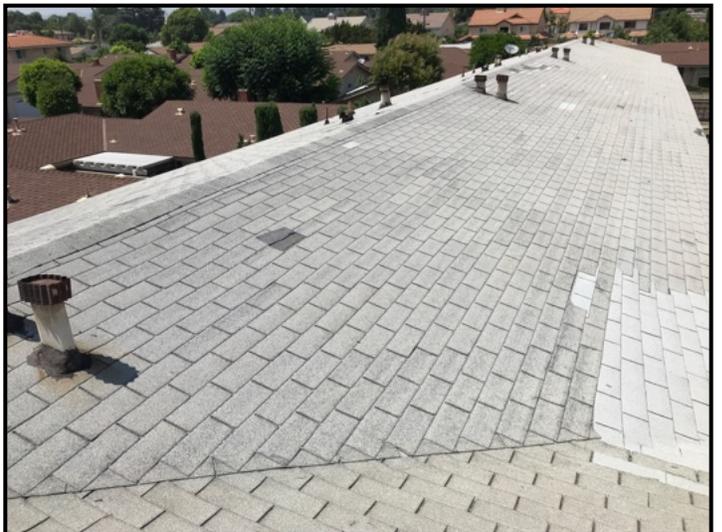
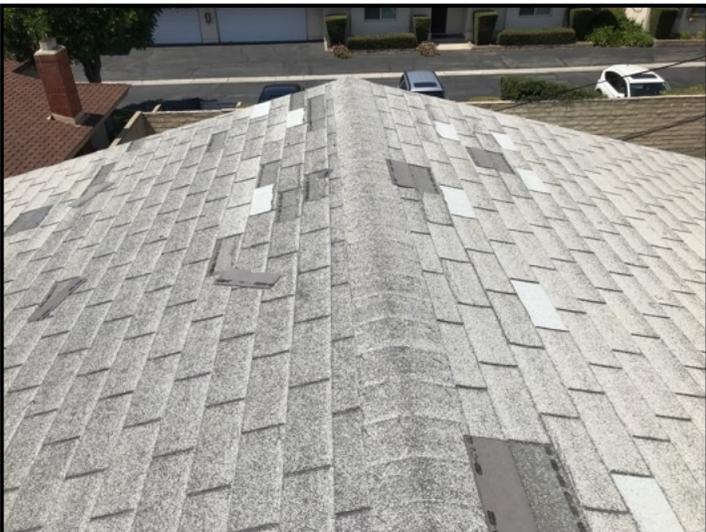
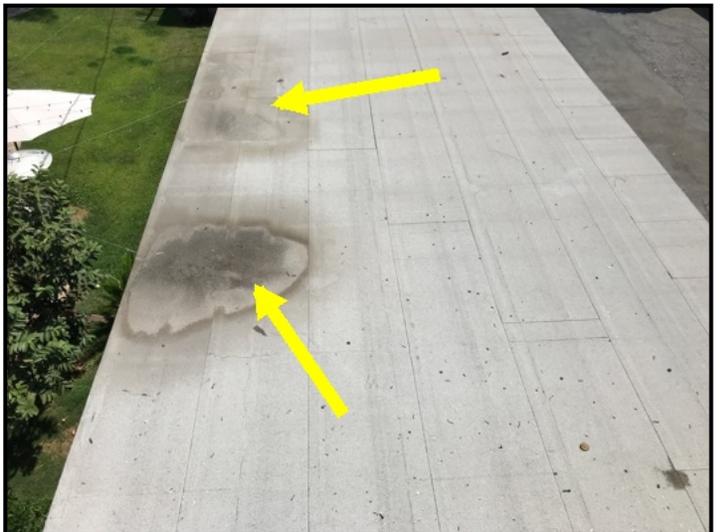
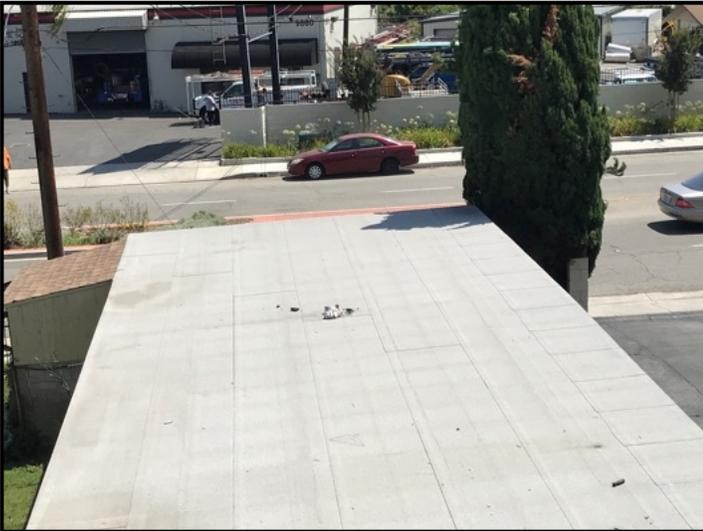
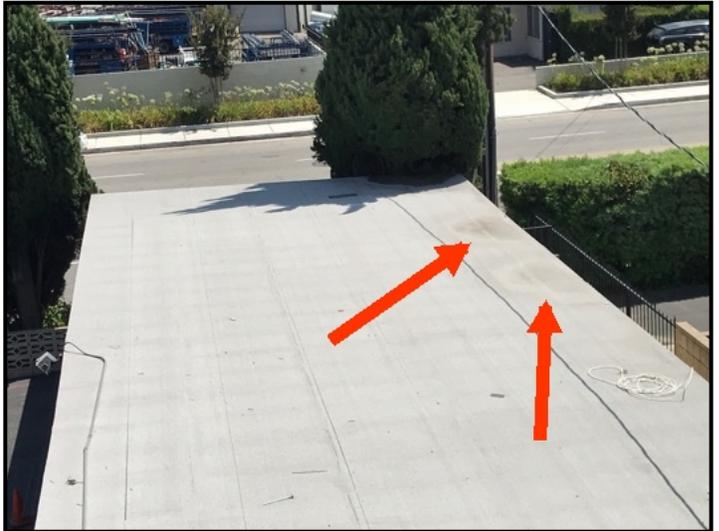
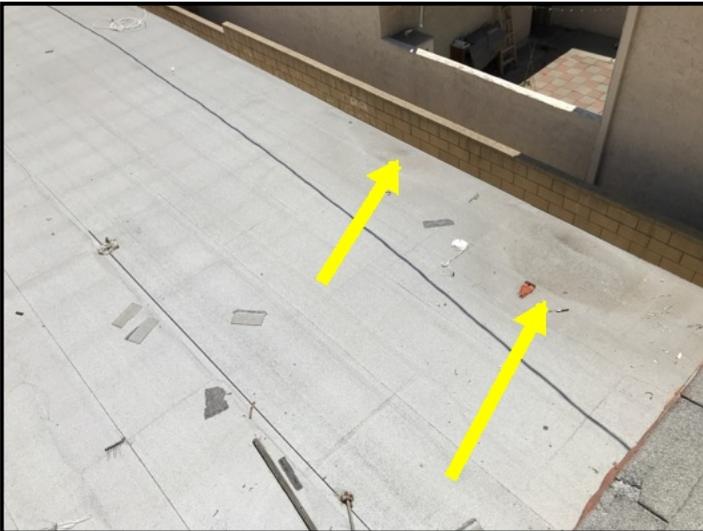
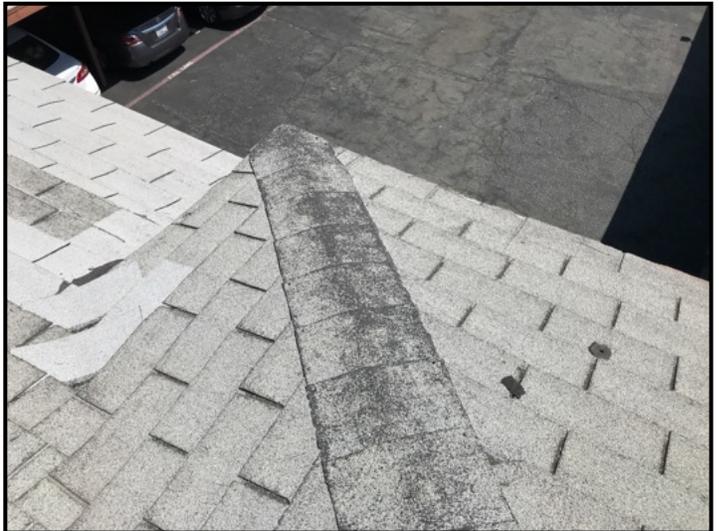
- Roofing material appears to be at or near the end of it's useful life.
- Moderate to significant deterioration of the roofing material was noted at time of inspection.
- Evidence of significant prior patching and/or repairs was noted at time of inspection.
- Evidence of improper roof drainage observed on the roof surface. Pooling water can cause deterioration of the roofing material and leaks. See photos.
- Damaged or missing shingles noted. Repair or replacement is needed.
- A licensed roofing contractor should be called to make further evaluation and repairs as needed.
- See photos.

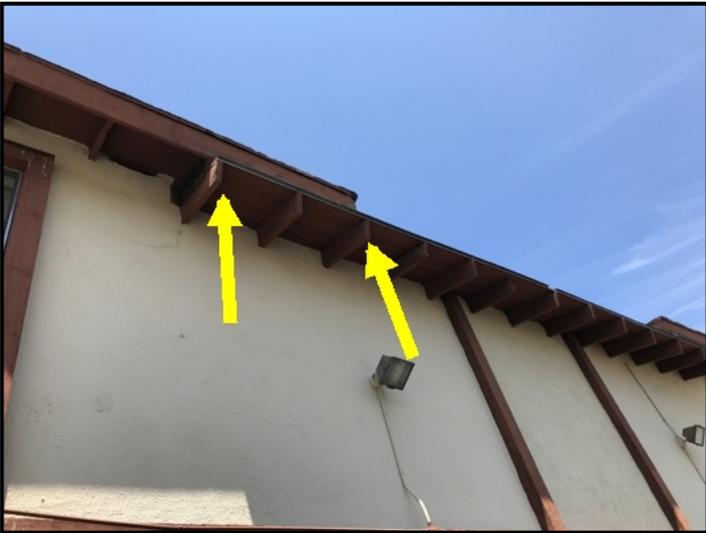
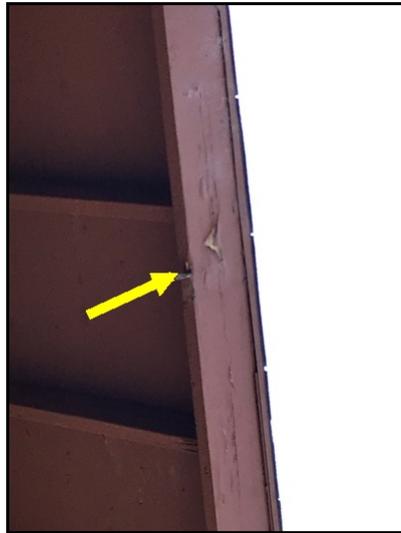
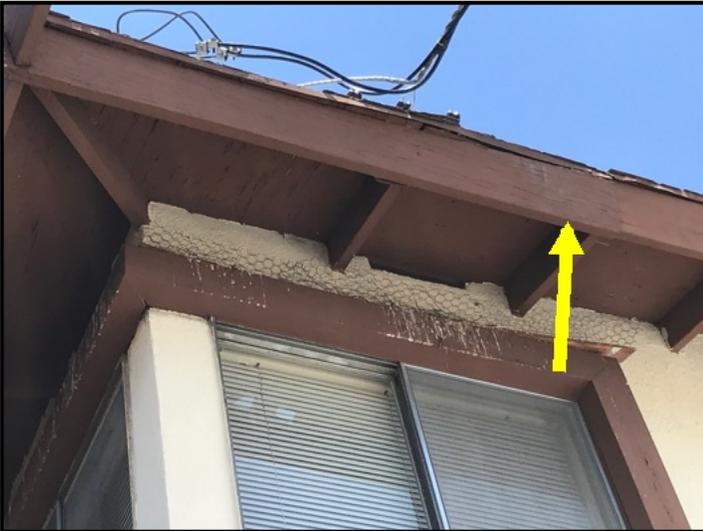
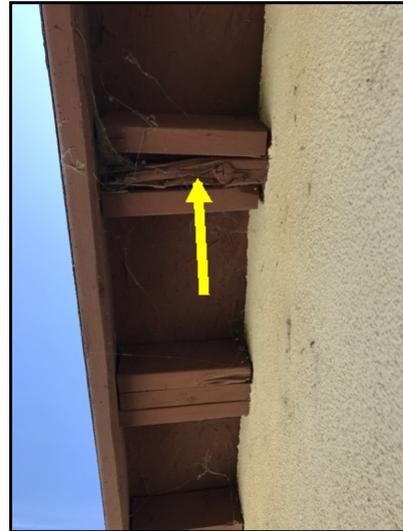
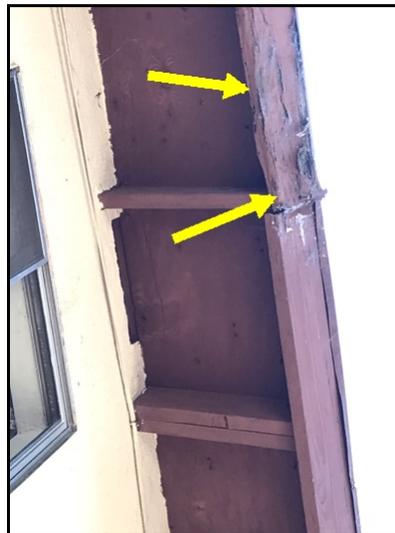
## 5. Roof Eaves Condition

- Moisture, rot or termite-like damage observed at the roof eave boards.
- Fascia boards are twisted and loose. See photo. Repair or replacement is recommended.
- Damage appears to be significant and will most likely require replacement of wood boards.
- Fascia boards are loose and or damaged. Repair or replacement is recommended.
- Further evaluation by a licensed termite inspector is recommended.
- See photos.

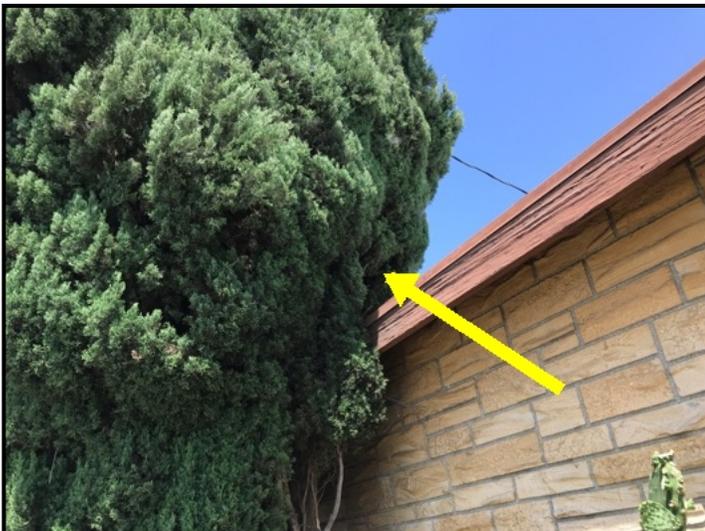
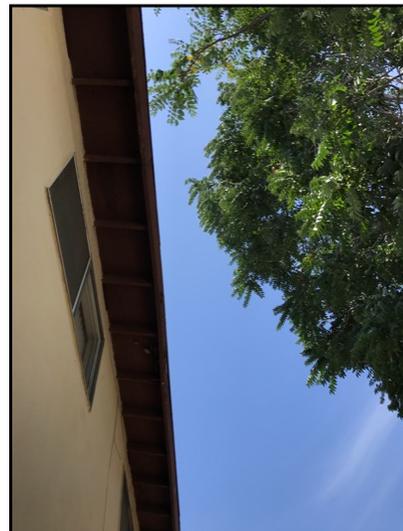
- Trees or other vegetation are touching or overhanging the roof. Damage is possible. Vegetation on the roof is also a source for rodent activity on the roof and the attic. Recommend trimming all vegetation or trees away from the roof structure.

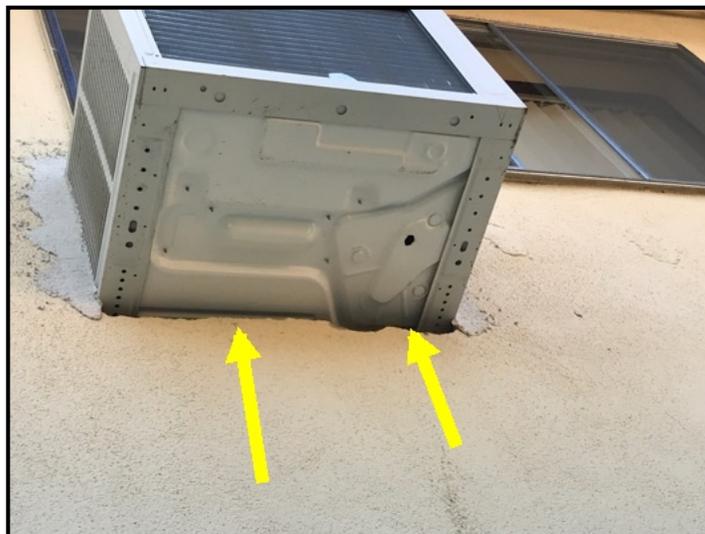
- Cracks are typical and not structurally significant.
- Cosmetic damage observed on the walls at time of inspection. Patching and re-painting is recommended.
- Wall is damaged and not properly sealed at the east side of the building due to a couple wall air conditioners installed. See photo. Proper patching is necessary to prevent moisture penetration and damage.

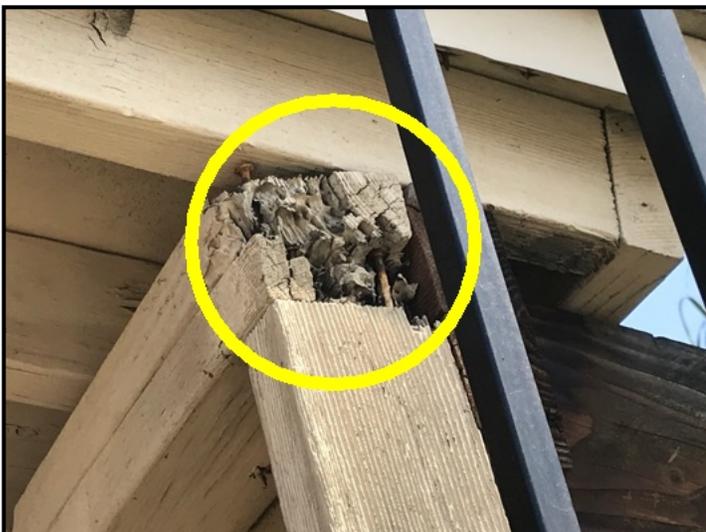
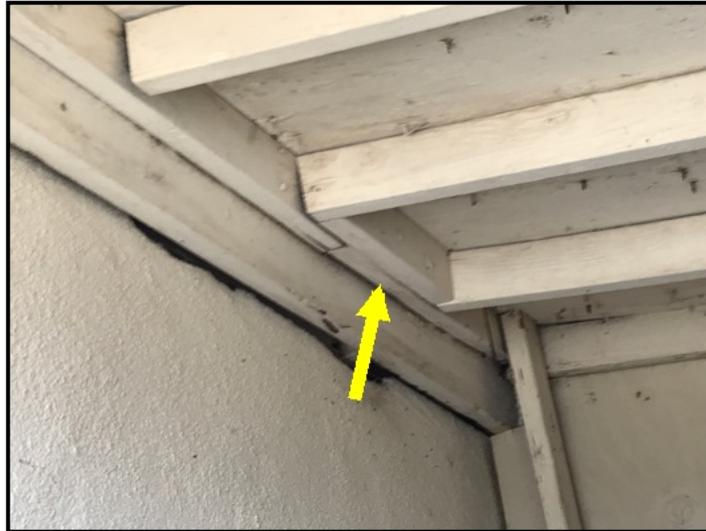
### 8. Miscellaneous

- Termite-like damage observed at the trash area wood structure. See photo. Further evaluation by a licensed termite inspector is recommended.

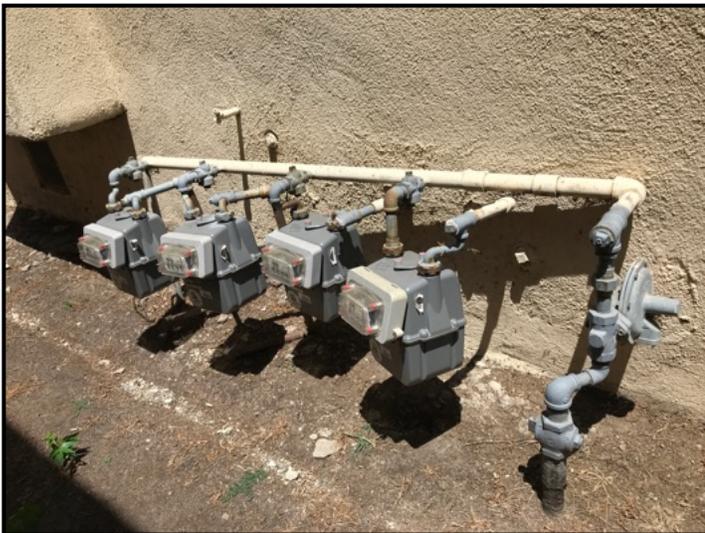
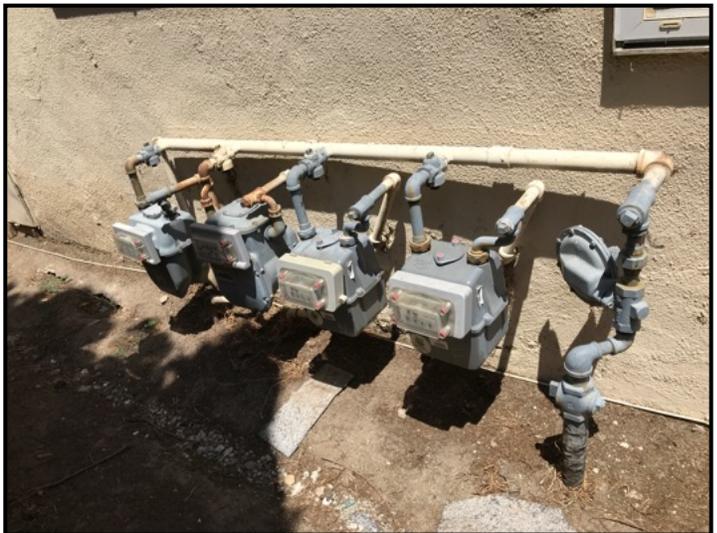
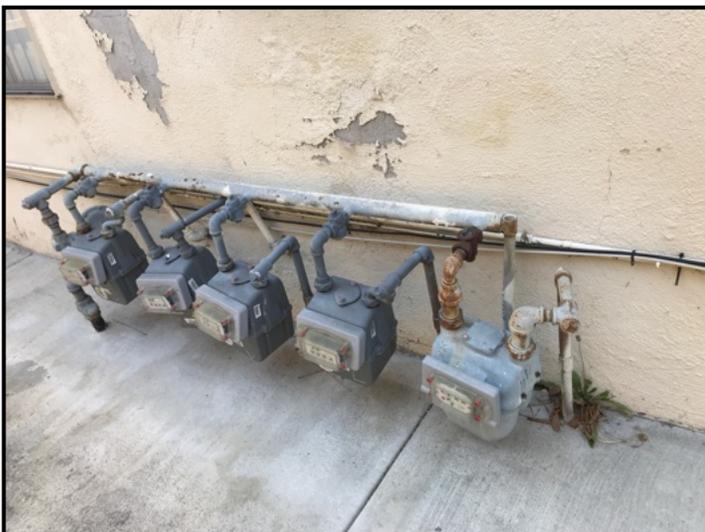
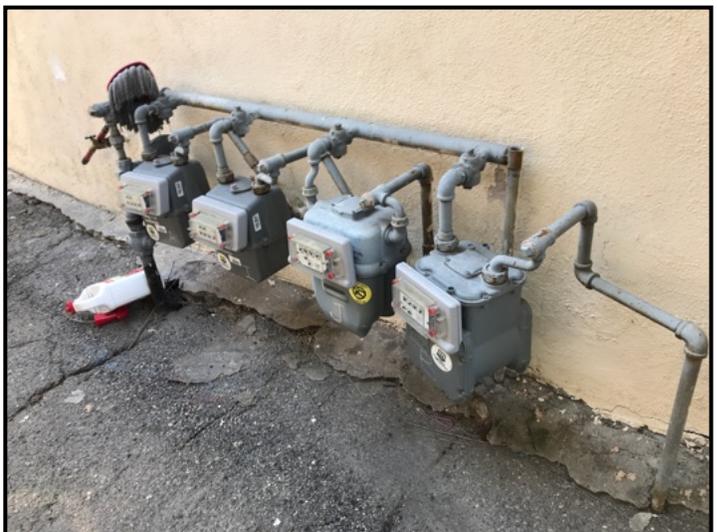
- Meter appears functional at time of inspection.
- Automatic gas seismic shut off valve not present.

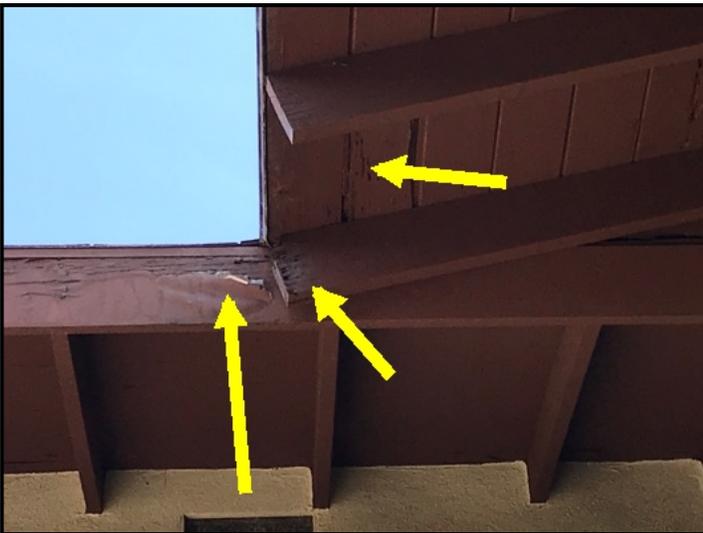
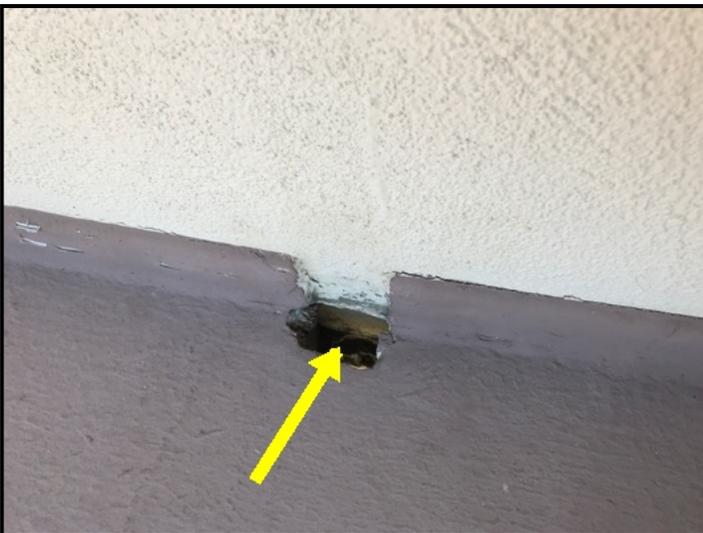
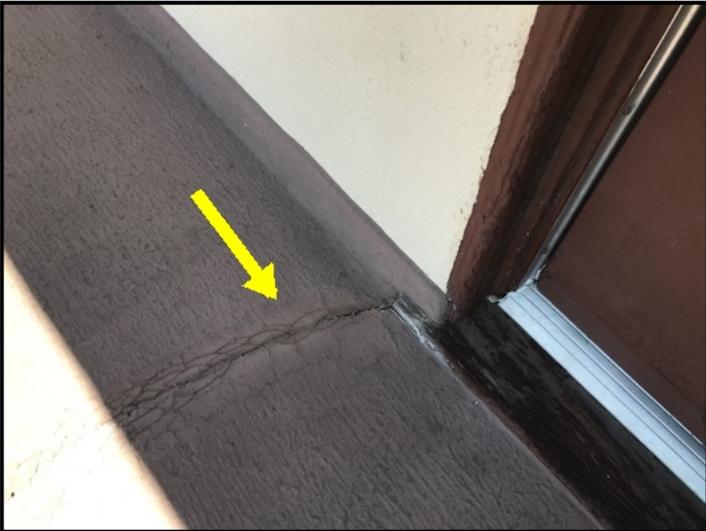
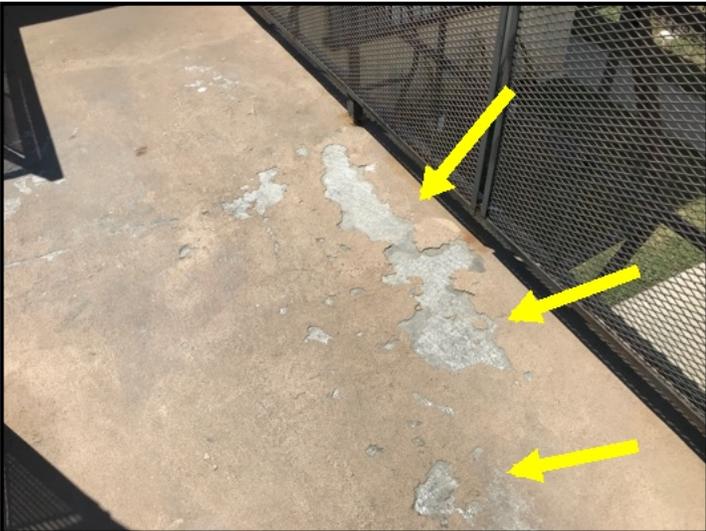
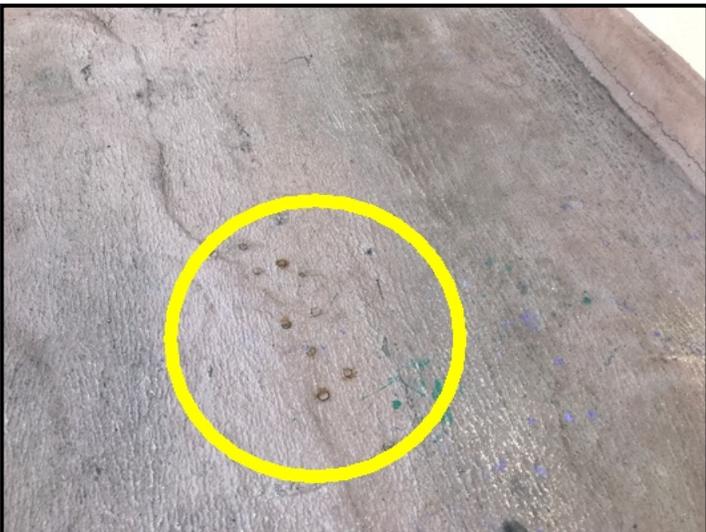
- **Floor Condition:**
- Significant cracks and deterioration observed at the balcony floor throughout the building. See photos. Resurfacing is recommended.
- Floor drains throughout the balcony do not have downspouts below. This can cause water damage on the floor system below. See photos.
- Further evaluation by a licensed contractor is recommended.
- See photos.
- **Cover Condition:**
- Rot, termite or moisture damage observed. Further evaluation by a licensed termite inspector is recommended.

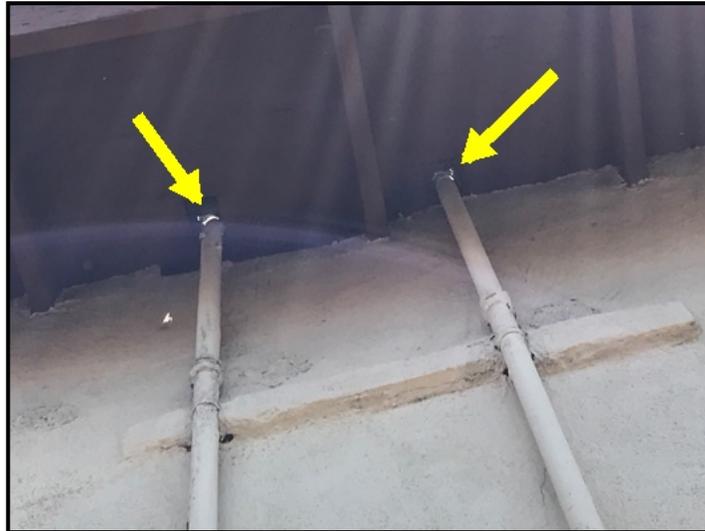
- No visible problems observed at time of inspection.
- Moisture penetration observed at the roof eave, under the electrical service entrance mast. Further evaluation by roofing contractor is recommended.
- See photos.

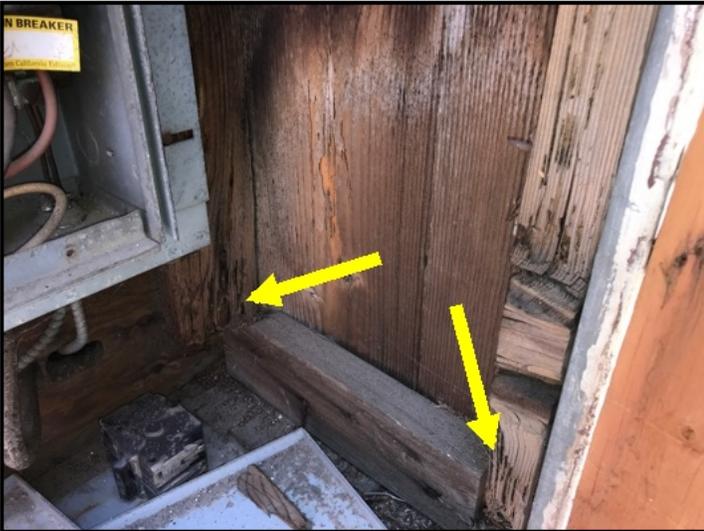
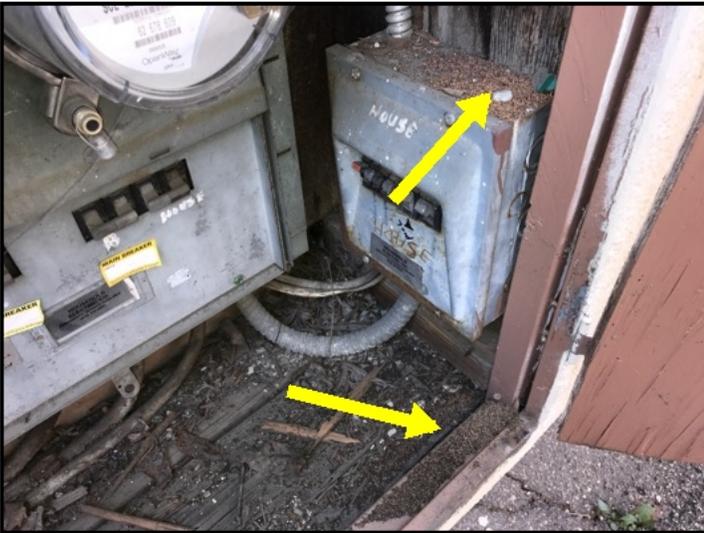
- Wood enclosures surrounding the main shut offs rot and termite damage. Inspection and or repair and replacement by a licensed termite and or general contractor is recommended.

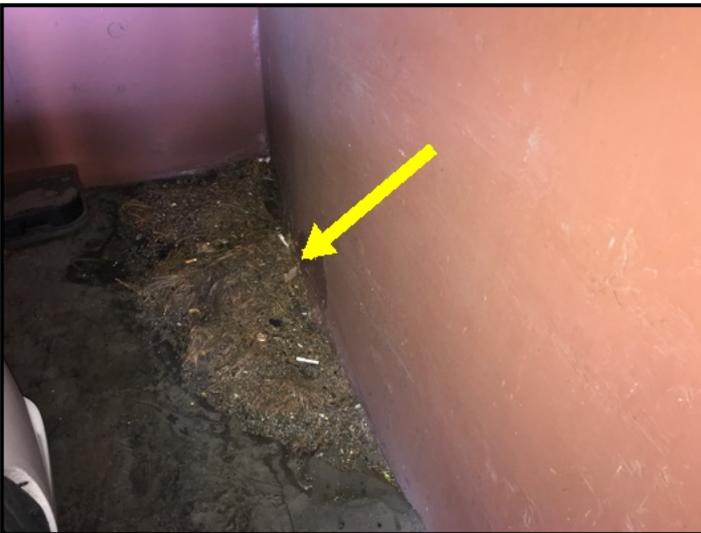
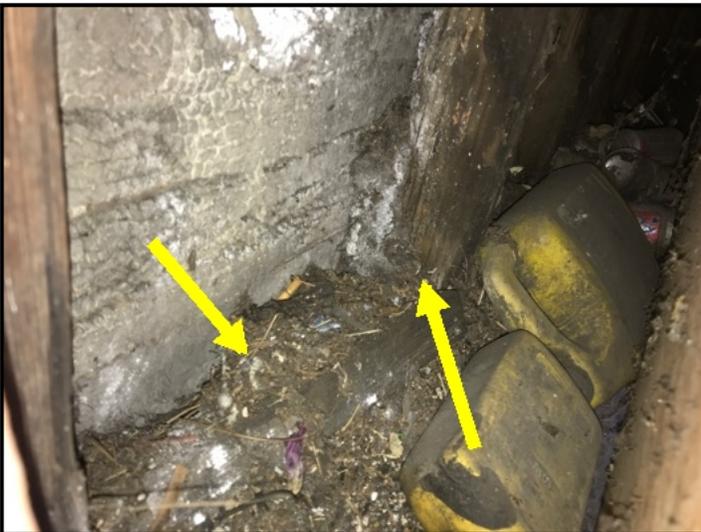
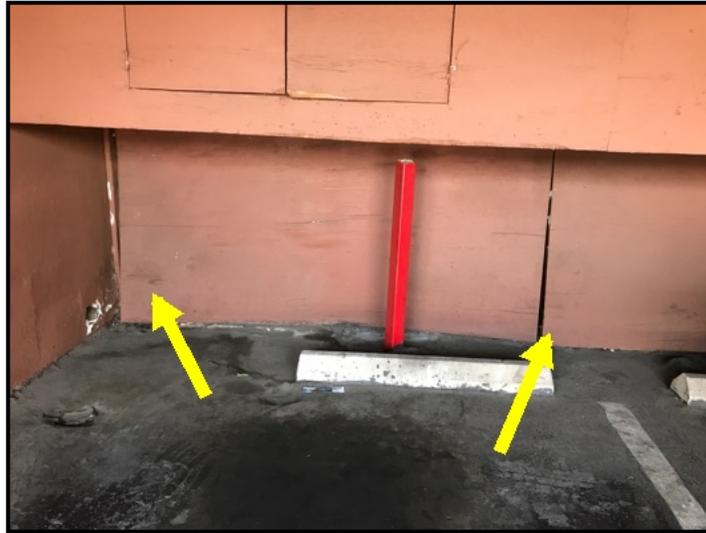
Observations:  
• Tree root damage observed at the south east carport wall. See photo. Removal of the tree stump is recommended  
• Significant termite like activity observed at the east carport wall. Wall is not fully visible due to plywood paneling. However, plywood paneling is loose and falling off. See photos.

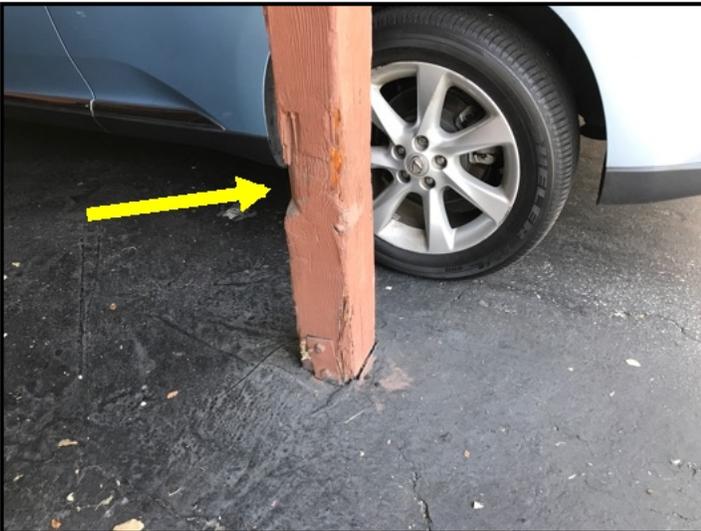
- Vehicle damage observed at the carport post. See photo. Repair or replacement is recommended.
- Vehicle damage was observed at the west carport wall. Repair or replacement is recommended.
- See photos.

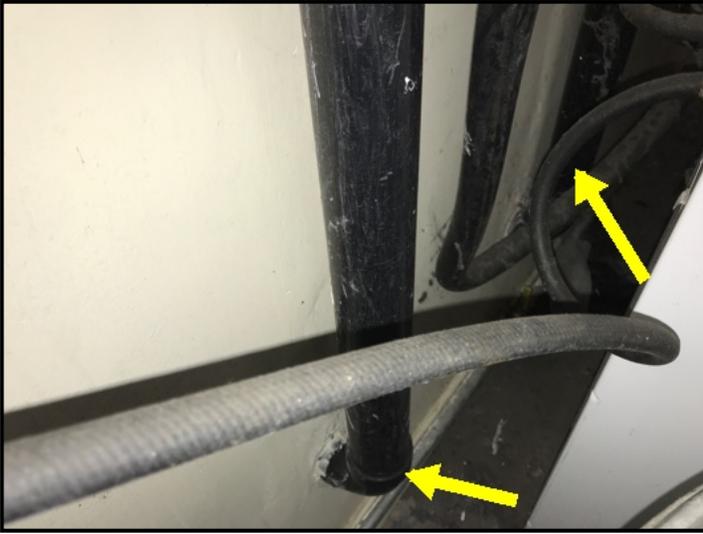
- Gas service pipe is provided.
- Dryer venting is damaged. Replacement is necessary.
- Drain line does not have a P-trap installed and may allow sewer gases to escape.

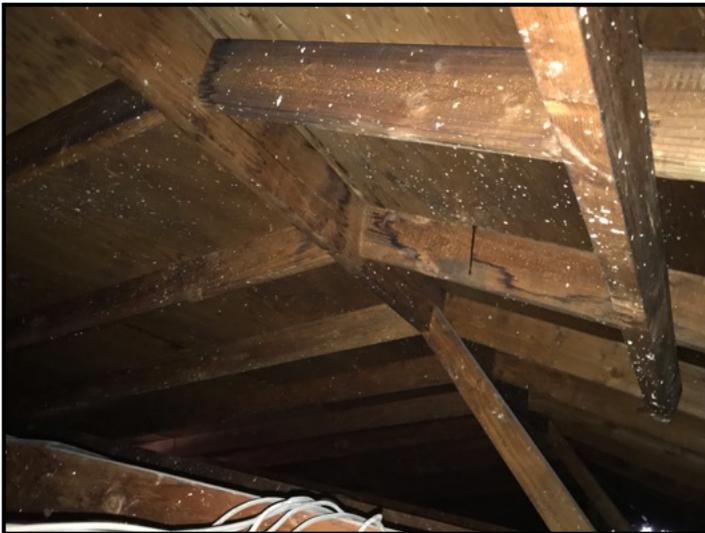
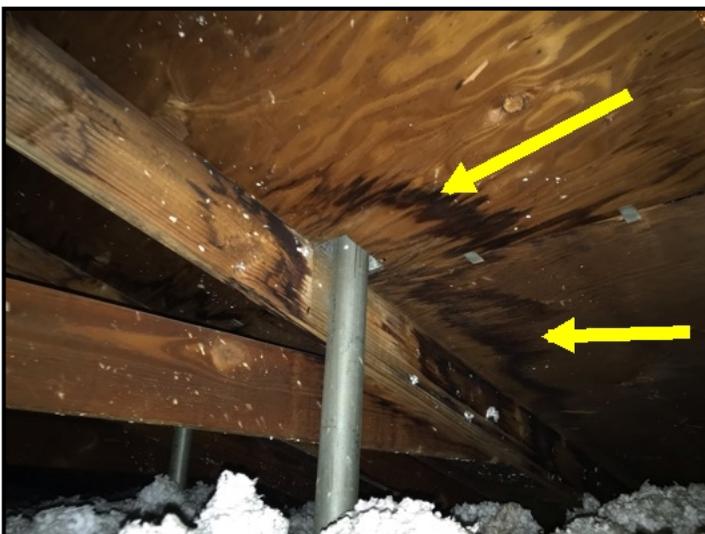
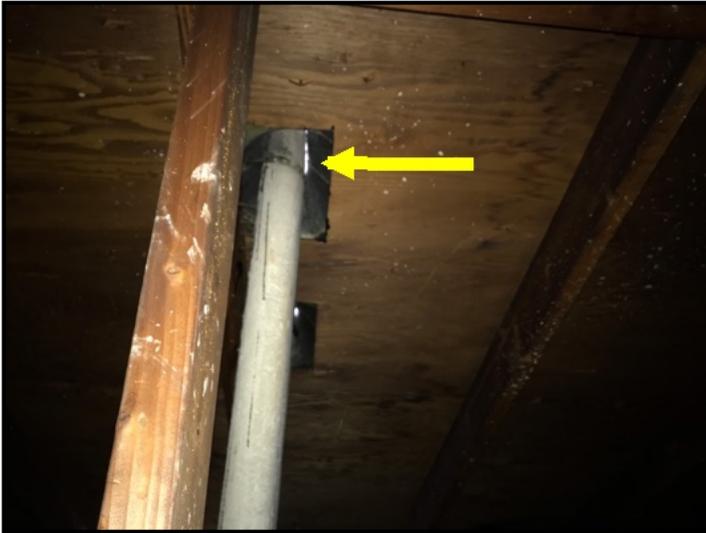
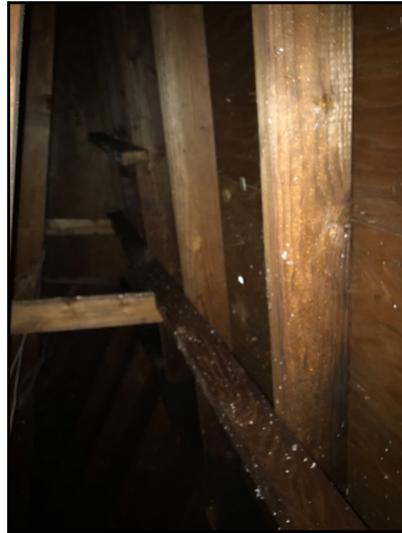
- No visible structural problems noted at time of inspection.
- Attic is accessible from more than one dwelling and there is no partition inside the attic. This poses a security problem to the occupants. It is recommended that locking hardware be installed on all attic access panels as a security enhancement.
- Moisture stains observed at the vent pipes.
- Unable to determine the status of the stains. Active leakage may be present.
- Termite-like activity observed in the attic area at time of inspection. Further evaluation by licensed termite inspector is recommended.
- Recommend further evaluation by a licensed roofing contractor.
- See photos.

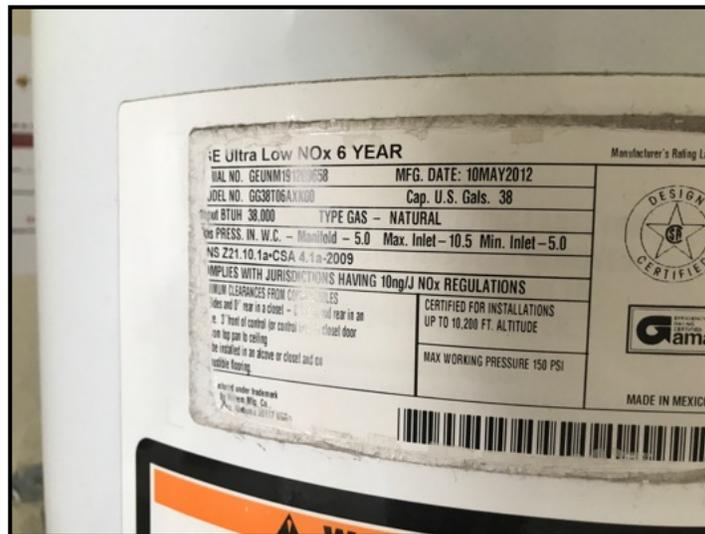
- Year Built: 2012
- 7-10 Years old. Unit is reaching the end of it's useful life. Although no problems may exist at time of inspection, the lifespan of a water heater is normally between 5 to 12 years. You may want to consider replacing with a newer unit for increased efficiency.

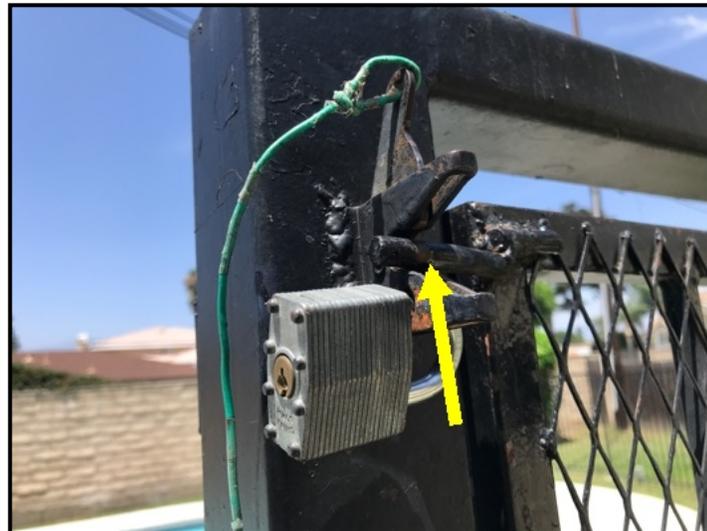
- Fencing appears functional at time of inspection.
- Self closing gate mechanism is present and operable. However, the gate does not latch when operated. Repair or replacement is necessary.
- California Senate Bill 442 and California Health and Safety Code requires a home inspector to specify which the following seven safety features are present and requires at least two of the features to be present.

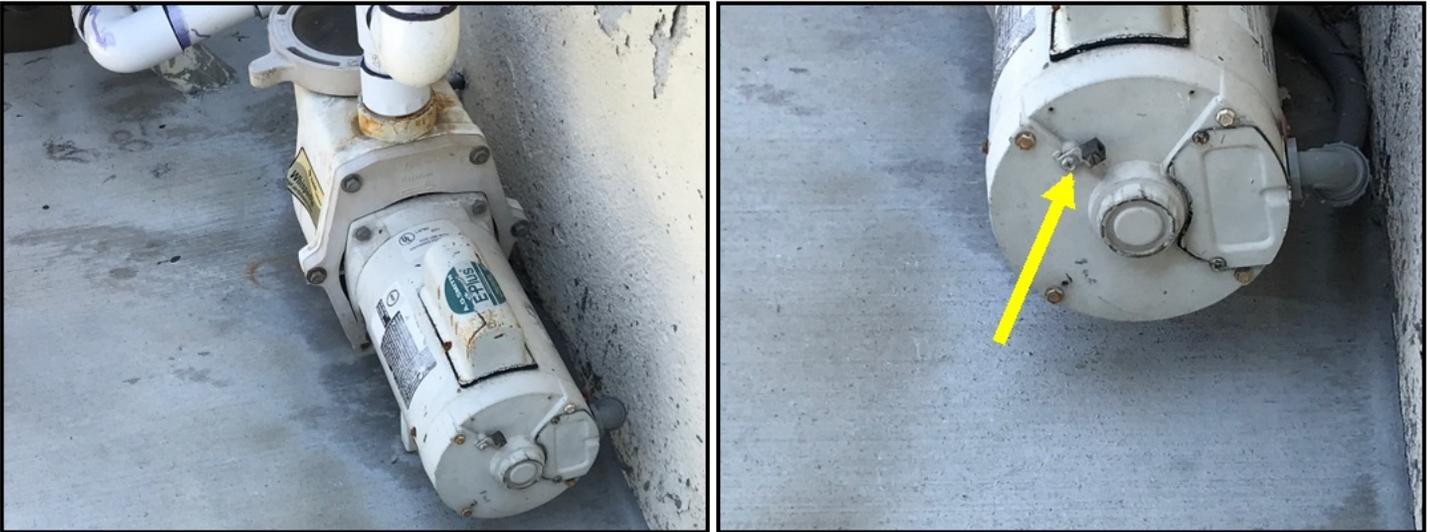
- Pumping equipment operated properly at time of inspection.
- **Motor does not have the bonding wire installed. Installation is required.**

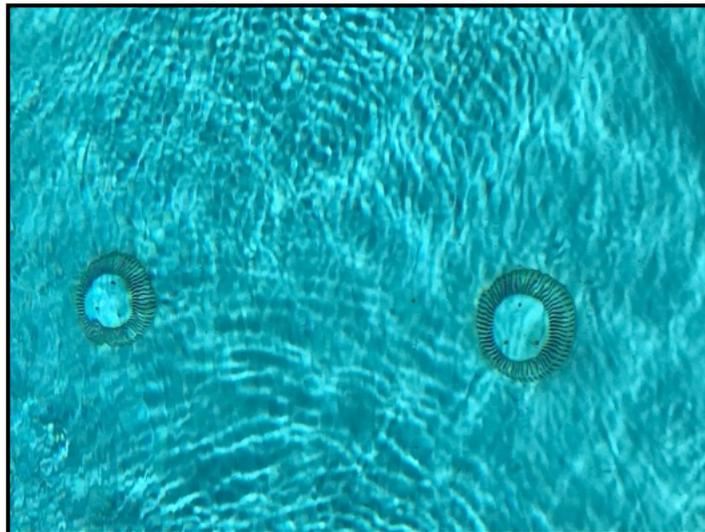
- Drain cover is present and properly installed.

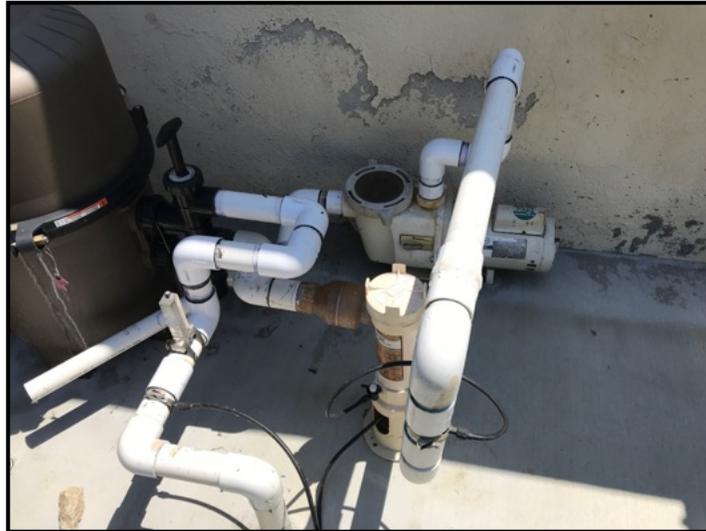
- No visible leaks observed at time of inspection.
- PVC pipes are not protected from UV rays. PVC is required to be painted or covered to prevent deterioration and damage.
- See photos.

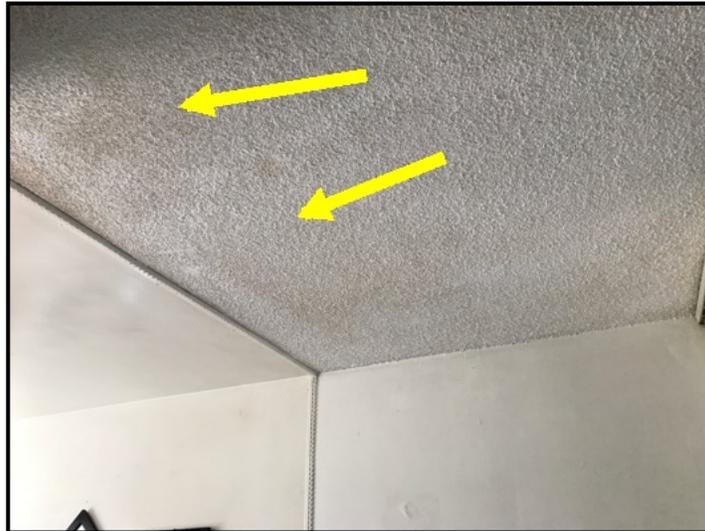
- Windows and doors operated properly at time of inspection.
- No visible problems noted at the floor at time of inspection.
- A representative number of outlets, switches and fixtures was operated and found to be in operable condition at time of inspection.
- Moisture stains and/or damage viewed on the ceiling.
- See photos.

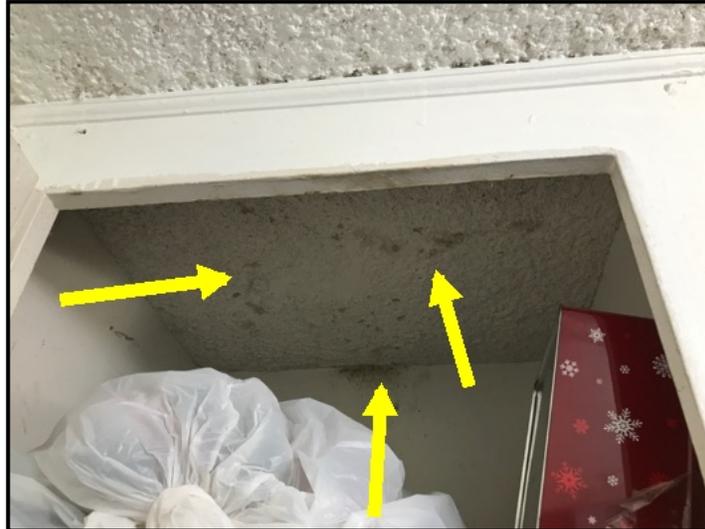
- Walls and ceiling appeared functional at time of inspection.
- A representative number of outlets, switches and fixtures was operated and found to be in operable condition at time of inspection.
- **Moisture stains and/or damage viewed on the closet ceiling or wall.**
- **Possible plumbing leak from dwelling above. Further evaluation by a plumbing contractor is recommended.**

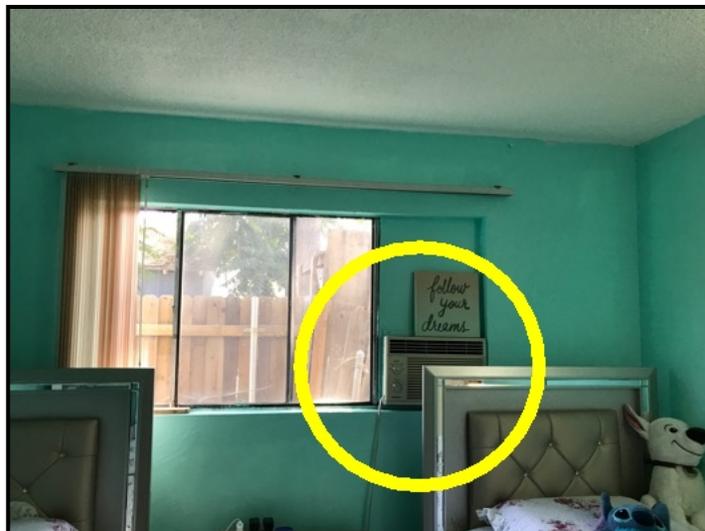
- Walls and ceiling appeared functional at time of inspection.
- No visible problems noted at the closet at time of inspection.
- No visible problems noted at the floor at time of inspection.
- A representative number of outlets, switches and fixtures was operated and found to be in operable condition at time of inspection.
- **Smoke detector is not installed. A smoke detector is required in every bedroom, adjacent hallway and every level of the dwelling prior to the close of escrow.**
- **Window is difficult to operate. Repair or replacement is recommended.**
- **Inadequate egress observe that bedroom. Air-conditioner is installed in the only bedroom window. This is not allowed by code. Removal is required.**

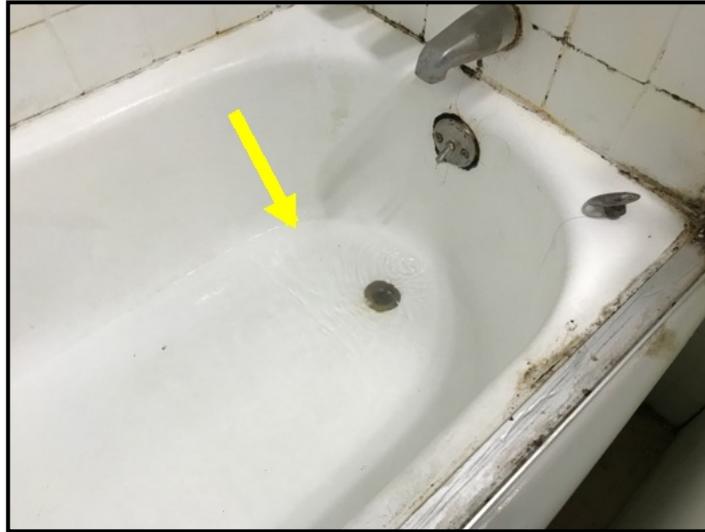
- Windows and doors operated properly at time of inspection.
- Walls and ceiling appeared functional at time of inspection.
- No visible floor problems noted at time of inspection.
- No visible electrical problems observed at time of inspection.
- Tub does not drain properly.
- Caulking is recommended at the tub or shower areas to prevent moisture penetration and damage behind the walls.
- Ground Fault Circuit Interrupter (GFCI) outlets are recommended for installation.

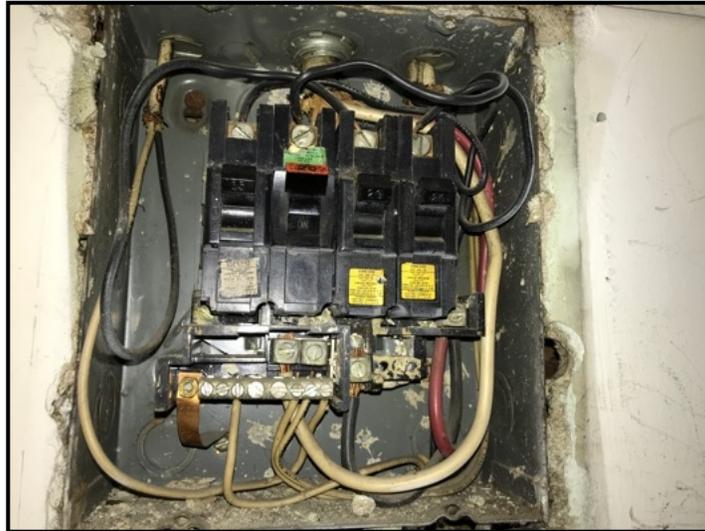
- Circuit and wire sizing correct so far as visible.
- It should be noted that the main electrical service was equipped with a "Stab-Loc" 240-volt - 100-amp circuit breaker disconnect panel manufactured by Federal Pacific Electric (FPE). This electrical service panel has been known to present a hazard by failing to trip under load causing arcing that could result in an electrical fire.

It is recommended that a state licensed electrical contractor be retained to evaluate its current operable condition before the close of escrow and transfer of title. It is also recommended that consideration be given to having this service panel replaced as a property upgrade in the interest of occupant safety.

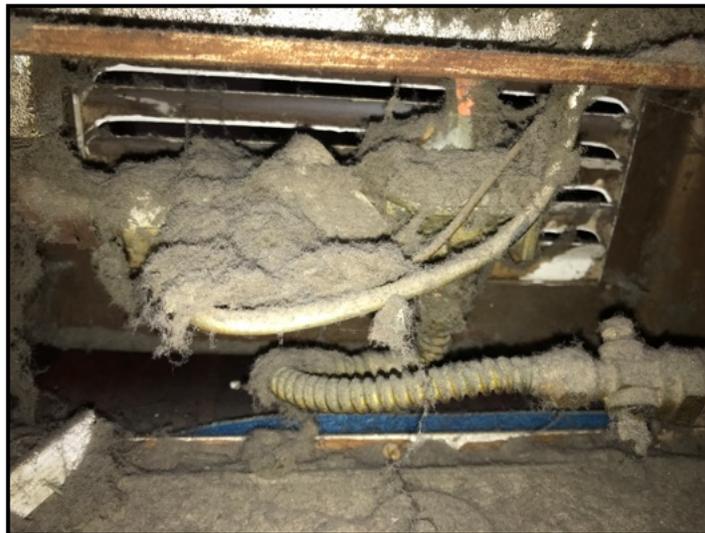
- Recommend cleaning the system thoroughly before using.
- Pilot light was not lit at time of inspection. Unable to inspect. Further evaluation by gas company is recommended.

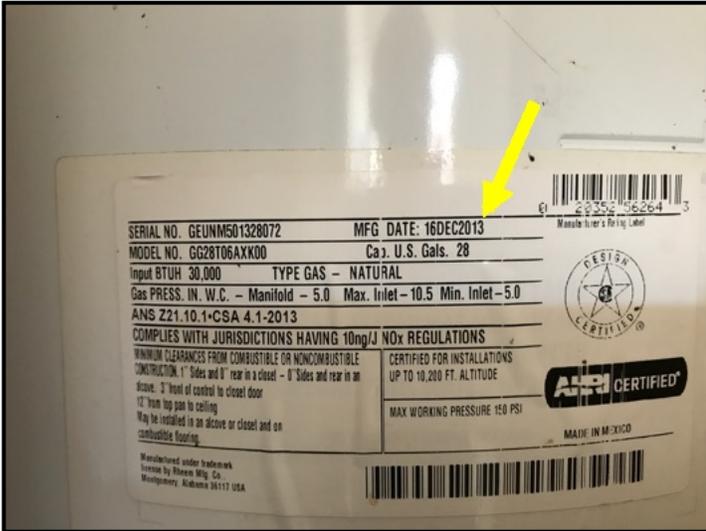
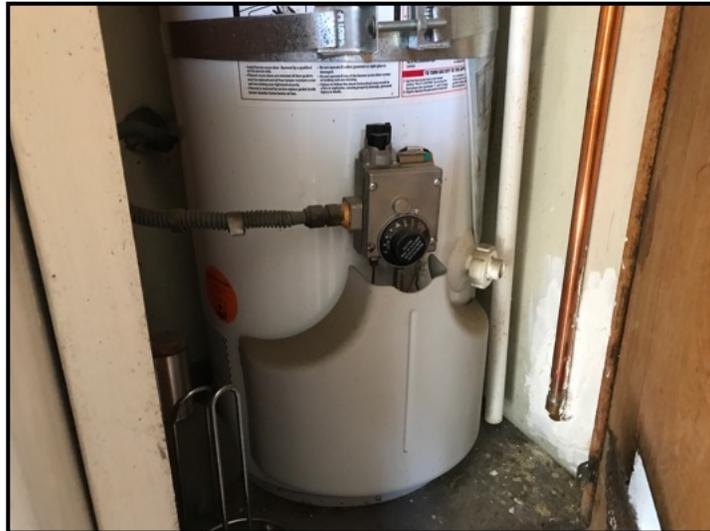
- Operated properly at time of the inspection.
- Temperature pressure relief valve discharge line is not installed. This is a potential hazard. Installation is required.
