# Villa Home Inspections

## Property Inspection Report

12345 Commercial Lane, Los Angeles, CA 90001  
Inspection prepared for: John Doe  
Real Estate Agent: - -

Date of Inspection: 7/30/2019 Time: 11:00 a.m.

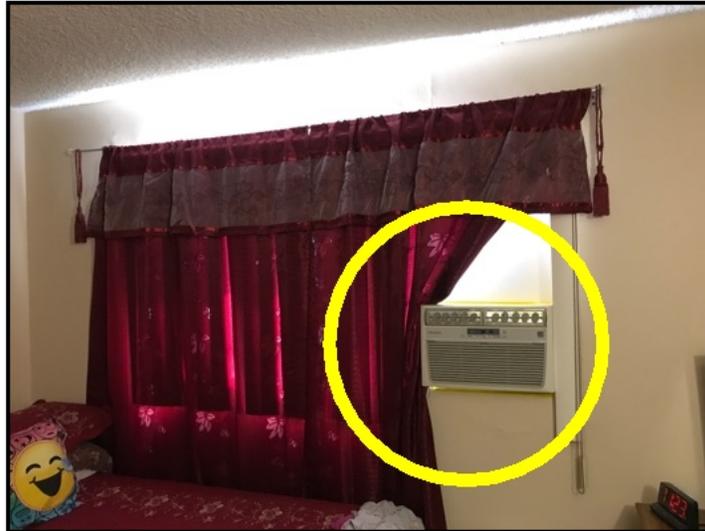
- No visible problems noted at time of inspection.
- **Inadequate egress observe that bedroom. Air-conditioner is installed in the only bedroom window. This is not allowed by code. Removal is required.**

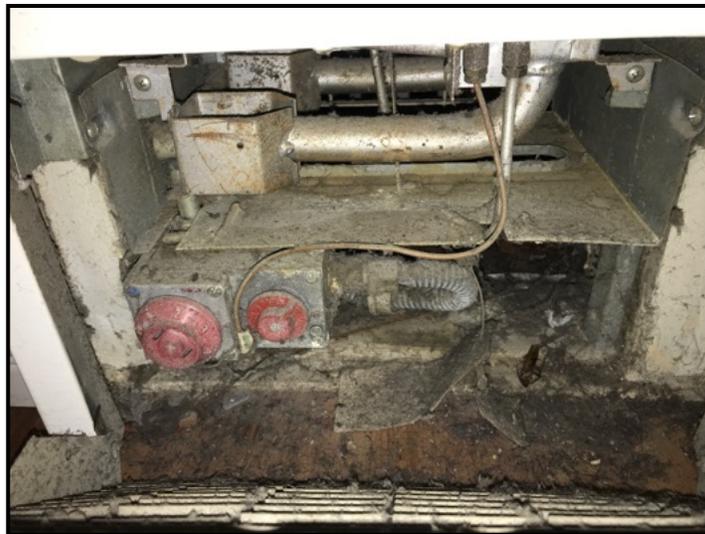
- Recommend cleaning the system thoroughly before using.
- Pilot light was not lit at time of inspection. Unable to inspect. Further evaluation by gas company is recommended.

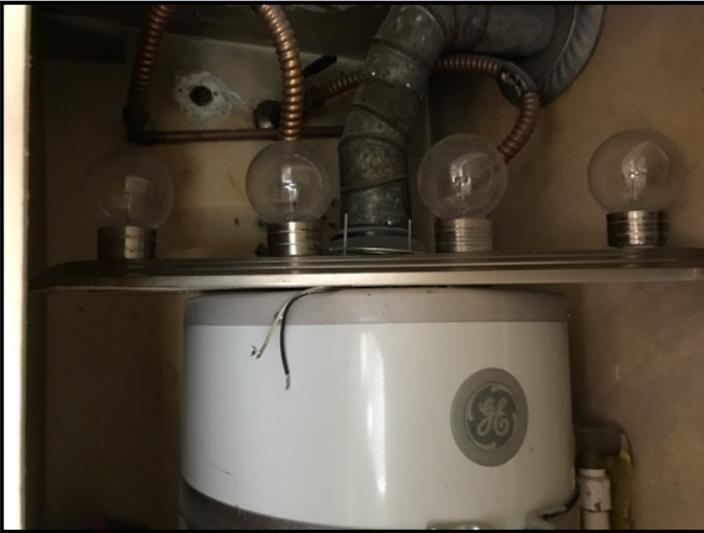
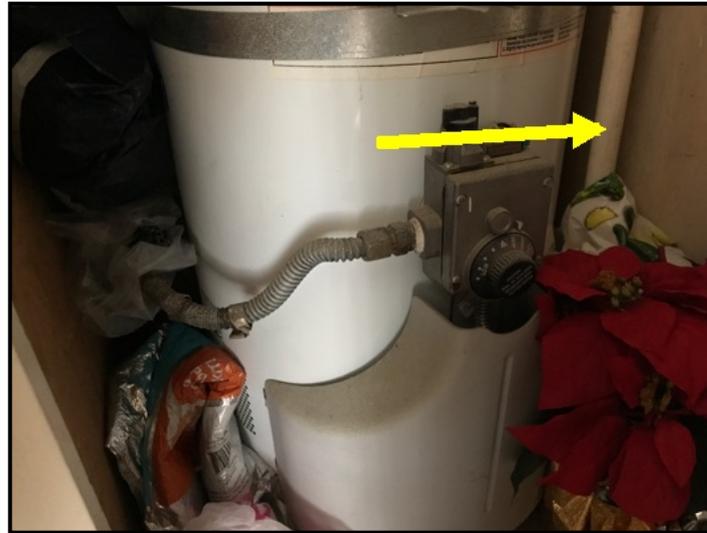
- Operated properly at time of the inspection.
- Temperature pressure relief valve discharge line is not installed. This is a potential hazard. Installation is required.

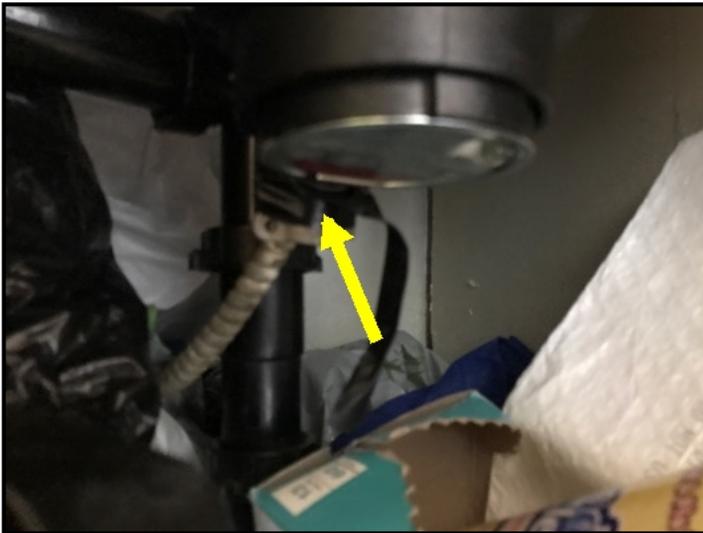
- Walls and ceiling appeared functional at time of inspection.
- A representative number of outlets, switches and fixtures was operated and found to be in operable condition at time of inspection.
- Minor to moderate wear and or damage observed on the kitchen counter top. Repair or replacement is recommended.
- Drawers are damaged or difficult to operate.
- Flooring is damaged or deteriorated. Repair or replacement is recommended.
- Exposed wiring observed at the garbage disposal. This is a potential hazard. Proper installation is required.
- See photos.

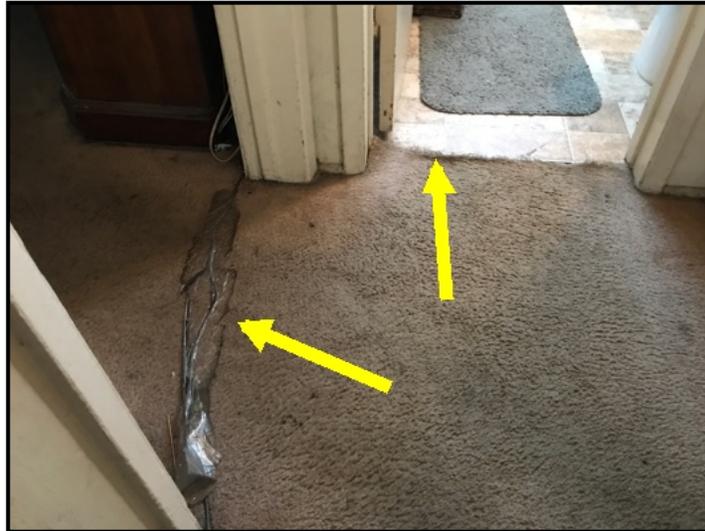
- Walls and ceiling appeared functional at time of inspection.
- No visible problems noted at the closet at time of inspection.
- A representative number of outlets, switches and fixtures was operated and found to be in operable condition at time of inspection.
- Flooring is damaged or deteriorated. Repair or replacement is recommended.

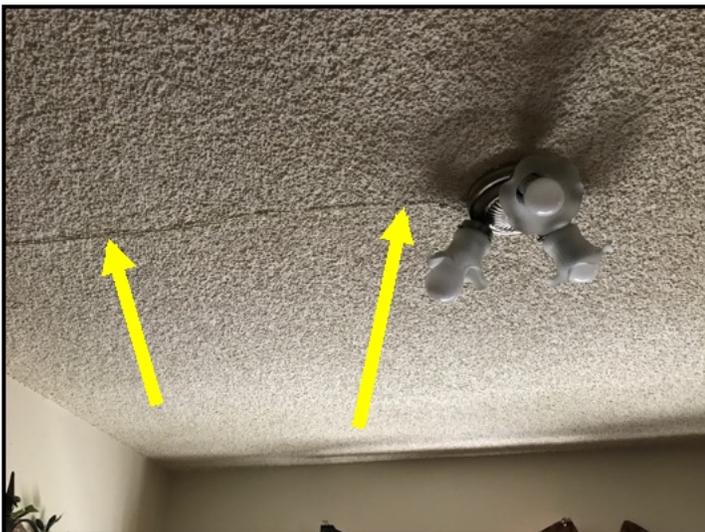
- Windows and doors operated properly at time of inspection.
- Walls and ceiling appeared functional at time of inspection.
- No visible problems noted at the floor at time of inspection.
- A representative number of outlets, switches and fixtures was operated and found to be in operable condition at time of inspection.
- **Smoke detector is not installed. A smoke detector is required in every bedroom, adjacent hallway and every level of the dwelling prior to the close of escrow.**
- **Window glass is cracked or broken. Replacement is required.**
- **Closet doors are fallen off the tracks. Proper installation is recommended.**
- **Improper installation of a light fixture on the ceiling. See photo. Proper installation or removal is required.**

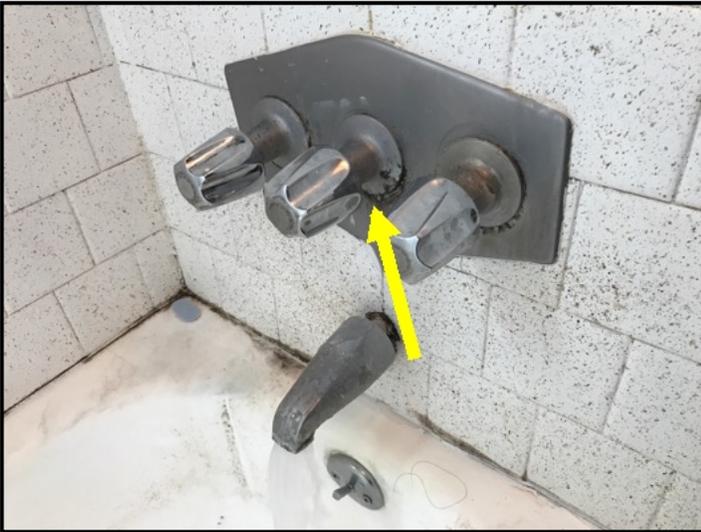
- Windows and doors operated properly at time of inspection.
- Walls and ceiling appeared functional at time of inspection.
- No visible floor problems noted at time of inspection.
- No visible electrical problems observed at time of inspection.
- **Tub faucet leaks when operated.**
- **Tub does not drain properly.**
- **Further evaluation and repairs as needed by a plumbing contractor is recommended.**
- **Caulking is recommended at the tub or shower areas to prevent moisture penetration and damage behind the walls.**
- **Ground Fault Circuit Interrupter (GFCI) outlets are recommended for installation.**

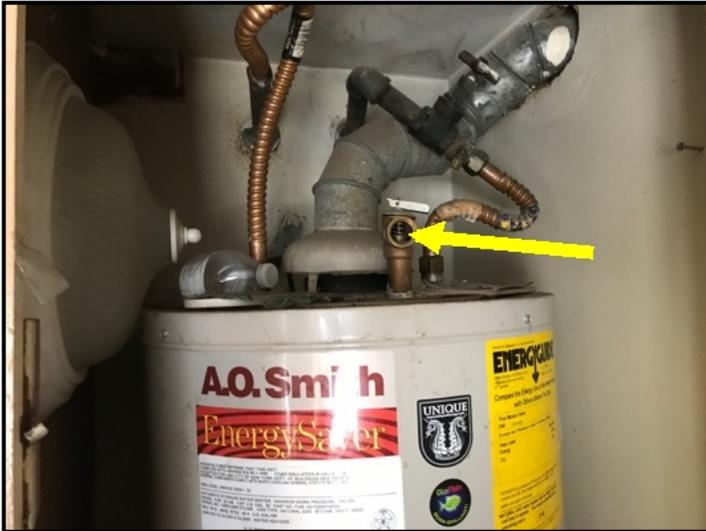
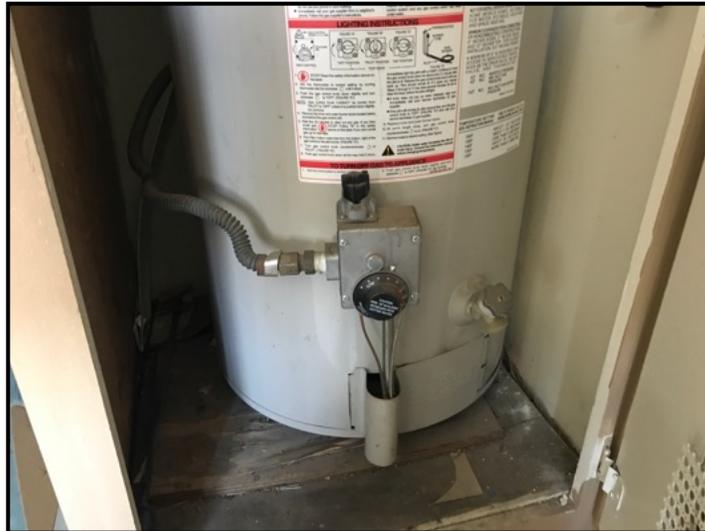
- Operated properly at time of the inspection.
- **Seismic straps are not installed on the heater. Installation of approved straps is required prior to the close of escrow.**
- **Temperature pressure relief valve discharge line is not installed. This is a potential hazard. Installation is required.**
- **Further evaluation and repairs by a plumbing contractor is recommended.**
- **See photo.**

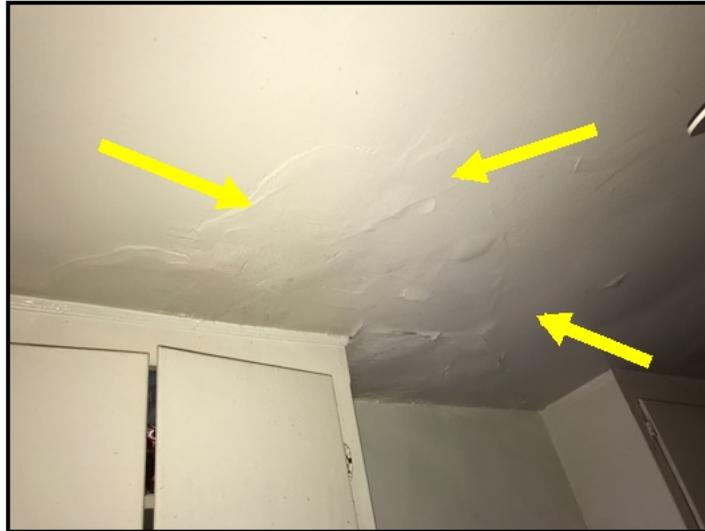
- Plumbing lines are functional at time of inspection.
- No visible problems noted at the counters and cabinets at time of inspection.
- Windows and doors operated properly at time of inspection.
- No visible problems noted at the floor at time of inspection.
- A representative number of outlets, switches and fixtures was operated and found to be in operable condition at time of inspection.
- **Window is difficult to operate. Repair or replacement is recommended.**
- **Moisture stains and/or damage viewed on the ceiling.**
- **Possible plumbing leak from dwelling above. Further evaluation by a plumbing contractor is recommended.**
- **Ground Fault Circuit Interrupter (GFCI) outlets are recommended for installation.**

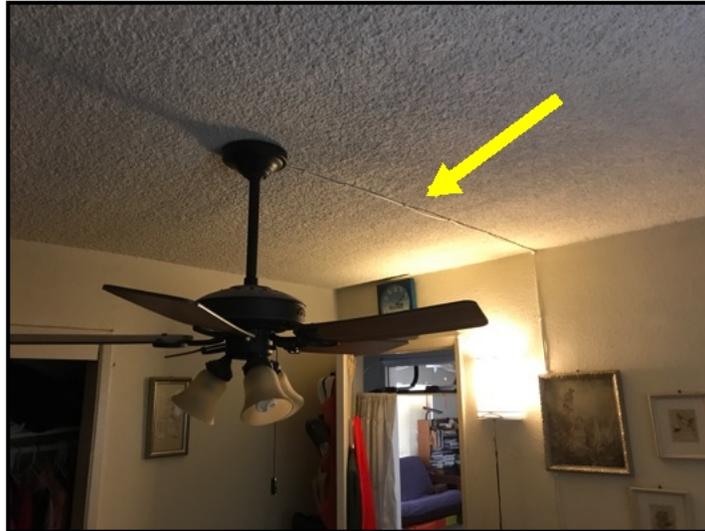
- Walls and ceiling appeared functional at time of inspection.
- No visible problems noted at the floor at time of inspection.
- A representative number of outlets, switches and fixtures was operated and found to be in operable condition at time of inspection.
- **Smoke detector is not installed. A smoke detector is required in every bedroom, adjacent hallway and every level of the dwelling prior to the close of escrow.**
- **Window is difficult to operate. Repair or replacement is recommended.**
- **Closet door is not installed. Installation is recommended.**
- **Improperly installed light fixture at the ceiling with romex stapled to the wall and ceiling. See photo. Removal is necessary.**

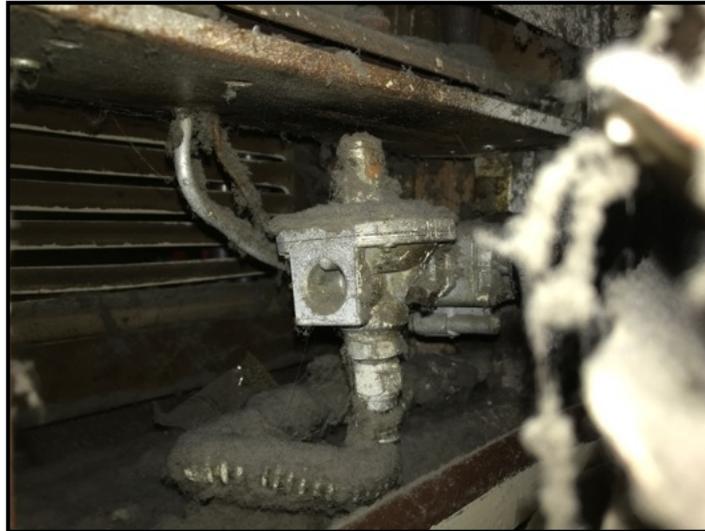
- Recommend cleaning the system thoroughly before using.
- Pilot light was not lit at time of inspection. Unable to inspect. Further evaluation by gas company is recommended.
- Unable to operate the mini split system at time of inspection. Unable to locate the control. Further evaluation is recommended.

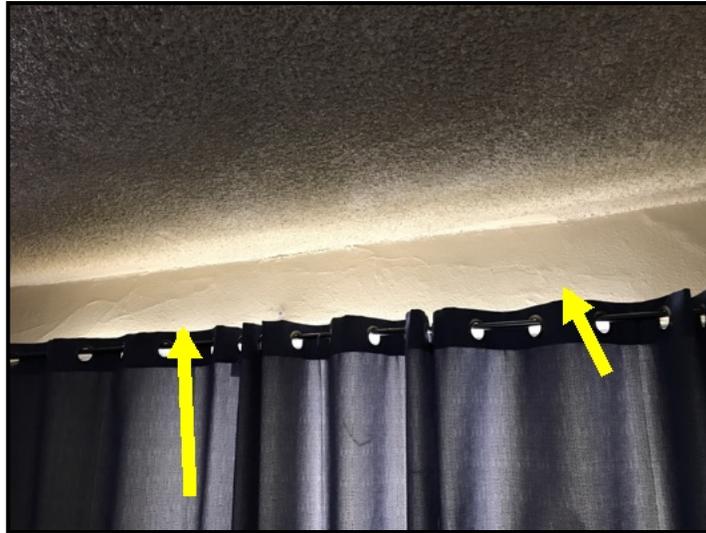
- Windows and doors operated properly at time of inspection.
- No visible problems noted at the floor at time of inspection.
- A representative number of outlets, switches and fixtures was operated and found to be in operable condition at time of inspection.
- **Moisture stains and/or damage viewed on the walls.**
- **Possible deck leak. Further evaluation by a roofing contractor is recommended.**

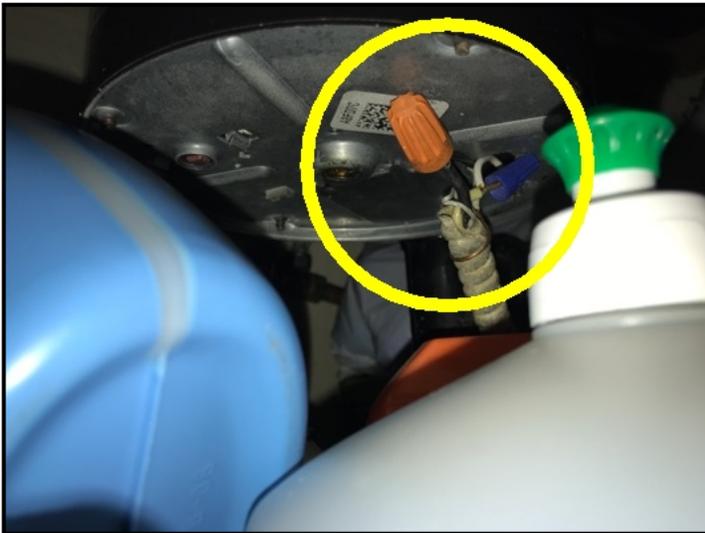
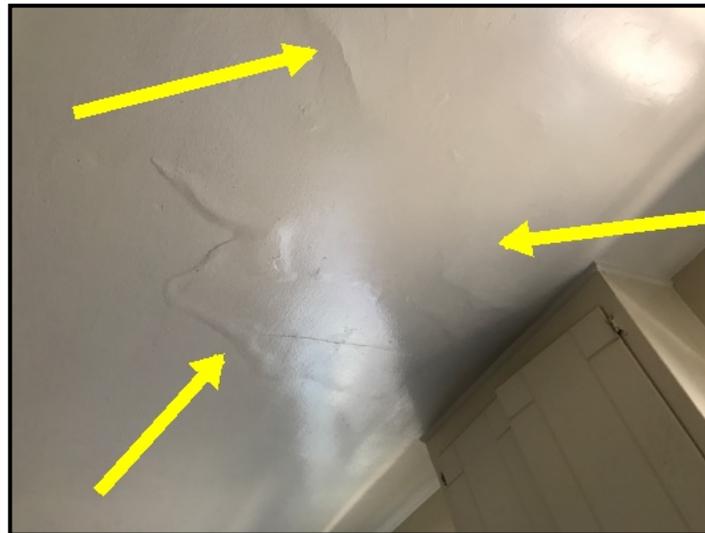
- **Caulking is recommended at the sink and backsplash areas to prevent moisture penetration and damage.**
- **Window is difficult to operate. Repair or replacement is recommended.**

- **Moisture stains and/or damage viewed on the ceiling.**
- **Possible plumbing leak from dwelling above. Further evaluation by a plumbing contractor is recommended.**

- **Ground Fault Circuit Interrupter (GFCI) outlets are recommended for installation.**
- **Exposed wiring observed at the garbage disposal. This is a potential hazard. Proper installation is required.**

- **A licensed plumbing contractor should be called to make necessary repairs.**
- **See photos.**

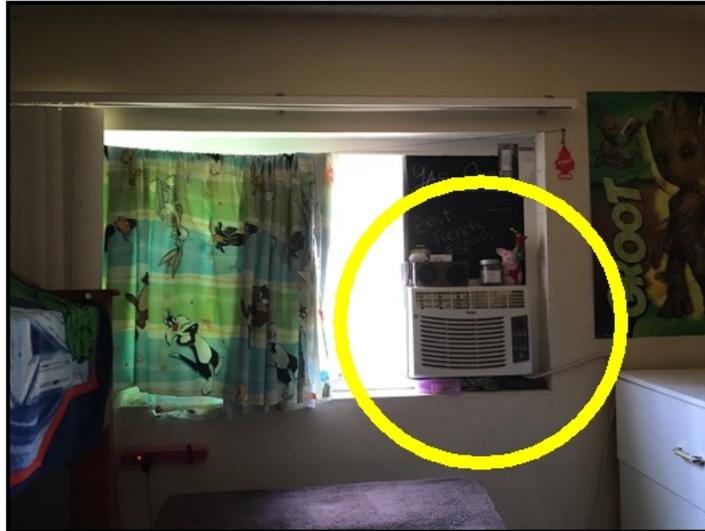
- Smoke detector is installed.
- Windows and doors operated properly at time of inspection.
- Walls and ceiling appeared functional at time of inspection.
- No visible problems noted at the closet at time of inspection.
- No visible problems noted at the floor at time of inspection.
- A representative number of outlets, switches and fixtures was operated and found to be in operable condition at time of inspection.
- **Inadequate egress observe that bedroom. Air-conditioner is installed in the only bedroom window. This is not allowed by code. Removal is required.**

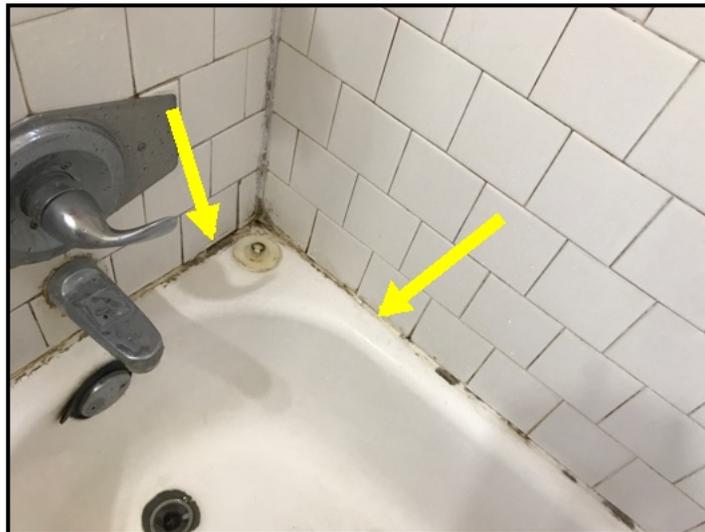
- No visible plumbing problems noted at time of inspection.
- Windows and doors operated properly at time of inspection.
- Walls and ceiling appeared functional at time of inspection.
- No visible floor problems noted at time of inspection.
- No visible electrical problems observed at time of inspection.
- Tub surround wall tiles are loose and or damaged. Repair or replacement is recommended.
- Ground Fault Circuit Interrupter (GFCI) outlets are recommended for installation.

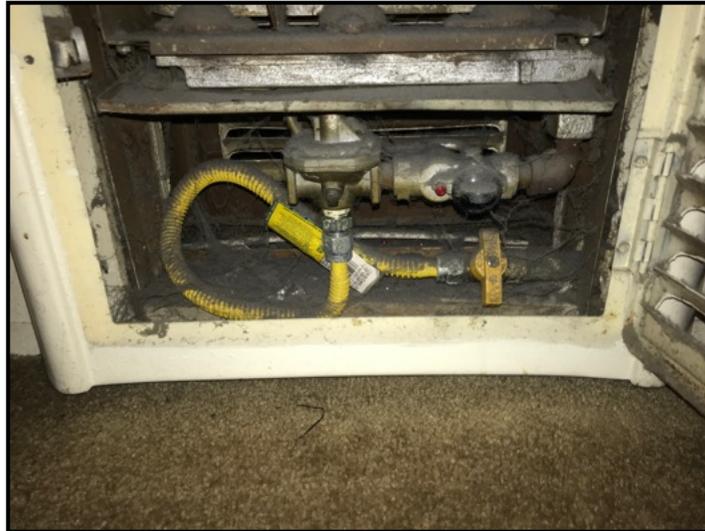
- Recommend cleaning the system thoroughly before using.
- Pilot light was not lit at time of inspection. Unable to inspect. Further evaluation by gas company is recommended.

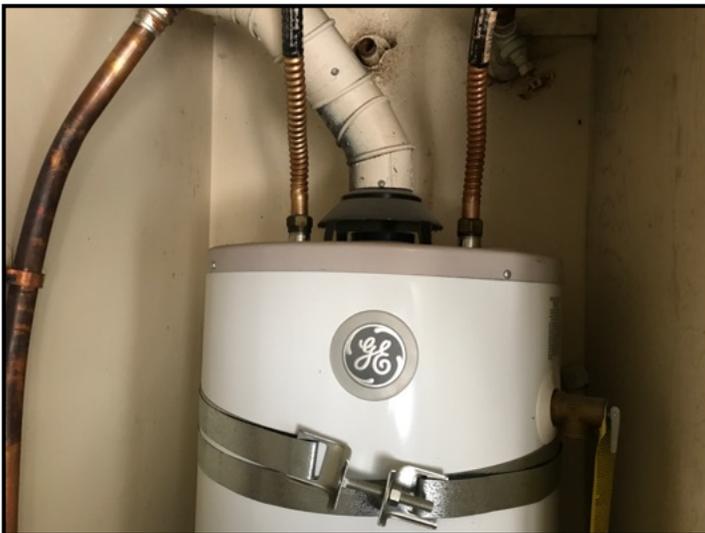
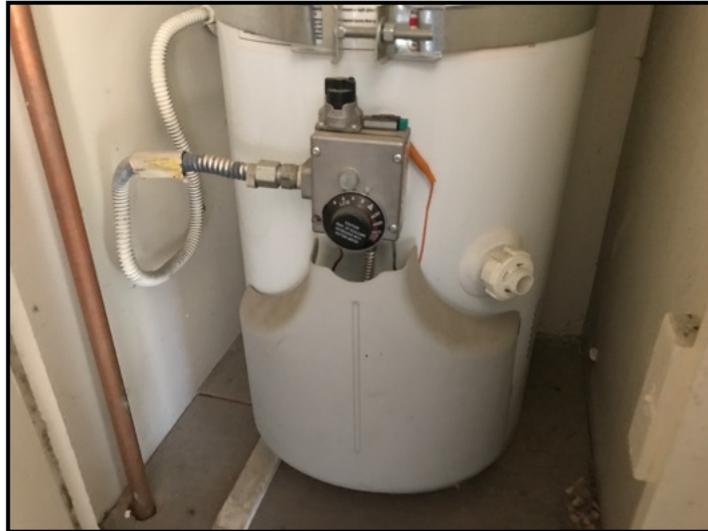
- Operated properly at time of the inspection.
- **Temperature pressure relief valve discharge line is not installed. This is a potential hazard. Installation is required.**

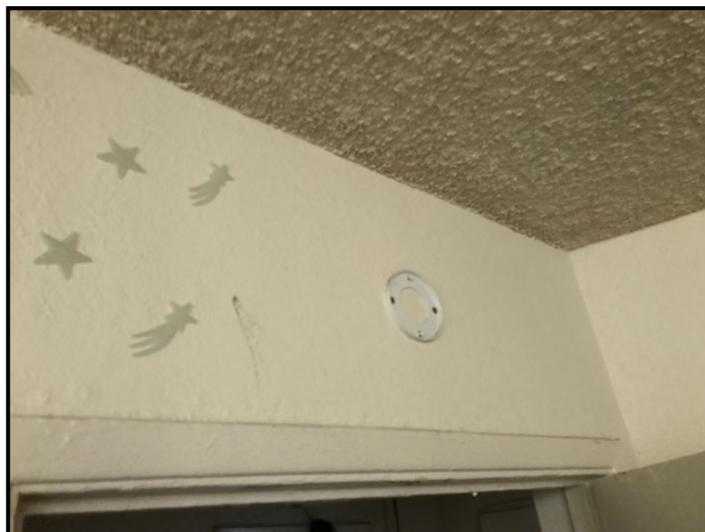
- Smoke detector is not installed. A smoke detector is required in every bedroom, adjacent hallway and every level of the dwelling prior to the close of escrow.
- Windows and doors operated properly at time of inspection.
- Walls and ceiling appeared functional at time of inspection.
- No visible problems noted at the closet at time of inspection.
- No visible problems noted at the floor at time of inspection.
- A representative number of outlets, switches and fixtures was operated and found to be in operable condition at time of inspection.

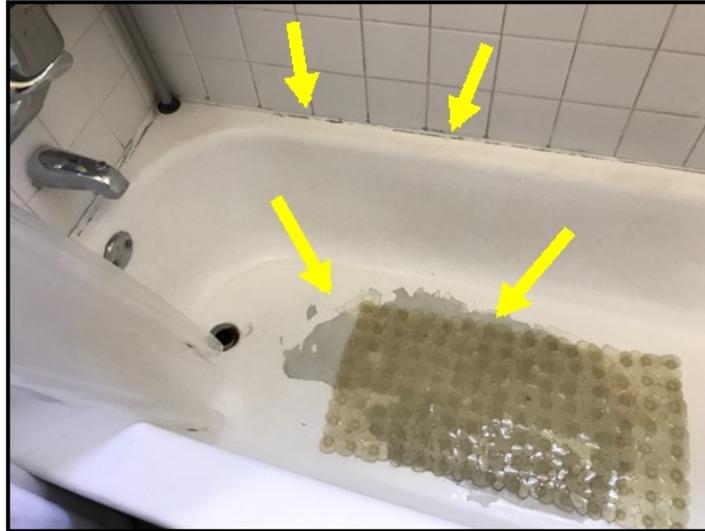
- No visible plumbing problems noted at time of inspection.
- Windows and doors operated properly at time of inspection.
- Walls and ceiling appeared functional at time of inspection.
- No visible floor problems noted at time of inspection.
- No visible electrical problems observed at time of inspection.
- Tub surface is damaged. Repair and or resurfacing is recommended.
- Caulking is recommended at the tub or shower areas to prevent moisture penetration and damage behind the walls.
- Ground Fault Circuit Interrupter (GFCI) outlets are recommended for installation.

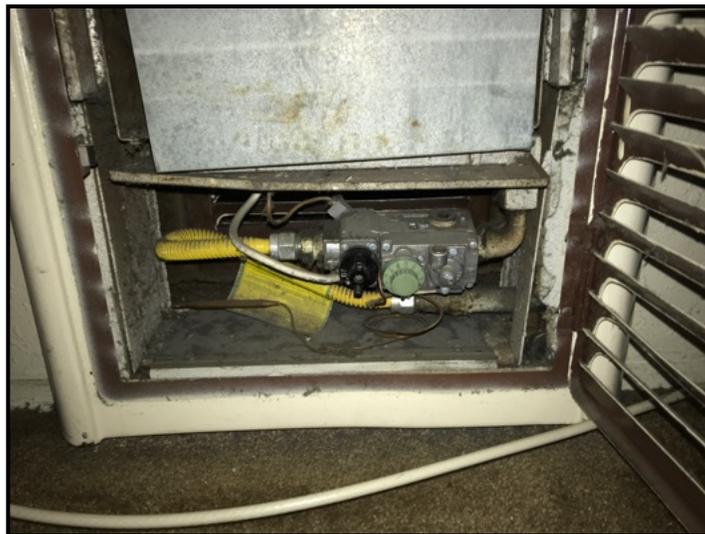
## 6. Heating System Condition

- Recommend cleaning the system thoroughly before using.
- Pilot light was not lit at time of inspection. Unable to inspect. Further evaluation by gas company is recommended.

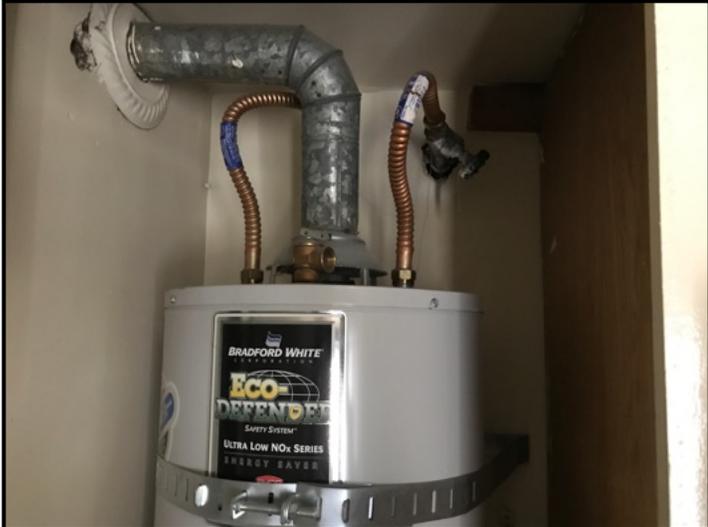
### 7. Water Heater Condition

- Operated properly at time of the inspection.
- **Temperature pressure relief valve discharge line is not installed. This is a potential hazard. Installation is required.**

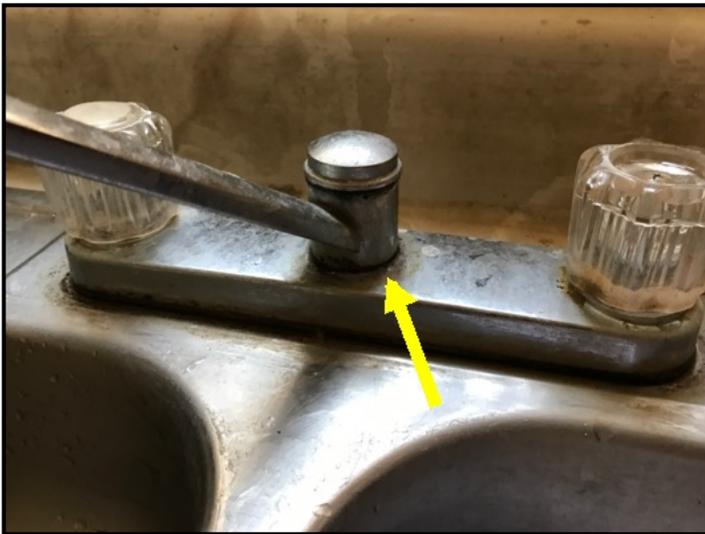
- No visible problems noted at the counters and cabinets at time of inspection.
- Windows and doors operated properly at time of inspection.
- No visible problems noted at the floor at time of inspection.
- A representative number of outlets, switches and fixtures was operated and found to be in operable condition at time of inspection.
- Leaks noted at the faucet at time of inspection.
- Drain lines leak under the sink.
- A licensed plumbing contractor should be called to make necessary repairs.
- Moisture stains and/or damage viewed on the ceiling.
- Possible plumbing leak from dwelling above. Further evaluation by a plumbing contractor is recommended.
- Ground Fault Circuit Interrupter (GFCI) outlets are recommended for installation.

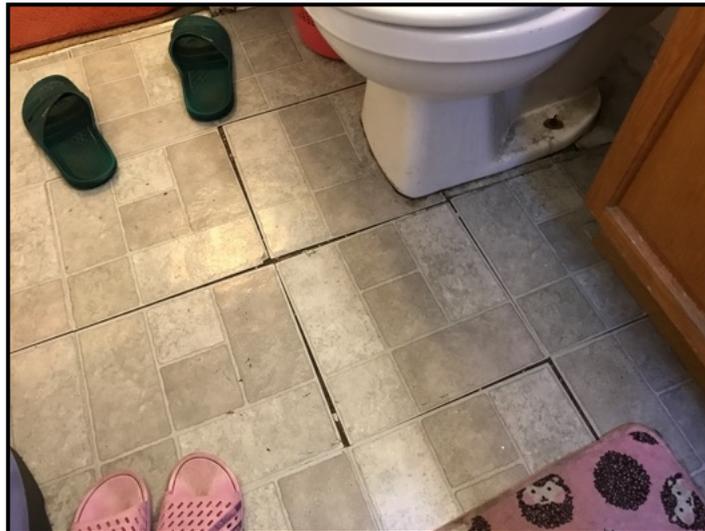
- No visible plumbing problems noted at time of inspection.
- Windows and doors operated properly at time of inspection.
- Walls and ceiling appeared functional at time of inspection.
- No visible electrical problems observed at time of inspection.
- Floor tiles are damaged or loose. Repair or replacement is recommended.
- Ground Fault Circuit Interrupter (GFCI) outlets are recommended for installation.

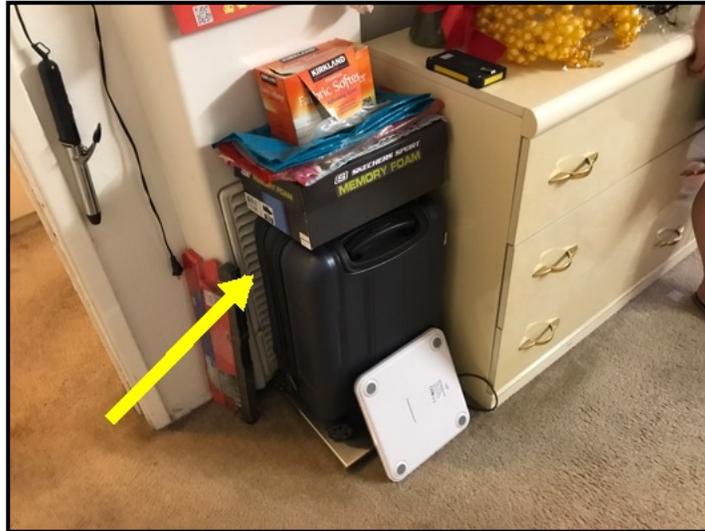
## 6. Heating System Condition

- Unable to inspect heater at time of the inspection. Heater is blocked by occupants belongings or furniture. Further evaluation by the gas company is recommended.

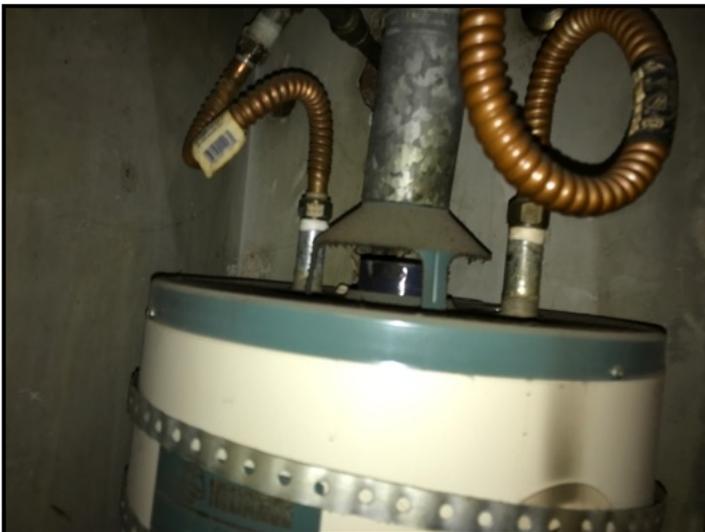
## 7. Water Heater Condition

- Operated properly at time of the inspection.
- Seismic straps are not installed on the heater. Installation of approved straps is required prior to the close of escrow.
- Temperature pressure relief valve discharge line is not installed. This is a potential hazard. Installation is required.
- Heater is over 15 years old. Unit has exceeded it's useful life. Although no problems may exist at time of inspection, the lifespan of a water heater is normally between 5 to 12 years. You may want to consider replacing with a newer unit for increased efficiency.

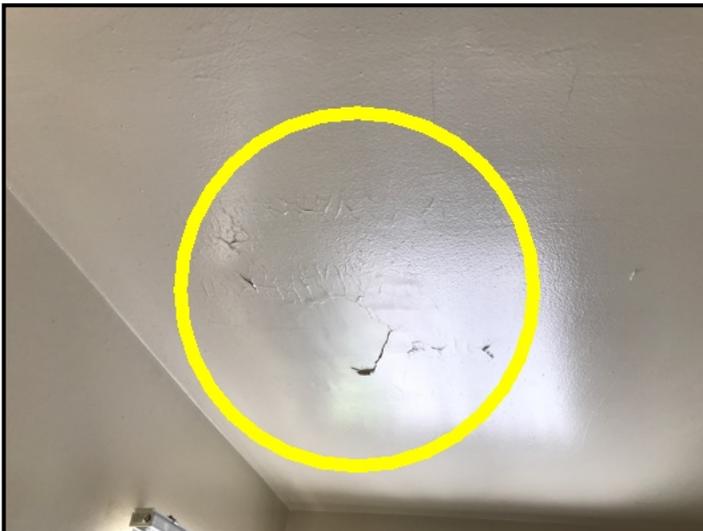
- Plumbing lines are functional at time of inspection.
- Drawers are damaged or difficult to operate.
- Caulking is recommended at the sink and backsplash areas to prevent moisture penetration and damage.
- Window is difficult to operate. Repair or replacement is recommended.
- Moisture stains and/or damage viewed on the ceiling.
- Possible roof leak. Further evaluation by a roofing contractor is recommended.
- Flooring is damaged or deteriorated. Repair or replacement is recommended.

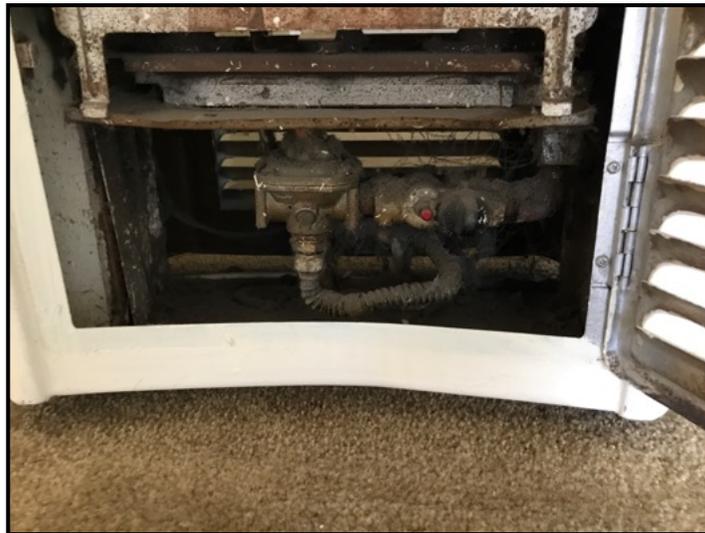
## 7. Heating System Condition

- **Recommend cleaning the system thoroughly before using.**
- **Pilot light was not lit at time of inspection. Unable to inspect. Further evaluation by gas company is recommended.**

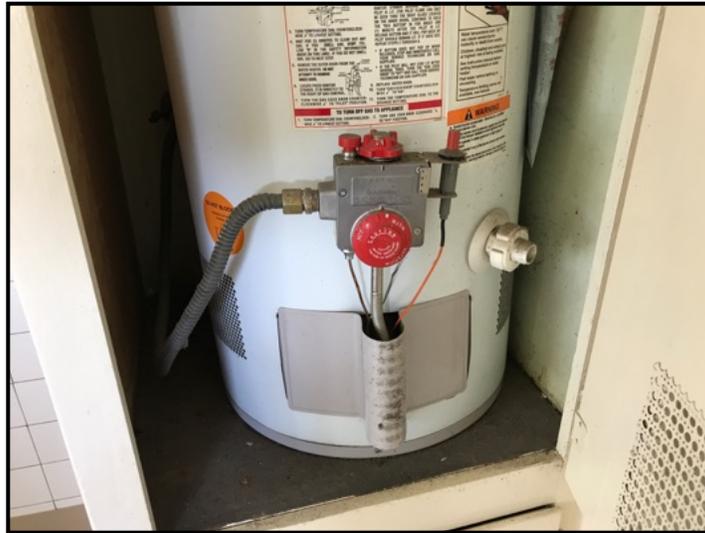
## 8. Water Heater Condition

- Operated properly at time of the inspection.
- **Seismic straps are not installed on the heater. Installation of approved straps is required prior to the close of escrow.**
- **Temperature pressure relief valve discharge line is not installed. This is a potential hazard. Installation is required.**

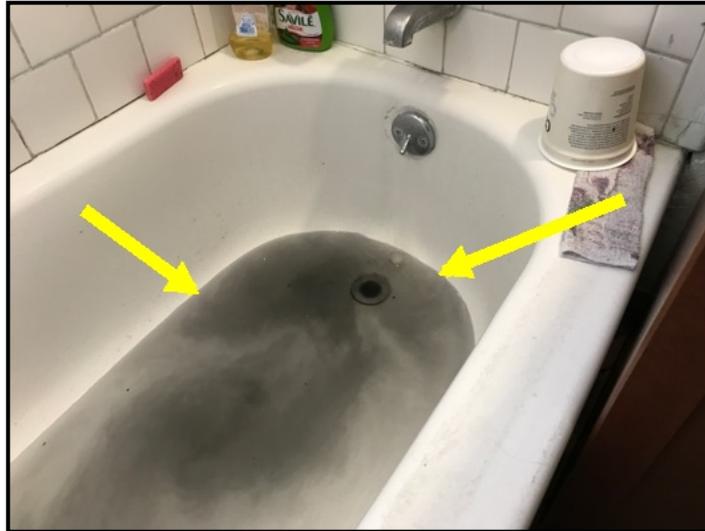
- Windows and doors operated properly at time of inspection.
- Walls and ceiling appeared functional at time of inspection.
- No visible floor problems noted at time of inspection.
- No visible electrical problems observed at time of inspection.
- **Tub does not drain properly.**
- **Further evaluation and repairs as needed by a plumbing contractor is recommended.**
- **See photos.**
- **Caulking is recommended at the tub or shower areas to prevent moisture penetration and damage behind the walls.**
- **Ground Fault Circuit Interrupter (GFCI) outlets are recommended for installation.**

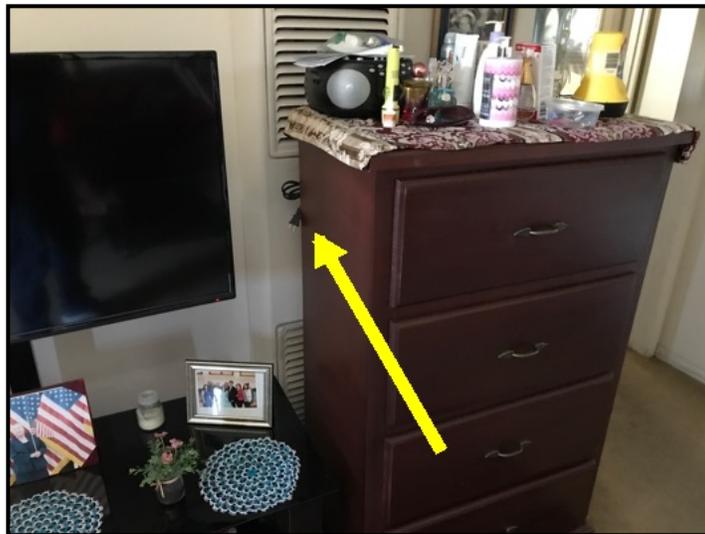
## 6. Heating System Condition

- Unable to inspect heater at time of the inspection. Heater is blocked by occupants belongings or furniture. Further evaluation by the gas company is recommended.

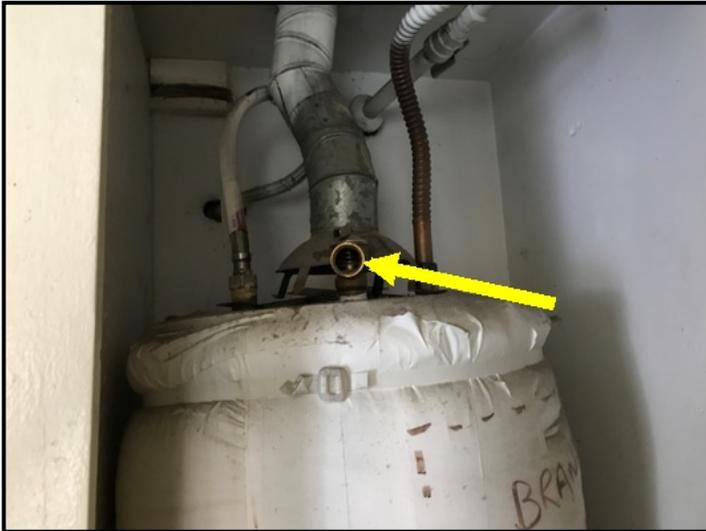
## 7. Water Heater Condition

- Operated properly at time of the inspection.
- Seismic straps are not installed on the heater. Installation of approved straps is required prior to the close of escrow.
- Heater is over 15 years old. Unit has exceeded it's useful life. Although no problems may exist at time of inspection, the lifespan of a water heater is normally between 5 to 12 years. You may want to consider replacing with a newer unit for increased efficiency.
- Temperature pressure relief valve discharge line is not installed. This is a potential hazard. Installation is required.

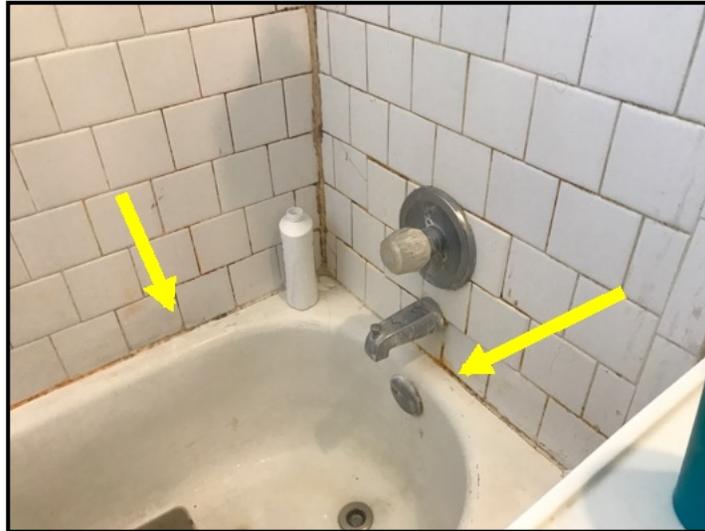
- No visible plumbing problems noted at time of inspection.
- Windows and doors operated properly at time of inspection.
- Walls and ceiling appeared functional at time of inspection.
- No visible floor problems noted at time of inspection.
- No visible electrical problems observed at time of inspection.
- **Tub surround wall tiles are loose and or damaged. Repair or replacement is recommended.**
- **Ground Fault Circuit Interrupter (GFCI) outlets are recommended for installation.**

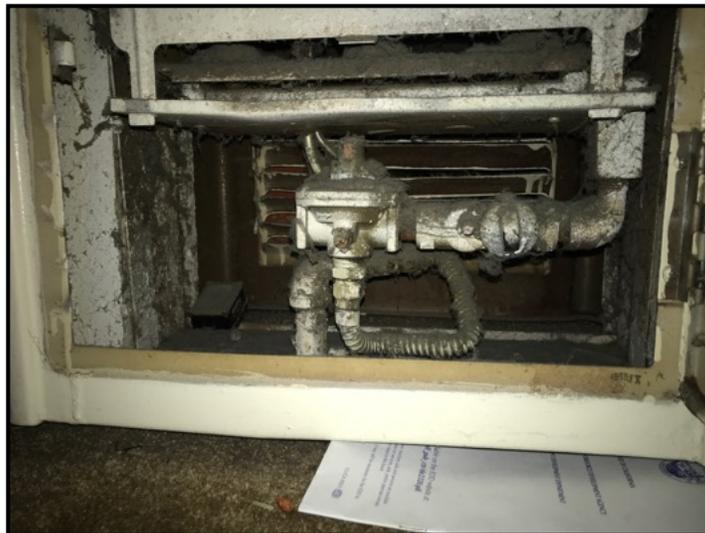
## 6. Heating System Condition

- Recommend cleaning the system thoroughly before using.
- Pilot light was not lit at time of inspection. Unable to inspect. Further evaluation by gas company is recommended.

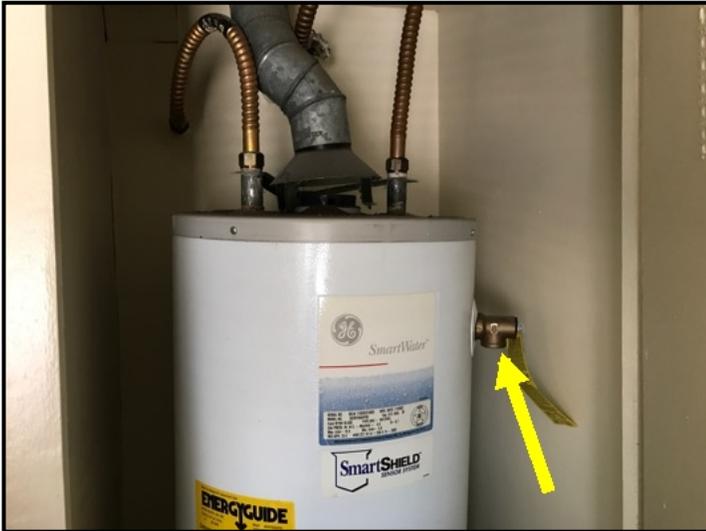
## 7. Water Heater Condition

- Operated properly at time of the inspection.
- Seismic straps are not installed on the heater. Installation of approved straps is required prior to the close of escrow.
- Heater is over 15 years old. Unit has exceeded its useful life. Although no problems may exist at time of inspection, the lifespan of a water heater is normally between 5 to 12 years. You may want to consider replacing with a newer unit for increased efficiency.
- Temperature pressure relief valve discharge line is not installed. This is a potential hazard. Installation is required.
- See photo.

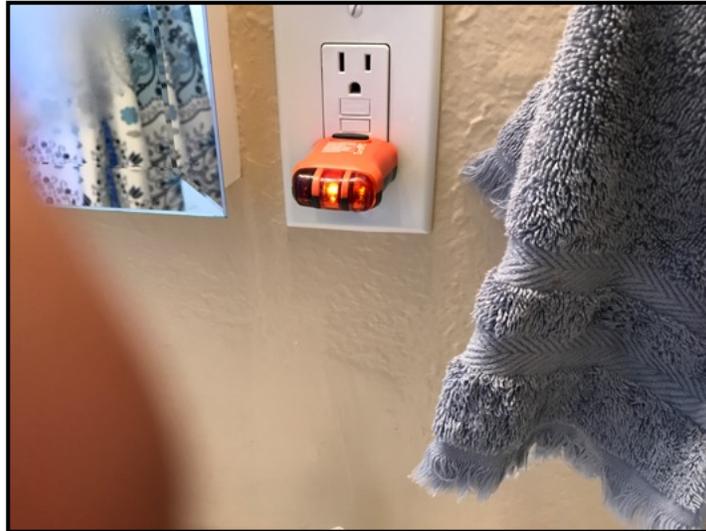
- No visible plumbing problems noted at time of inspection.
- Sink surface is damaged. Resurfacing or replacement is recommended.
- Windows and doors operated properly at time of inspection.
- Walls and ceiling appeared functional at time of inspection.
- No visible floor problems noted at time of inspection.
- **GFCI outlet did not operate properly at time of inspection. Repair or replacement is recommended.**

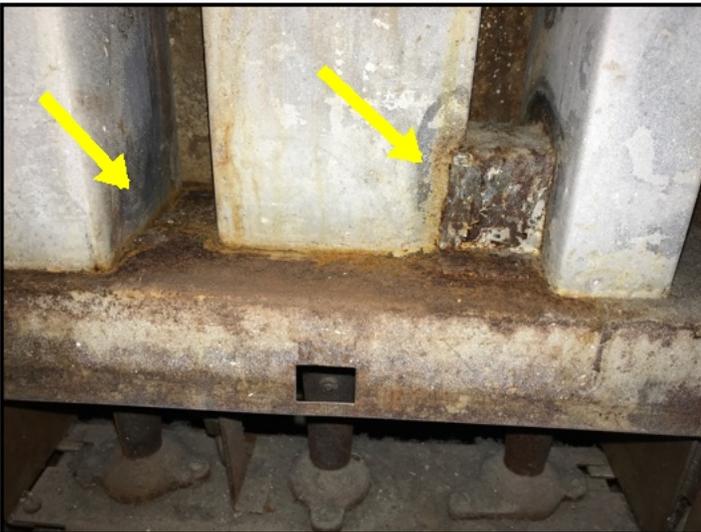
## 6. Heating System Condition

- Rust damage at the burners
- Recommend cleaning the system thoroughly before using.
- Pilot light was not lit at time of inspection. Unable to inspect. Further evaluation by gas company is recommended.

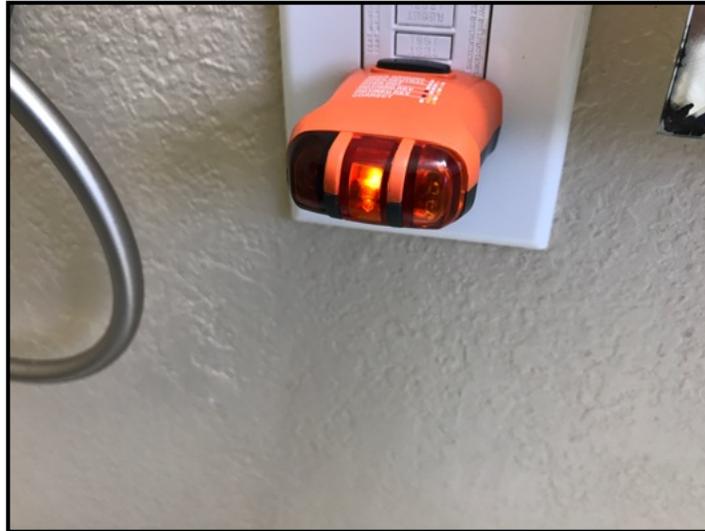
- No visible plumbing problems noted at time of inspection.
- Windows and doors operated properly at time of inspection.
- Walls and ceiling appeared functional at time of inspection.
- No visible floor problems noted at time of inspection.
- **GFCI outlet did not operate properly at time of inspection. Repair or replacement is recommended.**

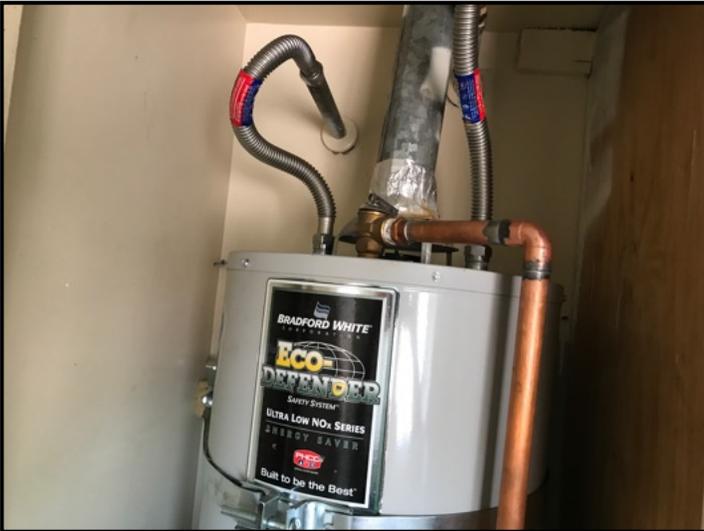
## 7. Water Heater Condition

- Operated properly at time of the inspection.
- Leaks note at the water supply lines.
- Further evaluation and repairs by a plumbing contractor is recommended.
- See photo.

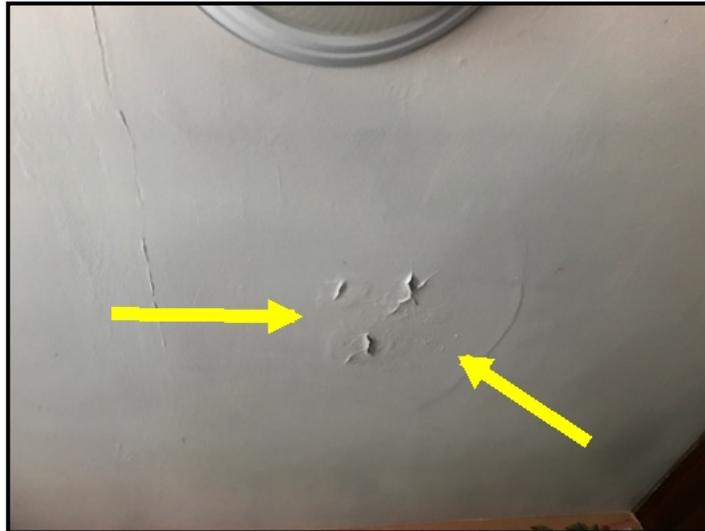
- Plumbing lines are functional at time of inspection.
- No visible problems noted at the counters and cabinets at time of inspection.
- Windows and doors operated properly at time of inspection.
- No visible problems noted at the floor at time of inspection.
- A representative number of outlets, switches and fixtures was operated and found to be in operable condition at time of inspection.
- **Moisture stains and/or damage viewed on the ceiling.**
- **Possible roof leak. Further evaluation by a roofing contractor is recommended.**
- **Ground Fault Circuit Interrupter (GFCI) outlets are recommended for installation.**

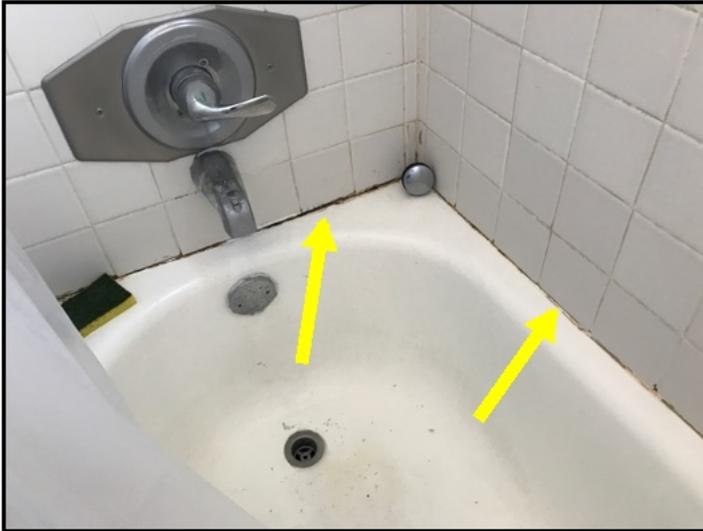
- No visible plumbing problems noted at time of inspection.
- Windows and doors operated properly at time of inspection.
- Walls and ceiling appeared functional at time of inspection.
- No visible floor problems noted at time of inspection.
- No visible electrical problems observed at time of inspection.
- Tub surround wall tiles are loose and or damaged. Repair or replacement is recommended.
- Caulking is recommended at the tub or shower areas to prevent moisture penetration and damage behind the walls.
- Ground Fault Circuit Interrupter (GFCI) outlets are recommended for installation.

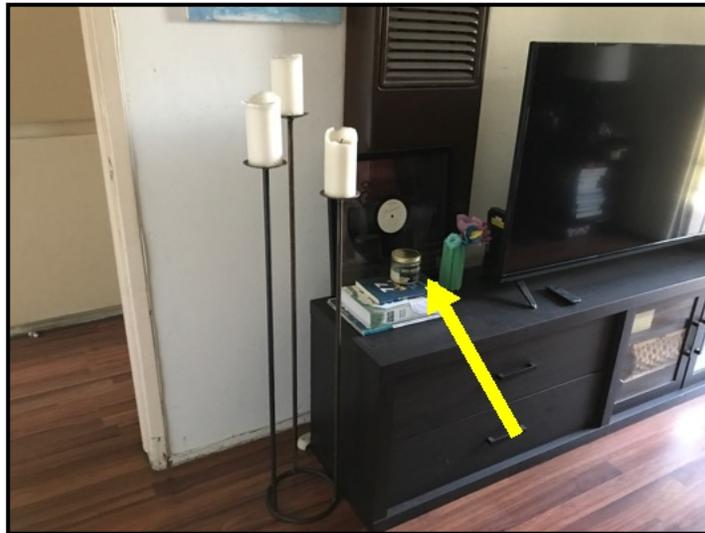
#### 5. Heating System Condition

- Unable to inspect heater at time of the inspection. Heater is blocked by occupants belongings or furniture. Further evaluation by the gas company is recommended.

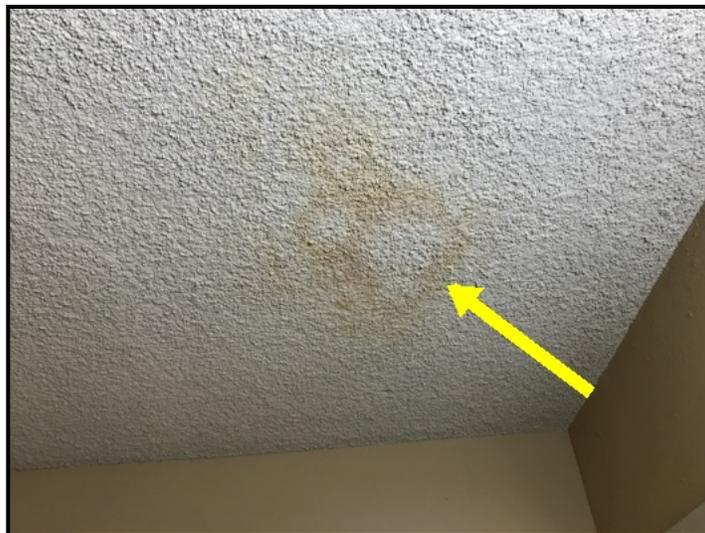
- Windows and doors operated properly at time of inspection.
- No visible problems noted at the closet at time of inspection.
- No visible problems noted at the floor at time of inspection.
- A representative number of outlets, switches and fixtures was operated and found to be in operable condition at time of inspection.
- **Smoke detector is not installed. A smoke detector is required in every bedroom, adjacent hallway and every level of the dwelling prior to the close of escrow.**
- **Moisture stains and/or damage viewed on the ceiling.**
- **Possible roof leak. Further evaluation by a roofing contractor is recommended.**

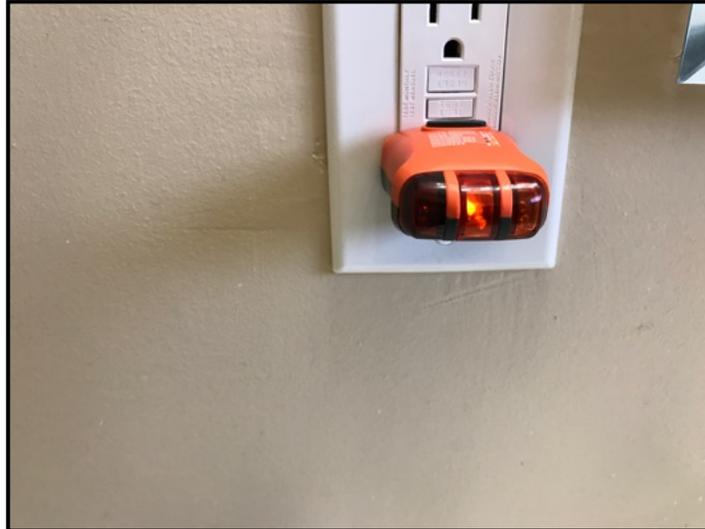
## 5. Bathrooms

- No visible plumbing problems noted at time of inspection.
- Windows and doors operated properly at time of inspection.
- Walls and ceiling appeared functional at time of inspection.
- No visible floor problems noted at time of inspection.
- **GFCI outlet did not operate properly at time of inspection. Repair or replacement is recommended.**
