# Villa Home Inspections

## Property Inspection Report

12345 Commercial Lane, Los Angeles, CA 90001  
Inspection prepared for: John Doe  
Real Estate Agent: - -

Date of Inspection: 7/30/2019 Time: 11:00 a.m.

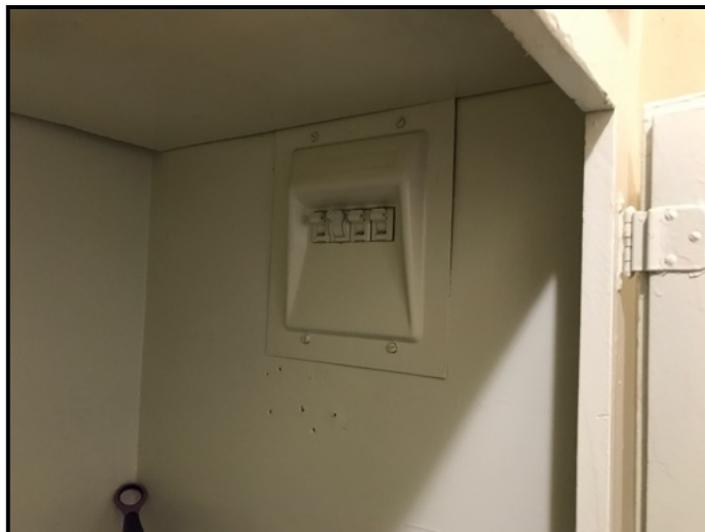
## 6. Electrical Panel Condition

- **Unable to remove electrical panel cover. Panel cover has been painted/sealed to the wall and removal would cause damage to the surrounding wall. Access to the interior of the panel is required.**

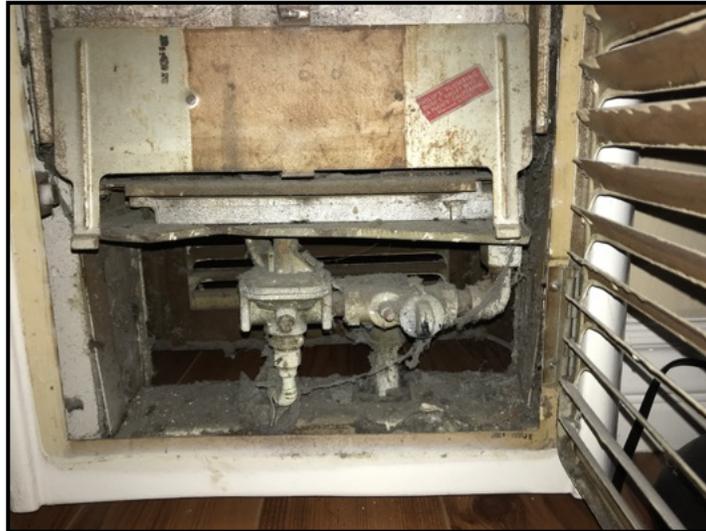
## 7. Heating System Condition

- **Recommend cleaning the system thoroughly before using.**
- **Pilot light was not lit at time of inspection. Unable to inspect. Further evaluation by gas company is recommended.**

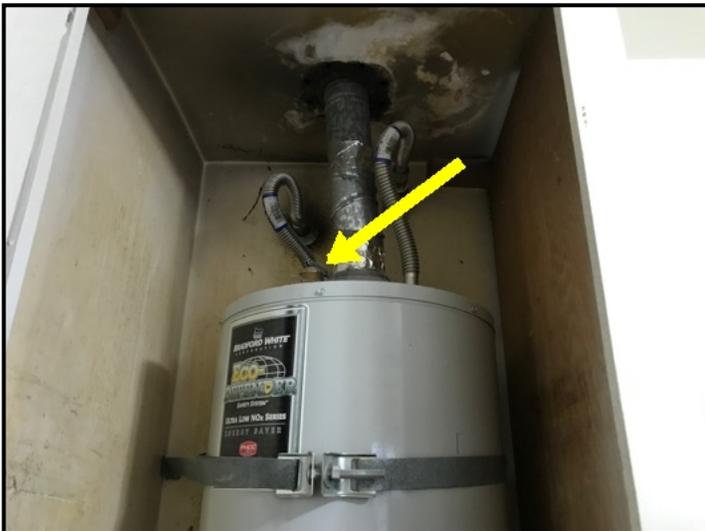
## 8. Water Heater Condition

- Operated properly at time of the inspection.
- Temperature pressure relief valve discharge line is not installed. This is a potential hazard. Installation is required.
- Moisture stains and damage observed on the ceiling surrounding the vent pipe. Possible roof leak. Further evaluation by a roofing contractor is recommended.
- Further evaluation and repairs by a plumbing contractor is recommended.
- See photo.

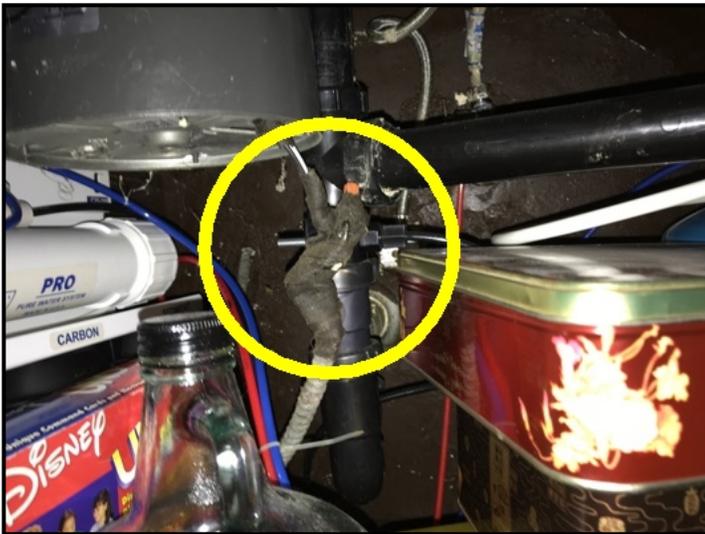
- Plumbing lines are functional at time of inspection.
- No visible problems noted at the counters and cabinets at time of inspection.
- Walls and ceiling appeared functional at time of inspection.
- Flooring is damaged or deteriorated. Repair or replacement is recommended.
- A representative number of outlets, switches and fixtures was operated and found to be in operable condition at time of inspection.
- Window is difficult to operate. Repair or replacement is recommended.
- Ground Fault Circuit Interrupter (GFCI) outlets are recommended for installation.
- See photos.
- Exposed wiring at the garbage disposal

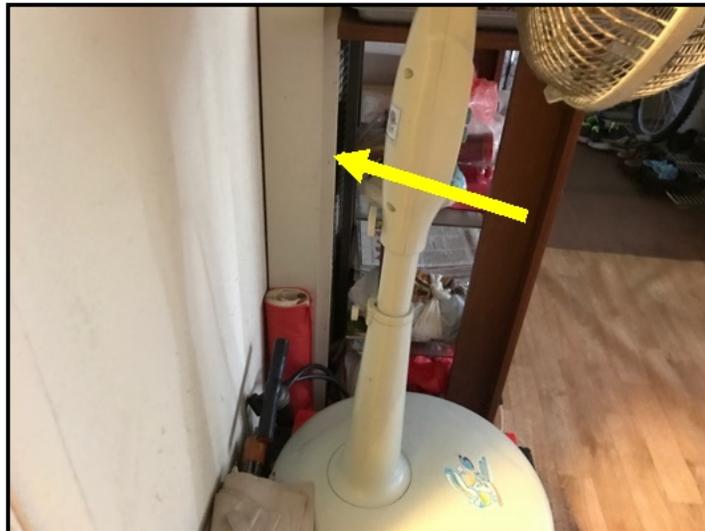
## 7. Heating System Condition

- **Unable to inspect heater at time of the inspection. Heater is blocked by occupants belongings or furniture. Further evaluation by the gas company is recommended.**

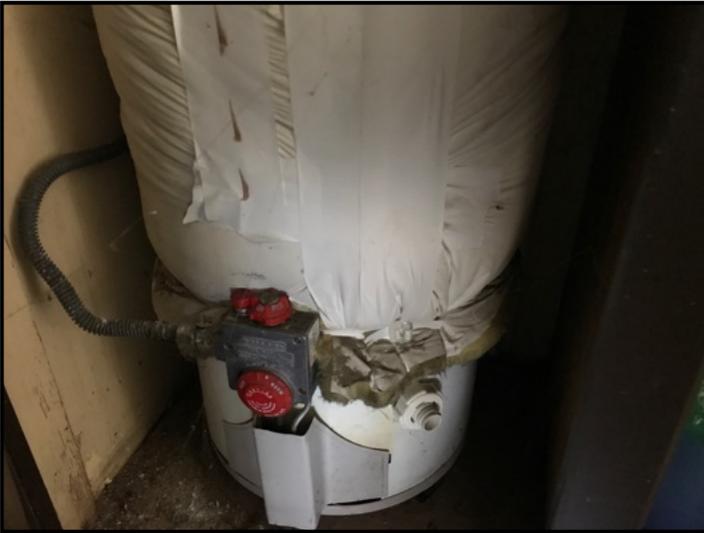
## 8. Water Heater Condition

- Operated properly at time of the inspection.
- **Seismic straps are not installed on the heater. Installation of approved straps is required prior to the close of escrow.**
- **Temperature pressure relief valve discharge line is not installed. This is a potential hazard. Installation is required.**
- **Moisture stains and damage observed on the ceiling surrounding the vent pipe. Possible roof leak. Further evaluation by a roofing contractor is recommended.**
- **Further evaluation and repairs by a plumbing contractor is recommended.**
- **See photo.**
