PROPERTY INSPECTION REPORT

12345 Main Street, Anytown, CA 90001

DATE OF INSPECTION: 12/9/2022

VILLA HOME INSPECTIONS

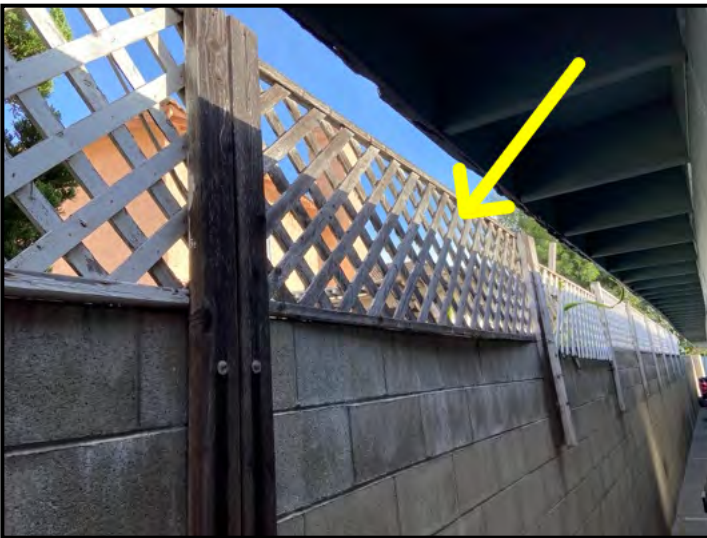
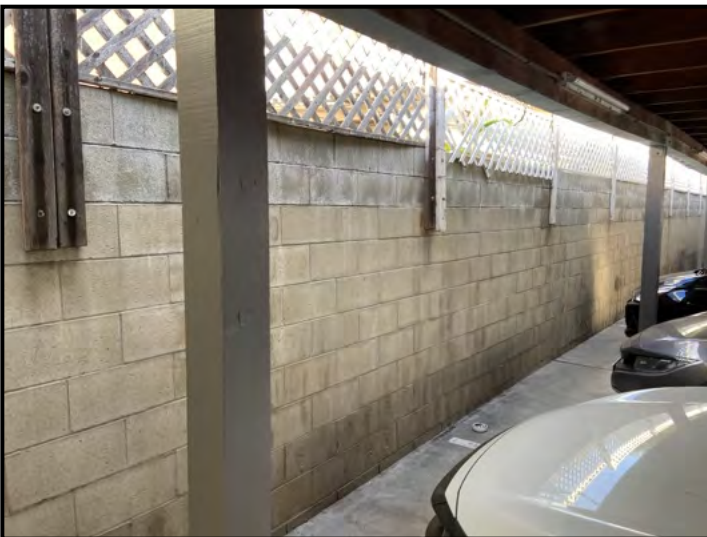
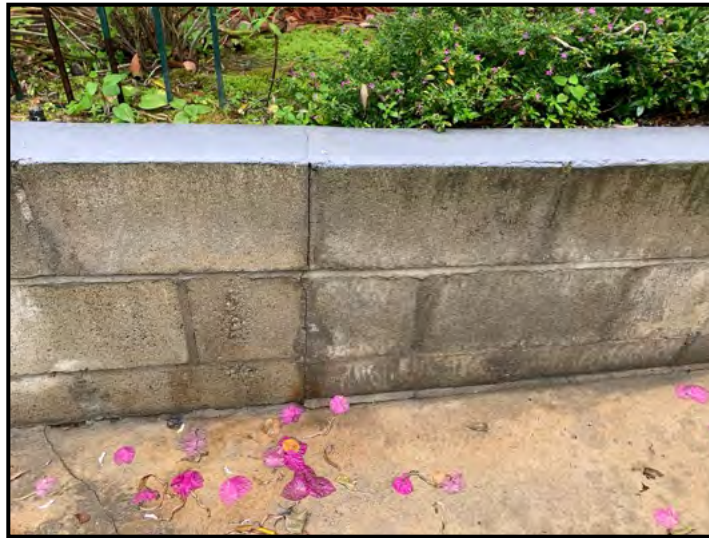
- Fencing appears functional.
- Common cracks noted on the block walls.
- See photos.
- Fence is leaning or falling. Repair or replacement is recommended.
- Paint finish is deteriorated or flaking. Repainting is recommended to prevent moisture damage.
- See photos.

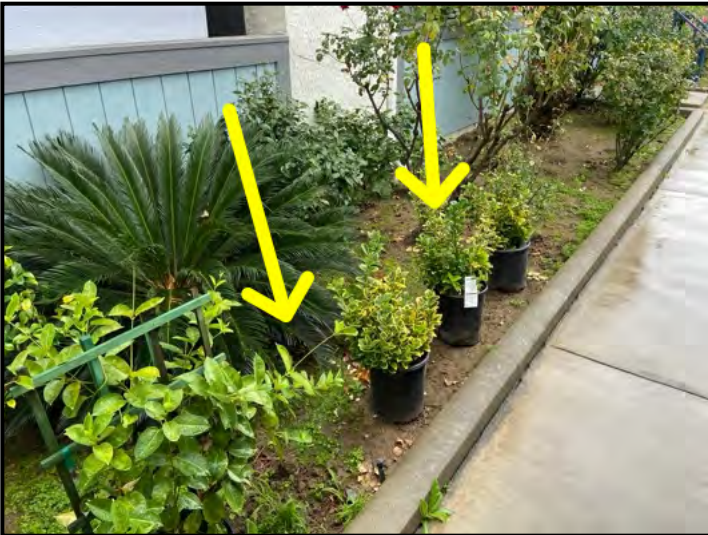
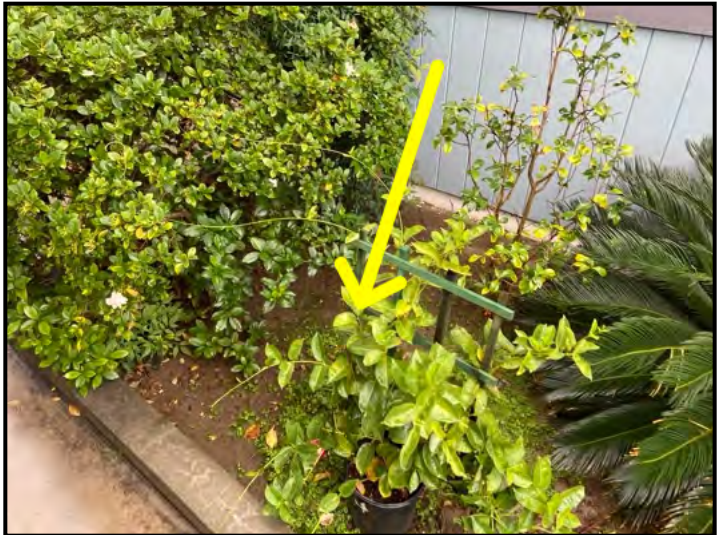
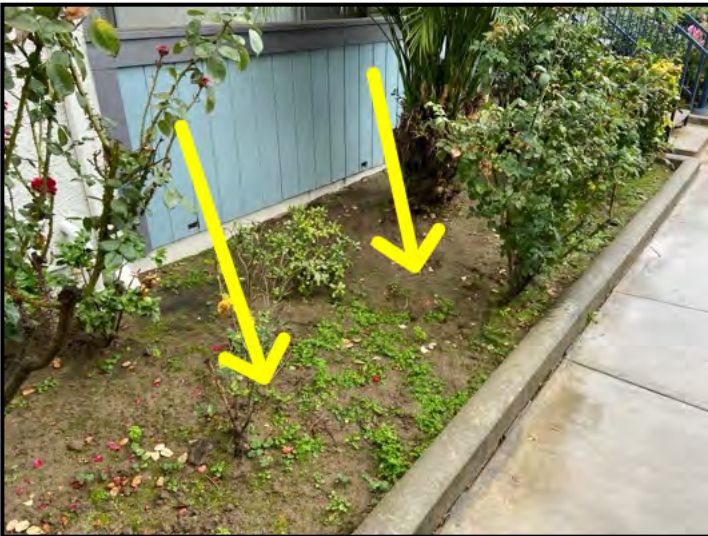
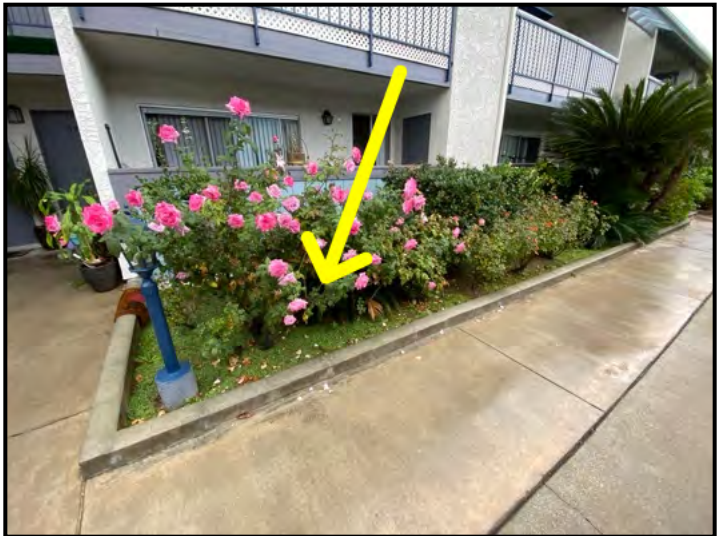
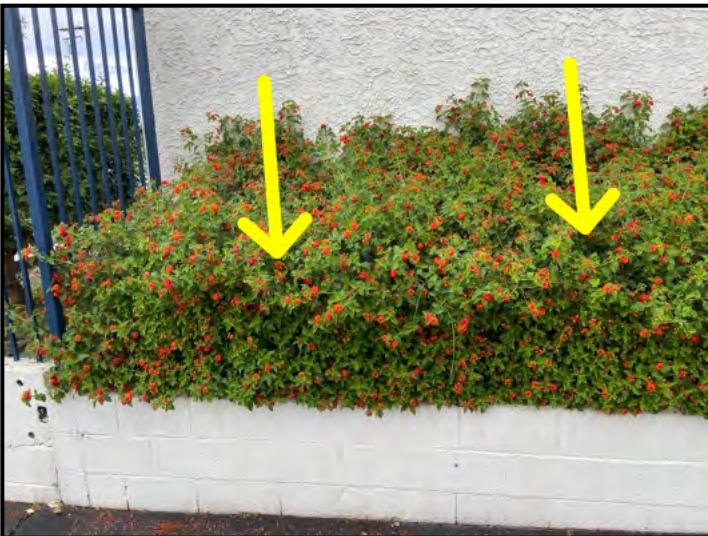
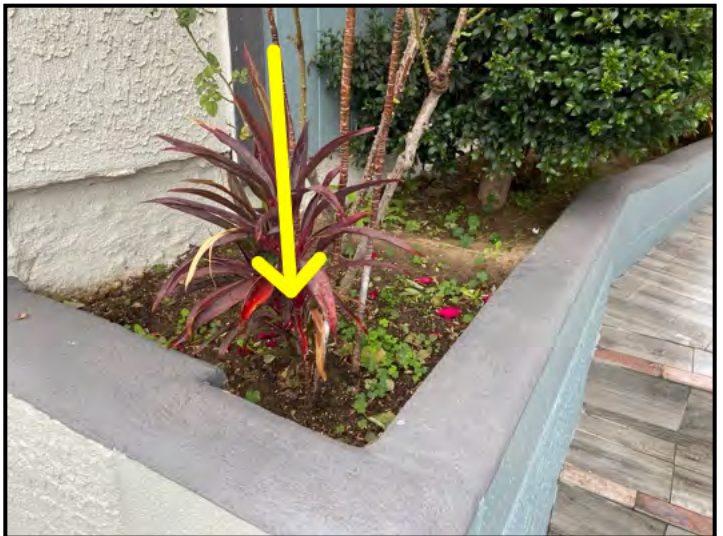
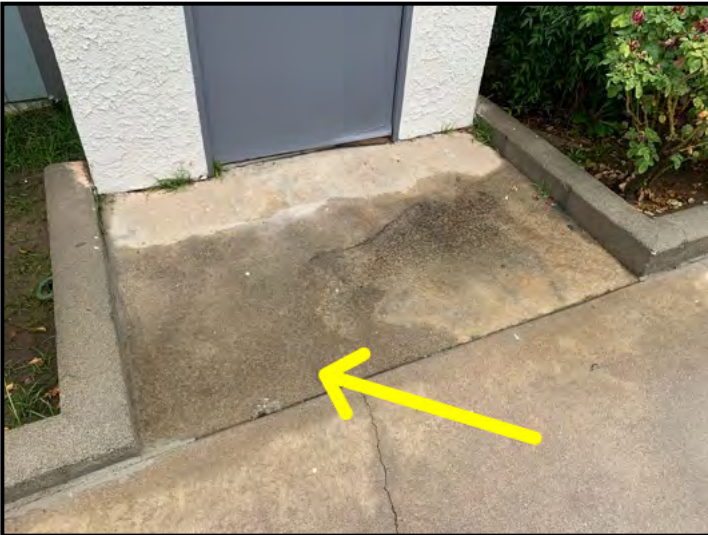
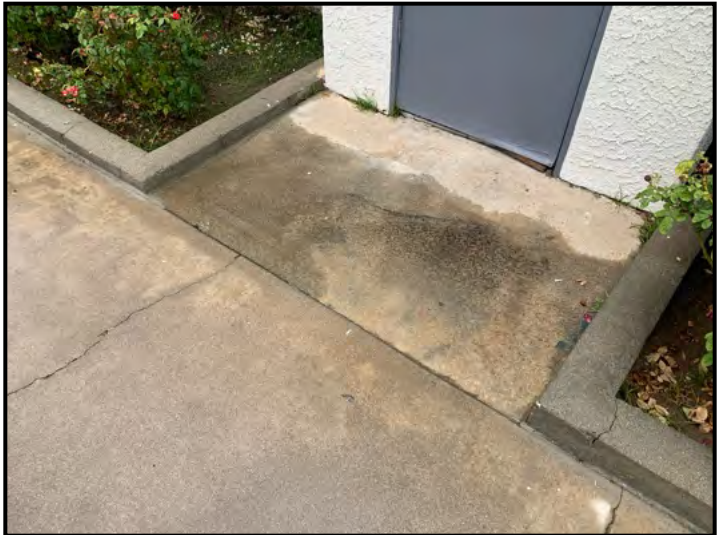
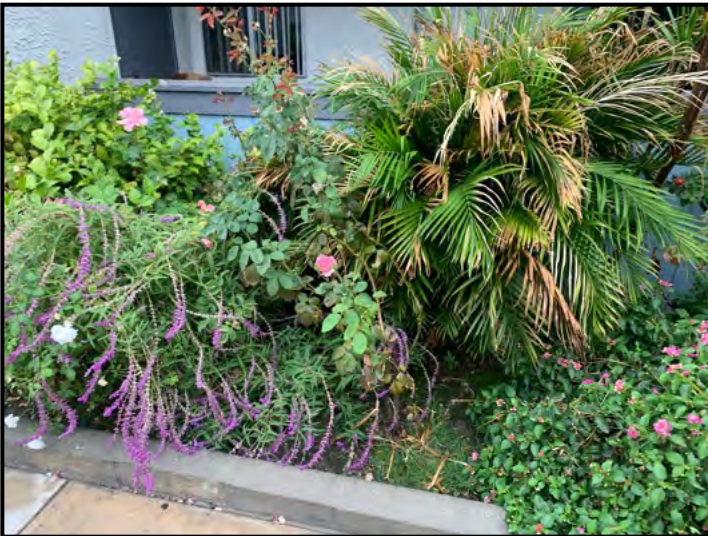
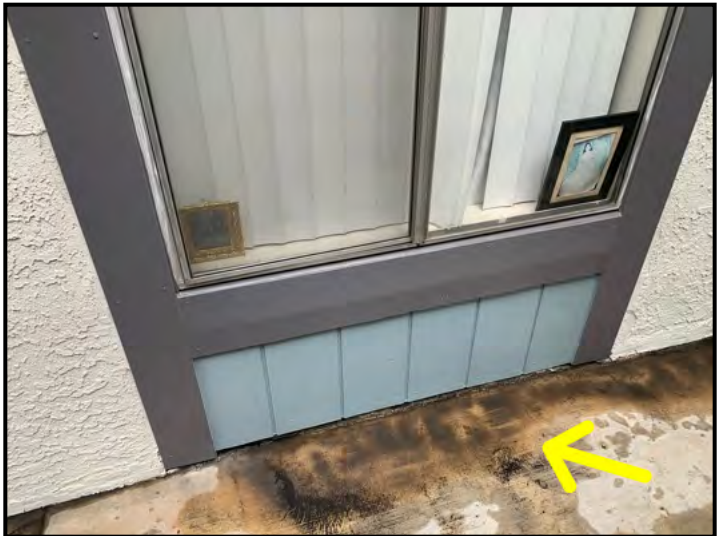
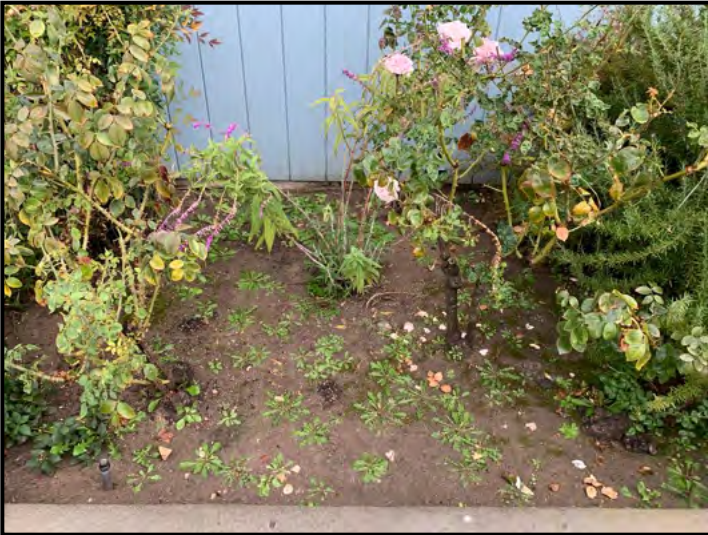
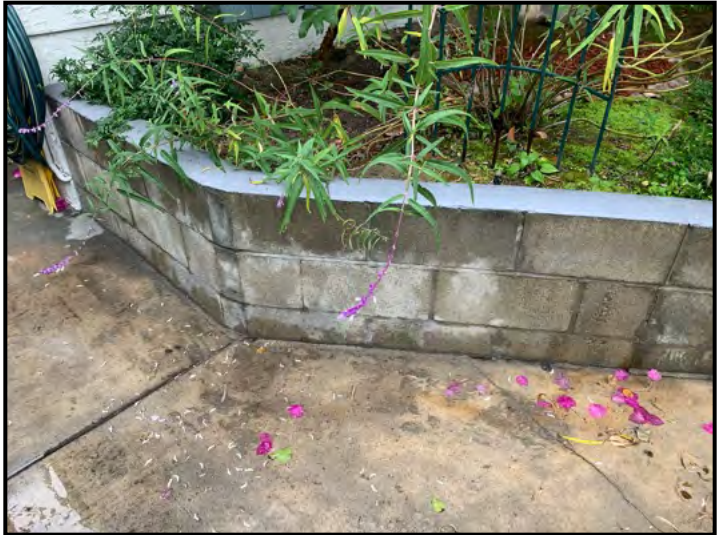
3. Grading & Site Drainage

Inspection Details		
Page 31 Item: 11	Other Information	<ul style="list-style-type: none"> • STORAGE SHED: Observed one or more storage sheds on the property. Storage sheds and detached structures (other than the garage) are not inspected and are not part of this inspection. Further evaluation may be needed.
Exterior Areas		
Page 33 Item: 2	Fence & Walls Condition	<ul style="list-style-type: none"> • Fence is leaning or falling. Repair or replacement is recommended. • Paint finish is deteriorated or flaking. Repainting is recommended to prevent moisture damage. • See photos.
Page 34 Item: 3	Grading & Site Drainage	<ul style="list-style-type: none"> • Planter areas near the house do not have a drainage system installed and retain water when it rains. This excess moisture, near the foundation of the house, can cause damage. Installation of a drainage system is recommended. • Signs of poor drainage observed at the North, North East side of the property. • Evidence of pooling water was observed at time of inspection. • Floor drains are filled with debris and may not allow adequate drainage. Further evaluation on clearing off all underground drains is recommended. • See photos.

- Planter areas near the house do not have a drainage system installed and retain water when it rains. This excess moisture, near the foundation of the house, can cause damage. Installation of a drainage system is recommended.
- Signs of poor drainage observed at the North, North East side of the property.
- Evidence of pooling water was observed at time of inspection.
- Floor drains are filled with debris and may not allow adequate drainage. Further evaluation on clearing off all underground drains is recommended.
- See photos.

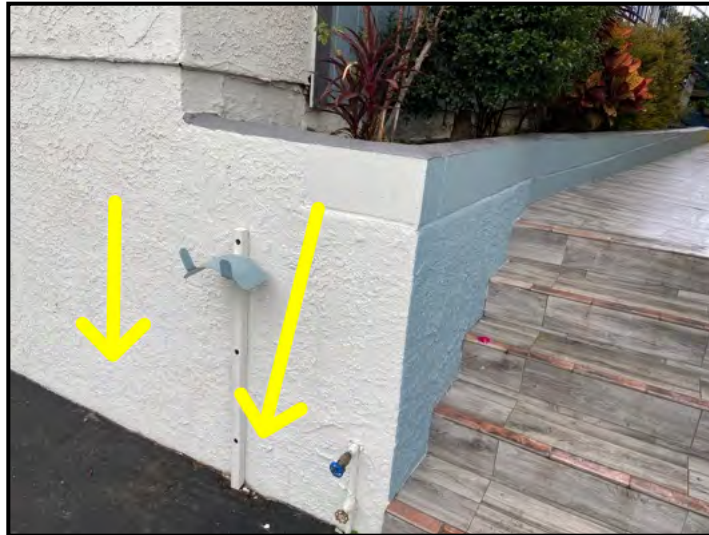
4. Retaining Wall Observations

Page 37 Item: 4	Retaining Wall Observations	<ul style="list-style-type: none"> • No drainage weep holes are installed at the bottom of the wall. Improper drainage behind the wall can cause damage and eventual failure. Installation of a drainage system is recommended. • See photos.

- Common cracks were noted at time of the inspection.
- No drainage weep holes are installed at the bottom of the wall. Improper drainage behind the wall can cause damage and eventual failure. Installation of a drainage system is recommended.
- See photos.

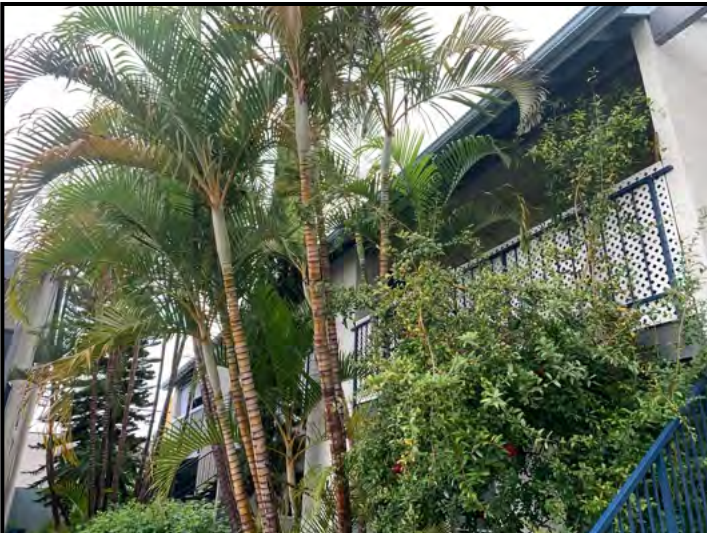
5. Landscaping Observations

Page 38 Item: 5	Landscaping Observations	<ul style="list-style-type: none"> • Trimming plants away from the structure is recommended to prevent damage and rodent infestation. • Trees are within 6 feet of foundation. Monitor for potential root damage. • Trees or other vegetation are touching or overhanging the roof. Damage is possible. Vegetation on the roof is also a source for rodent activity on the roof and the attic. Recommend trimming all vegetation or trees away from the roof structure. • Brush growth is too close to the structure (under 100 ft.). Removal is recommended for fire safety. • Tree branches overhanging roof and/or against siding. Trim trees that are in contact or proximity to home, as branches can abrade siding and damage roofing. • See photos.
Page 39 Item: 6	Exterior Stairs & Steps	<ul style="list-style-type: none"> • Moisture and rot damage observed on more than one of the landings at top of the stairs. Tenant informed Inspector that new artificial turf was installed recently and the condition of the decks was not good. Further evaluation is recommended. Removal of the artificial turf may be necessary.

- Landscaping appears adequately maintained.
- Trimming plants away from the structure is recommended to prevent damage and rodent infestation.
- Trees are within 6 feet of foundation. Monitor for potential root damage.
- Trees or other vegetation are touching or overhanging the roof. Damage is possible. Vegetation on the roof is also a source for rodent activity on the roof and the attic. Recommend trimming all vegetation or trees away from the roof structure.
- Brush growth is too close to the structure (under 100 ft.). Removal is recommended for fire safety.
- Tree branches overhanging roof and/or against siding. Trim trees that are in contact or proximity to home, as branches can abrade siding and damage roofing.
- See photos.

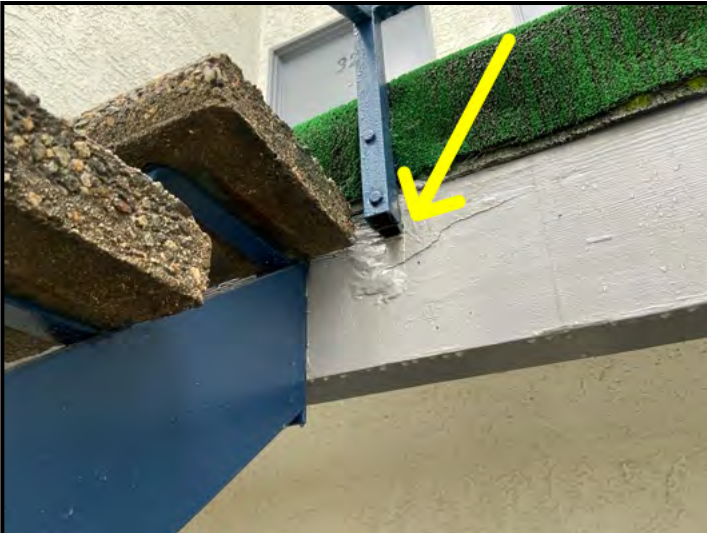
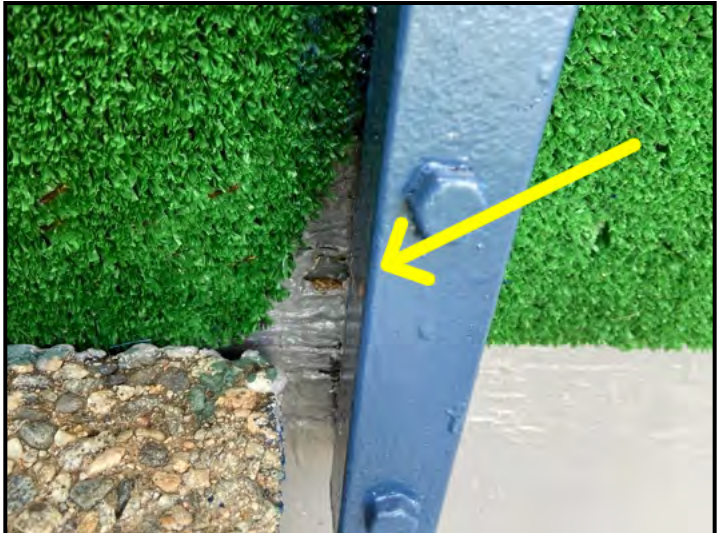
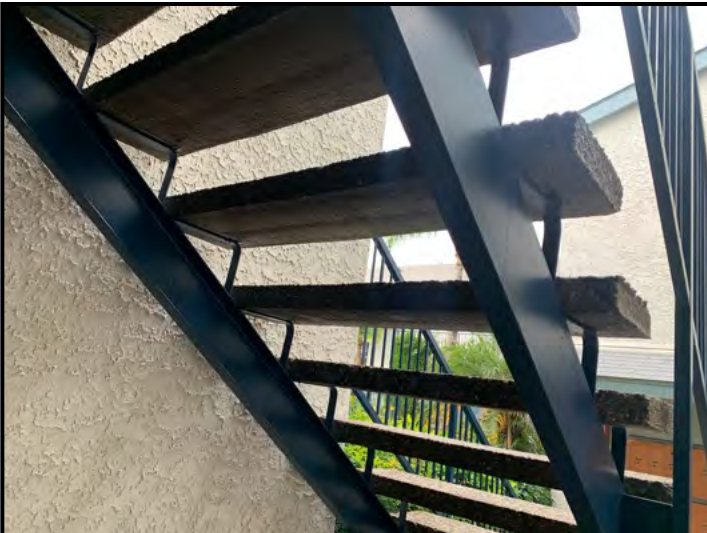
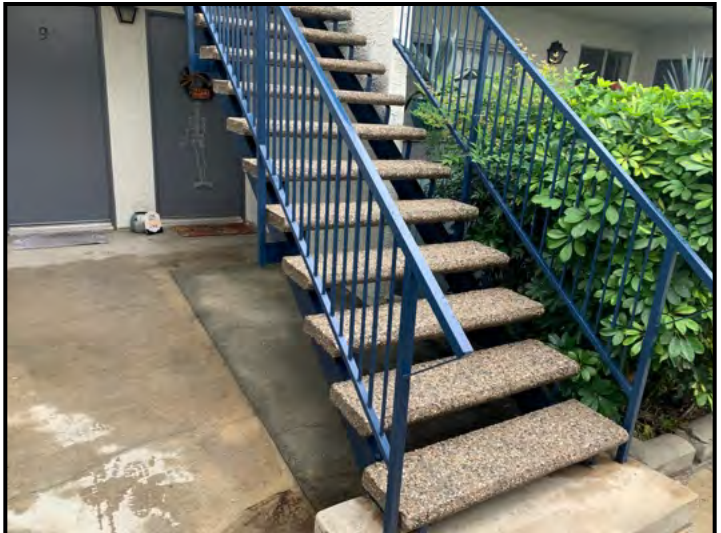
6. Exterior Stairs & Steps

- No visible problems noted at time of inspection.
- Hand railing is functional.
- See photos.
- **Moisture and rot damage observed on more than one of the landings at top of the stairs. Tenant informed Inspector that new artificial turf was installed recently and the condition of the decks was not good. Further evaluation is recommended. Removal of the artificial turf may be necessary.**

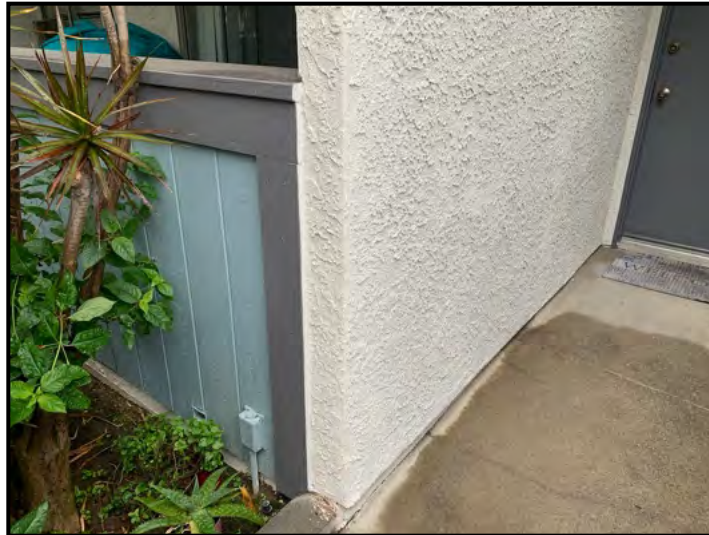
7. Exterior Wall Condition

- No visible problems were noted during the inspection.
- Cracks are typical and not structurally significant.
- See photos.

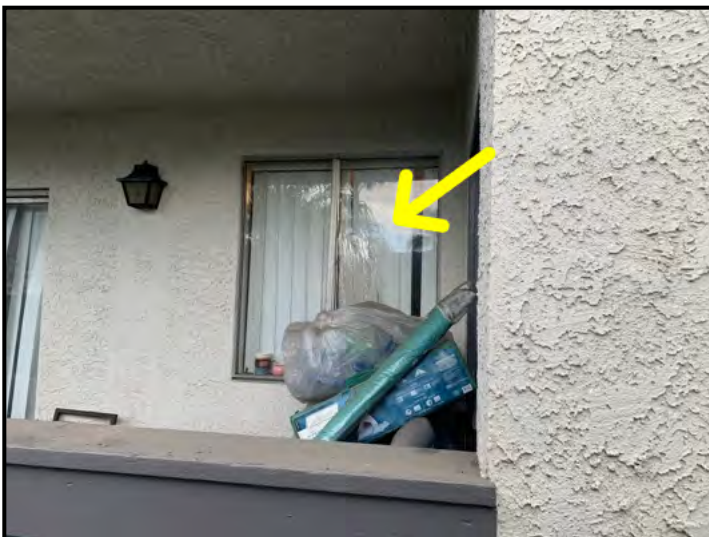
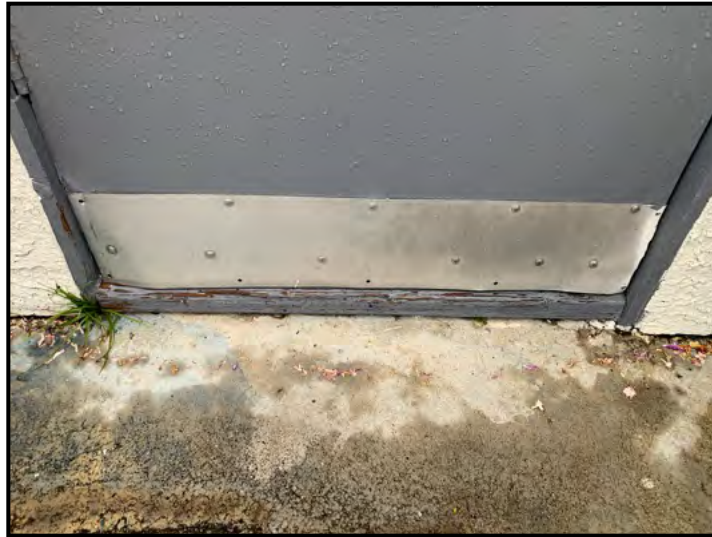
Page 40 Item: 9	Doors & Windows Observations	<ul style="list-style-type: none"> • Glass is cracked or broken. Replacement is required. • Some windows are hard to operate or painted closed. • One or more doors are delaminated or have moisture damage. Repair or replacement is recommended. • Exterior door is improper type. All exterior doors must be solid type. • See photos.
Porch, Patios & Decks		
Page 42 Item: 2	Decks & Balconies Observations	<ul style="list-style-type: none"> • Carpet restricts viewing and inspection of the balconies, stair landings and patio floors. See exterior stairs comments and photos. Further evaluation is recommended, and may necessitate the removal of the carpet. • Wood beams on some of the decks appear to have some rot/termite damage and moderate size cracking. See photos. • Most decks and porches have been covered with synthetic turf material which holds moisture and causes significant amount of rot damage underneath. See photos. • See photos.

- Glass is cracked or broken. Replacement is required.
- Some windows are hard to operate or painted closed.
- One or more doors are delaminated or have moisture damage. Repair or replacement is recommended.
- Exterior door is improper type. All exterior doors must be solid type.
- See photos.

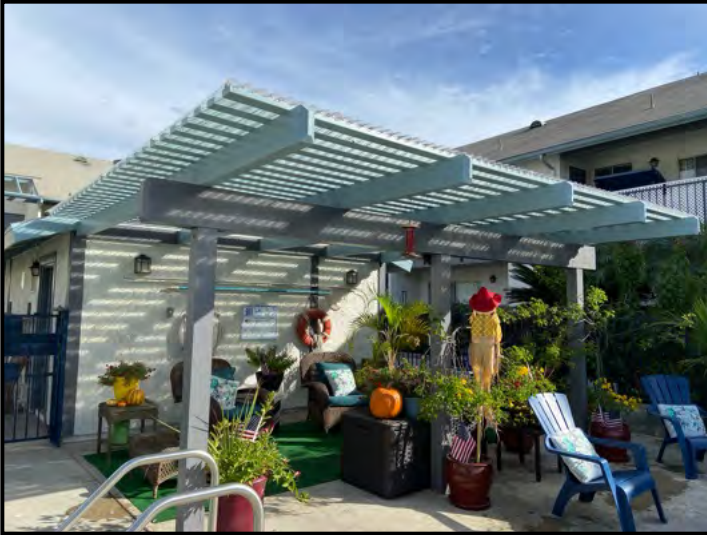
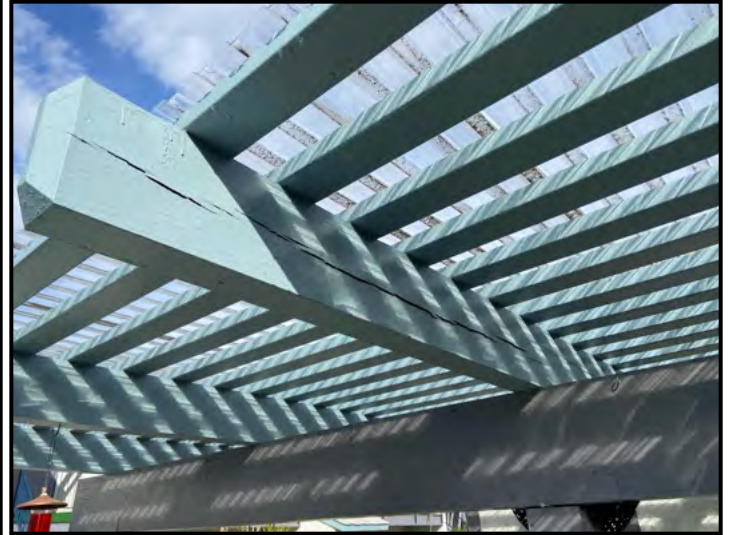
1. Patios Observations

- Floor Condition:
 - No visible problems observed at time of inspection.
 - Cracks noted are typical.
- Cover Condition:
 - No visible problems observed at time of inspection.

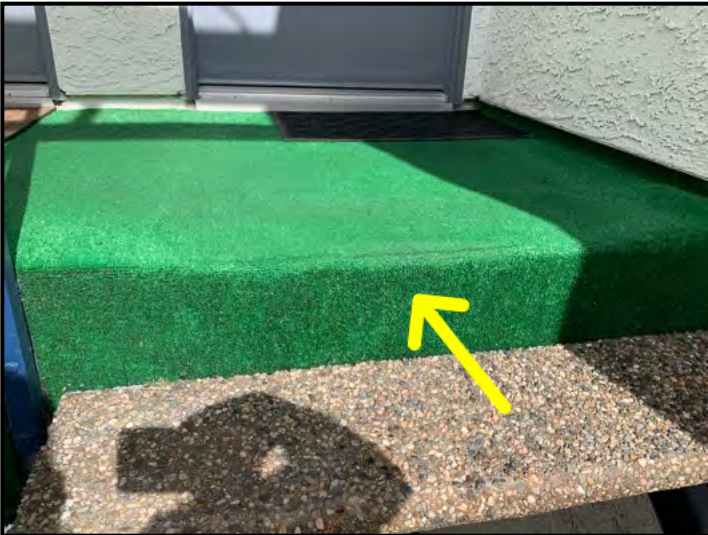
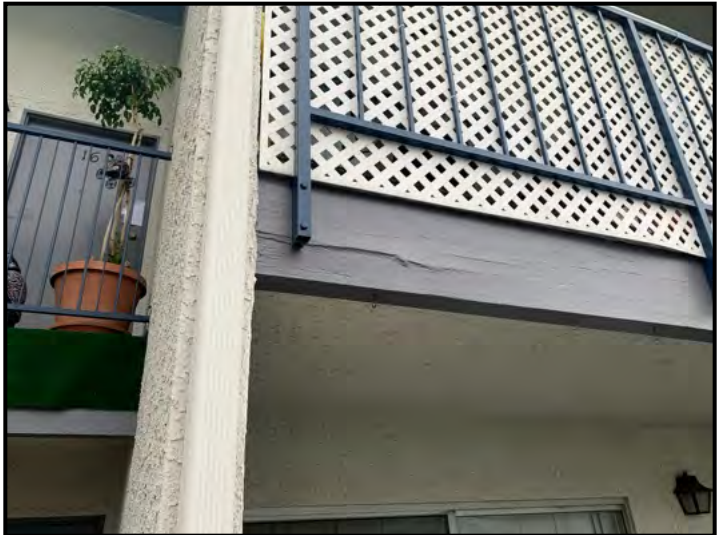
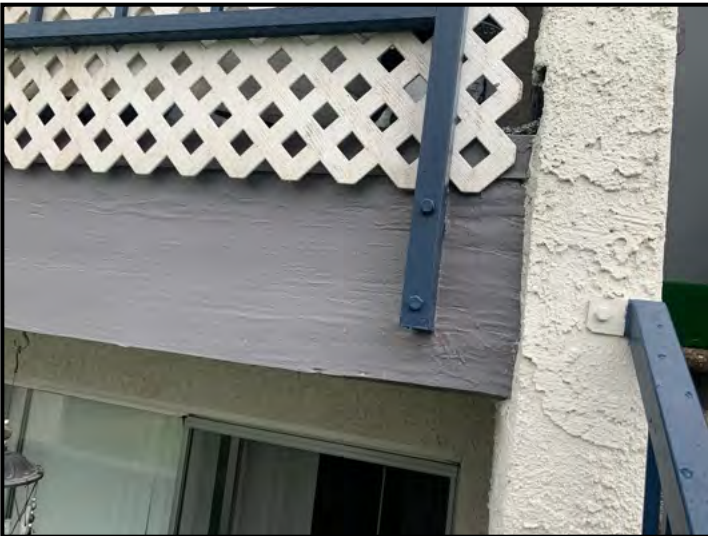
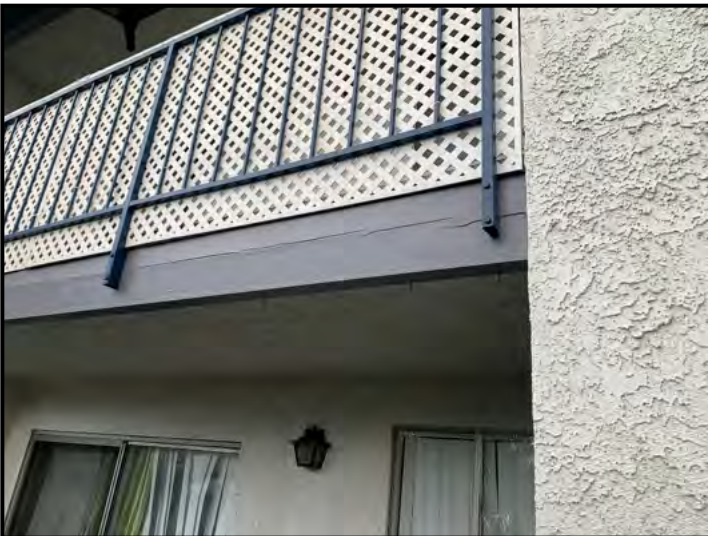
2. Decks & Balconies Observations

- Deck underside is not accessible for inspection. Further evaluation may be necessary.
- Balcony underside is covered with wood or stucco and is not accessible for inspection. Further evaluation may be necessary.
- Carpet restricts viewing and inspection of the balconies, stair landings and patio floors. See exterior stairs comments and photos. Further evaluation is recommended, and may necessitate the removal of the carpet.
- Wood beams on some of the decks appear to have some rot/termite damage and moderate size cracking. See photos.
- Most decks and porches have been covered with synthetic turf material which holds moisture and causes significant amount of rock damage underneath. See photos.
- See photos.

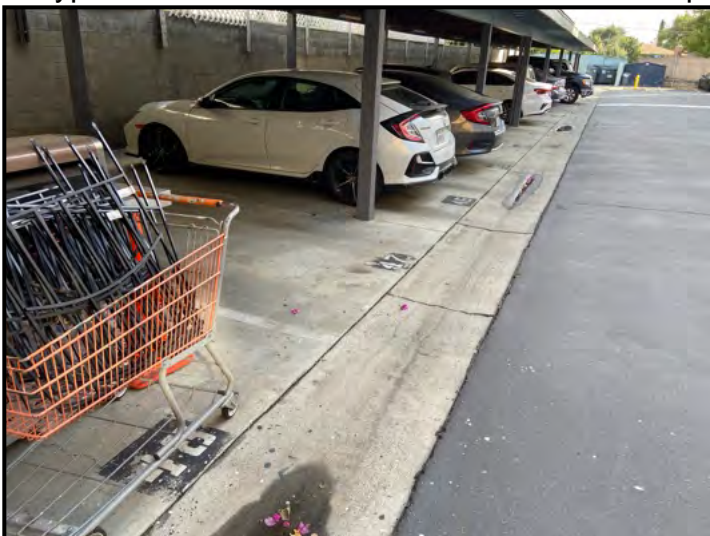
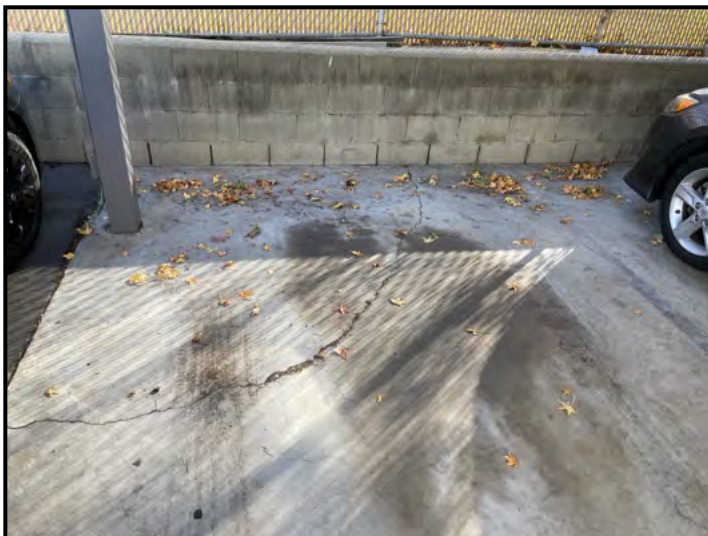
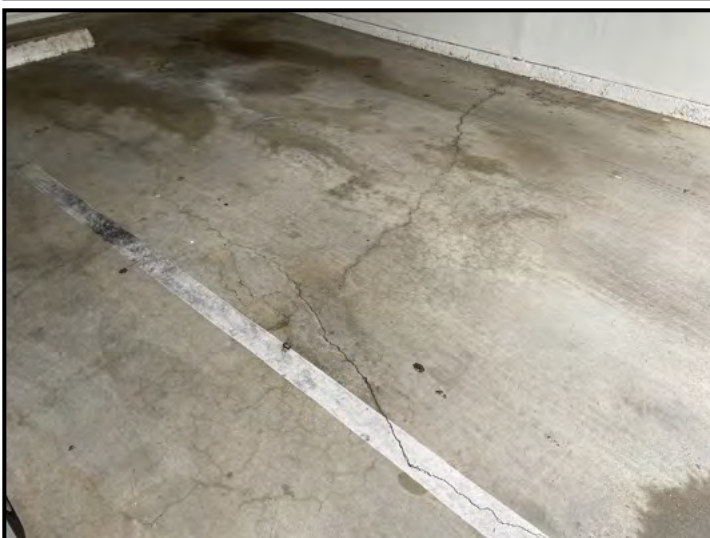
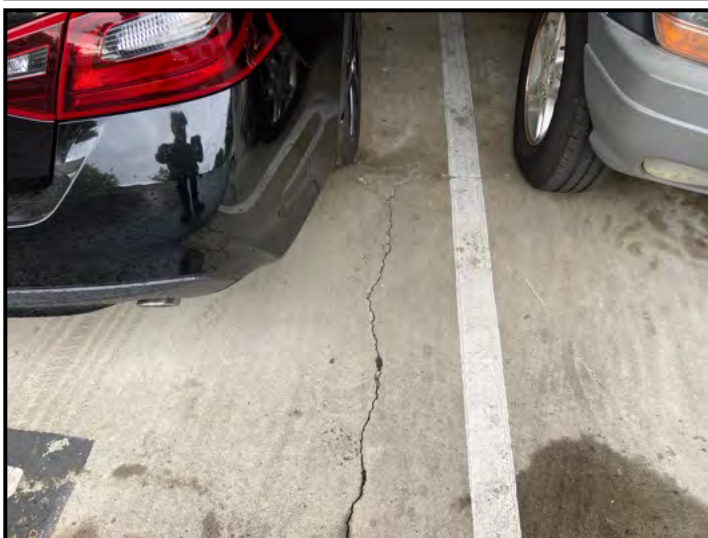
1. Floor Condition

- Typical cracks noted on the floor at time of inspection.

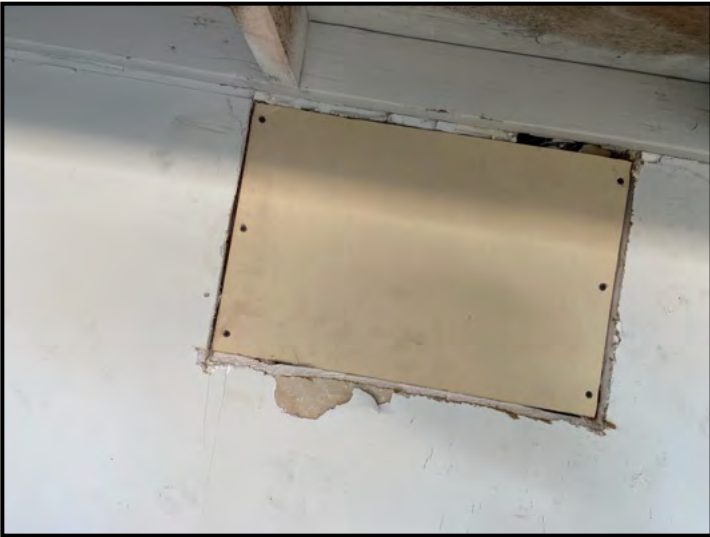
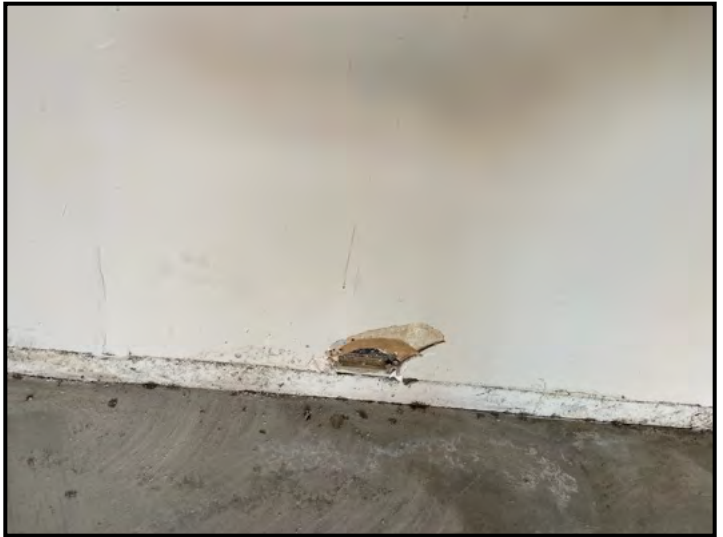
- A breach (holes) in the fire separation wall between the dwelling and garage was observed at the walls. In the event of a fire, flames and smoke could spread rapidly inside and up the wall, into the attic and across the dwelling. This is a hazard. The fire separation wall between the garage and dwelling cannot have any holes and must be covered with approved fire rated materials, like Type X drywall or stucco. Repairs are required to re-establish the fire rating of the wall.
- See Photos.

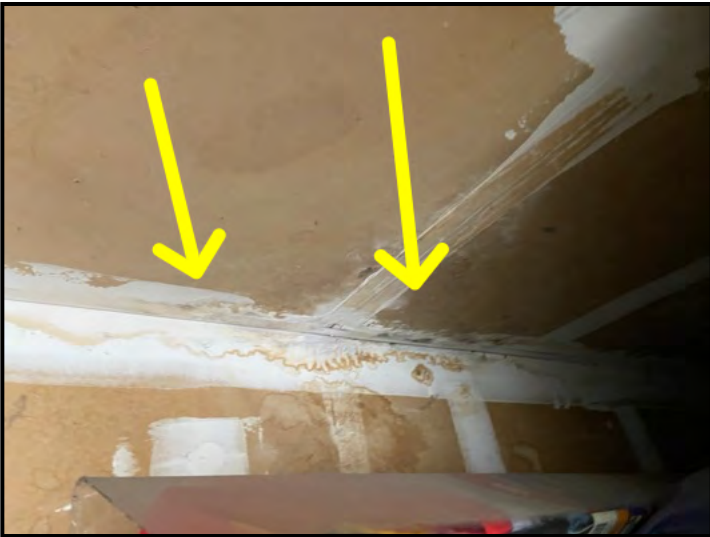
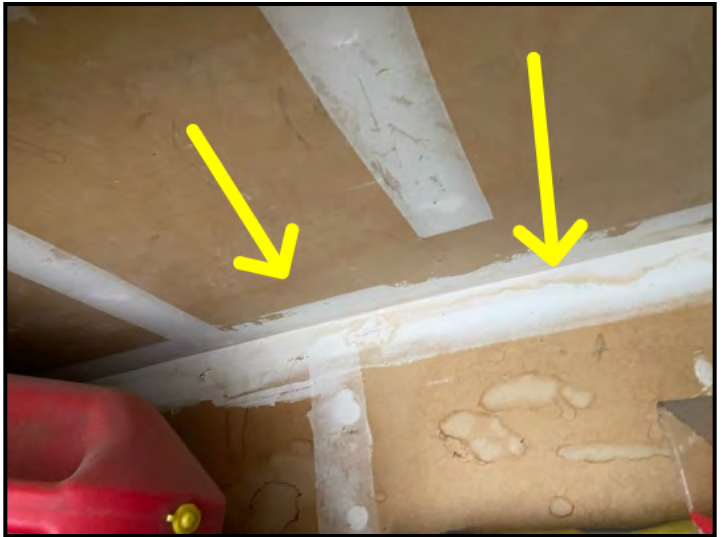
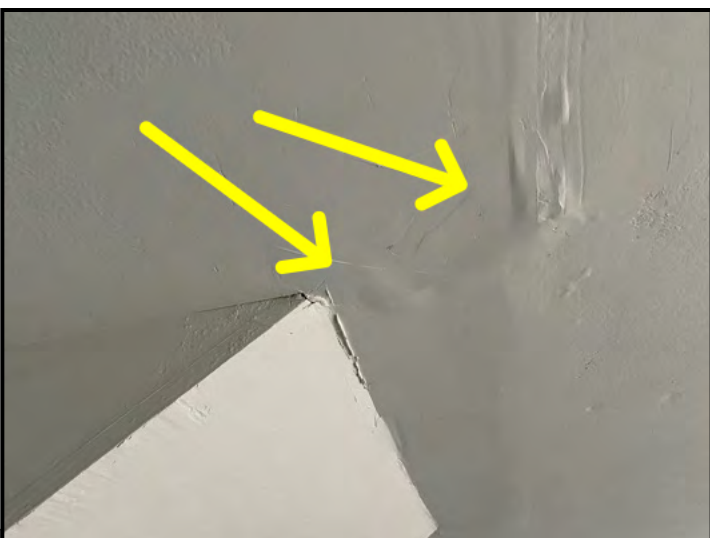
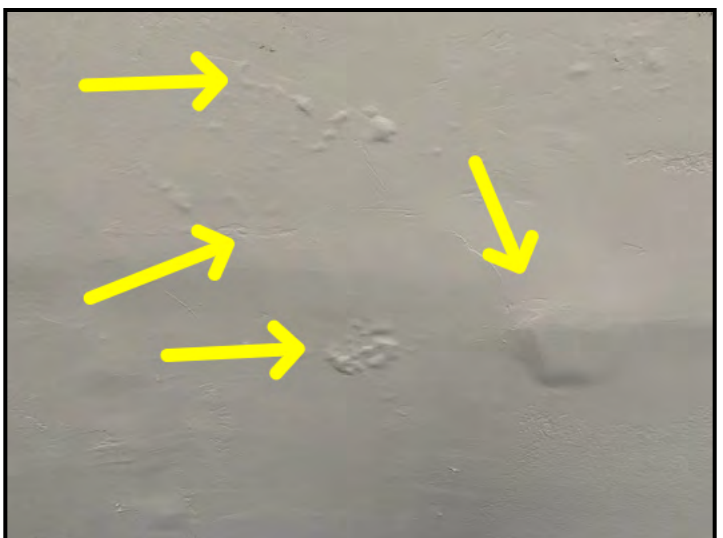
3. Walls & Ceiling

- Moisture stains or damage observed on the garage ceiling.
- Possible plumbing leak. Further evaluation by a plumbing contractor is recommended.
- See photos.

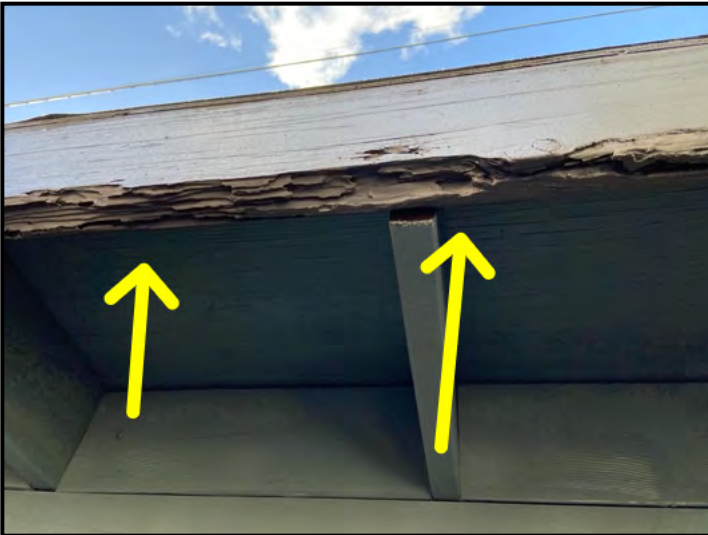
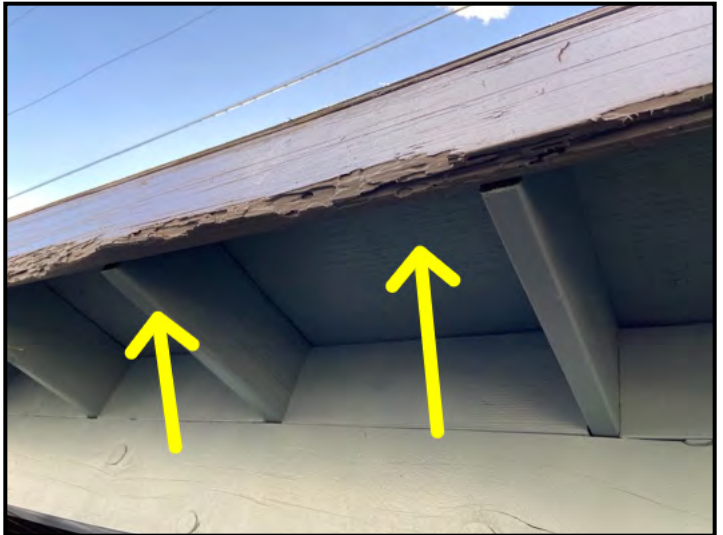
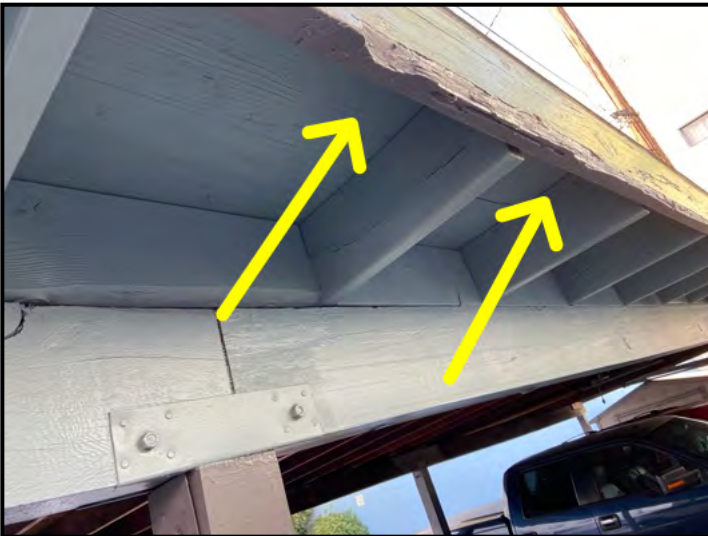
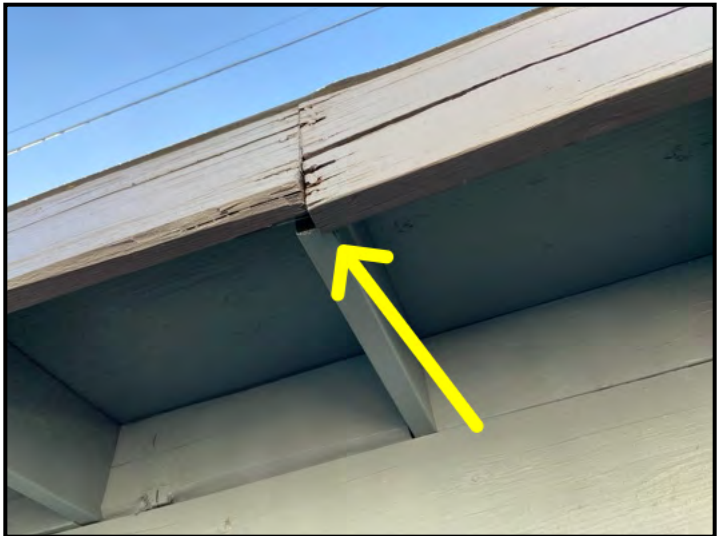
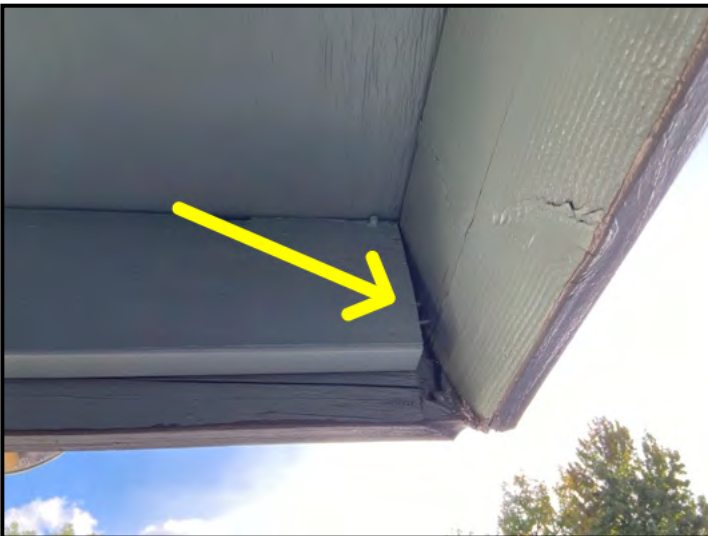
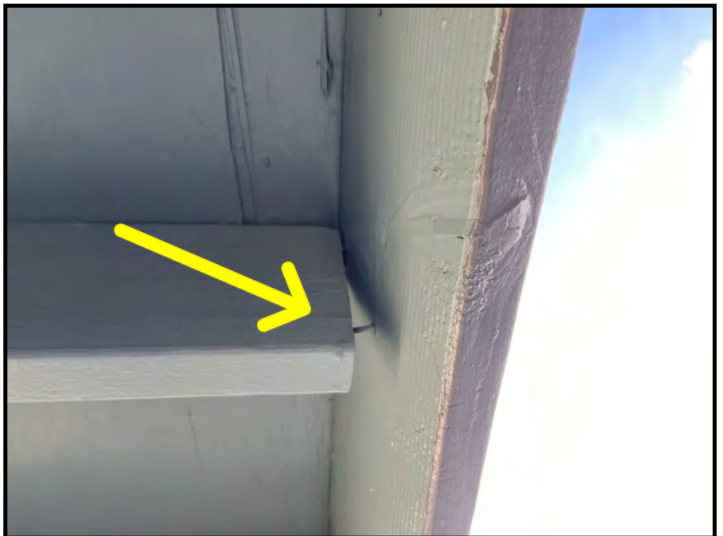
5. Carport Condition

- Moisture, rot or termite damage observed at the East fascia boards.
- Fascia boards are twisted and loose. See photo. Repair or replacement is recommended.
- Further evaluation by licensed termite inspector is recommended.
- Paint finish is deteriorated or flaking. Repainting is recommended to prevent moisture penetration and damage.
- Moisture penetration and or damage observed on the roof structure. Further evaluation by roofing contractor is recommended.
- See photos.
- Improper slope or low areas in carport causing in adequate drainage noted. See photos.
- Some damaged drywall inside carport area noted. See photos.

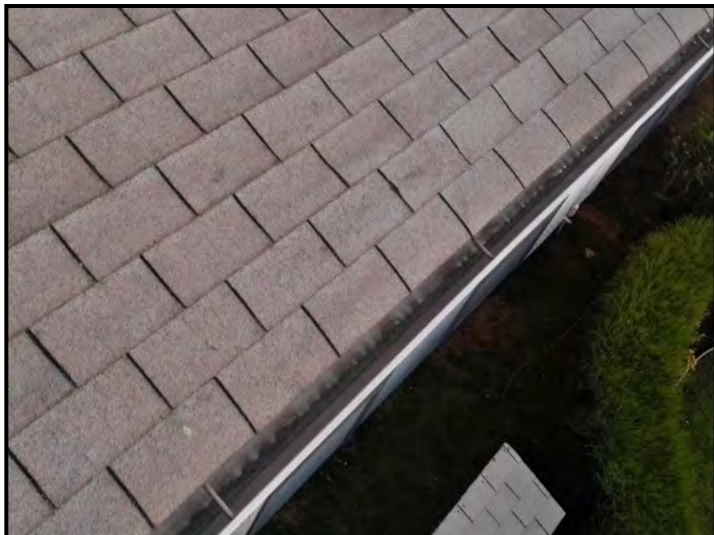
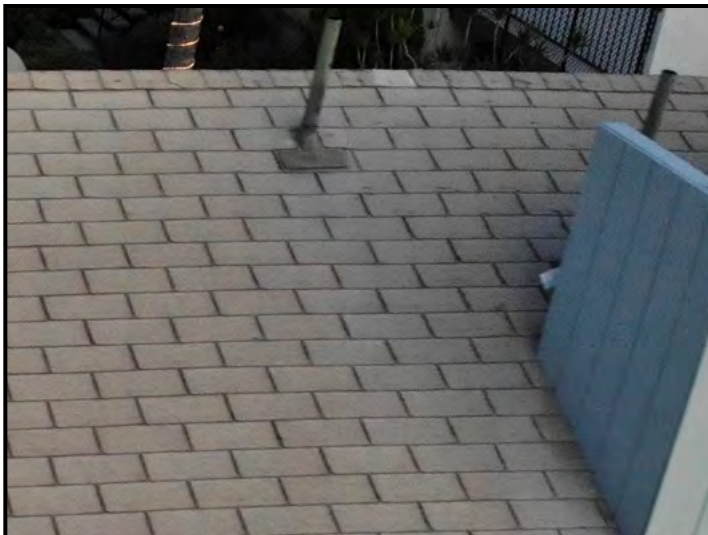
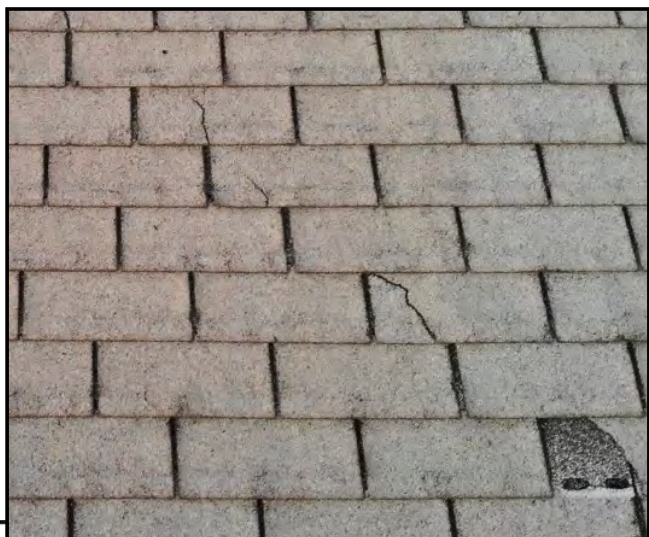
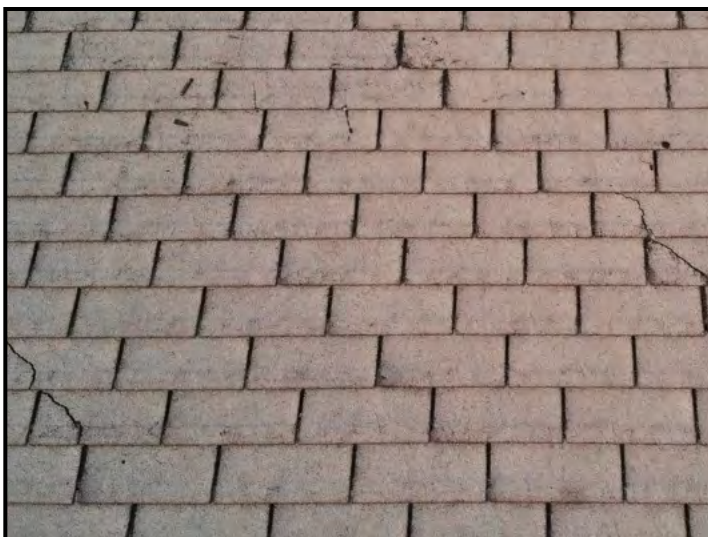
4. Covering Condition

- Moderate deterioration of the roofing material was noted at time of inspection.
- Moderate to significant cracking and clawing of the roofing shingles observed throughout the roofs at time of inspection. Cracking and clawing of shingles are the result of long term weathering and an advanced shingle age.
- A licensed roofing contractor should be called to make further evaluation and repairs as needed.
- See photos.
