PROPERTY INSPECTION REPORT

12345 Main Street, Anytown, CA 90001

DATE OF INSPECTION: 12/9/2022

VILLA HOME INSPECTIONS

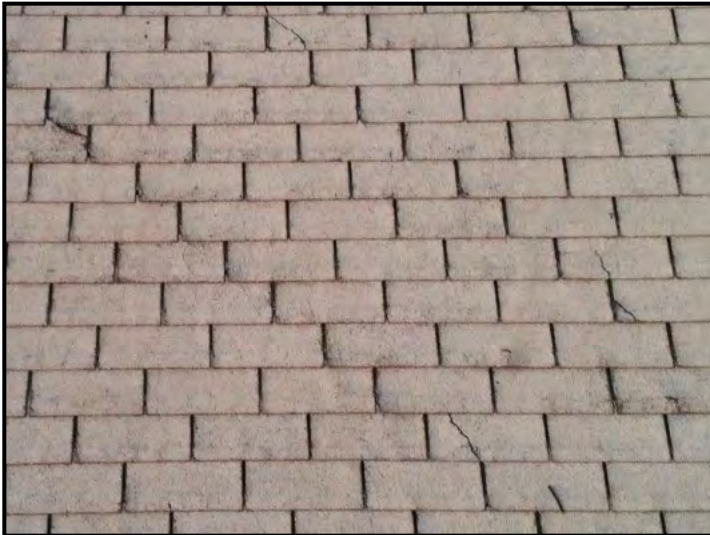
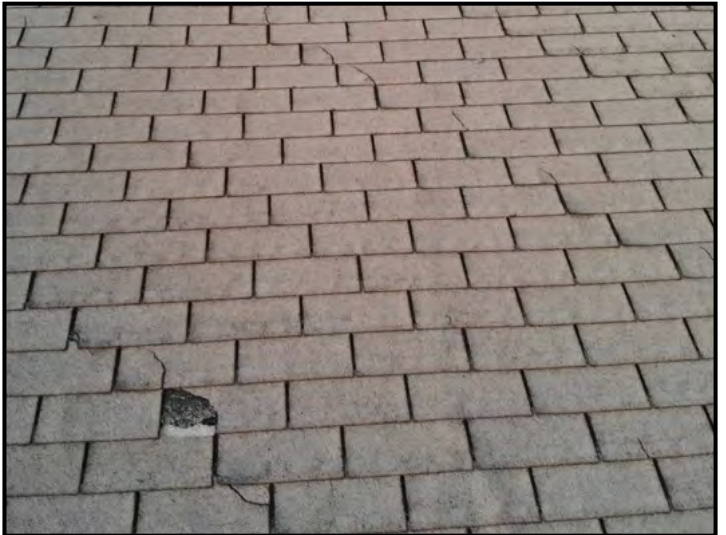
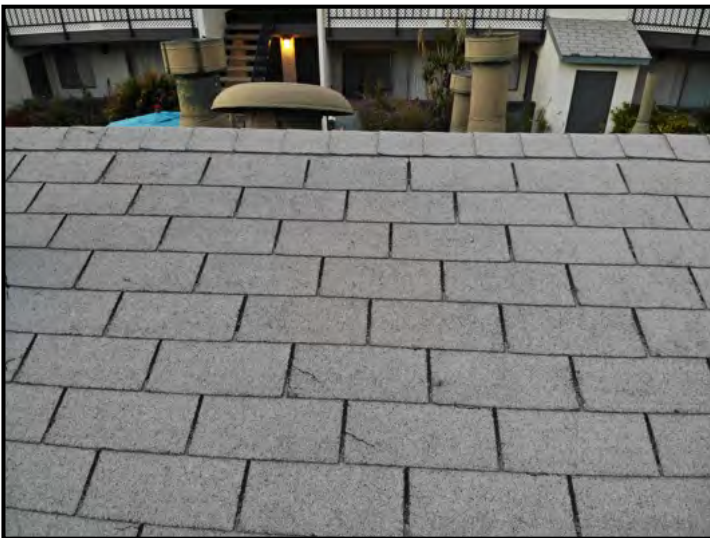
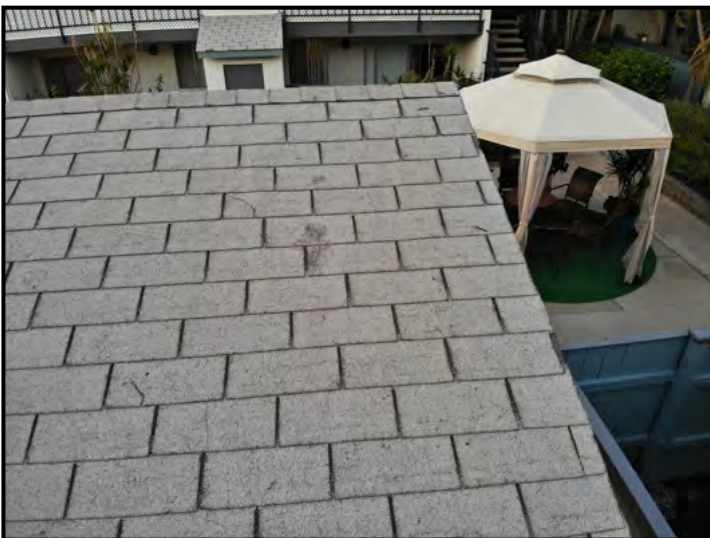
4. Covering Condition

- Moderate deterioration of the roofing material was noted at time of inspection.
- Moderate to significant cracking and clawing of the roofing shingles observed throughout the roofs at time of inspection. Cracking and clawing of shingles are the result of long term weathering and an advanced shingle age.
- A licensed roofing contractor should be called to make further evaluation and repairs as needed.
- See photos.

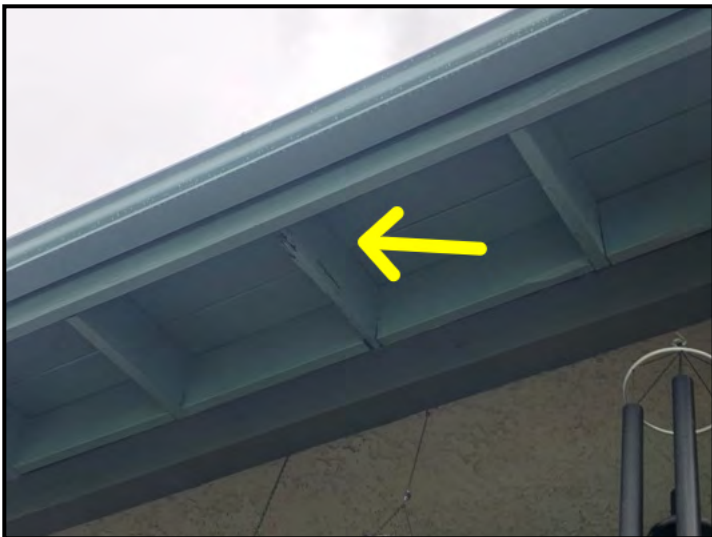
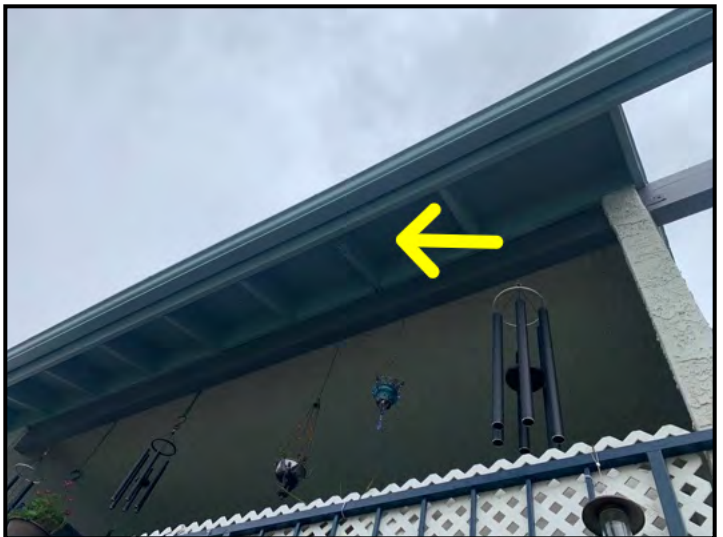
5. Roof Eaves Condition

- No visible problems observed at time of inspection.
- Moisture, rot or termite-like damage observed at the roof eave boards.
- Moisture, rot or termite-like damage observed on the fascia boards (roof edge board).
- Further evaluation by a licensed termite inspector is recommended.
- See photos.

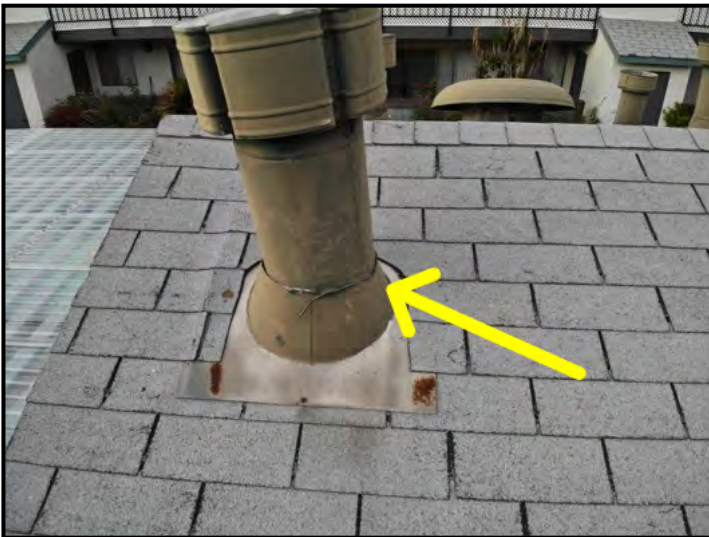
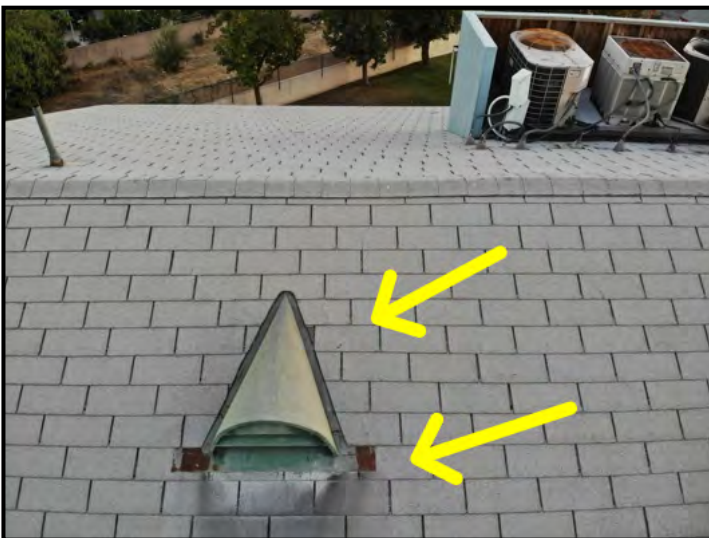
6. Flashings Condition

- Flashings do not appear to be properly sealed at the wall junctions.
- Flashings do not appear to be properly sealed at the vent pipes.
- Flashings do not appear to be properly sealed at the HVAC systems throughout the roofs.
- Typical maintenance is recommended.
- See photos.

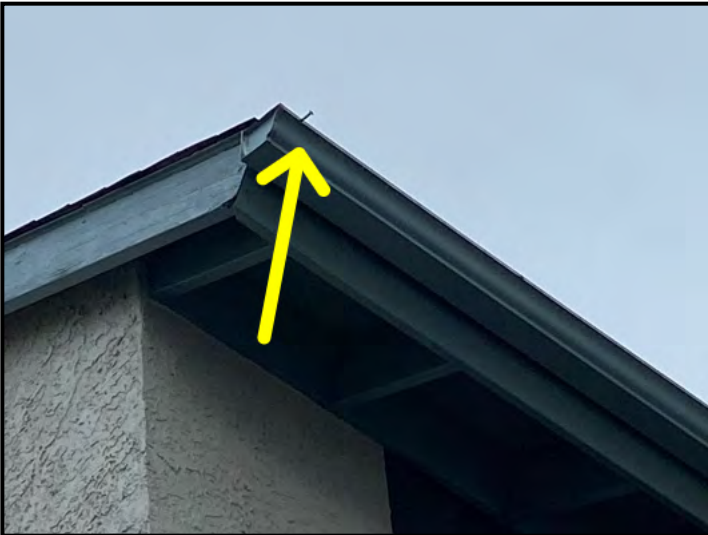
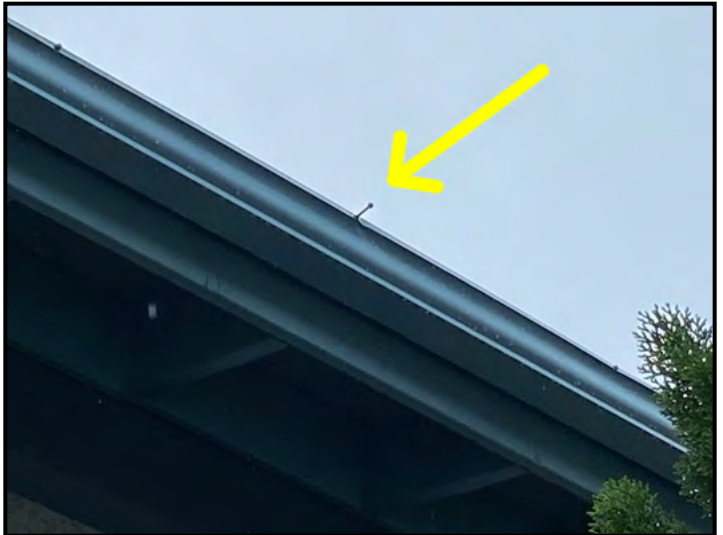
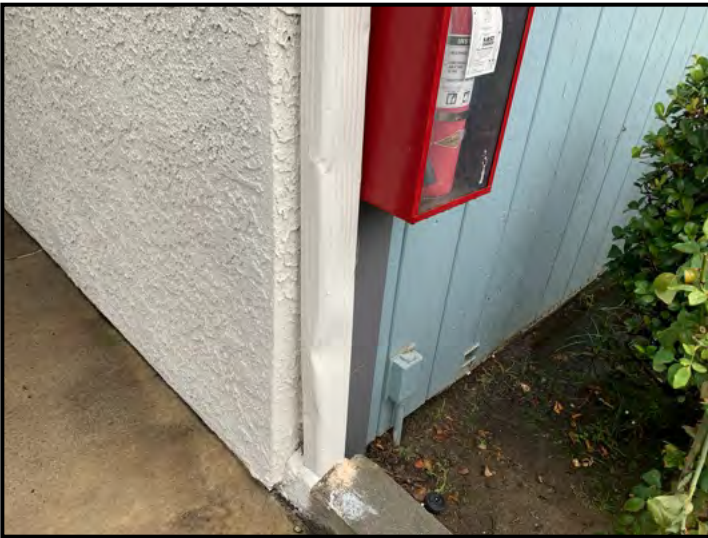
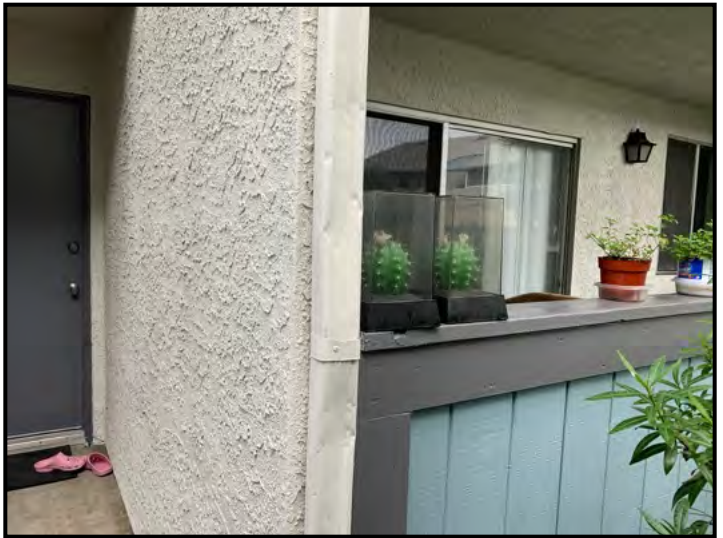
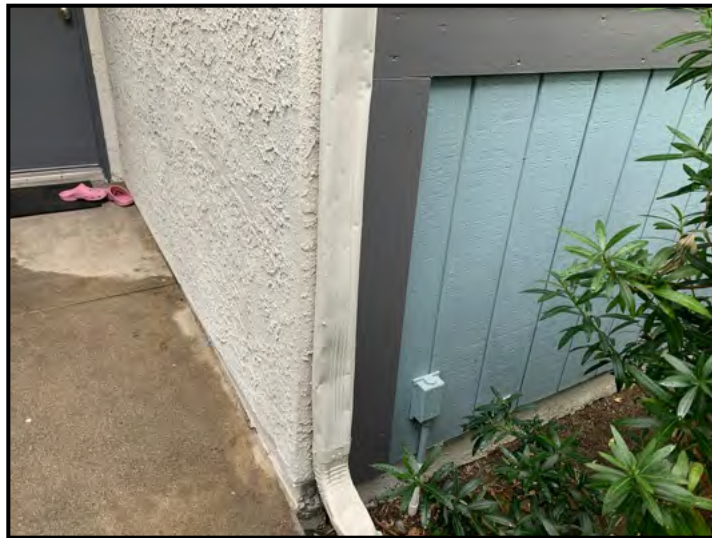
7. Gutters & Downspouts

- Gutters are loose or improperly installed.
- Repair or replacement is recommended.
- Consider installing additional gutters and downspouts to help with site drainage.
- Recommend re-routing the downspouts to drain away from the building. Excess moisture near the foundation may cause settlement and foundation problems.
- Some downspouts were damaged throughout the complex. See photos.

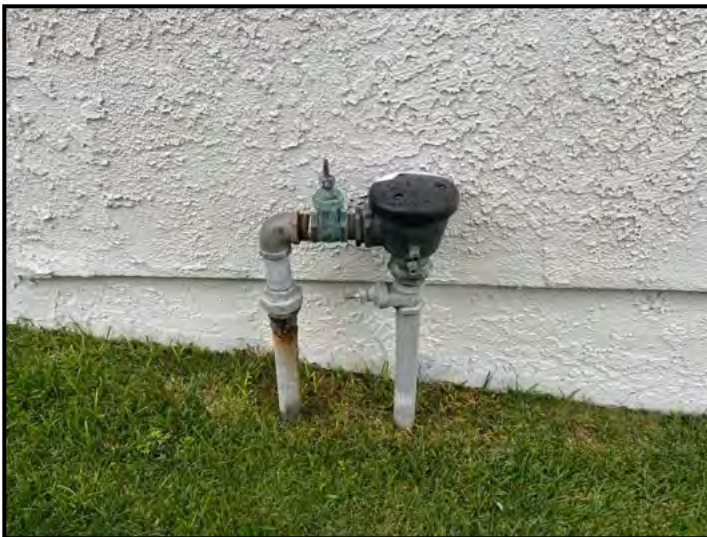
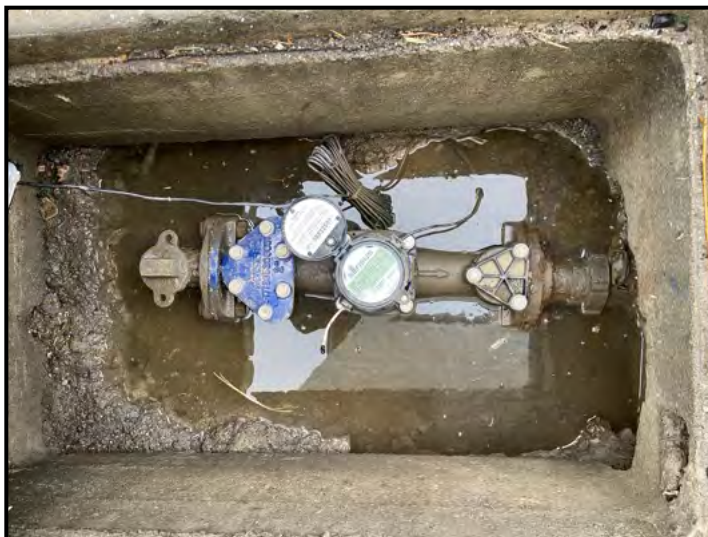
6. Main Line Condition

- Excessive corrosion is observed on or near the main water shut off valve.
- Meter box was flooded at time of inspection. Unable to determine which side of the meter is leaking. Further evaluation by plumbing contractor is recommended.
- A licensed plumbing contractor should be called for further evaluation and repairs.
- See photos.

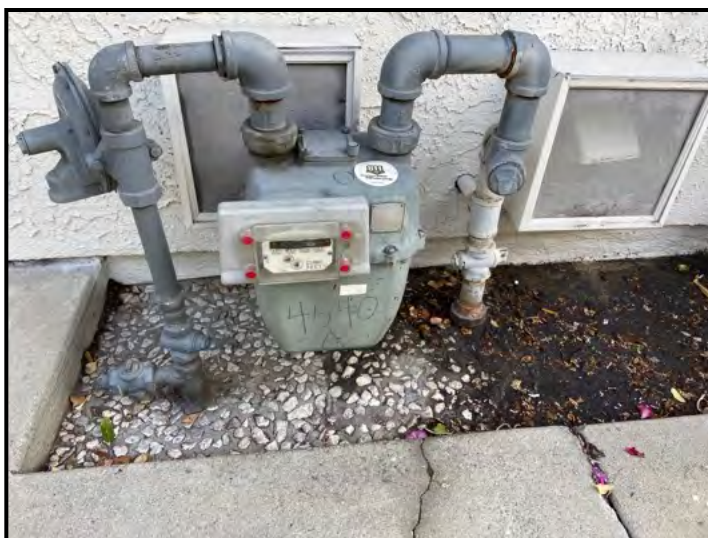
9. Fuel System Condition

- Meter appears functional at time of inspection.
- **Automatic gas seismic shut off valve not present. Installation may be required by your fire insurance company and or may save you money on your premium if installed. Please contact your insurance agent for more information.**

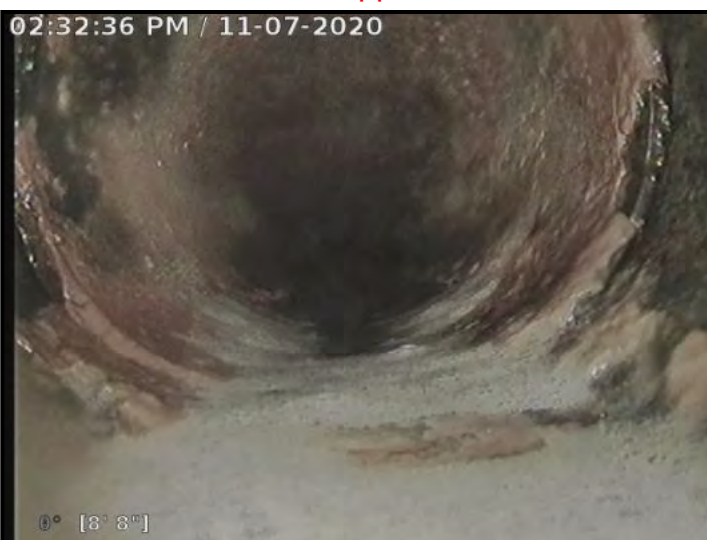
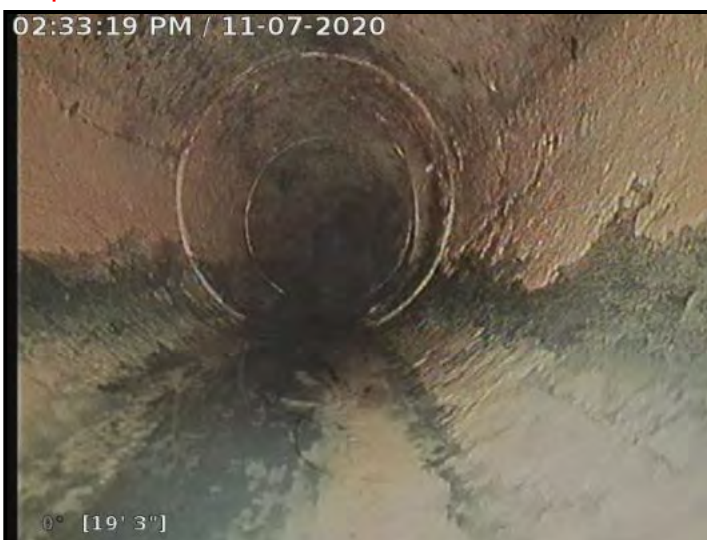
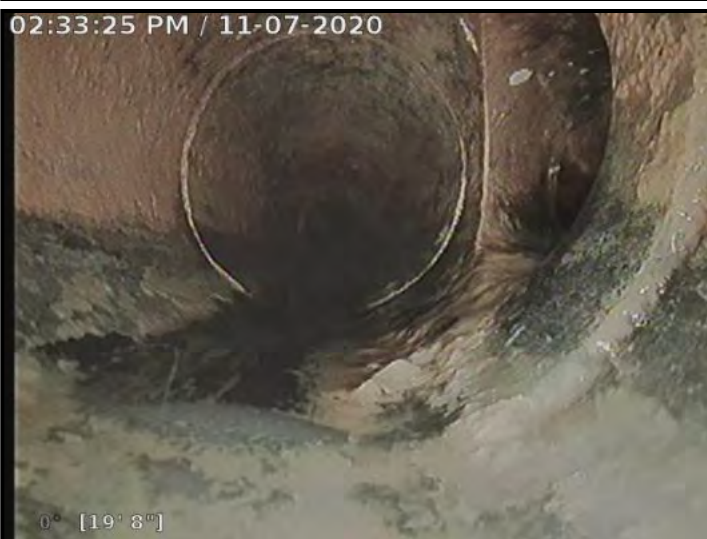
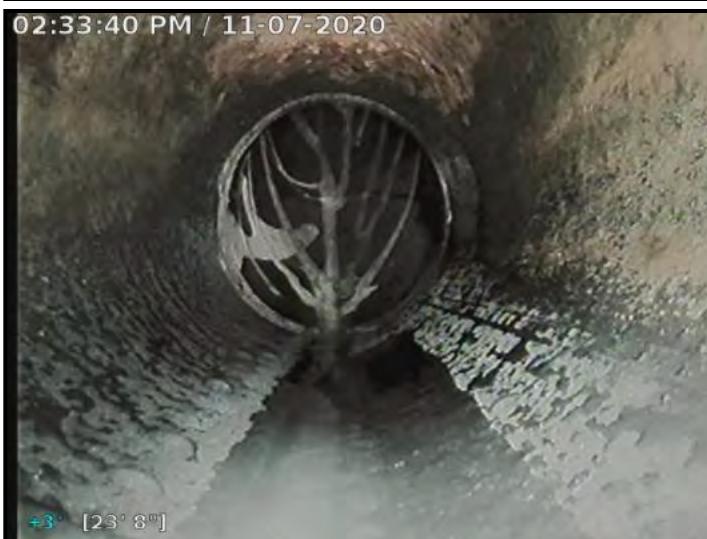
10. Clean Outs

- The sewer lines appeared to be in satisfactory condition and generally in good condition at time of inspection. No immediate action is recommended at this point.
- Grease buildup observed inside the drain line. The grease can eventually lead to blockages if not cleaned out. Other materials traveling down the pipe can get caught up on these build-ups and inhibit the flow of waste. Hyro-jetting should be considered to clear the grease.
- Offset pipes observed. An offset is where two sections of pipes meet but do not line up correctly.
- The offsets observed appear minimal and do not require immediate action.

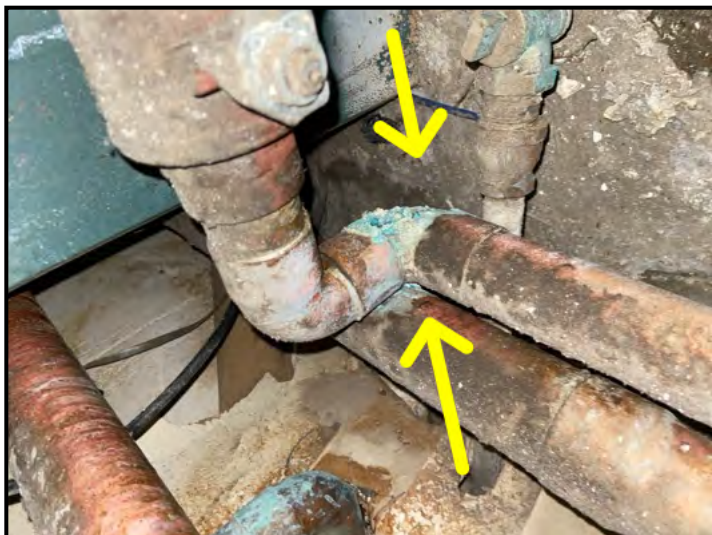
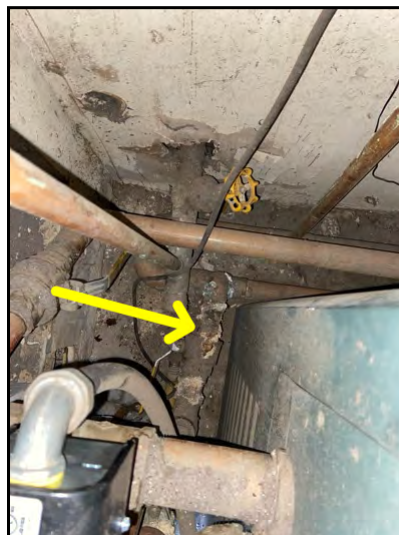
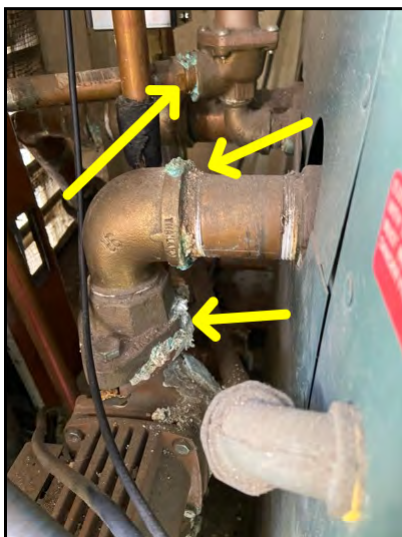
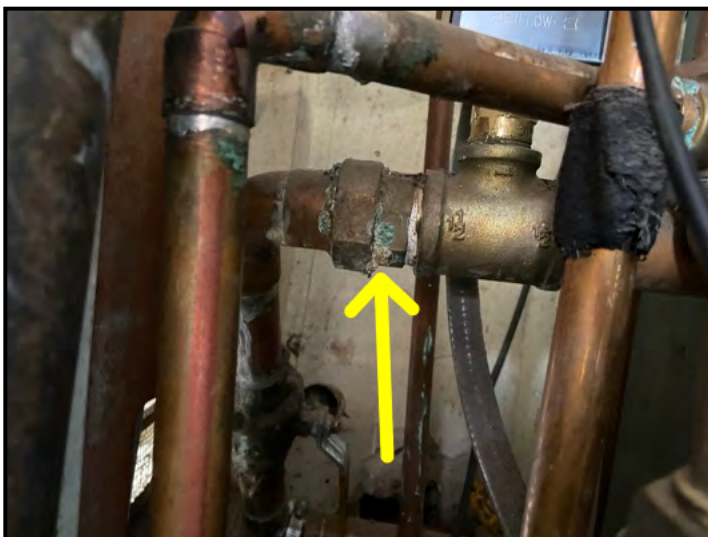
3. Condition

- Rust and corrosion was noted on the water lines.
- Leaks noted at the water supply lines.
- Gas line does not have the required sediment trap installed.
- Moisture stains and damage observed on the ceiling surrounding the vent pipe. Possible roof leak. Further evaluation by a roofing contractor is recommended.
- Further evaluation and repairs by a plumbing contractor is recommended.
- See photo.

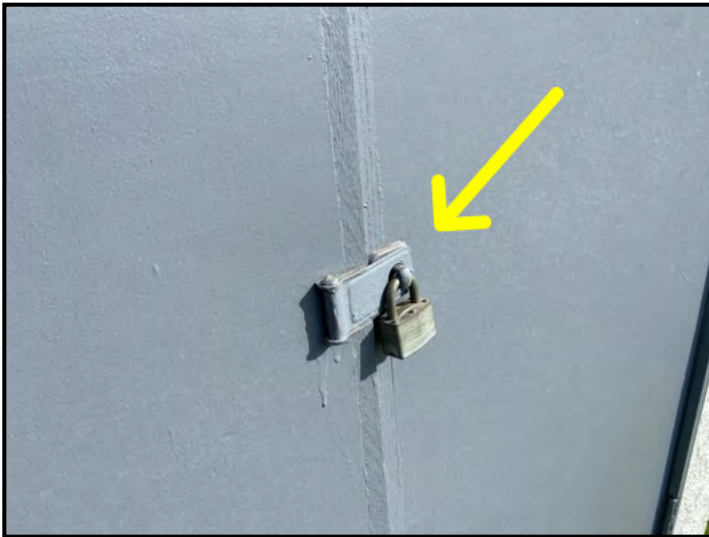
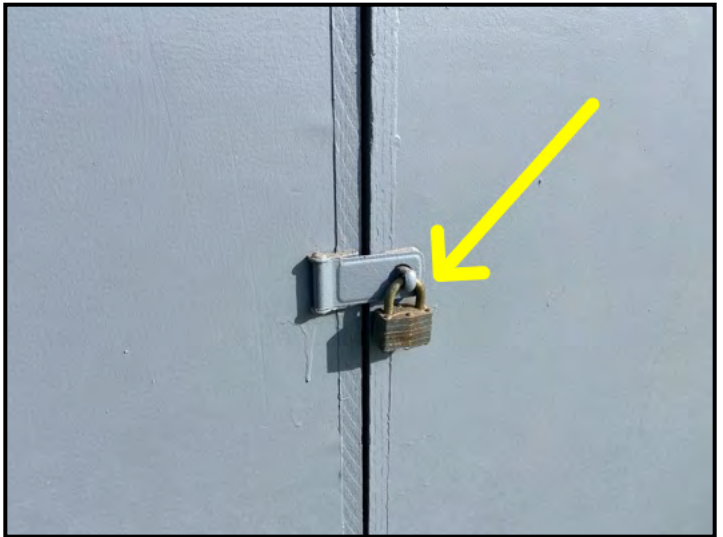
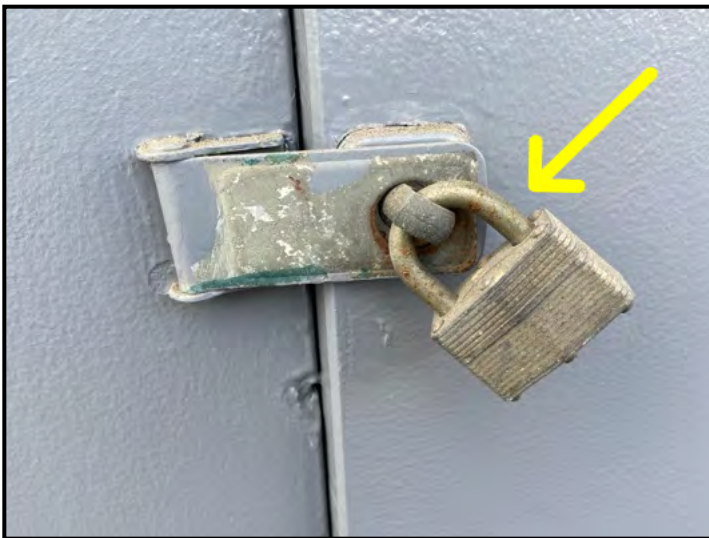
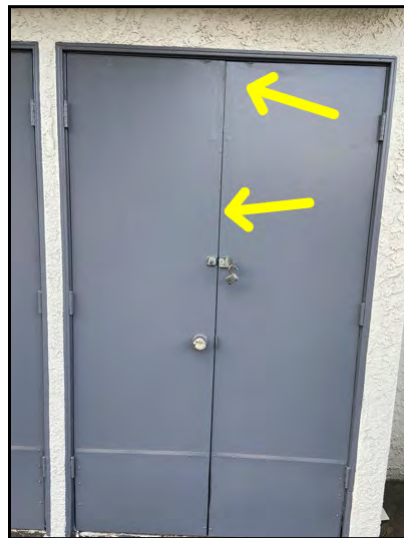
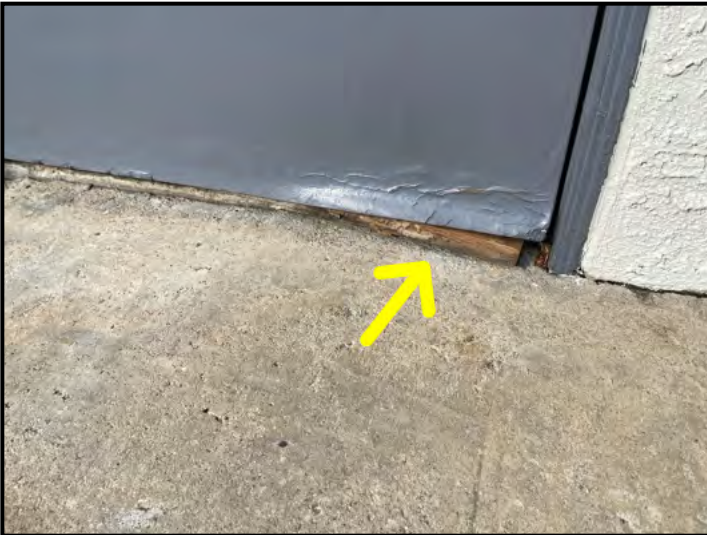
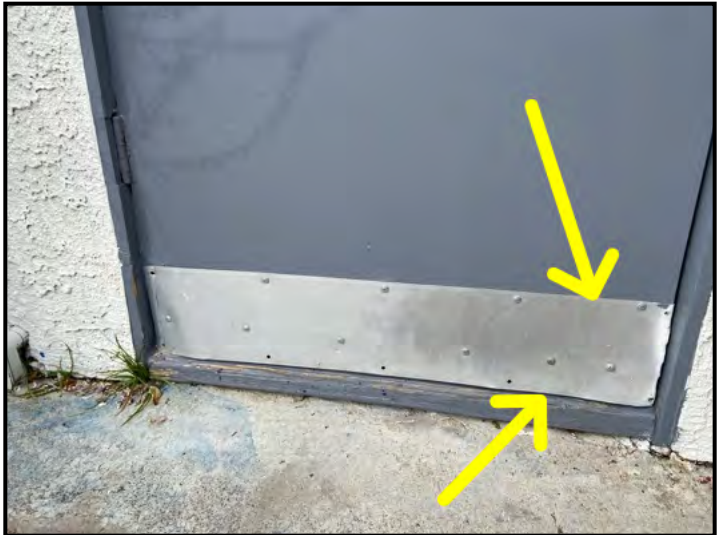
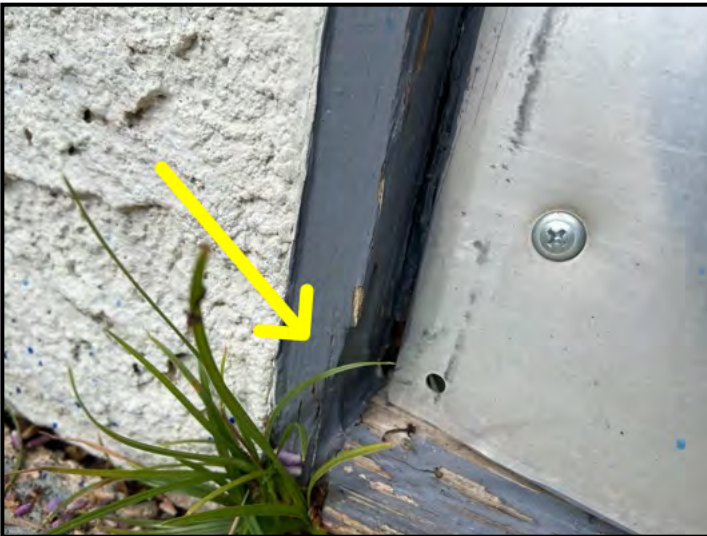
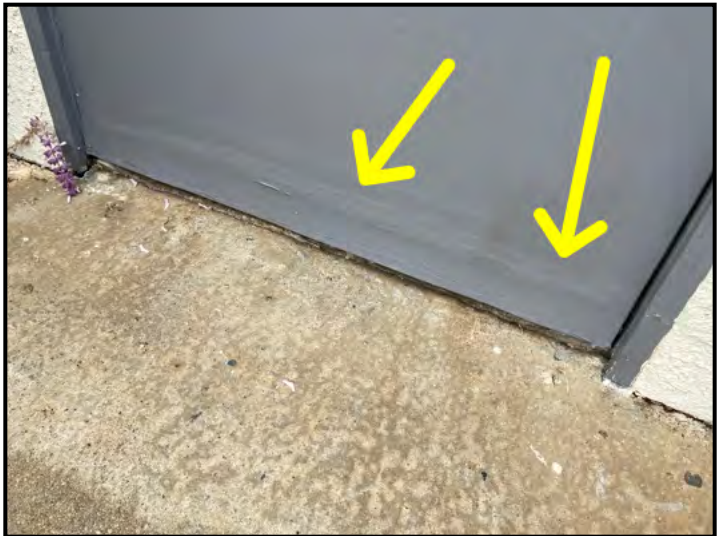
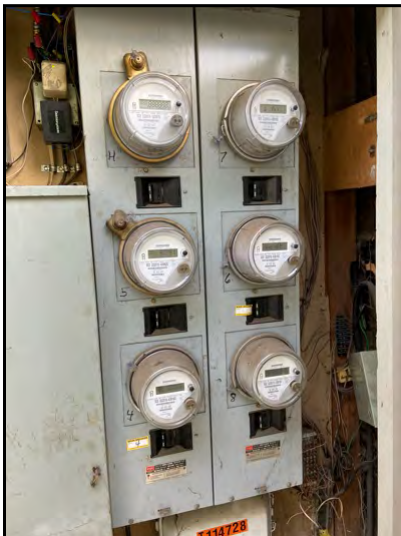
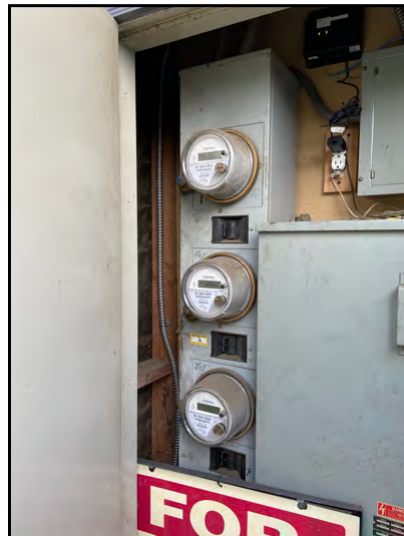
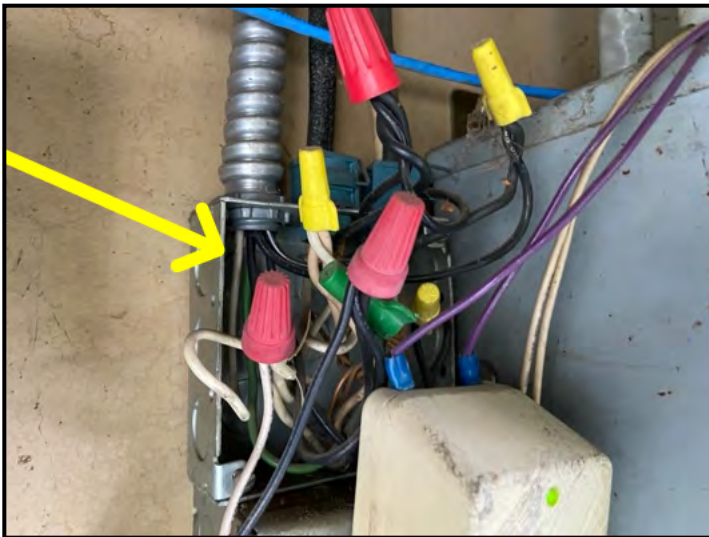
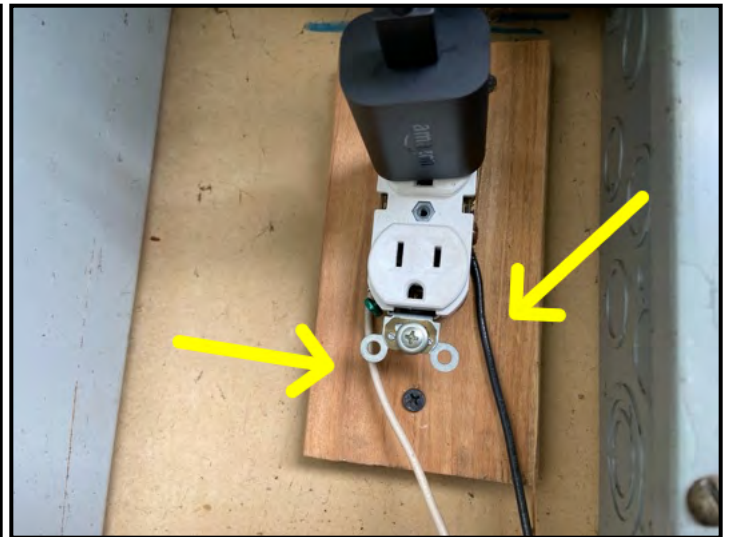
1. Main Shut Off Condition

- Unable to access several of the main electrical shut off closets throughout the property. See photos. Several were padlocked shut and one door was stuck and would not open.
- Moisture damage observed at more than one electrical closet doors and door jambs. Repair or replacement is recommended. See photos.
- Exposed and unsafe wiring observed inside the electrical shut off closet at the West building. There is also an unsafe installation of an electrical outlet. See photos. Further evaluation by a licensed electrical contractor is recommended.

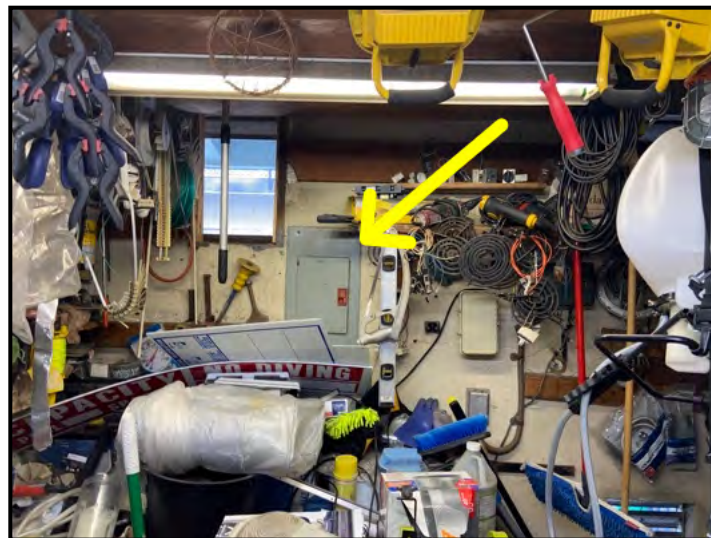
4. Sub Panel 1 Condition

- Panel was blocked by occupants belongings at time of inspection. A minimum clearance of 36 inches in front and 30 inches on each side is required. Removal of any obstructions is required.
- See photos.

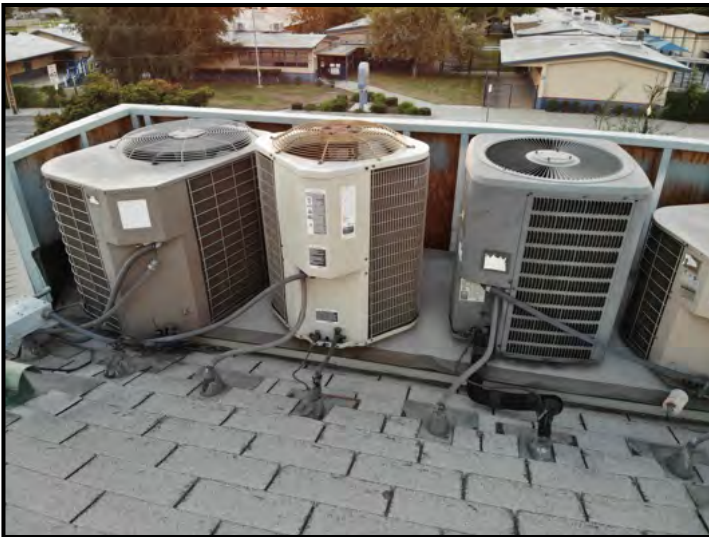
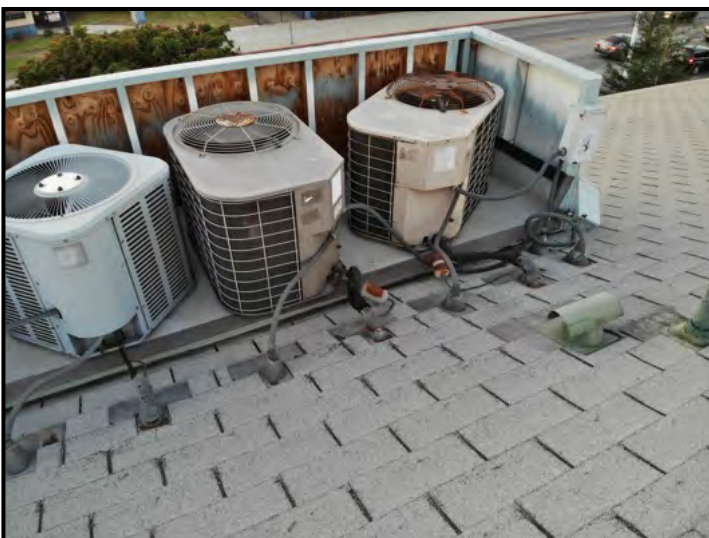
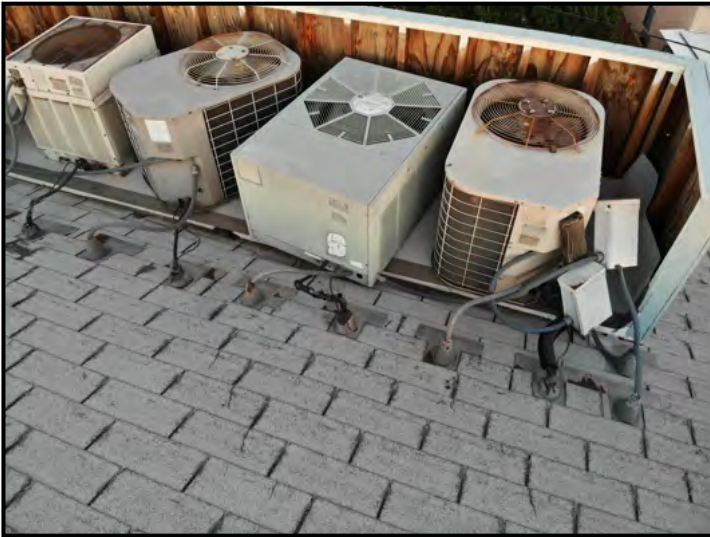
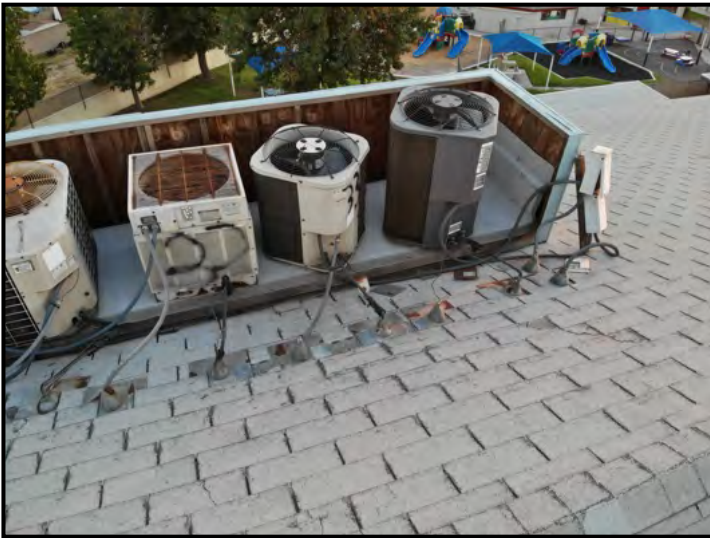
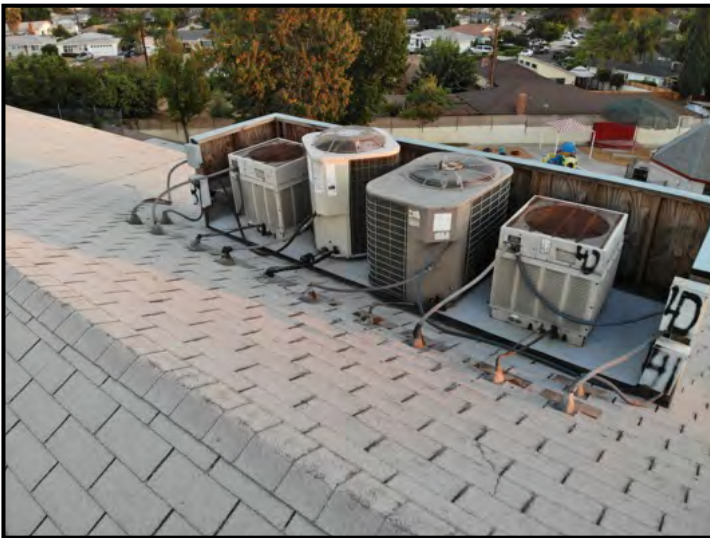
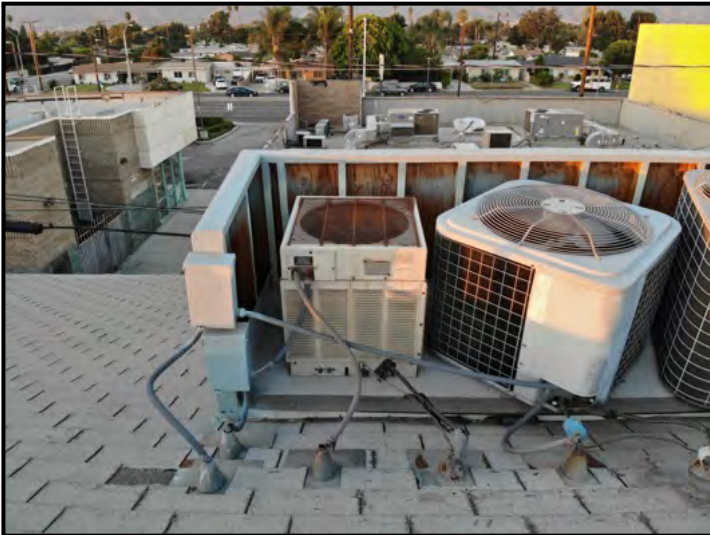
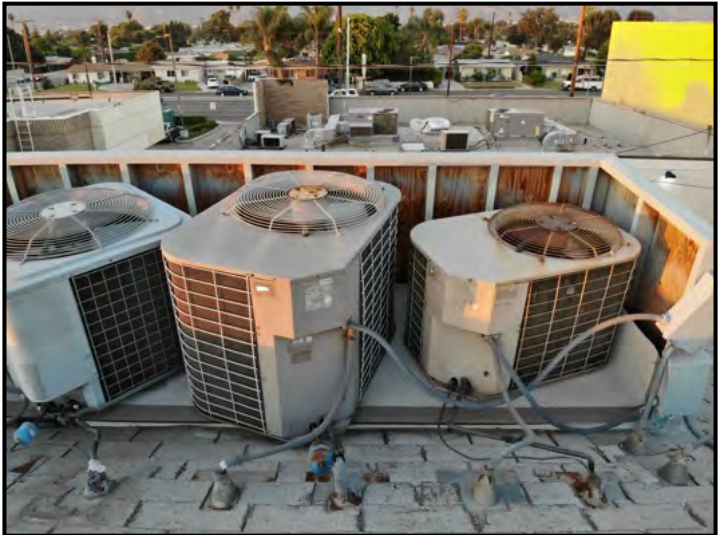
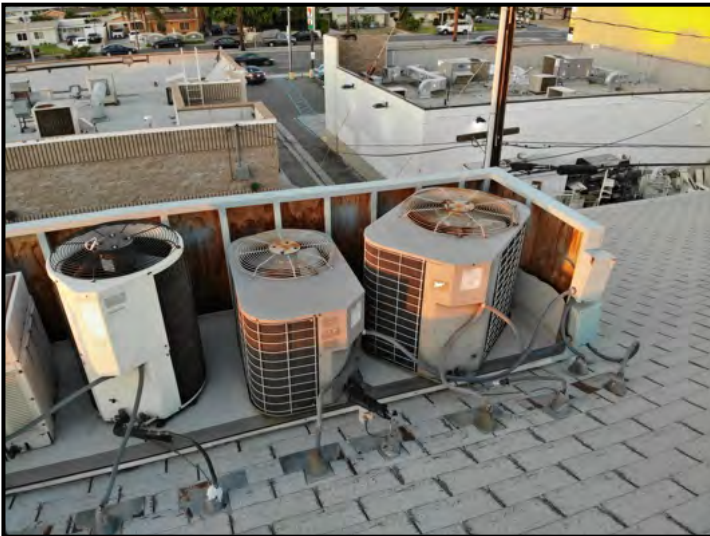
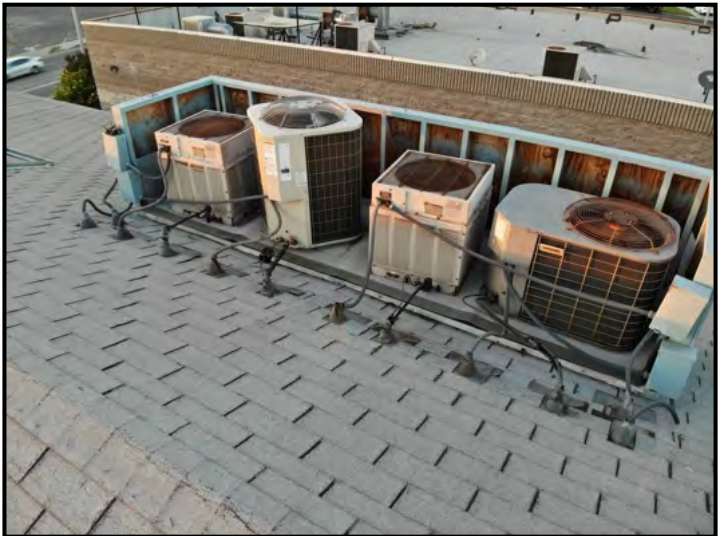
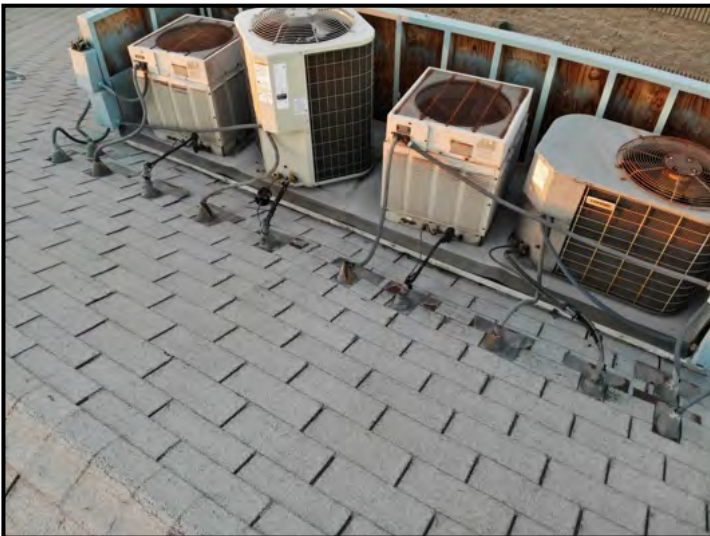
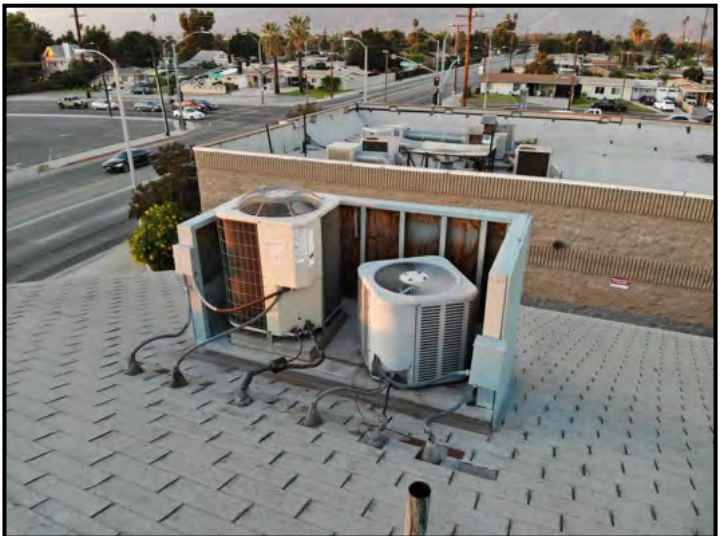
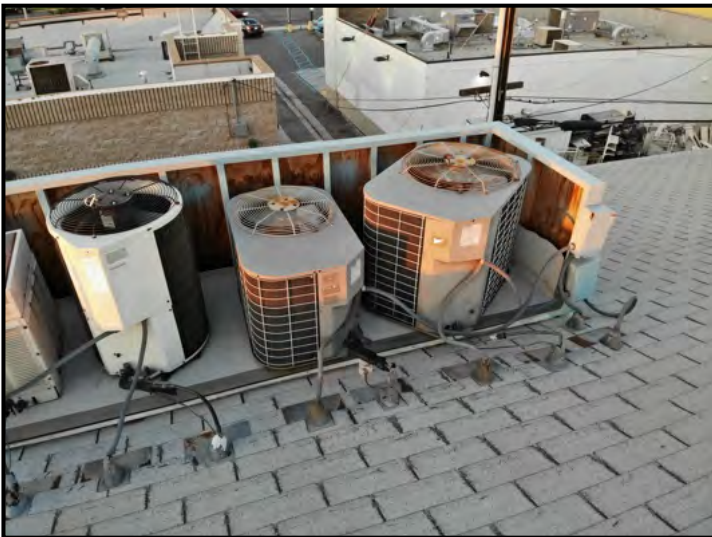
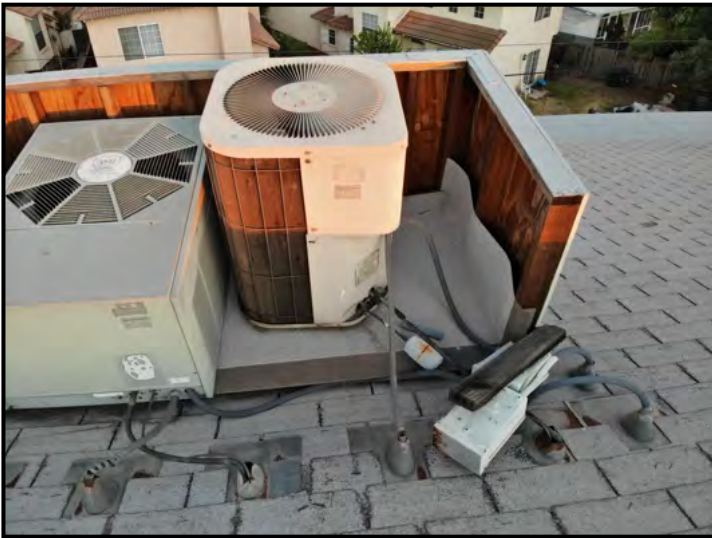
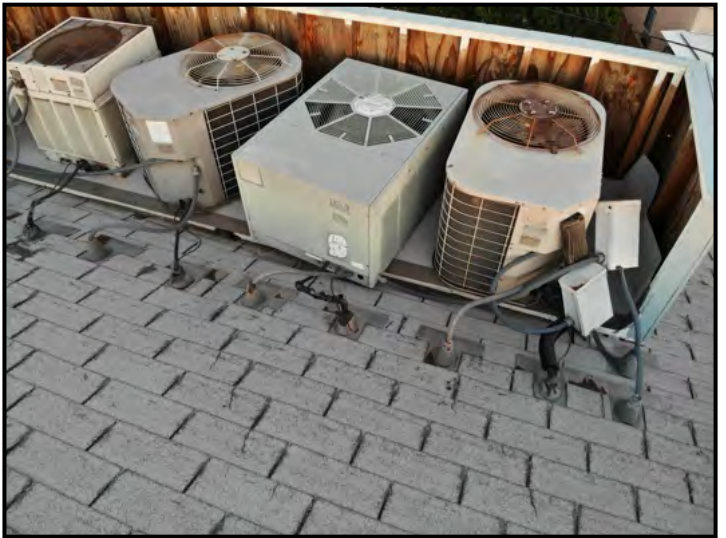
1. System Condition

- Condenser units are dirty throughout the property and in need of cleaning and maintenance.
- Insulation on the refrigeration lines of the condensers is deteriorated or missing throughout the property. Repair or replacement is recommended.
- A licensed HVAC contractor should be called to make further evaluation and repairs as needed.
- See photos.

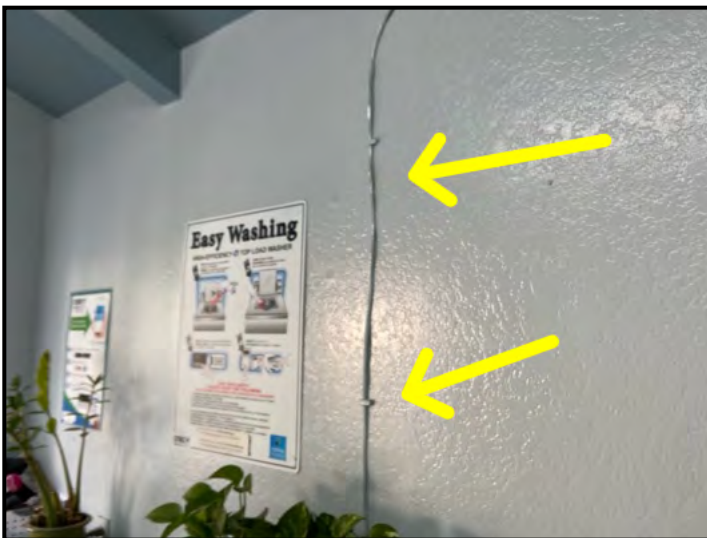
6. Electrical Condition

- A representative number of outlets, switches and fixtures was operated and found to be in operable condition at time of inspection.
- Improperly installed, exposed and unsafe romex wiring observed in the laundry room. See photos. Proper Installation or removal is necessary.

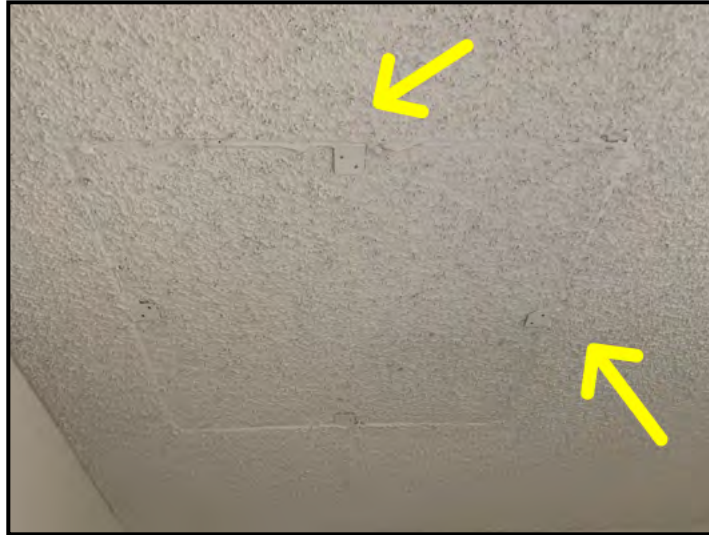
2. Condition

- Only a couple attic entrances were found but we're unable to access at time of inspection. Attic entrances were completely sealed shut and unable to access. See photo.
- See photos.

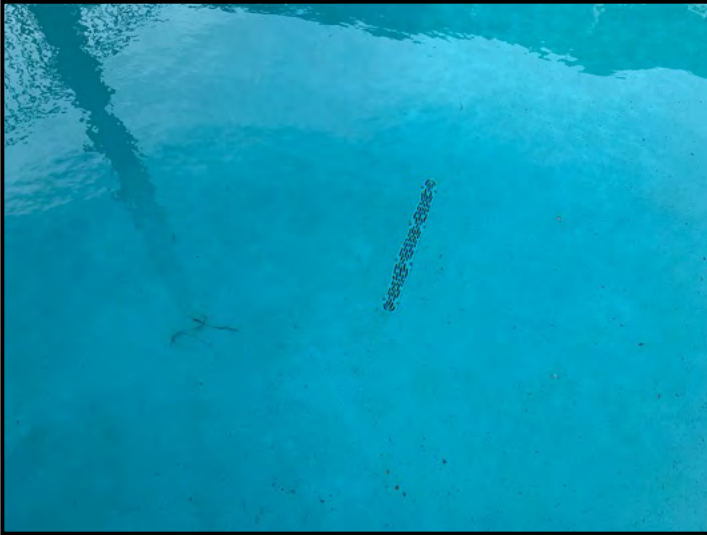
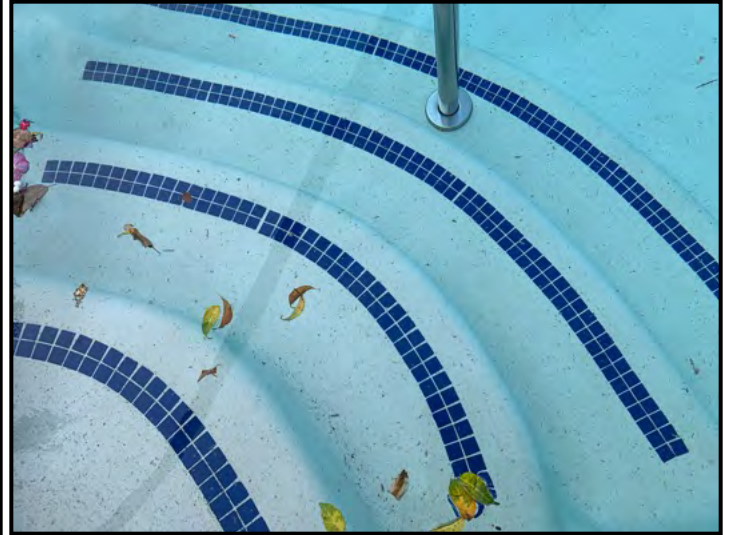
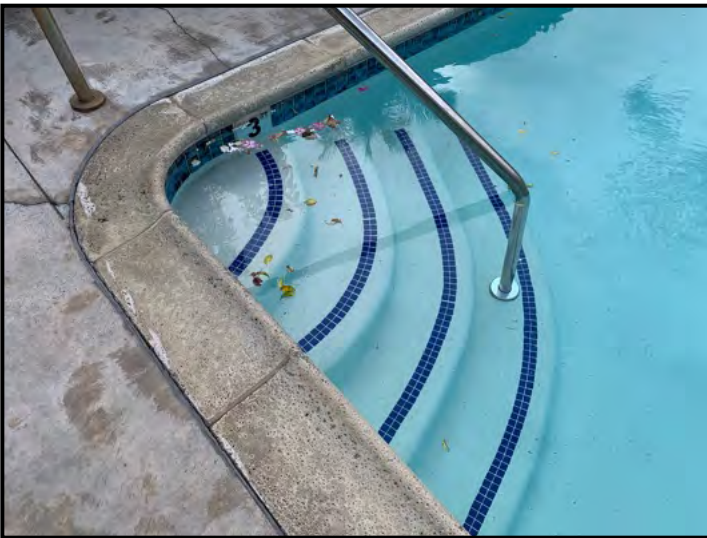
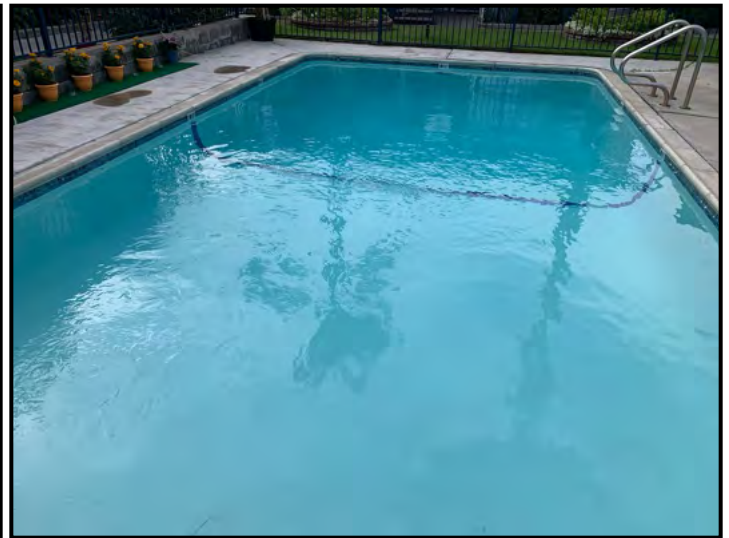
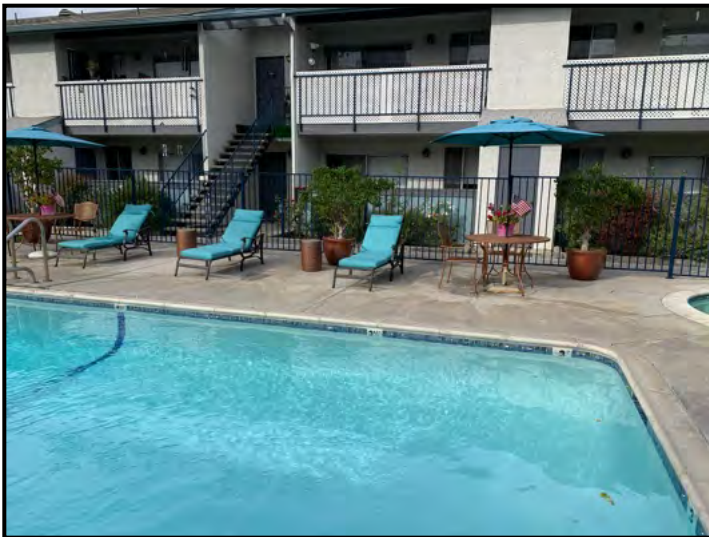
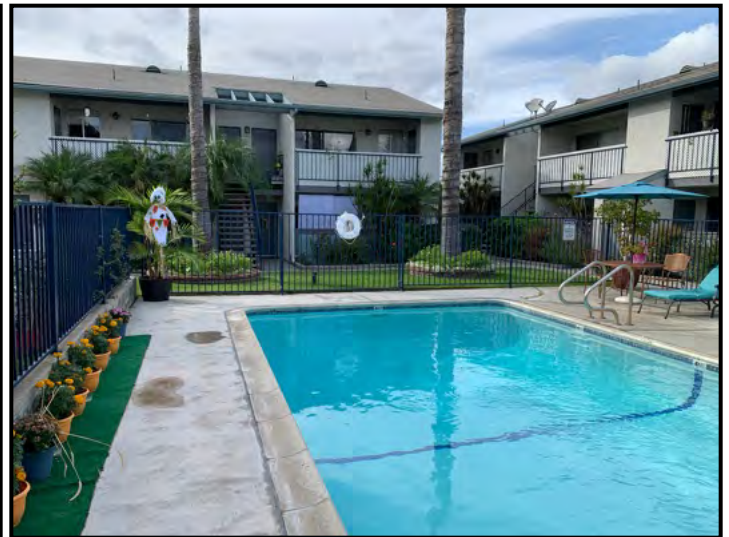
1. Pool Surface

- Pool surface appears to be within its useful life, with no significant damage or deterioration.
- See photos.
