PROPERTY INSPECTION REPORT

12345 Main Street, Anytown, CA 90001

DATE OF INSPECTION: 12/9/2022

VILLA HOME INSPECTIONS

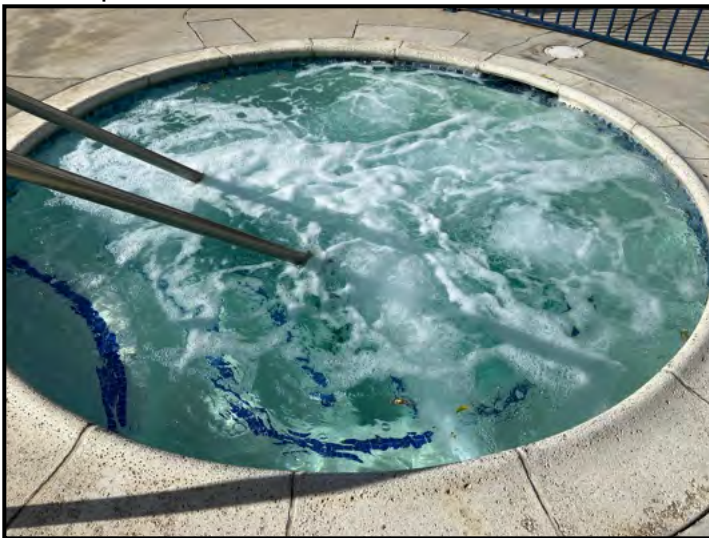
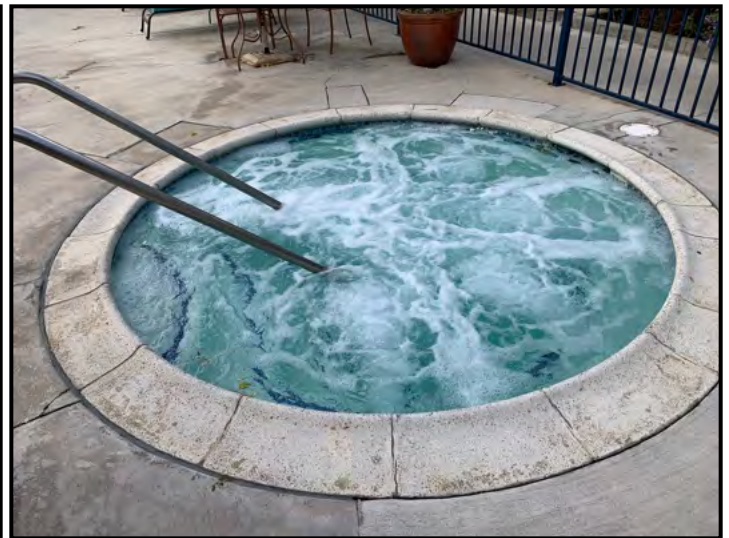
2. Spa/Hot Tub Condition

- Spa surface appears to be within its useful life, with no significant damage or deterioration.
- All controls operated properly at time of inspection.
- See photos.

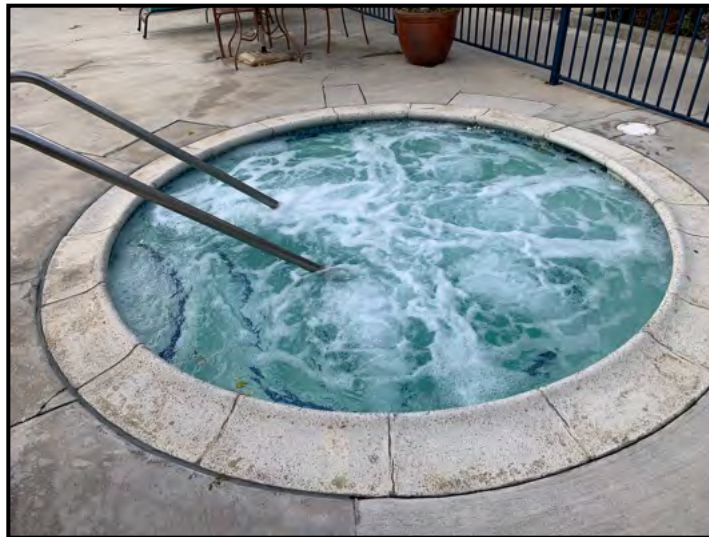
3. Fencing & Safety

- Fencing appears functional at time of inspection.
- Self closing gate mechanism is present and operable.
- Fencing is present and properly installed.

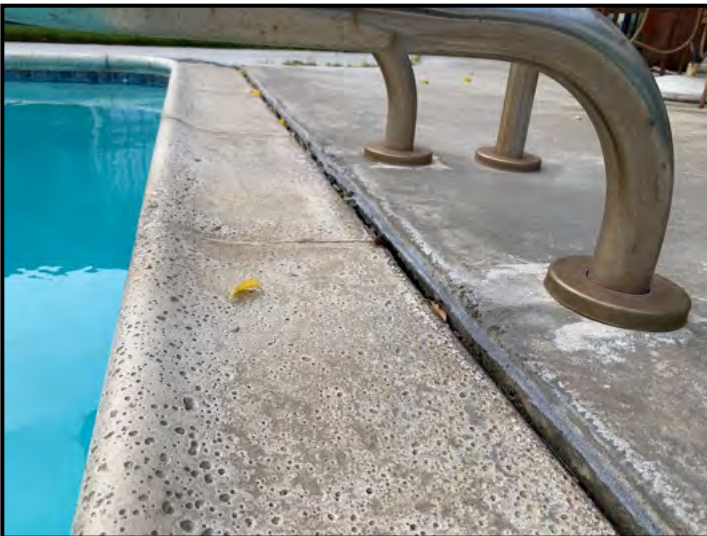
4. Decking Condition

- Coping is not sealed properly. Application of sealant is recommended to prevent moisture penetration behind pool walls.
- Cracks observed on the coping around the pool. This is an indication of rusted steel reinforcement (rebar) inside the bond beam (structural support around the top of the pool walls) and may be a structural concern in the future if not repaired.
- Concrete deck has moderate cracks and may need further evaluation by a masonry or pool contractor.
- North west corner of the pool decking appears to have been lifted up and is no longer level with the pool. See photos
- See photos.

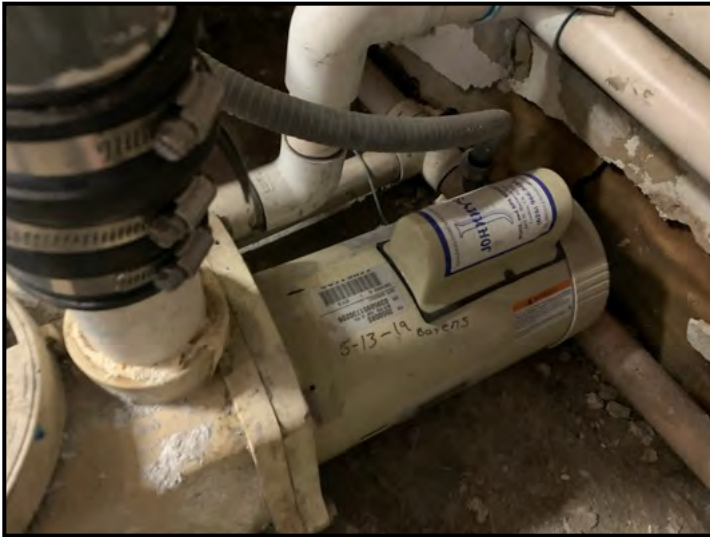
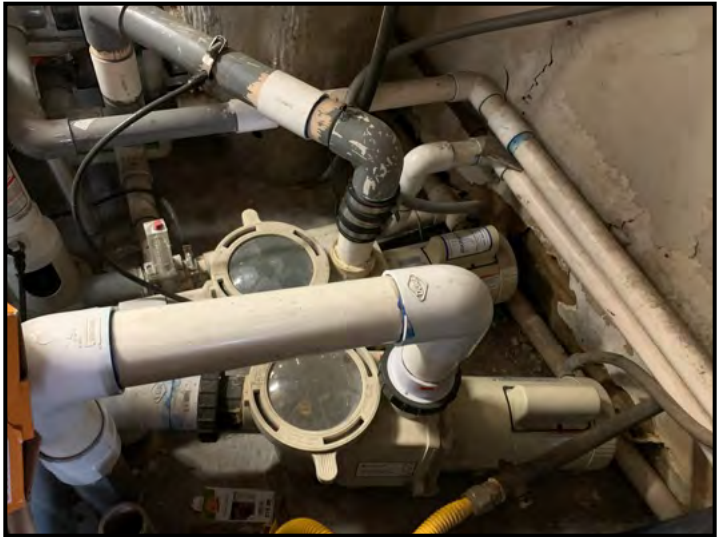
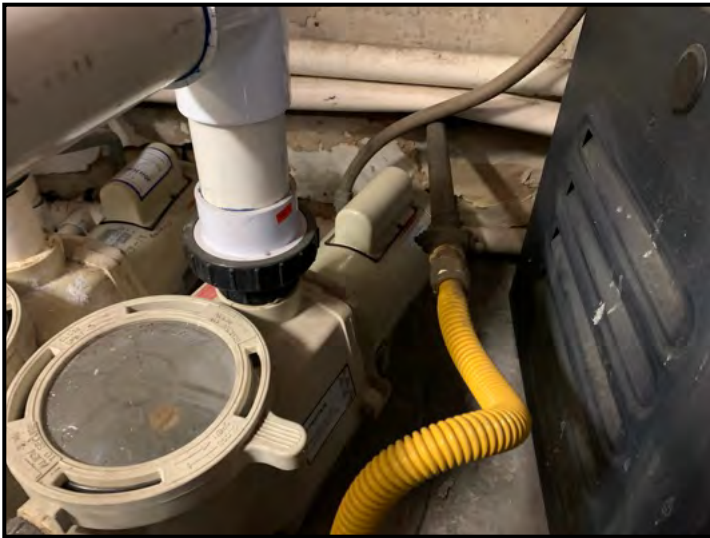
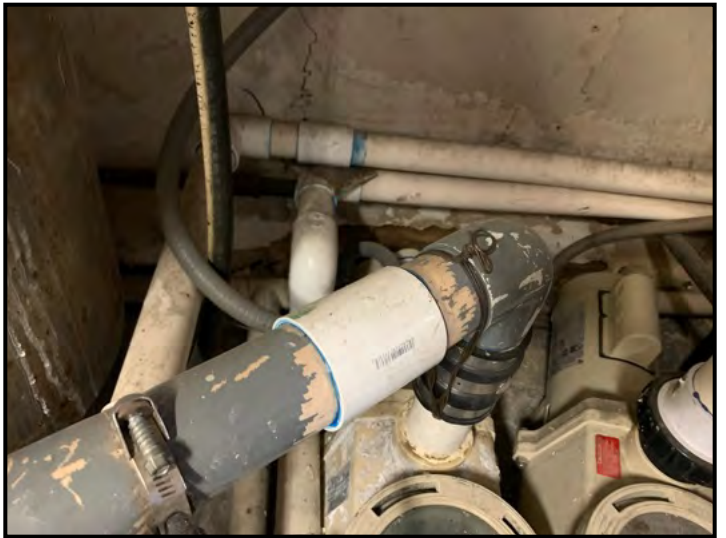
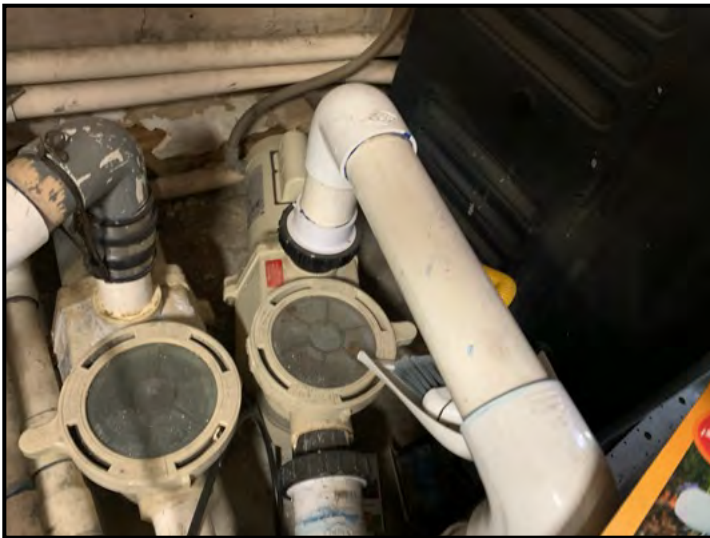
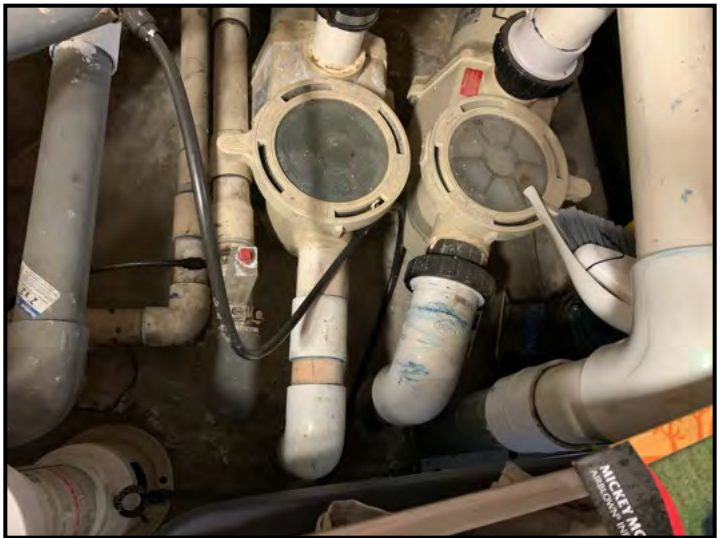
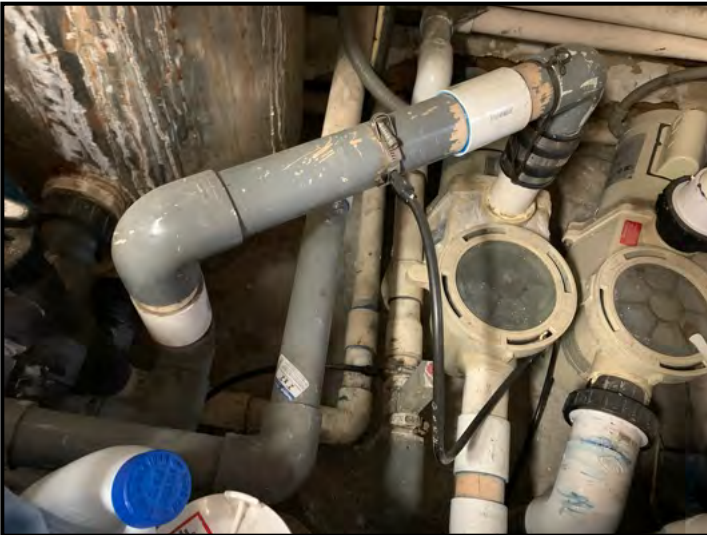
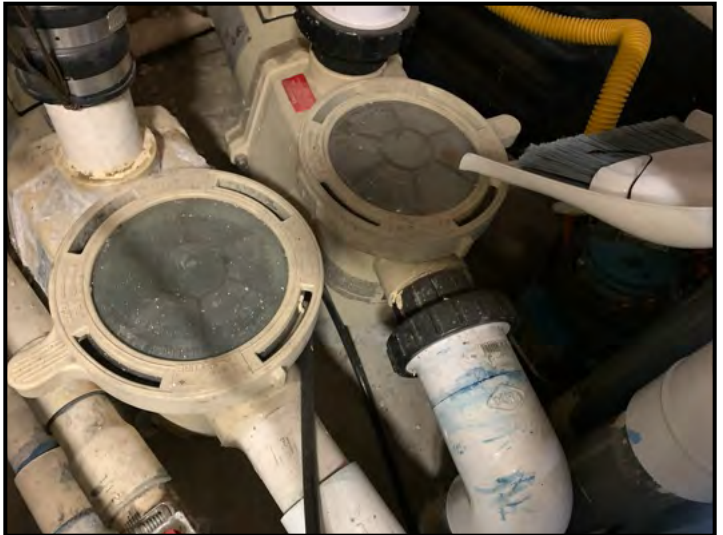
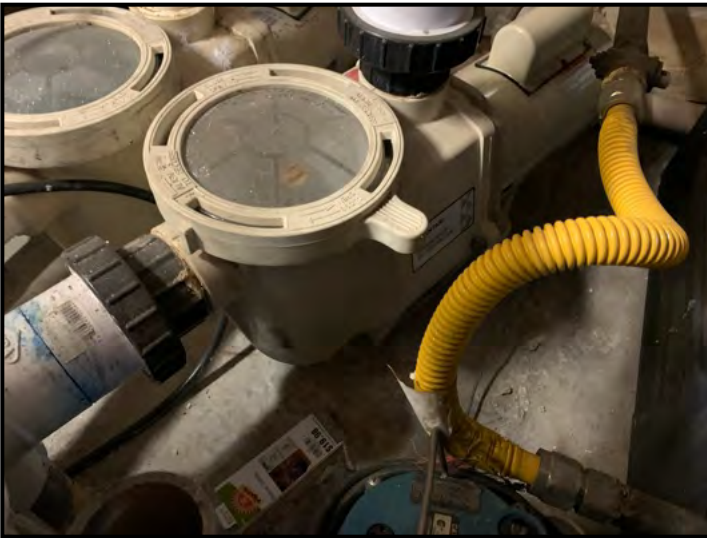
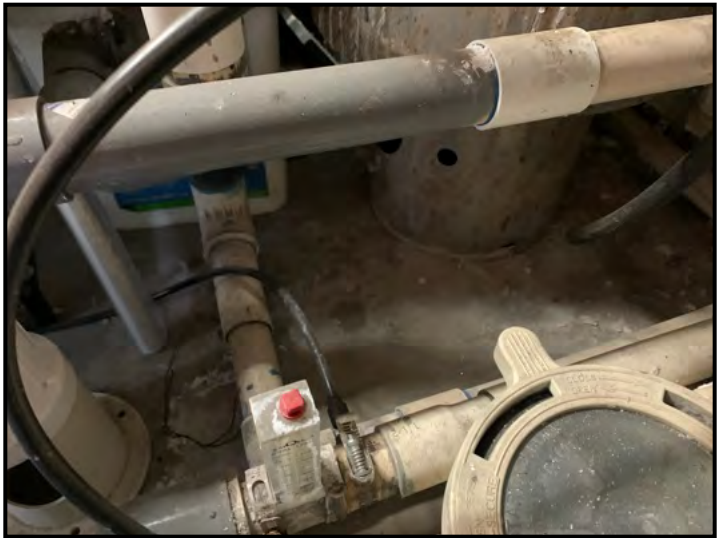
- Pumping equipment operated properly at time of inspection.
- See photos.

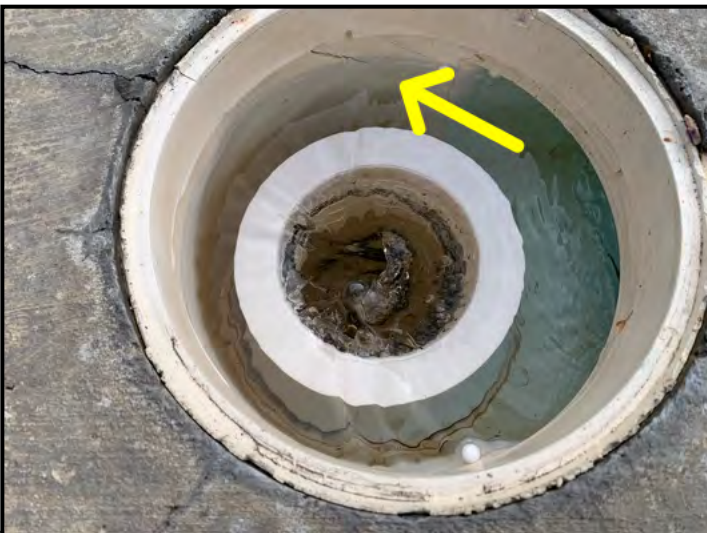
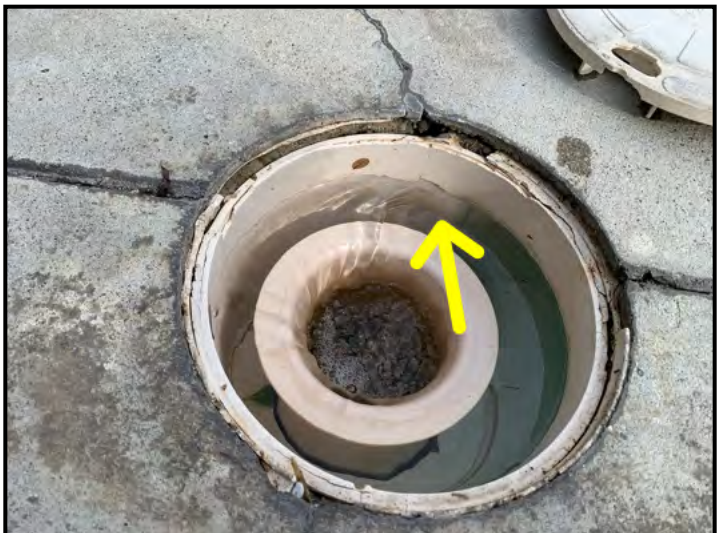
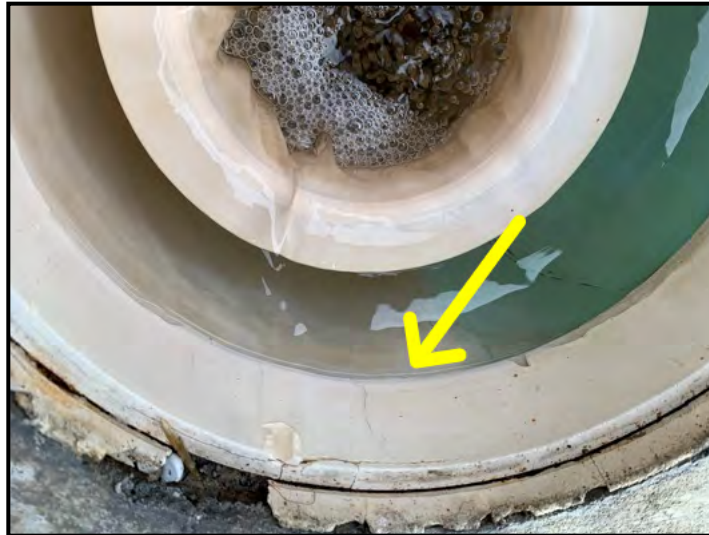
8. Skimmer Basket

- Skimmer body is cracked or damaged and may leak under the pool deck. Repair or replacement is necessary.
- See photos.

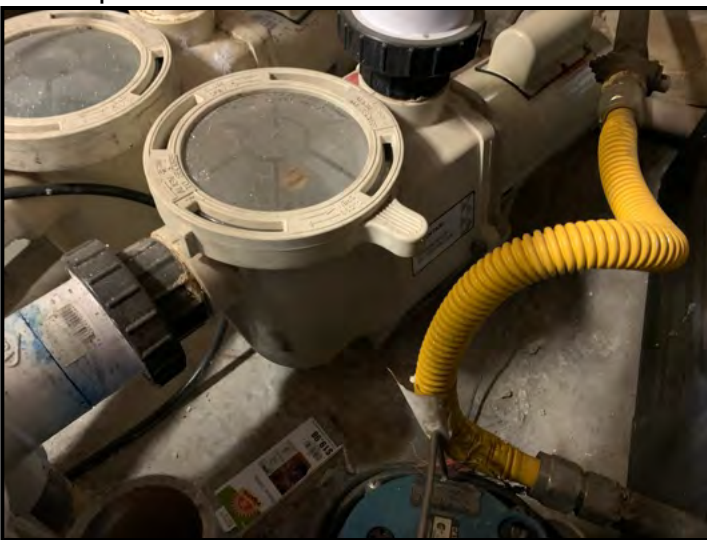
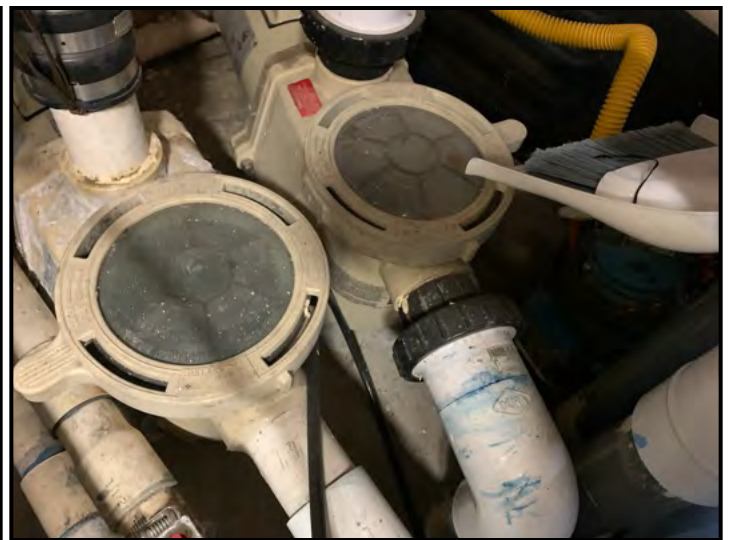
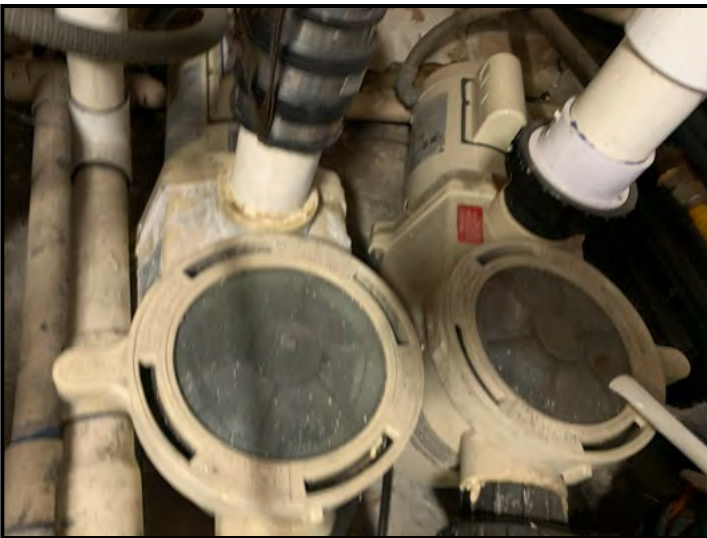
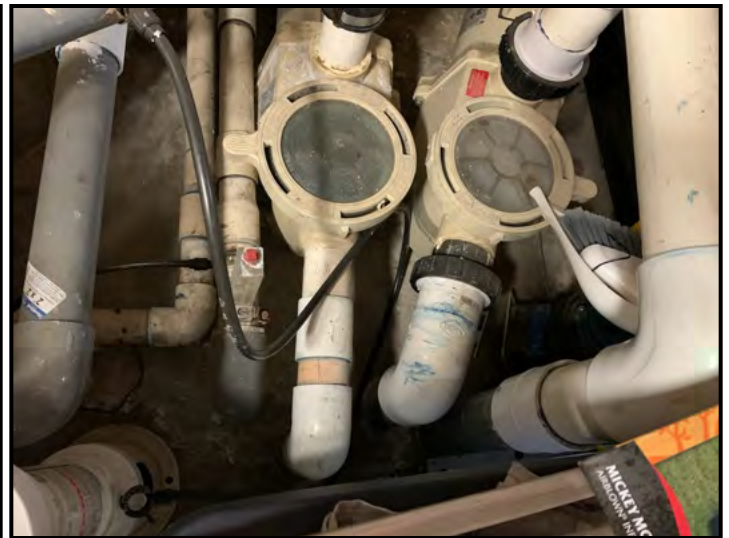
9. Strainer

- No visible problems observed at time of inspection.
- See photos.

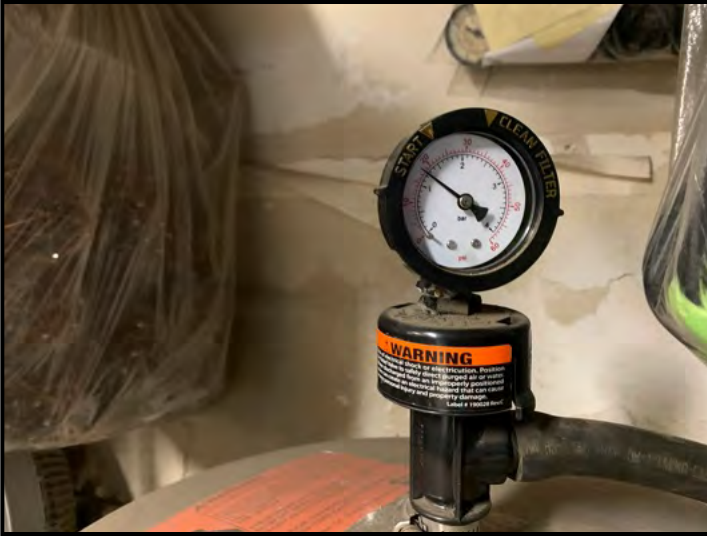
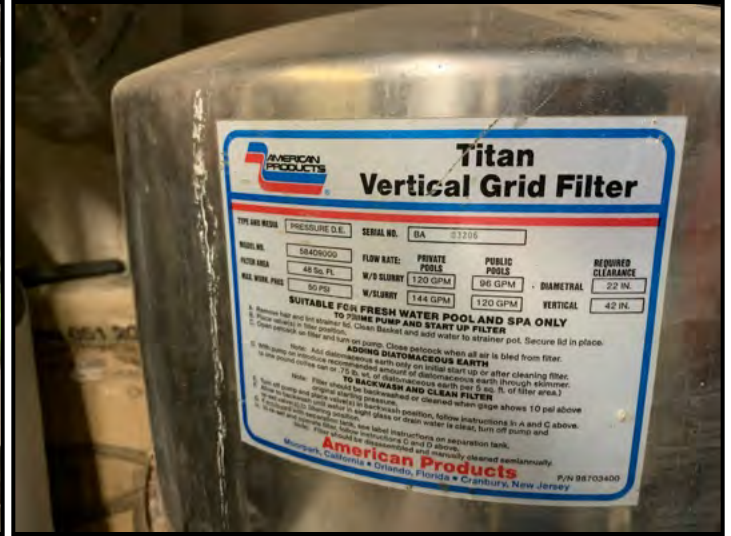
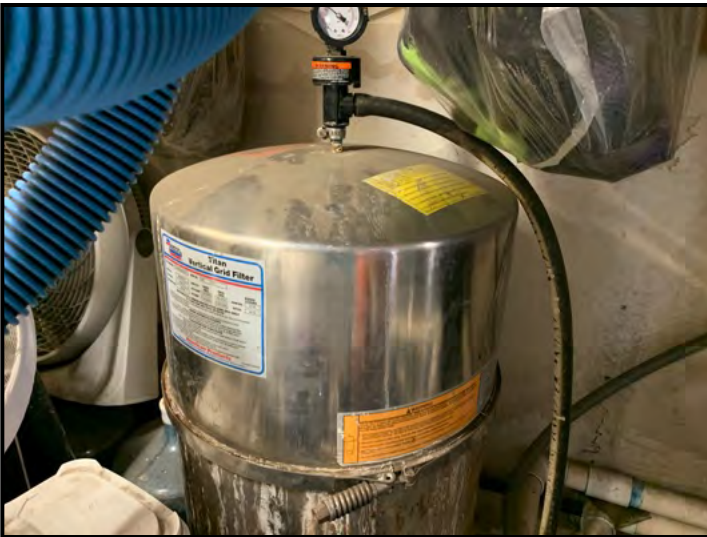
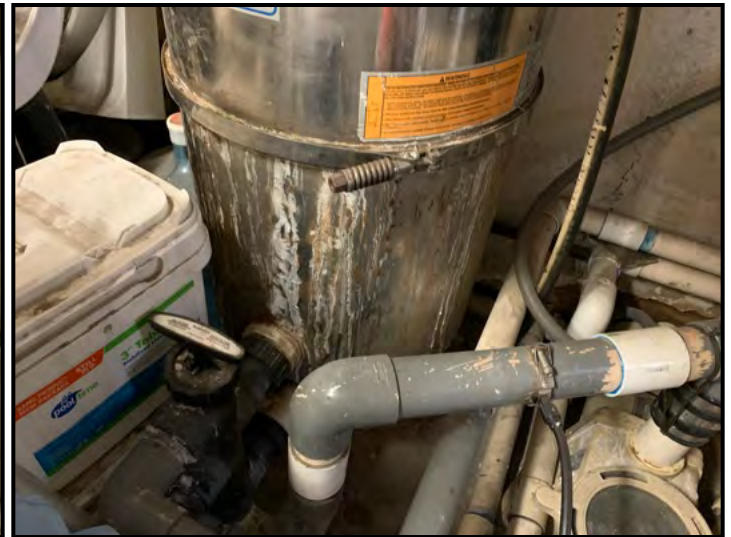
10. Filter Condition

- Filter appeared to operate properly at time of inspection.
- See photos.

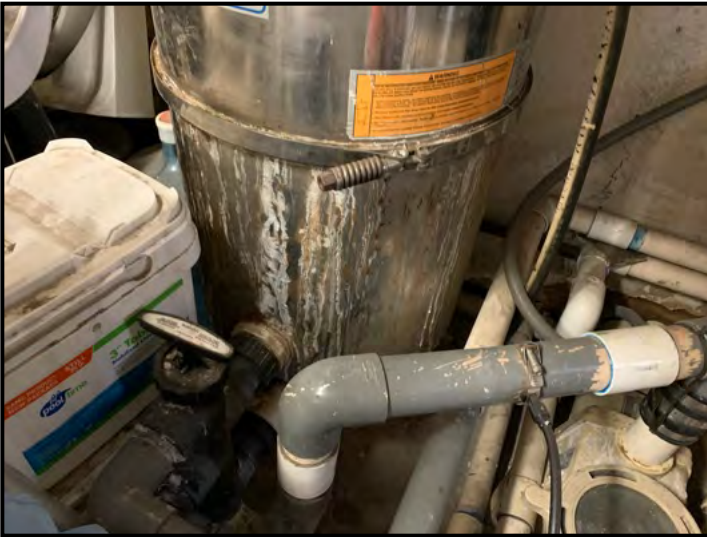
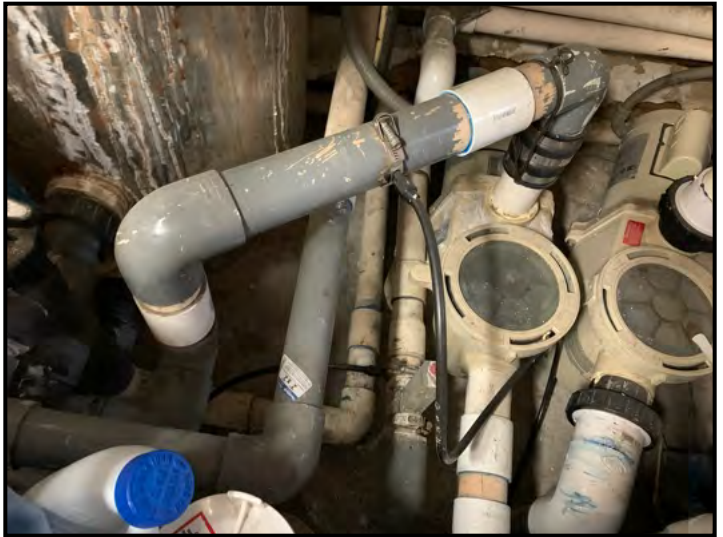
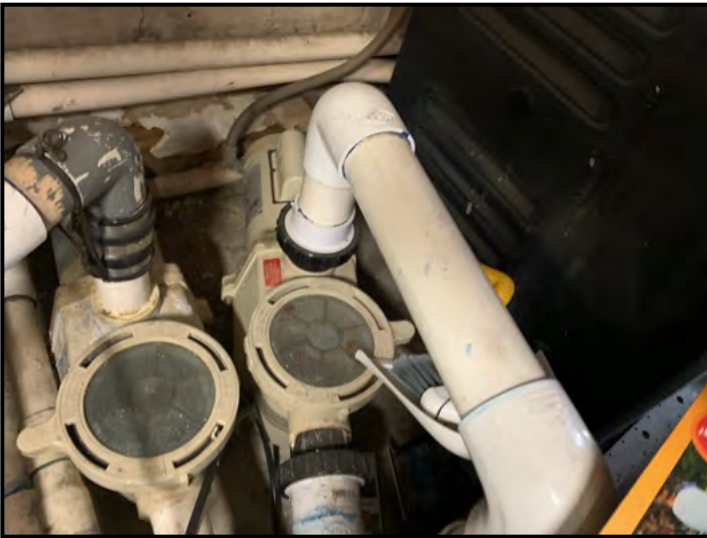
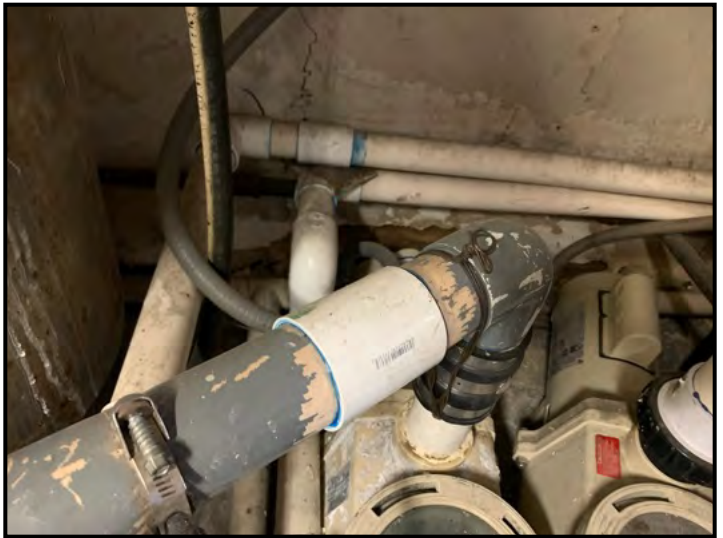
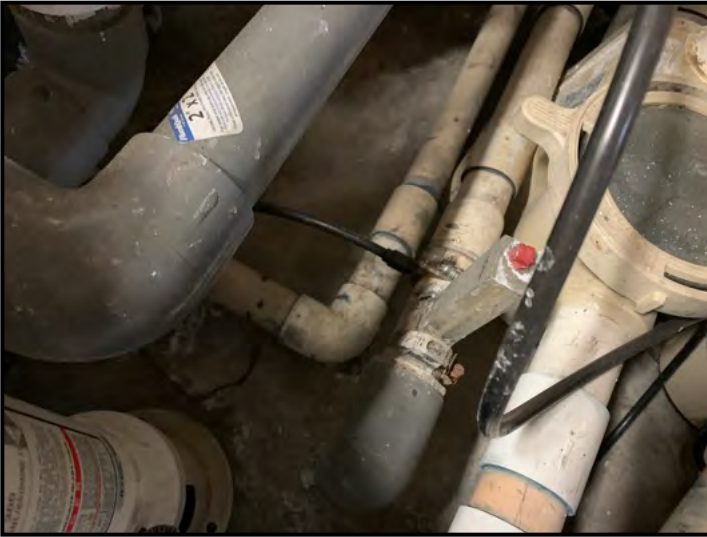
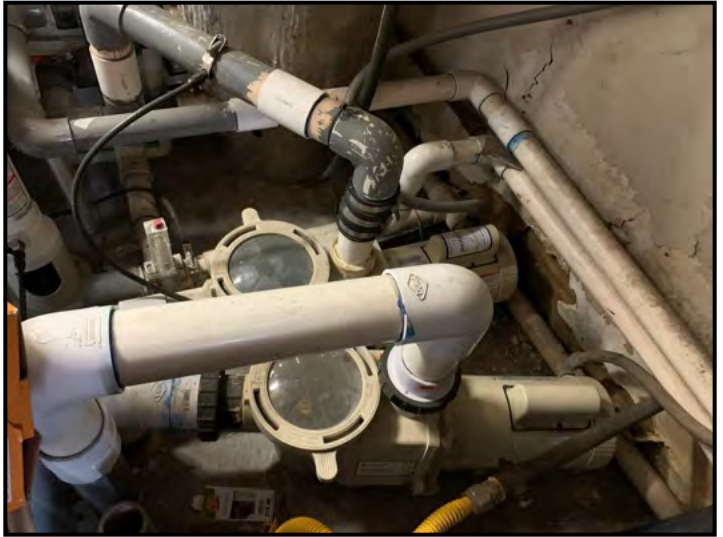
12. Plumbing Line Condition

- No visible problems observed at time of inspection.
- Some patching or prior replacement of piping is noted.
- See photos.

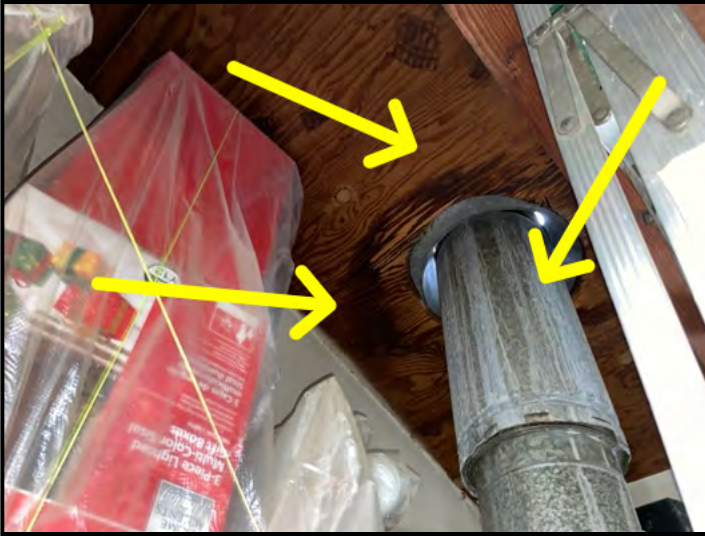
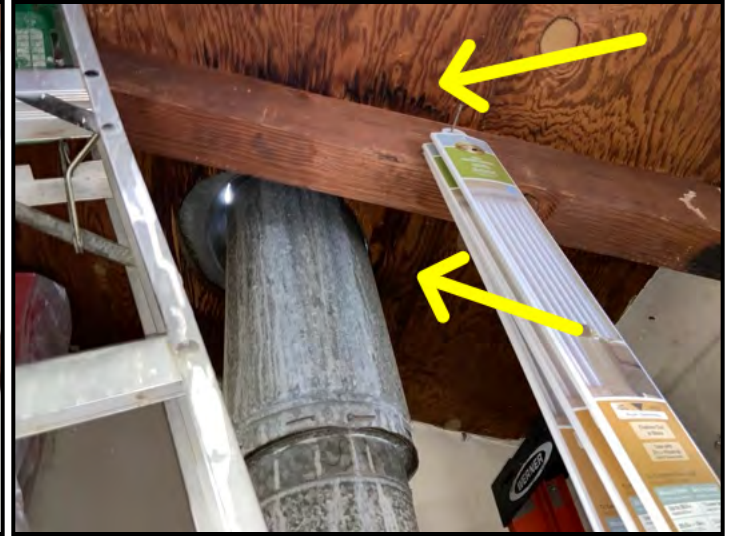
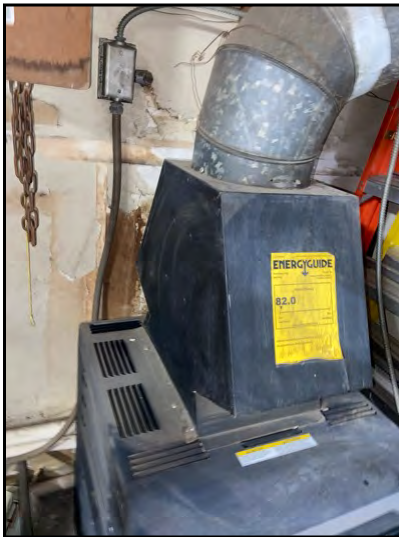
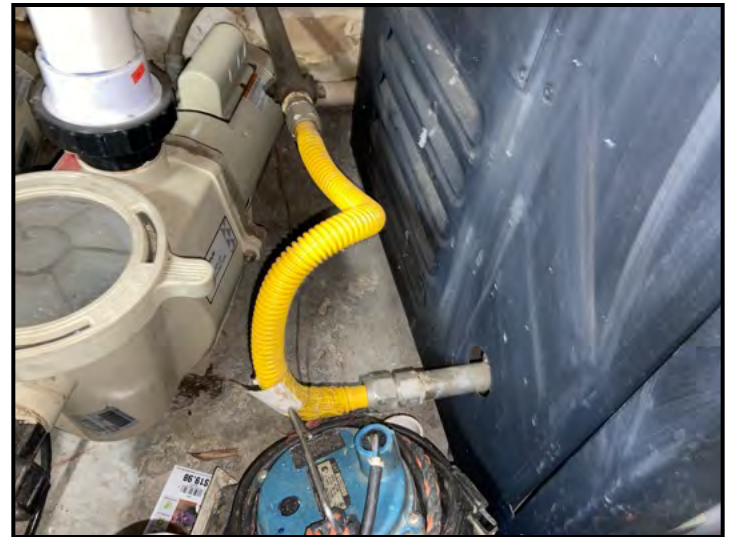
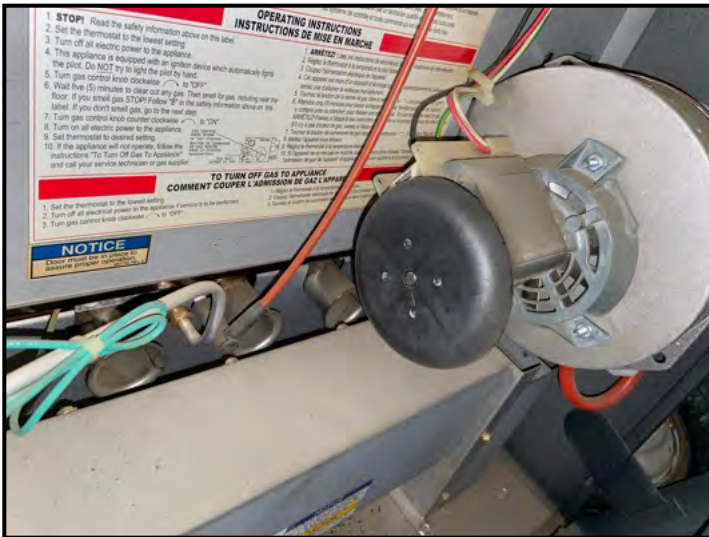
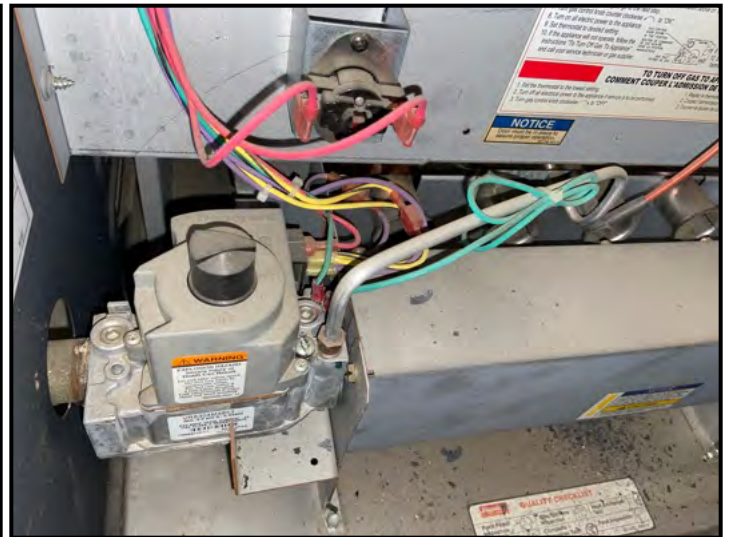
13. Heater Condition

- Heater operated properly at time of inspection.
- Heater operated properly at time of inspection.
- **Heater is dirty and should be cleaned thoroughly prior to use.**
- **See photos.**

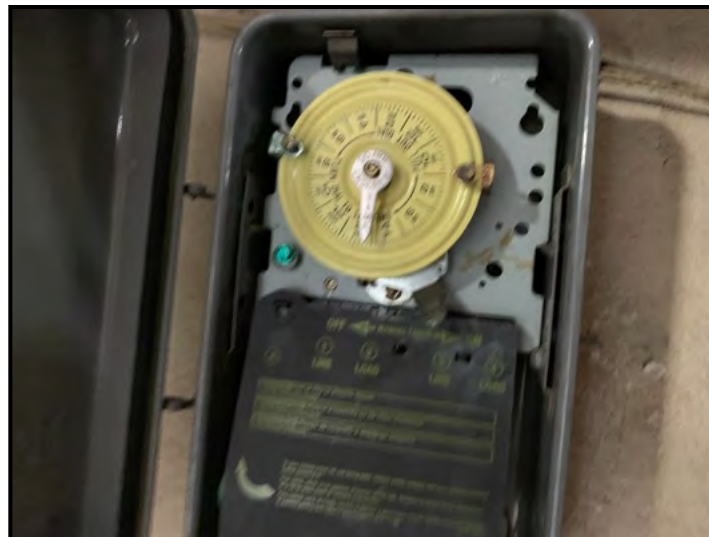
14. Electronic Controls

- Timer appeared to operate properly at time of inspection. Inspector does not change timing or programming during inspection.
- See photos.

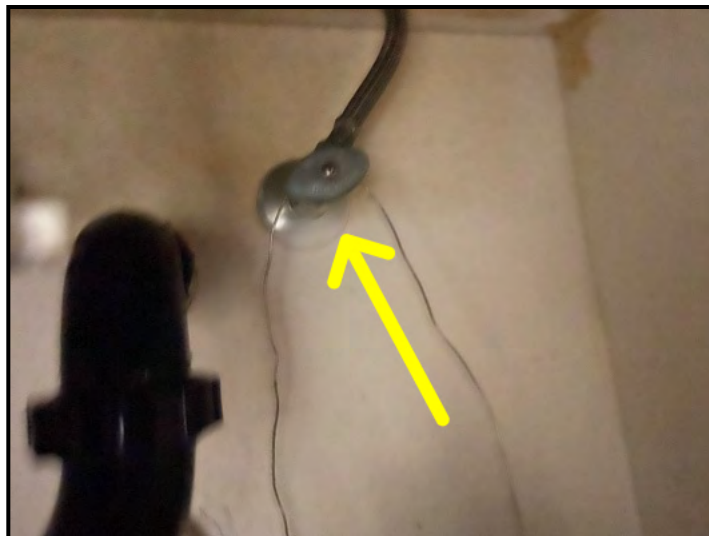
- Leaks noted at the supply lines under the sink at time of inspection.
- Exhaust fan is significantly noisy when operated. Repair or replacement is needed.
- Floor tiles are damaged or loose. Repair or replacement is recommended.

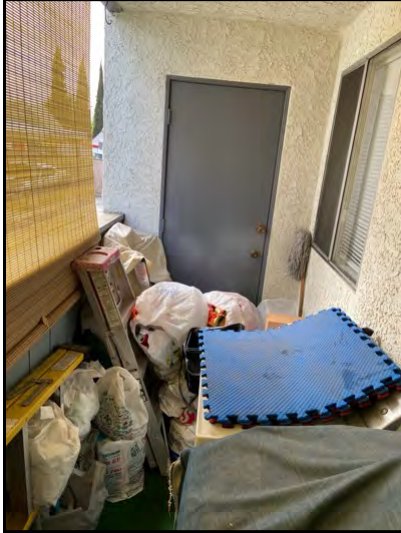
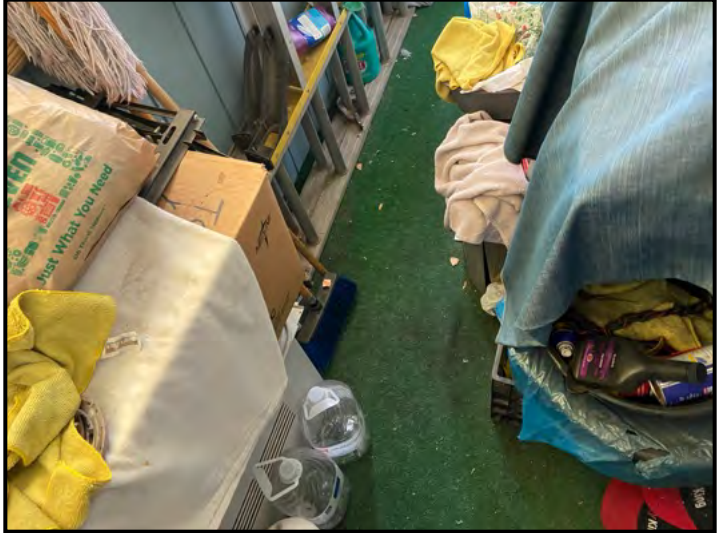
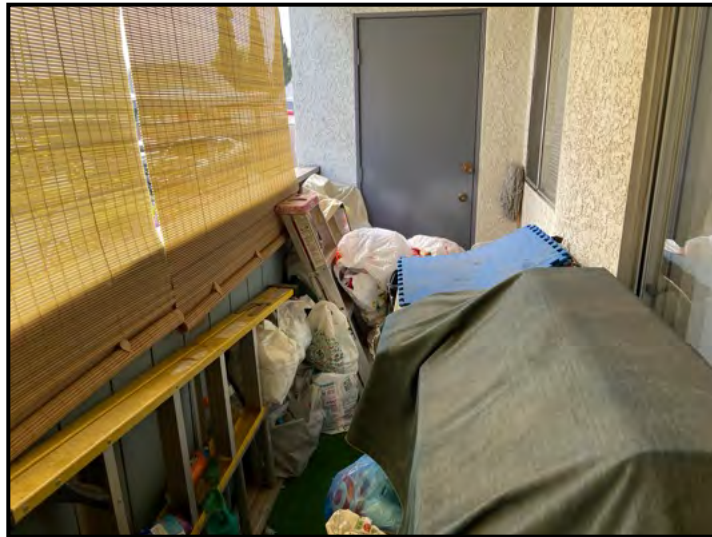
- Carpet restricts viewing.
- Unable to fully view the balcony/ patio due to occupants belongings. See photos.

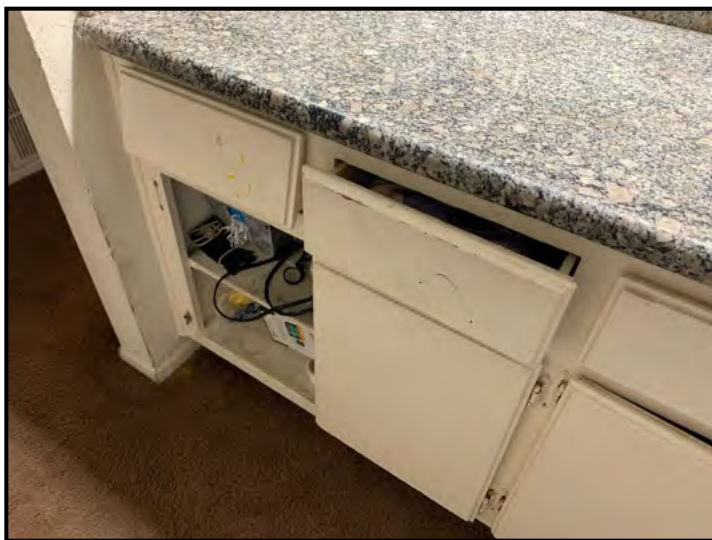
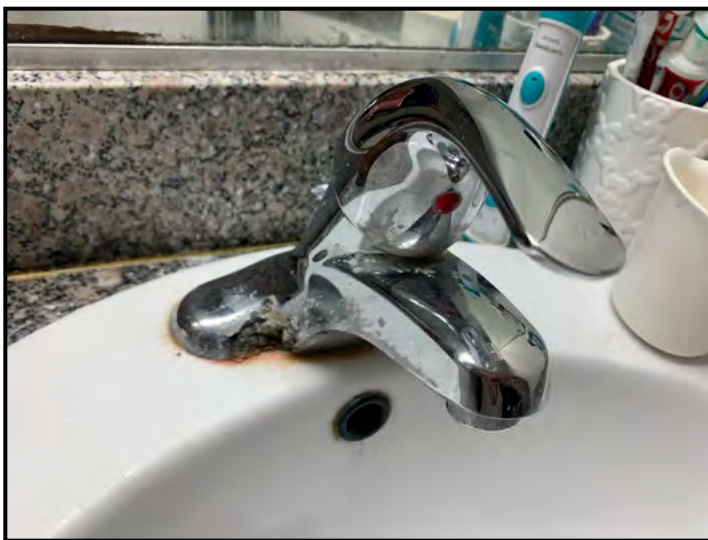
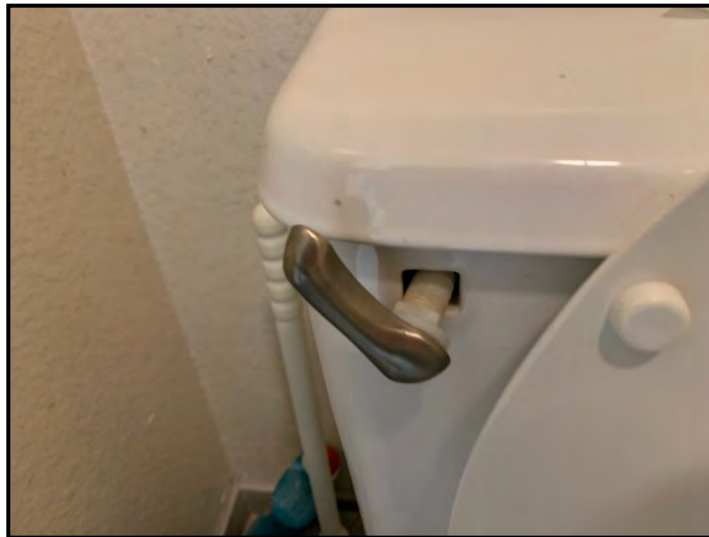
- No visible problems observed at the doors and windows at time of inspection.
- Walls and ceiling appeared functional at time of inspection.
- No visible floor problems noted at time of inspection.
- **Toilet does not flush properly. Minor repairs are needed.**
- **Repair or replacement is recommended.**
- **See photos.**
- **Vanity door or drawer is damaged or broken. Repair or replacement is recommended.**
- **Caulking is recommended at the tub or shower areas to prevent moisture penetration and damage behind the walls.**
- **Exhaust fan did not operate noisily at time of inspection. Repair or replacement is necessary.**
- **See photos.**
- **Bathroom faucet has considerable amount of corrosion and needs to be replaced**
- **Toilet handle is broken**

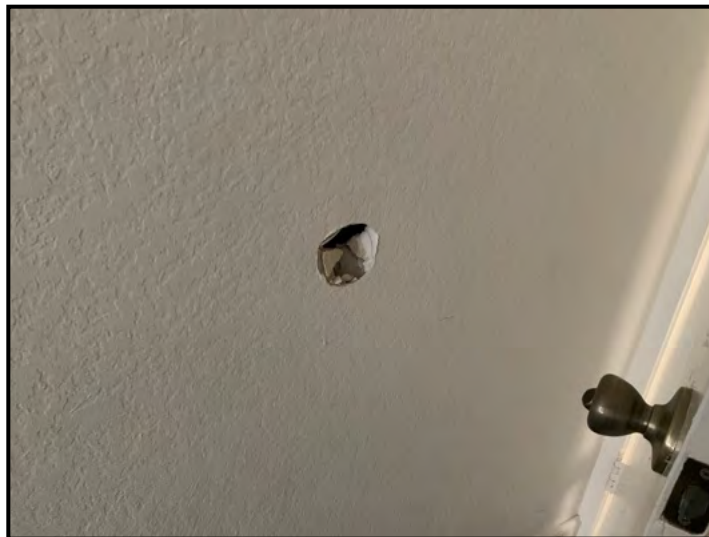
- Windows and doors operated properly at time of inspection.
- No visible problems noted at the closet at time of inspection.
- No visible problems noted at the floor at time of inspection.
- A representative number of outlets, switches and fixtures was operated and found to be in operable condition at time of inspection.
- **Smoke detector is not installed. A smoke detector is required in every bedroom, adjacent hallway and every level of the dwelling prior to the close of escrow.**
- **Moisture stains and/or damage viewed on the walls.**

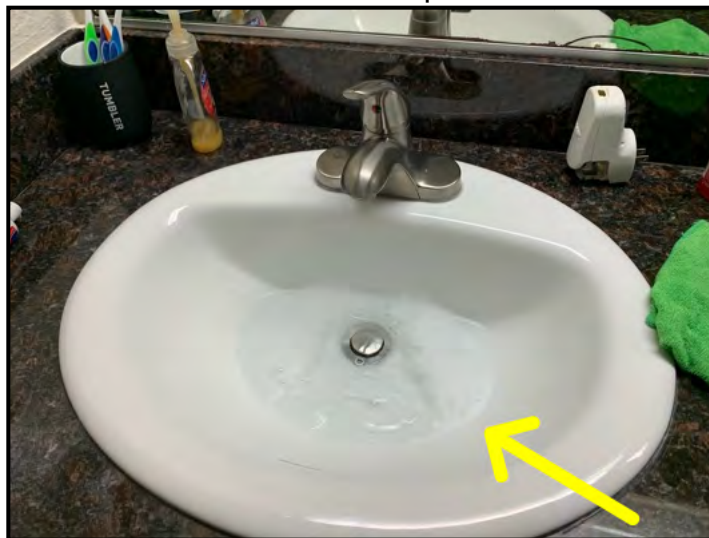
5. Bathrooms

- Sink does not drain properly.
- No visible problems noted at the sink and vanity at time of inspection.
- No visible problems noted at the tub/shower area at time of inspection.
- No visible problems observed at the doors and windows at time of inspection.
- Walls and ceiling appeared functional at time of inspection.
- No visible floor problems noted at time of inspection.
- No visible electrical problems observed at time of inspection.

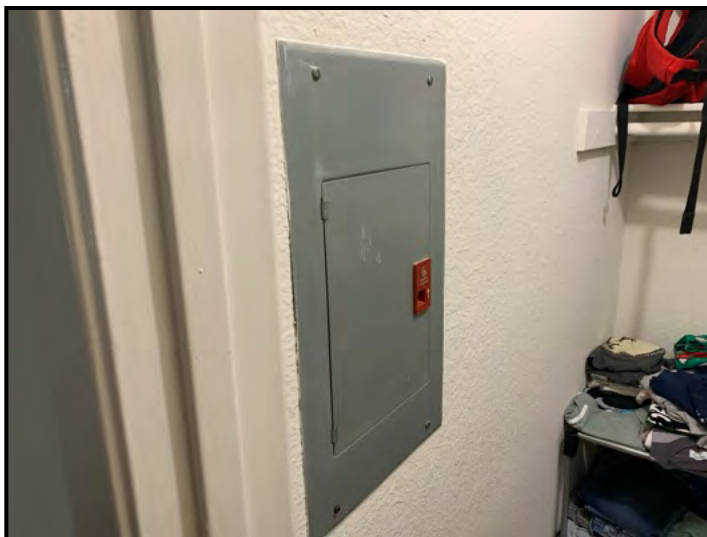
6. Electrical Panel Condition

- Unable to remove electrical panel cover. Panel cover has been painted/sealed to the wall and removal would cause damage to the surrounding wall. Access to the interior of the panel is required.
- See photos.
- Electrical panel is located in bedroom closet which is not allowed

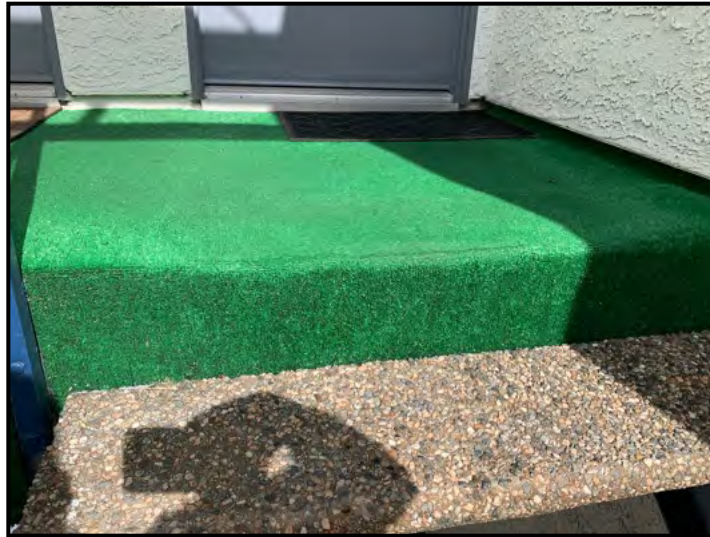
- Deck underside is not accessible for inspection. Further evaluation may be necessary.
- Balcony underside is covered with wood or stucco and is not accessible for inspection. Further evaluation may be necessary.
- No visible problems observed at time of inspection.
- Carpet restricts viewing.
- Rot, termite or moisture damage observed.
- See photos.
- Balcony is covered with turf which holds moisture and causes rot damage underneath

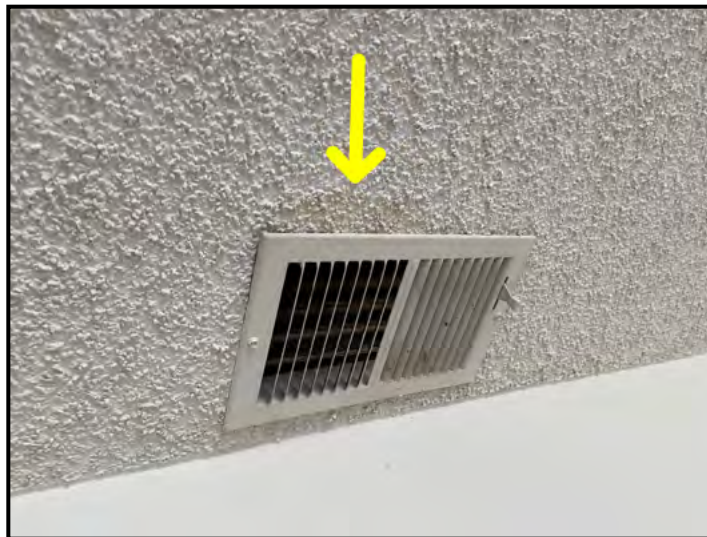
- Moisture stains and/or damage viewed on the ceiling.
- Possible roof leak. Further evaluation by a roofing contractor is recommended.
- See photos.

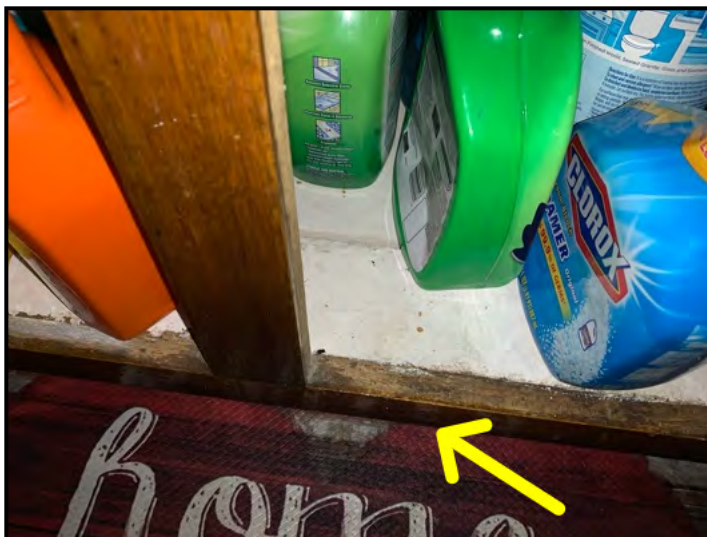
- No visible plumbing problems noted at time of inspection.
- Windows and doors operated properly at time of inspection.
- Walls and ceiling appeared functional at time of inspection.
- No visible problems noted at the floor at time of inspection.
- A representative number of outlets, switches and fixtures was operated and found to be in operable condition at time of inspection.
- **Moisture damage noted on the cabinets. Repair or replacement is recommended.**

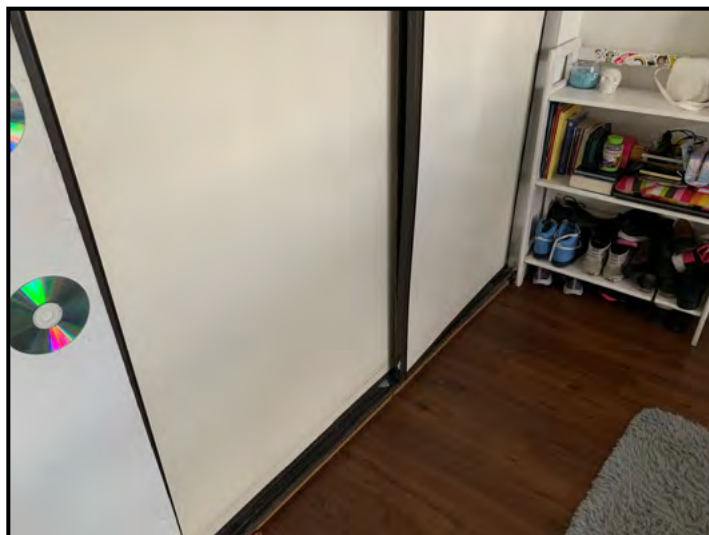
- Walls and ceiling appeared functional at time of inspection.
- No visible problems noted at the floor at time of inspection.
- A representative number of outlets, switches and fixtures was operated and found to be in operable condition at time of inspection.
- **Smoke detector is not installed. A smoke detector is required in every bedroom, adjacent hallway and every level of the dwelling prior to the close of escrow.**
- **See photos.**
- **Closet doors are fallen off the tracks. Proper installation is recommended.**
- **See photos.**
- **Closet doors do not operate properly in and falling off tracks.**
- **Bedroom door is damaged and missing hardware**

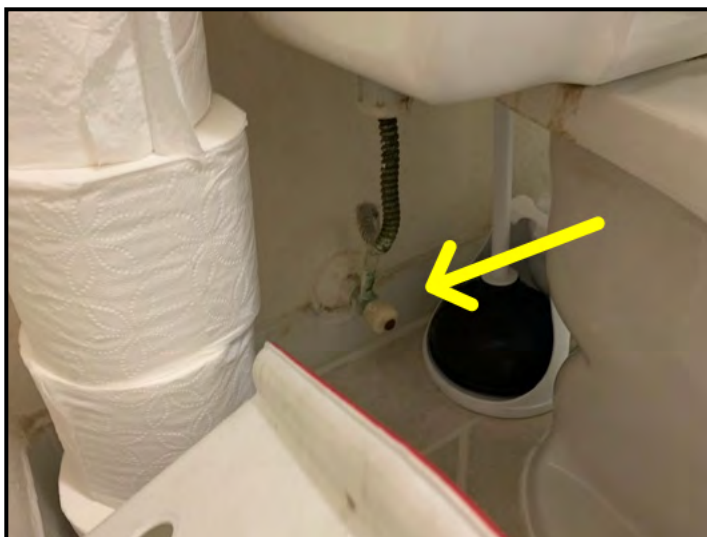
5. Bathrooms

- No visible problems noted at the sink and vanity at time of inspection.
- No visible problems noted at the tub/shower area at time of inspection.
- No visible problems observed at the doors and windows at time of inspection.
- Walls and ceiling appeared functional at time of inspection.
- No visible floor problems noted at time of inspection.
- No visible electrical problems observed at time of inspection.
- **Rust and corrosion observed on the water supply valves under the sink.**
- **Water supply valve for toilet is older valve, has significant amount of corrosion around valve and water line. Needs to be replaced**

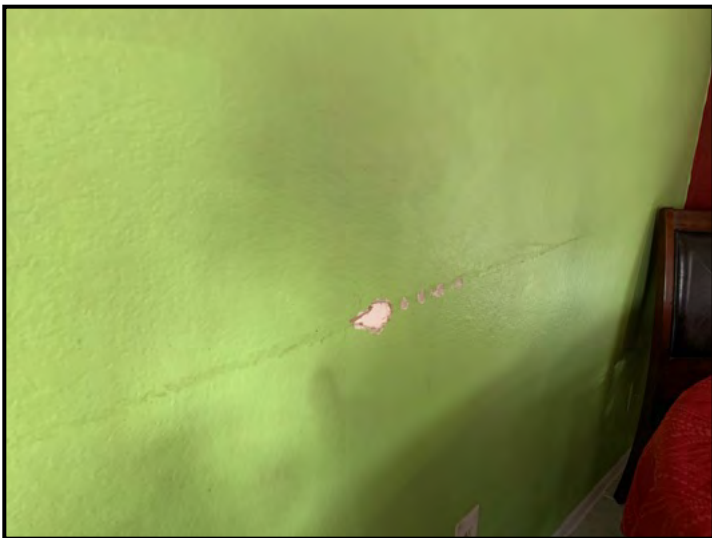
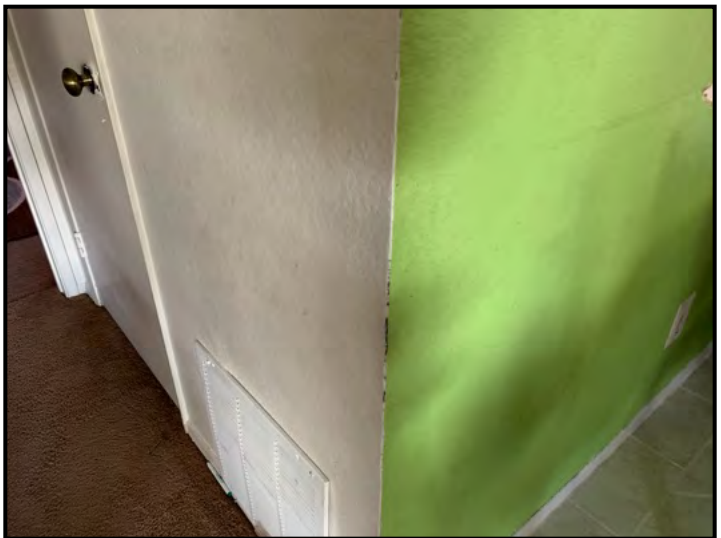
1. Living & Dining Room

- Windows and doors operated properly at time of inspection.
- No visible problems noted at the floor at time of inspection.
- A representative number of outlets, switches and fixtures was operated and found to be in operable condition at time of inspection.
- **Moisture stains and/or damage viewed on the walls.**
