PROPERTY INSPECTION REPORT

12345 Main Street, Anytown, CA 90001

DATE OF INSPECTION: 12/9/2022

VILLA HOME INSPECTIONS

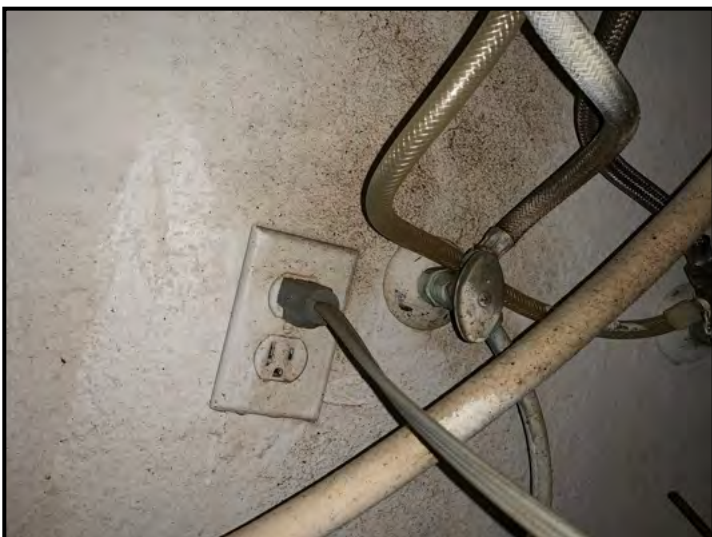
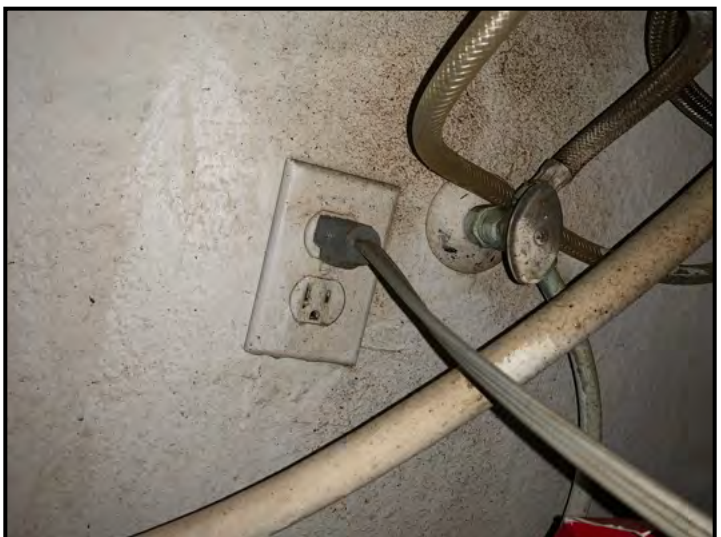
2. Kitchen

- No visible problems noted at the counters and cabinets at time of inspection.
- Windows and doors operated properly at time of inspection.
- Walls and ceiling appeared functional at time of inspection.
- No visible problems noted at the floor at time of inspection.
- A representative number of outlets, switches and fixtures was operated and found to be in operable condition at time of inspection.
- **Rust and corrosion observed on the water supply valves under the sink.**

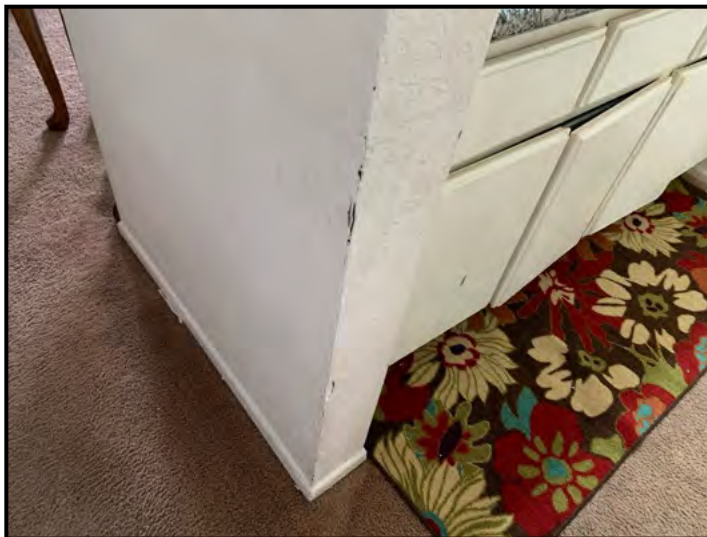
3. Hallway

- Carbon monoxide alarm is installed in the dwelling.
- No visible problems noted at the closet at time of inspection.
- No visible problems noted at the floor at time of inspection.
- A representative number of outlets, switches and fixtures was operated and found to be in operable condition at time of inspection.
- **Smoke detector is not installed. A smoke detector is required in every bedroom, adjacent hallway and every level of the dwelling prior to the close of escrow.**
- **Moisture stains and/or damage viewed on the walls.**

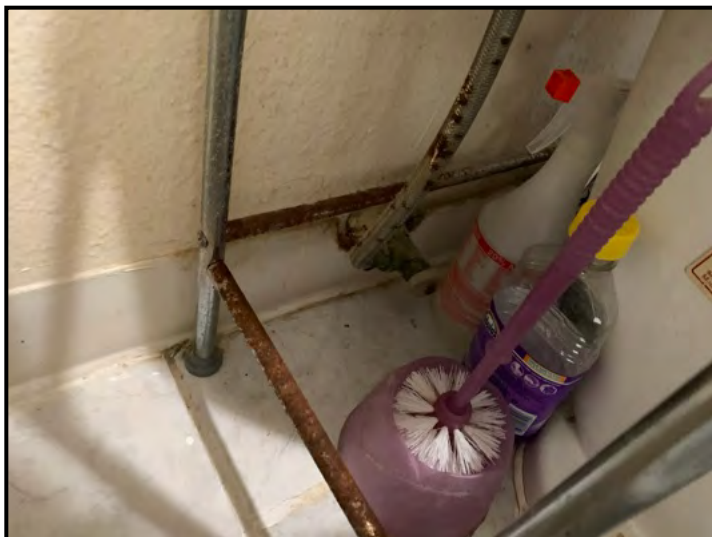
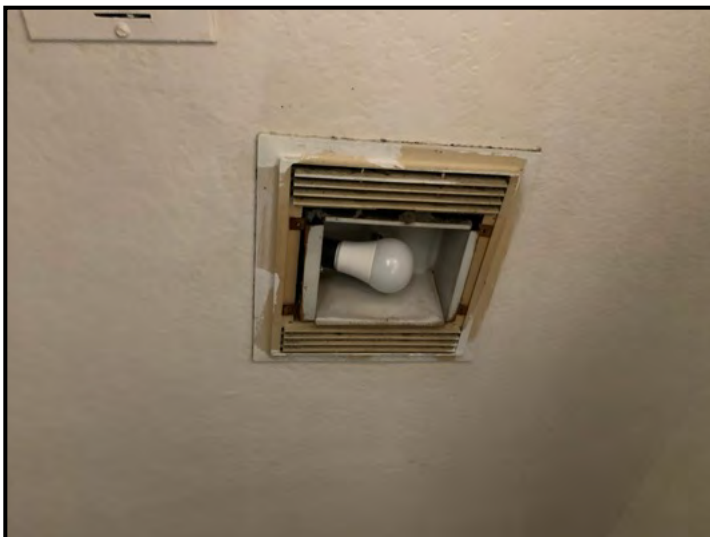
- No visible problems noted at the sink and vanity at time of inspection.
- No visible problems noted at the tub/shower area at time of inspection.
- No visible problems observed at the doors and windows at time of inspection.
- Walls and ceiling appeared functional at time of inspection.
- No visible floor problems noted at time of inspection.
- **Rust and corrosion observed on the water supply valves**
- **Exhaust fan did not operate at time of inspection. Repair or replacement is necessary.**

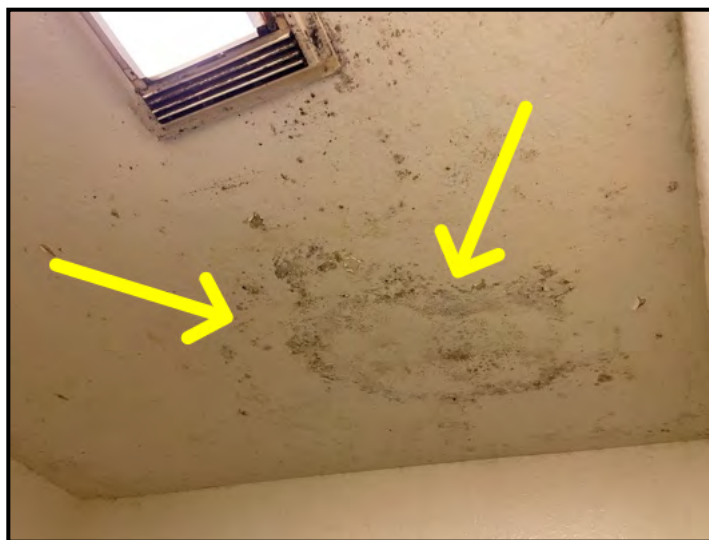
- Leaks noted at the faucet at time of inspection.
- Repair or replacement is recommended.
- Vanity door or drawer is damaged or broken. Repair or replacement is recommended.
- Repair or replacement is recommended.
- Moisture stains and/or damage viewed on the ceiling.
- Possible roof leak. Further evaluation by a roofing contractor is recommended.
- See photos.

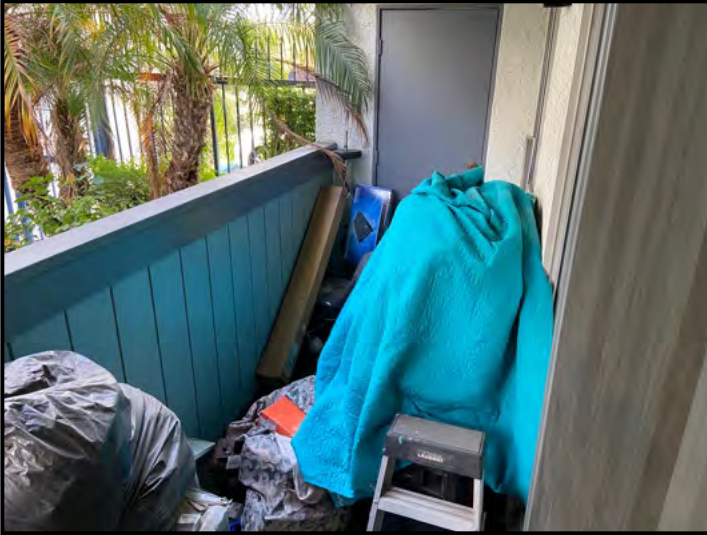
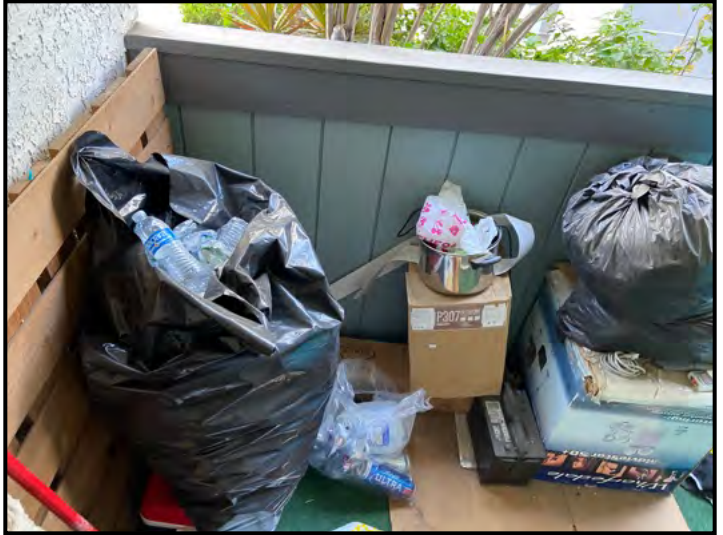
- **Unable to inspect the balcony/patio due to occupants belongings. See photo.**

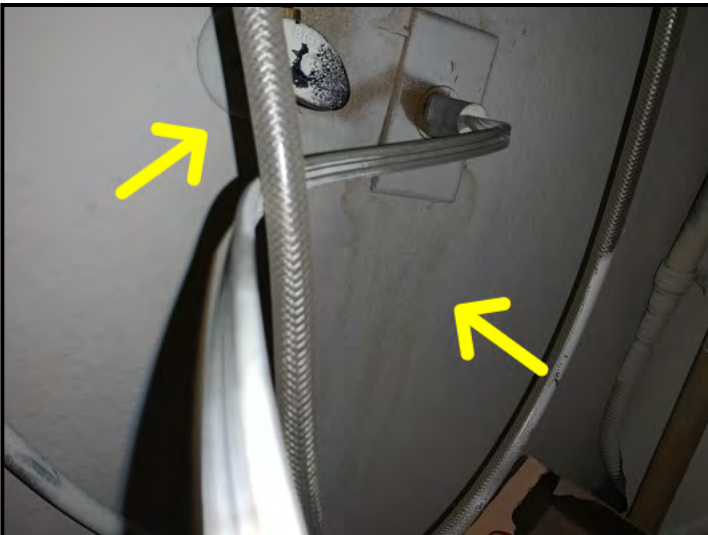
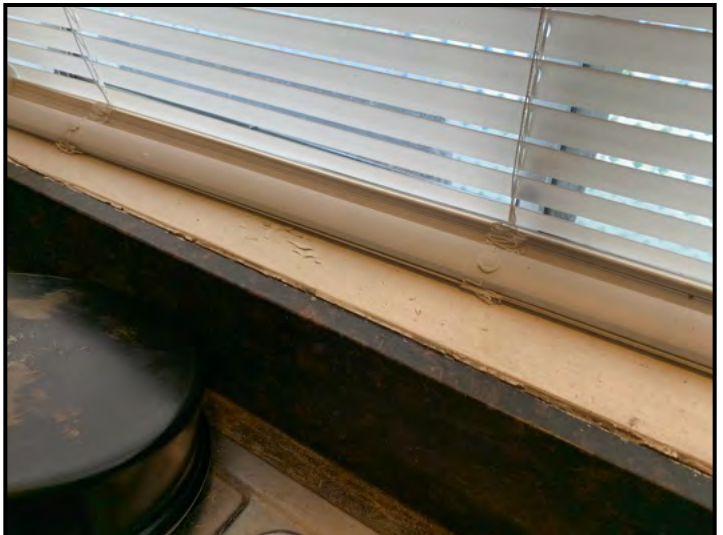
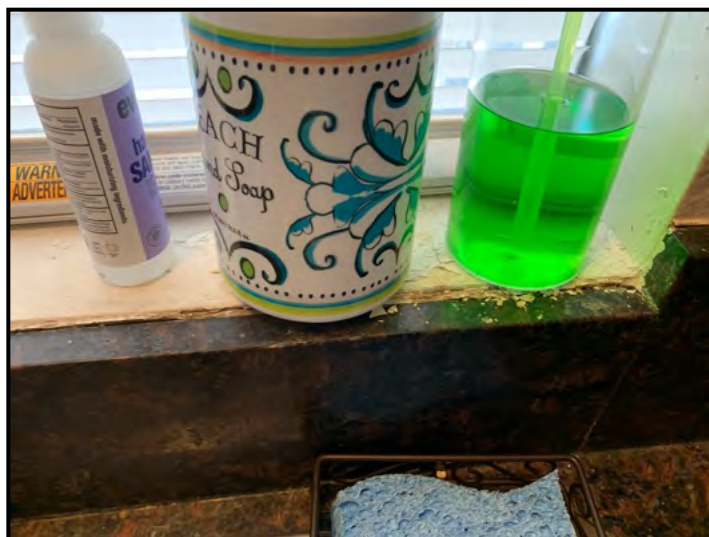
- No visible problems noted at the counters and cabinets at time of inspection.
- Walls and ceiling appeared functional at time of inspection.
- No visible problems noted at the floor at time of inspection.
- A representative number of outlets, switches and fixtures was operated and found to be in operable condition at time of inspection.
- Leaks noted at the supply lines under the sink at time of inspection.
- Evidence of moisture penetration observed at the window. Window may need caulking or sealant application on the exterior.
- Window is difficult to operate. Repair or replacement is recommended.
- See photos.

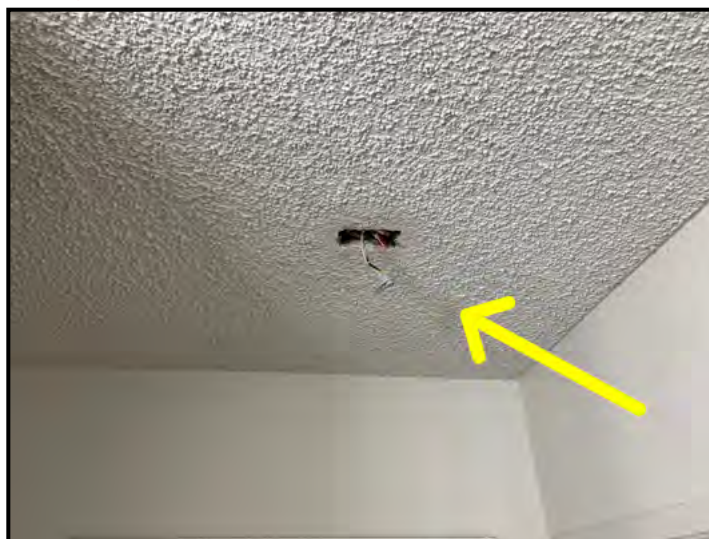
- Carbon monoxide alarm is installed in the dwelling.
- Walls and ceiling appeared functional at time of inspection.
- No visible problems noted at the closet at time of inspection.
- No visible problems noted at the floor at time of inspection.
- A representative number of outlets, switches and fixtures was operated and found to be in operable condition at time of inspection.
- **Smoke detector is not installed. A smoke detector is required in every bedroom, adjacent hallway and every level of the dwelling prior to the close of escrow.**

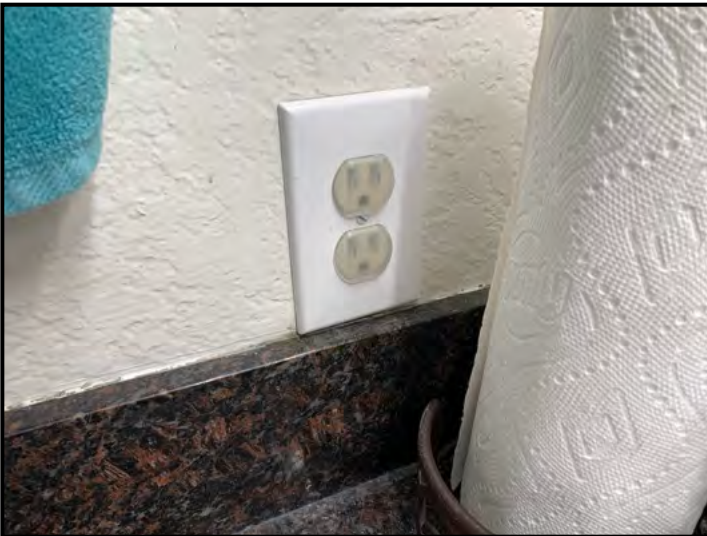
- No visible plumbing problems noted at time of inspection.
- No visible problems noted at the sink and vanity at time of inspection.
- No visible problems noted at the tub/shower area at time of inspection.
- No visible problems observed at the doors and windows at time of inspection.
- No visible floor problems noted at time of inspection.
- **Moisture stains and/or damage viewed on the walls.**
- **See photos.**
- **Ground Fault Circuit Interrupter (GFCI) outlets are recommended for installation.**
- **See photos.**

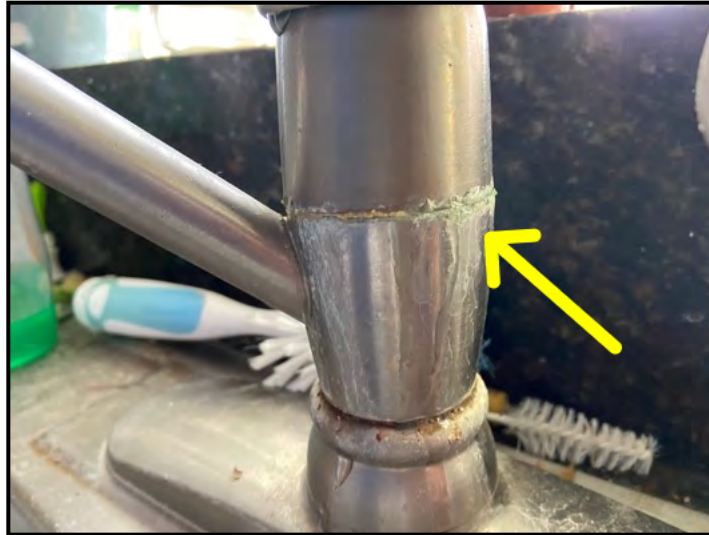
- Leaks noted at the faucet at time of inspection.
- A licensed plumbing contractor should be called to make necessary repairs.
- See photos.

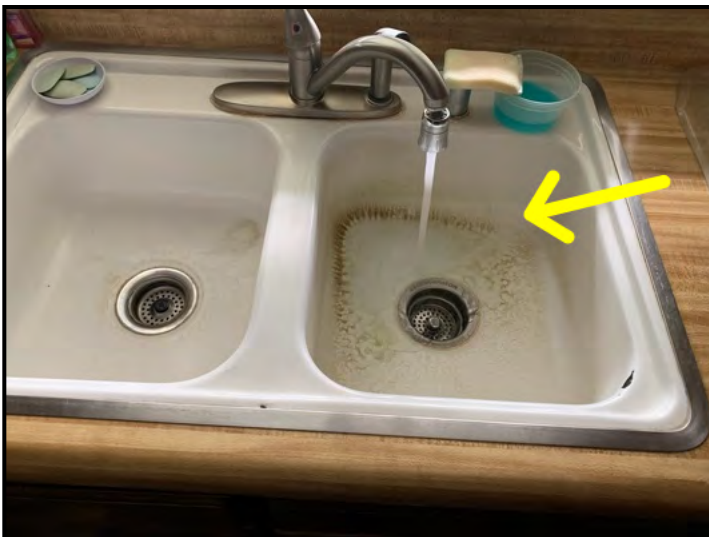
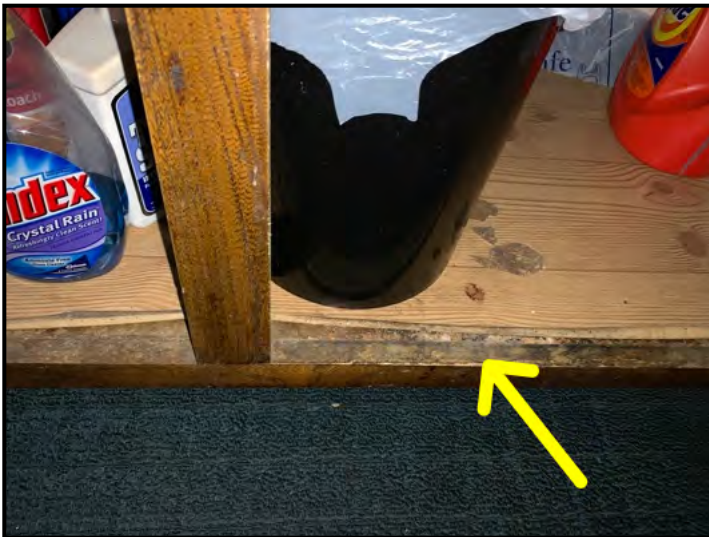
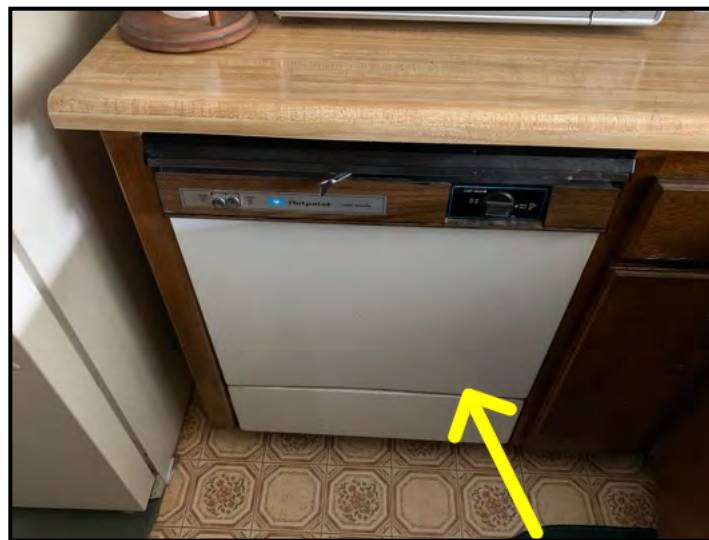
- Windows and doors operated properly at time of inspection.
- Walls and ceiling appeared functional at time of inspection.
- No visible problems noted at the floor at time of inspection.
- A representative number of outlets, switches and fixtures was operated and found to be in operable condition at time of inspection.
- Low water pressure was noted at the faucet.
- Dishwasher did not operate at time of inspection.
- Sink surface is damaged or worn. Repair or resurfacing is recommended.
- Moisture damage noted on the cabinets. Repair or replacement is recommended.
- See photos.
- Dishwasher is original older appliance needs to be replaced.
- Range fan is original and his damaged and needs to be replaced

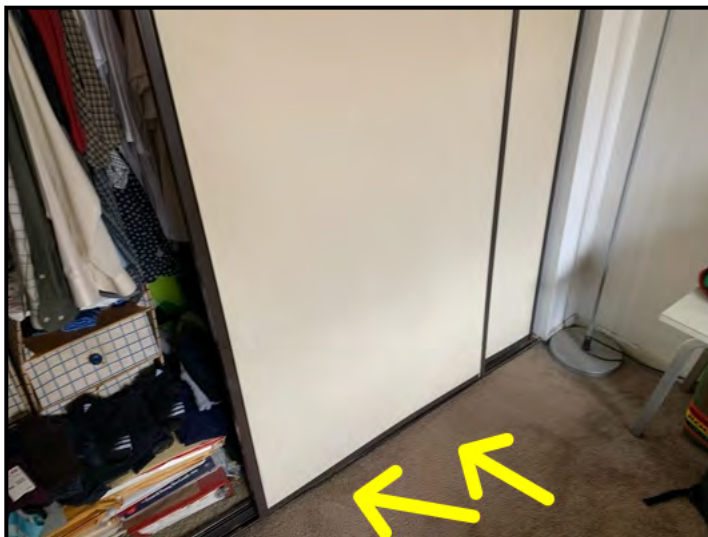
- Windows and doors operated properly at time of inspection.
- Walls and ceiling appeared functional at time of inspection.
- No visible problems noted at the floor at time of inspection.
- A representative number of outlets, switches and fixtures was operated and found to be in operable condition at time of inspection.
- **Smoke detector is not installed. A smoke detector is required in every bedroom, adjacent hallway and every level of the dwelling prior to the close of escrow.**
- **Closet doors are fallen off the tracks. Proper installation is recommended.**

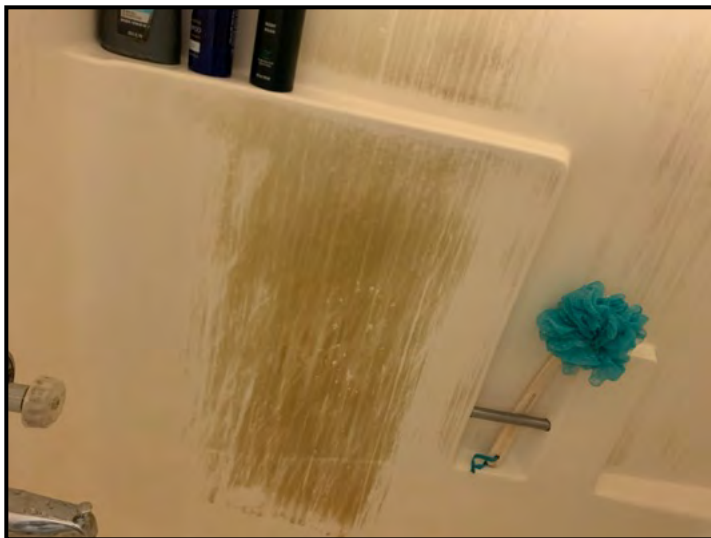
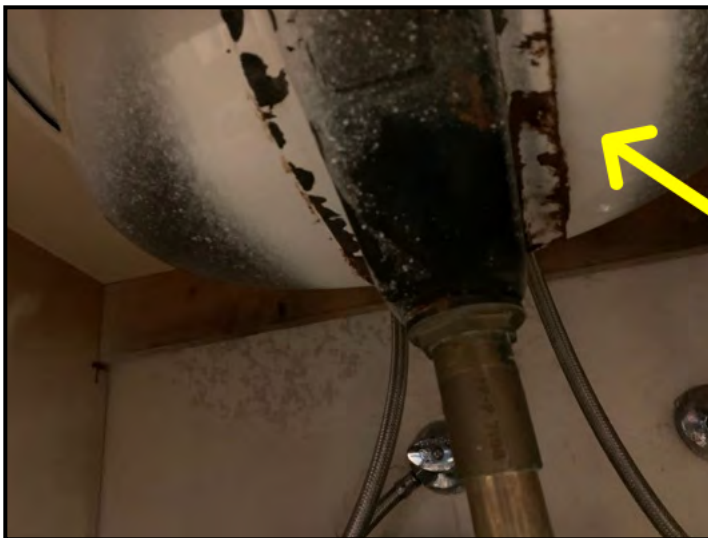
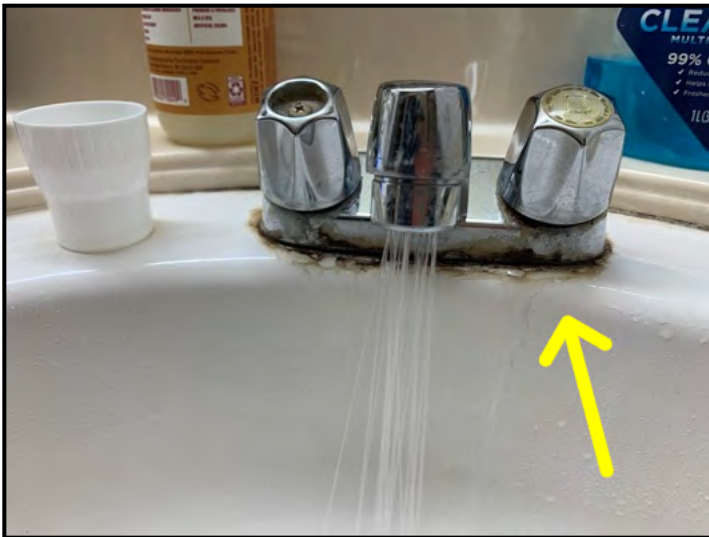
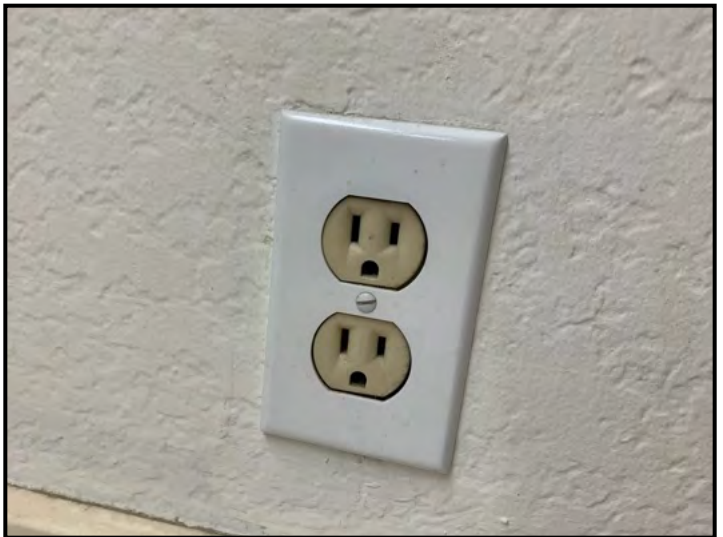
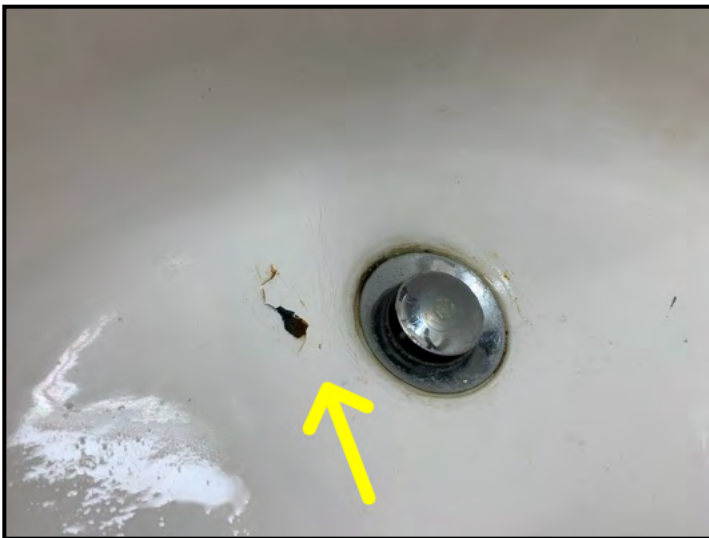
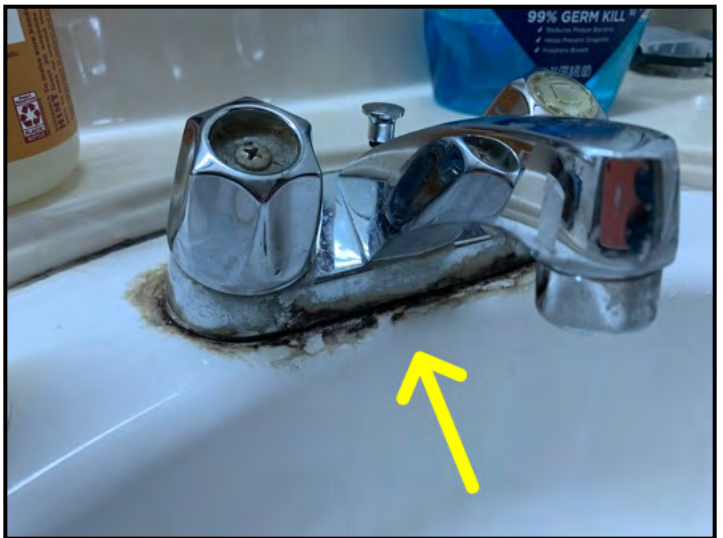
- Leaks noted at the faucet at time of inspection.
- Leaks observed under the sink.
- Rust and corrosion observed on the faucet
- Sink does not drain properly.

- See photos.
- Sink surface is damaged. Resurfacing or replacement is recommended.
- Sink has rust damage. This model of sink was manufactured defectively by welding the overflow channel to the bottom of the sink. This causes rapid rusting under the sink, which then protrudes to the top and generally causes leaks. Replacement of the sink is necessary.

- Repair or replacement is recommended.
- Tub surface is damaged. Repair and or resurfacing is recommended.
- Caulking is recommended at the tub or shower areas to prevent moisture penetration and damage behind the walls.

- Ground Fault Circuit Interrupter (GFCI) outlets are recommended for installation.

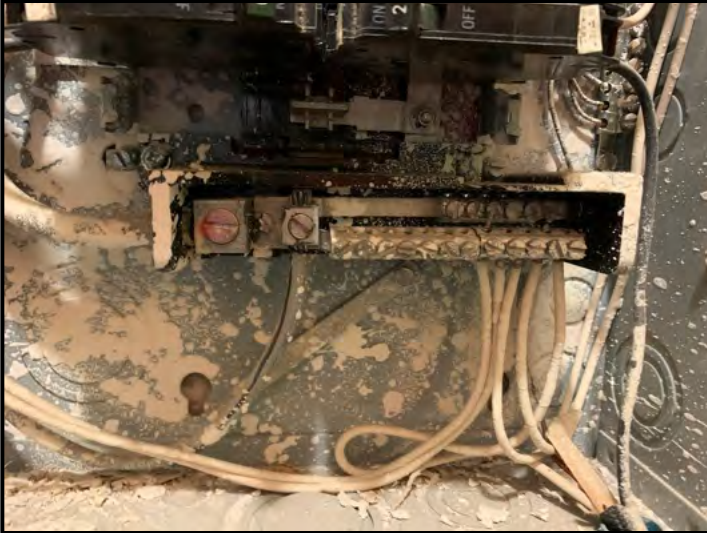
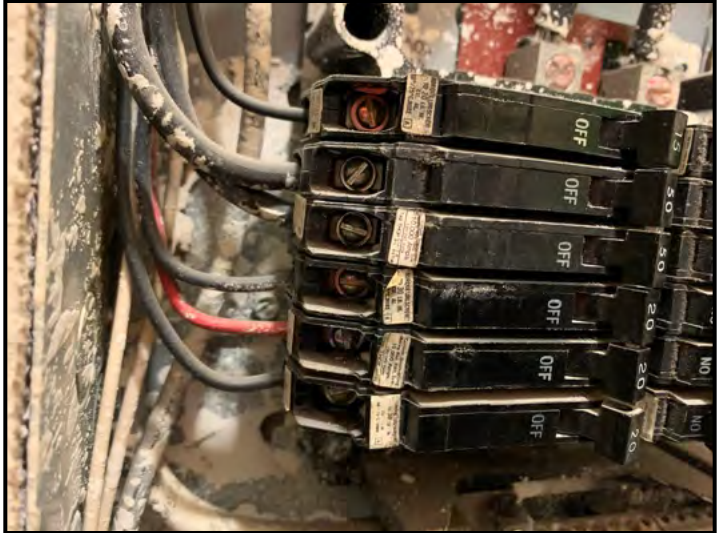
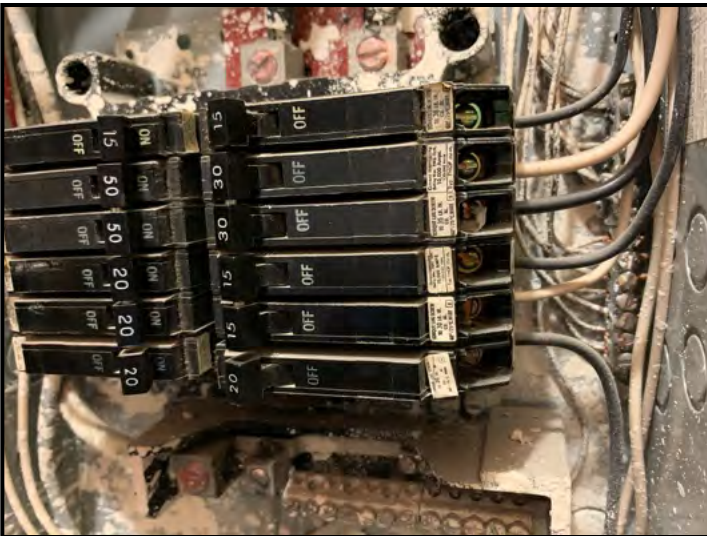
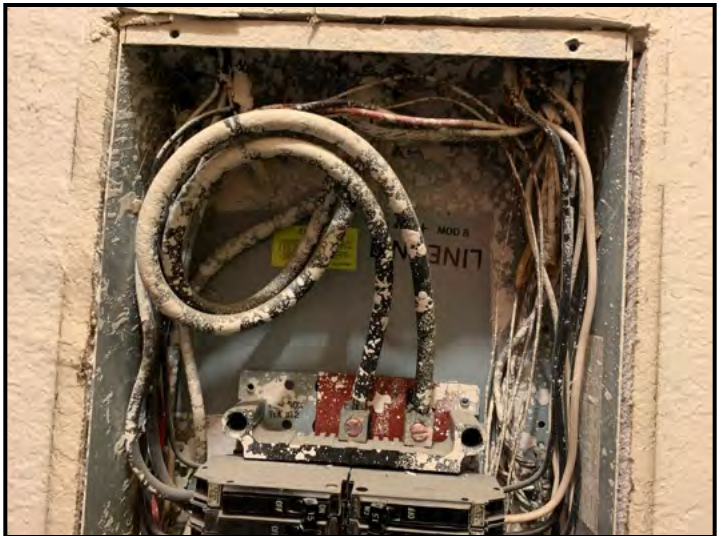
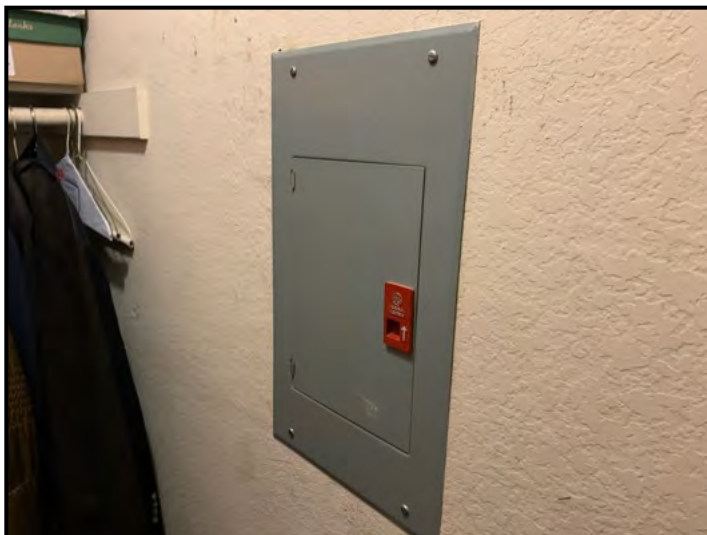
- Circuit and wire sizing correct so far as visible.
- Grounding system is present.
- See photos.
- **Electrical panel is located in bedroom closet which is not allowed**

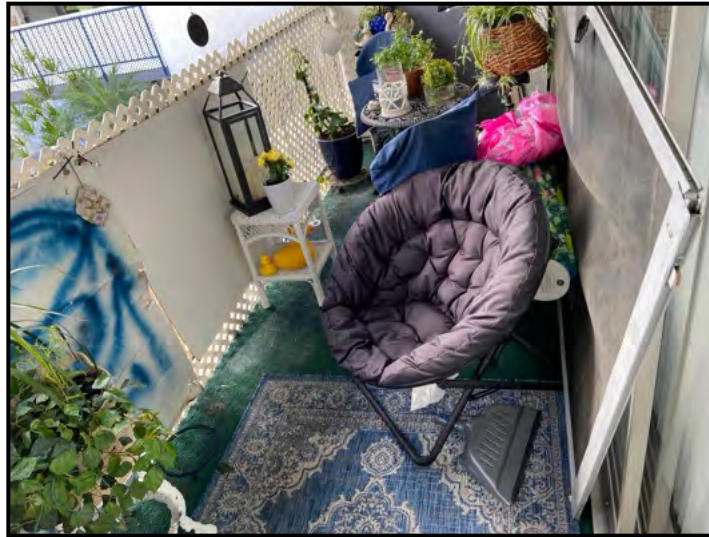
- Carpet restricts viewing.
- Unable to fully view the balcony/ patio due to occupants belongings. See photos.

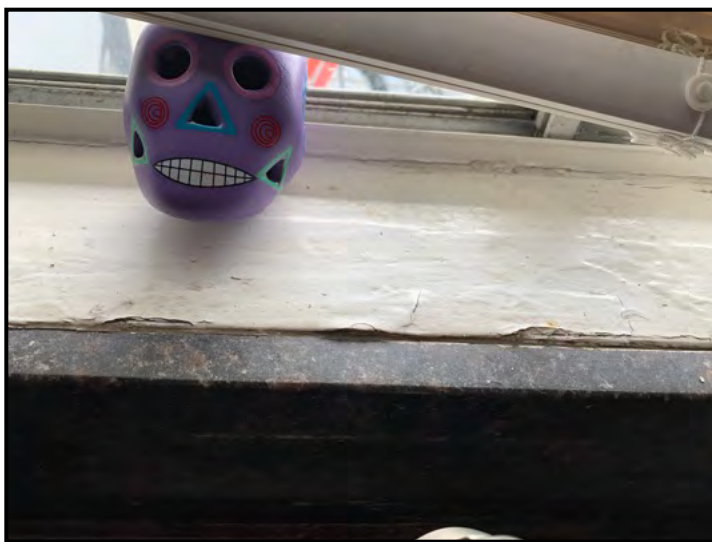
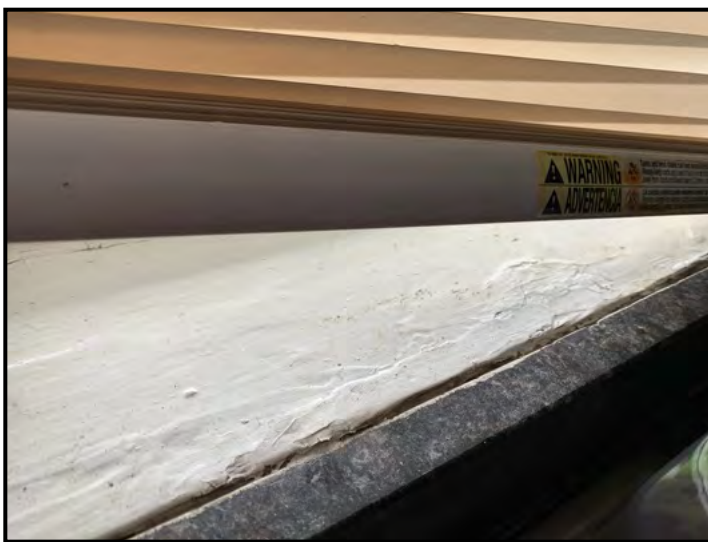
- No visible plumbing problems noted at time of inspection.
- No visible problems noted at the counters and cabinets at time of inspection.
- Walls and ceiling appeared functional at time of inspection.
- No visible problems noted at the floor at time of inspection.
- A representative number of outlets, switches and fixtures was operated and found to be in operable condition at time of inspection.
- Evidence of moisture penetration observed at the window. Window may need caulking or sealant application on the exterior.
- See photos.

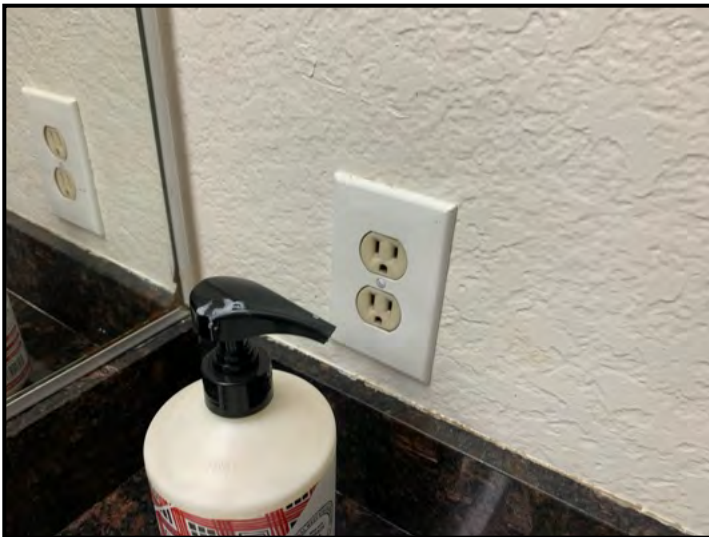
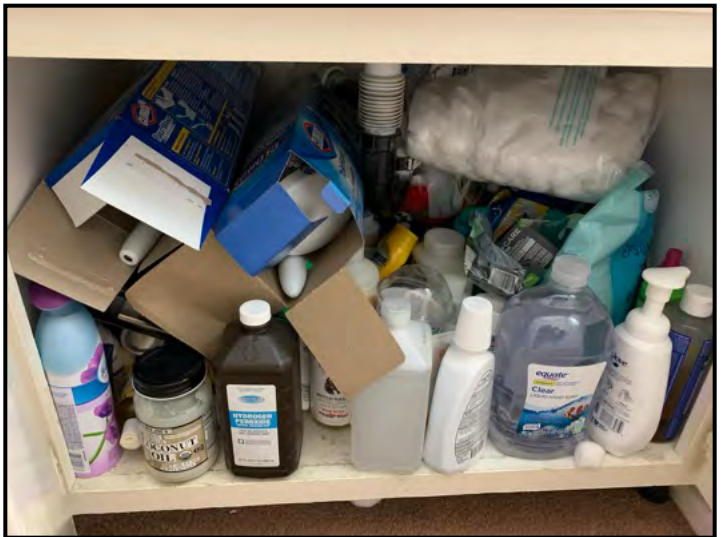
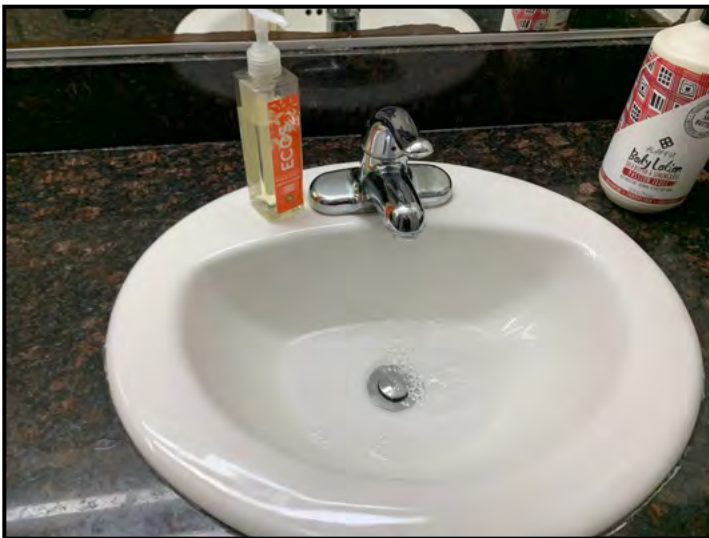
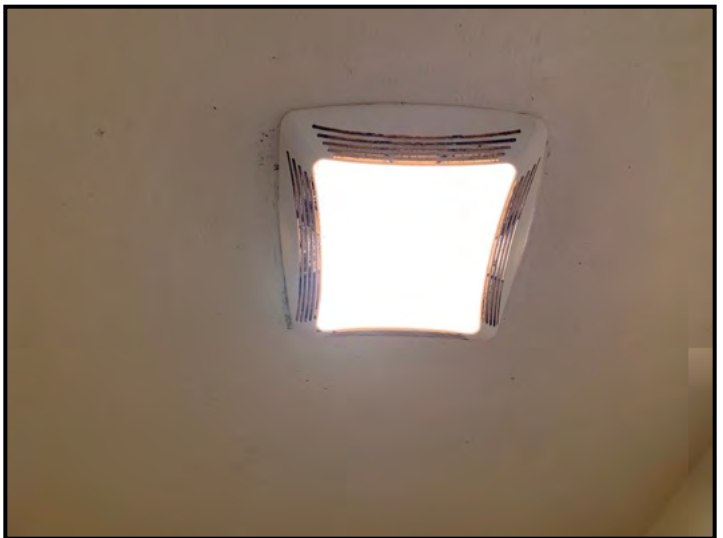
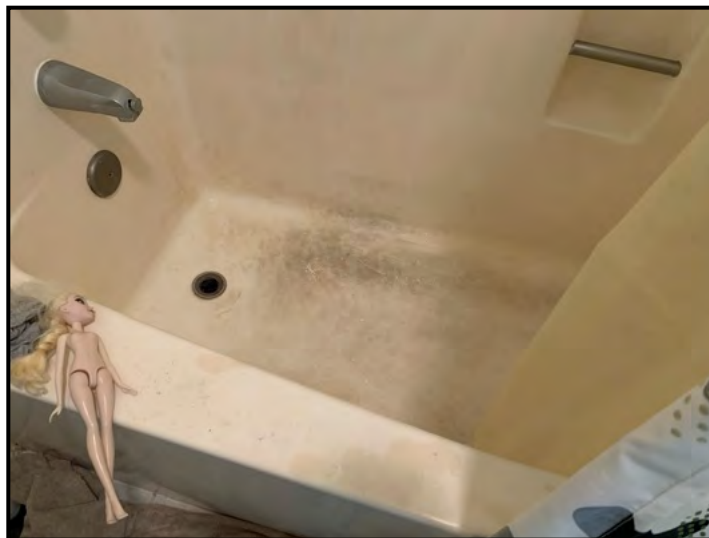
- No visible problems noted at the sink and vanity at time of inspection.
- No visible problems observed at the doors and windows at time of inspection.
- Walls and ceiling appeared functional at time of inspection.
- No visible floor problems noted at time of inspection.
- **Sink does not drain properly.**
- **Tub surface is damaged. Repair and or resurfacing is recommended.**
- **Caulking is recommended at the tub or shower areas to prevent moisture penetration and damage behind the walls.**
- **Exhaust fan did not operate noisily at time of inspection. Repair or replacement is necessary.**
- **Ground Fault Circuit Interrupter (GFCI) outlets are recommended for installation.**

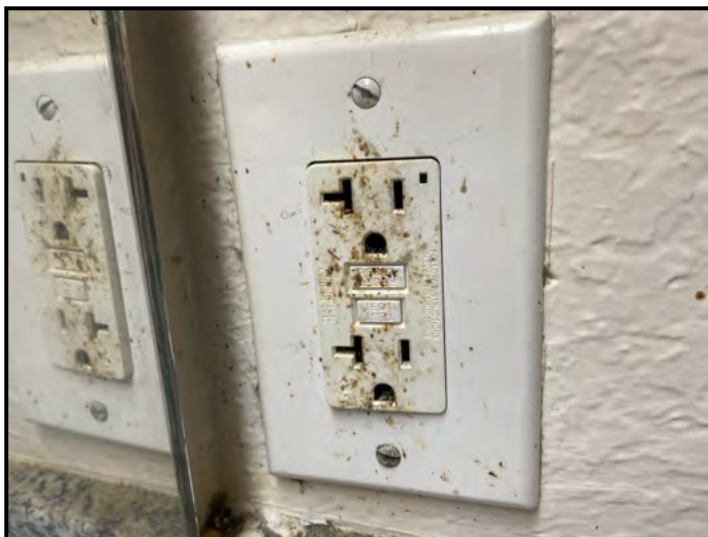
- A roach infestation was observed throughout the dwelling at time of inspection. Fumigation is necessary.
- See photos.

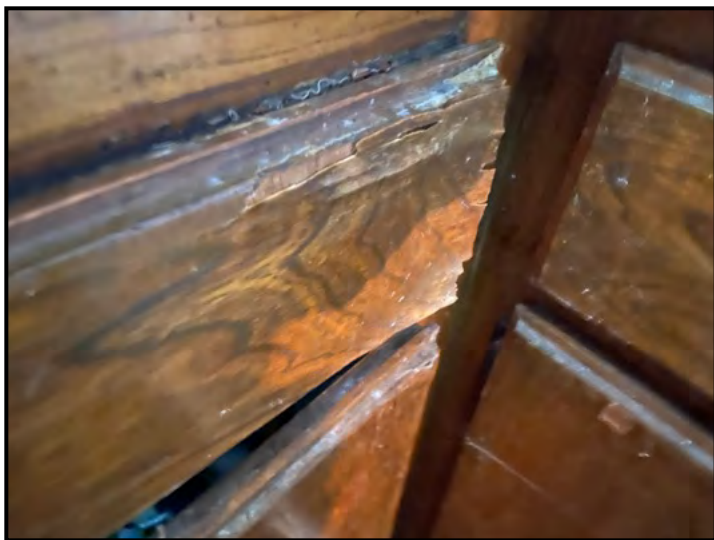
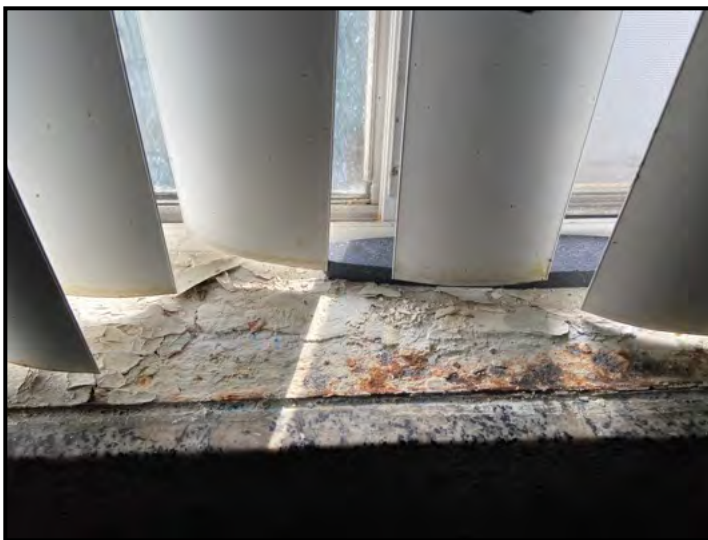
- No visible plumbing problems noted at time of inspection.
- Moisture damage noted on the cabinets. Repair or replacement is recommended.
- Evidence of moisture penetration observed at the window. Window may need caulking or sealant application on the exterior.

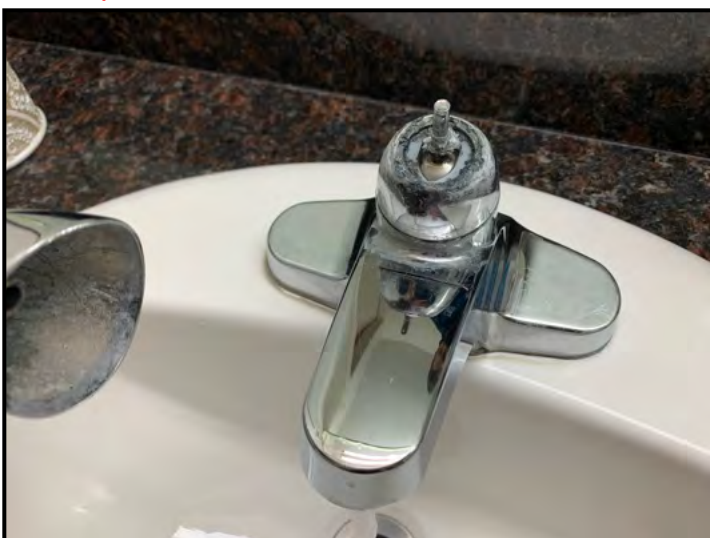
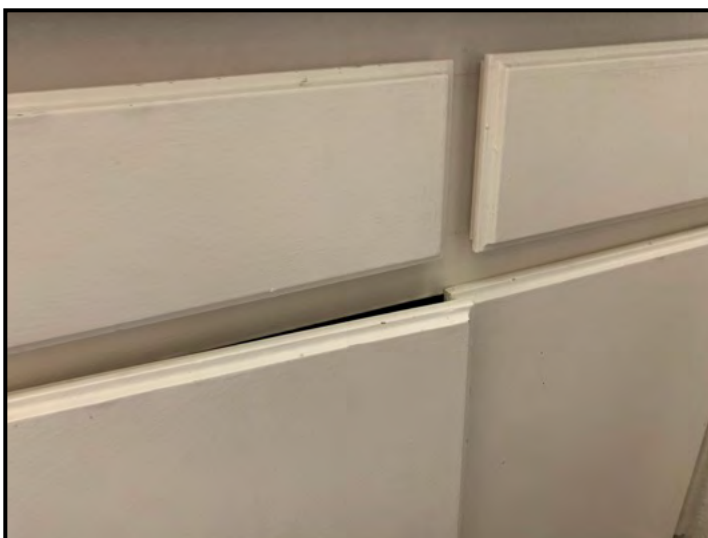
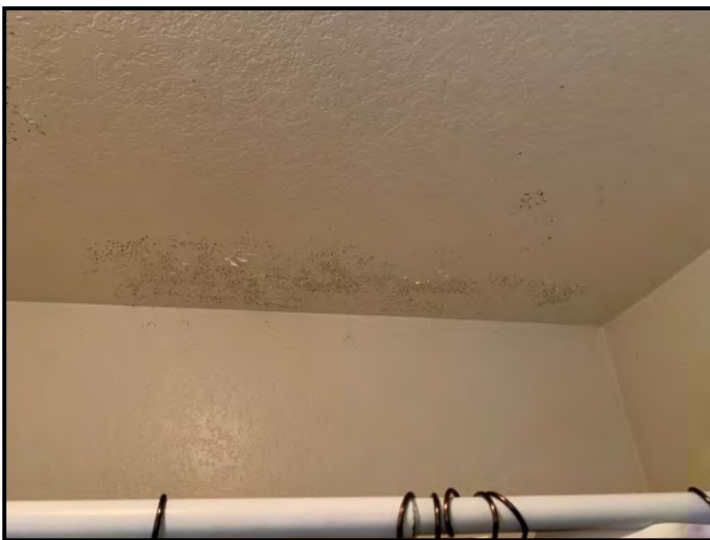
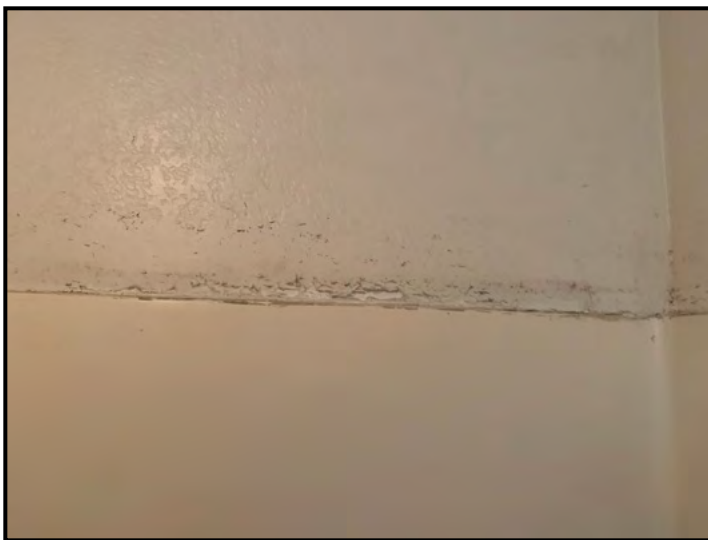
- No visible problems observed at the doors and windows at time of inspection.
- No visible floor problems noted at time of inspection.
- No visible electrical problems observed at time of inspection.
- **Repair or replacement is recommended.**
- **See photos.**
- **Vanity door or drawer is damaged or broken. Repair or replacement is recommended.**
- **Repair or replacement is recommended.**
- **Caulking is recommended at the tub or shower areas to prevent moisture penetration and damage behind the walls.**
- **Moisture stains and/or damage viewed on the ceiling.**
- **Moisture stains and/or damage viewed on the walls.**
- **See photos.**

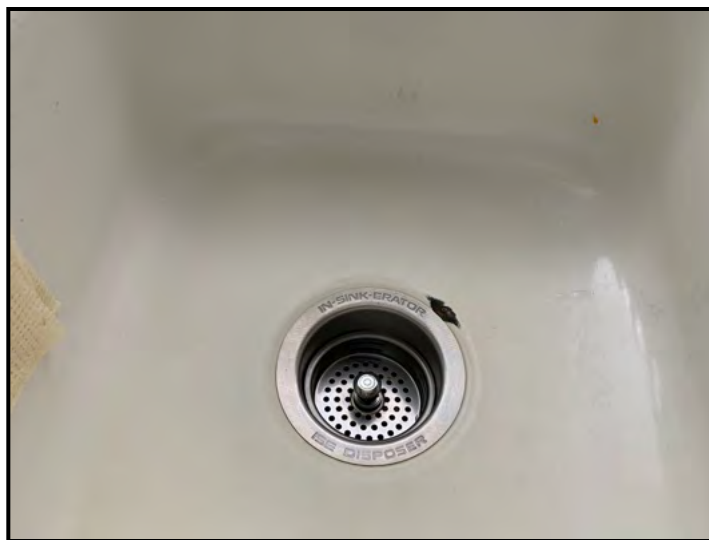
- No visible plumbing problems noted at time of inspection.
- No visible problems noted at the counters and cabinets at time of inspection.
- Windows and doors operated properly at time of inspection.
- Walls and ceiling appeared functional at time of inspection.
- No visible problems noted at the floor at time of inspection.
- A representative number of outlets, switches and fixtures was operated and found to be in operable condition at time of inspection.
- See photos.
- Kitchen sink surface is damaged

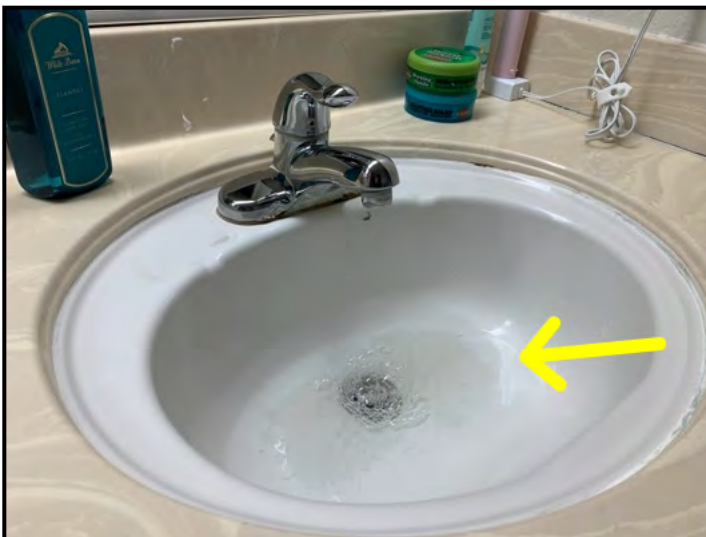
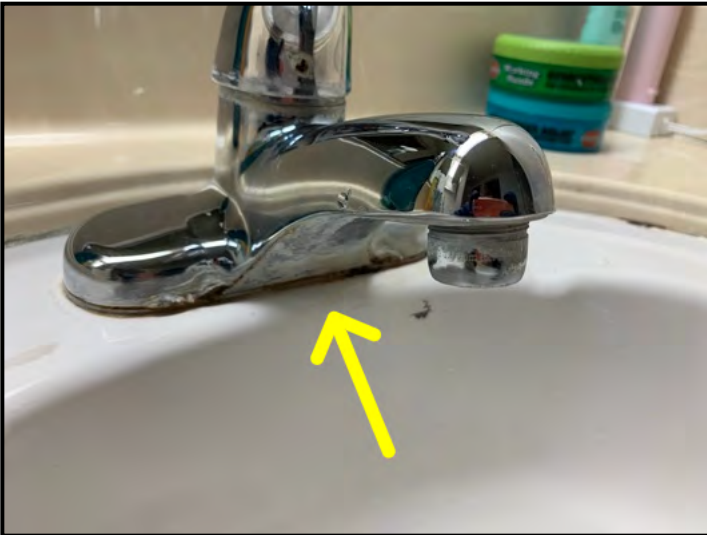
- No visible problems noted at the sink and vanity at time of inspection.
- No visible problems noted at the tub/shower area at time of inspection.
- No visible problems observed at the doors and windows at time of inspection.
- Walls and ceiling appeared functional at time of inspection.
- No visible floor problems noted at time of inspection.
- No visible electrical problems observed at time of inspection.
- **Sink does not drain properly.**
- **See photos.**
- **See photos.**
- **Bathroom sink surface is damaged**
- **Bathroom faucet has corrosion and is damaged**
- **Supply valve is older style has significant amount of corrosion and does not work properly.**

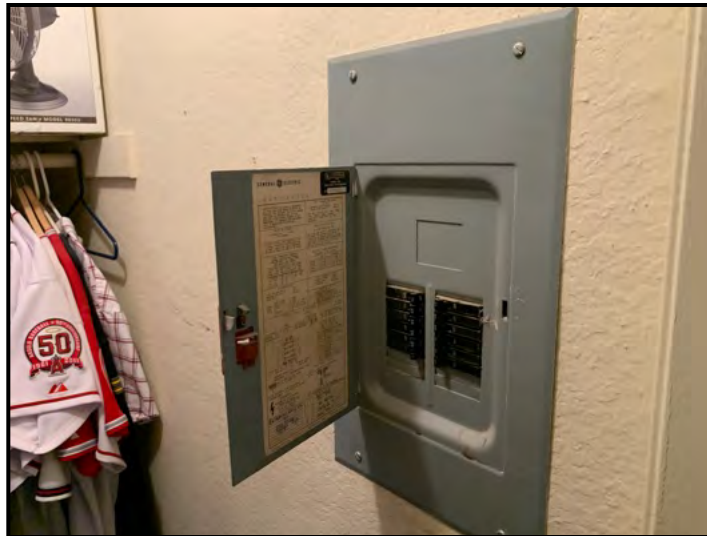
6. Electrical Panel Condition

- Circuit and wire sizing correct so far as visible.
- Grounding system is present.
- See photos.
- Electrical panel located in bedroom closet which is not allowed

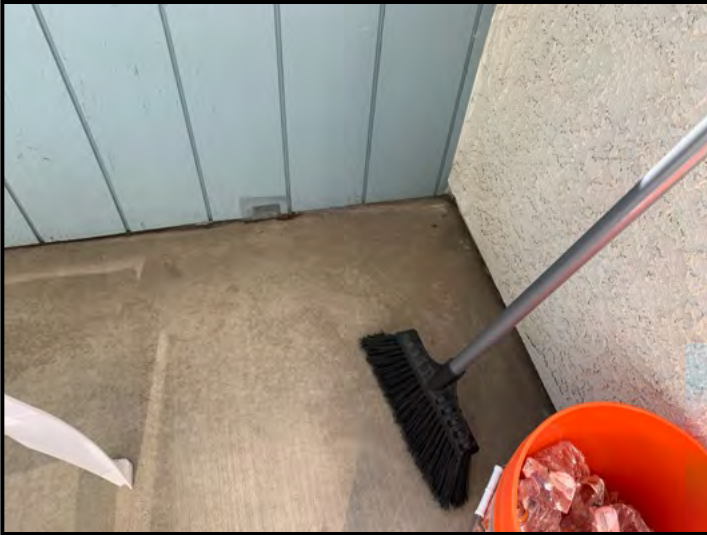
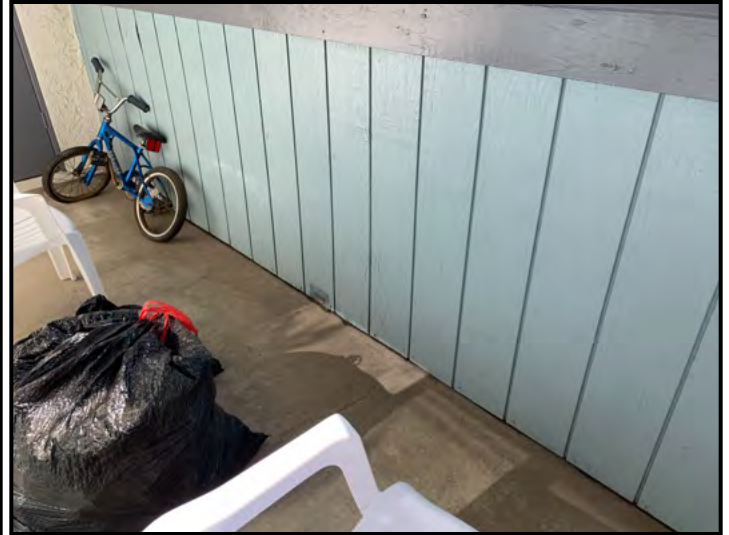
- Deck underside is not accessible for inspection. Further evaluation may be necessary.
- Balcony underside is covered with wood or stucco and is not accessible for inspection. Further evaluation may be necessary.
- No visible problems observed at time of inspection.
- No visible problems observed at time of inspection.
- See photos.

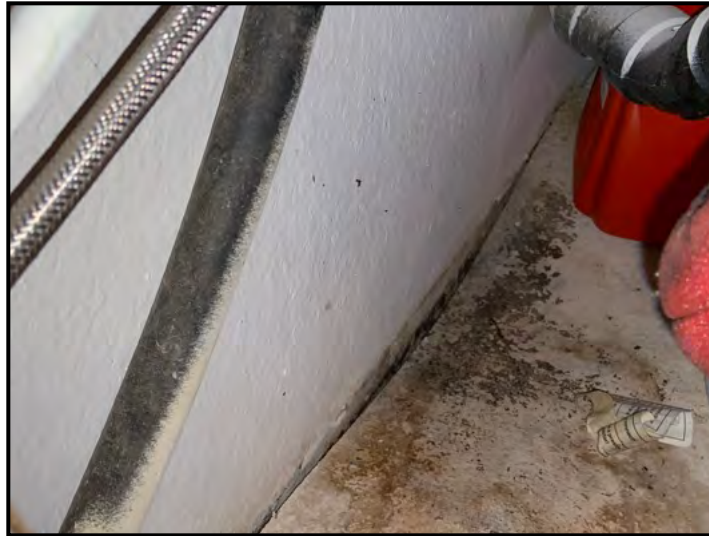
- No visible plumbing problems noted at time of inspection.
- No visible problems noted at time of inspection.
- **Moisture damage and mold observed on the cabinet under the kitchen sink. See photos.**

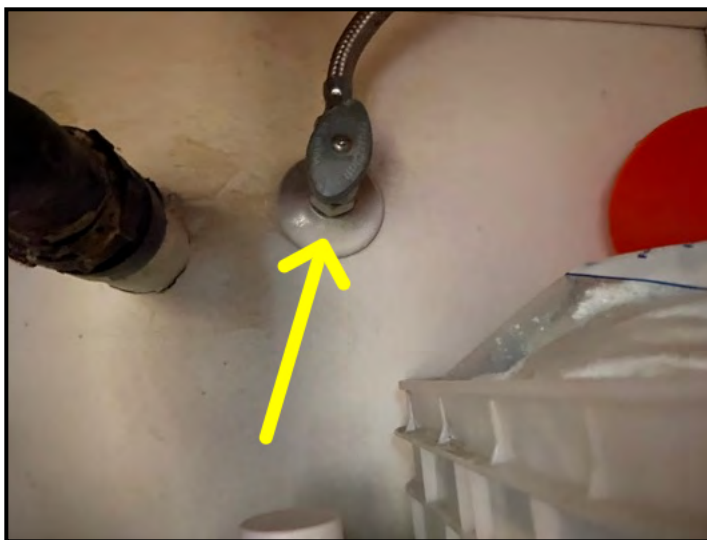
- Leaks noted at the supply lines under the sink at time of inspection.
- Further evaluation and repairs as needed by a plumbing contractor is recommended.
- See photos.
