PROPERTY INSPECTION REPORT

12345 Main Street, Anytown, CA 90001

DATE OF INSPECTION: 12/9/2022

VILLA HOME INSPECTIONS

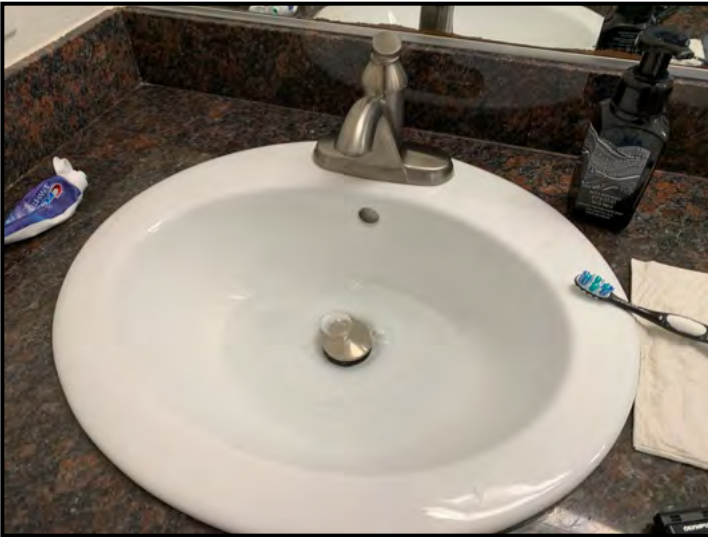
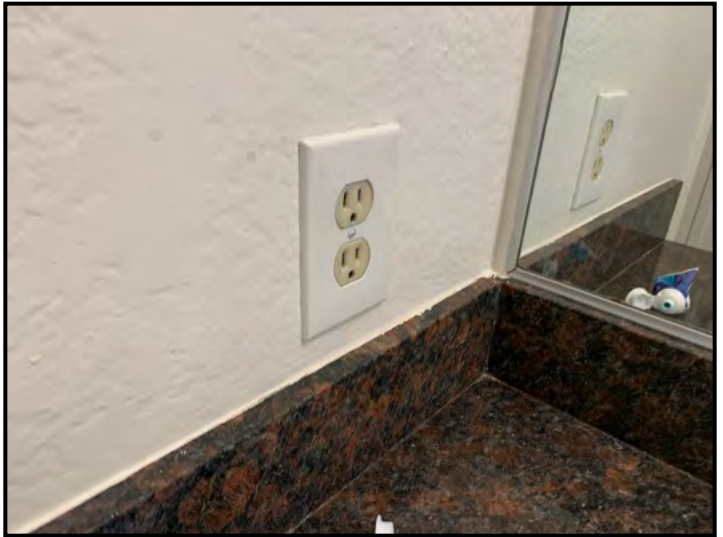
- No visible problems noted at the sink and vanity at time of inspection.
- No visible problems noted at the tub/shower area at time of inspection.
- No visible problems observed at the doors and windows at time of inspection.
- Walls and ceiling appeared functional at time of inspection.
- No visible floor problems noted at time of inspection.
- **Sink does not drain properly.**
- **See photos.**
- **Ground Fault Circuit Interrupter (GFCI) outlets are recommended for installation.**
- **See photos.**

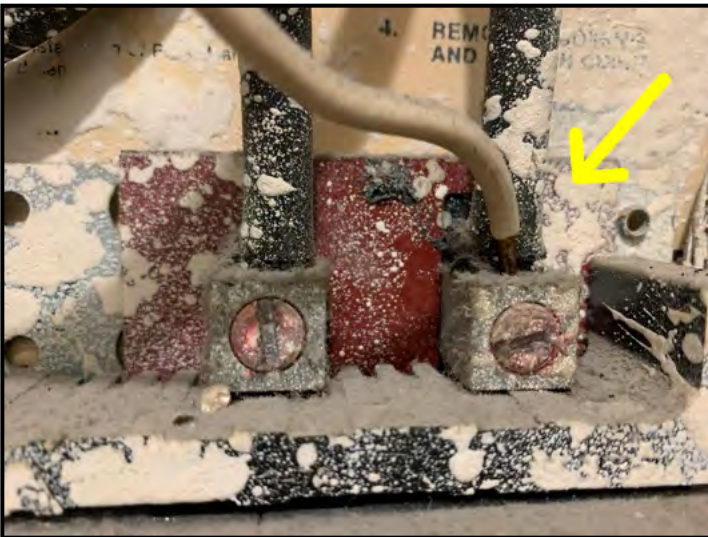
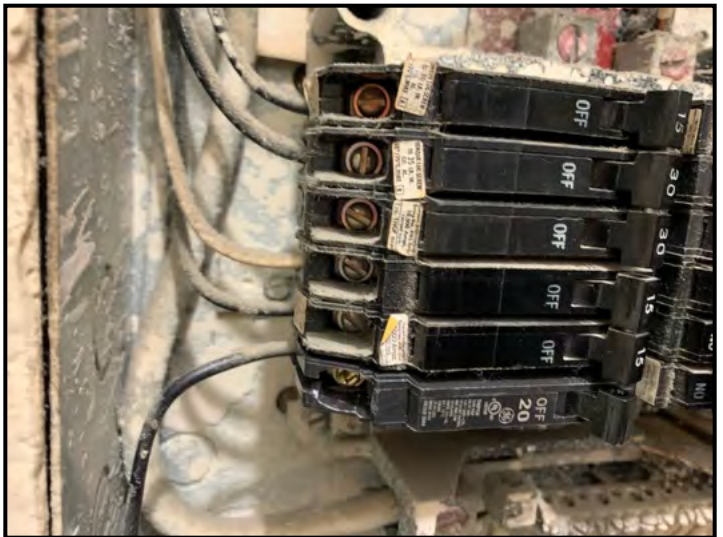
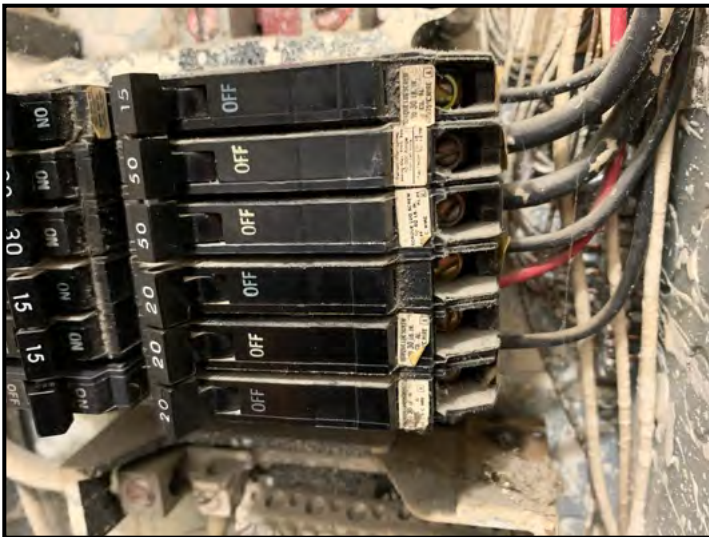
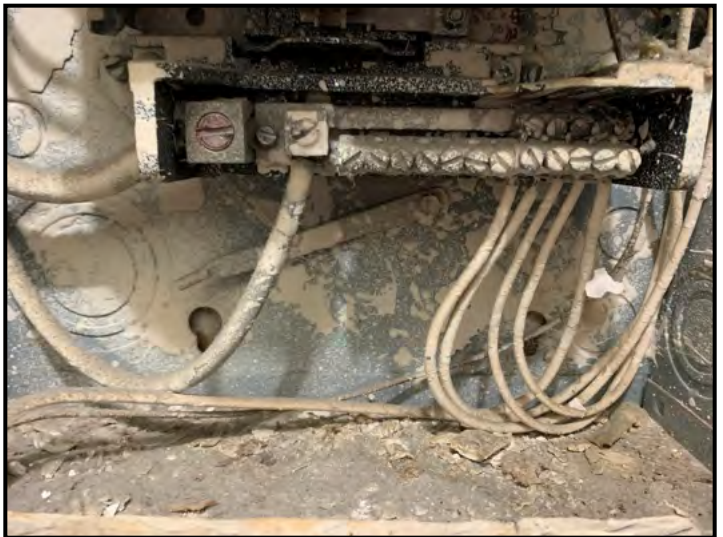
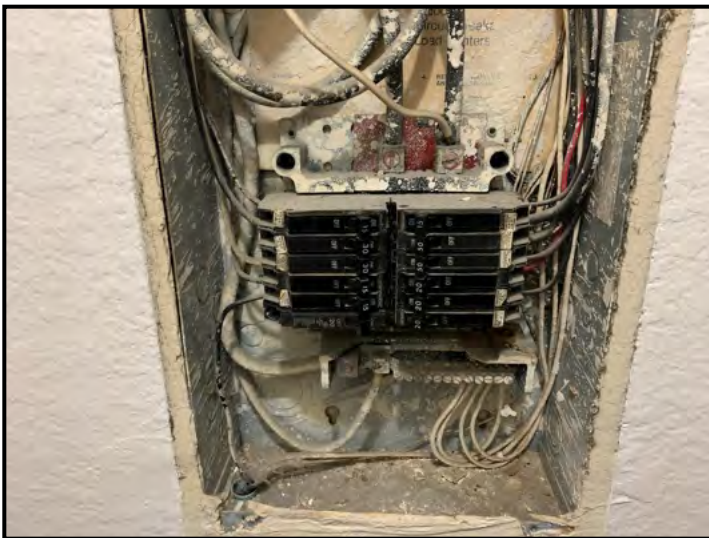
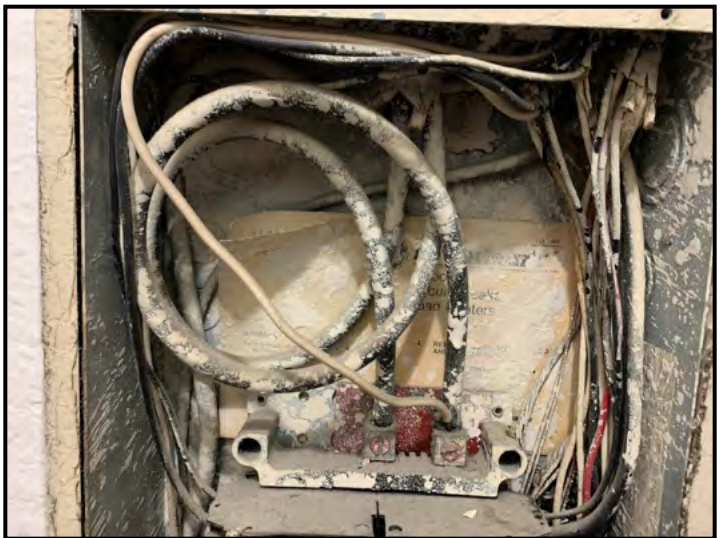
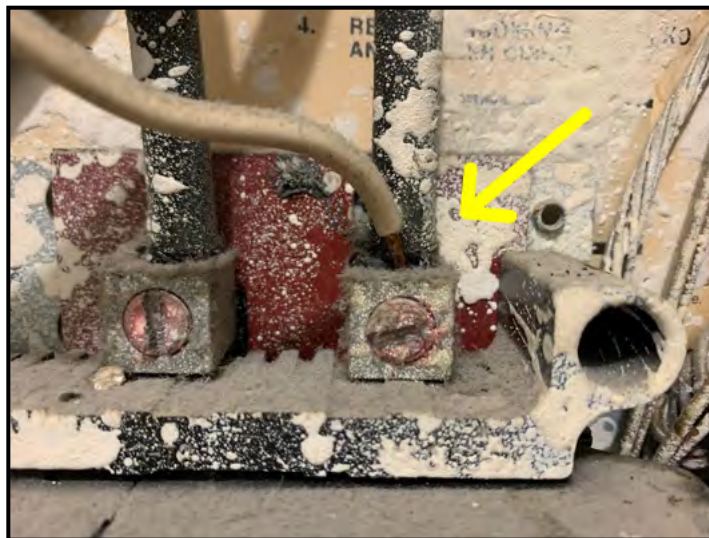
6. Electrical Panel Condition

- Circuit and wire sizing correct so far as visible.
- Grounding system is present.
- Have a licensed electrician make further evaluation and corrections as needed.
- See photos.
- Neutral wire connected where service wires connect. See photo.
- Electrical panel located in bedroom closet which is not allowed

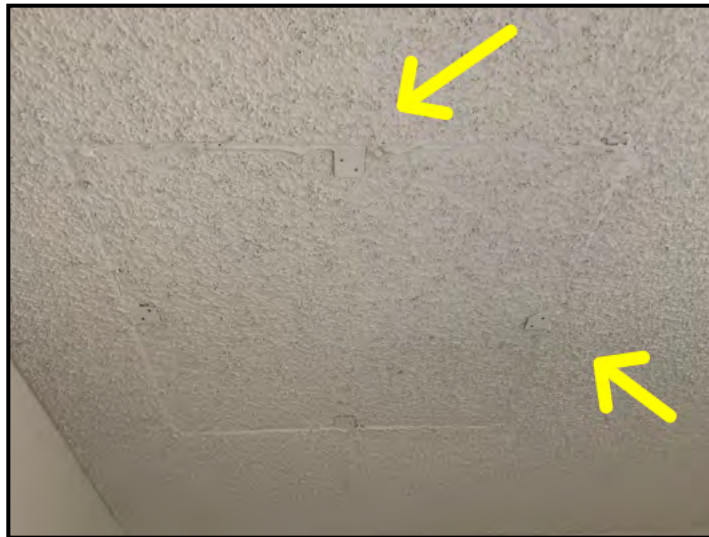
- **Attic entrance has been completely sealed and is unable to enter at time of inspection**

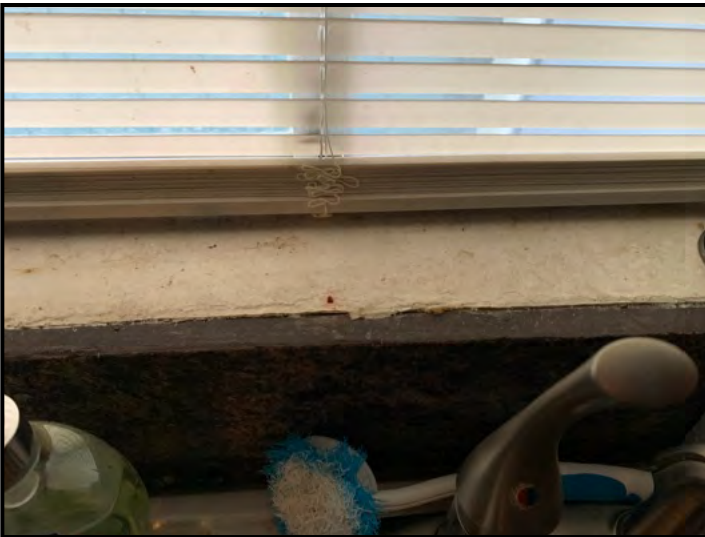
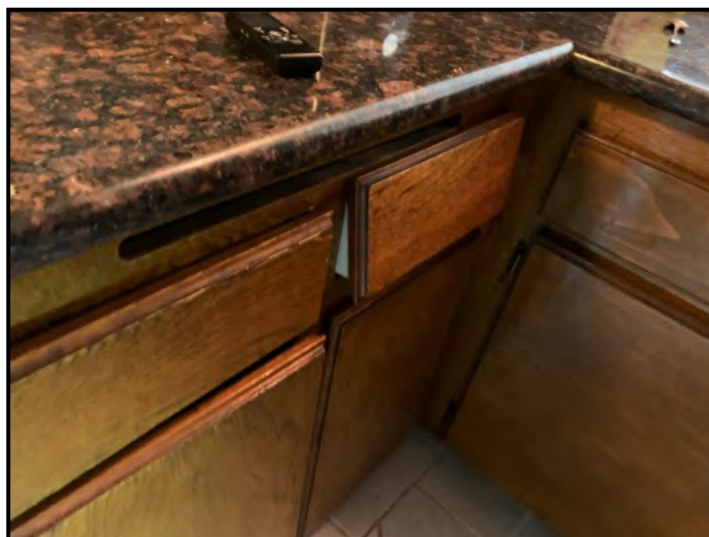
- No visible plumbing problems noted at time of inspection.
- Walls and ceiling appeared functional at time of inspection.
- No visible problems noted at the floor at time of inspection.
- A representative number of outlets, switches and fixtures was operated and found to be in operable condition at time of inspection.
- Sink surface is damaged or worn. Repair or resurfacing is recommended.
- Moisture damage noted on the cabinets. Repair or replacement is recommended.
- Evidence of moisture penetration observed at the window. Window may need caulking or sealant application on the exterior.
- Window is difficult to operate. Repair or replacement is recommended.

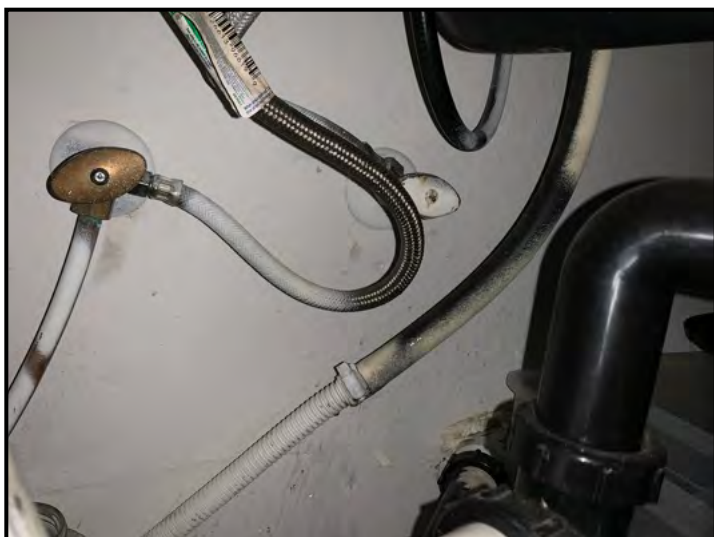
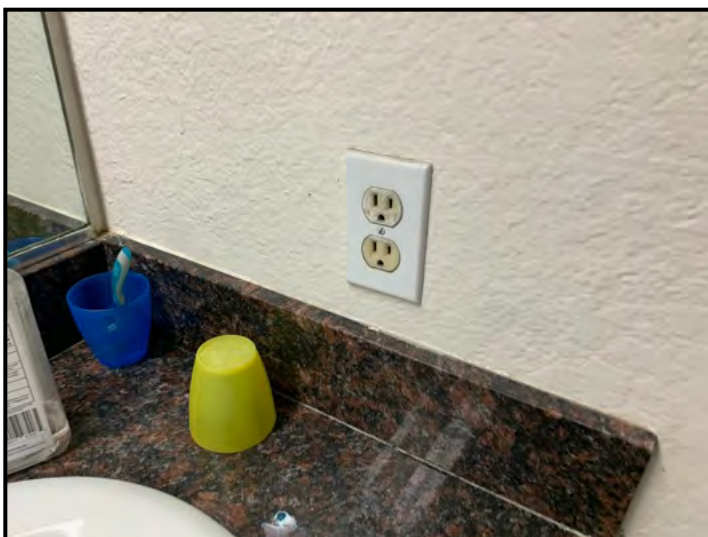
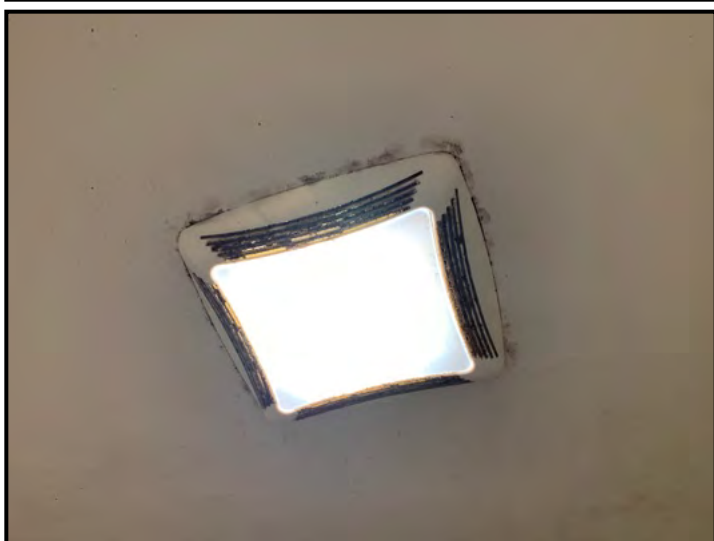
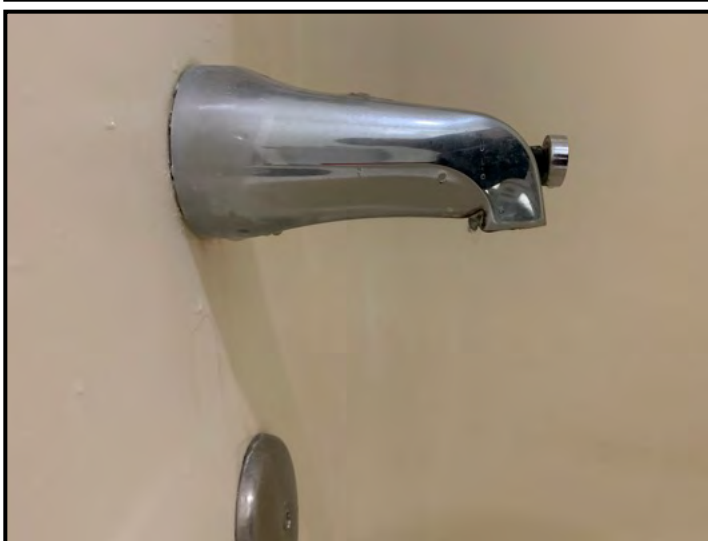
- No visible problems noted at the sink and vanity at time of inspection.
- No visible problems noted at the tub/shower area at time of inspection.
- No visible problems observed at the doors and windows at time of inspection.
- Walls and ceiling appeared functional at time of inspection.
- No visible floor problems noted at time of inspection.
- **Rust and corrosion observed on the water supply valves under the sink.**
- **Tub faucet leaks when operated.**
- **See photos.**
- **Exhaust fan did not operate noisily at time of inspection. Repair or replacement is necessary.**
- **Ground Fault Circuit Interrupter (GFCI) outlets are recommended for installation.**
- **See photos.**

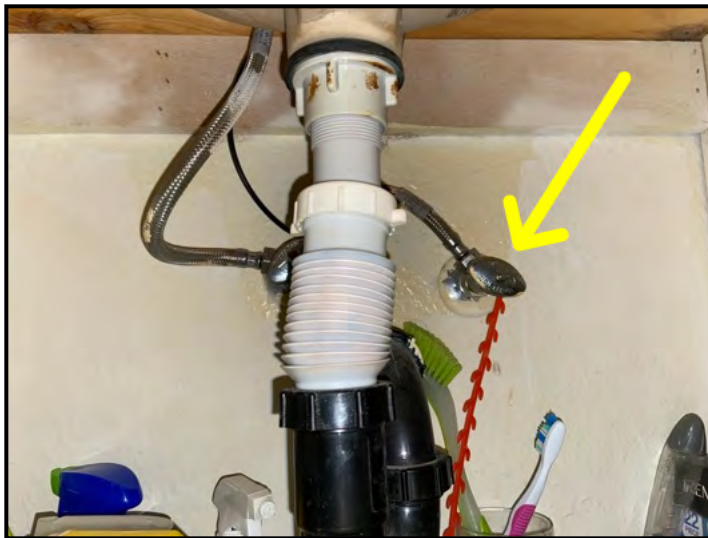
- Leaks noted at the supply lines under the sink at time of inspection.
- Further evaluation and repairs as needed by a plumbing contractor is recommended.
- See photos.

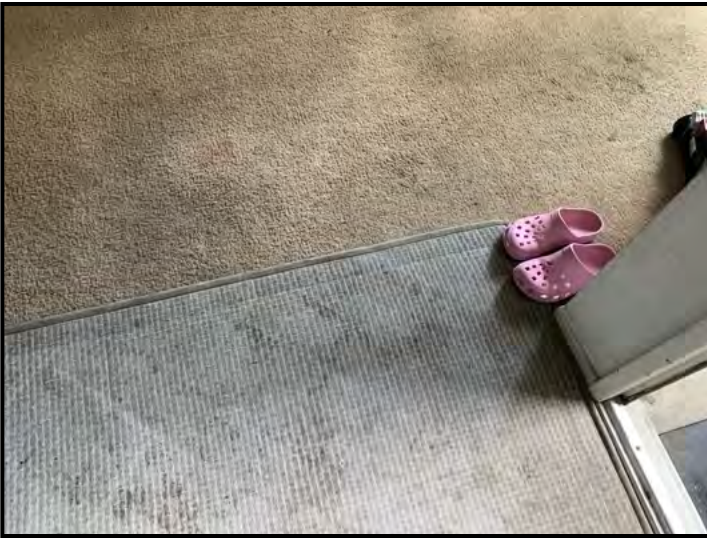
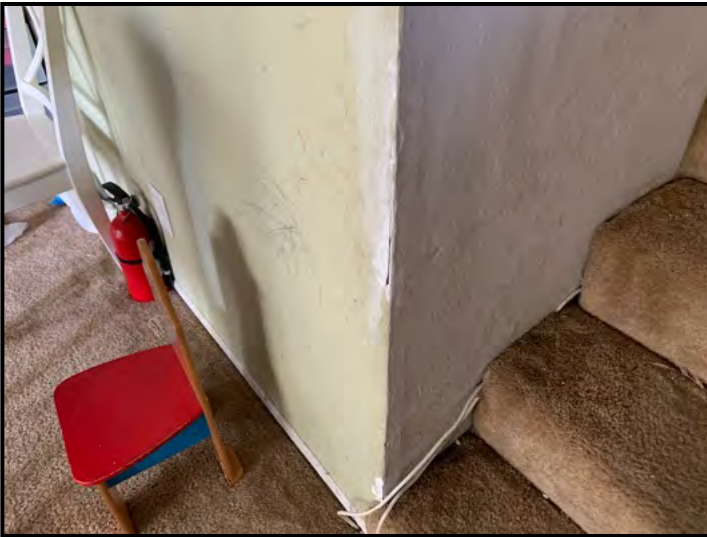
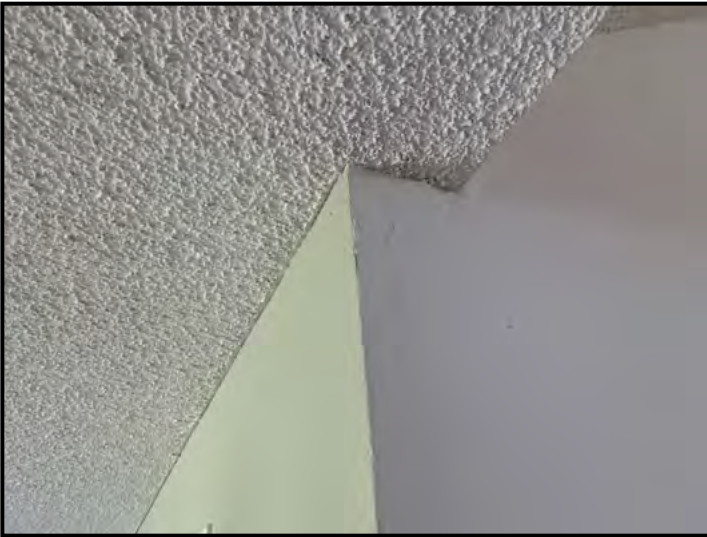
- Windows and doors operated properly at time of inspection.
- A representative number of outlets, switches and fixtures was operated and found to be in operable condition at time of inspection.
- **Moisture stains and/or damage viewed on the ceiling.**
- **Moisture stains and/or damage viewed on the walls.**
- **Flooring is damaged or deteriorated. Repair or replacement is recommended.**

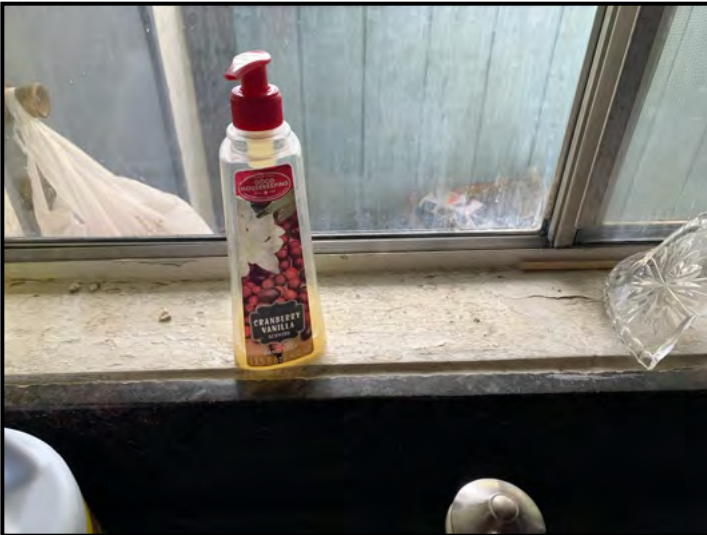
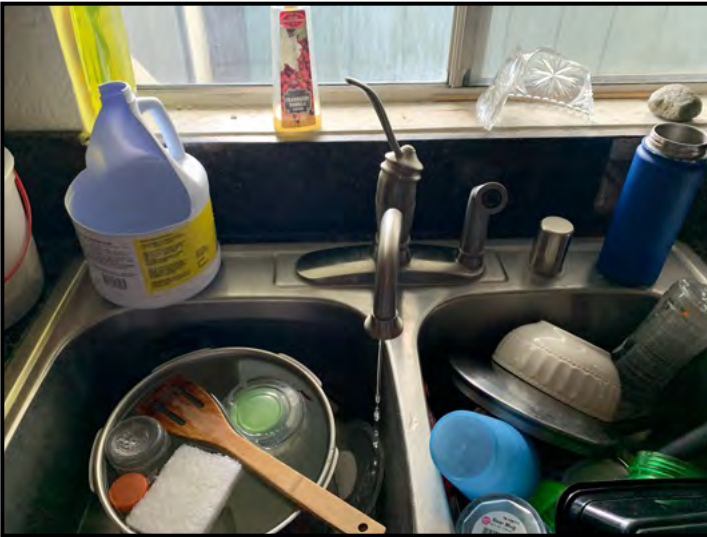
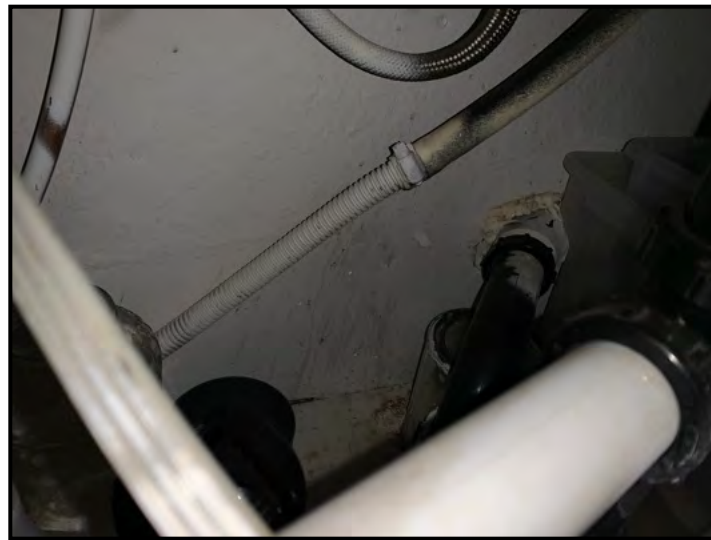
2. Kitchen

- No visible problems noted at the counters and cabinets at time of inspection.
- Windows and doors operated properly at time of inspection.
- Walls and ceiling appeared functional at time of inspection.
- No visible problems noted at the floor at time of inspection.
- A representative number of outlets, switches and fixtures was operated and found to be in operable condition at time of inspection.
- **Low water pressure was noted at the faucet.**
- **See photos.**
- **Little to no flow on hot water side in kitchen**
- **Supply line valves underneath kitchen sink are old and frozen I need to be replaced**

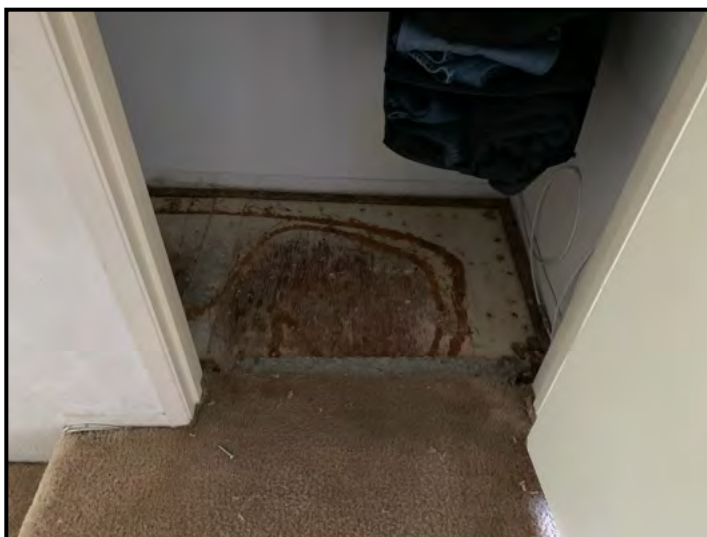
- Smoke detector is installed.
- Carbon monoxide alarm is installed in the dwelling.
- Walls and ceiling appeared functional at time of inspection.
- A representative number of outlets, switches and fixtures was operated and found to be in operable condition at time of inspection.
- **Flooring is damaged or deteriorated. Repair or replacement is recommended.**
- **See photos.**
- **Hallway closet is missing carpet and has no finish the flooring installed**

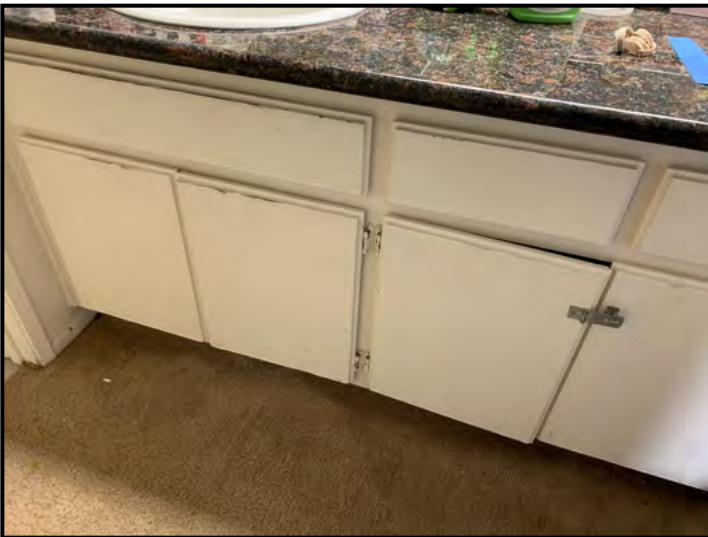
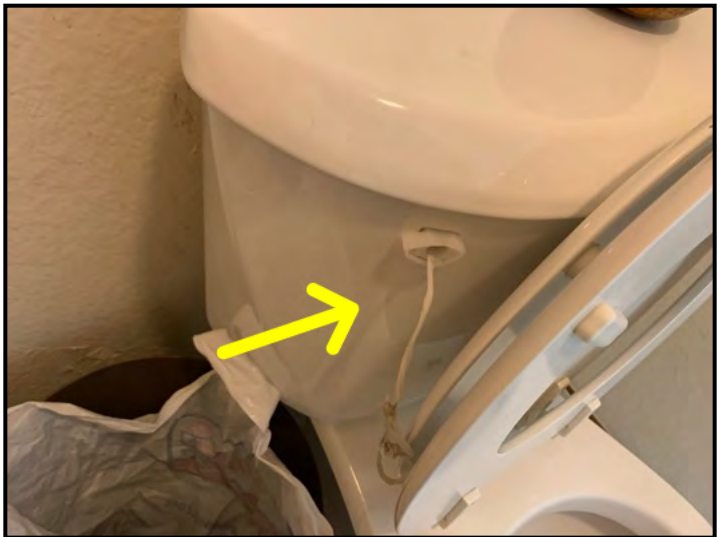
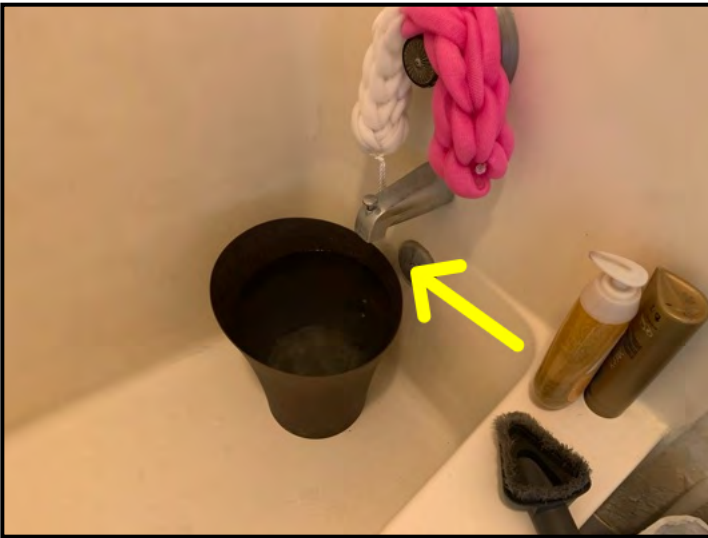
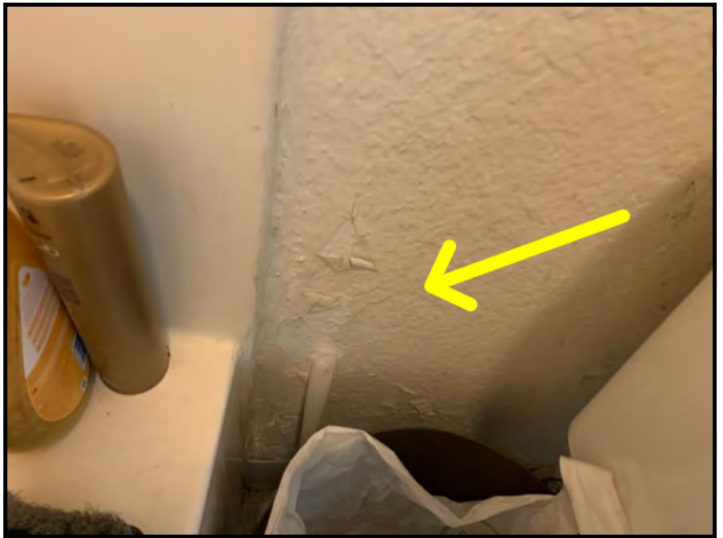
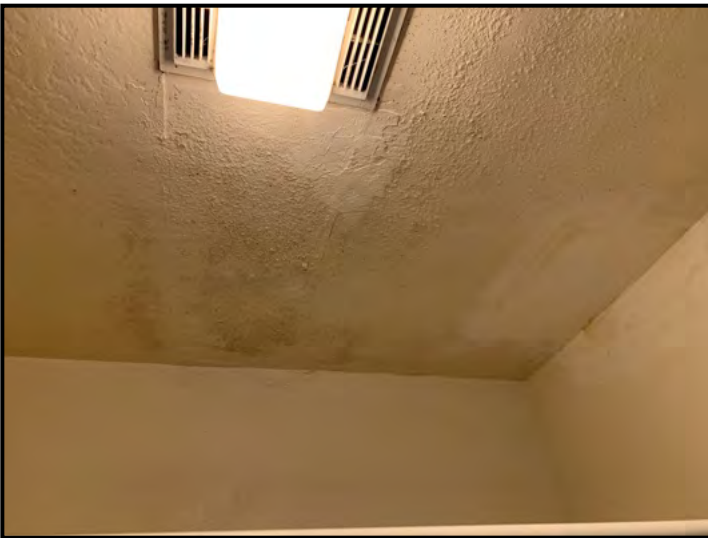
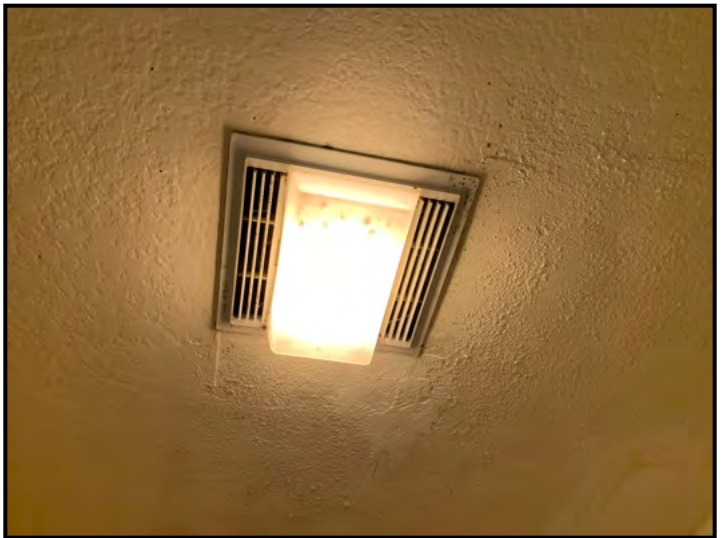
- No visible problems noted at the tub/shower area at time of inspection.
- No visible problems observed at the doors and windows at time of inspection.
- No visible floor problems noted at time of inspection.
- **Leaks noted at the faucet at time of inspection.**
- **Toilet is broken and does not flush properly. Minor repairs are needed.**
- **Repair or replacement is recommended.**
- **Vanity door or drawer is damaged or broken. Repair or replacement is recommended.**
- **Caulking is recommended at the tub or shower areas to prevent moisture penetration and damage behind the walls.**
- **Moisture stains and/or damage viewed on the walls.**
- **See photos.**
- **Exhaust fan did operated noisily at time of inspection. Repair or replacement is necessary.**

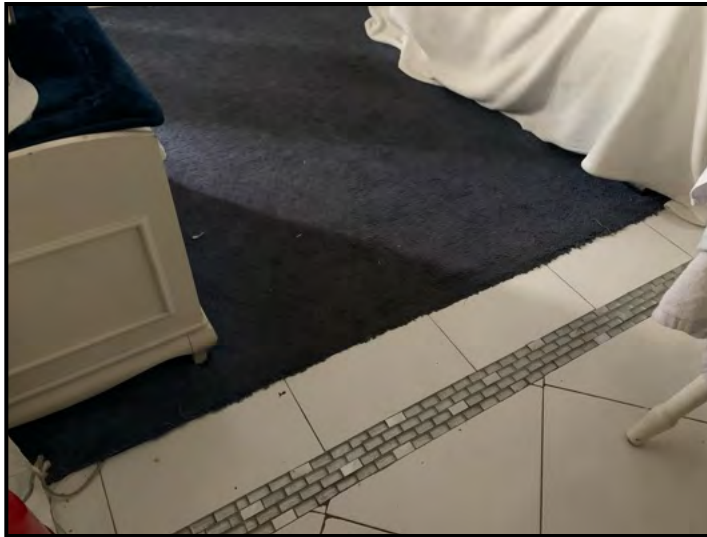
- Windows and doors operated properly at time of inspection.
- Walls and ceiling appeared functional at time of inspection.
- A representative number of outlets, switches and fixtures was operated and found to be in operable condition at time of inspection.
- **Flooring is damaged or deteriorated. Repair or replacement is recommended.**
- **See photos.**

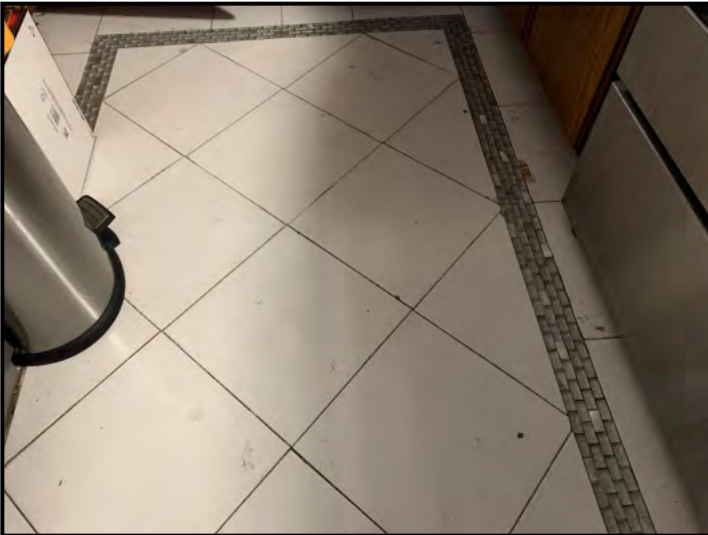
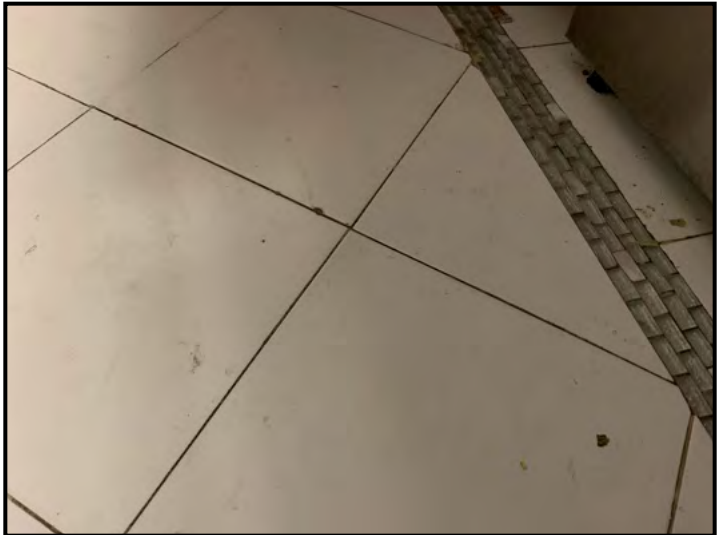
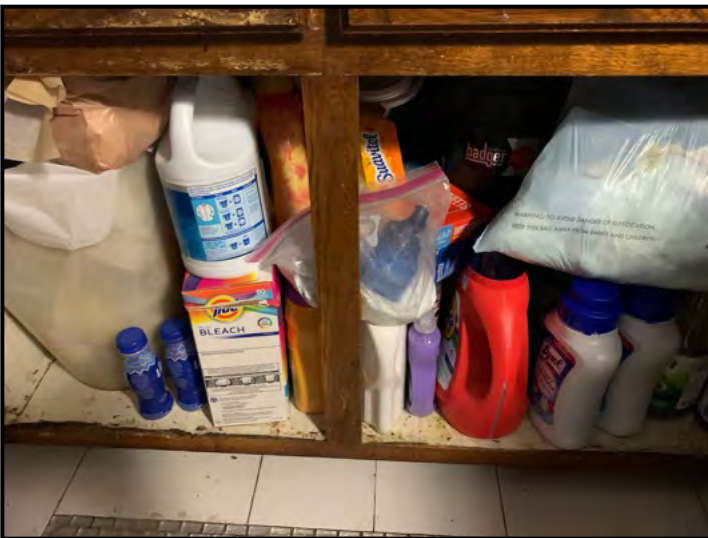
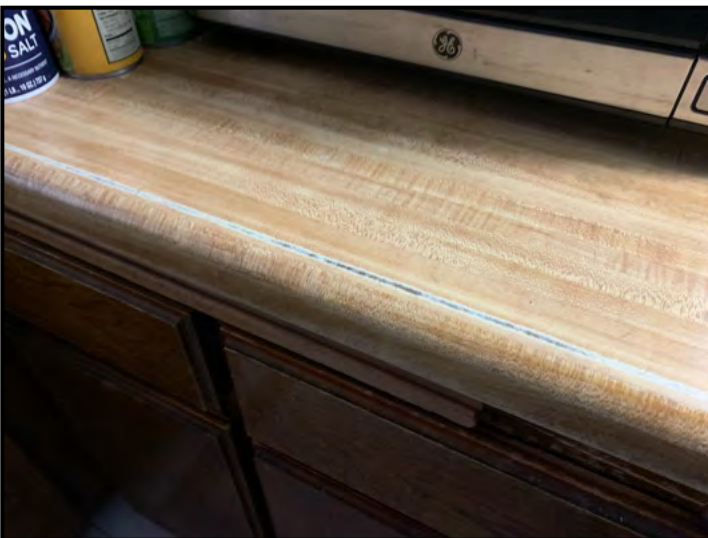
2. Kitchen

- No visible plumbing problems noted at time of inspection.
- Windows and doors operated properly at time of inspection.
- Walls and ceiling appeared functional at time of inspection.
- A representative number of outlets, switches and fixtures was operated and found to be in operable condition at time of inspection.
- **Minor to moderate wear and or damage observed on the kitchen counter top. Repair or replacement is recommended.**
- **Moisture damage noted on the cabinets. Repair or replacement is recommended.**
- **Flooring is damaged or deteriorated. Repair or replacement is recommended.**
- **See photos.**

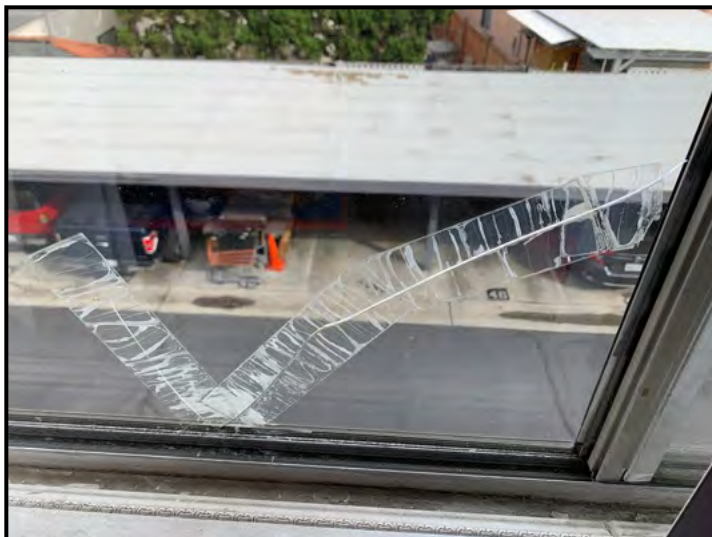
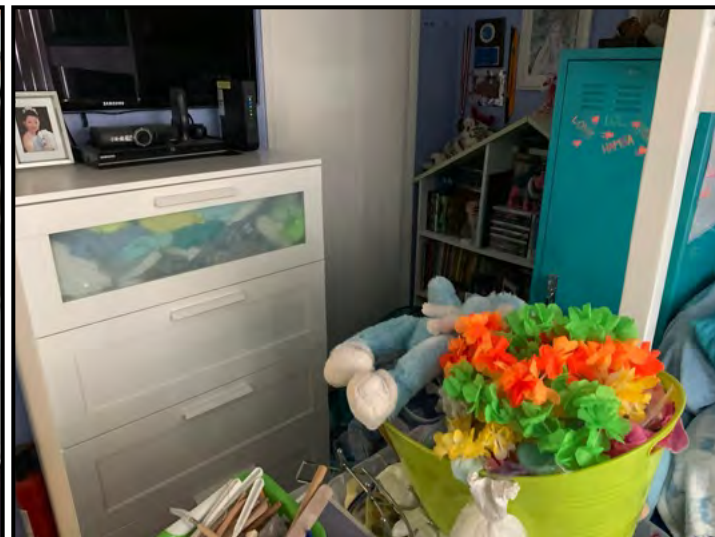
- Windows and doors operated properly at time of inspection.
- Walls and ceiling appeared functional at time of inspection.
- No visible problems noted at the closet at time of inspection.
- No visible problems noted at the floor at time of inspection.
- A representative number of outlets, switches and fixtures was operated and found to be in operable condition at time of inspection.
- **Smoke detector is not installed. A smoke detector is required in every bedroom, adjacent hallway and every level of the dwelling prior to the close of escrow.**
- **See photos.**
- **Bedroom window is cracked and broken.**
- **Could not access closet due to personal belongings blocking entrance.**

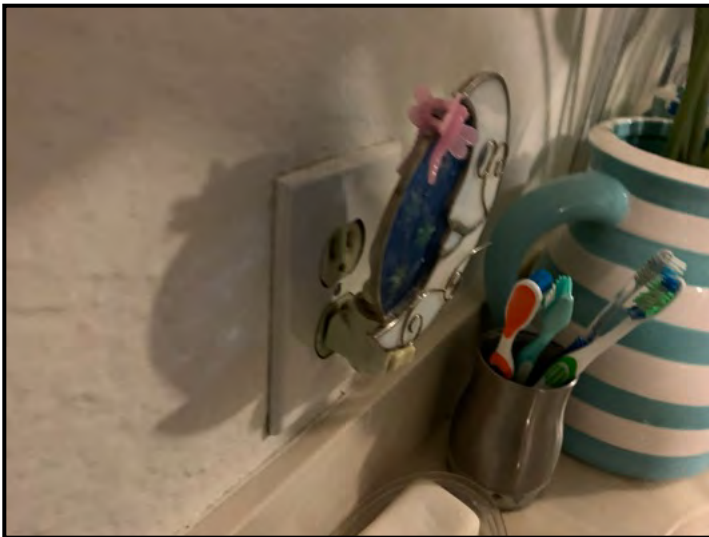
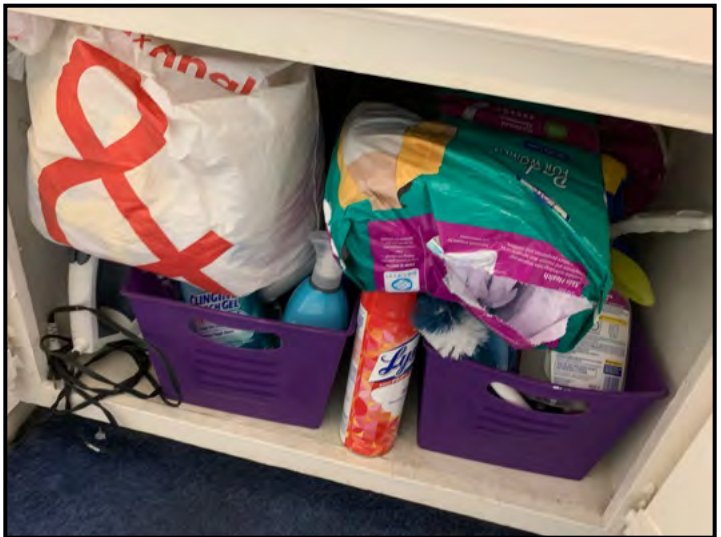
5. Bathrooms

- No visible plumbing problems noted at time of inspection.
- No visible problems noted at the sink and vanity at time of inspection.
- No visible problems noted at the tub/shower area at time of inspection.
- No visible problems observed at the doors and windows at time of inspection.
- Walls and ceiling appeared functional at time of inspection.
- No visible floor problems noted at time of inspection.
- **Ground Fault Circuit Interrupter (GFCI) outlets are recommended for installation.**

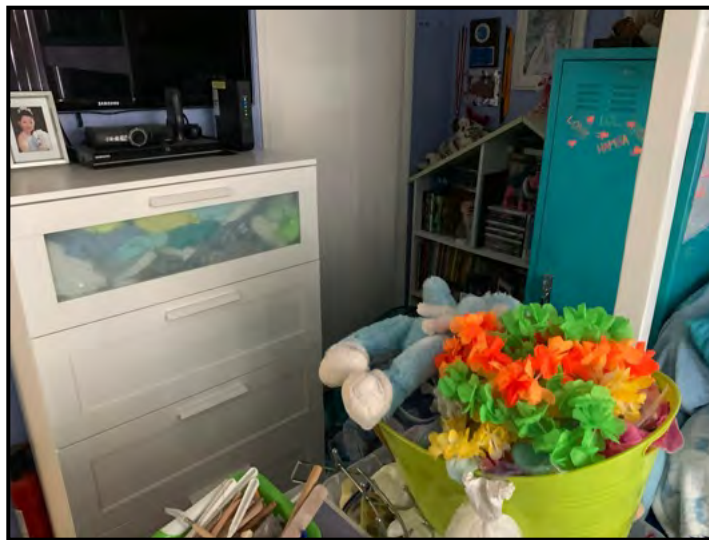
6. Electrical Panel Condition

- Electrical panel is inside bedroom closet which is not allowed
- Closet in which electrical panel was inside could not be accessed due to personal belongings blocking entrance.

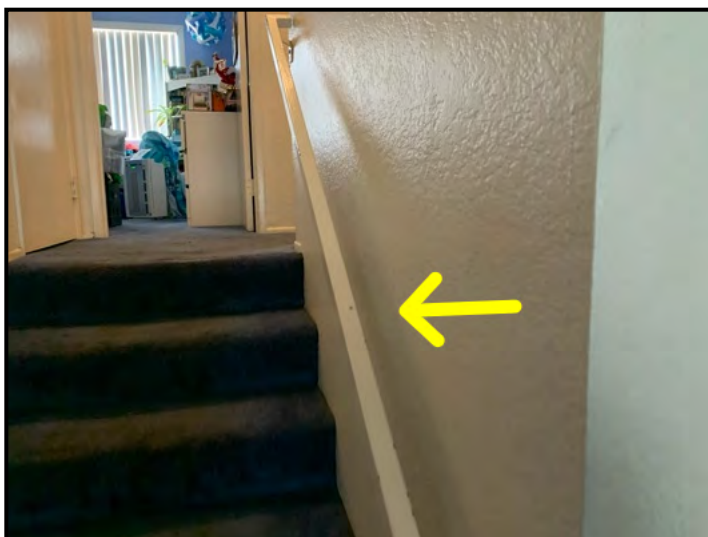
- Hand railing is loose or damaged. Repair or replacement is required.
- See photos.

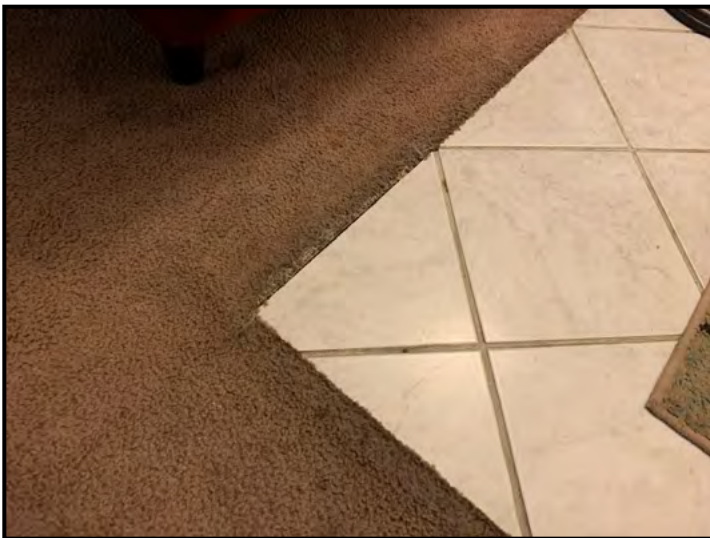
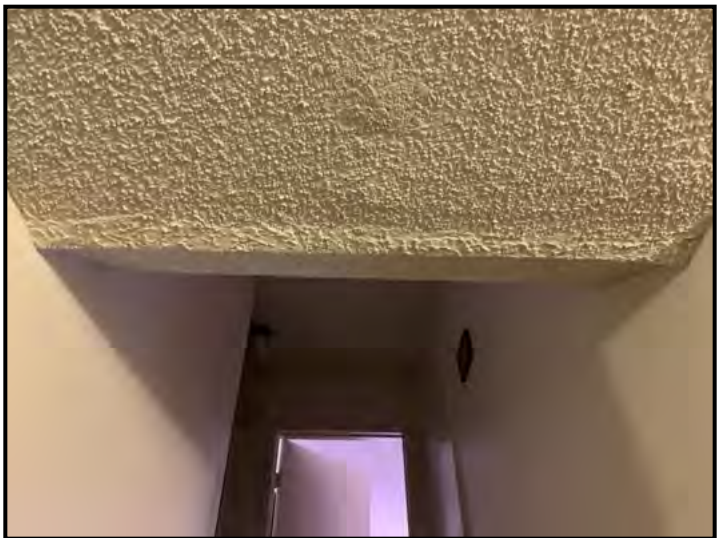
- Windows and doors operated properly at time of inspection.
- A representative number of outlets, switches and fixtures was operated and found to be in operable condition at time of inspection.
- **Moisture stains and/or damage viewed on the ceiling.**
- **Flooring is damaged or deteriorated. Repair or replacement is recommended.**

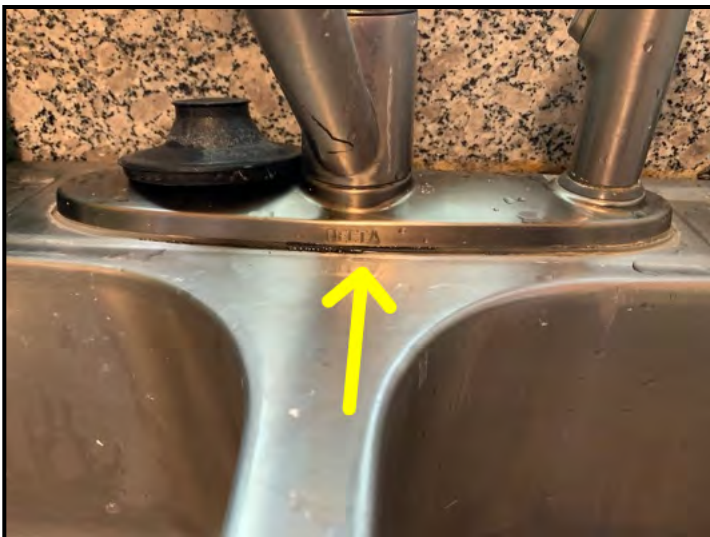
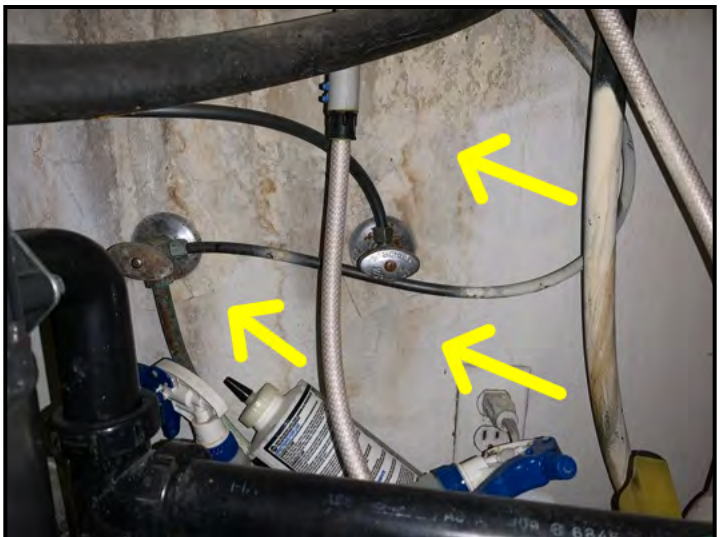
2. Kitchen

- Windows and doors operated properly at time of inspection.
- Walls and ceiling appeared functional at time of inspection.
- No visible problems noted at the floor at time of inspection.
- A representative number of outlets, switches and fixtures was operated and found to be in operable condition at time of inspection.
- **Leaks noted at the faucet at time of inspection.**
- **Rust and corrosion observed on the water supply valves under the sink.**
- **Moisture damage noted on the cabinets. Repair or replacement is recommended.**

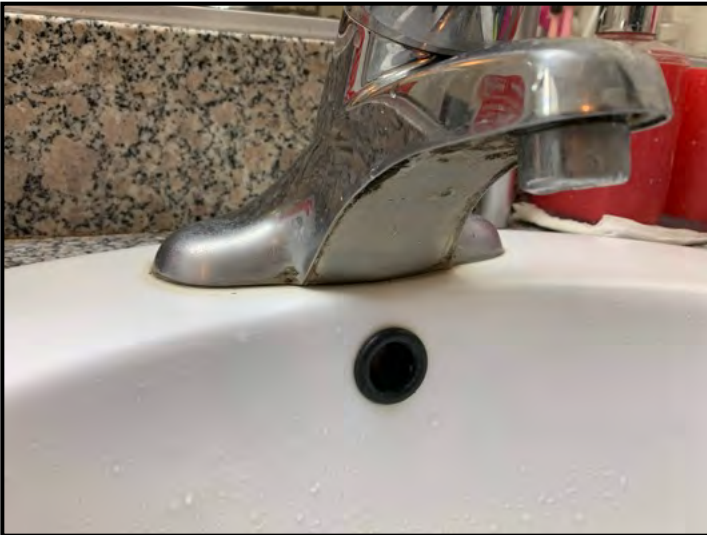
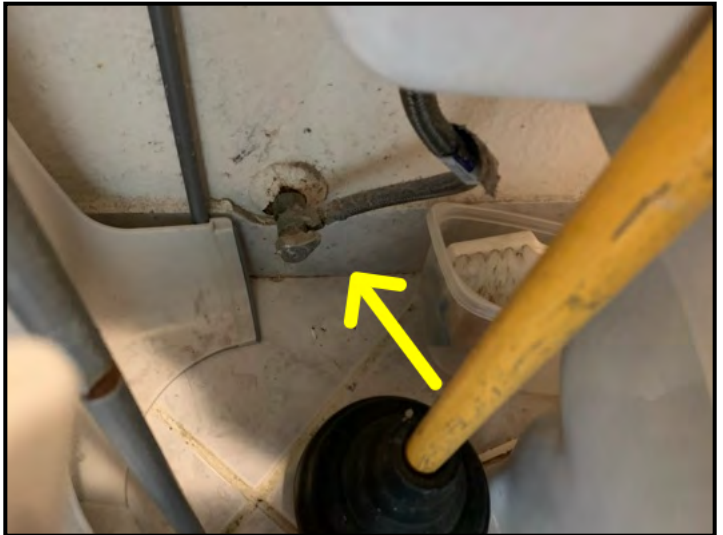
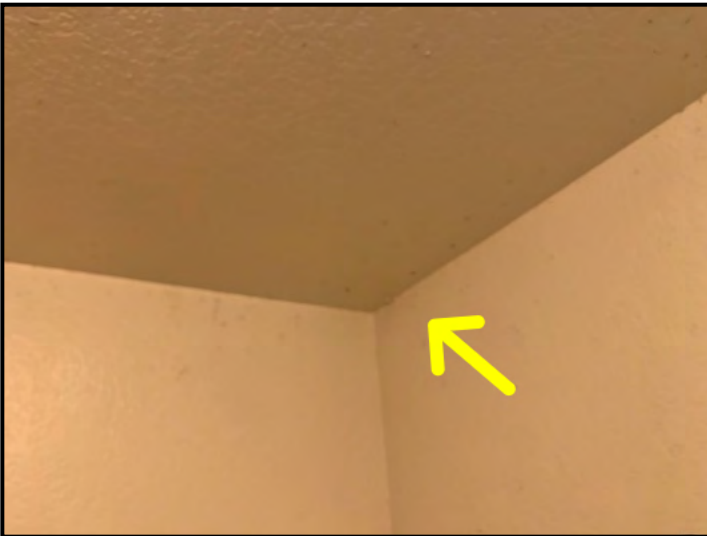
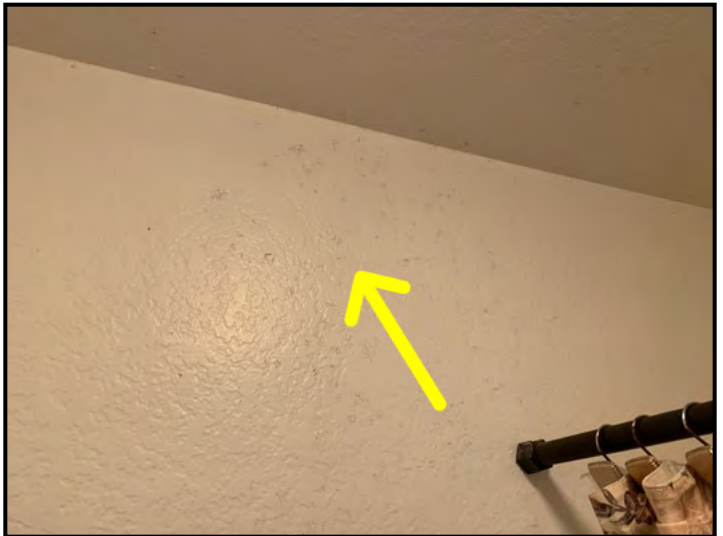
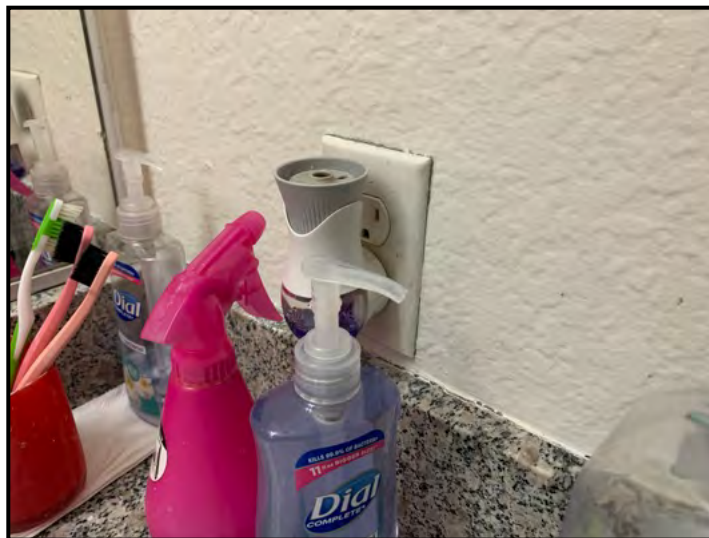
- No visible problems noted at the sink and vanity at time of inspection.
- No visible problems noted at the tub/shower area at time of inspection.
- No visible problems observed at the doors and windows at time of inspection.
- No visible floor problems noted at time of inspection.
- **Rust and corrosion observed on the water supply valves**
- **Faucet has corrosion and is damaged**
- **Repair or replacement is recommended.**
- **See photos.**
- **Moisture stains and/or damage viewed on the ceiling.**
- **Moisture stains and/or damage viewed on the walls.**
- **See photos.**
- **Ground Fault Circuit Interrupter (GFCI) outlets are recommended for installation.**

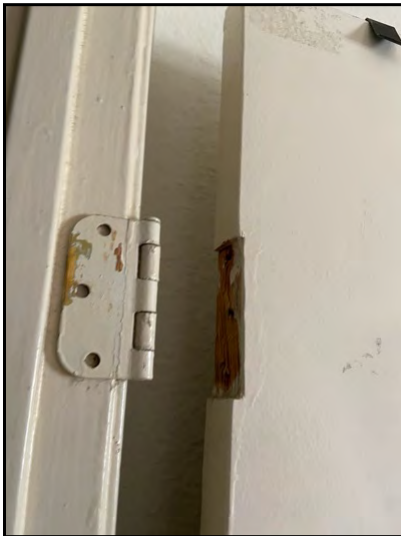
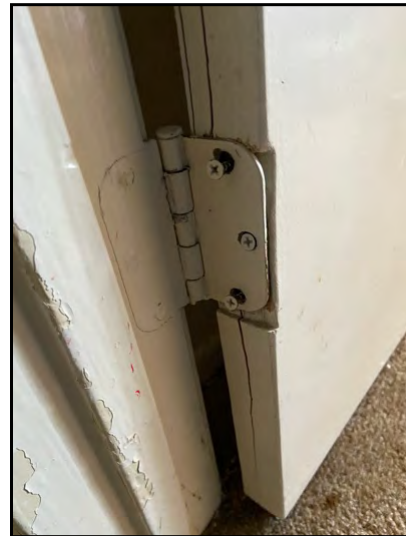
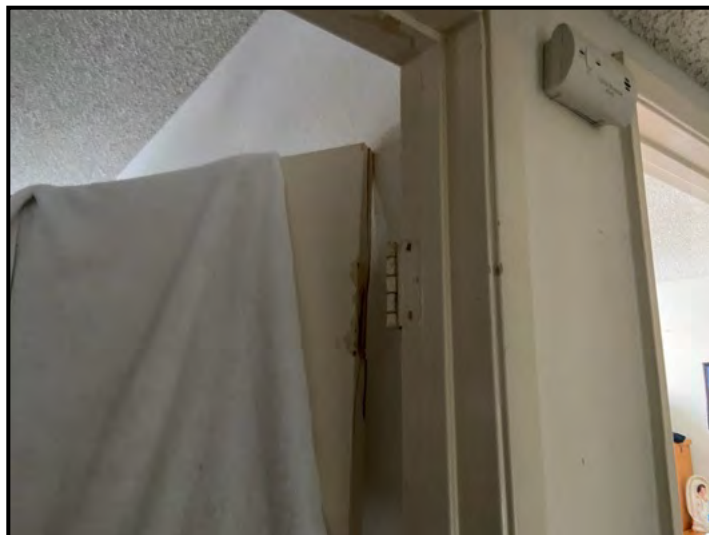
- Window glass is cracked or broken. Replacement is required.
- Door hinges are loose or falling off and do not allow the door to close properly. Repair or replacement.
- Closet doors are fallen off the tracks. Proper installation is recommended.

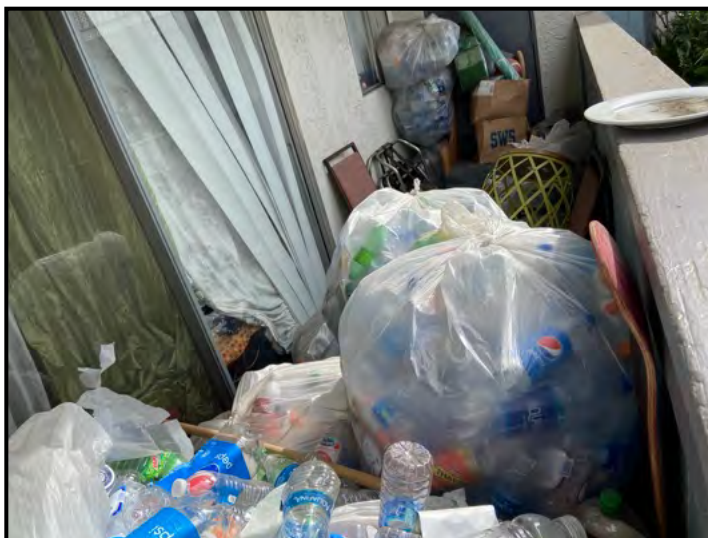
- **Unable to inspect patio/balcony due to occupants belongings. See photos.**
