PROPERTY INSPECTION REPORT

12345 Main Street, Anytown, CA 90001

DATE OF INSPECTION: 12/9/2022

VILLA HOME INSPECTIONS

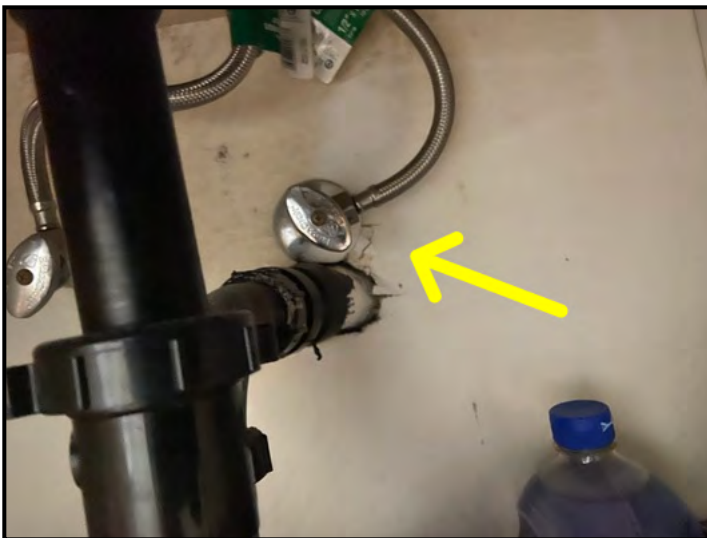
- **Leaks noted at the faucet at time of inspection.**
- **Leaks noted at the supply lines under the sink at time of inspection.**
- **Further evaluation and repairs as needed by a plumbing contractor is recommended.**
- **See photos.**

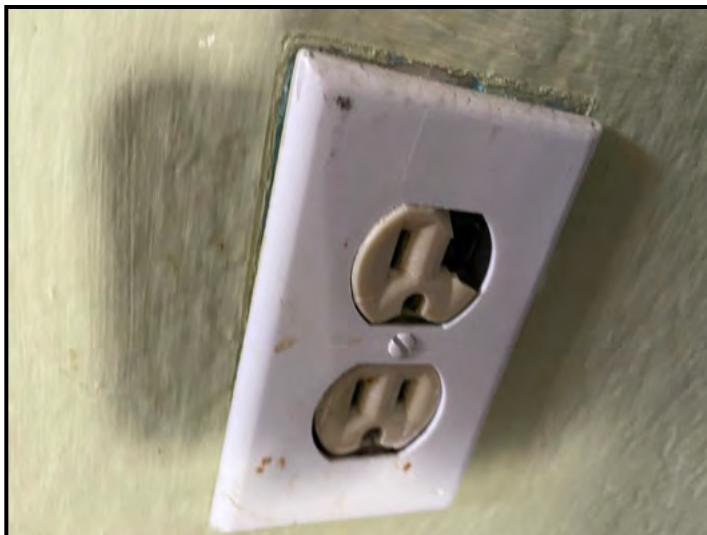
- Broken electrical outlet observed. See photo. Replacement is necessary for safety.

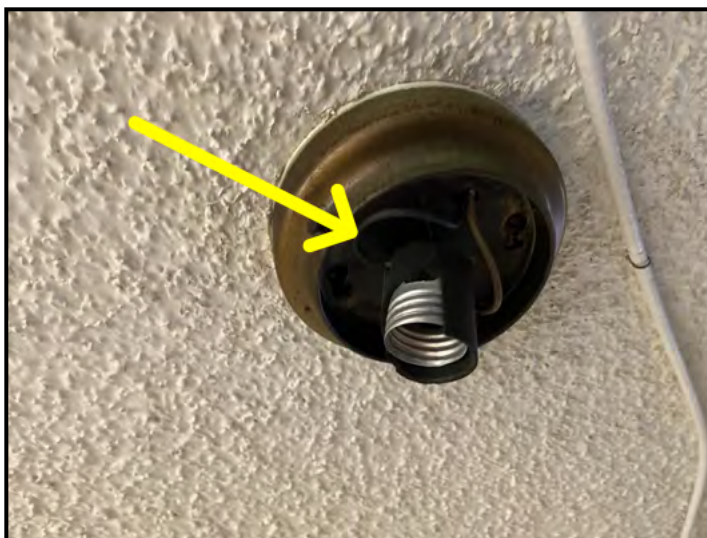
- Broken electrical light fixture observed. See photo. Replacement is necessary.

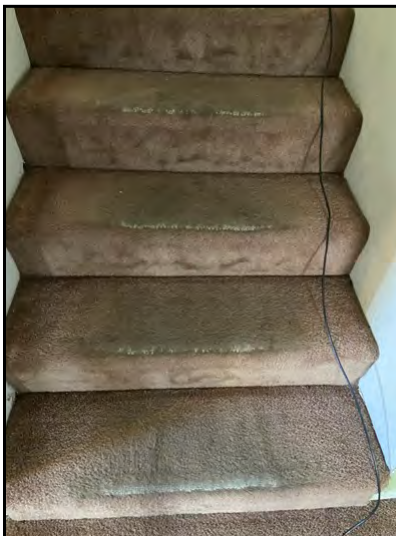
- Carpet throughout the stairs is torn and poses a trip and fall hazard. See photos.

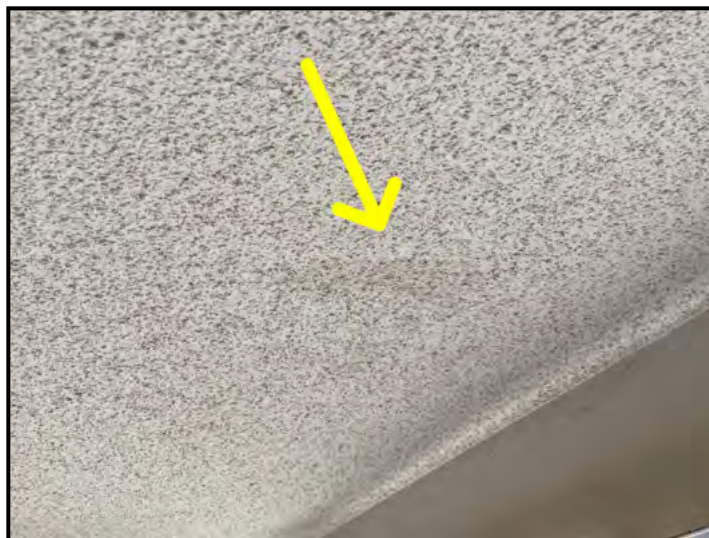
- Moisture stains and/or damage viewed on the ceiling.
- Possible roof leak. Further evaluation by a roofing contractor is recommended.

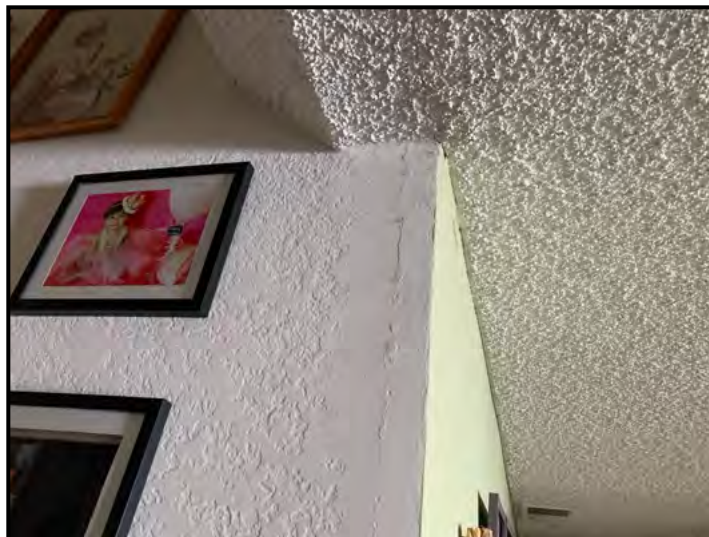
- Windows and doors operated properly at time of inspection.
- No visible problems noted at the floor at time of inspection.
- A representative number of outlets, switches and fixtures was operated and found to be in operable condition at time of inspection.
- **Moisture stains and/or damage viewed on the walls.**
- **See photos.**
- **Minor damage and patchwork noted in the living room on walls near hallway**

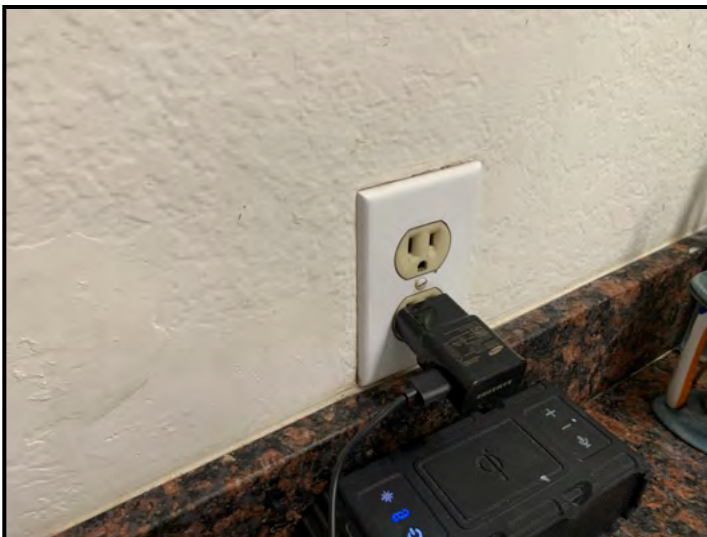
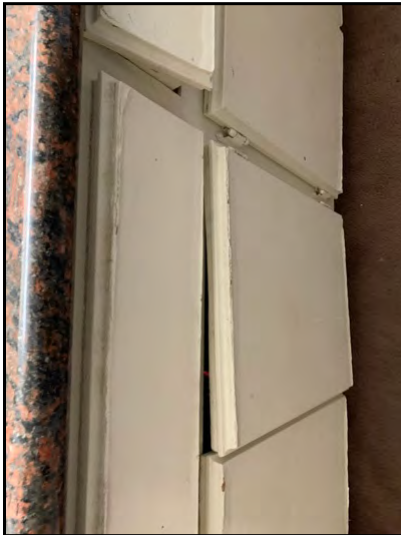
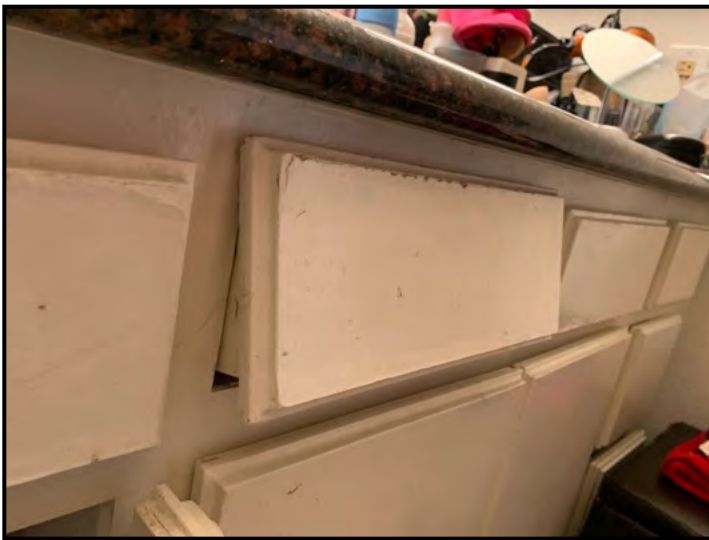
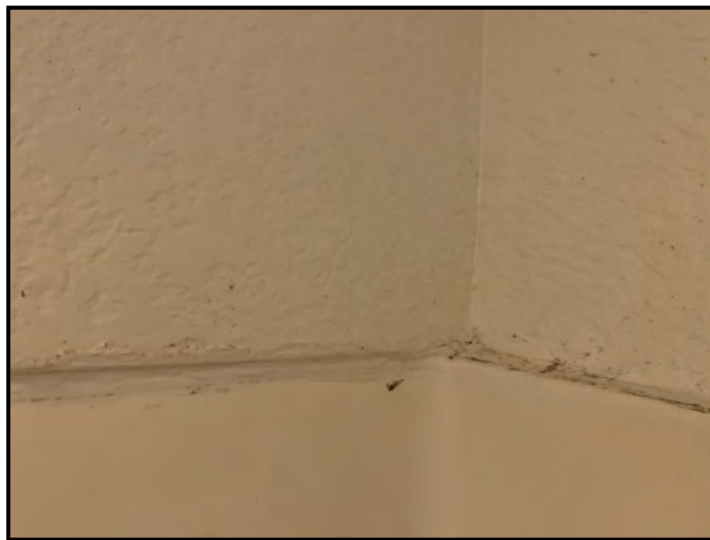
- No visible plumbing problems noted at time of inspection.
- No visible problems observed at the doors and windows at time of inspection.
- No visible floor problems noted at time of inspection.
- **Rust and corrosion observed on the water supply valves**
- **Vanity door or drawer is damaged or broken. Repair or replacement is recommended.**
- **Caulking is recommended at the tub or shower areas to prevent moisture penetration and damage behind the walls.**
- **Moisture stains and/or damage viewed on the walls.**
- **Ground Fault Circuit Interrupter (GFCI) outlets are recommended for installation.**

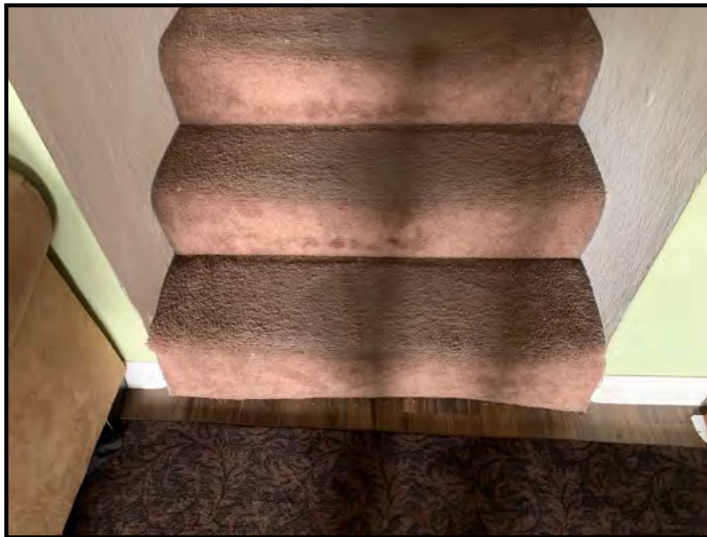
- See photos.
- Carpet on stairs is deteriorated and damaged

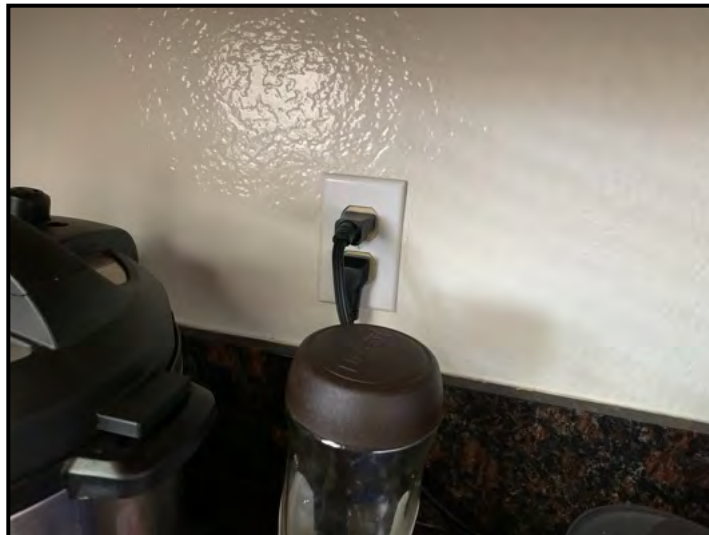
- No visible plumbing problems noted at time of inspection.
- No visible problems noted at the counters and cabinets at time of inspection.
- Windows and doors operated properly at time of inspection.
- Walls and ceiling appeared functional at time of inspection.
- No visible problems noted at the floor at time of inspection.
- **Ground Fault Circuit Interrupter (GFCI) outlets are recommended for installation.**
- **See photos.**

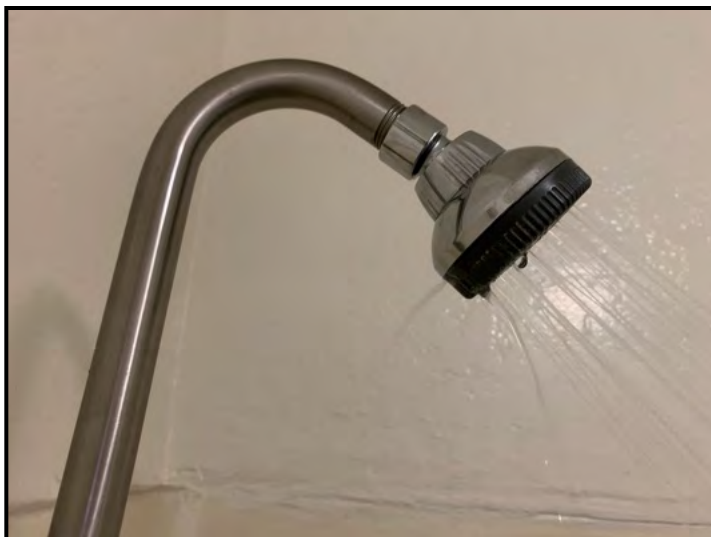
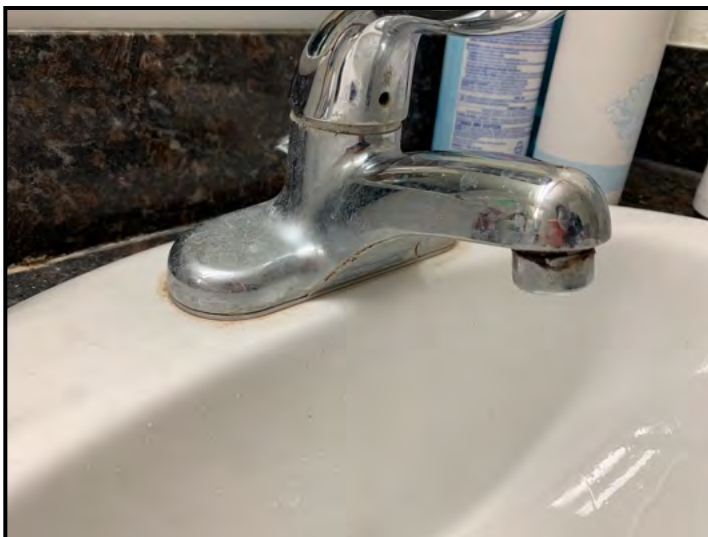
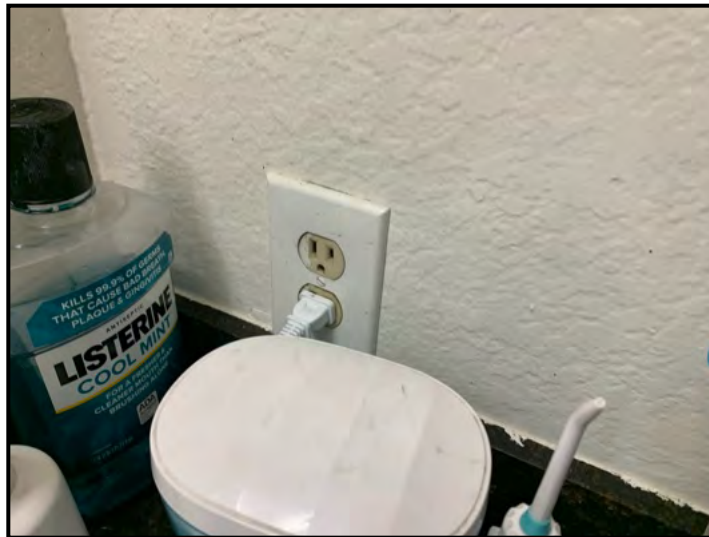
- No visible problems noted at the sink and vanity at time of inspection.
- No visible problems observed at the doors and windows at time of inspection.
- Walls and ceiling appeared functional at time of inspection.
- No visible floor problems noted at time of inspection.
- **Rust and corrosion observed on the faucet**
- **Shower head leaks when operated.**
- **See photos.**
- **Caulking is recommended at the tub or shower areas to prevent moisture penetration and damage behind the walls.**
- **Ground Fault Circuit Interrupter (GFCI) outlets are recommended for installation.**
- **See photos.**

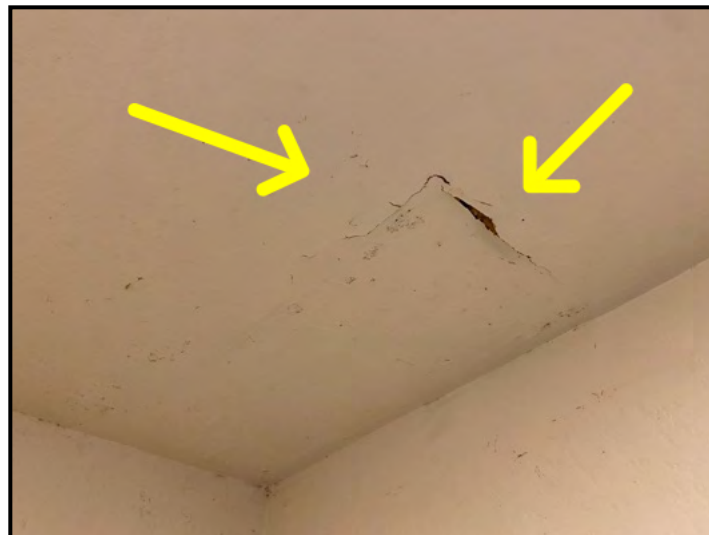
- No visible plumbing problems noted at time of inspection.
- **Moisture stains and/or damage viewed on the ceiling.**
- **Possible plumbing leak from dwelling above. Further evaluation by a plumbing contractor is recommended.**
- **See photos.**

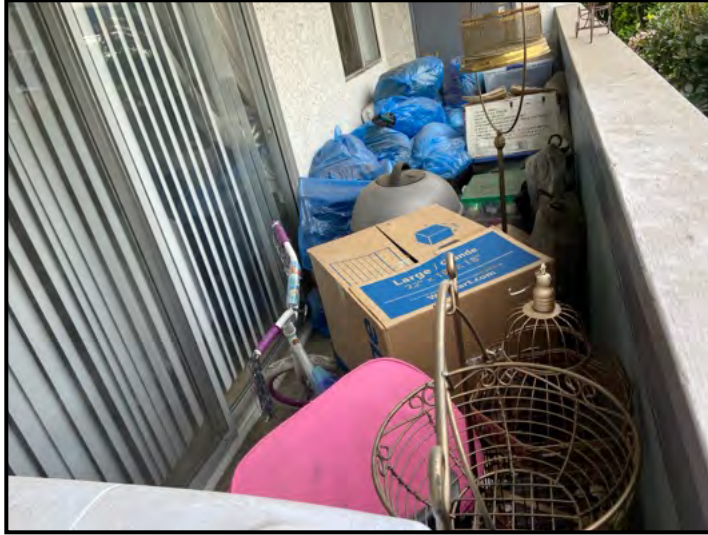
- Unable to inspect patio/balcony due to occupants belongings. See photos.

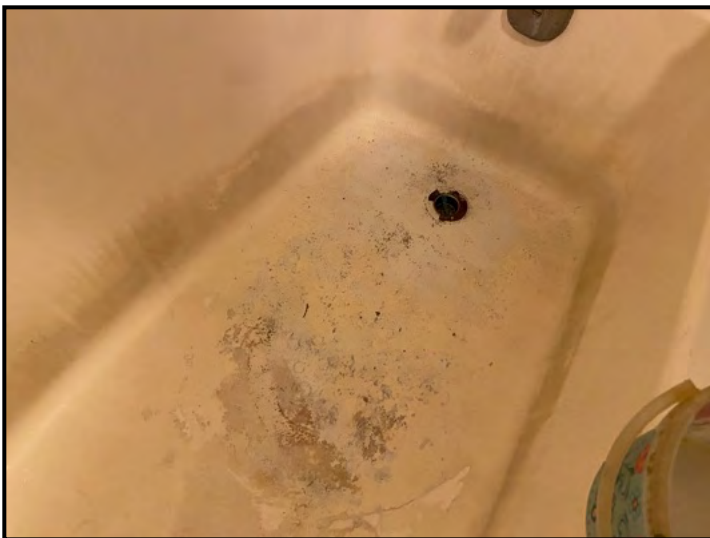
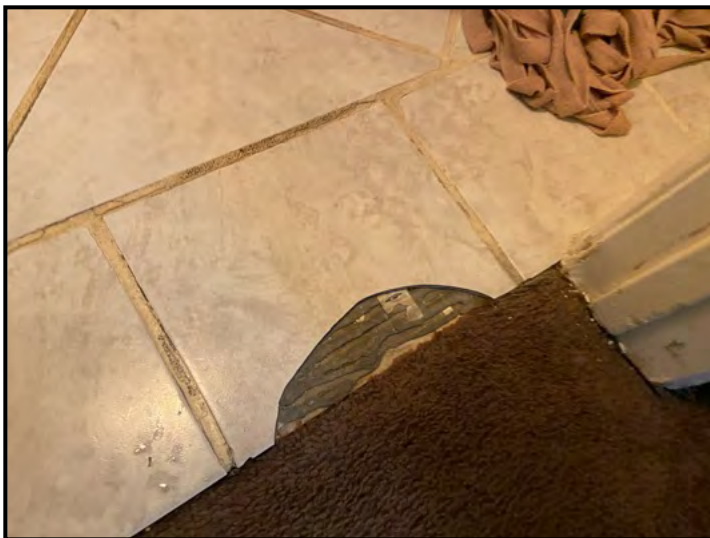
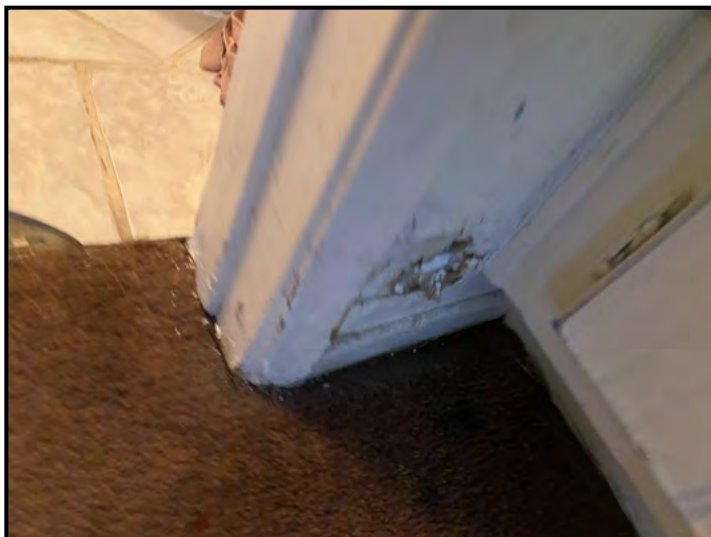
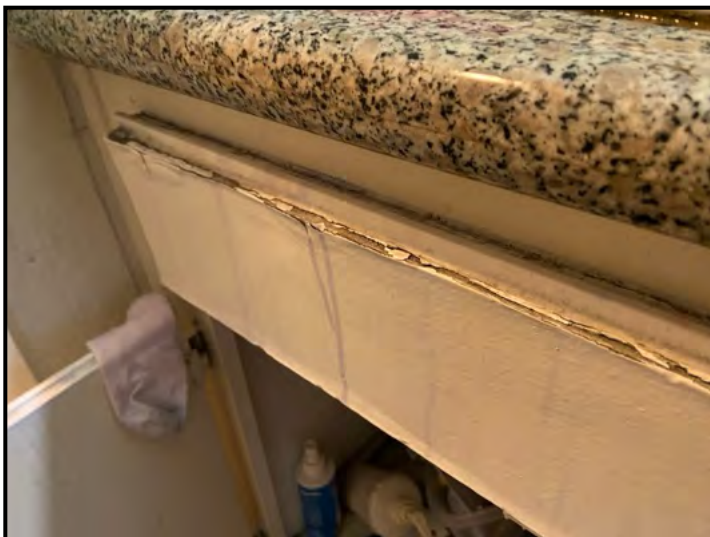
- Vanity door or drawer is damaged or broken. Repair or replacement is recommended.
- Tub surface is damaged. Repair and or resurfacing is recommended.
- Moisture stains and/or damage viewed on the walls.
- Floor tiles are damaged or loose. Repair or replacement is recommended.
- Repair or replacement is recommended.
- See photos.

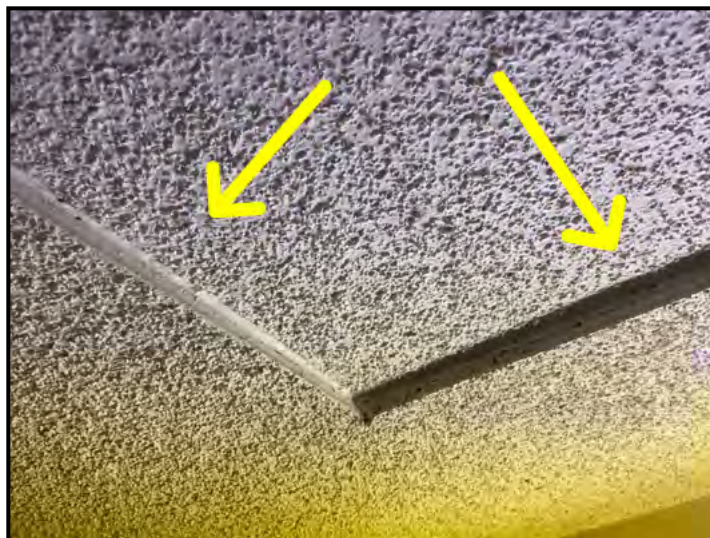
- Unable to enter attic at time of inspection. Attic entrance was sealed. See photo.

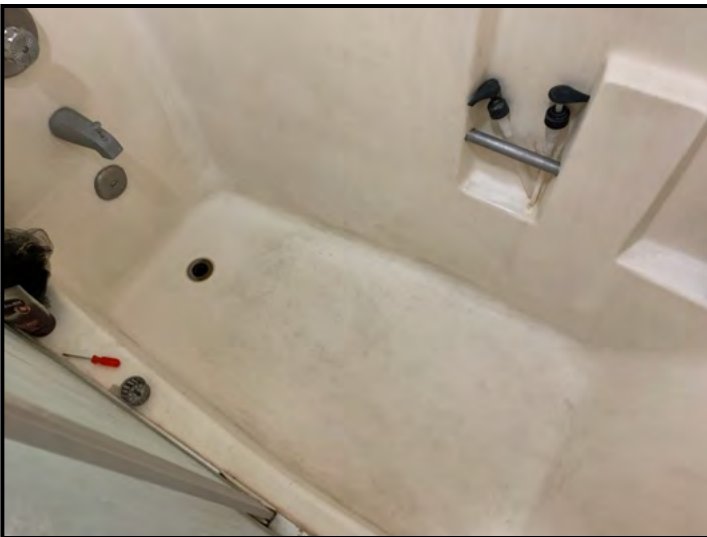
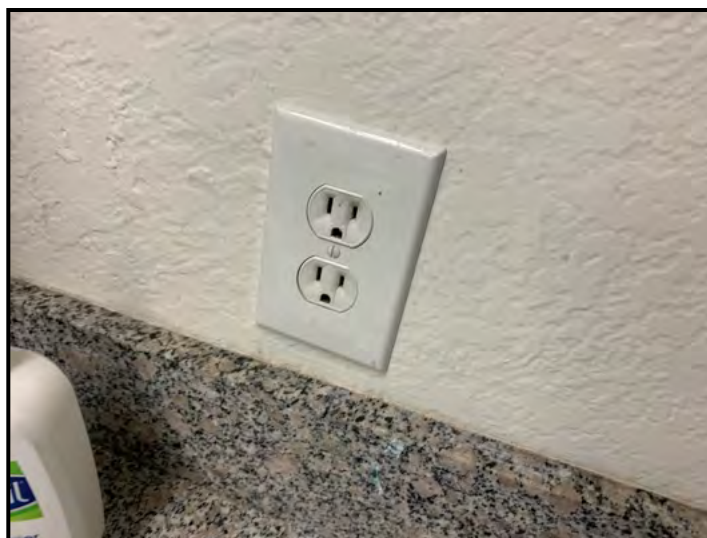
- No visible plumbing problems noted at time of inspection.
- No visible problems noted at the sink and vanity at time of inspection.
- No visible problems observed at the doors and windows at time of inspection.
- Walls and ceiling appeared functional at time of inspection.
- **Tub surface is damaged. Repair and or resurfacing is recommended.**
- **Caulking is recommended at the tub or shower areas to prevent moisture penetration and damage behind the walls.**
- **Floor tiles are damaged or loose. Repair or replacement is recommended.**
- See photos.
- **Ground Fault Circuit Interrupter (GFCI) outlets are recommended for installation.**
- See photos.

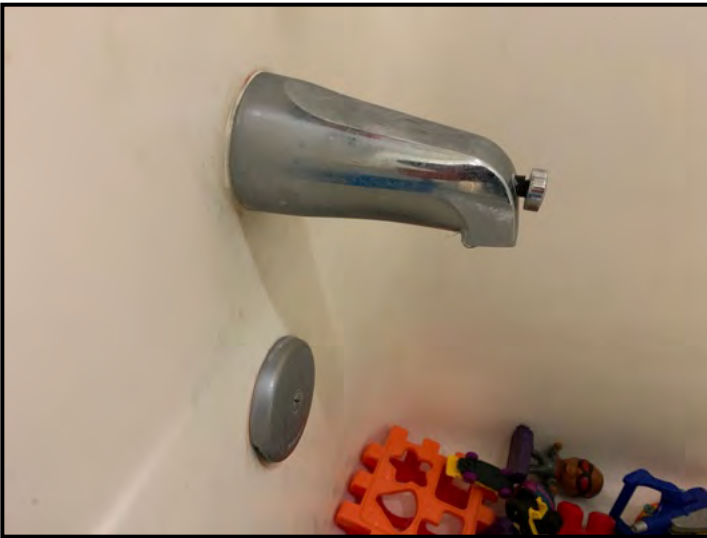
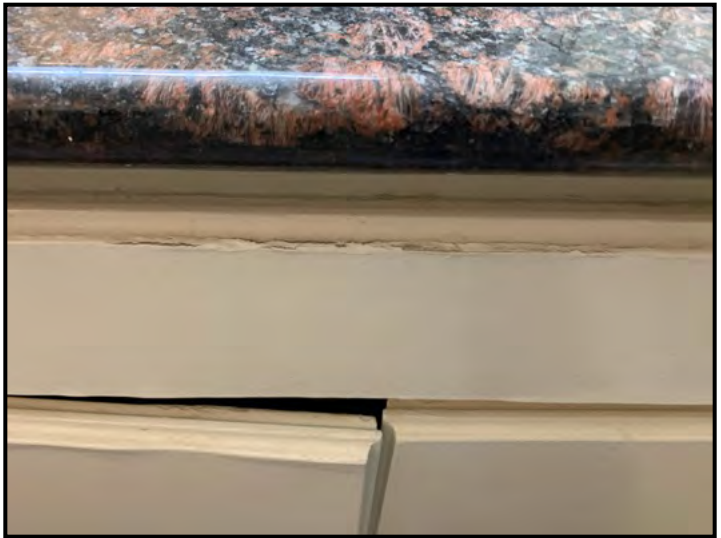
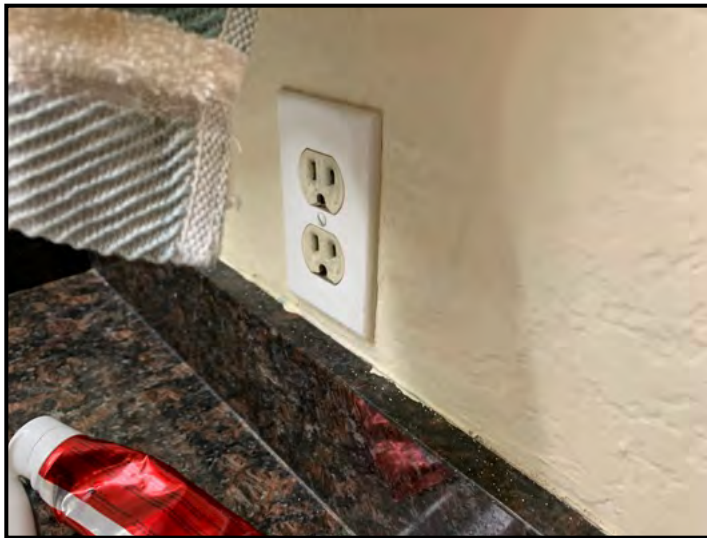
- No visible problems noted at the tub/shower area at time of inspection.
- No visible problems observed at the doors and windows at time of inspection.
- Walls and ceiling appeared functional at time of inspection.
- No visible floor problems noted at time of inspection.
- **Tub faucet leaks when operated.**
- **See photos.**
- **Vanity door or drawer is damaged or broken. Repair or replacement is recommended.**
- **Ground Fault Circuit Interrupter (GFCI) outlets are recommended for installation.**
- **See photos.**

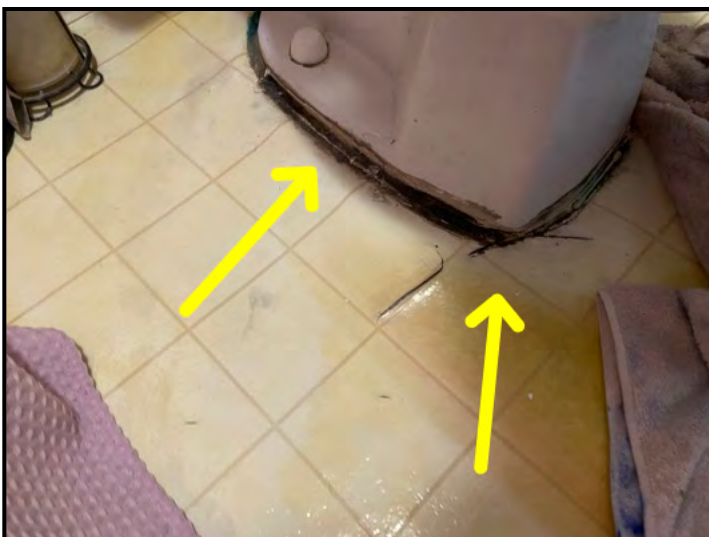
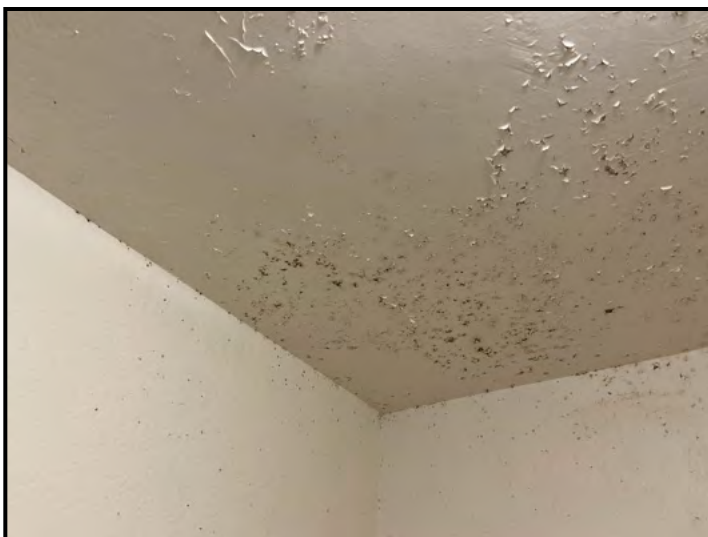
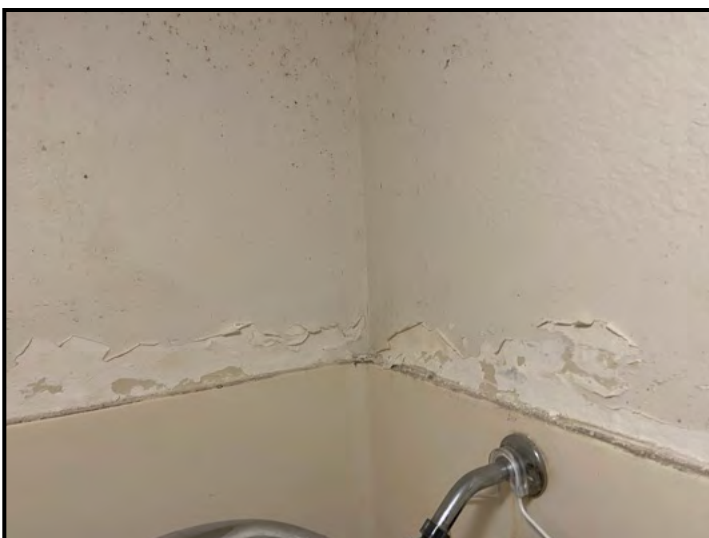
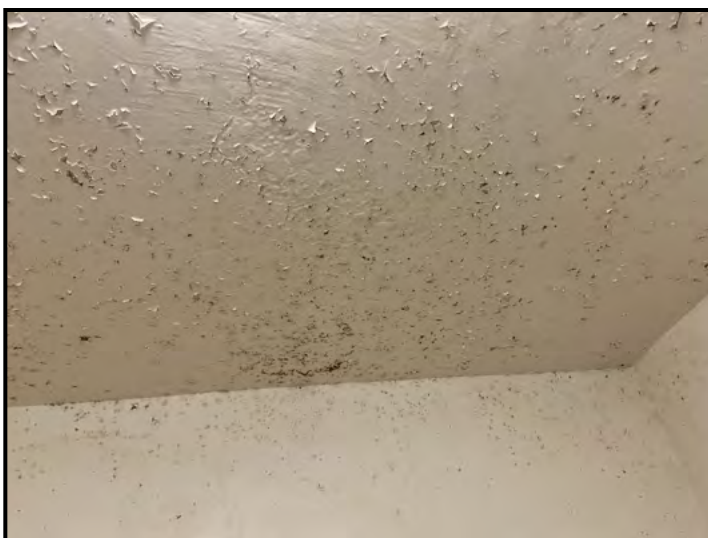
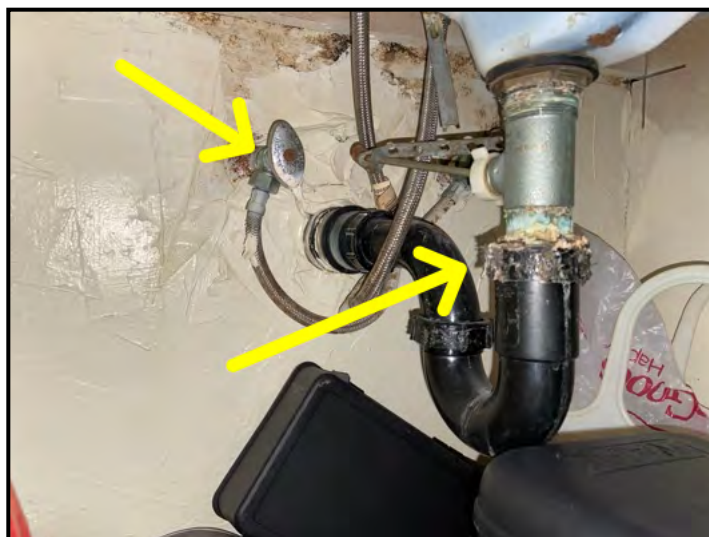
- Leaks noted at the supply lines under the sink at time of inspection.
- Leaks observed at the drain lines under the sink.
- Tub faucet leaks when operated.
- Moisture stains and/or damage viewed on the ceiling.
- Moisture stains and/or damage viewed on the walls.
- GFCI outlet did not operate properly at time of inspection. Repair or replacement is recommended.
- Significant damage observed at the floor surrounding the toilet. Subfloor appears soft and damaged. See photos. Further evaluation by a licensed contractor is recommended.
- Further evaluation and repairs as needed by a plumbing contractor is recommended.
- See photos.

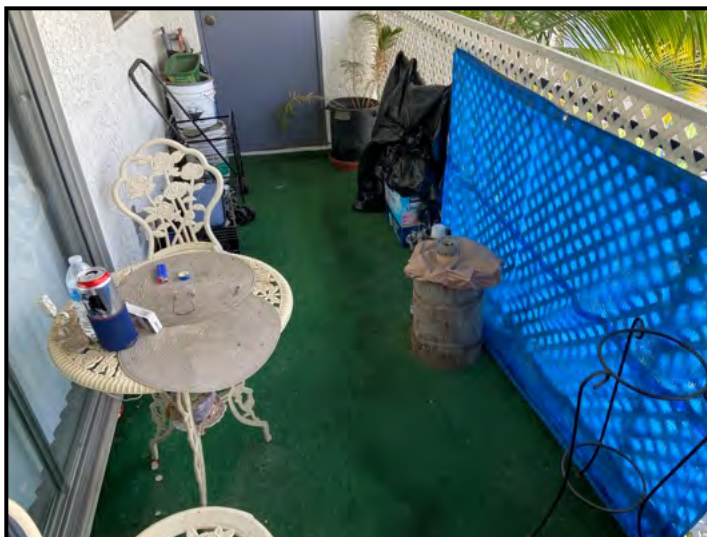
- Carpet restricts viewing of the floor. Further evaluation is recommended.

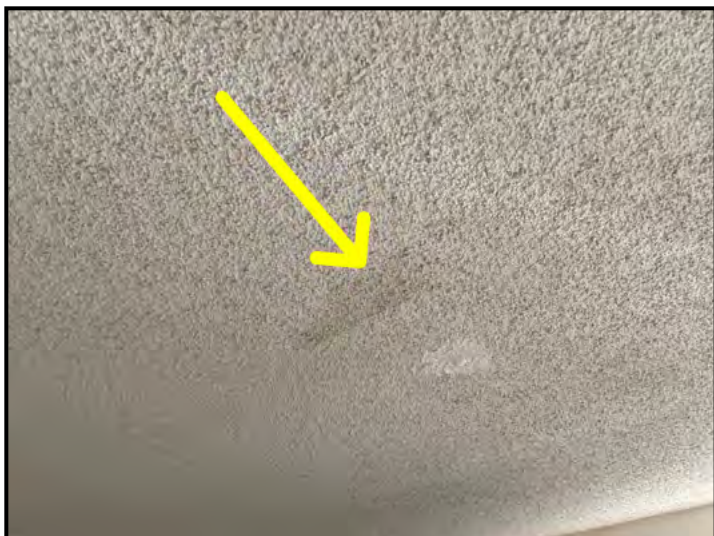
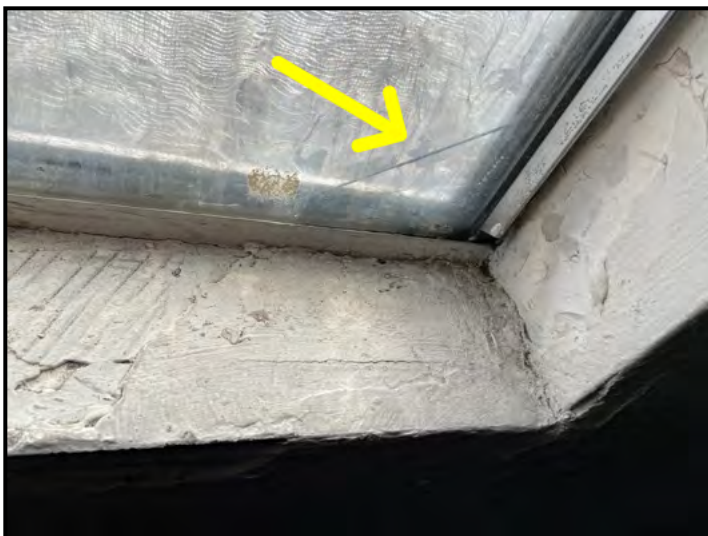
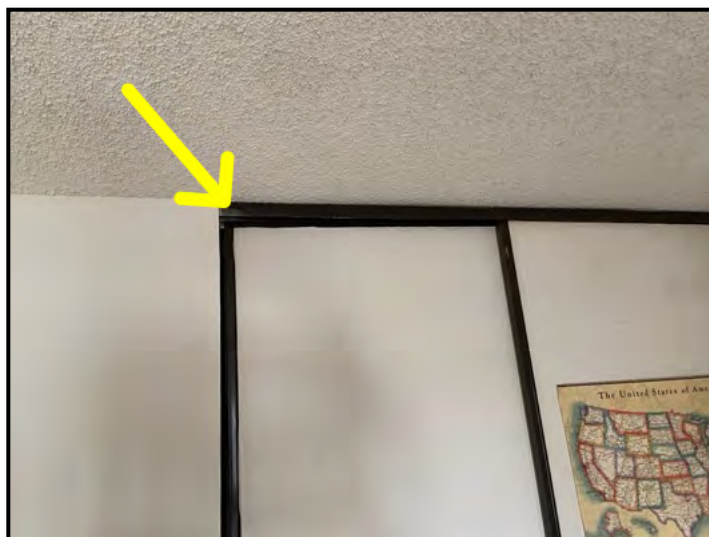
- Window glass is cracked or broken. Replacement is required.
- Moisture stains and/or damage viewed on the ceiling.
- Possible roof leak. Further evaluation by a roofing contractor is recommended.
- Closet doors are fallen off the tracks. Proper installation is recommended.
- See photos.

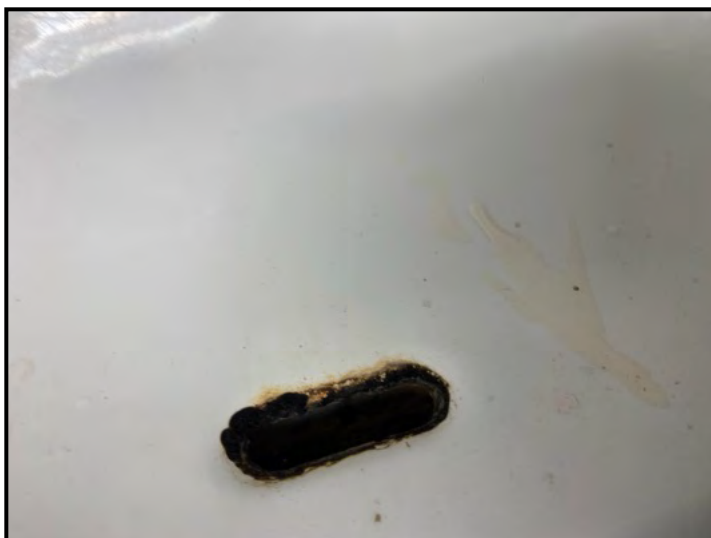
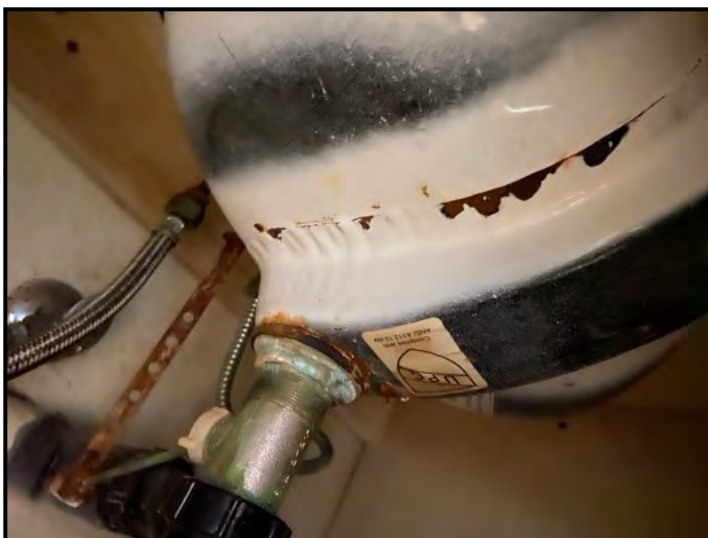
- Significant moisture damage observed under the sink.
- Sink has rust damage. This model of sink was manufactured defectively by welding the overflow channel to the bottom of the sink. This causes rapid rusting under the sink, which then protrudes to the top and generally causes leaks. Replacement of the sink is necessary.
- Tub faucet is not sealed at the wall and will allow moisture penetration.
- Mirror is damaged. Medicine cabinet mirror is missing. Replacement of both is recommended.

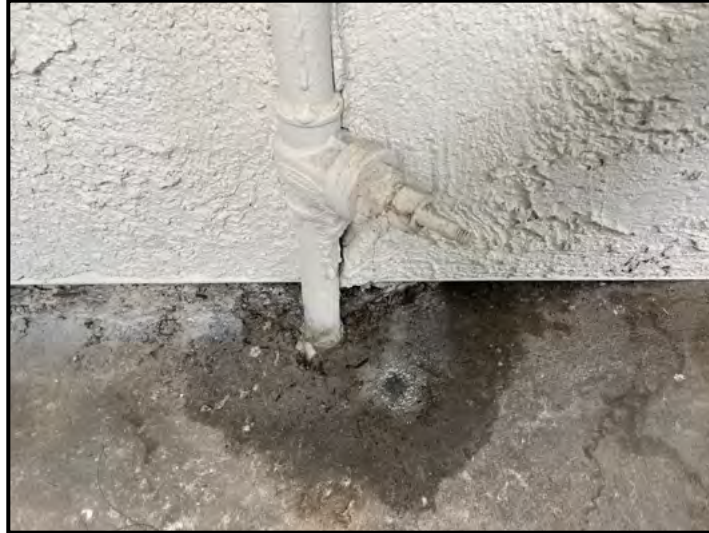
- Main water shut off located at the patio is leaking. See photo. Repairs by a plumbing contractor are recommended.

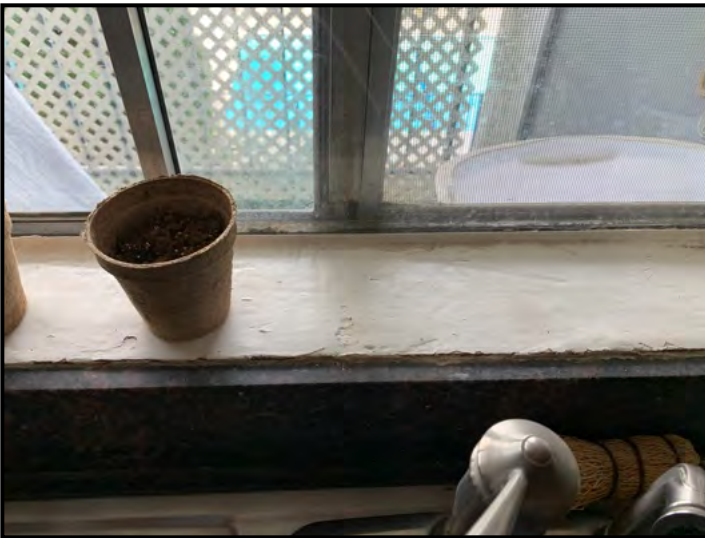
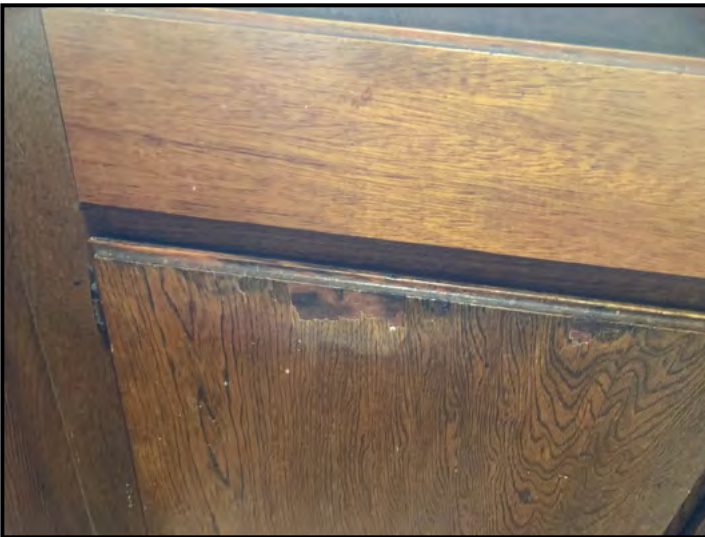
- No visible plumbing problems noted at time of inspection.
- Windows and doors operated properly at time of inspection.
- Walls and ceiling appeared functional at time of inspection.
- No visible problems noted at the floor at time of inspection.
- A representative number of outlets, switches and fixtures was operated and found to be in operable condition at time of inspection.
- **Moisture damage noted on the cabinets. Repair or replacement is recommended.**
- **Evidence of moisture penetration observed at the window. Window may need caulking or sealant application on the exterior.**
- **See photos.**
- **Kitchen stove is damaged and needs to be repaired or replaced**

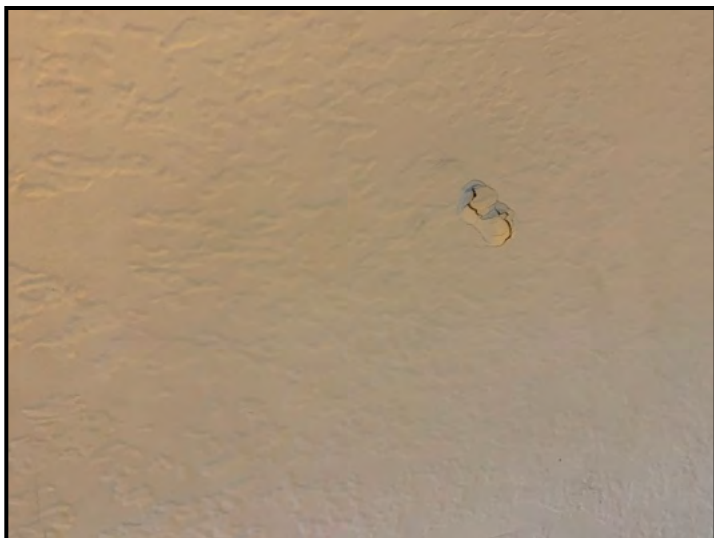
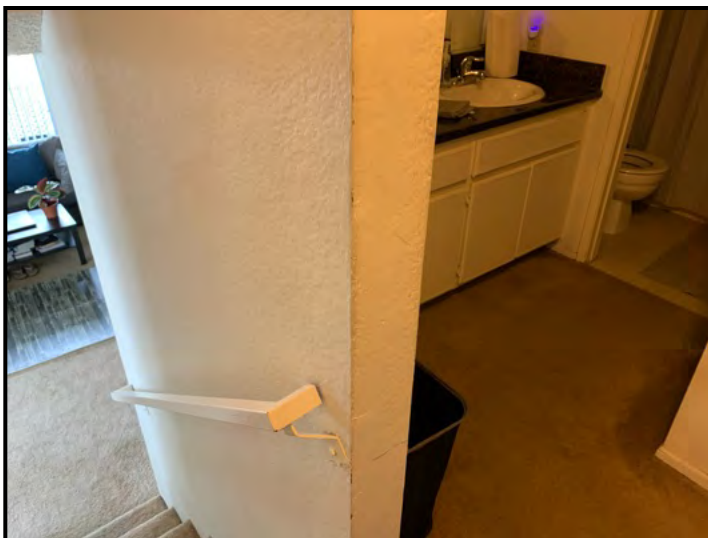
- Smoke detector is installed.
- Carbon monoxide alarm is installed in the dwelling.
- No visible problems noted at the closet at time of inspection.
- No visible problems noted at the floor at time of inspection.
- A representative number of outlets, switches and fixtures was operated and found to be in operable condition at time of inspection.
- **Moisture stains and/or damage viewed on the walls.**
- **See photos.**

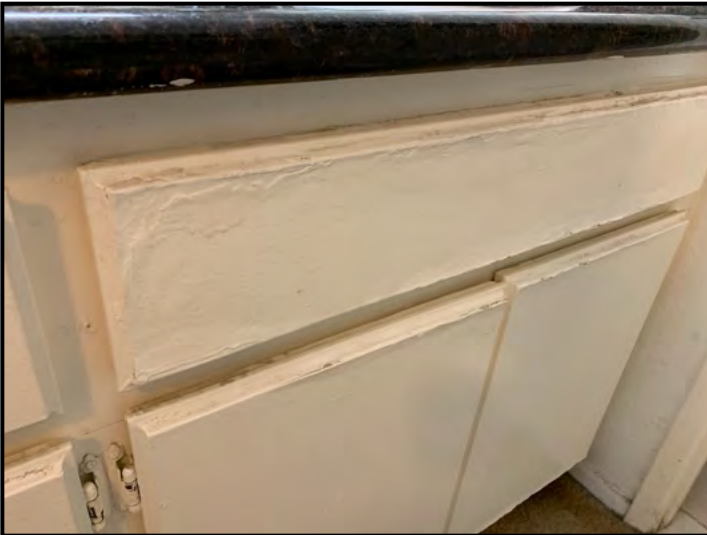
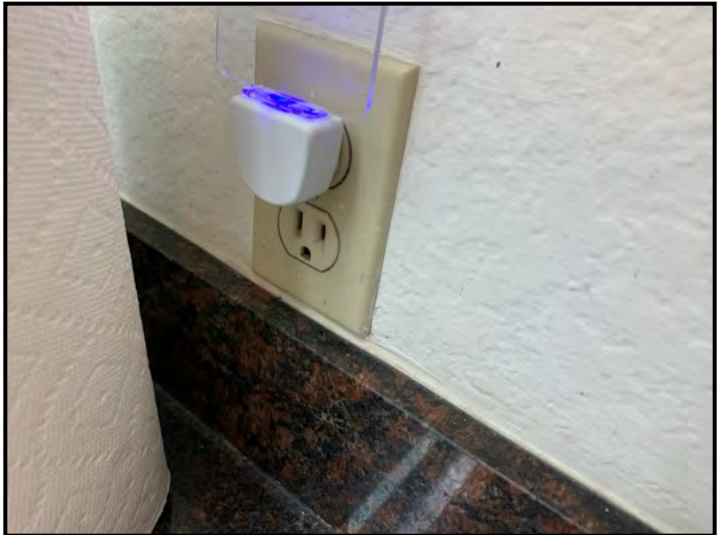
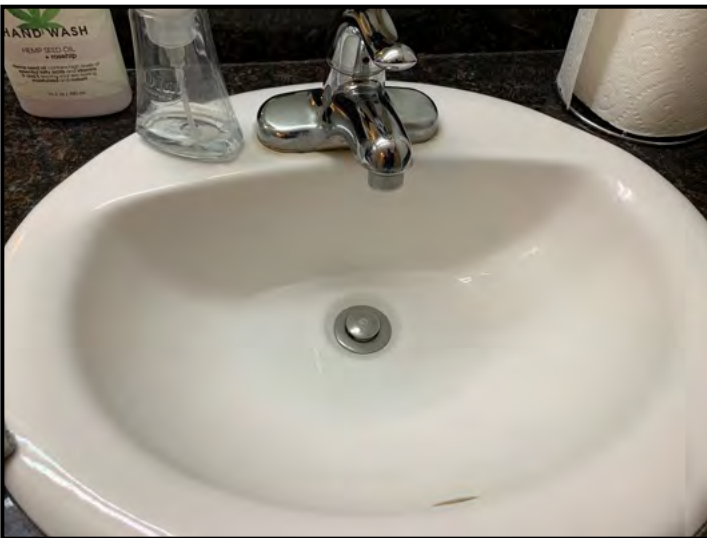
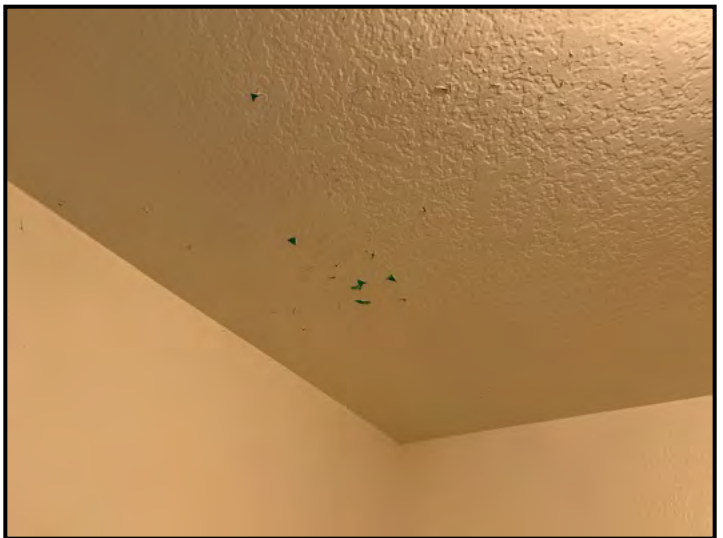
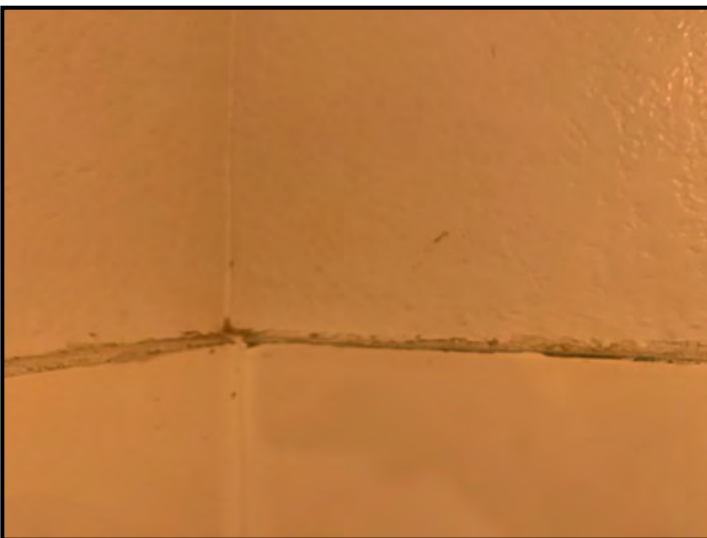
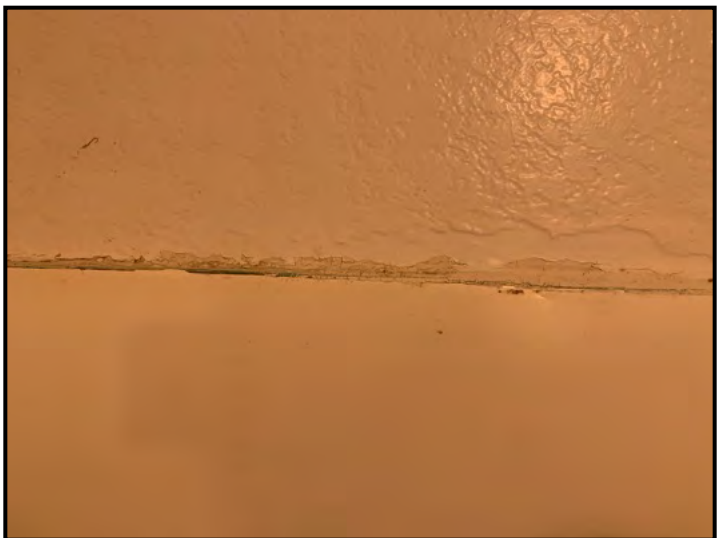
- No visible plumbing problems noted at time of inspection.
- No visible problems observed at the doors and windows at time of inspection.
- No visible floor problems noted at time of inspection.
- **Vanity door or drawer is damaged or broken. Repair or replacement is recommended.**
- **Caulking is recommended at the tub or shower areas to prevent moisture penetration and damage behind the walls.**
- **Moisture stains and/or damage viewed on the ceiling.**
- **Moisture stains and/or damage viewed on the walls.**
- **See photos.**
- **Ground Fault Circuit Interrupter (GFCI) outlets are recommended for installation.**
- **See photos.**

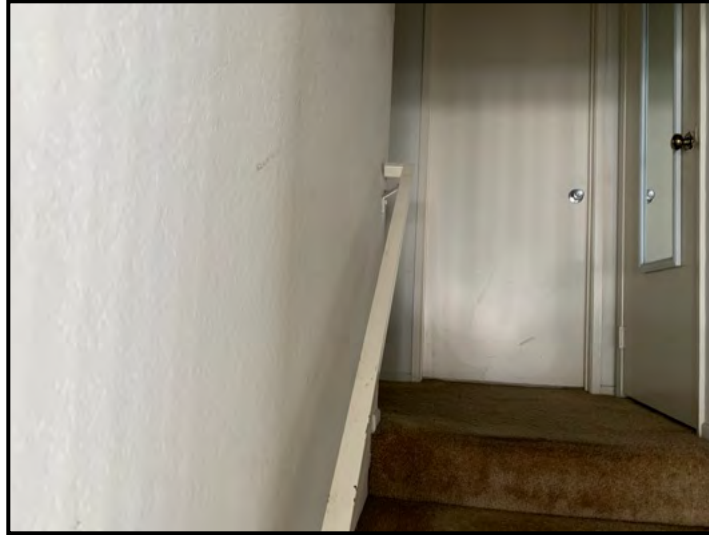
- Hand railing is loose or damaged. Repair or replacement is required.
- See photos.
